2024 PRIOR LAKE OUTLET SYSTEM ANNUAL OPERATIONS REPORT

PRIOR LAKE-SPRING LAKE
WATERSHED DISTRICT

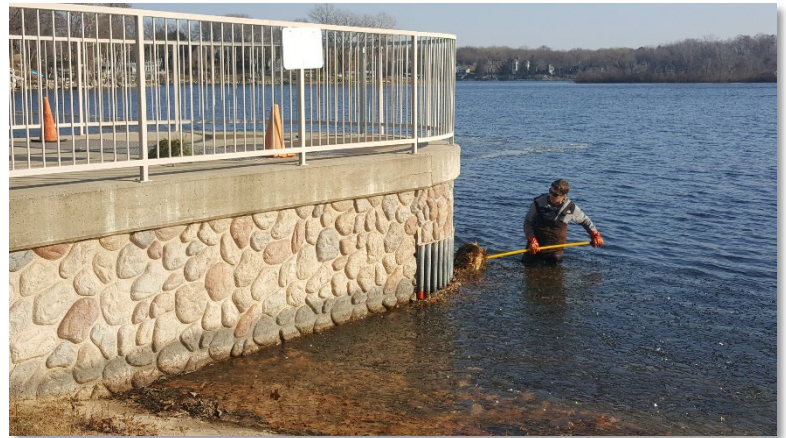
FIGURE 2 - REMOVING VEGETATION FROM OUTLET STRUCTURE

The new structure requires minimal maintenance to operate. Once Prior Lake reaches a water level elevation of 902.45 feet, water starts spilling over the accordion shaped weir located inside the trash rack. Maintenance includes visual inspections, greasing gates, and removing debris from the trash rack. Removing vegetation and other debris from the trash rack is the most time-consuming and labor-intensive task (Figure 2). When the structure is operating (Prior Lake is greater than 902.45'), the structure will be inspected no less than once a week, and as much as twice per day, depending on the lake level and amount of vegetation getting caught on the trash rack.

Inspections and debris removal are typically conducted by PLSLWD staff. During times when water is high and substantial amounts of vegetation are getting caught on the track rack, the City of Prior Lake staff have helped remove vegetation to ensure the Outlet Structure was not blocked.

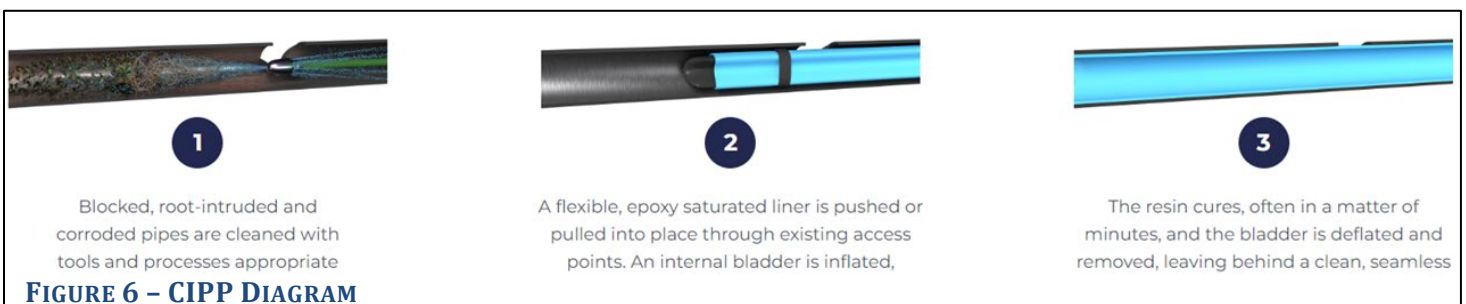
FIGURE 6 – CIPP DIAGRAM

In 2022, American Environmental televised the pipe and found that the pipe is still in good to fair condition. However, many small longitudinal cracks, light to medium leaks, and light to medium mineral deposits around joints (sign of infiltration) were observed throughout entire length of the pipe. The contractor suggested cured-in-place-pipe (CIPP) lining as a suggested fix for the current observed issues. The pipe review summary is shown in Attachment H.

The current pipe is over 40 feet deep in some places, with narrow easements that would not allow a full pipe replacement. Throughout 2023 and 2024, watershed District staff, partners, and dedicated residents from across the watershed were determined to find funding to extend the life of Prior Lake’s greatest line of defense against flooding. District staff and partners worked extensively to secure project funding, including lobbying for state bonding funds and applying for multiple grants. In August, the District was awarded a \$850,000 MPCA “Stormwater Resiliency Implementation” grant that would cover approximately 90% of the estimated project cost. Construction of a CIPP project is expected to begin in the winter of 2025-2026, extending the lifespan of the pipe by another 50 years.
