2014 PRIOR LAKE OUTLET SYSTEM ANNUAL OPERATIONS REPORT

February 2015

PRIOR LAKE - SPRING LAKE
WATERSHED DISTRICT

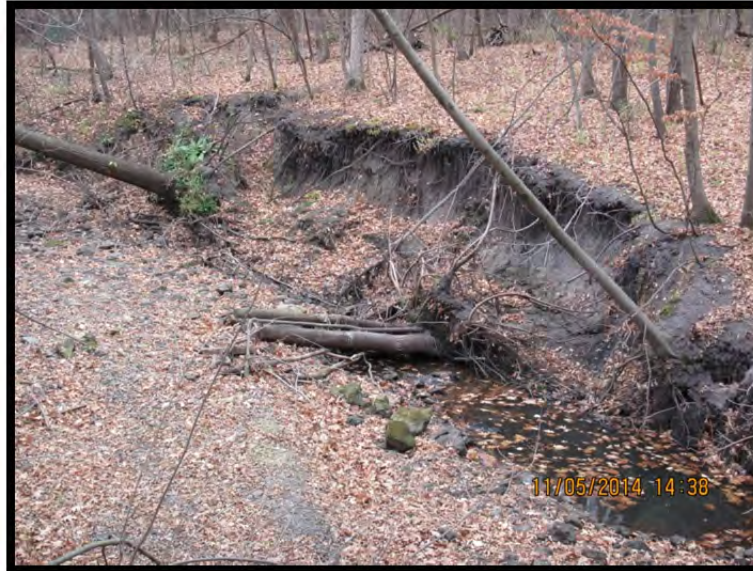
FIGURE 6 BANK EROSION AND FALLEN TREES

Extreme velocity and duration of flow during the flood caused bank erosion to worsen along the entire length of the channel (see Figure 6). According to a Bank Erosion Survey conducted by EOR in fall of 2014, over 20,000 feet of bank erosion was observed. Many trees fell into the channel due to the erosion as well. Details of this survey can be found in Attachment J.

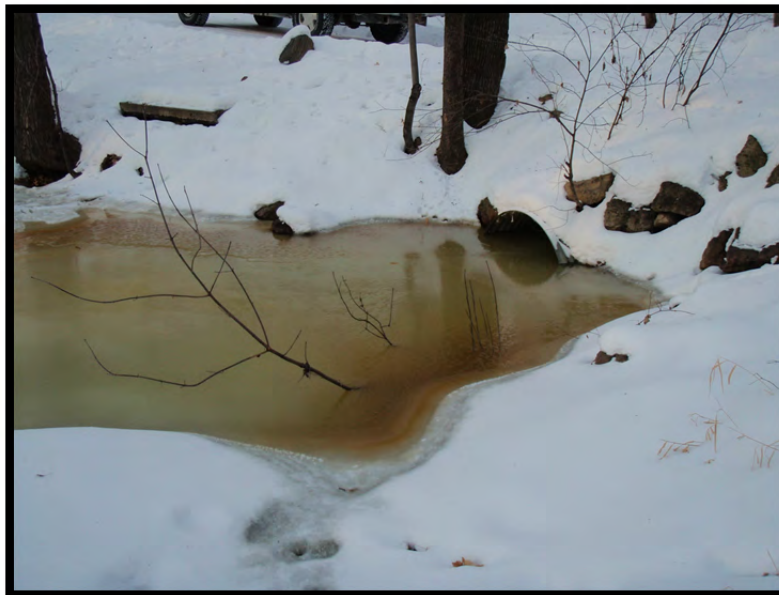
FIGURE 7 GROUNDWATER SEEPS IN JANUARY

In early January, segment 2 experienced what appeared to be groundwater seepage during some below-zero temperatures. The water continued to rise and then freeze, causing a concern that the culvert under Kes Driveway would become completely frozen which could cause the culvert to become plugged. Fortunately, the water stopped rising and flowing after about a week and never plugged completely (see Figure 7).

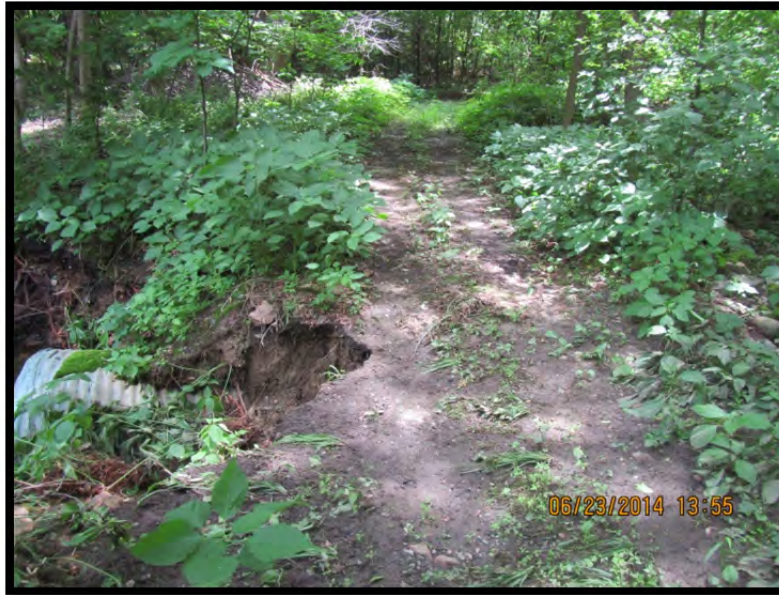
FIGURE 8 KES FIELD ROAD CROSSING EROSION

Due to the 2014 flood, the Kes field road crossing has eroded on the downstream side of the crossing and also experienced some piping (water flowing along the outside of culvert). The PLSLWD is working with FEMA to repair this crossing (See Figure 8).

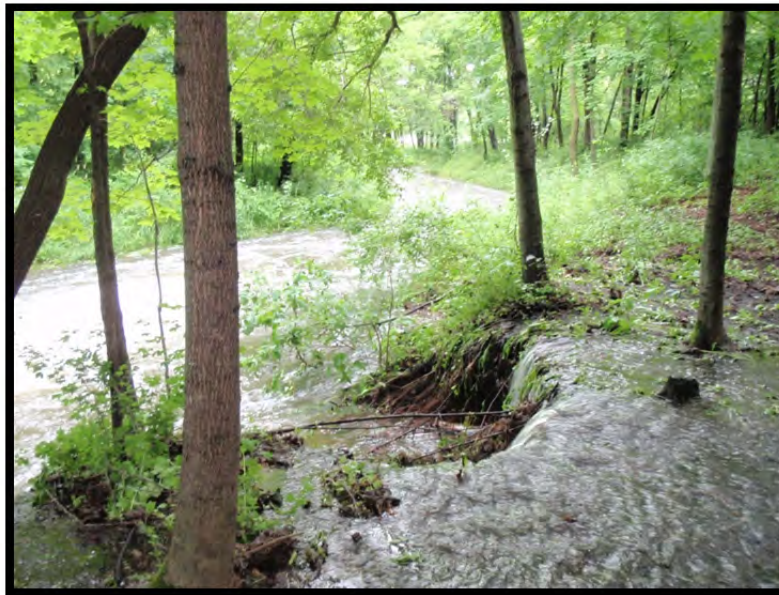
FIGURE 9 PIKE LAKE PARK BANK EROSION

Also in segment 2, the Pike Lake Park crossing experienced erosion along the bank due to the water overtopping the road and creating a gouge in the bank where the water eroded the bank as it flowed back into the channel (Figure 9). PLSLWD is working with FEMA to repair this erosion.

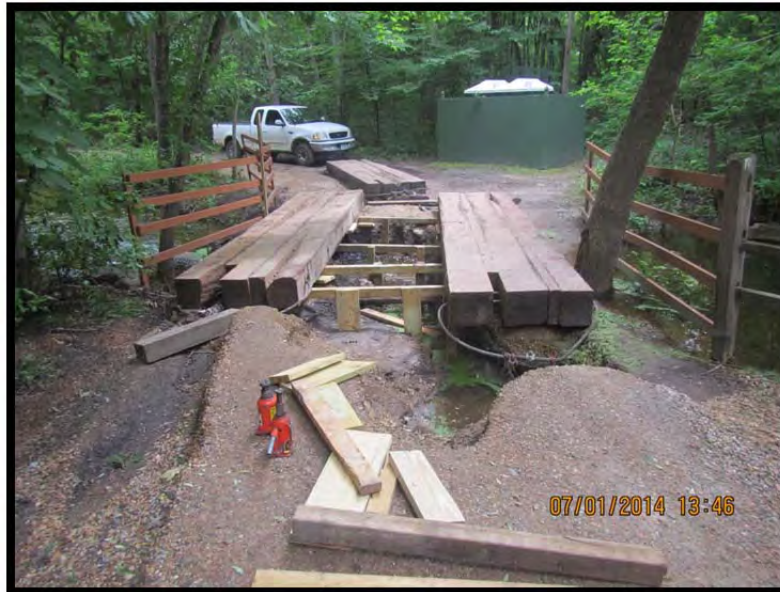
FIGURE 10 KICIYAPI CULVERT CROSSING DURING EMERGENCY REPAIR

Segment 3 had two areas of damage – the KiciYapi culvert and the Strauss Driveway crossing. The KiciYapi culvert was damaged during the flood because the culvert was rusted and the increased velocities eroded the soil around the culvert (See Figure 10). In addition, when the road overtopped, more erosion occurred and was impassible. A permit was issued and the SMSC repaired the culvert over the 2014-2015 winter.

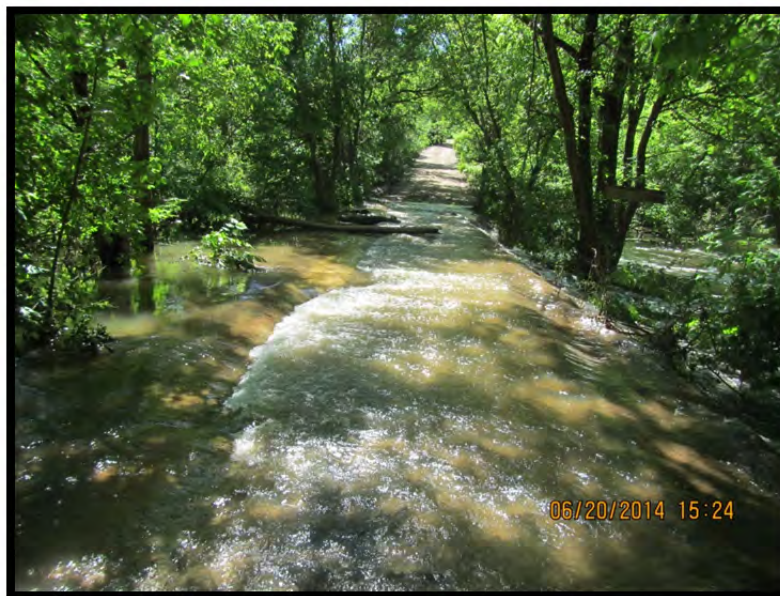
FIGURE 11 STRAUSS DRIVEWAY DURING FLOOD

In Segment 3, the Strauss driveway overtopped with water, dropping debris and eroding the driveway (See Figure 11). The City of Prior Lake removed the debris from the driveway.

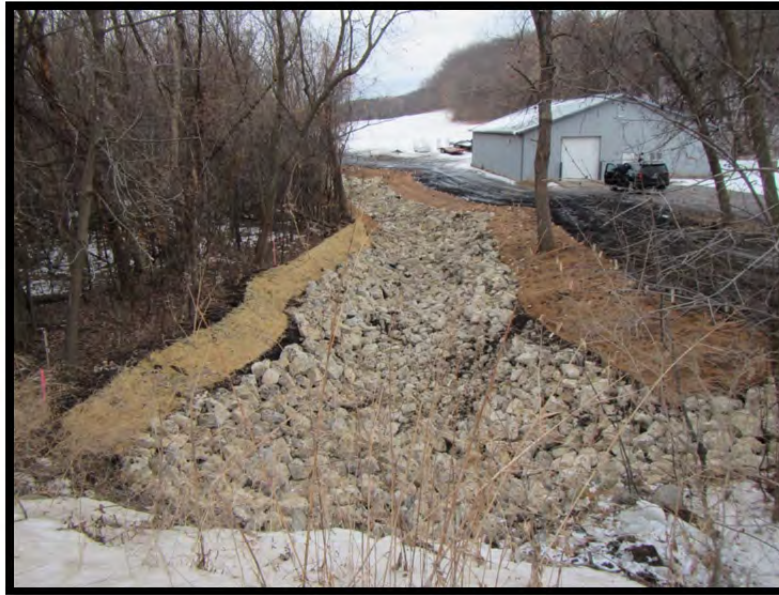
FIGURE 12 SEGMENT 4A REALIGNMENT

Bank erosion in segment 4a was temporarily repaired to prevent a homeowner's pole building from falling into the channel. A more permanent fix will move the entire channel away from the driveway and realign the channel in its original location. The realignment will be completed in 2015 (see Figure 12 for progress as of January 2015).

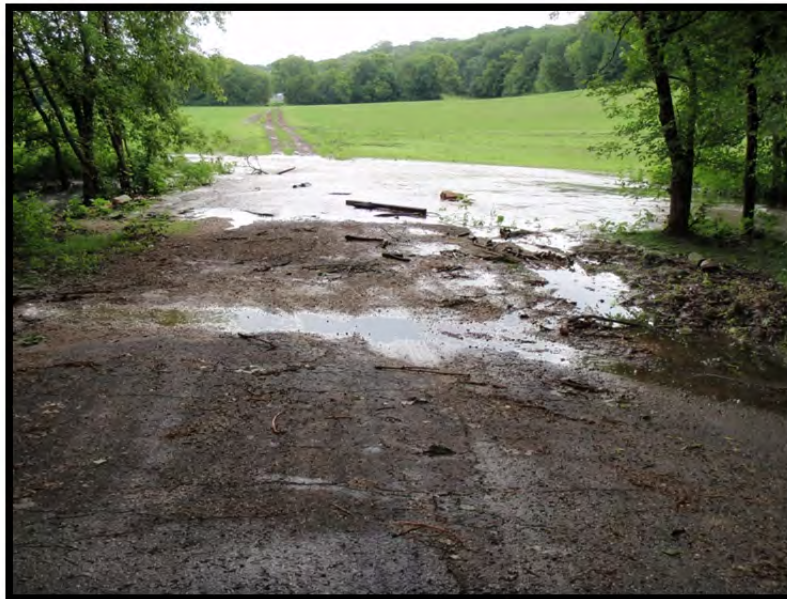
FIGURE 13 JACKSON TRAIL DURING FLOOD

In segment 4a, two crossings were damaged during the flood. The Jackson culvert was overtopped by water (Figure 13), but no significant damage resulted. More gravel was added to the crossing to replace the gravel that was washed away in the flood.

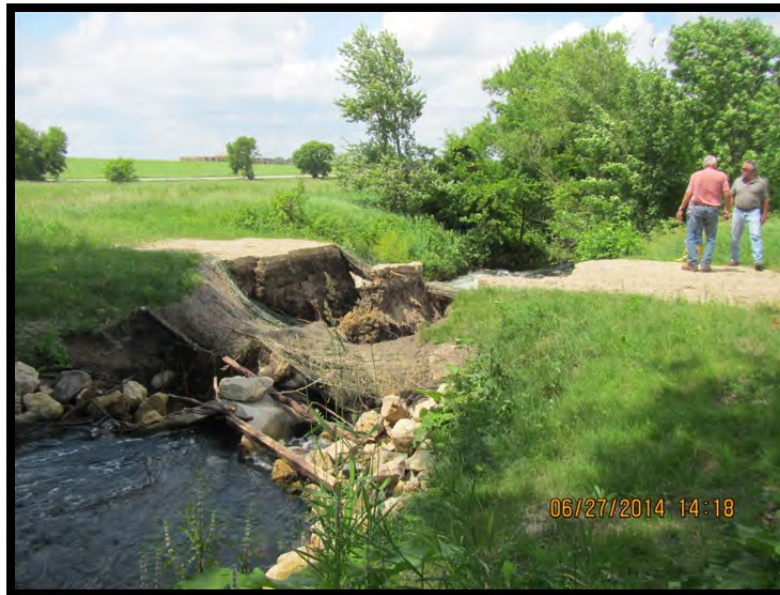
FIGURE 14 GONYEA CULVERT AFTER FLOOD

Another culvert in Segment 4a (Gonyea, aka Field Road downstream of Jackson Trail) was washed out and in need of replacement (See Figure 14). This culvert was installed by Minnesota Dirt Works in October 2013. The PLSLWD is working with FEMA to get funding for repair of this culvert.

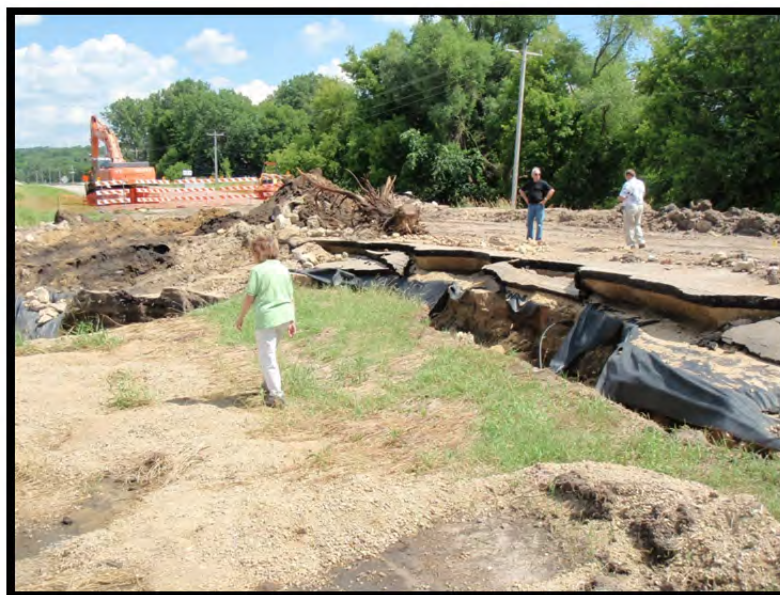
FIGURE 15 COUNTY ROAD 16 AFTER FLOOD DAMAGE

At the end of Segment 4, the culvert under County Road 16 was clogged and caused the water to overtop the road and erode the walking path and road (See Figure 15). Scott County repaired this crossing.

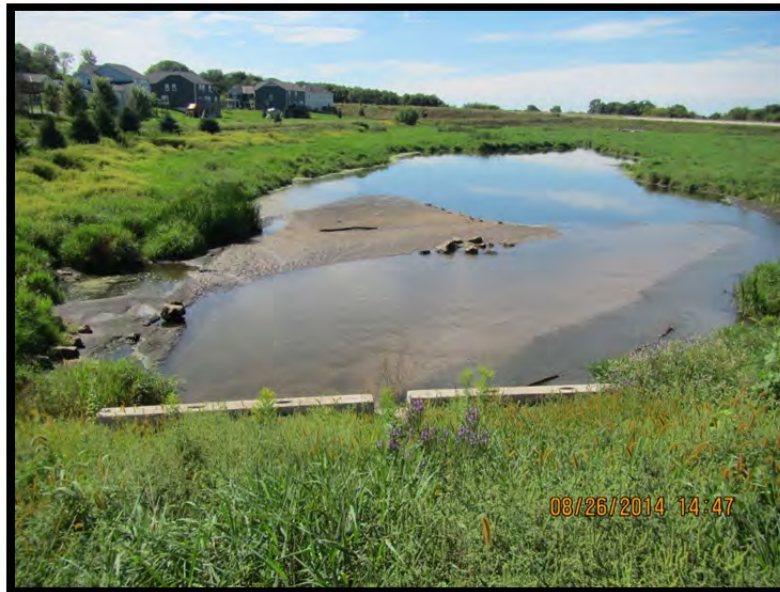
FIGURE 16 SEDIMENT DELTA IN SEGMENT 5

Segment 5 collected more sediment deposition during the flood due to upstream erosion (See Figure 16). PLSLWD is seeking funds from the State for removal of this sediment delta.

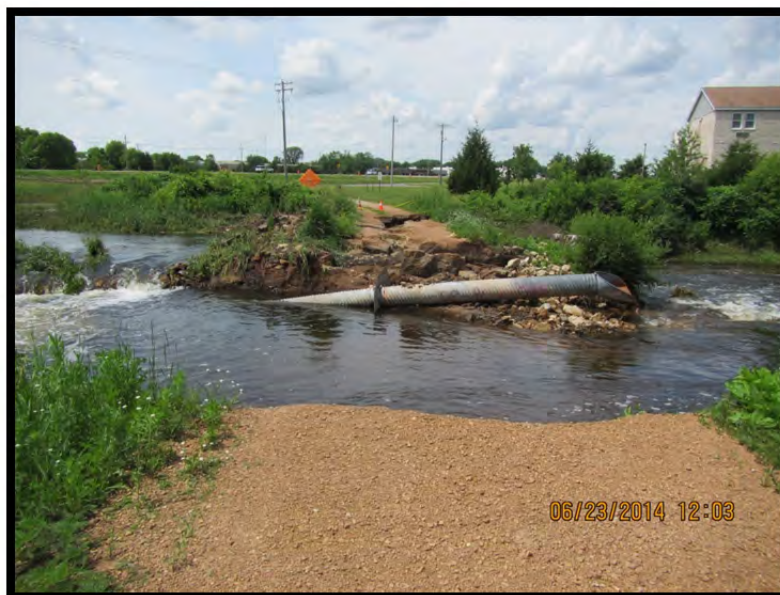
FIGURE 17 USFWS DRIVEWAY DURING FLOOD

Segment 8 had two culverts with damage. The USFWS driveway got completely washed out (See Figure 17). The USFWS may be replacing this crossing, or possibly removing it for good.

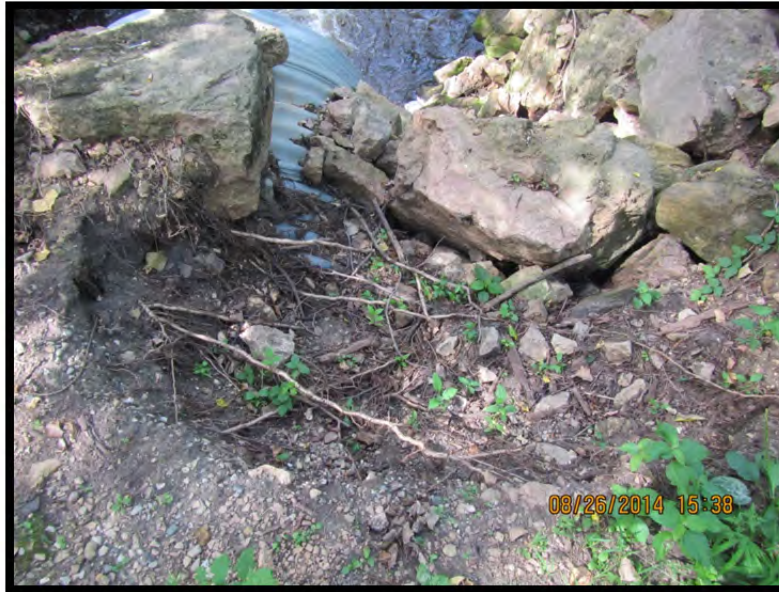
FIGURE 18 EROSION AT SERVICE TRAIL CROSSING AFTER FLOOD

The Service Trail crossing experienced some erosion on the downstream side as well (See Figure 18). At the time this report was written, it is unclear who will be repairing this erosion.
