PRIOR LAKE - SPRING LAKE
WATERSHED DISTRICT

2015 Prior Lake Outlet System Annual Operations Report

2015 PRIOR LAKE OUTLET SYSTEM ANNUAL OPERATIONS REPORT

By: Jaime Rockney
PLSLWD Water Resources Specialist
February 2016

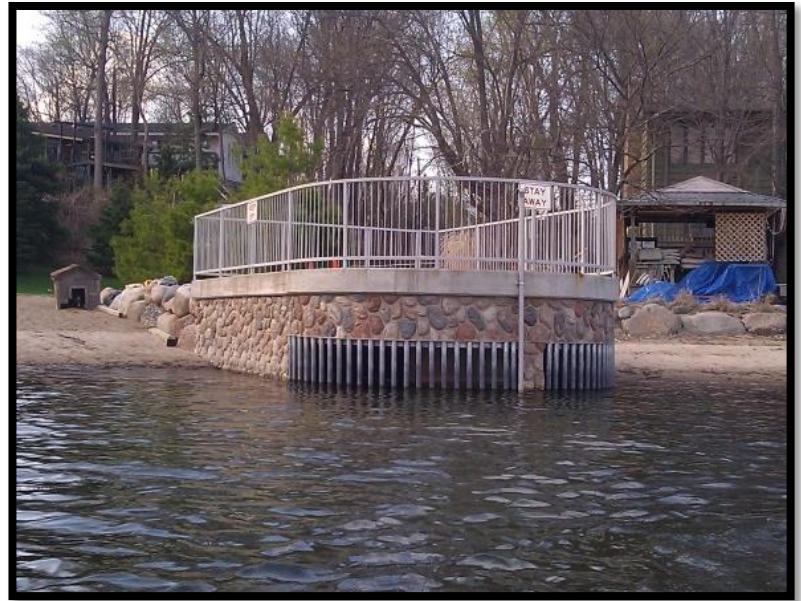
FIGURE 2 OUTLET STRUCTURE

The new structure needs minimal maintenance in order to operate. Once Prior Lake reaches 902.5', water starts spilling over the accordion shaped weir located inside the trash rack. Maintenance includes visual inspections, greasing gates, and removing debris from the trash rack. Removing vegetation and other debris from the trash rack is the most time-consuming and labor-intensive task (see Figure 3). When the structure is operating (Prior Lake is greater than 902.5'), the structure will be inspected no less than once a week, and as much as twice per day (depending on the lake level and amount of vegetation getting stuck on the trash rack). Inspections and debris removal is typically conducted by PLSLWD staff. During the 2014 flood, however, the City of Prior Lake staff helped remove vegetation once per day and on the weekends in addition to District staff also removing the vegetation daily in order to ensure Outlet Structure was not blocked.

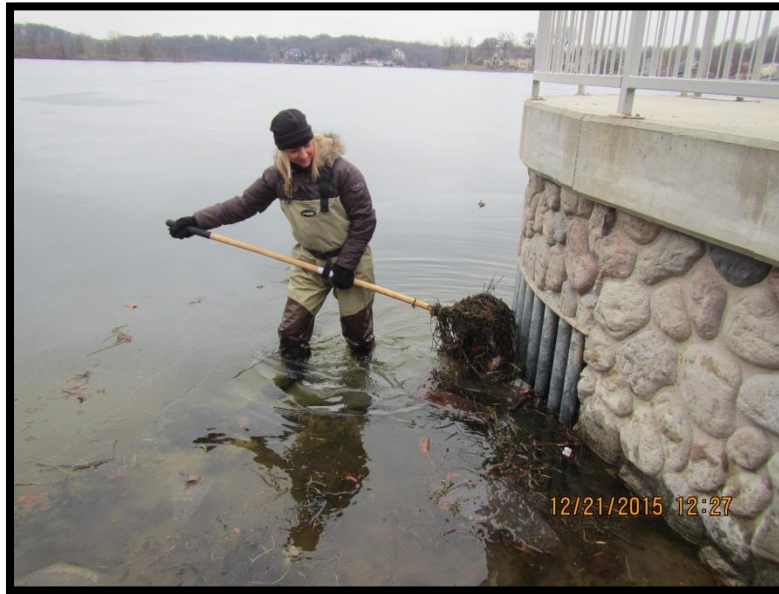
FIGURE 3 – REMOVING VEGETATION FROM THE OUTLET STRUCTURE GRATE

During 2015 operations, the Prior Lake Outlet Structure performed well throughout the duration that water discharged from the lake. The Prior Lake elevation overtopped the outlet weir from July 15 to August 14, August 17 to September 12, and remained above 902.5 after November 18 through the end of the year. In order to reduce the risk of flooding, the District opened the Low Flow gate on December 21 due to high lake levels, saturated conditions, and minimal storage capacity in the watershed (Figure 4). Opening the Low Flow gate allows more water through the outlet structure, resulting in the lake level lowering more quickly and creating more storage. In its 102 days of discharge during 2015, an estimated 1.60 feet of vertical volume was eliminated from the lake through the Prior Lake Outlet Structure (see Attachment D). It is estimated that the lake level of Prior Lake could have reached approximately 904.51 feet without operating the outlet structure. Attachment D is provided for comparison between years on the overall usage of the Prior Lake Outlet Structure. The numbers shown are calculated based on the most accurate information available. They are not exact and are intended for yearly comparisons only. Attachments E and F show daily Prior Lake elevations throughout 2015.

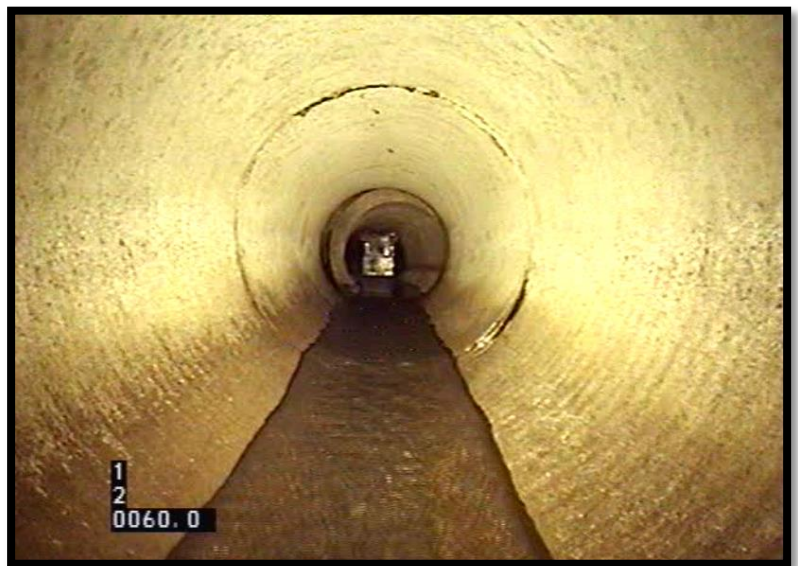
FIGURE 5 IMAGE OF OUTLET PIPE DURING TELEVISION

In general, the lake outfall pipe is in good to fair condition. They identified one defect that is coded red for immediate attention. The reinforcement is visible on the edge of the pipe on the downstream end of manhole number 3. Exposed steel is subject to rusting and allows water into the concrete pipe. This defect can be repaired with a cementitious coating; however it is in a difficult location being at the end of the pipe.

The pipe also has leaking joints with mineral deposits in every pipe segment and some of these joints are likely the source of the fine deposits found downstream of manhole number 4. They identified a number of dripping leaks, but perhaps the most significant dripping water was found at manhole number 6.

While the volume of water leaking through an individual joint may not be substantial, the accumulation of mineral deposits will affect the hydraulic capacity of the pipeline and perhaps more importantly, the movement of fine soils from the area surrounding the pipe can eventually shorten the life of the pipeline as the supporting soils are lost and the pipe can move. Visu-Sewer recommends the JPA/MOA partners consider a project to inject chemical grout in the leaking joints, before lining the existing pipe. Significant leaks must be stopped to facilitate lining work anyway.

In 2016, the spalling joint and manholes gutter bases will be repaired. Originally, the JPA/MOA partners planned to repair the spalling joint in 2015, but determined it would be more cost effective to repair the spalling joint and smooth the manholes at the same time. The chemical grouting is scheduled to be completed in 2017.

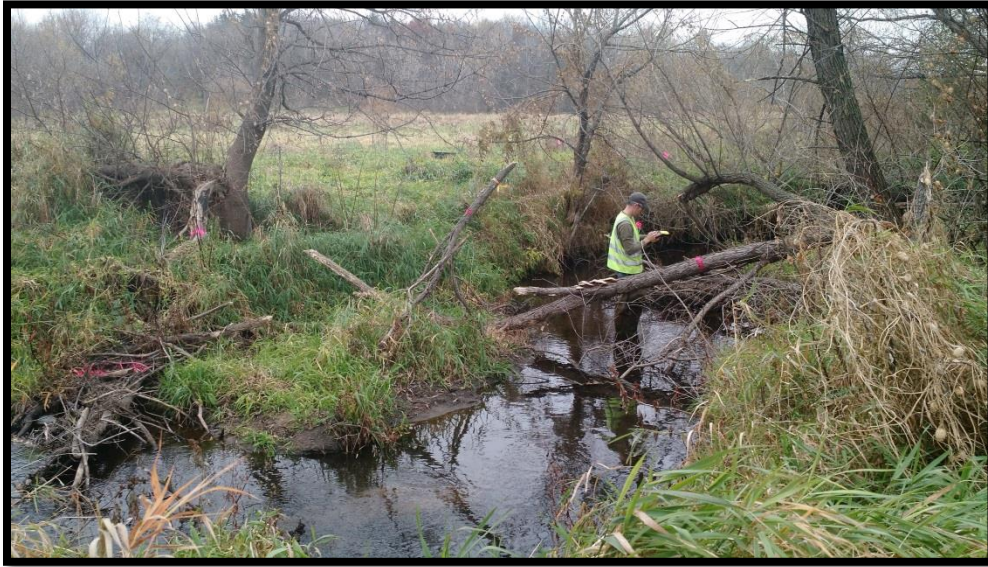
FIGURE 8 MARKING TREES FOR REMOVAL

The Prior Lake Outlet Channel incurred substantial damage during the 2014 flood, including downed trees, accumulated woody debris, sediment accumulation, culvert damage and over 20,000 feet of bank erosion. In 2015, most of the tree removal work was completed and one of the culverts was repaired. The rest of the work will begin in 2016. The Federal Emergency Management Administration (FEMA) has approved federal funding to cover 75% of the costs of the 2014 flood damage to the PLOC. The State of

As one of the first steps to repair the flood damage, the District Engineer, EOR, surveyed the PLOC and developed tree removal plans, which included removing downed trees and woody debris from the 2014 flood. The plans also included removing downed trees that were posing a maintenance issue in the channel, but were not a direct result of the flood.

The District hired Wetland Habitat Restorations, LLC (WHR) to remove the downed trees and woody debris from all Segments except 6 and part of 8 in the PLOC. Trees were not removed from Segment 6 because there are almost no trees in Segment 6. In Segment 8, USFWS owns some property and their management plan requires woody debris to stay in place for habitat. The majority of the tree removal was completed in 2015, but the project was officially complete on January 27, 2016. Some additional tree removals for maintenance purposes will be removed by the Institution/Community Work Crew Program through the State of Minnesota in 2016.

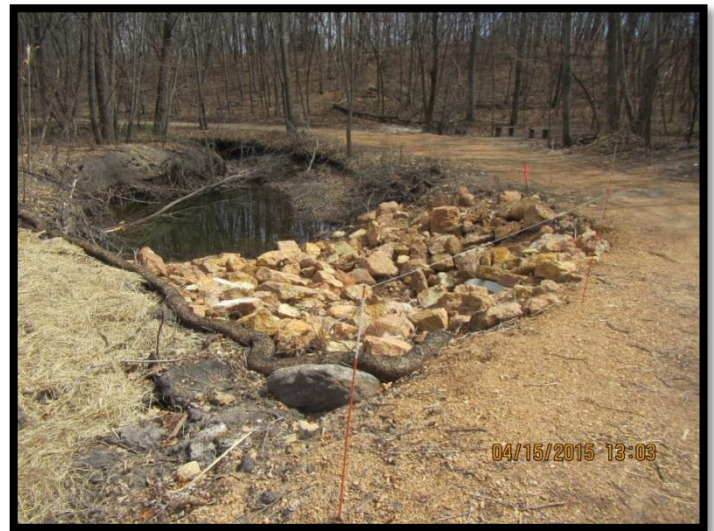
FIGURE 10 KICIYAPI CULVERT REPLACEMENT

Damage to the KiciYapi, USFWS, Gonyea, and Kes field crossings occurred during the 2014 flood. In partnership with the Shakopee Mdewakanton Sioux Community, the KiciYapi Culvert was replaced in 2015. Bolton and Menk designed the replacement culvert and FEMA and the State of MN helped fund this culvert replacement. The USFWS culvert crossing was completely washed out so the USFWS decided to remove the crossing and with help from the Scott SWCD, restore the crossing in include a wider flood plain and native plant species. In 2016, the Kes Field Crossing culvert will be repaired and the Gonyea Culvert will be repositioned.

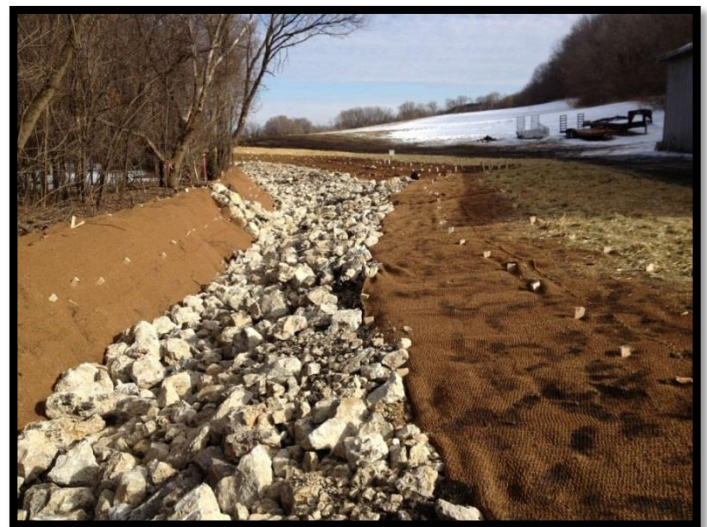
FIGURE 11 REALIGNMENT OF SEGMENT 4A

Part of the channel was realigned in Segment 4A in 2015. Over time, streams naturally remeander, but this section of the channel remeandered (eroded) to the extent that the driveway and barn of the adjacent property was being compromised and the channel was no longer completely within the original easement. EOR designed and Sunram constructed the project. Trees were removed on one of the adjacent landowner's properties in order to move the channel back into its original location. At the request of the landowner, these trees were replaced Scott Soil and Water Conservation District was hired by the District to coordinate the tree replacement with the landowner. Given the narrow width of the easement, the channel is now lined with riprap, stout stakes and a mix of grasses in order to reduce future erosion potential.

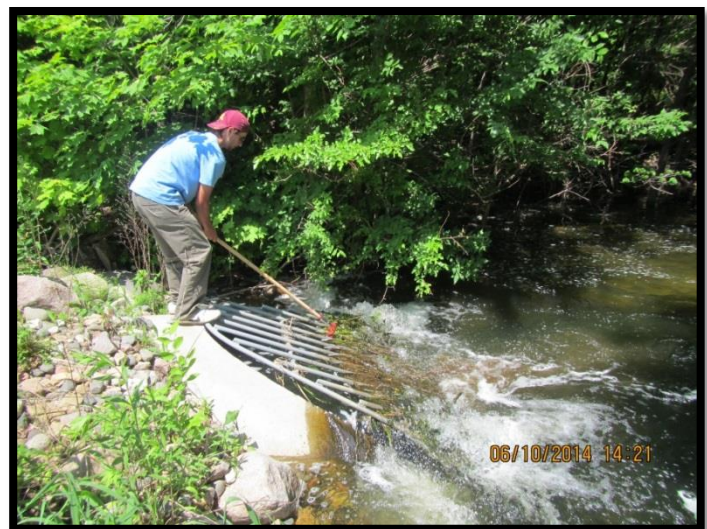
FIGURE 12 REMOVING VEGETATION STUCK ON GRATE

Removal of vegetation and debris from several culverts and/or grates throughout the year to ensure free flows was the primary extent of the additional maintenance that occurred.

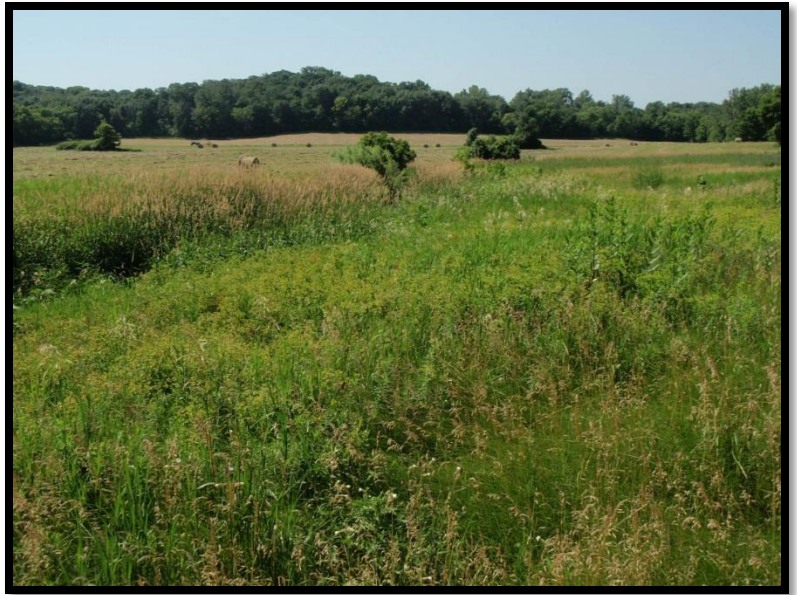
FIGURE 15 LEAFY SPURGE IN SEGMENT 7

- In 2015, Garlic Mustard was hand cut by EOR on May 15 in segments 3 through 8. EOR released flea beetles on June 26 in Segment 7 to treat the leafy spurge in that segment.
