# 2016 PRIOR LAKE OUTLET SYSTEM ANNUAL OPERATIONS REPORT

By: Jaime Rockney  
PLSLWD Water Resources Specialist  
February 2017

PRIOR LAKE - SPRING LAKE  
WATERSHED DISTRICT

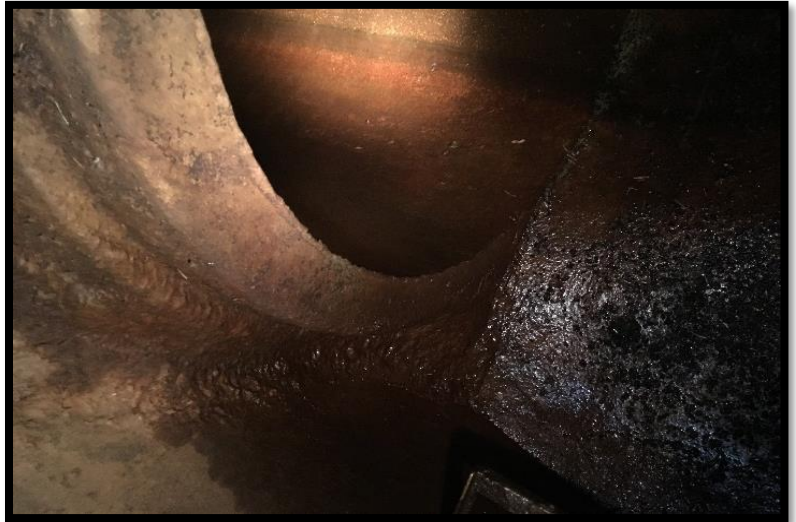
In general, the lake outfall pipe is in good to fair condition. They identified one defect that is coded red for immediate attention. The reinforcement is visible on the edge of the pipe on the downstream end of manhole number 3. Exposed steel is subject to rusting and allows water into the concrete pipe.

**FIGURE 5 MANHOLE BENCH BEFORE SMOOTHING**

In 2016, the spalling joint and manholes gutter bases were repaired by IBA Manhole (Figure 5 & Figure 6). This work should decrease turbulence at the manhole benches and allow the pipe to reach full capacity faster.

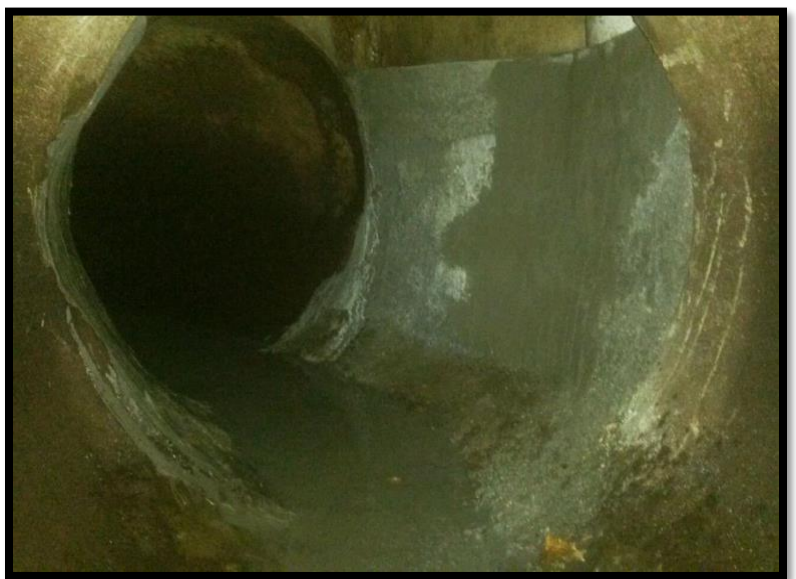
**FIGURE 6 MANHOLE BENCH AFTER SMOOTHING**

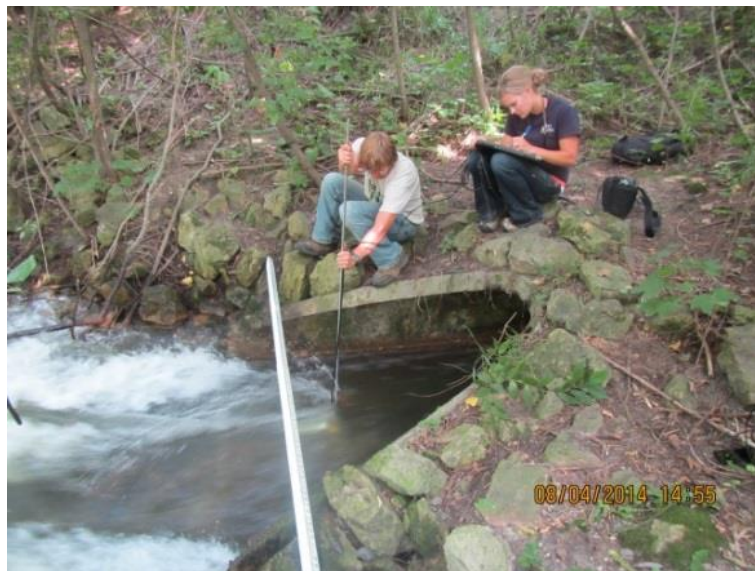
- 2) Another area subject to error is measuring the depth of the water during the flow measurements. Because the velocity is very high and often exceeds 10 feet per second, the water splashes onto the flow meter rod, making it difficult to determine the correct depth (See Figure 6). Staff does the best they can to estimate depth. When available, a machete is used to measure depth as it is slender and does not splash water as high.

**Figure 5 Water splashing on wading rod making it difficult to get accurate depth.**

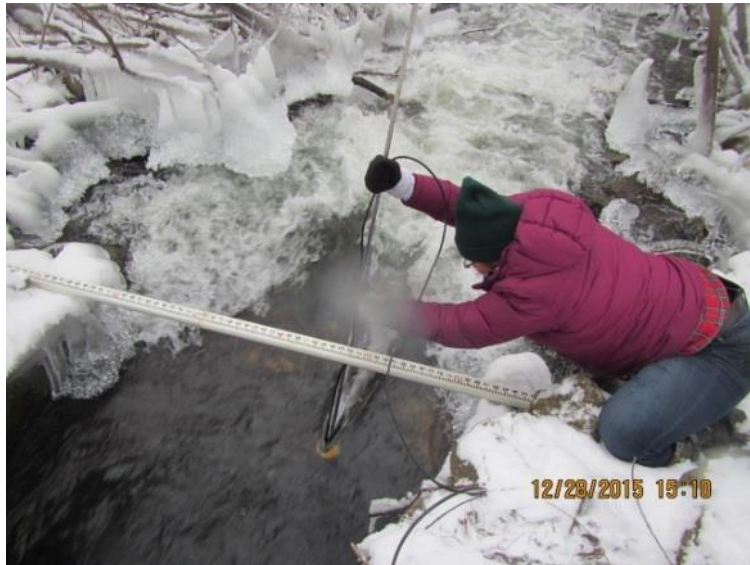
- 3) Since the water is flowing very fast, it is impossible to stand in the stream. Staff must kneel on the side of the culvert and reach across the culvert to take the velocity readings (Figure 6). Reaching the middle of the stream is difficult and extremely dangerous since the water is moving very swiftly. If safety was a concern, the staff person did not collect the velocity measurements in the middle of the culvert. This

**Figure 6 Safety issues make it difficult to take measurements in the middle of the cross section.**
