2017 PRIOR LAKE OUTLET SYSTEM ANNUAL OPERATIONS REPORT

By: Jaime Rockney
PLSLWD Water Resources Specialist
February 2018

PRIOR LAKE - SPRING LAKE
WATERSHED DISTRICT

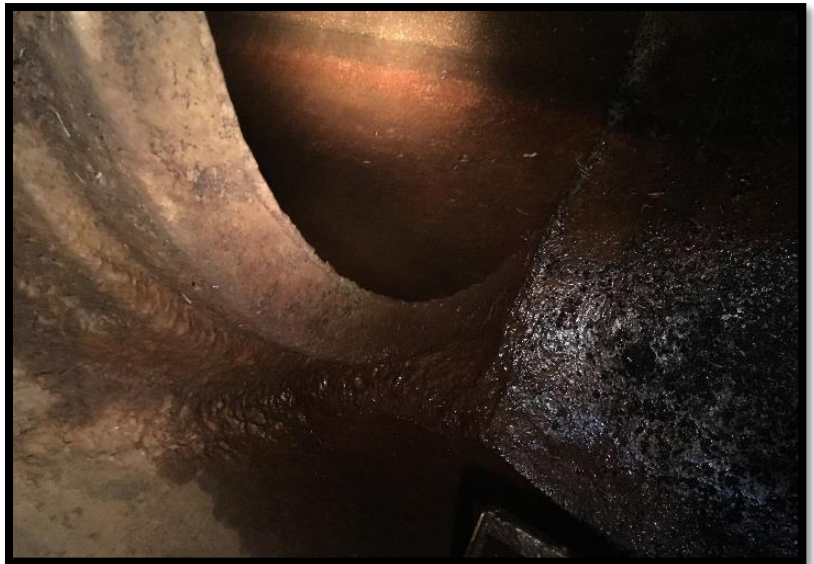
FIGURE 5 MANHOLE BENCH BEFORE SMOOTHING

In general, the lake outfall pipe is in good to fair condition. They identified one defect that is coded red for immediate attention. The reinforcement is visible on the edge of the pipe on the downstream end of manhole number 3. Exposed steel is subject to rusting and allows water into the concrete pipe.

The pipe also has leaking joints with mineral deposits in every pipe segment and some of these joints are likely the source of the fine deposits. While the volume of water leaking through an individual joint may not be substantial, the accumulation of mineral deposits will affect the hydraulic capacity of the pipeline and perhaps more importantly, the movement of fine soils from the area surrounding the pipe can eventually shorten the life of the pipeline as the supporting soils are lost and the pipe can move.

In 2016, the spalling joint and manholes gutter bases were repaired by IBA Manhole (Figure 5 & Figure 6). This work decreased turbulence at the manhole benches and allows the pipe to reach full capacity faster.

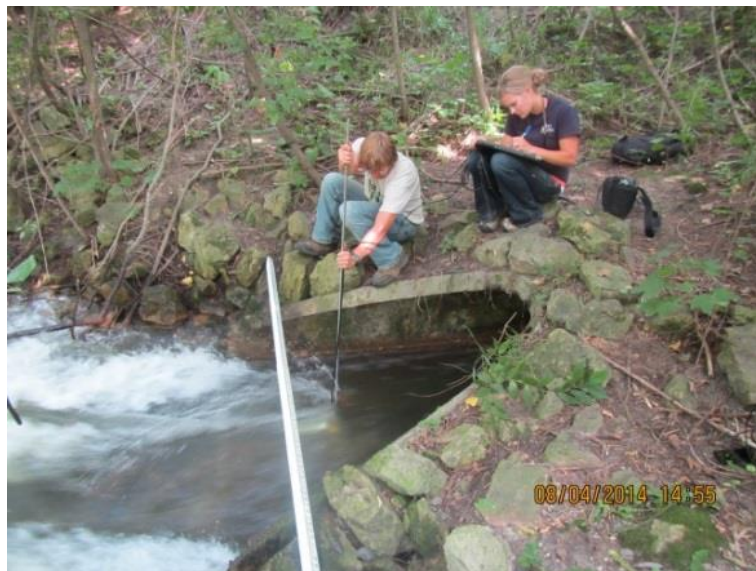
- 2) Another area subject to error is measuring the depth of the water during the flow measurements. Because the velocity is very high and often exceeds 10 feet per second, the water splashes onto the flow meter rod, making it difficult to determine the correct depth (See Figure 6). Staff does the best they can to estimate depth. When available, a machete is used to measure depth as it is slender and does not splash water as high.

Figure 5 Water splashing on wading rod making it difficult to get accurate depth.
