# 2018 PRIOR LAKE OUTLET SYSTEM ANNUAL OPERATIONS REPORT

By: Jaime Rockney  
PLSLWD Water Resources Specialist  
February 2019

PRIOR LAKE – SPRING LAKE  
WATERSHED DISTRICT

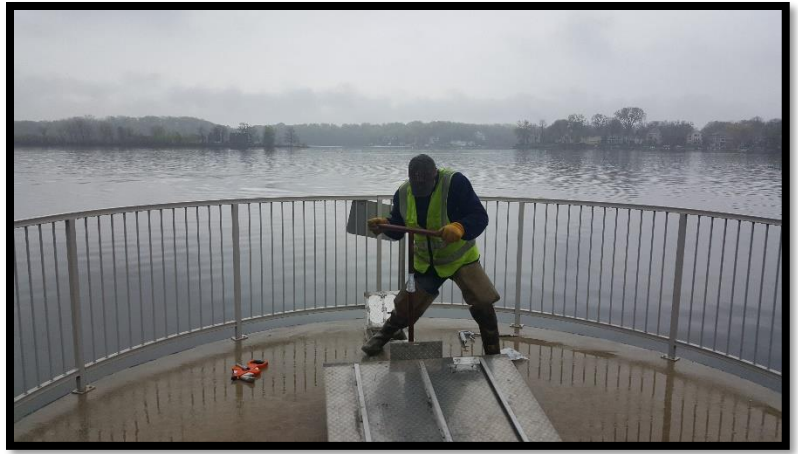
**FIGURE 3 – OPENING THE LOW-FLOW GATE**

At certain lake levels, the Low Flow gate allows more water through the outlet structure, resulting in the lake level lowering more quickly and creating more storage (see Attachment C). To reduce the risk of flooding, the District opened the Low Flow gate from on March 9 due to anticipated high lake levels. However, due to ice in the channel, there were some blockages in culverts from ice chunks causing flooding. The main gate of the outlet structure was closed on March 12 to stop all flow to the channel. On March 19, after the risk of flooding was removed, the main gate was opened slightly to allow the water to melt some of the ice in the culverts. The PLSLWD staff opened the main gate a little more on March 21 and all the way on March 26. However, it was later realized that the main gate was only approximately 75% open and was actually opened all the way on May 8. It was noticed after a flow measurement was taken at the end of the outlet pipe and the result was lower than expected (37cfs instead of ~55 cfs). The main gate is very hard to turn and sometimes seems like it is done turning because it gets extremely hard to turn, but it actually is not. The low-flow gate remained open since March 9 and was closed on May 24 for the rest of the year (See Figure 3).

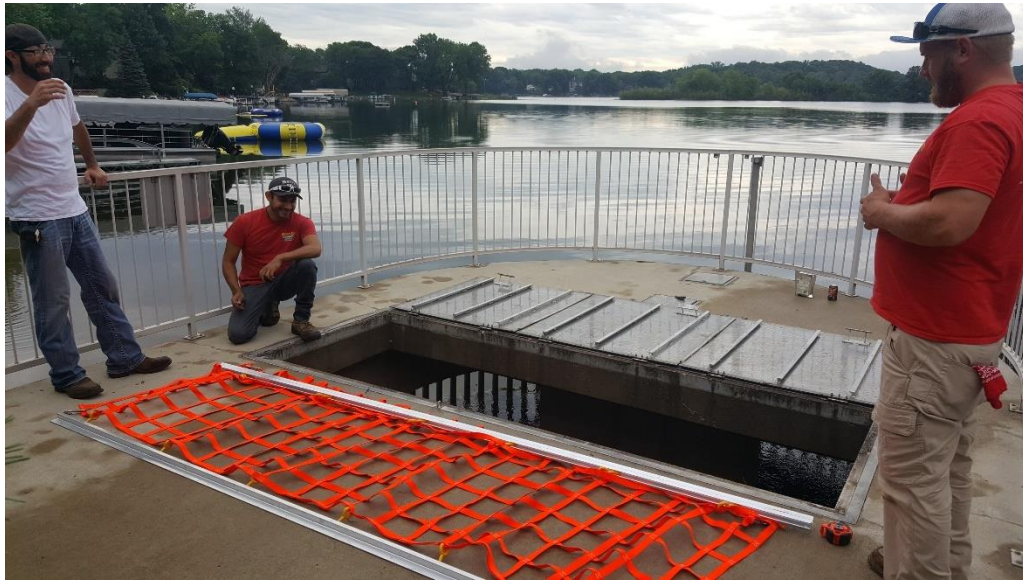
**FIGURE 9 NEW SAFETY NET AT OUTLET STRUCTURE**

In 2018, a safety net was installed under the large trap doors at the outlet structure (see Figure 9). This was a huge safety concern. Without the safety net, it was possible to fall into the outlet structure which is connected to the outlet pipe, which travels underground until reaching the west side of Highway 21 (approximately 1/3 mile long).

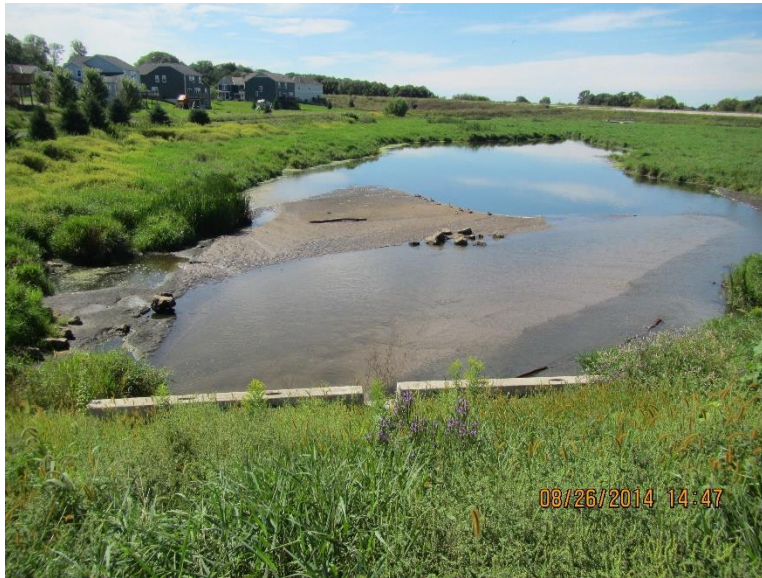
**FIGURE 11 SEDIMENT DELTA**

The Prior Lake Outlet Channel incurred substantial damage during the 2014 flood, including downed trees, accumulated woody debris, sediment accumulation, culvert damage and over 2.8 miles of bank erosion. In 2015, most of the tree and woody debris removal work was completed and one of the culverts (KiciYapi) was repaired by the Shakopee Mdewakanton Sioux Community. Removal of the remaining trees and woody debris, culvert repairs (Gonyea and Kes Field Crossing), and Pike Lake Park stream crossing repair work was completed in 2016. The sediment delta was excavated in spring of 2018. Due to permit and engineering design delays, the Bank Erosion project is expected to begin in the Summer of 2019. The Federal Emergency Management Administration (FEMA) has approved federal funding to cover 75% of the costs of the 2014 flood damage to the PLOC. The State of Minnesota will pay the remaining 25%.

After the washout of County Road 16, a lot of sediment accumulated along the channel in segment 5, including a sediment delta formed in the channel just downstream of Pike Lake Road after the flood in 2014 (see Figure 11). The delta was excavated in the end of 2017 and sediment within the channel was removed in early 2018 by BKJ Land Company. The costs of this project will be reimbursed by FEMA, however, the City of Shakopee did pay BKJ extra to remove some additional sediment that had accumulated before the flood.
