Project Name | PLOC Channel Inspections**Date** | 2/15/2019**To / Contact info** | Diane Lynch, Jaime Rockney**Cc / Contact info** | Carl Almer**From / Contact info** | Mike Majeski**Regarding** | Channel and Vegetation Inspections – 2018 Summary

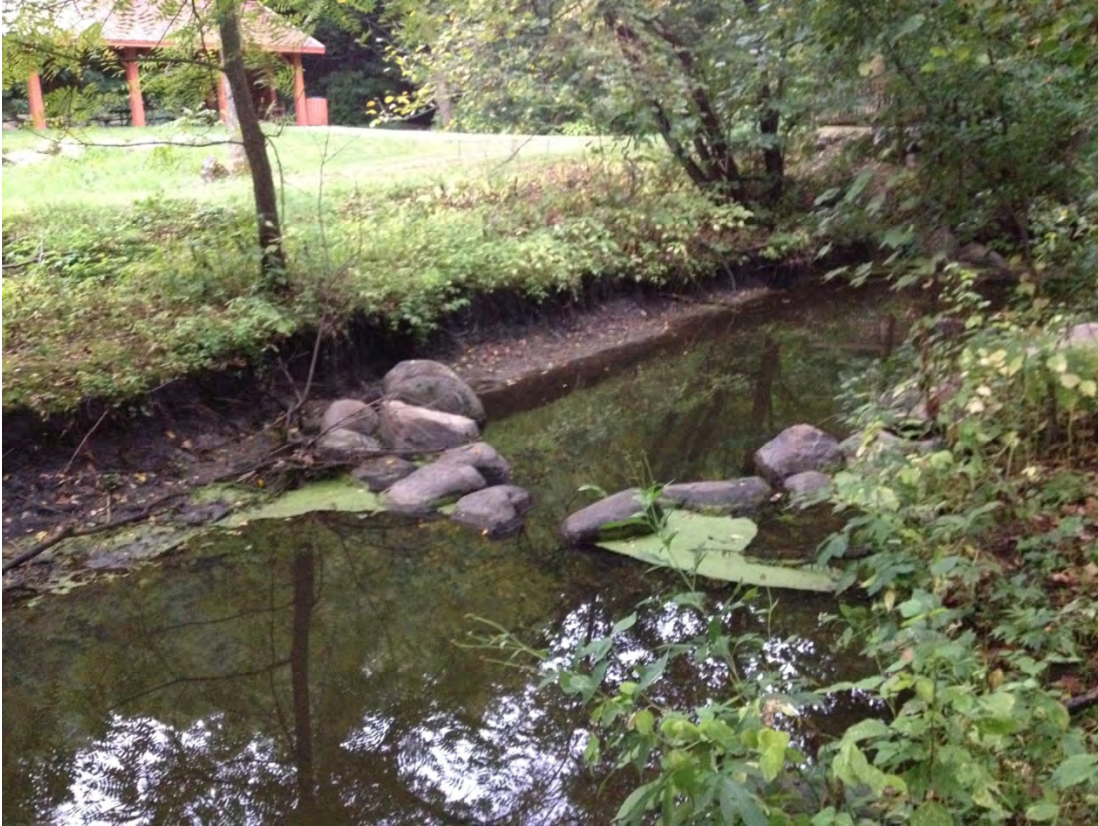
Bank erosion was observed along the left bank adjacent to the boulder cross vane located immediately downstream of Jeffers Pass NW near Jeffers Pond Elementary School (Figure 1). The erosion is the result of flow occurring between the terminus of the boulder vane and the adjacent bank. No other recent bank erosion was observed within this segment. Minor channel obstructions were located in the same areas identified in 2016 including a five-inch diameter ash tree found lying across the channel approximately 200 feet upstream of Fountain Hills Road, and several large tree trunks and branches found lying across and within the channel in the forested reach just upstream of County Road 42. The old field crossing located immediately upstream of CR 42 has mostly eroded away, but the culvert continues to function at lower flows (Figure 2). The trash rack on the upstream end of the CR 42 culvert was not obstructing flow during the channel inspections (Figure 3).

Figure 1. Bank erosion adjacent to the boulder cross vane near Jeffers Pond Elementary School

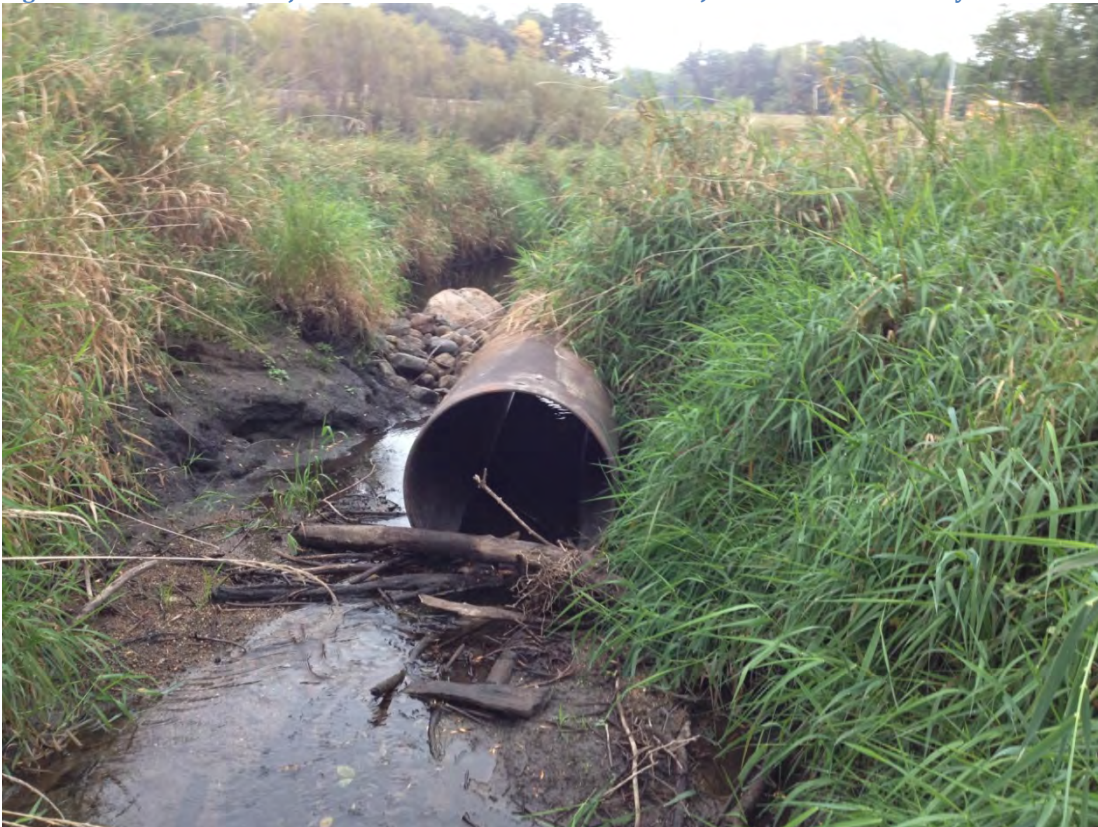
Figure 2. Old field road crossing and culvert located immediately upstream of CR 42

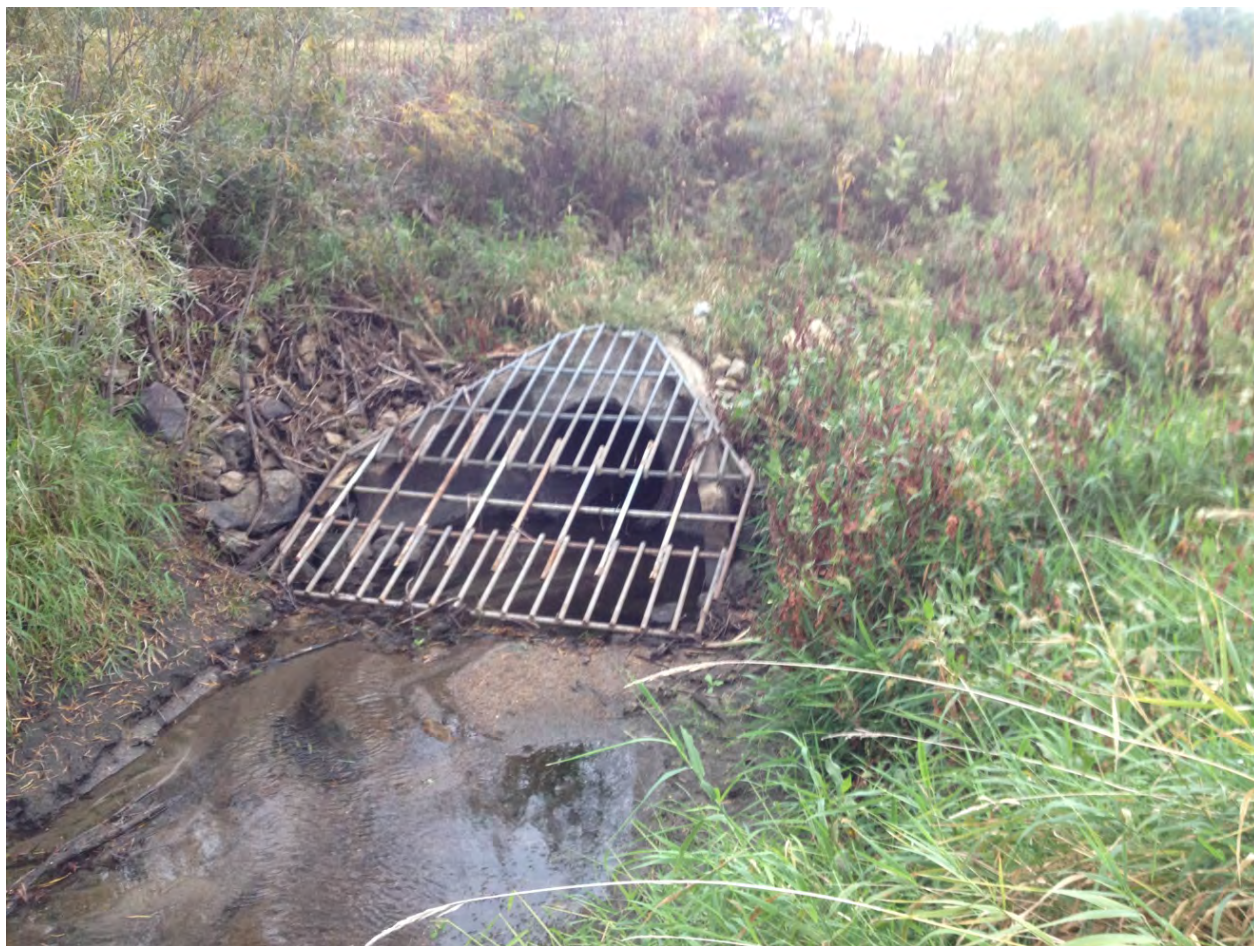
Figure 3. Trash rack at upstream end of CR 42 culvert

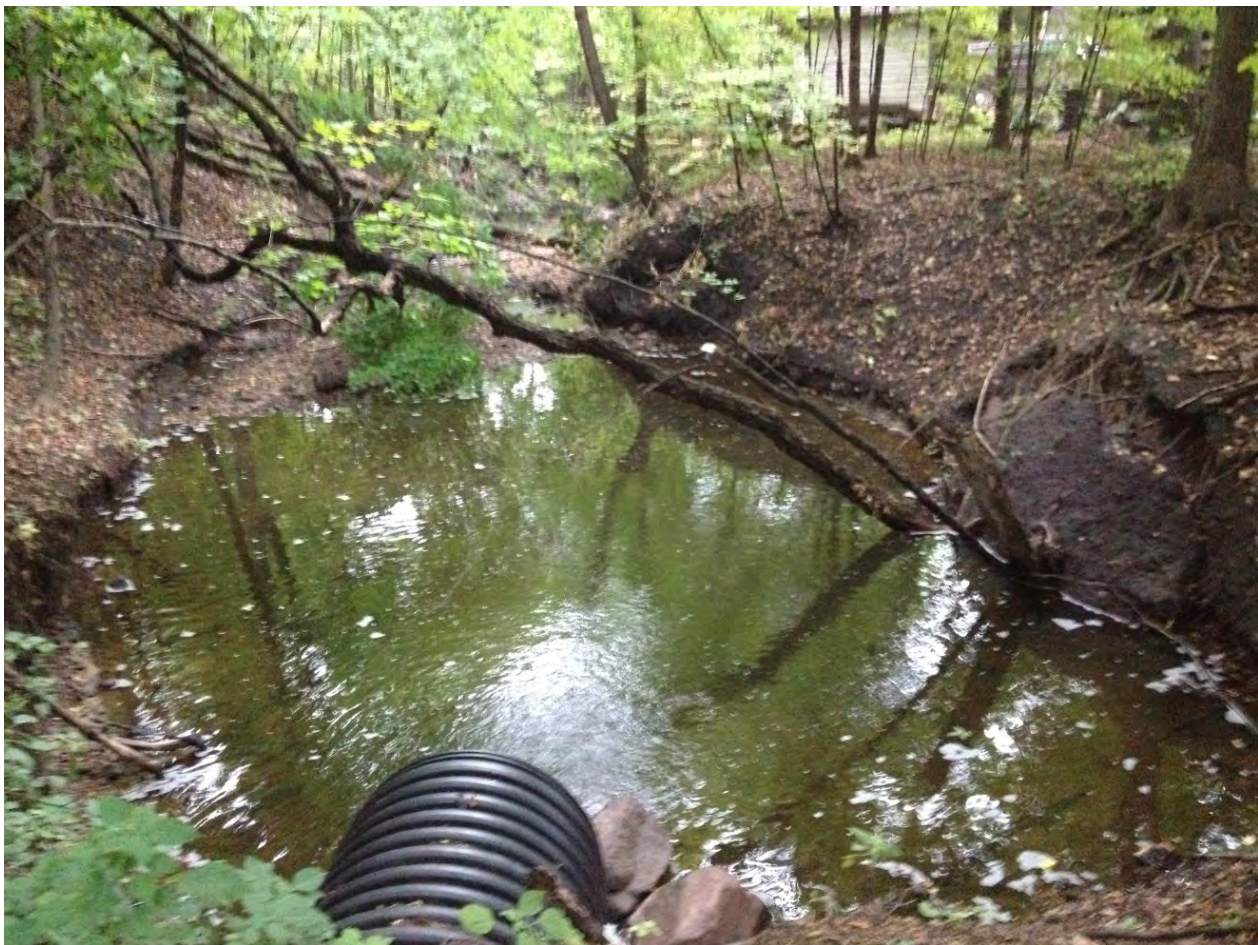
Several down trees were observed across the channel in areas previously identified with bank erosion. In particular, two trees have fallen across the channel just downstream of the 2nd stream crossing due to bank erosion and undercutting of the root boles (Figure 5). Bank erosion continues to occur throughout this segment, particularly in areas damaged by previous flood events. In addition, channel widening is occurring below perched culverts, especially downstream of the 3rd crossing where the riprap in the center of the channel is directing flow into the adjacent stream banks, resulting in localized bank erosion (Figure 6). The bank that was repaired to the east of the 4th crossing at Pike Lake Park is holding up well with vegetation starting to become established (Figure 7). A large sediment delta has formed at the outlet of Segment 2 in Pike Lake (Figure 8). This sediment delta should be removed if future channel work is proposed in Segment 2.

Figure 5. Down trees over the channel downstream of the 2nd crossing

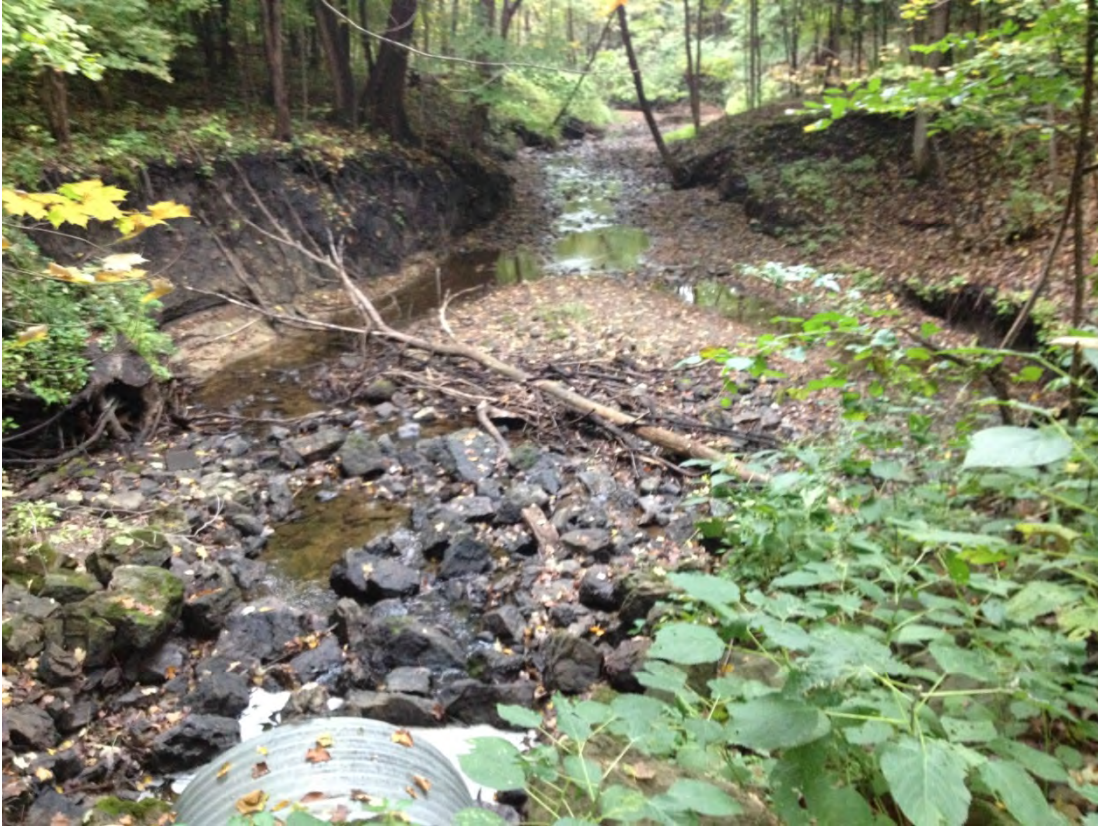
Figure 6. Riprap downstream of the 3rd crossing causing channel widening

- Repair overly-wide channels downstream of perched culverts if not being addressed by the proposed bank repair work
- Remove the sediment delta at the outlet of Segment 2 in Pike Lake

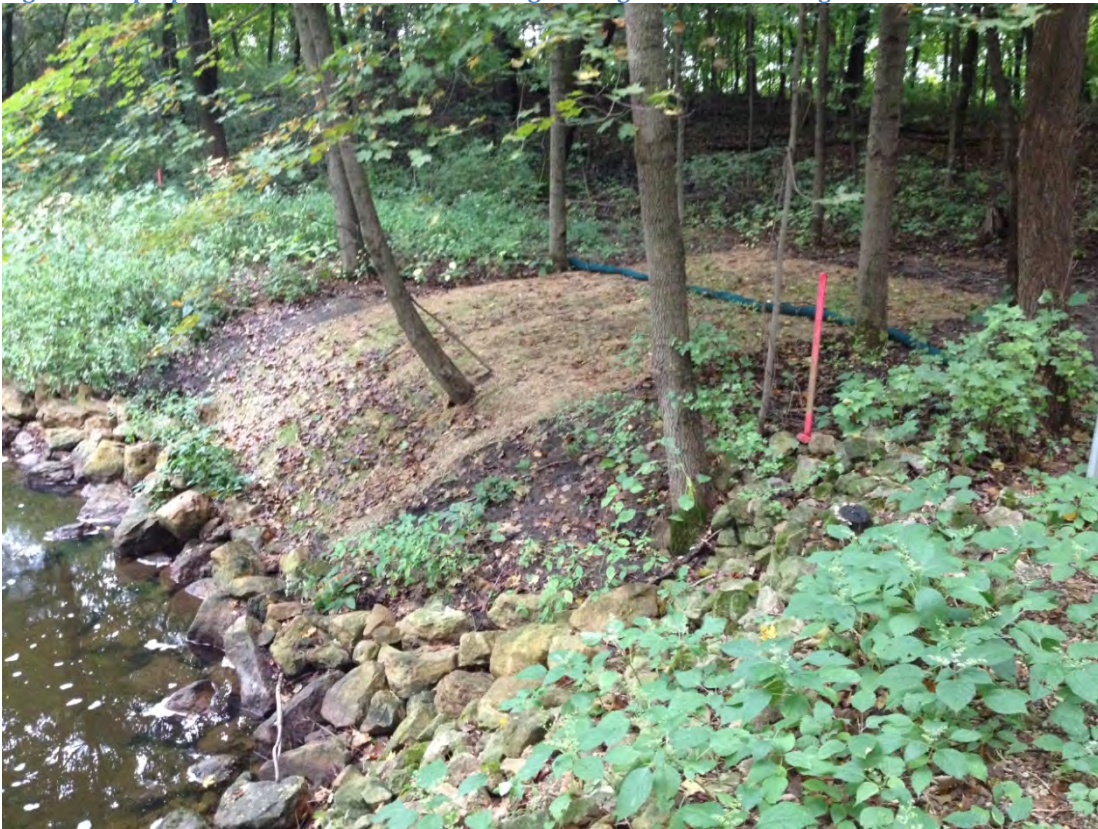
Figure 7. Stream bank stabilized with erosion control blanket east of the Pike Lake Park crossing

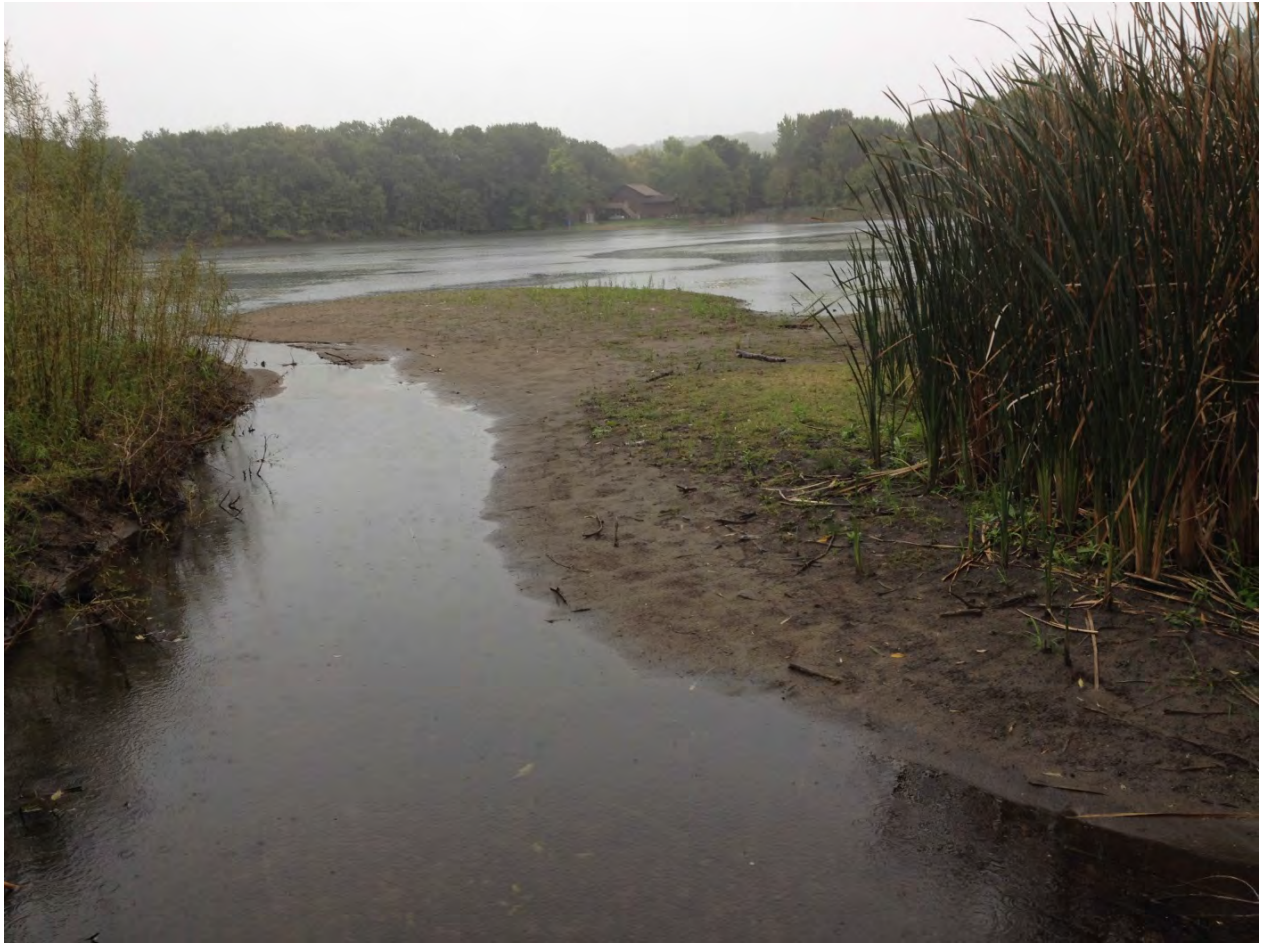
Figure 8. Sediment delta at the outlet of Segment 2 to Pike Lake

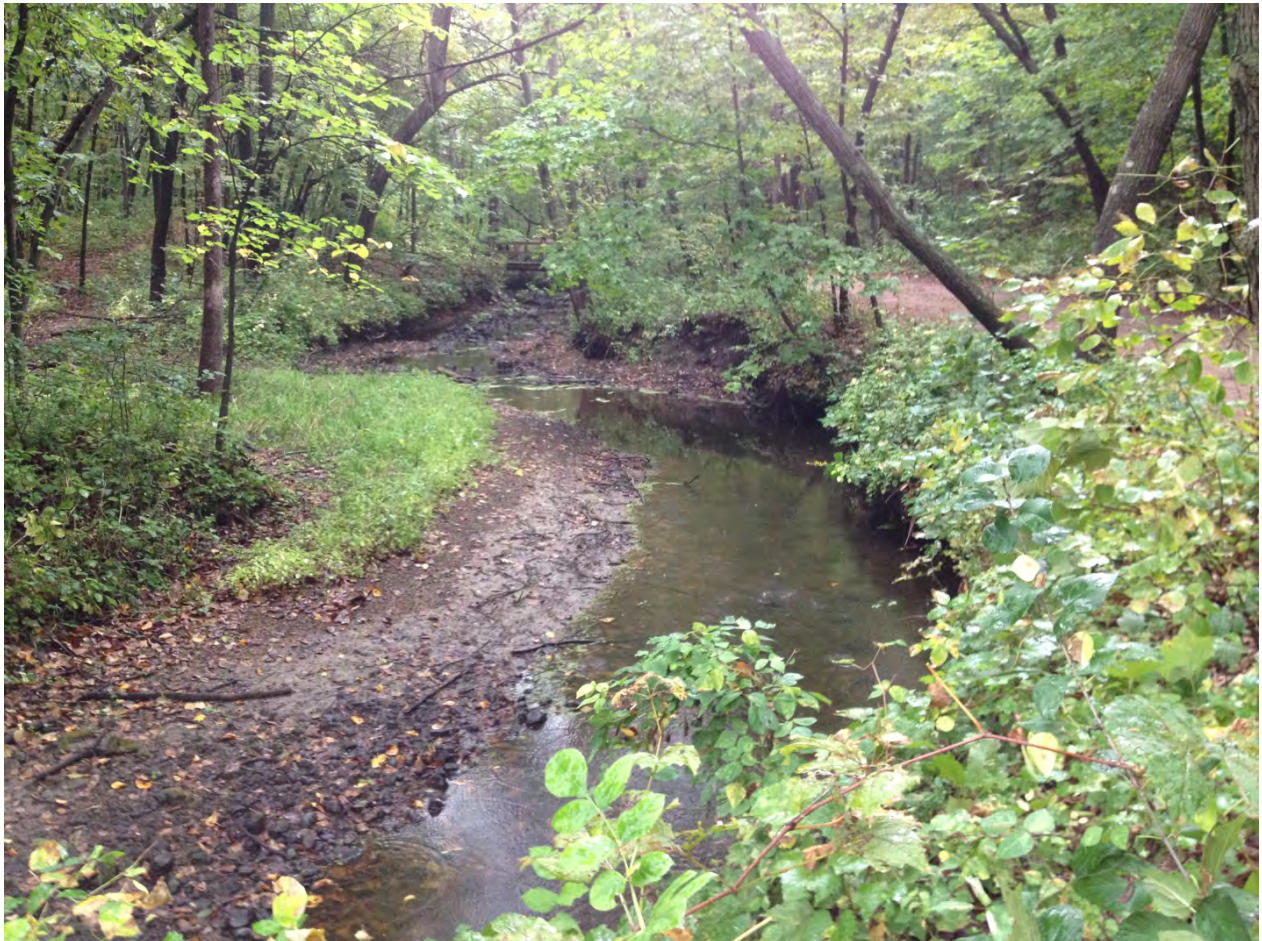
Bank erosion continues to occur in areas previously affected by large flood events, particularly along the reach at the upstream end of the Kici Yapi property (Figure 10). A few eroding banks are beginning to self-heal now that the toe of the slope has been stabilized with rock and vegetation (Figure 11). The stream bank along the left side of the channel downstream of the private driveway crossing continues to erode (Figure 12).

Figure 10. Bank erosion along the right bank immediately downstream of the Kici Yapi crossing

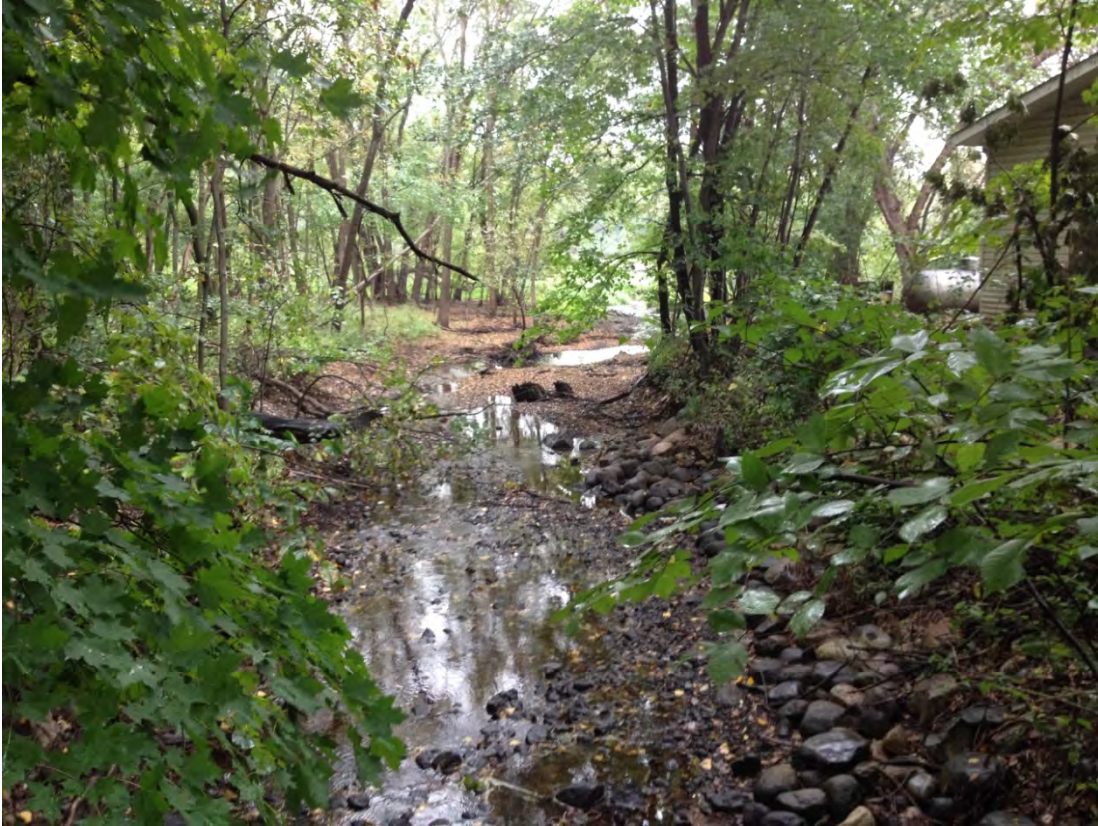
Figure 11. Self-healing stream bank with boulder toe and vegetated slope

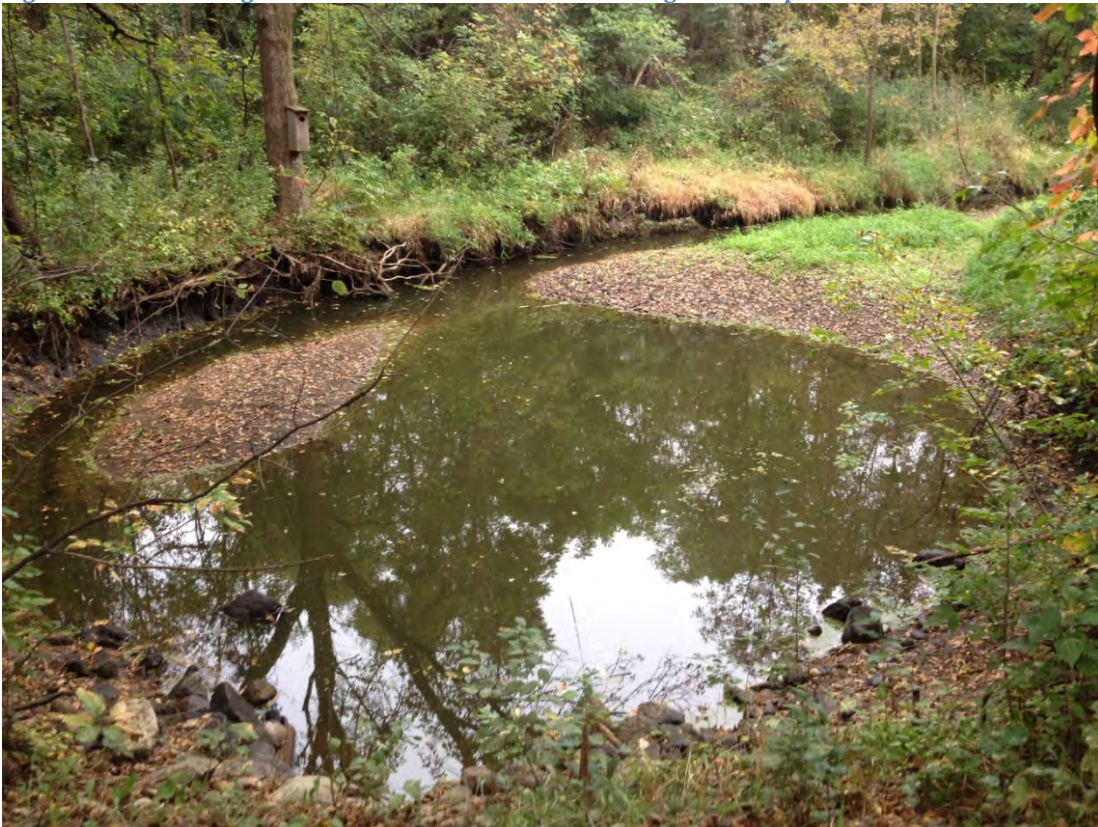
Figure 12. Stream bank erosion along left bank downstream of the private driveway crossing

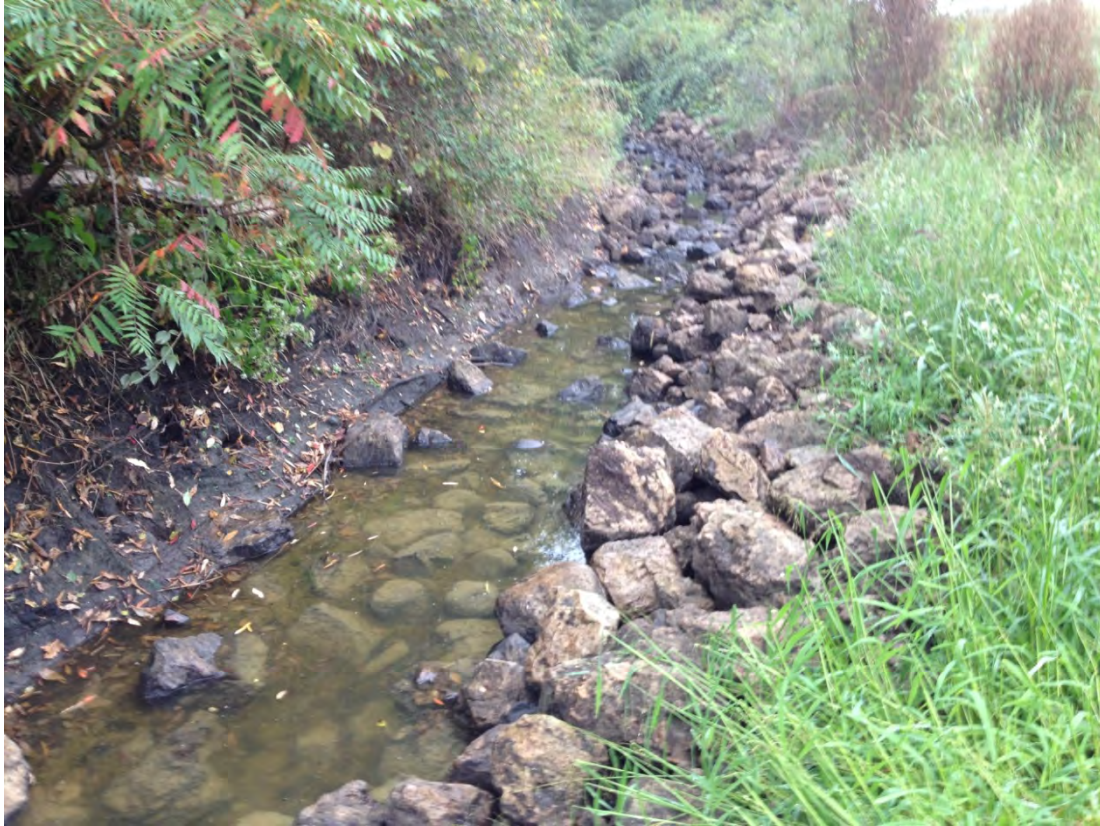
The restored channel in Segment 4A would benefit from re-positioning of the existing riprap. There appears to be a sufficient volume of riprap along the right side of the channel to address the erosion that is occurring along the toe of the left bank (Figure 14). The riprap located above the baseflow elevation could be removed and placed along the left bank to stabilize the toe. Immediately downstream of the Jackson Trail culvert, the riprap in the center of the channel continues to cause localized bank erosion and channel widening near the culvert (Figure 15). Bank erosion continues to advance within this segment, particularly at sites damaged by previous flood events (Figure 16). In Segment 4B, the large box elder tree that had fallen over the channel near the upstream end of the segment is obstructing flows within the channel (Figure 17). Poor riparian vegetation exists within the old pastured reach, with several species of invasive thistle (*Cirsium* spp.) occurring throughout Segment 4B.

Figure 14. Minor bank erosion along the left bank of Segment 4A

- Re-position existing riprap along restored channel in Segment 4A
- Remove riprap in center of channel immediately downstream of Jackson Trail
- Remove fallen box elder tree at upstream end of the Muhlenhardt property

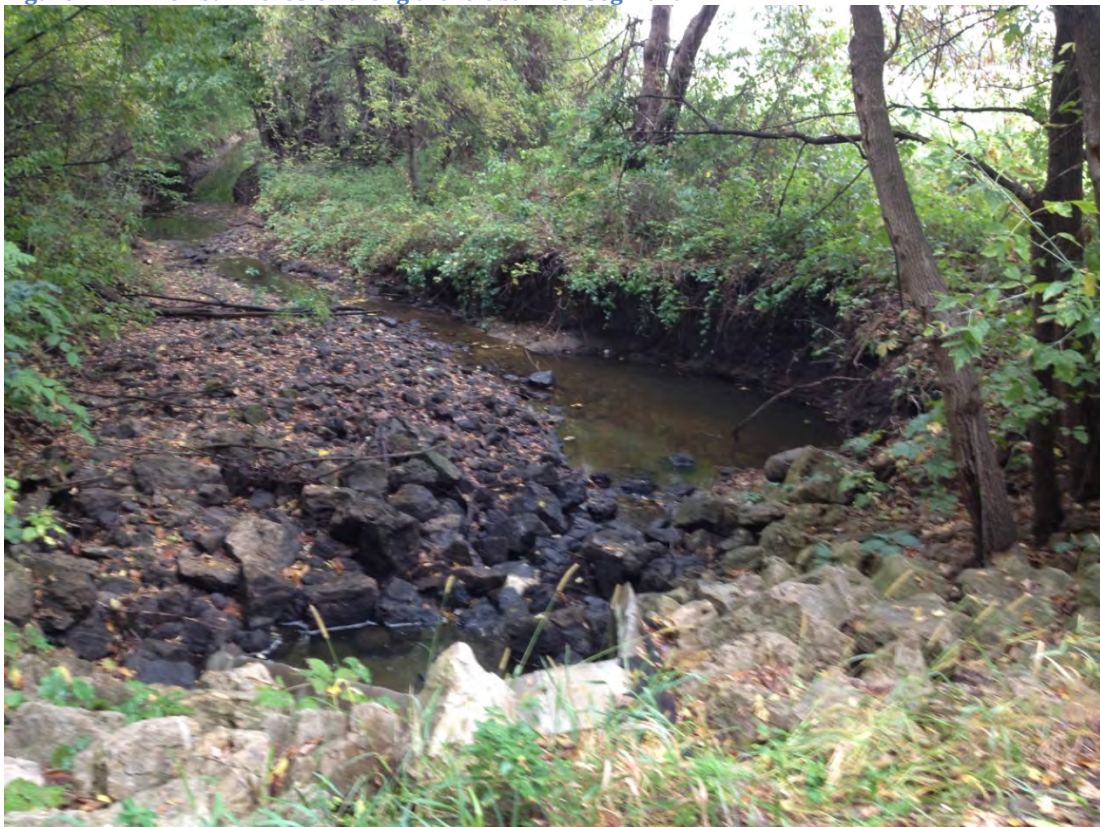
Figure 15. Riprap downstream of the Jackson Trail culvert causing bank erosion along the right bank

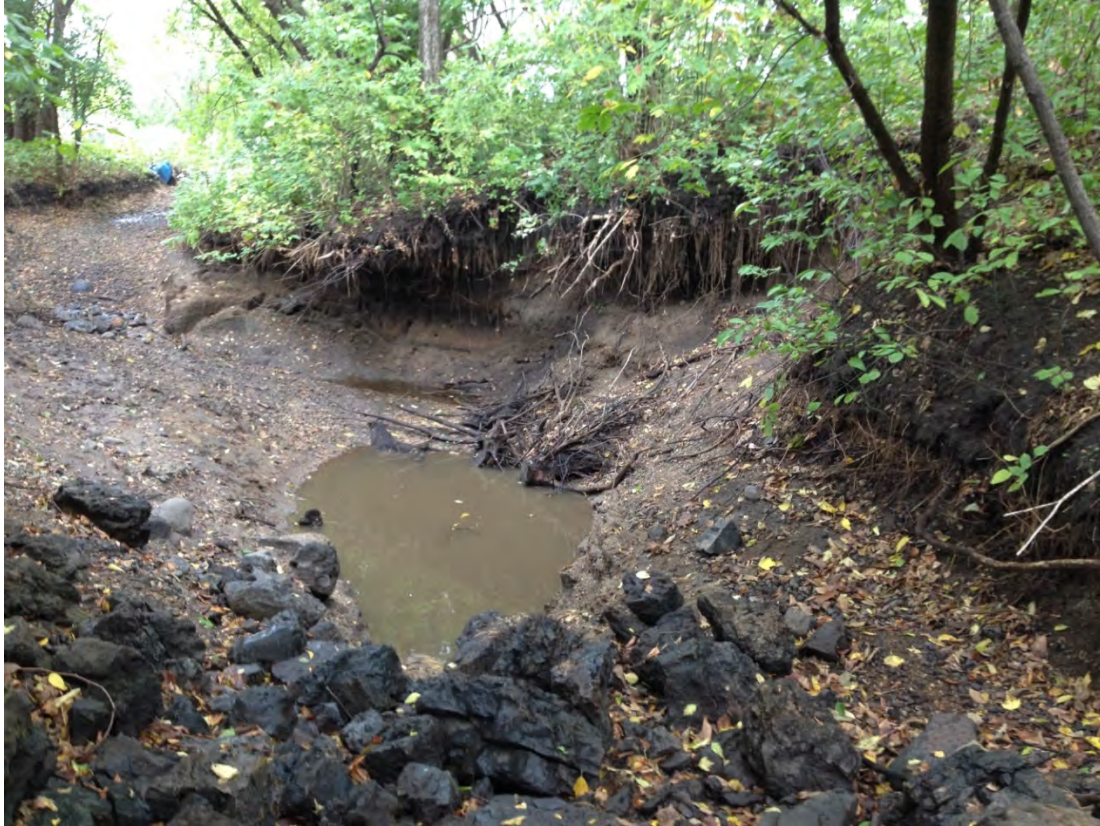
Figure 16. Continued bank erosion downstream of the Gonyea culvert in Segment 4A

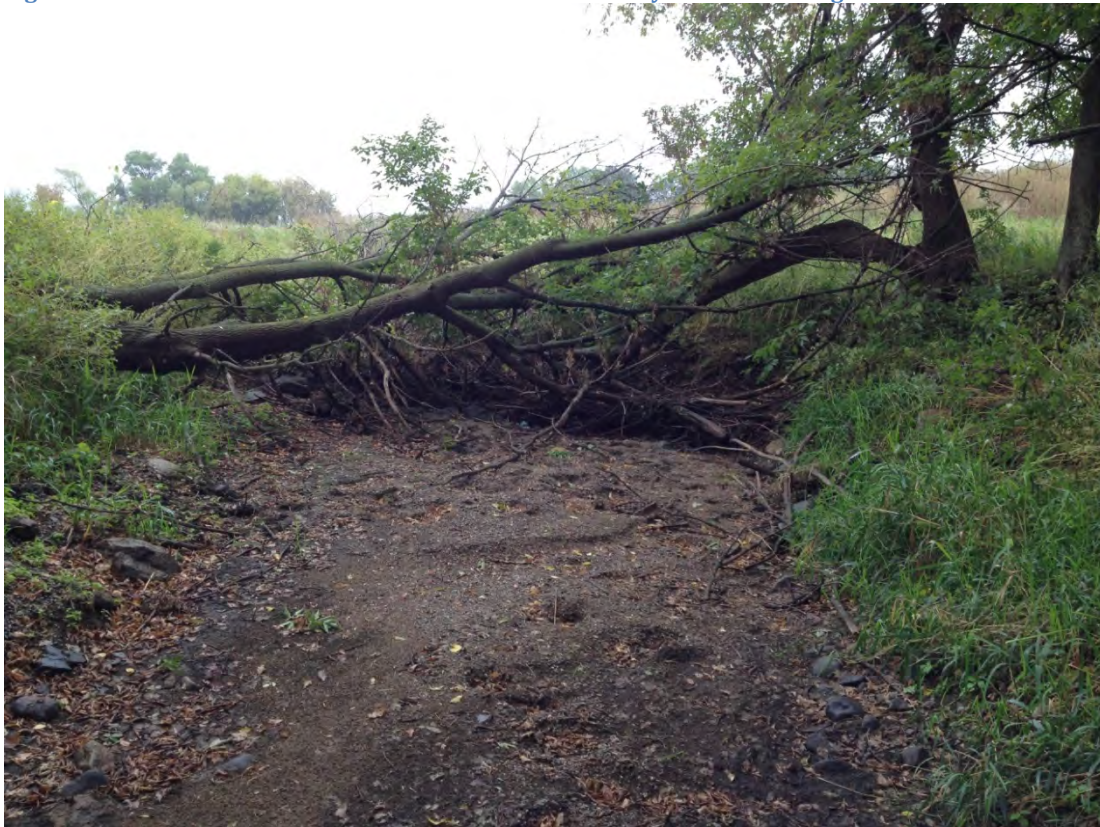
Figure 17. Down box elder tree over the channel at the upstream end of Segment 4B/ cattle pasture

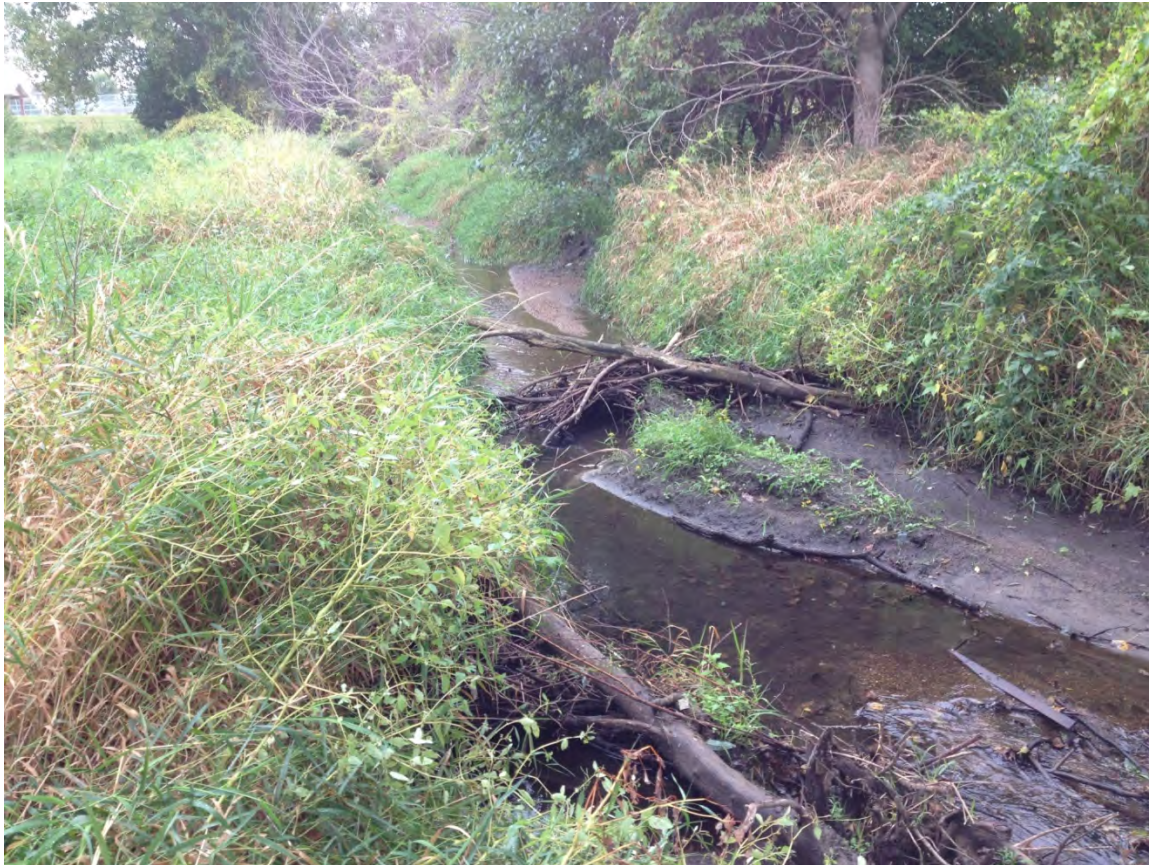
There were no significant channel obstructions found in this segment. A few tree trunks and branches occur within the channel just west of the 90 degree ditch bend in Segment 5B, but do not appear to be obstructing flow at this time (Figure 20). The channel banks throughout this segment are in fairly good condition with reed canary grass (*Phalaris arundinacea*) and tree roots providing ample surface protection (Figure 21). However, stream banks that were damaged by previous flood events continue to slowly erode. Despite recent dredging efforts in the sediment pond downstream of Pike Lake Road, a new sediment delta has already formed at the upstream end of the pond (Figure 22).

Figure 20. Down tree trunks and branches located west of the 90 degree ditch bend

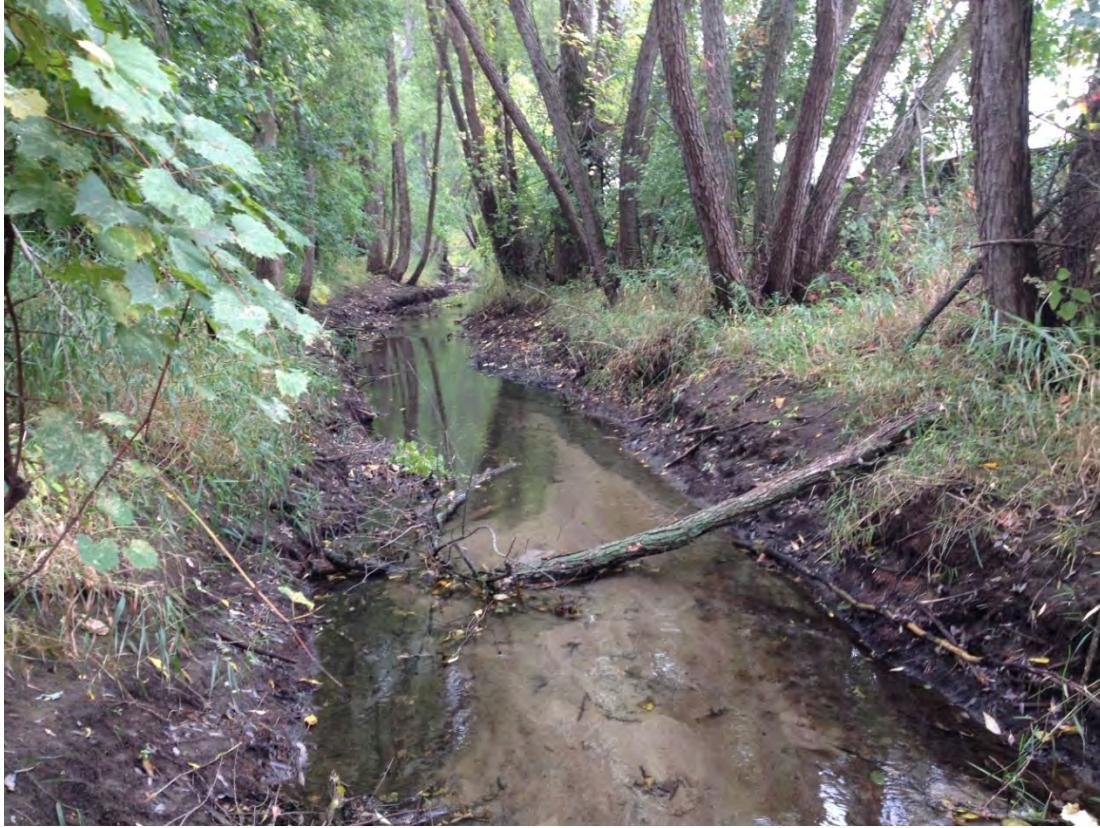
Figure 21. Stream bank protection from tree roots and grasses

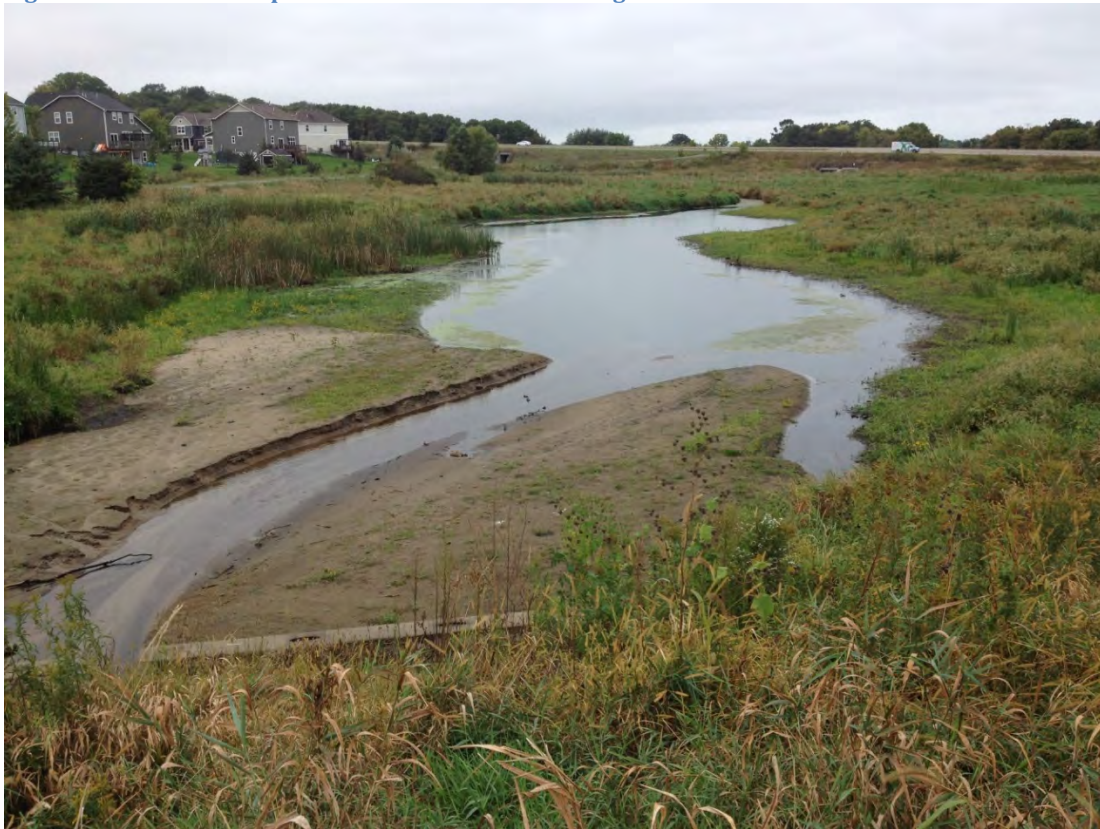
Figure 22. Sediment delta located downstream of Pike Lake Trail (Segment 5C)

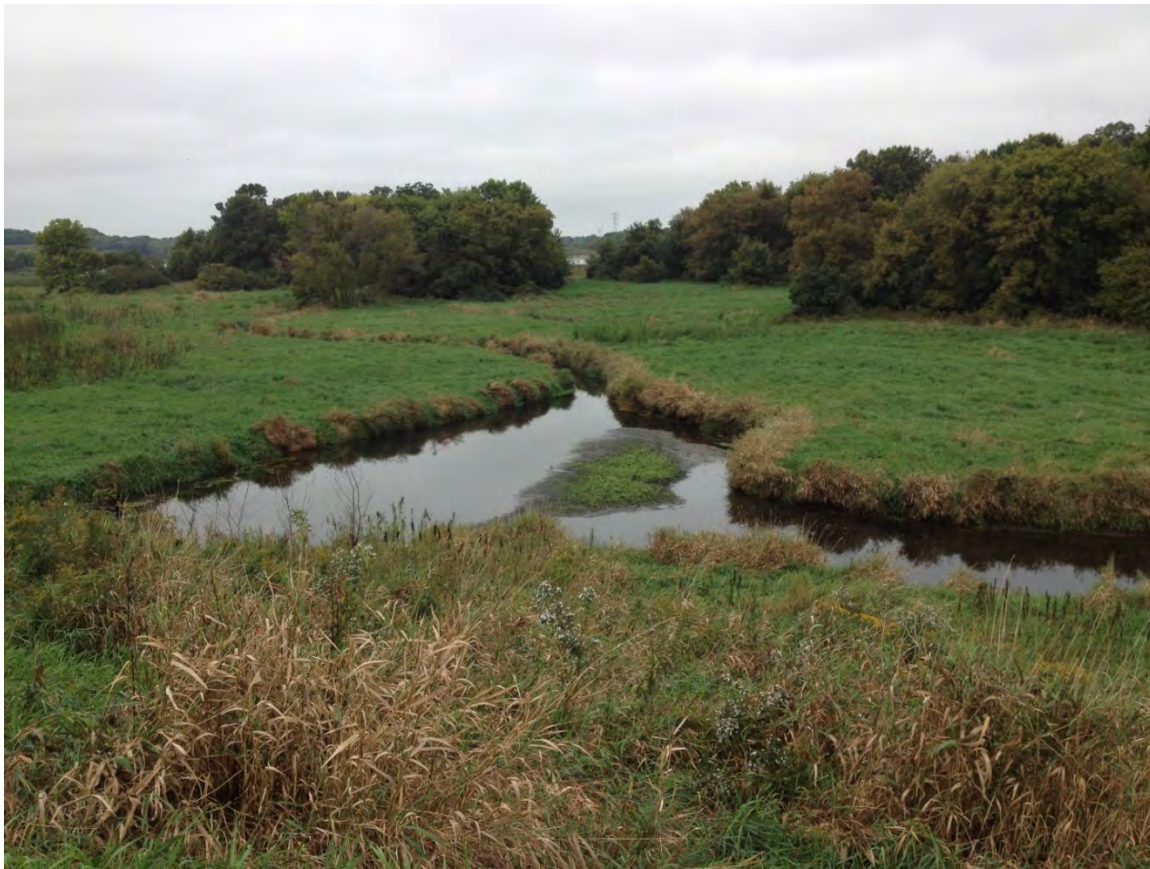
A small sediment delta has formed immediately downstream of the County Road 21 box culverts and is affecting flow through the bypass channel, particularly during low flows (Figure 26). No other channel obstructions were found in this segment. The Deans Lake weir appears to be in good condition and was free of debris at the time of the inspection. The channel banks throughout this segment are well vegetated and show little evidence of bank erosion (Figure 27, Figure 28).

Figure 26. Sediment delta downstream of County Road 21 affecting low flows through the bypass channel (located on the right side of the image)

- Remove the sediment delta located immediately downstream of County Road 21 adjacent to the Deans Lake bypass channel

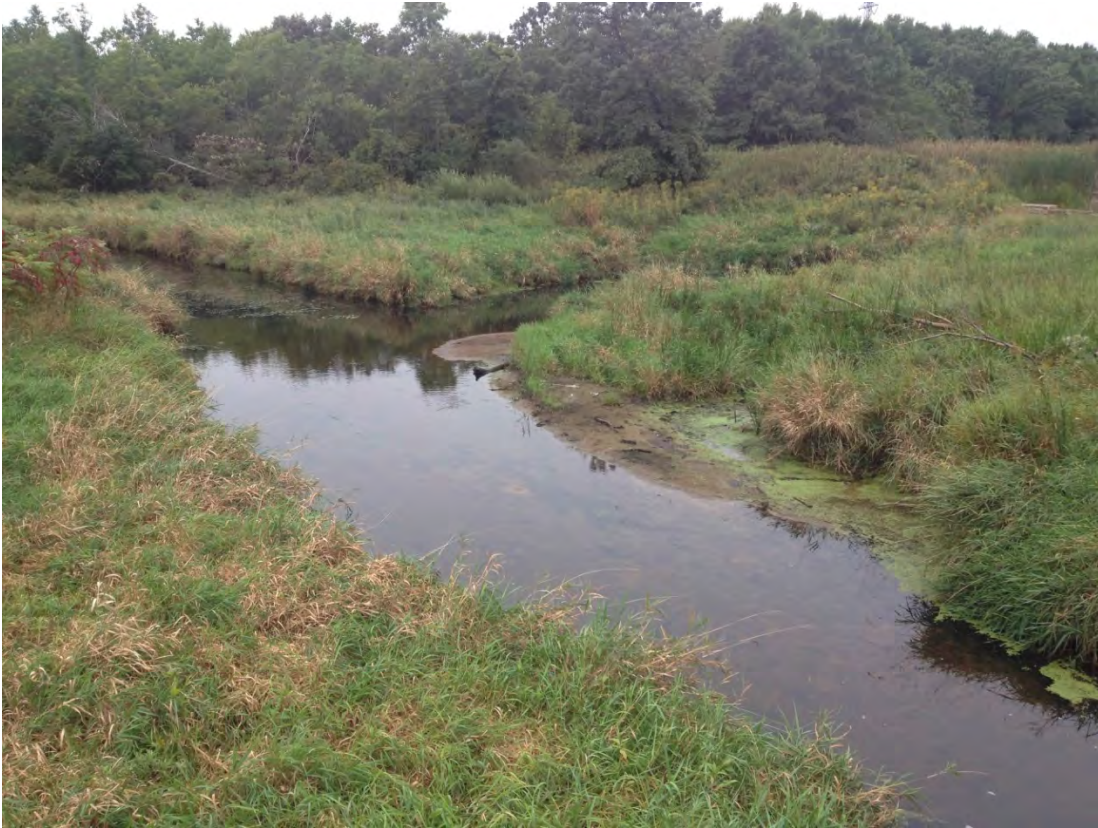
Figure 27. Vegetated stream banks downstream of Deans Lake weir

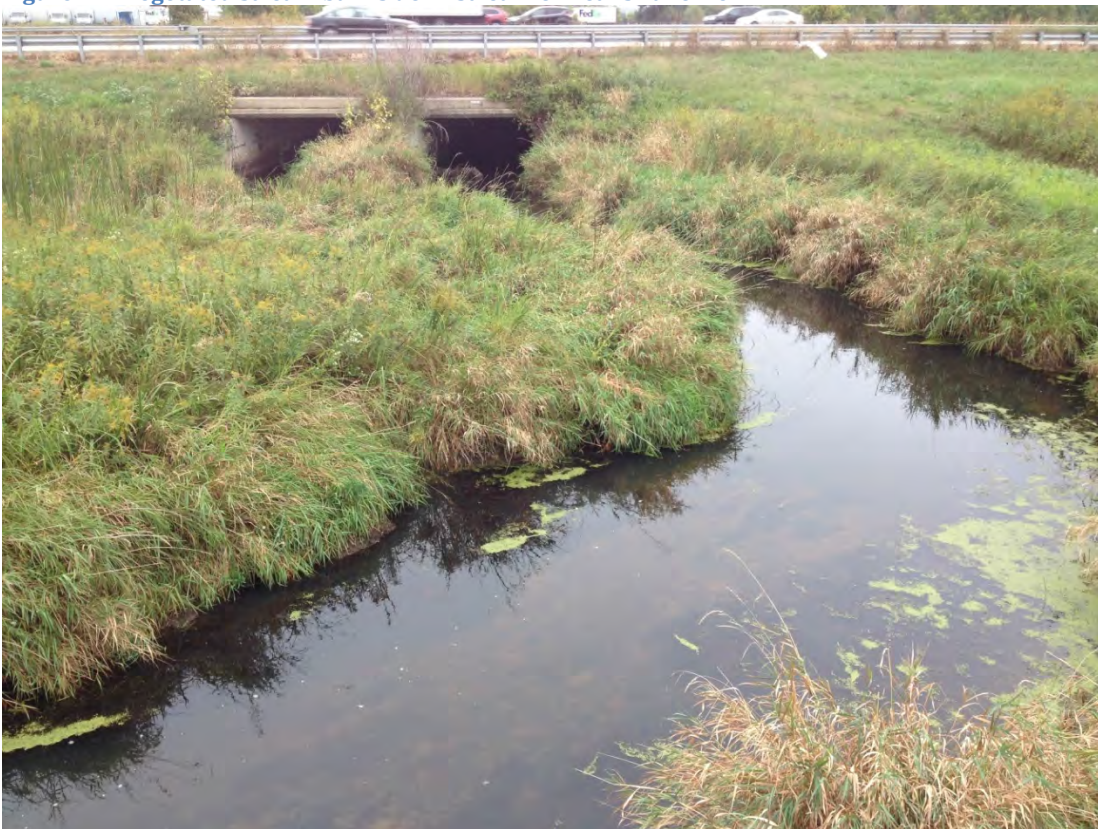
Figure 28. Vegetated stream banks upstream of Highway 169

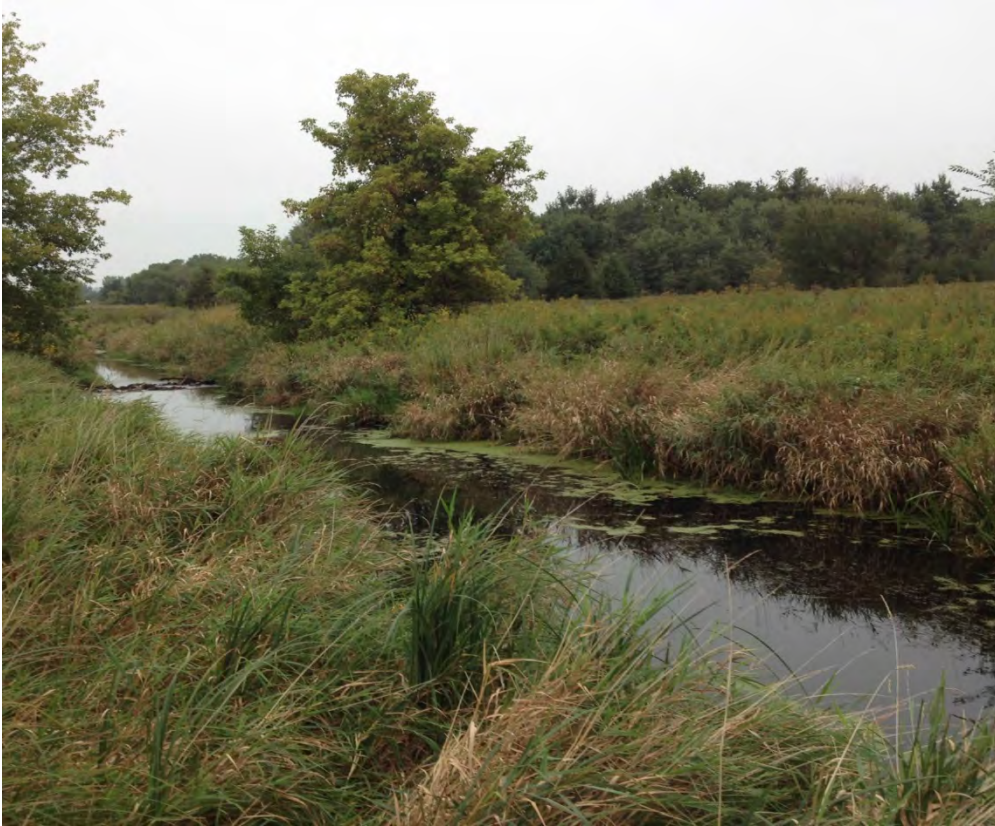
The channel banks between Highway 169 and the Quarry Lake Park crossing are well vegetated and show little evidence of bank erosion (Figure 30). The sheet pile weirs located in this segment are still operational and mostly free of debris. No channel obstructions were found within this segment; however, bank erosion continues to occur in areas damaged by previous flood events, particularly at the far downstream end of Segment 7A (Figure 31). Woody debris still occurs within the channel in Segment 7B, and the large oak tree that had fallen into the channel in 2016 is still partially obstructing flow (Figure 32). Bank erosion in Segment 7B continues to occur in areas previously damaged by flood events. Several trees growing on the channel banks have undercut root boles and will likely fall into the channel if the banks are not restored (Figure 33). In particular, a large bur oak tree located on an outside meander is being threatened by an active bank undercut. Bank toe restoration and a flow deflector would help protect this tree from falling into the channel. At the far downstream end of Segment 7B where the Metropolitan Council Environmental Services interceptor work was completed in the summer of 2017, the channel banks appear to be stable and vegetation has become established (Figure 34).

Figure 30. Vegetated stream banks in the upper reach of Segment 7A
