Project Name | PLOC Channel Inspections**Date** | 2/15/2019**To / Contact info** | Diane Lynch, Jaime Rockney**Cc / Contact info** | Carl Almer**From / Contact info** | Mike Majeski**Regarding** | Channel and Vegetation Inspections – 2018 Summary

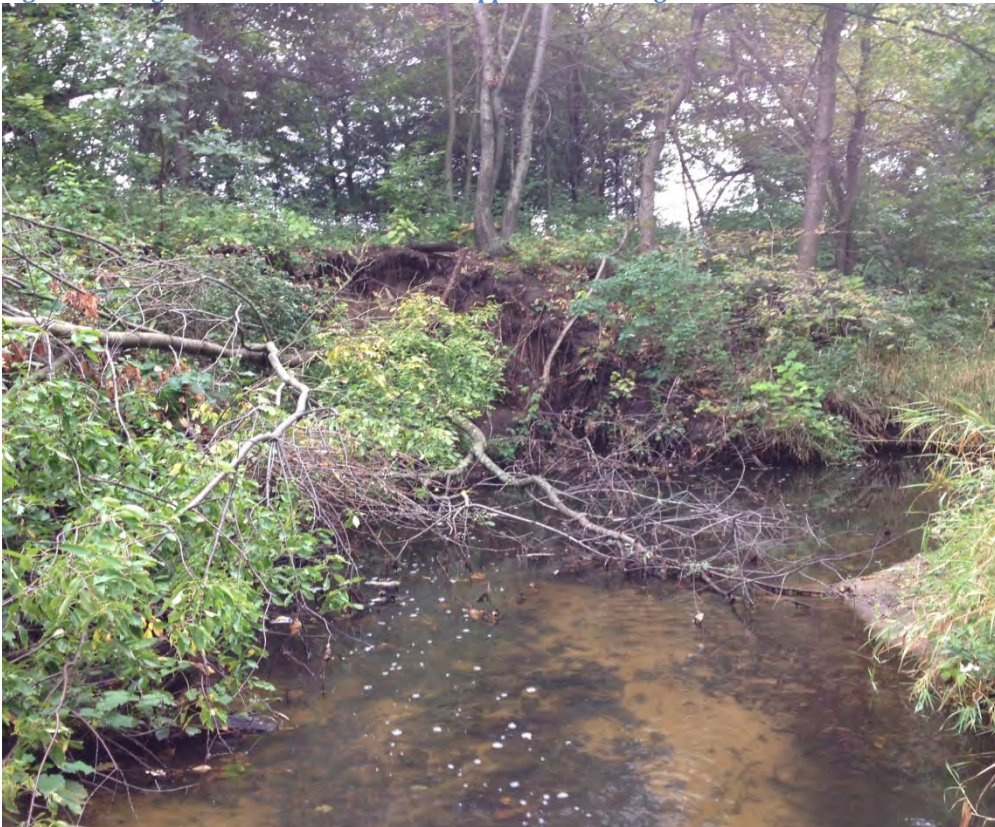
Figure 31. Bank erosion and down tree in the forested reach of Segment 7A

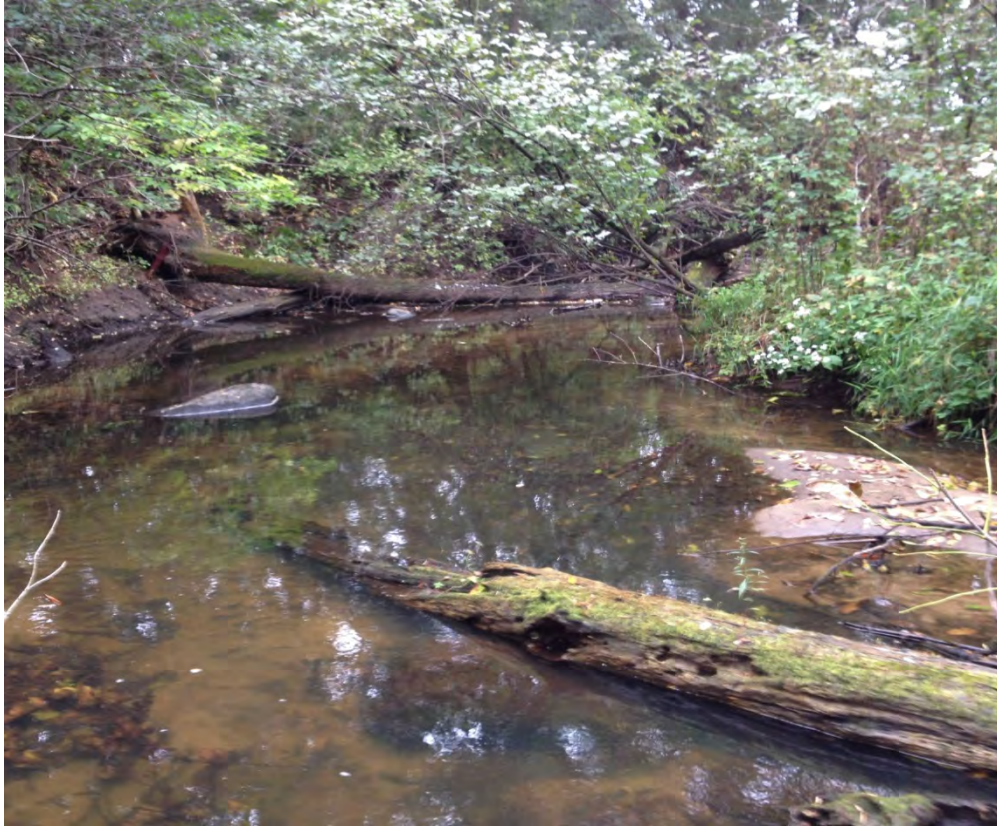
Figure 32. Fallen oak tree partially obstructing flow in Segment 7B

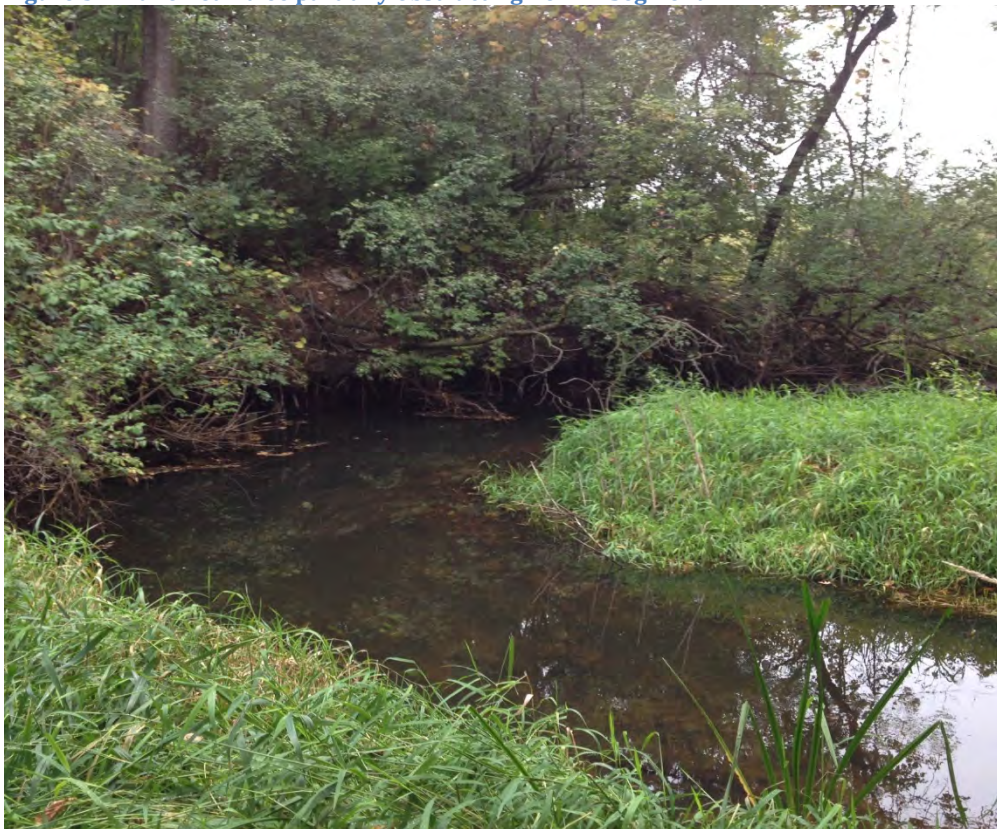
Figure 33. An active undercut bank threatening several trees in Segment 7B

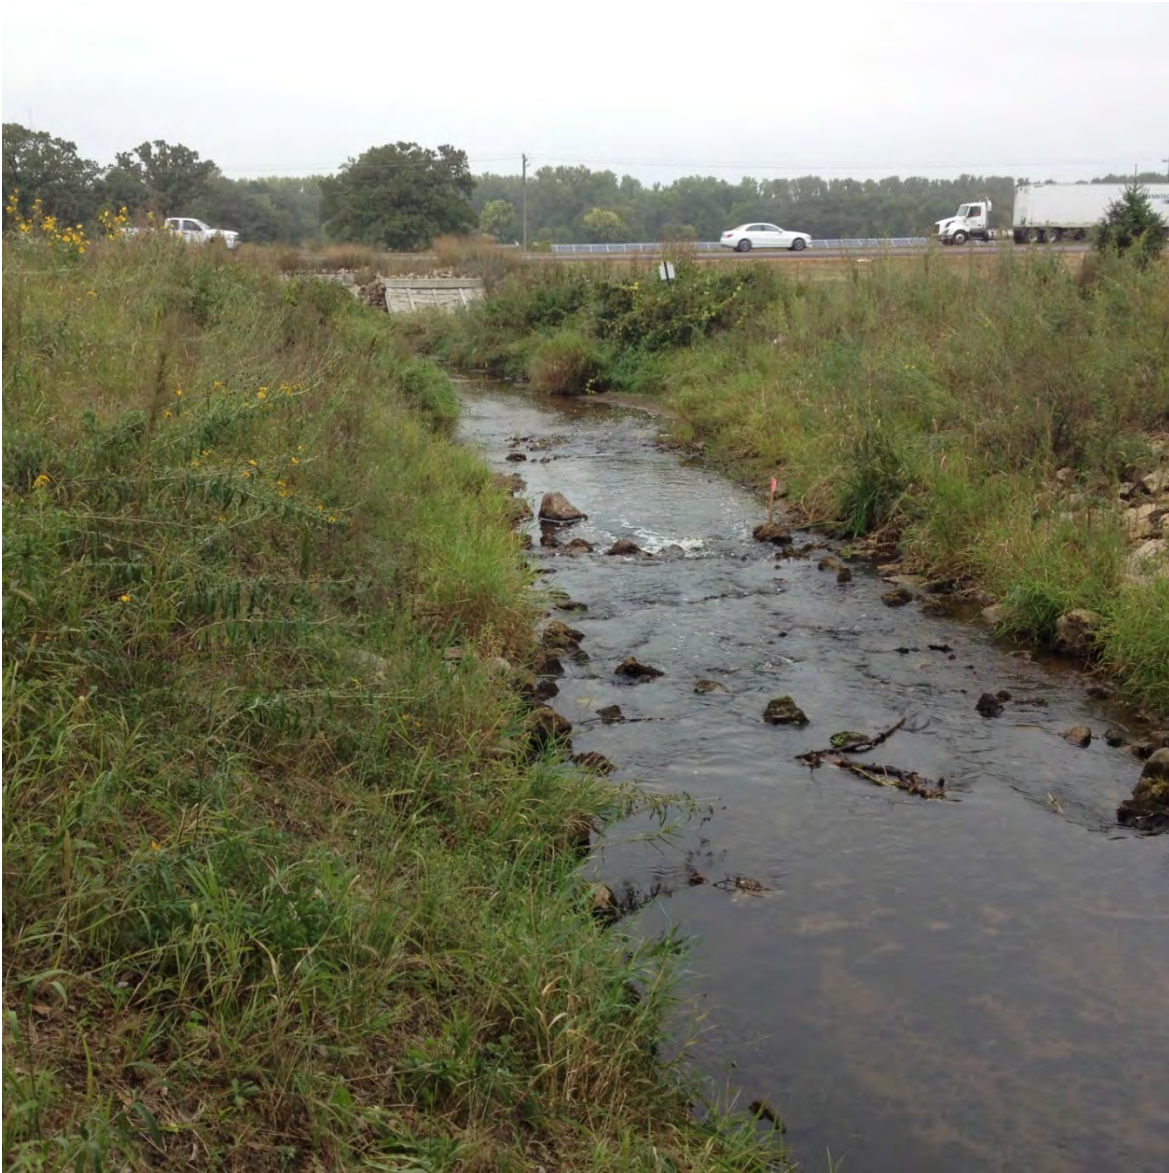
Figure 34. Vegetated stream banks at the downstream end of Segment 7B where MCES interceptor work was completed in 2017
