Project Name | PLOC Channel Inspections**Date** | 12/10/2019**To / Contact info** | Diane Lynch, Jaime Rockney**Cc / Contact info** | Carl Almer**From / Contact info** | Mike Majeski**Regarding** | Channel and Vegetation Inspections – 2019 Summary

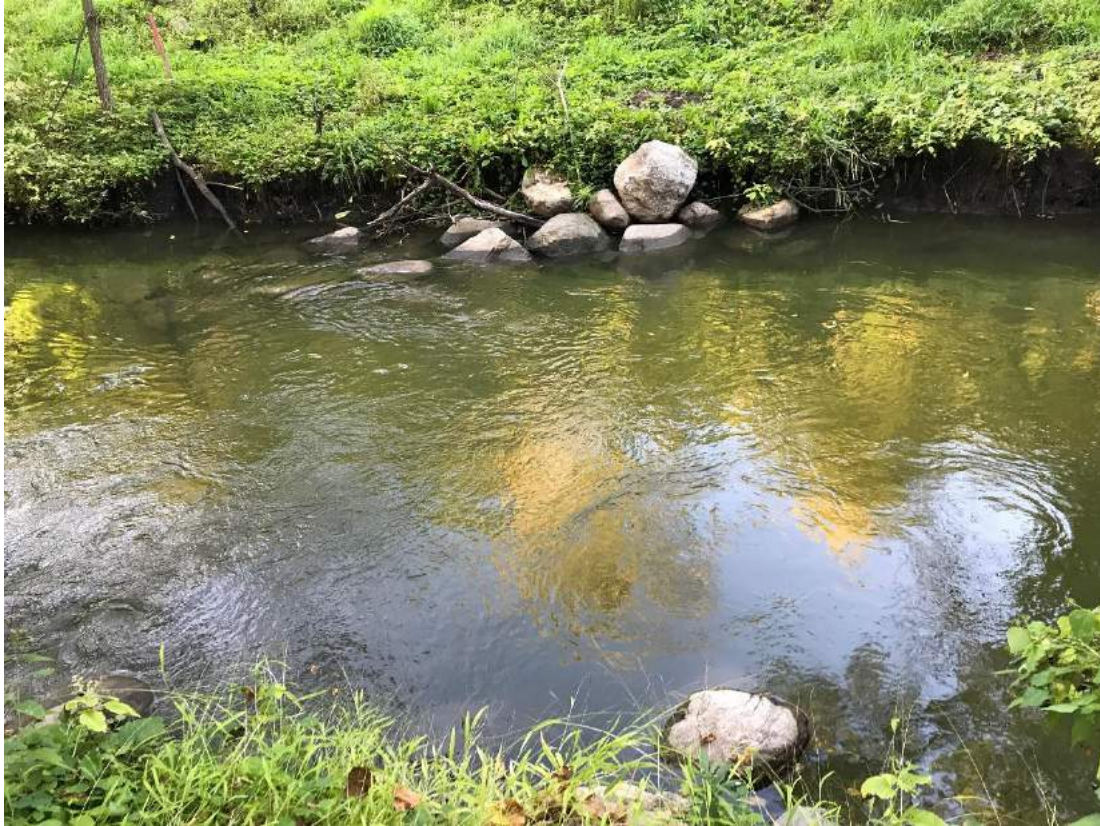
The boulder cross vane located immediately downstream of Jeffers Pass NW near Jeffers Pond Elementary School had been repaired with additional rock (Figure 1). Other FEMA-funded bank repairs completed in 2019 included repair of the walking bridge abutments and installation of boulder toe along previously eroded stream banks. No recent bank erosion was observed within this segment. Minor channel obstructions were located at the same areas identified in previous surveys including several large tree trunks and branches found lying across and within the channel in the wooded area just upstream of County Road 42, and a small beaver dam located just downstream of Fountain Hills Road (Figure 2). The bottom of the trash rack on the upstream end of the CR 42 culvert was partially obstructed with debris in September (Figure 3).

Figure 1. Repaired boulder cross vane near Jeffers Pond Elementary School

- Continue inspections in 2020 and monitor FEMA funded bank repair work completed in 2019

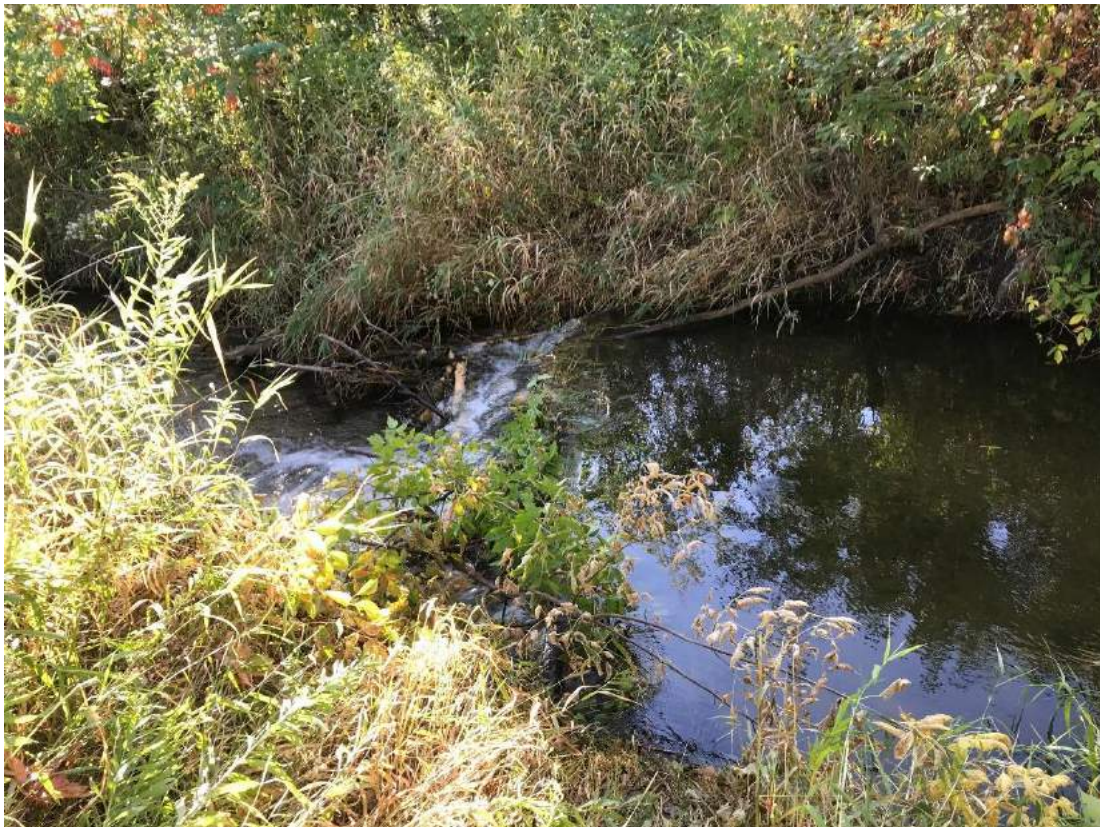
Figure 2. Small beaver dam located downstream of Fountain Hills Road

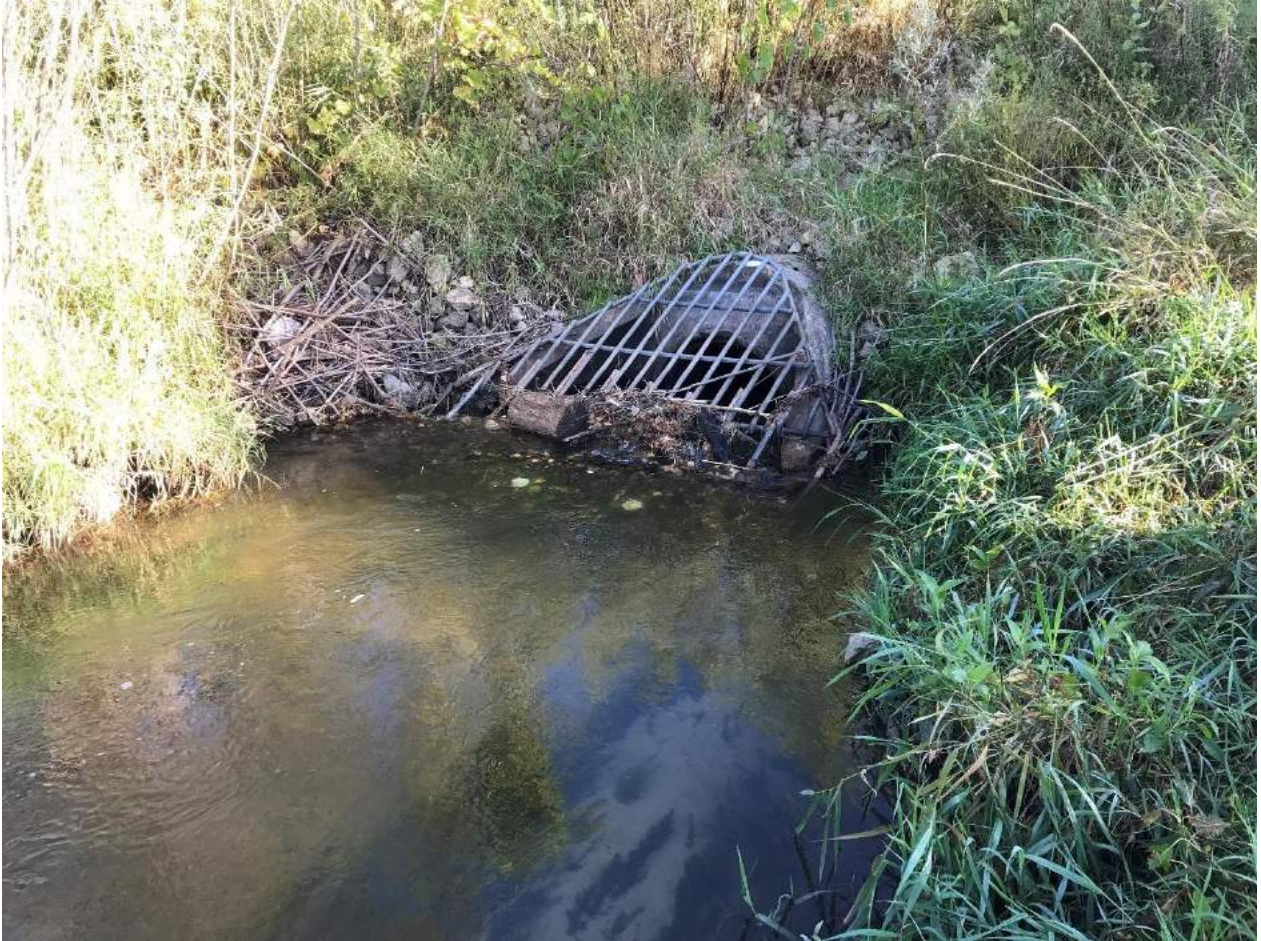
Figure 3. Debris jam in trash rack at upstream end of CR 42 culvert

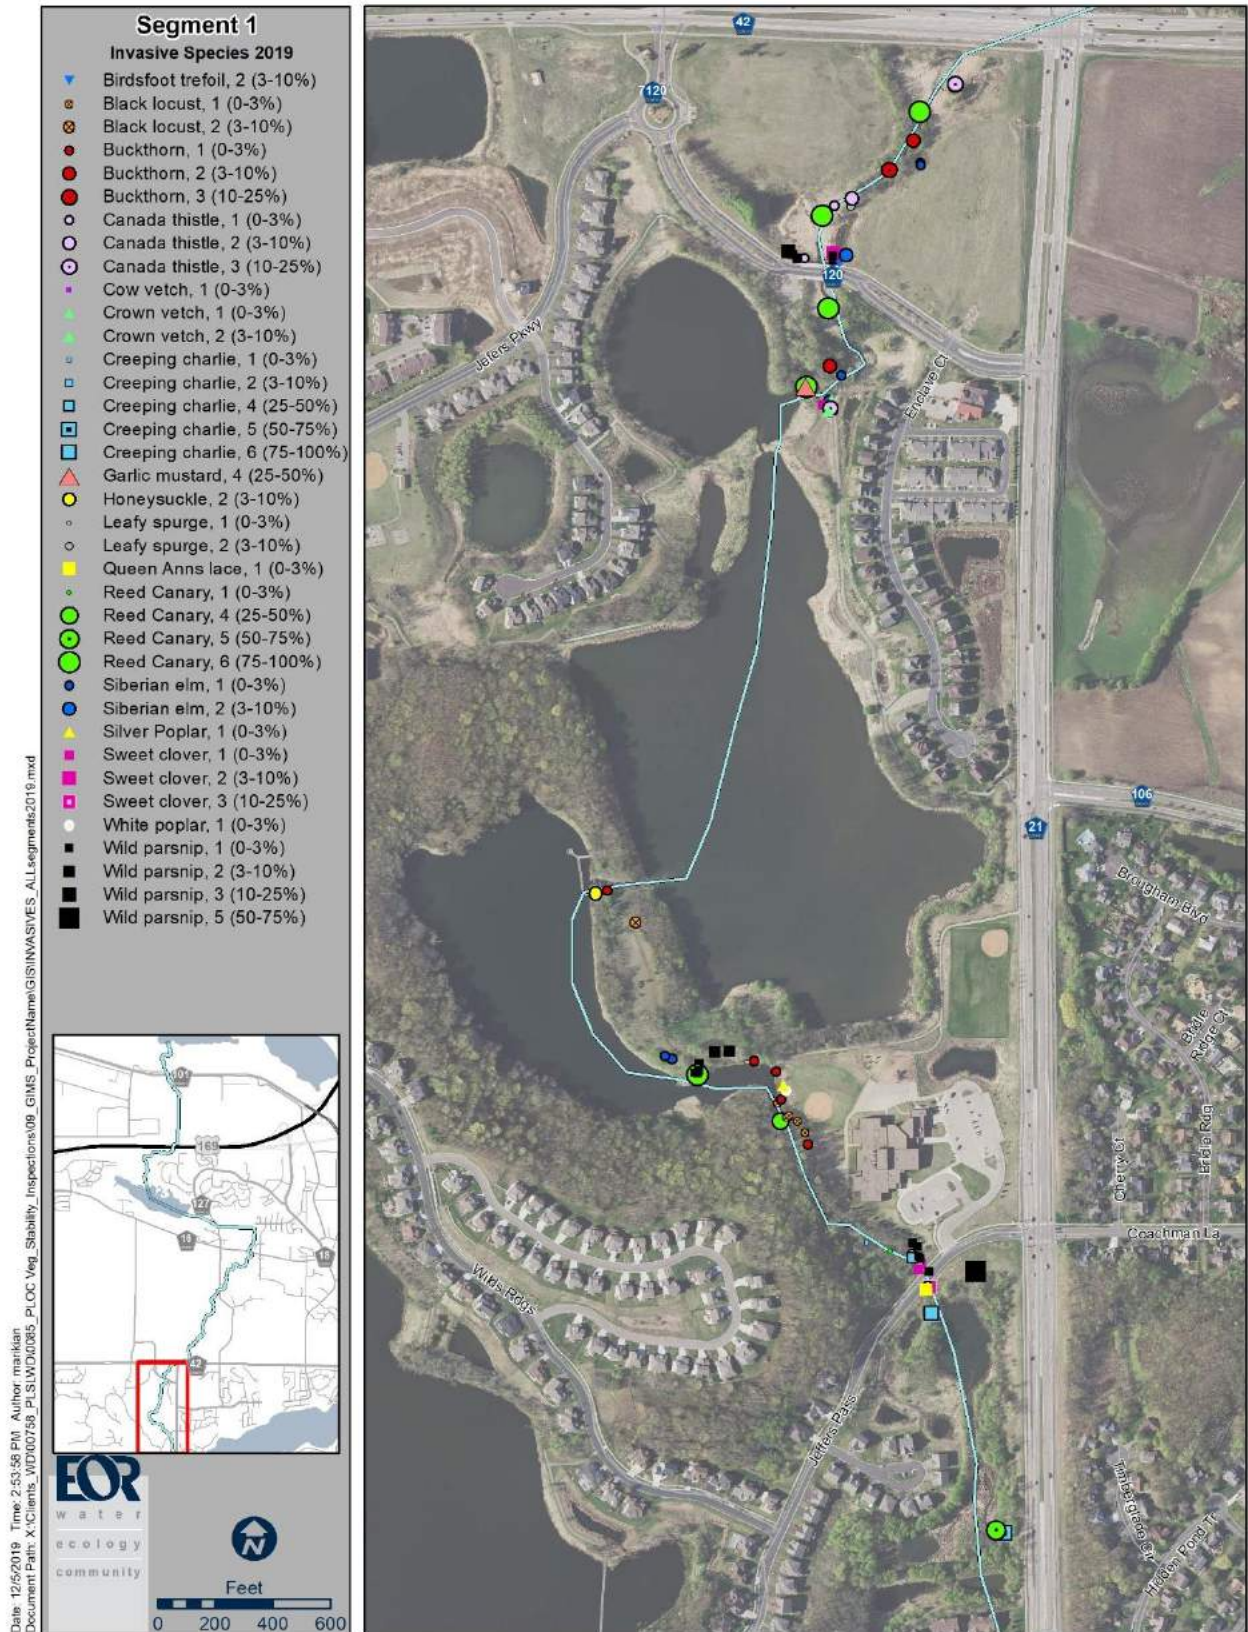
A few black locust (*Robinia pseudoacacia*) saplings were located along the paved walking path west of Jeffers Pond Elementary School. In addition, two new populations of wild parsnip were found in 2019, including a large patch in the grassy area southwest of the intersection of Jeffers Pass NW and Eagle Creek Avenue, and about 20 plants were located in a grassy opening northeast of Chickadee Landing on Jeffers Pond Elementary property. These satellite wild parsnip populations were treated by AES in July 2019 and should be closely monitored in the spring/early summer of 2020 to determine if any new plants exist in the area. Any basal rosettes located should be treated with herbicide with follow-up inspections and treatments conducted in early July to prevent the plants from maturing and producing seed. Figure 4 shows the locations and areal coverages of existing invasive species identified in this segment.

Figure 4. Invasive species and associated areal coverages (in parenthesis) along Segment 1

- Foliar spray or cut stump treatment of black locust saplings located along the paved walking path west of Jeffers Pond Elementary School
- Scout and treat wild parsnip, especially in the areas identified in 2019. Conduct the work in June to prevent plants from maturing and producing seed

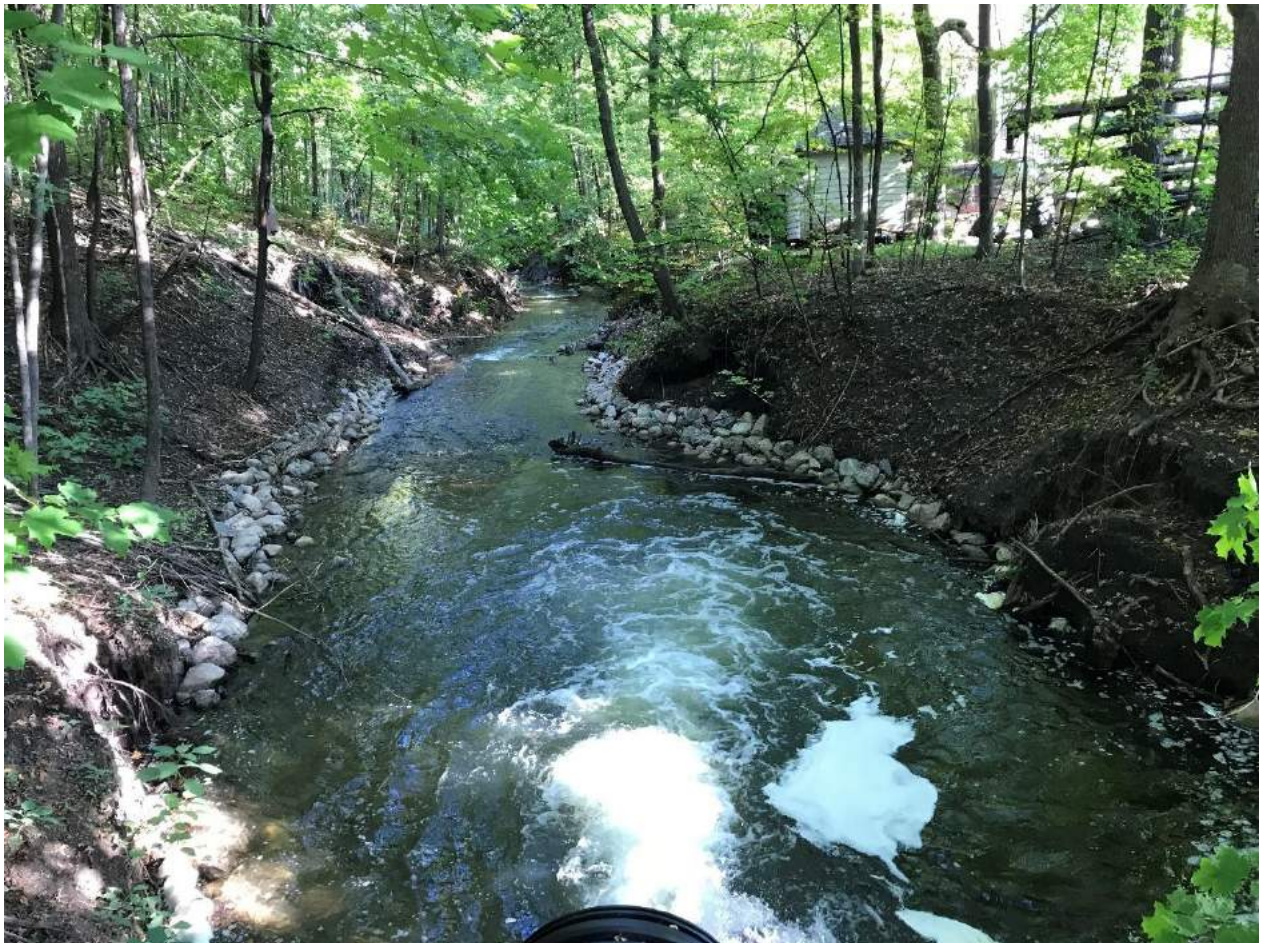
Numerous stream banks within this segment have been repaired since 2018 through the FEMA bank repair project (Figures 5-7). Nearly all previously documented down trees and channel obstructions have been removed as part of this effort; however, a few small woody debris obstructions remain in the channel. The primary bank stabilization practice implemented was the placement of boulder toe along the sides of the channel. Rootwads were also utilized along a few banks for toe stability and habitat improvements (Figure 8). The bank repairs have reduced toe erosion throughout the segment, but some banks continue to erode in areas where bank repair activities have not occurred. The large sediment delta previously identified at the inlet to Pike Lake was not visible during the site inspections due to high water.

Figure 5. Boulder toe bank stabilization installed downstream of the 2nd crossing

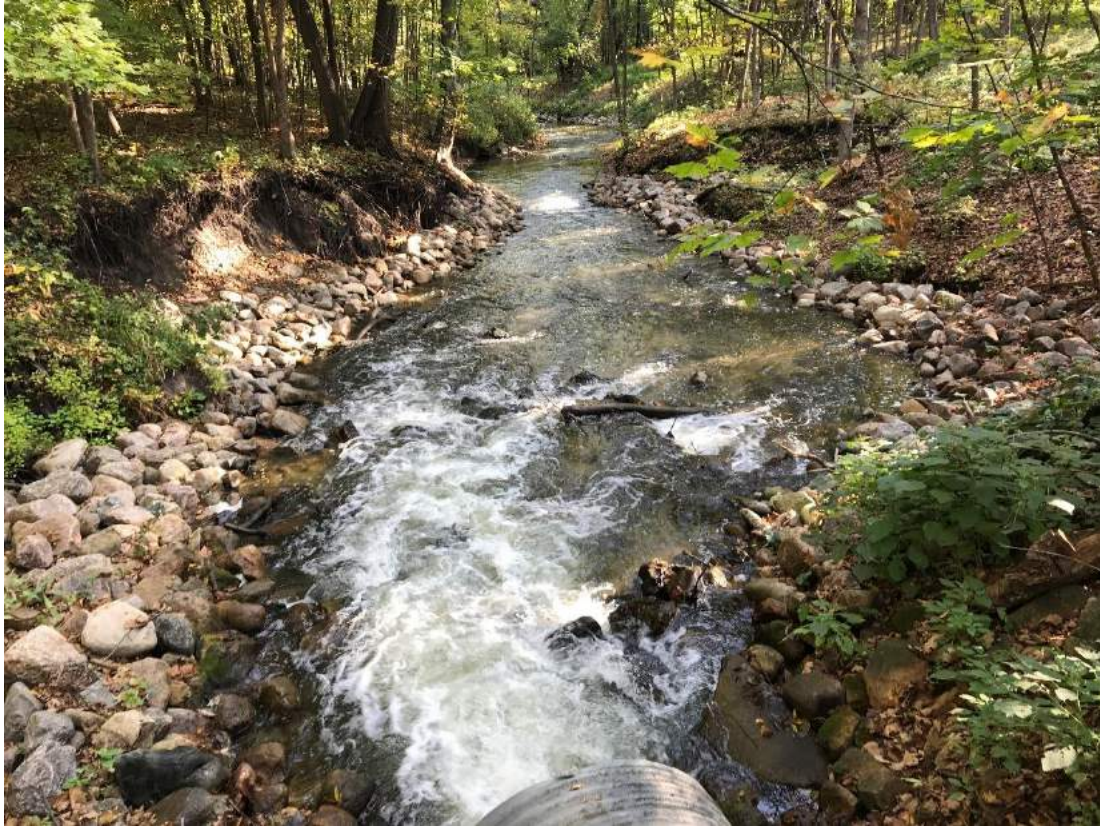
Figure 6. Boulder toe bank stabilization installed downstream of the 3rd crossing

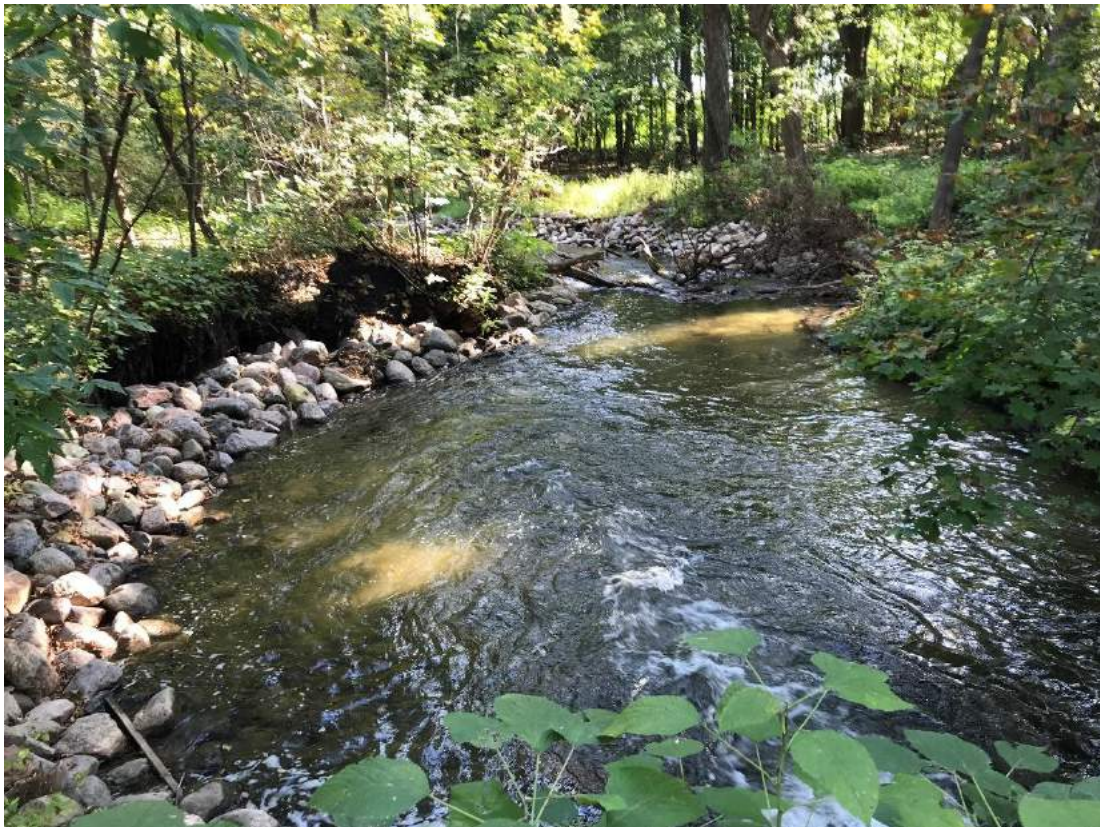
Figure 7. Boulder toe bank stabilization installed downstream of the 4th crossing (upstream of Pike Lake Park)

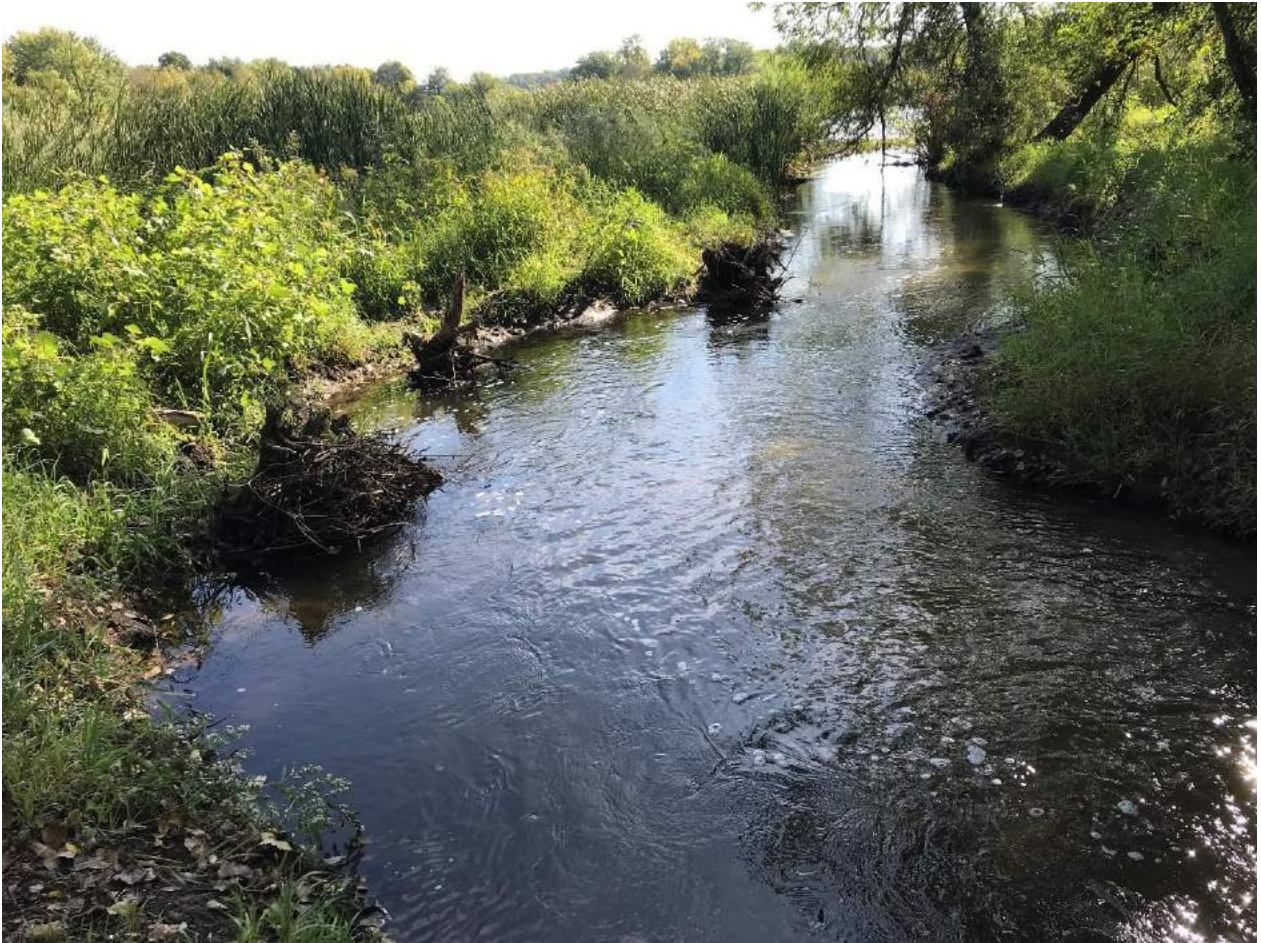
Figure 8. Rootwads installed along outside bank just upstream of Pike Lake

- Continue inspections in 2020 and monitor FEMA funded bank repair work completed in 2019
- Remove the sediment delta at the outlet of Segment 2 in Pike Lake

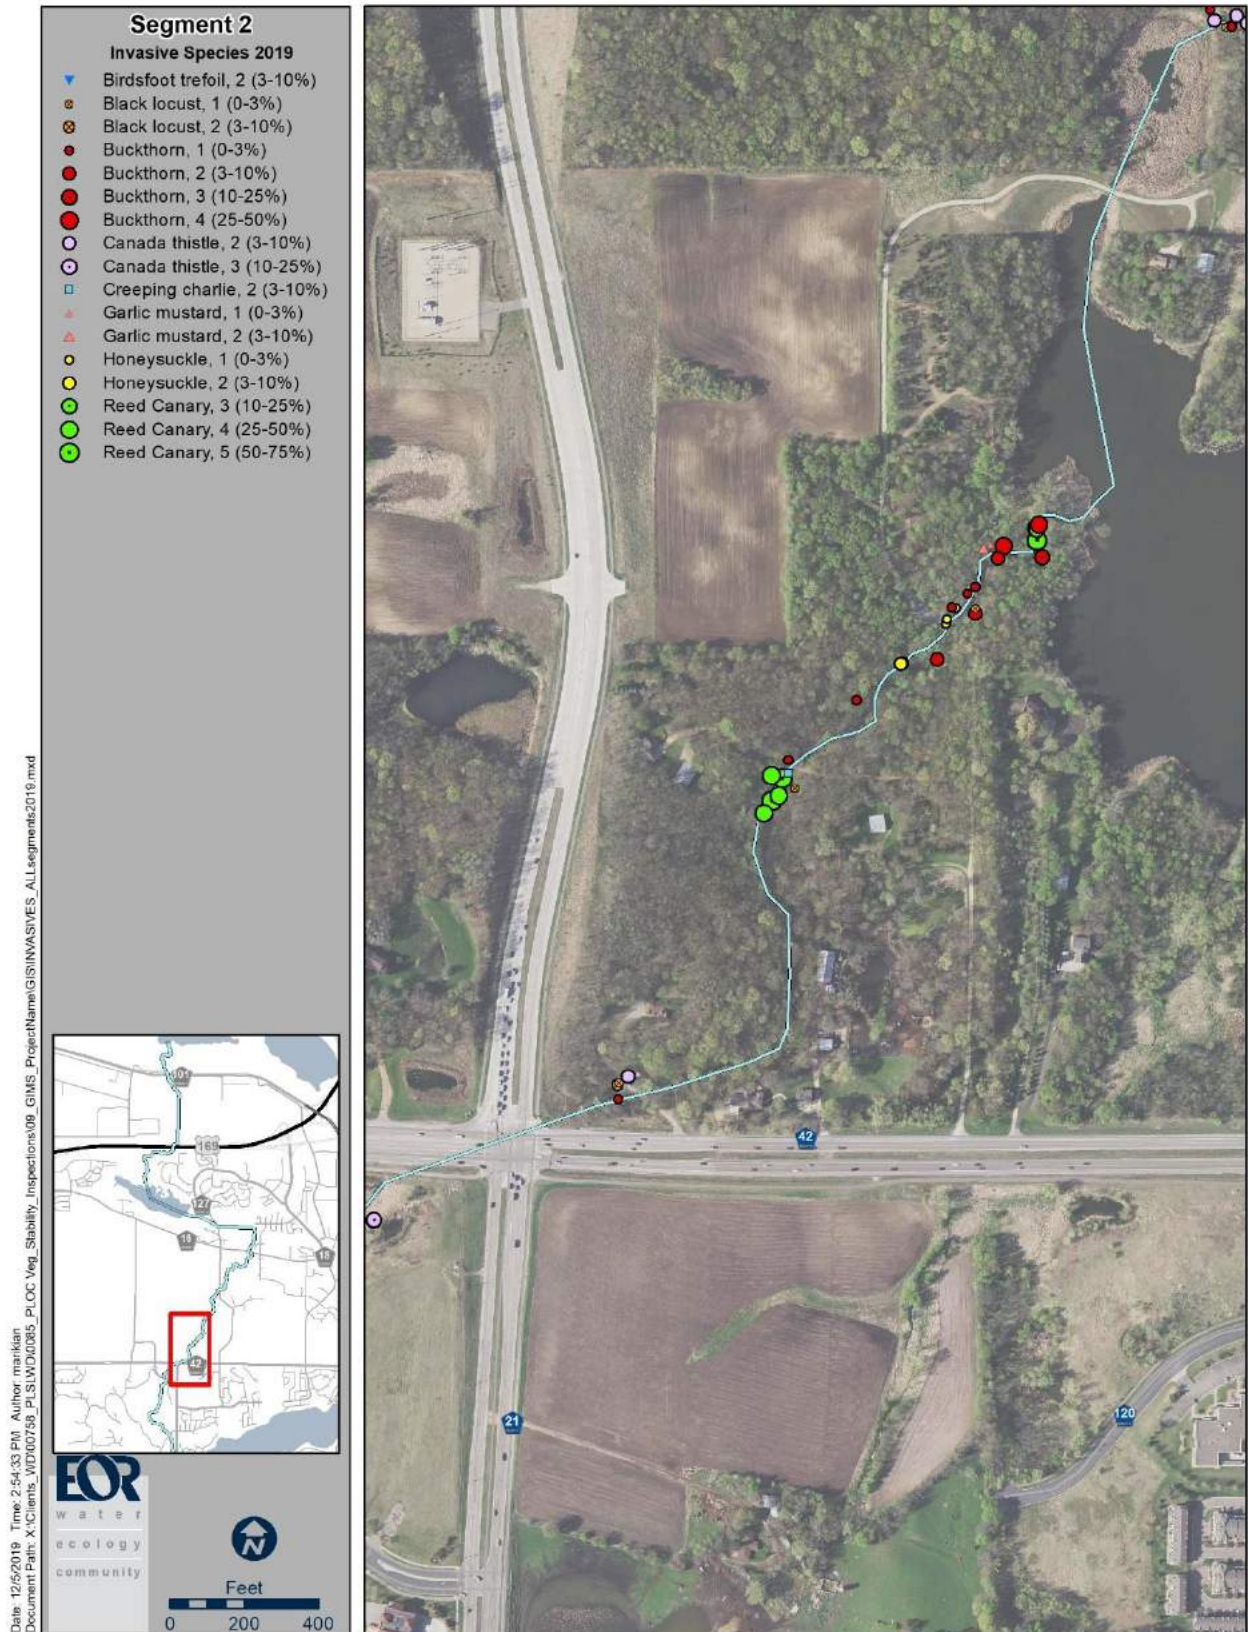
No new invasive species were found. Figure 9 shows the locations and areal coverages of previously identified invasive species in this segment.

Figure 9. Invasive species and associated areal coverages (in parenthesis) along Segment 2

- Scout and treat for woody invasive species in previously managed areas

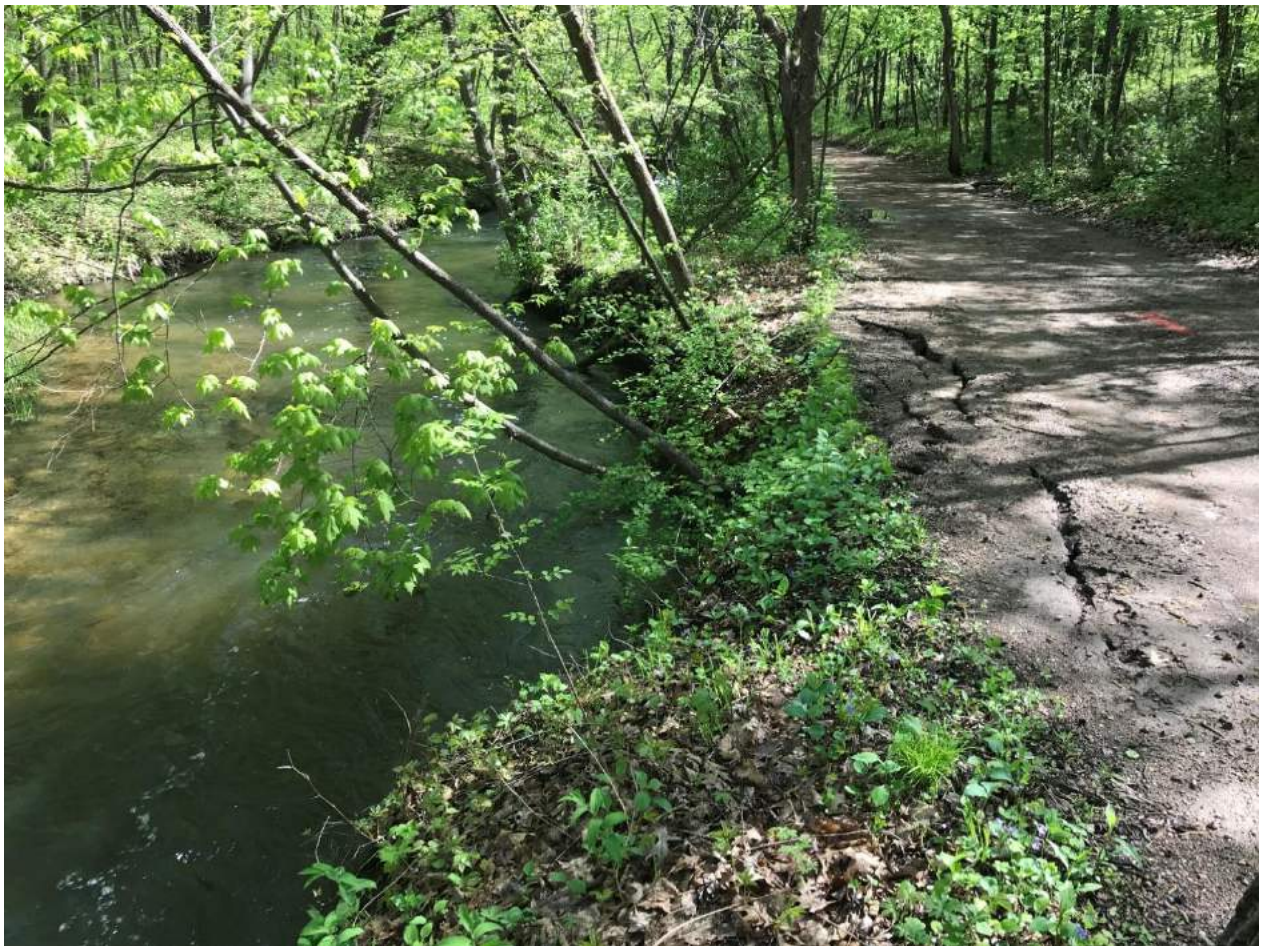
Following spring snowmelt and high flows in the outlet channel in 2019, two banks adjacent to the Kici Yapi gravel road began to rotationally slump, resulting in the formation of cracks (Figure 10) and subsequent bank failure (Figure 11) along the edge of the gravel road adjacent to the channel. Shakopee Mdewakaton Sioux Community staff repaired the failed banks with fieldstone boulders during the spring/summer of 2019 (Figure 12). Bank erosion continues to occur in areas previously affected by large flood events, particularly along the upstream half of the Kici Yapi property (Figure 13). Banks continue to self-heal in areas where toe stabilization practices were previously implemented (Figure 14).

Figure 10. Rotational slumping and formation of cracks along the gravel road of the Kici Yapi property

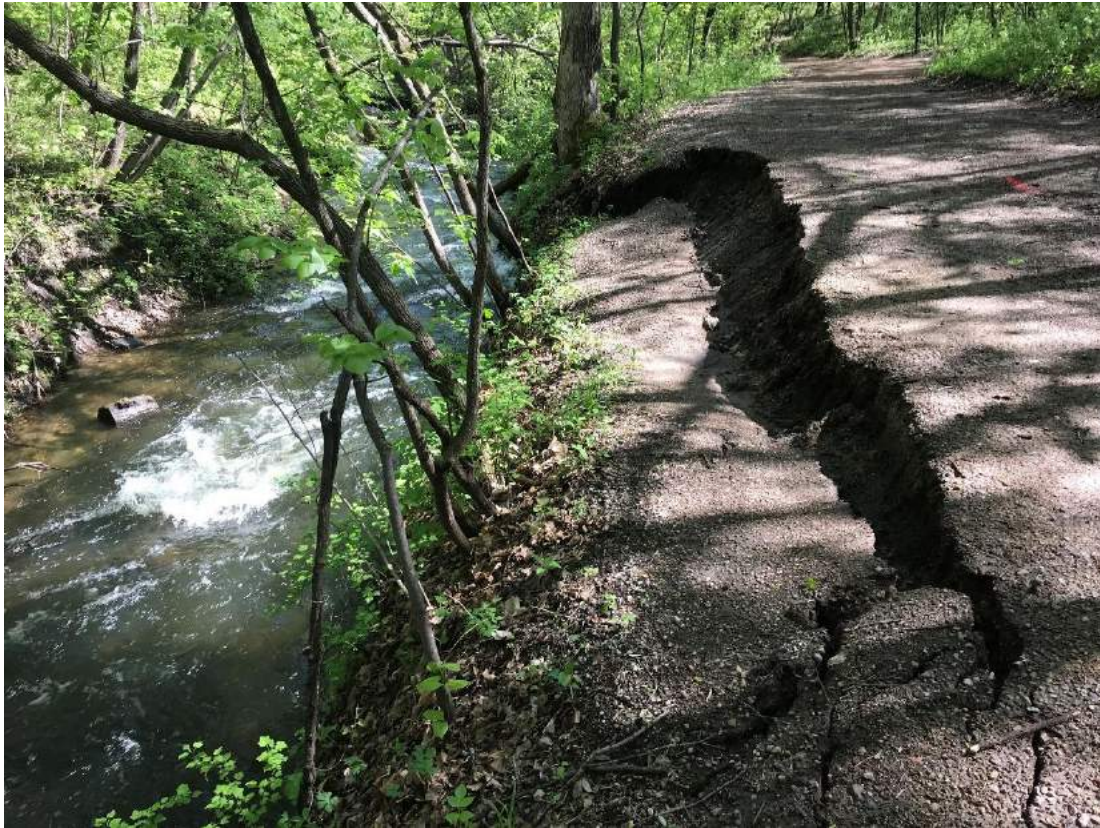
Figure 11. Rotational slumping and bank failure along the gravel road of the Kici Yapi property

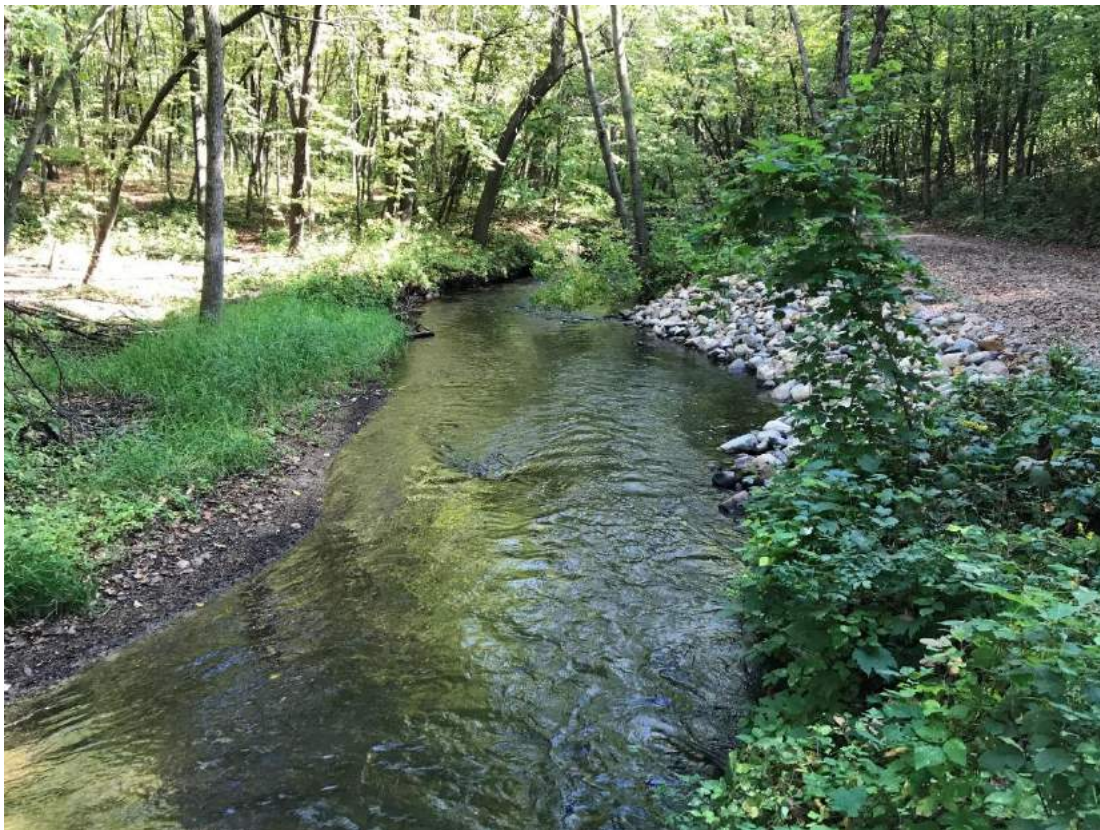
Figure 12. Stream bank repair along the gravel road of the Kici Yapi property

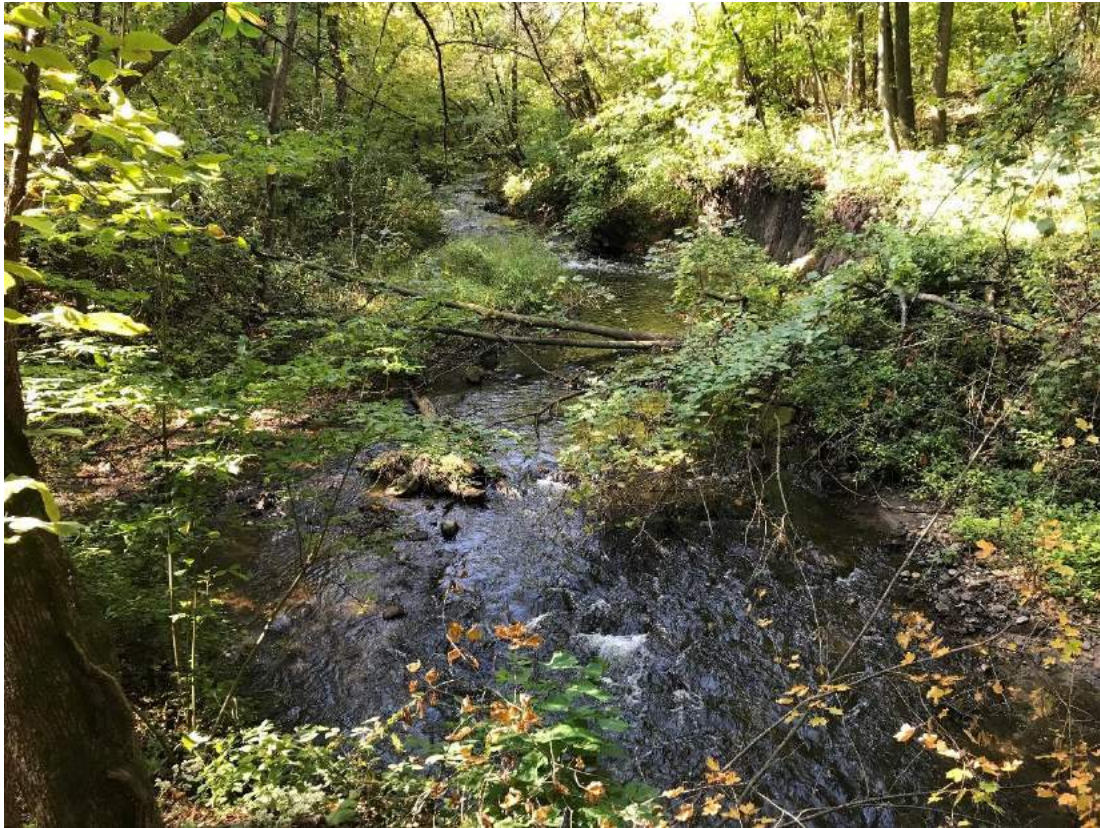
Figure 13. Bank erosion within the middle reach of the Kici Yapi property

- Continue inspections in 2020 and monitor FEMA funded bank repairs when completed

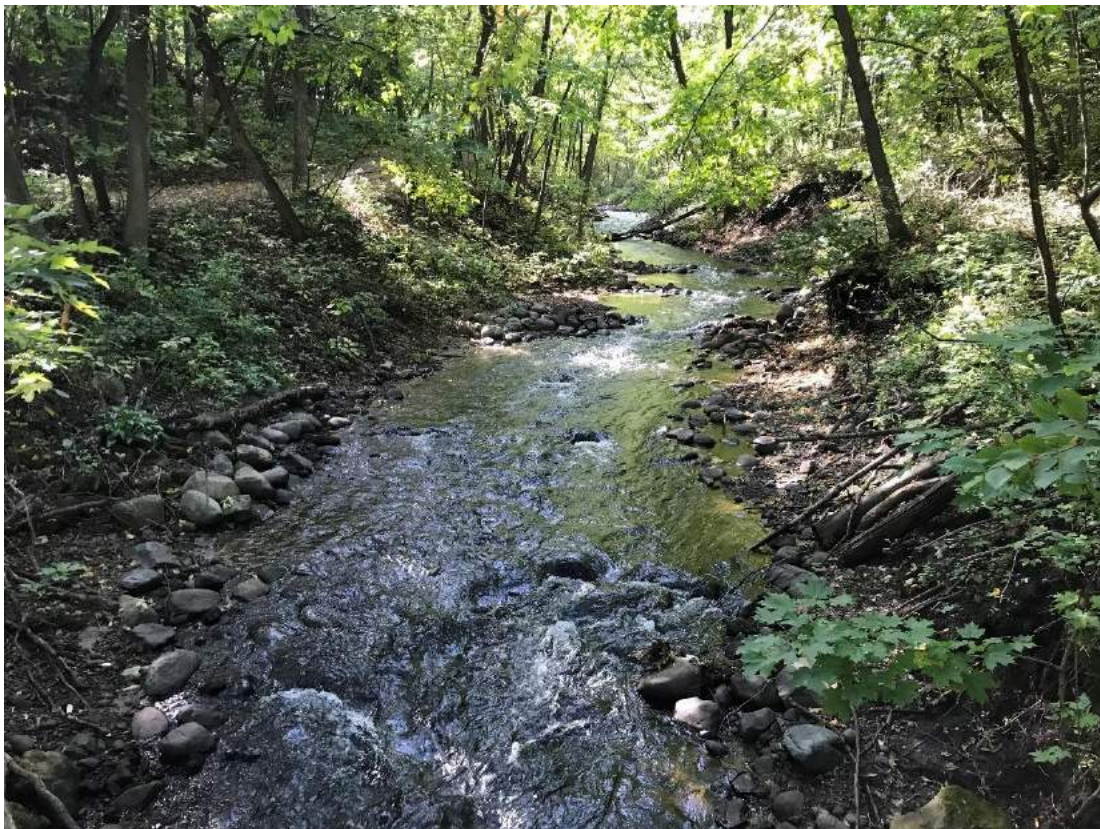
Figure 14. Channel condition near the downstream end of the Kici Yapi property

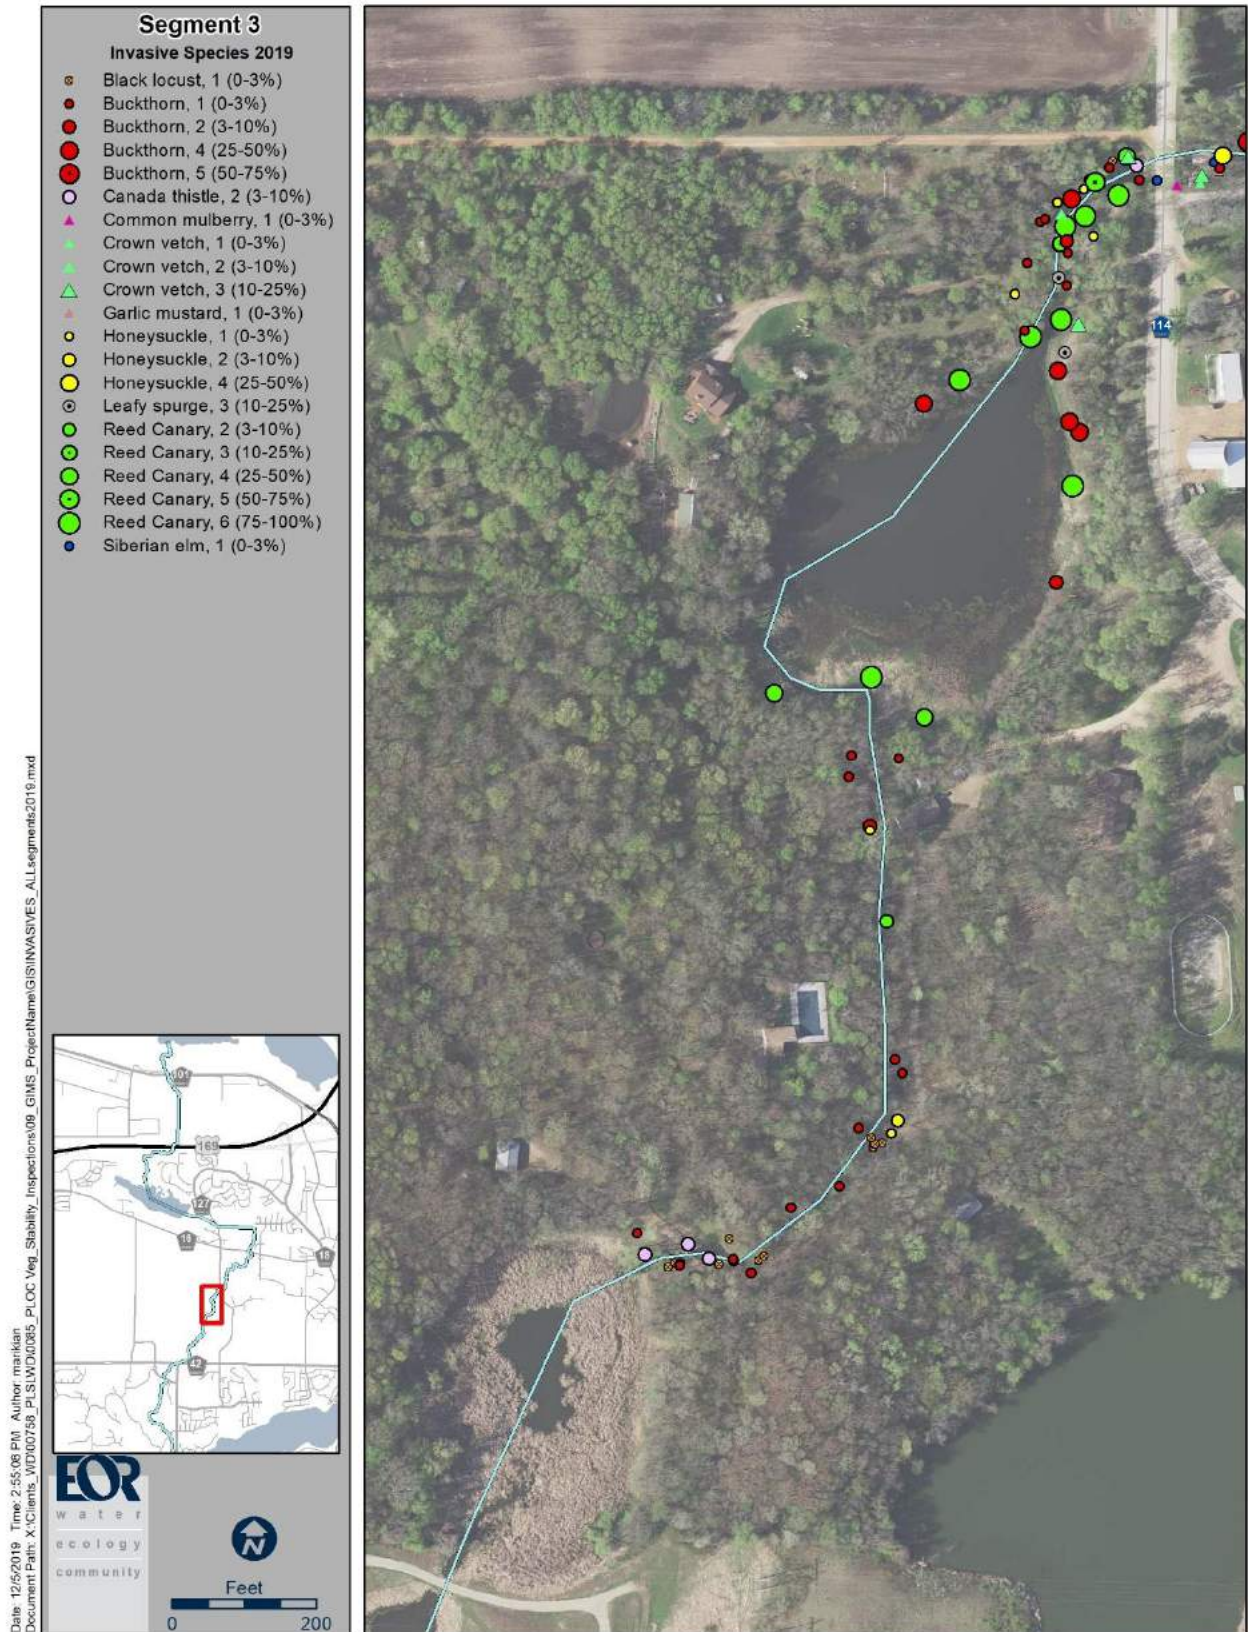
No new invasive species were found in this segment. Common buckthorn (*Rhamnus cathartica*) and bush honeysuckle (*Lonicera spp.*) saplings were observed in areas previously managed. Continued foliar spray treatments will be needed to reduce the population of the saplings in this segment. Figure 15 shows the locations and areal coverages of previously identified invasive species in this segment.

Figure 15. Invasive species and associated areal coverages (in parenthesis) along Segment 3

- Scout and treat for woody invasive species in areas not addressed by the proposed FEMA bank repair work

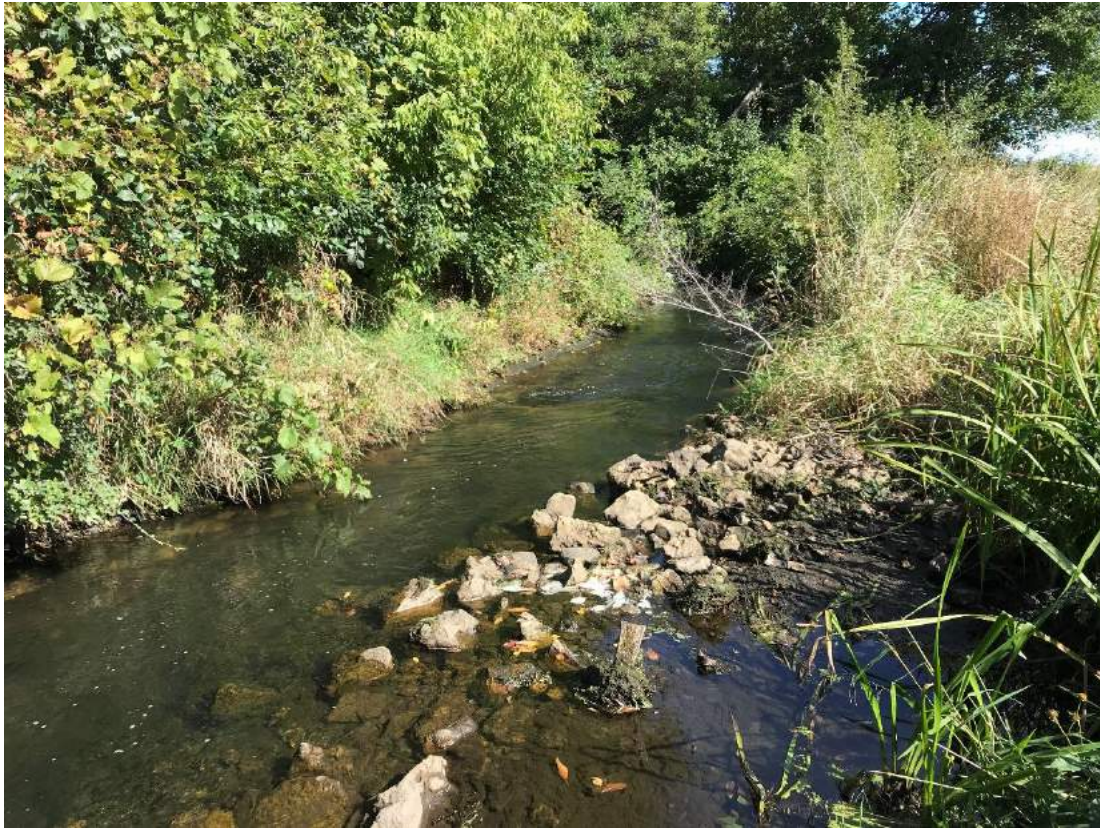
The restored channel in Segment 4A is stable but would benefit from re-positioning of the existing riprap in the channel. There appears to be a sufficient volume of riprap along the right side of the channel to address the minor toe erosion along the left bank (Figure 16). Immediately downstream of the Jackson Trail culvert, the riprap in the center of the channel continues to cause localized bank erosion and channel widening below the culvert (Figure 17). Bank erosion continues to advance within this segment, particularly at sites damaged by previous flood events. In the middle reach of Segment 4B, a recent bank slump was found in 2019 where the toe had been eroded away (Figure 18). In addition, several recently fallen trees were found lying across and within the channel of Segment 4A and were partially affecting flows at high stage (Figure 19, Figure 20). In Segment 4B, the large box elder tree that had fallen over the channel near the upstream end of the segment is still present within the channel. Grazing within the old pastured reach has ceased, resulting in strong regrowth of riparian vegetation along the channel (Figure 21). The removal of cattle from this reach has resulted in a significant improvement to the channel, and the previously trampled stream banks are beginning to self-heal. Bank erosion is now limited to the areas where vertical banks exist (Figure 22).

Figure 16. Channel condition of Segment 4A downstream of Pike Lake Road

- Re-position existing riprap along restored channel in Segment 4A
- Continue inspections in 2020 and monitor FEMA funded bank repairs when completed
- Remove fallen trees within the channel between the Gonyea culvert and the idle pasture in Segment 4B

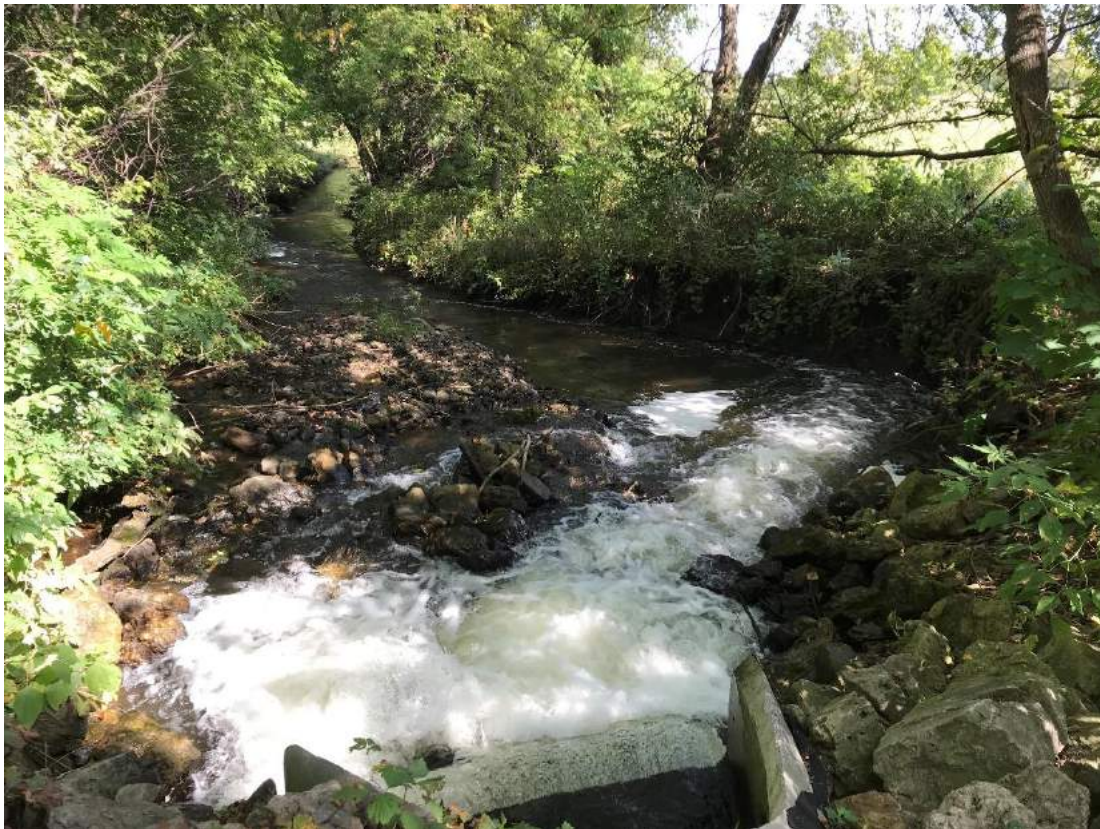
Figure 17. Riprap downstream of the Jackson Trail culvert causing bank erosion along the right bank
