Project Name | PLOC Channel Inspections**Date** | 12/10/2019**To / Contact info** | Diane Lynch, Jaime Rockney**Cc / Contact info** | Carl Almer**From / Contact info** | Mike Majeski**Regarding** | Channel and Vegetation Inspections – 2019 Summary

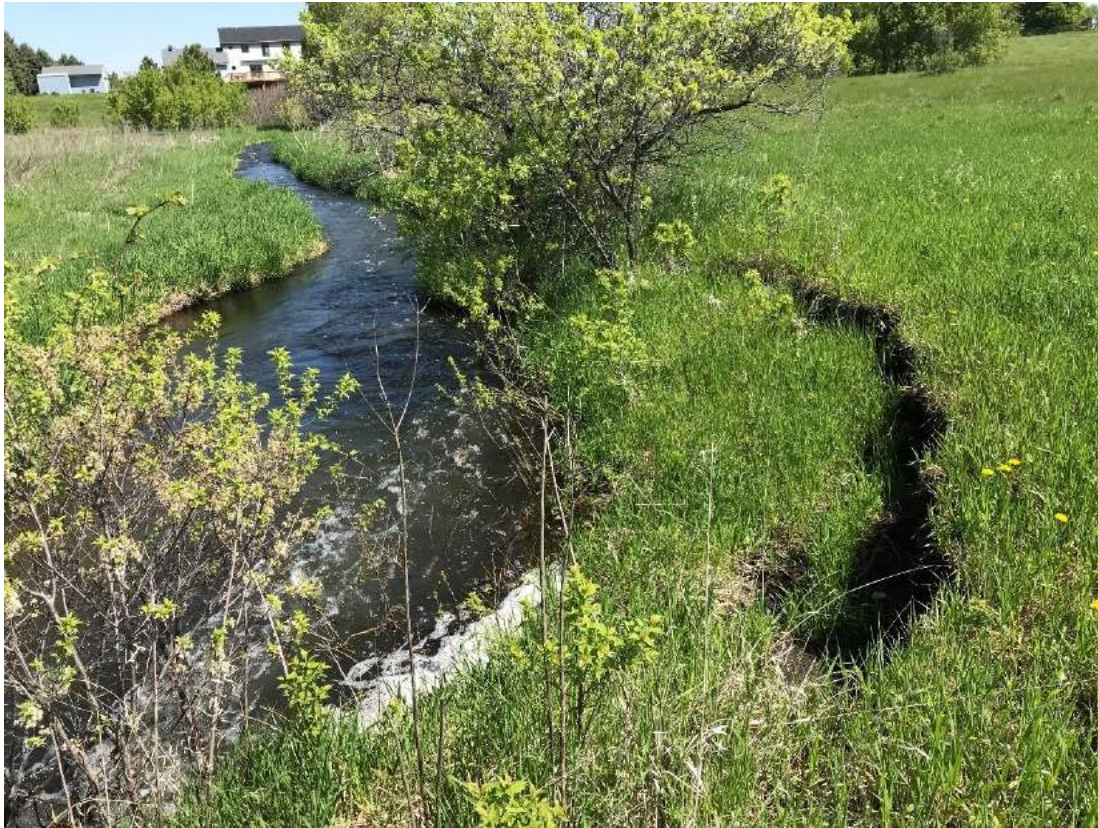
The restored channel in Segment 4A is stable but would benefit from re-positioning of the existing riprap in the channel. There appears to be a sufficient volume of riprap along the right side of the channel to address the minor toe erosion along the left bank (Figure 16). Immediately downstream of the Jackson Trail culvert, the riprap in the center of the channel continues to cause localized bank erosion and channel widening below the culvert (Figure 17). Bank erosion continues to advance within this segment, particularly at sites damaged by previous flood events. In the middle reach of Segment 4B, a recent bank slump was found in 2019 where the toe had been eroded away (Figure 18). In addition, several recently fallen trees were found lying across and within the channel of Segment 4A and were partially affecting flows at high stage (Figure 19, Figure 20). In Segment 4B, the large box elder tree that had fallen over the channel near the upstream end of the segment is still present within the channel. Grazing within the old pastured reach has ceased, resulting in strong regrowth of riparian vegetation along the channel (Figure 21). The removal of cattle from this reach has resulted in a significant improvement to the channel, and the previously trampled stream banks are beginning to self-heal. Bank erosion is now limited to the areas where vertical banks exist (Figure 22).

Figure 18. Recent rotational slump within the middle reach of Segment 4A

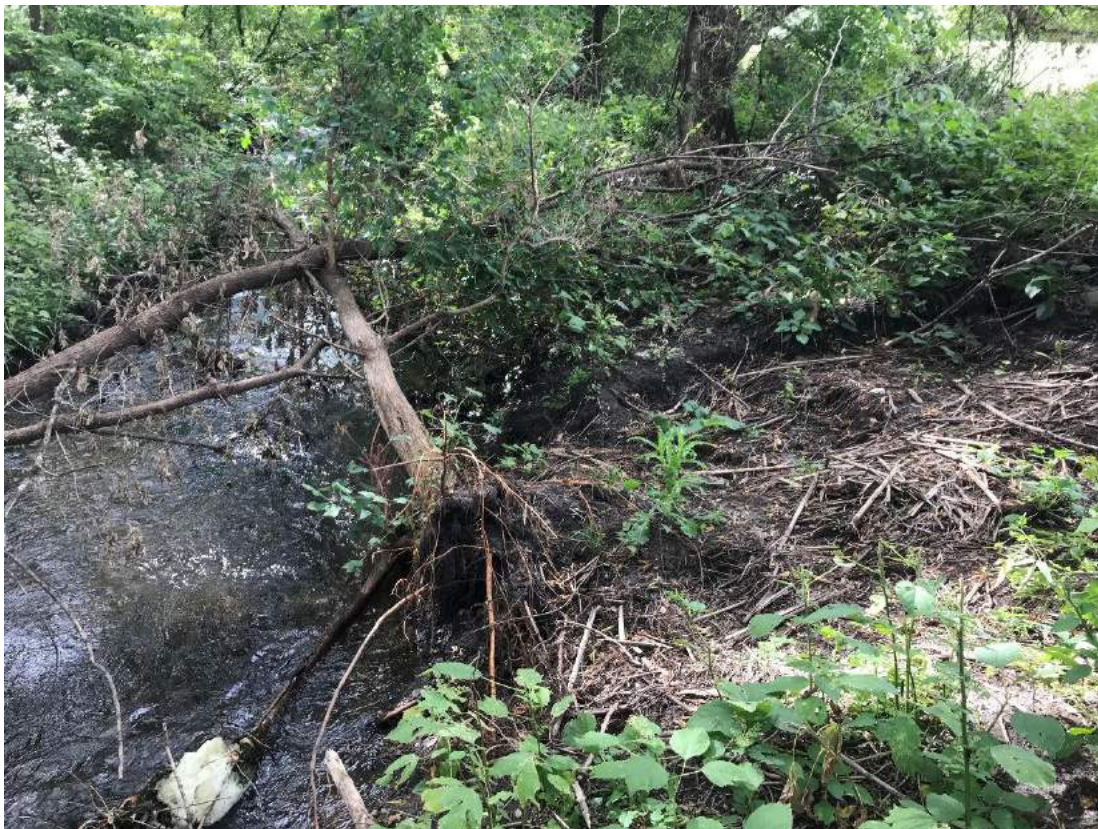
Figure 19. Down trees over the channel downstream of the Gonyea culvert in Segment 4A

- Re-position existing riprap along restored channel in Segment 4A
- Continue inspections in 2020 and monitor FEMA funded bank repairs when completed
- Remove fallen trees within the channel between the Gonyea culvert and the idle pasture in Segment 4B

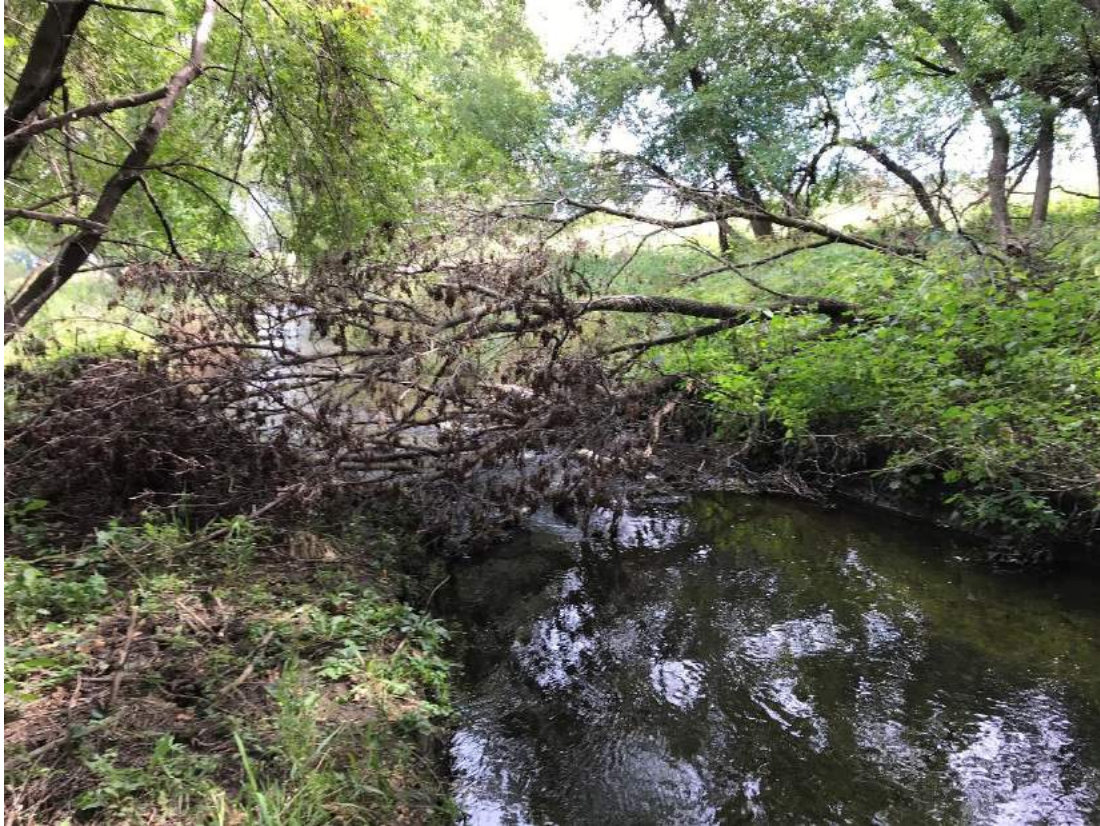
Figure 20. Fallen box elder tree over the channel at the fence crossing at upstream end of the idle pasture

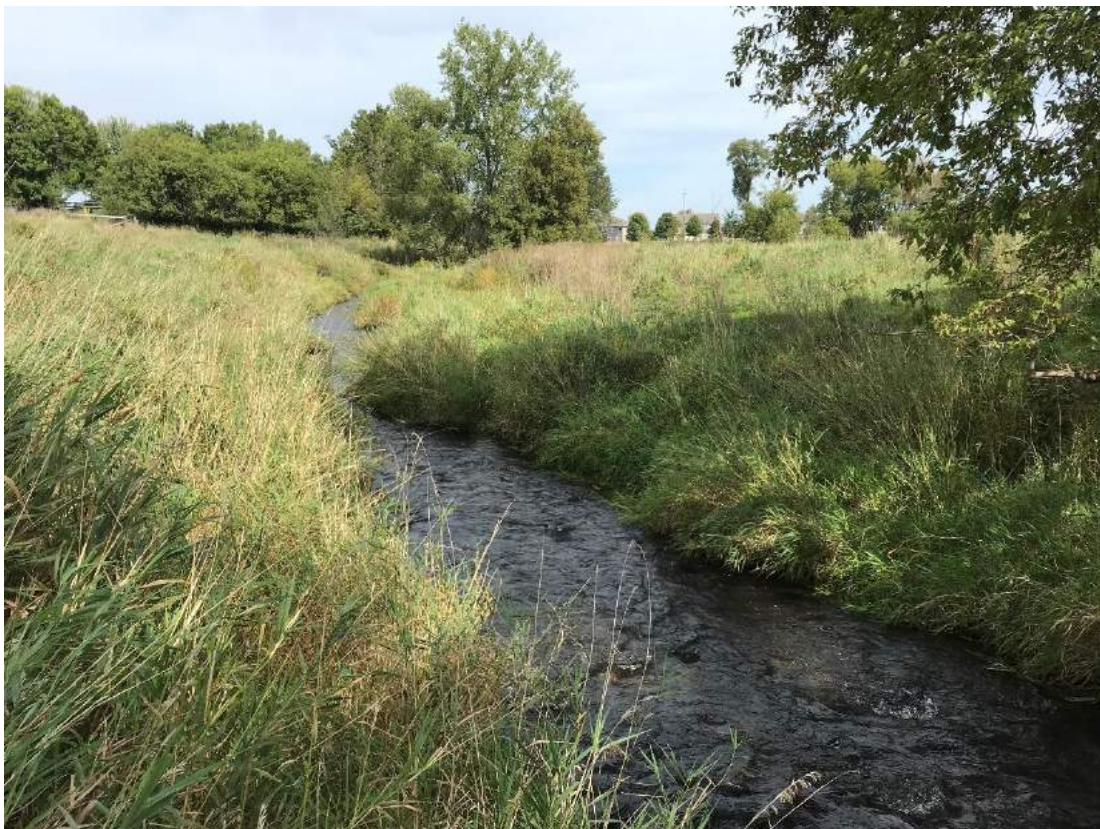
Figure 21. Self-healing stream banks and regrowth of riparian vegetation within the idle pasture of Segment 4B

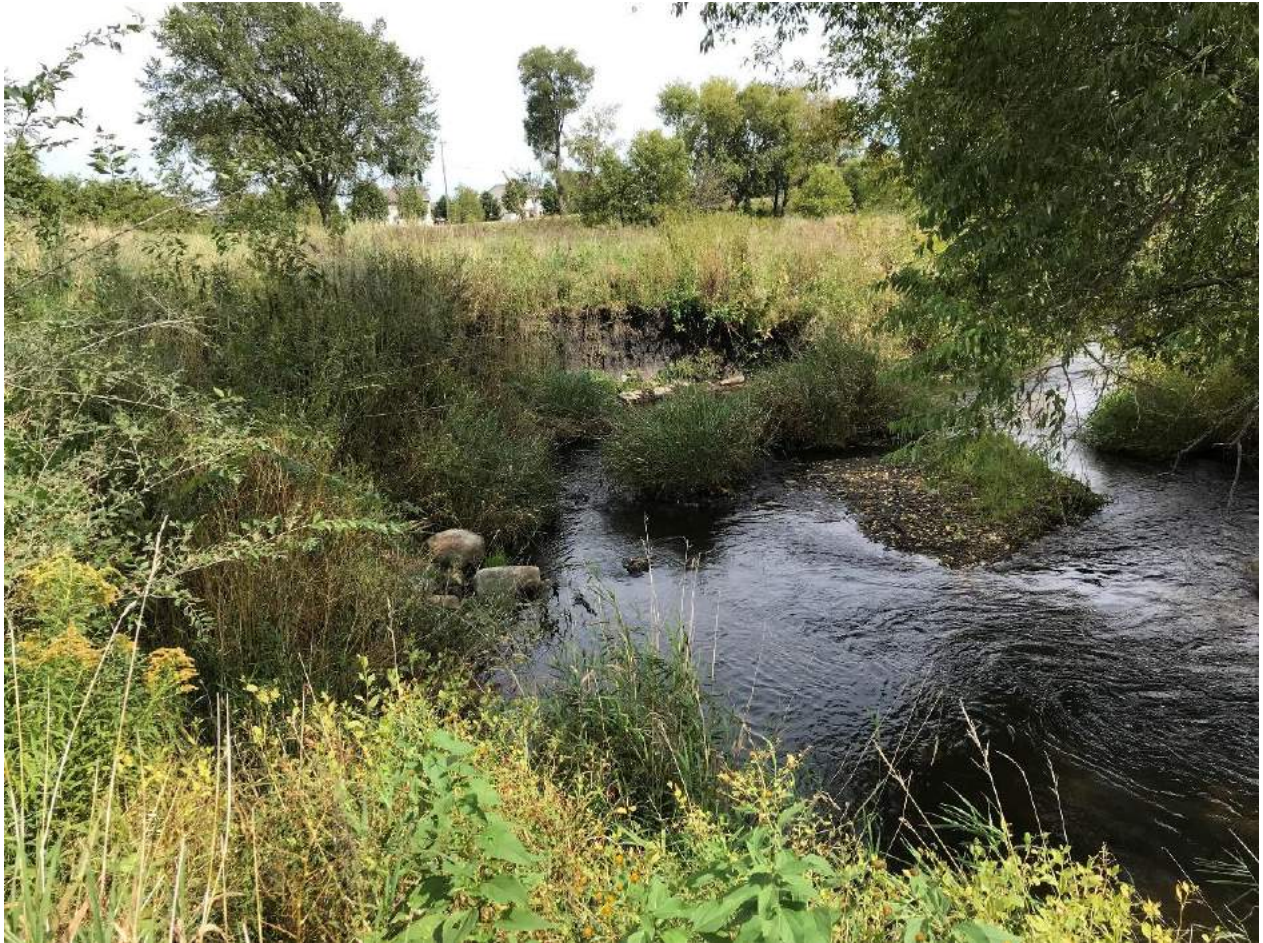
Figure 22. Vertical bank erosion continues in areas previously documented in Segment 4B

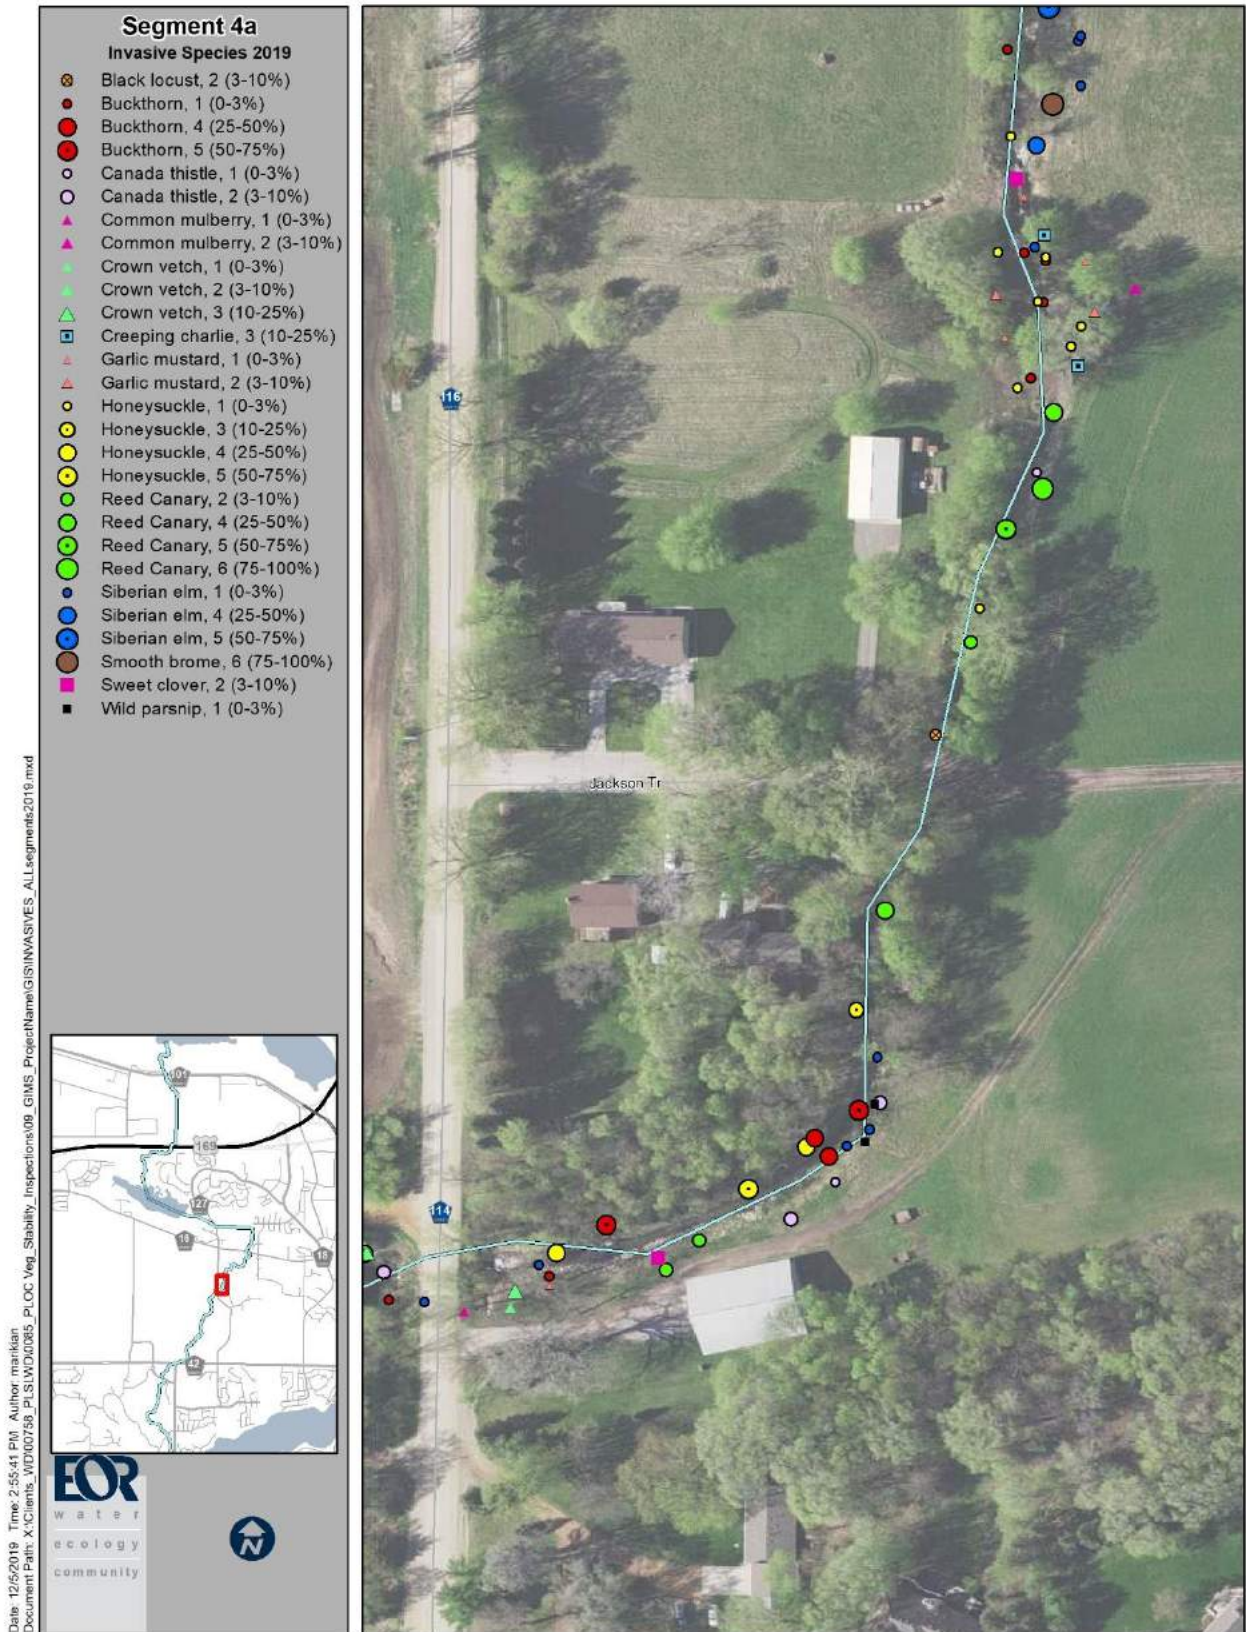
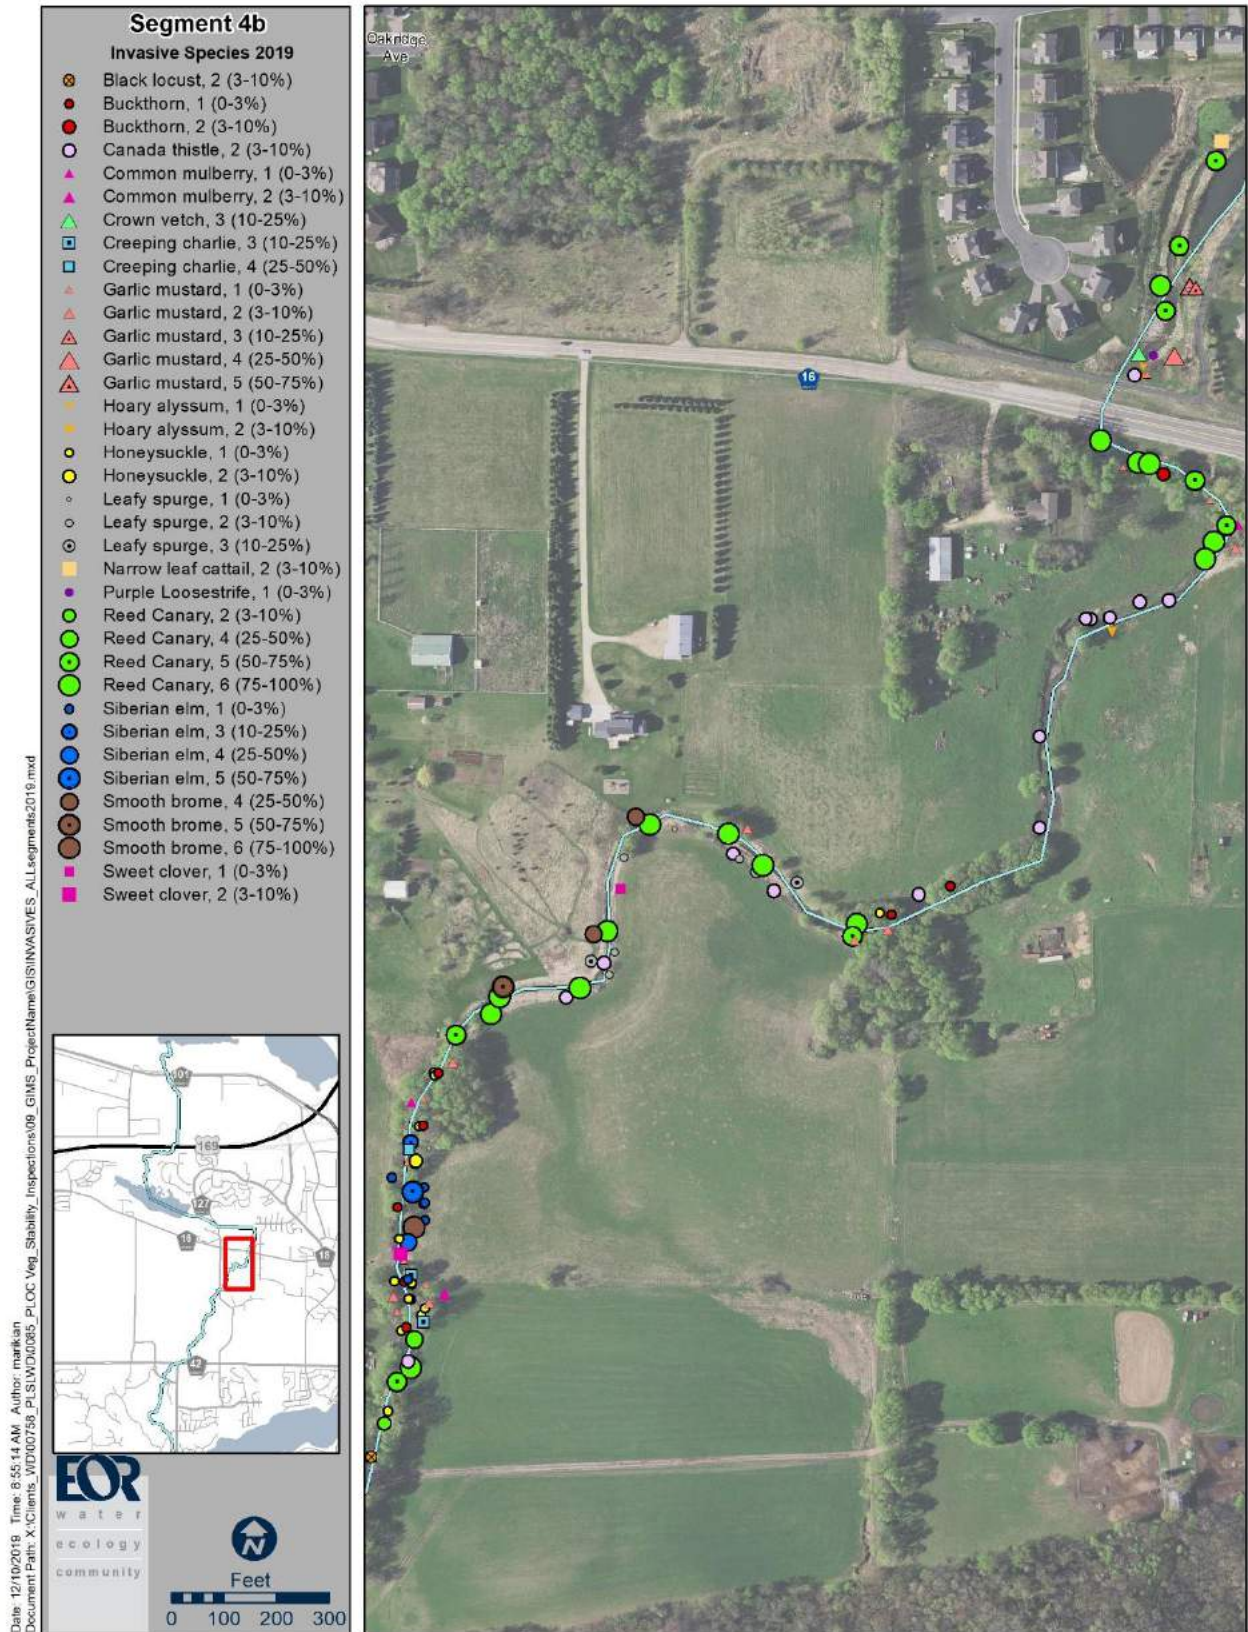
In May 2019, eight wild parsnip plants were found in the restored reach in Segment 4A. In addition, several patches of garlic mustard (*Alliaria petiolata*) containing over 50 plants were also found. Reconnaissance for purple loosestrife was conducted in July 2019 but no plants were found in the areas that were previously managed. Monitoring for wild parsnip and purple loosestrife should continue in 2020 to determine if any new plants exist in the area. Any basal rosettes found should be treated with herbicide, with follow-up inspections and treatments conducted in early July to prevent the plants from maturing and producing seed. Common buckthorn and bush honeysuckle saplings were found in areas previously managed. Continued foliar spray treatments will be needed to reduce the population of the saplings in this segment. Figure 23 and Figure 24 show the locations and areal coverages of previously identified invasive species in this segment.

Figure 23. Invasive species and associated areal coverages (in parenthesis) along Segment 4A

- Scout and treat for woody invasive species in areas not addressed by the proposed FEMA bank repair work
- Scout and treat for purple loosestrife and wild parsnip in areas previously managed. Conduct the work in June or early July to prevent plants from maturing and producing seed

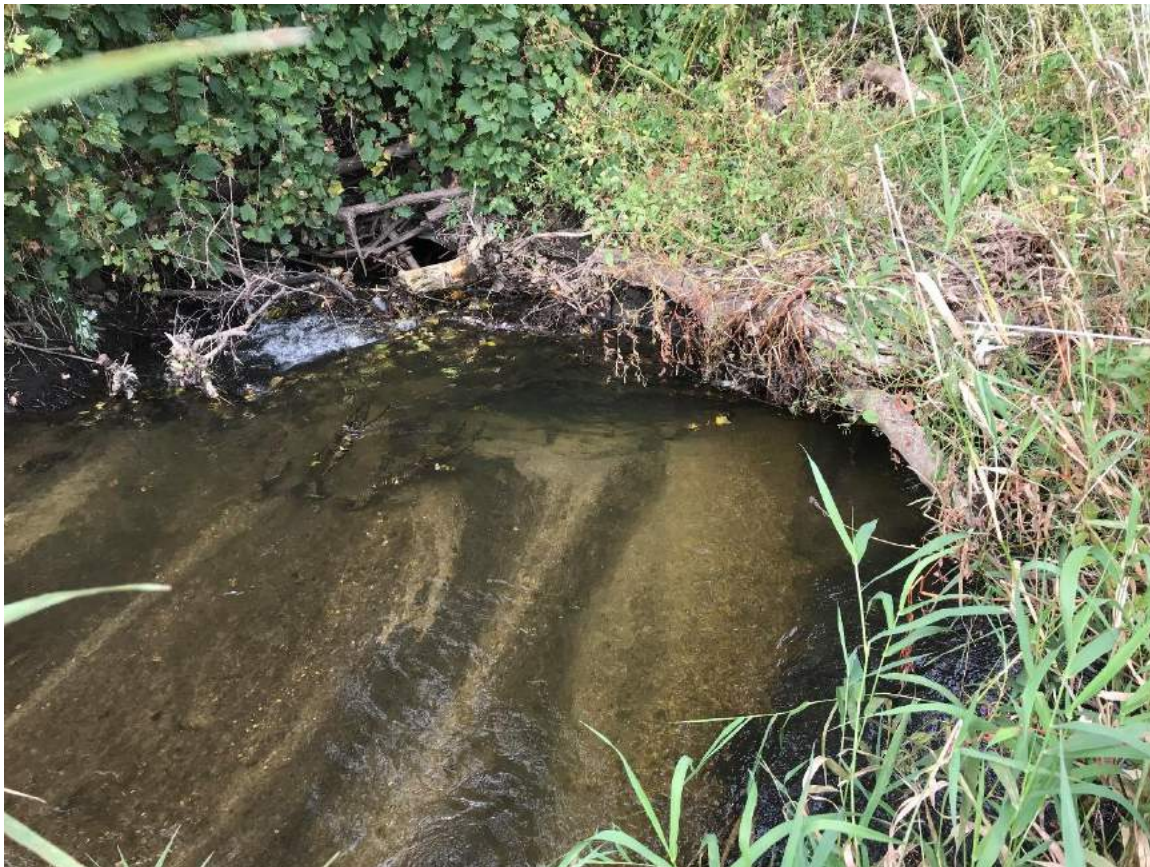
A small debris obstruction was observed at the upstream end of the twin culverts where the channel bends 90-degrees to the west in Segment 5B (Figure 25). Several recently fallen trees were found lying across and within the channel in Segment 5B, some of which are partially affecting flow (Figure 26, Figure 27). In addition, a small beaver dam was found within the channel between the old field road crossings in Segment 5B (Figure 28). The channel banks throughout this segment are in fair condition with reed canary grass (*Phalaris arundinacea*) and tree roots providing ample surface protection in most areas. However, stream banks that were damaged by previous flood events continue to erode. A large sediment delta has re-developed within the pond located downstream of Pike Lake Road (Figure 29).

Figure 25. Debris obstruction at the upstream end of twin culverts located at the 90-degree ditch bend

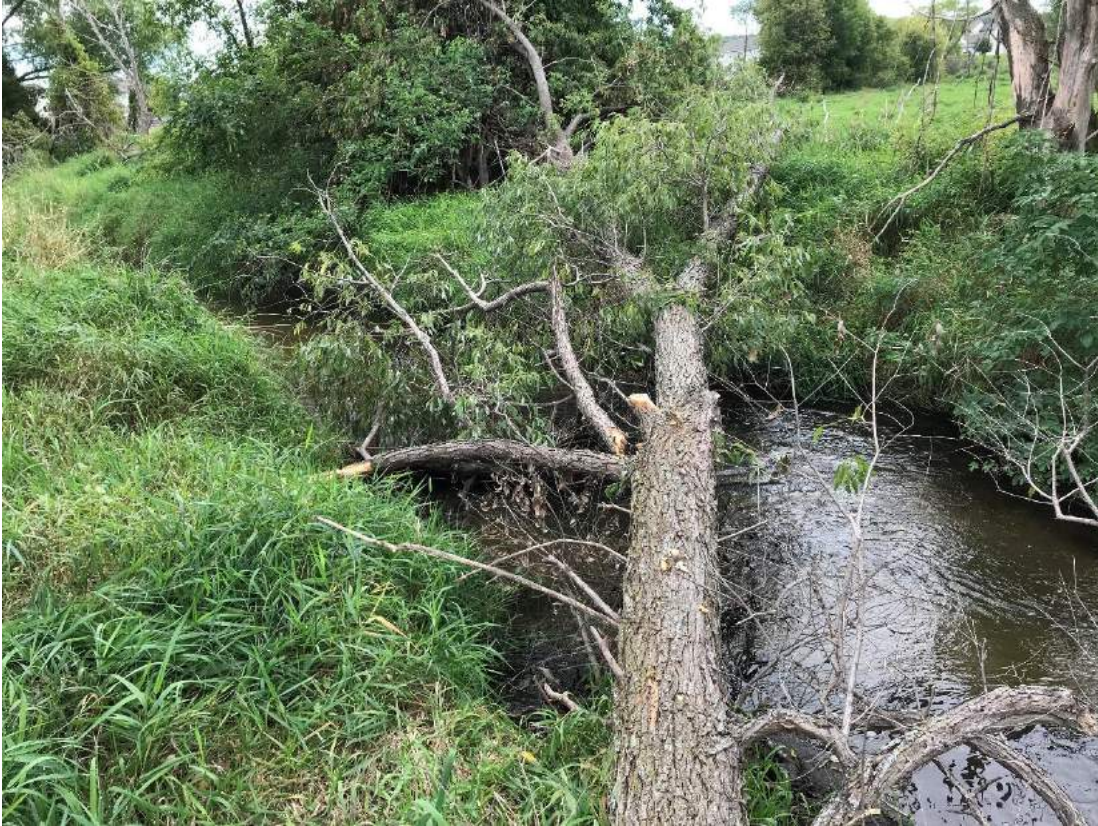
Figure 26. Fallen willow tree over the channel in Segment 5B

- Remove fallen trees within the channel between the 90-degree ditch bend and Pike Lake Road, continue inspections in 2020

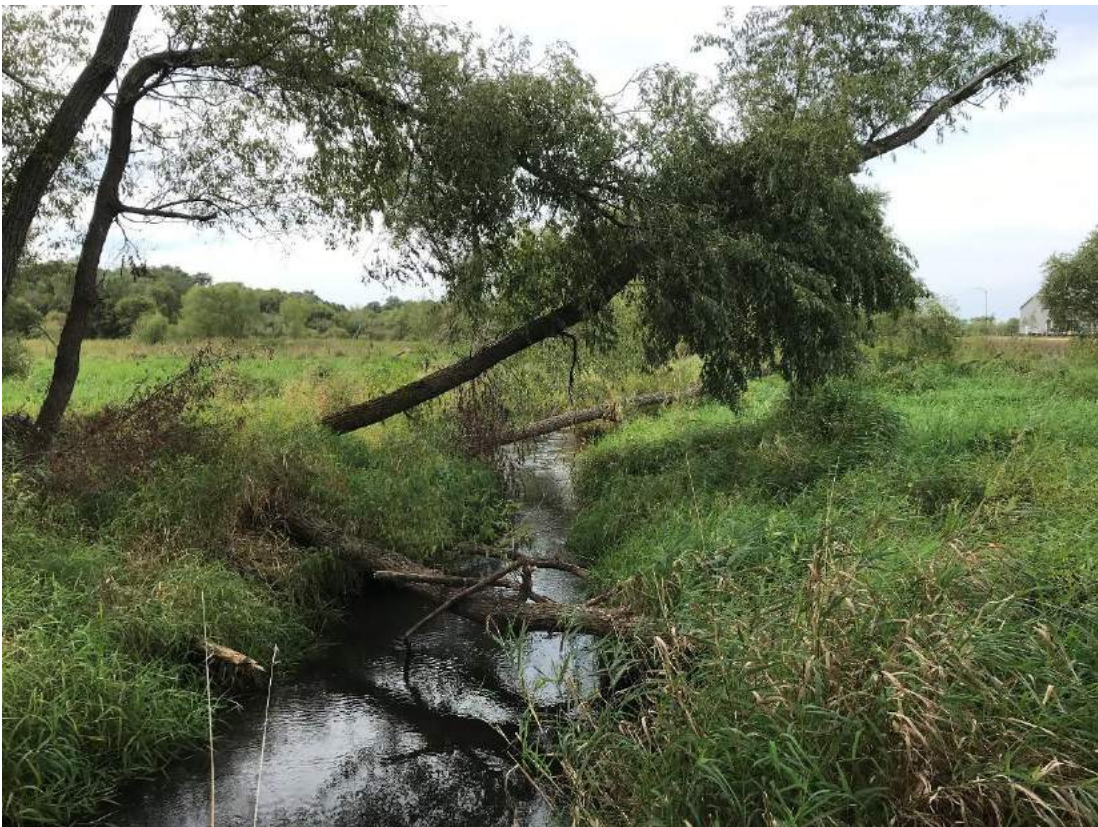
Figure 27. Several fallen trees over the channel in Segment 5B

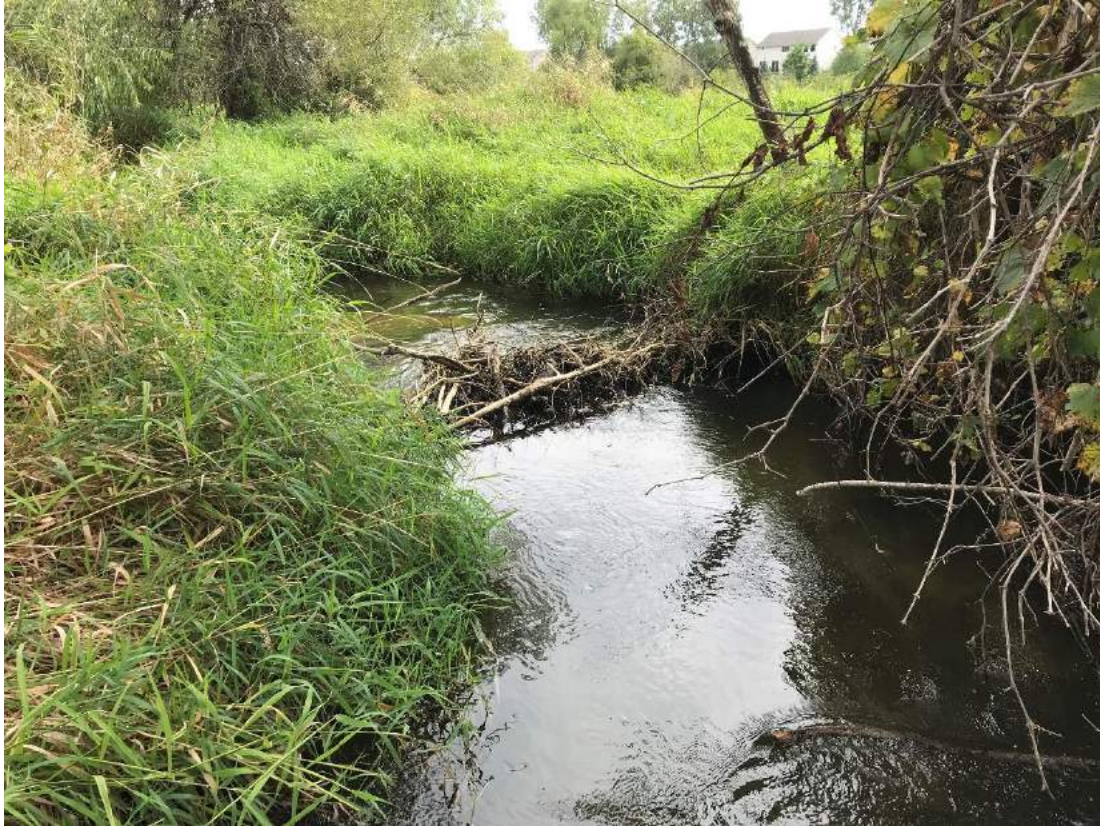
Figure 28. Small beaver dam within Segment 5B

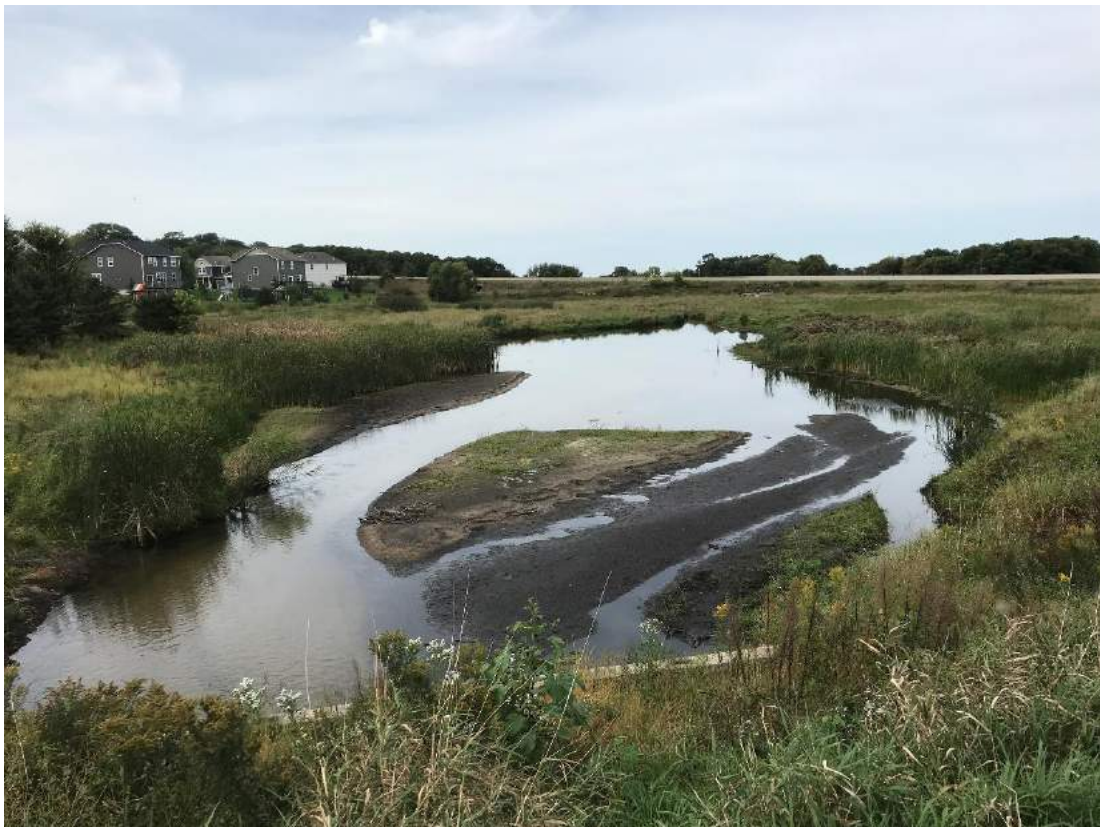
Figure 29. Sediment delta located downstream of Pike Lake Road (Segment 5C)

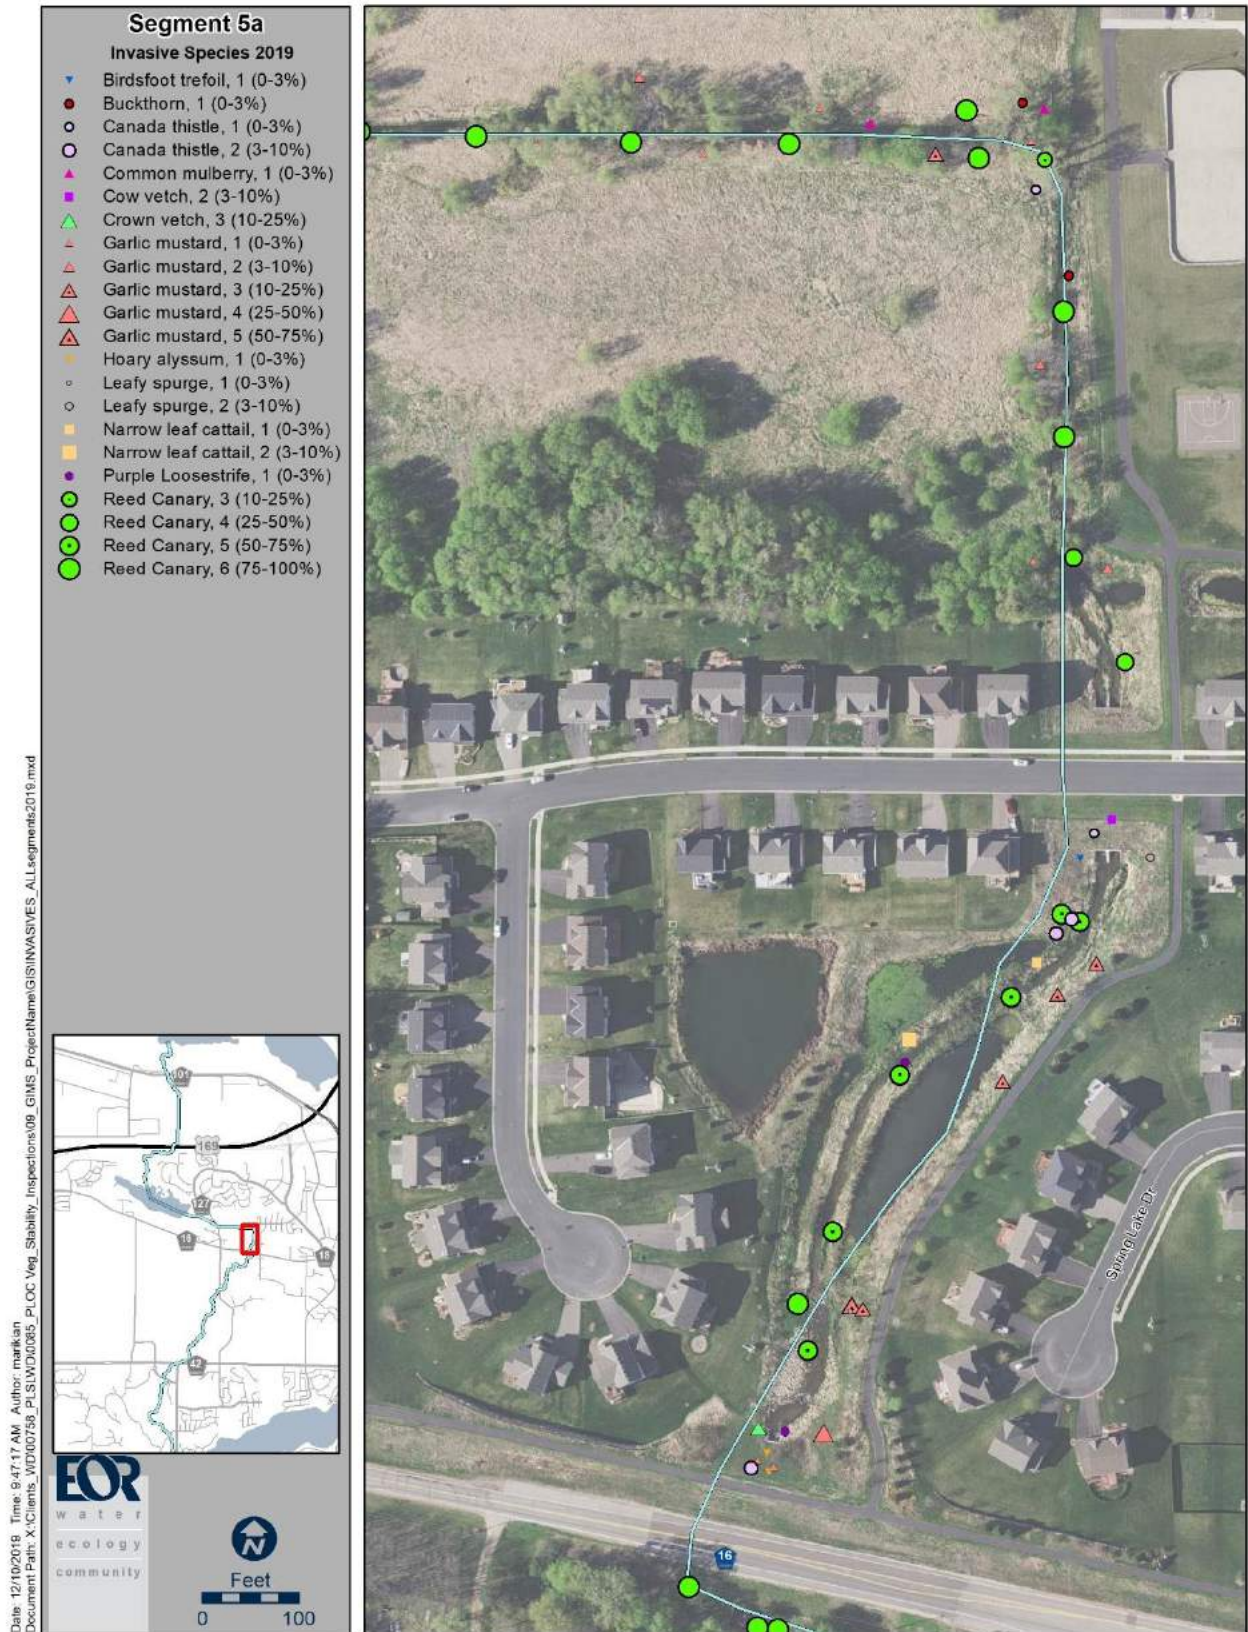
The management efforts to treat purple loosestrife located downstream of the CR 16 box culverts in Segment 5A were successful. Only one plant was found during the July inspection, and the plant was dug out by hand to remove the root system. This area should be monitored closely again in the summer of 2020 and any new plants should be promptly treated or removed before flowers develop. Purple loosestrife management in this area is particularly important since this site is located adjacent to three large wetland/pond areas and connects to other downstream wetlands, as well as Deans Lake. Figure 30-Figure 32 show the locations and areal coverages of previously identified invasive species in this segment.

Figure 30. Invasive species and associated areal coverages (in parenthesis) along Segment 5A

- Scout and treat for purple loosestrife in areas that were managed downstream of County Road 16 in Segment 5A. Conduct the work in early July to prevent plants from maturing and producing seed

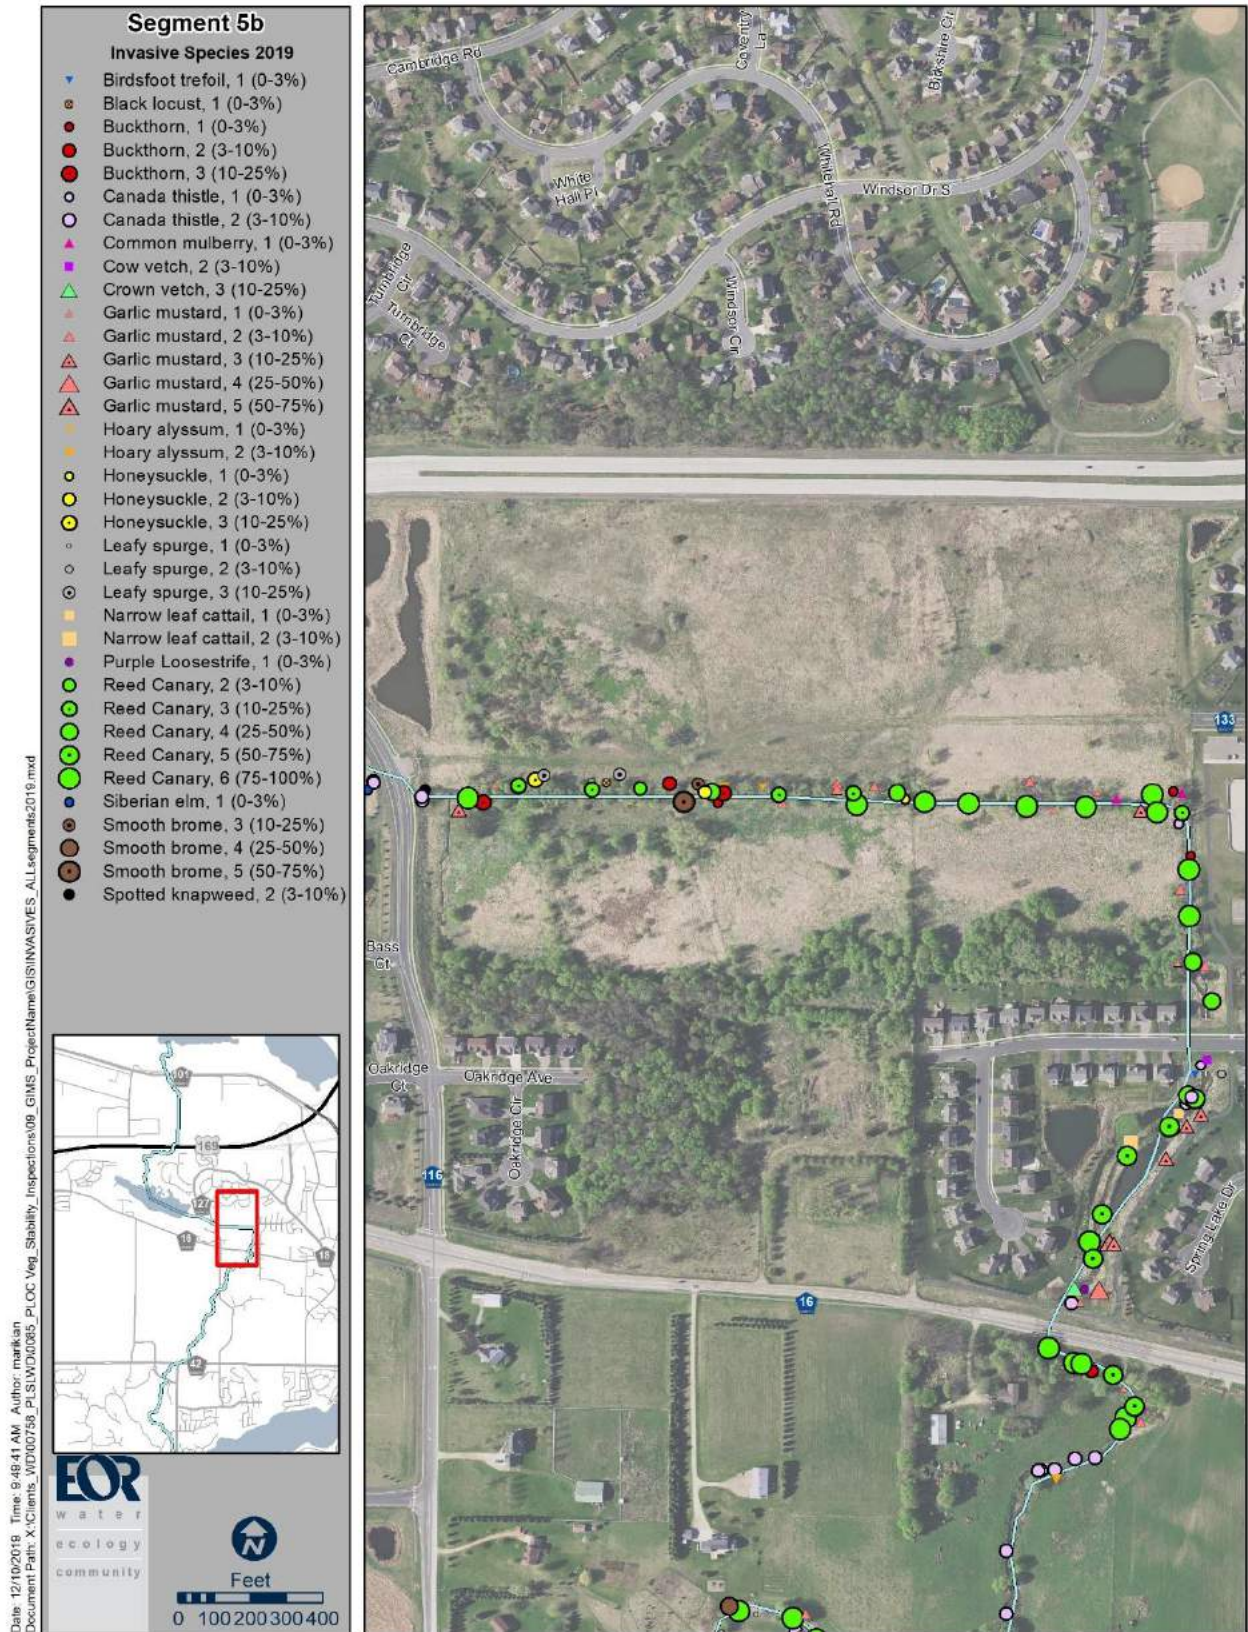
Figure 31. Invasive species and associated areal coverages (in parenthesis) along Segment 5B

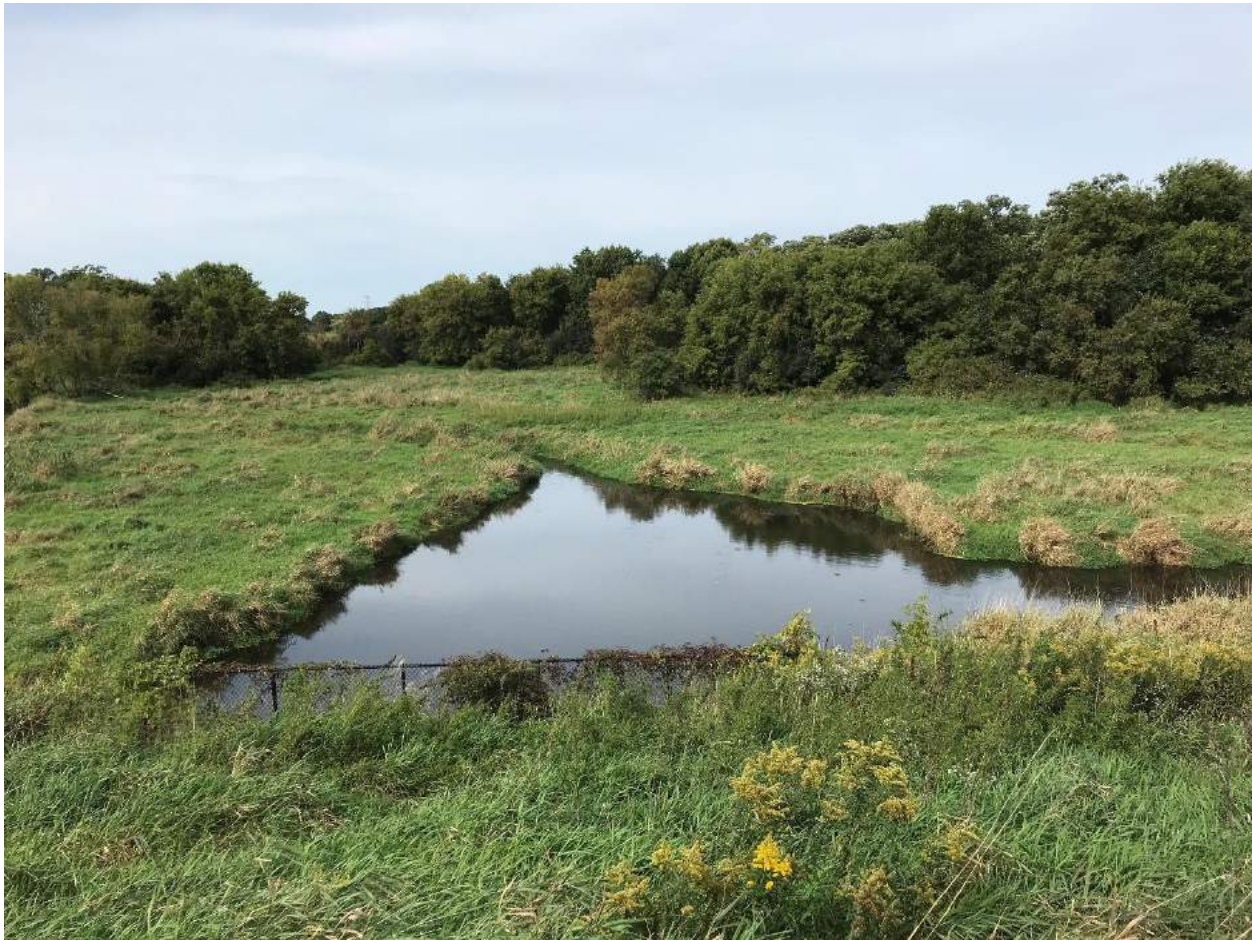
The small sediment delta documented in 2018 was not visible during the 2019 assessments but likely still occurs at the upstream end of the bypass channel downstream of the County Road 21 box culverts (Figure 33). No other channel obstructions were found in this segment. The Deans Lake weir appears to be in good condition and was free of debris at the time of the surveys. The channel banks throughout this segment are well vegetated and show little evidence of bank erosion (Figure 34 and Figure 35).

Figure 33. Channel downstream of County Road 21

- Remove the sediment delta at the upstream end of the Deans Lake bypass channel located downstream of County Road 21. Continue inspections in 2020

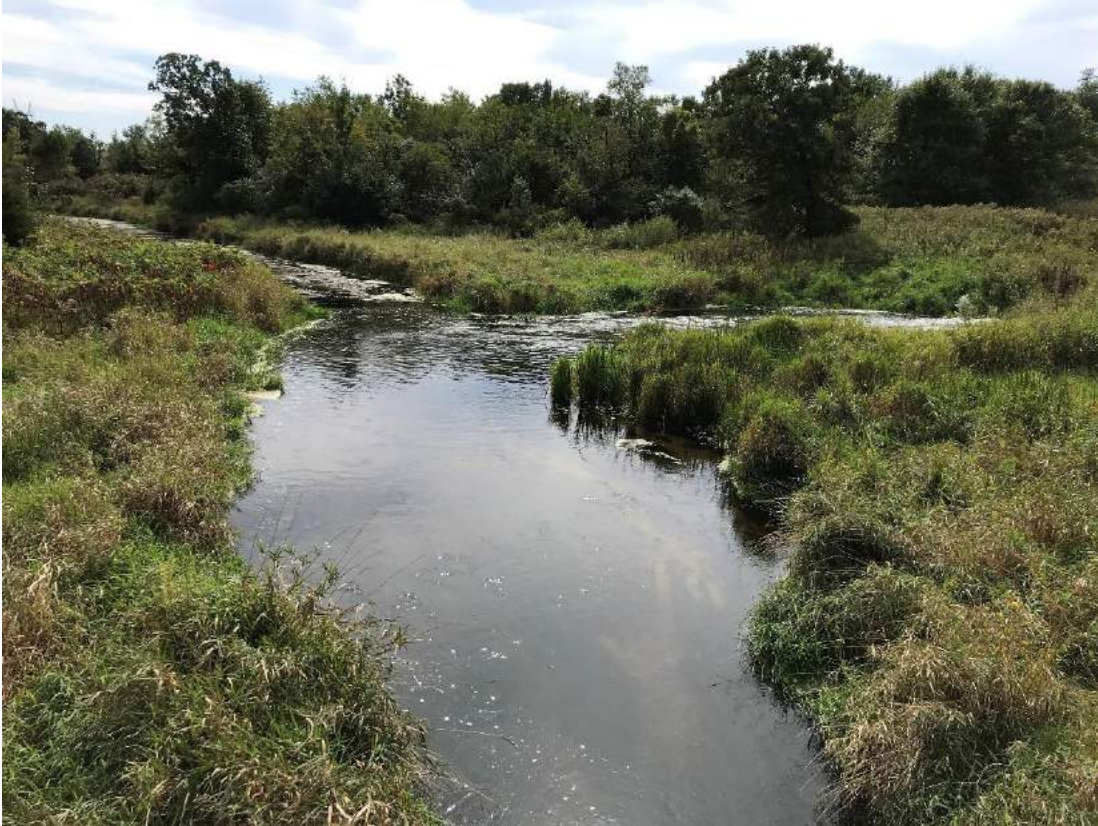
Figure 34. Vegetated stream banks downstream of the Deans Lake weir

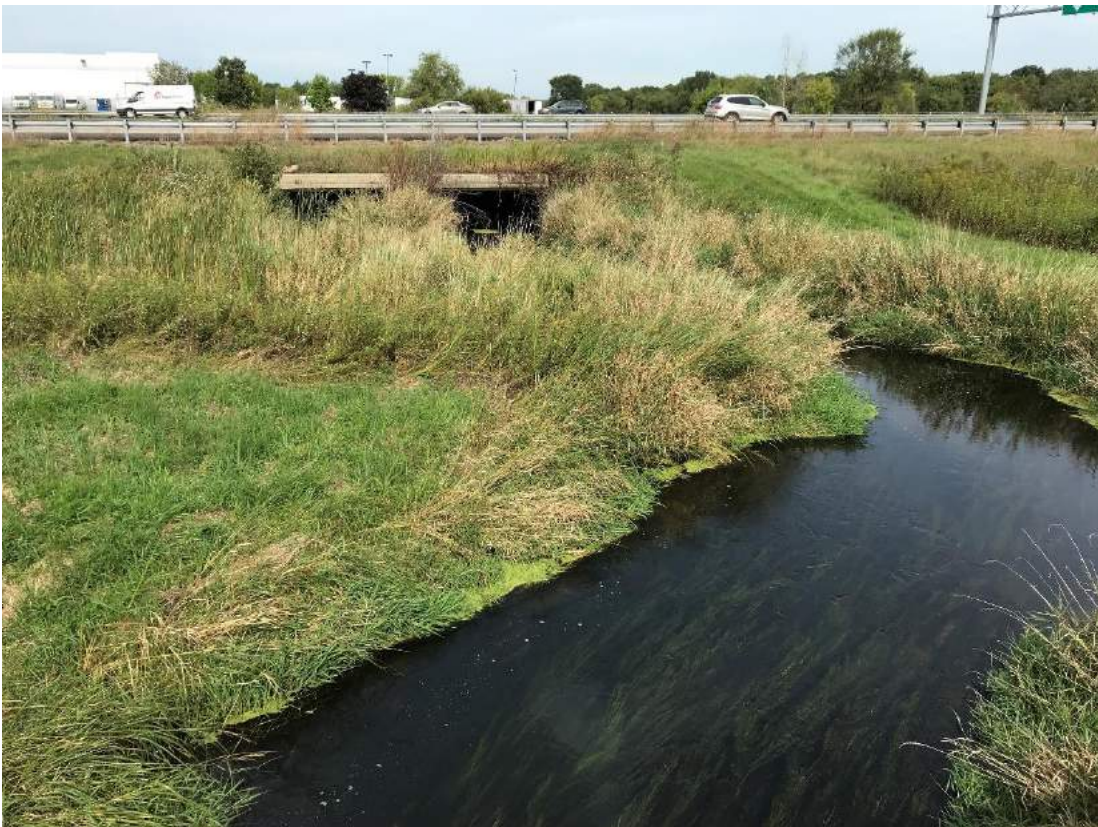
Figure 35. Vegetated stream banks upstream of Highway 169
