Project Name | PLOC Channel Inspections**Date** | 12/10/2019**To / Contact info** | Diane Lynch, Jaime Rockney**Cc / Contact info** | Carl Almer**From / Contact info** | Mike Majeski**Regarding** | Channel and Vegetation Inspections – 2019 Summary

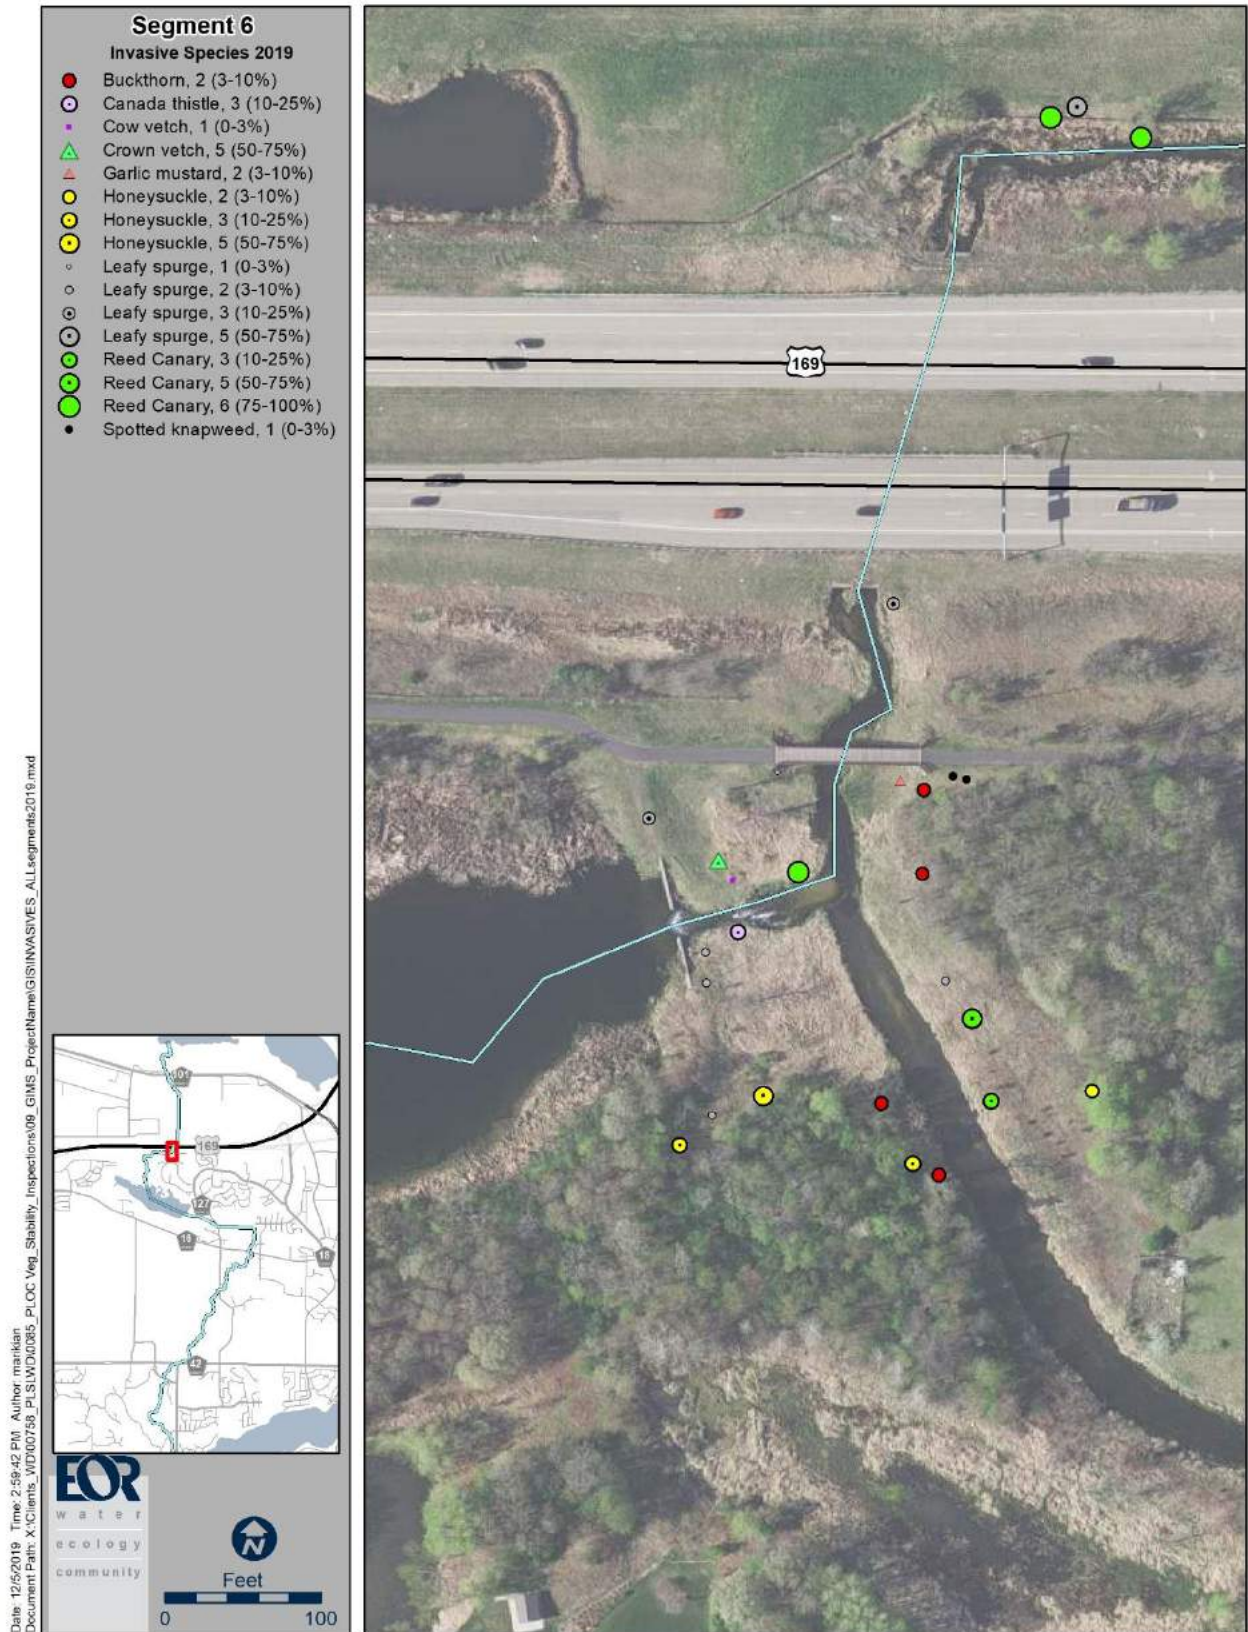
No purple loosestrife plants were found downstream of the Dean's Lake weir where management was conducted in 2017. Although no plants were found in 2018 or 2019, it is recommended this area continue to be monitored in the summer of 2020 and any new plants should be promptly removed before flowers develop. Treatment and/or removal of purple loosestrife in this area is particularly important since the site is located near Deans Lake and connects to other downstream wetlands. Figure 36 shows the locations and areal coverages of previously identified invasive species in this segment.

Figure 36. Invasive species and associated areal coverages (in parenthesis) along Segment 6

- Scout and treat for purple loosestrife immediately downstream of Deans Lake weir. Conduct the work in early July to prevent plants from maturing and producing seed

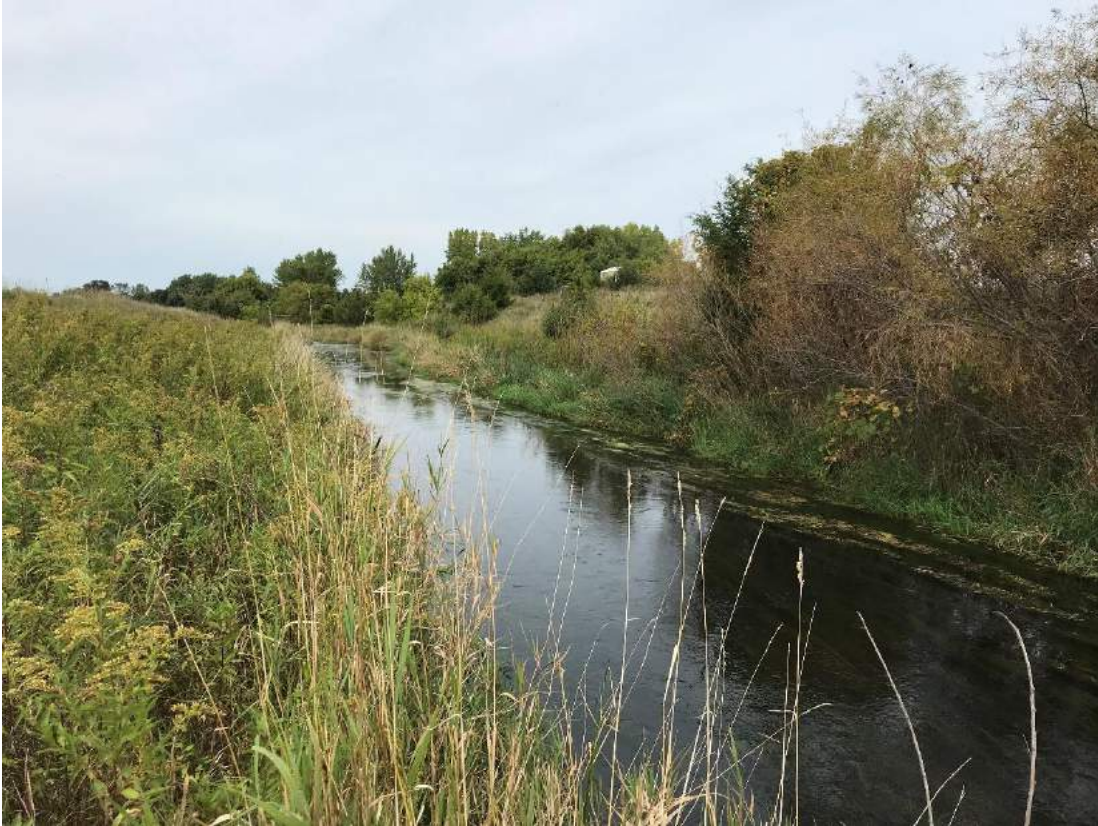
The channel banks downstream of Highway 169 are well vegetated and show little evidence of bank erosion (Figure 37). The sheet pile weirs located in this segment were mostly free of debris during the surveys. No channel obstructions were found within this segment; however, bank erosion continues to occur in areas damaged by previous flood events, particularly at the far downstream end of Segment 7A. A recent bank failure was found just upstream of Quarry Lake Park (Figure 38). The bank failure resulted in a large amount of sediment that entered the outlet channel, though it appears the sediment was transported downstream as there was little indication of localized flow deflection or channel aggradation from the sediment. In Segment 7A, a tree had recently fallen into the channel as a result of bank erosion (Figure 39). In Segment 7B, woody debris still occurs within the channel as previously documented, including the large oak tree that had fallen into the channel in 2016 that is still partially obstructing flow (Figure 40). Bank erosion in Segment 7B continues to occur in areas previously damaged by flood events. Several trees growing on the channel banks have undercut root boles and will likely fall into the channel if the banks are not restored. Vegetation has become well established in the reach where the Metropolitan Council Environmental Services interceptor work was completed in the summer of 2017 (Figure 41).

Figure 37. Vegetated stream banks in the upper reach of Segment 7A

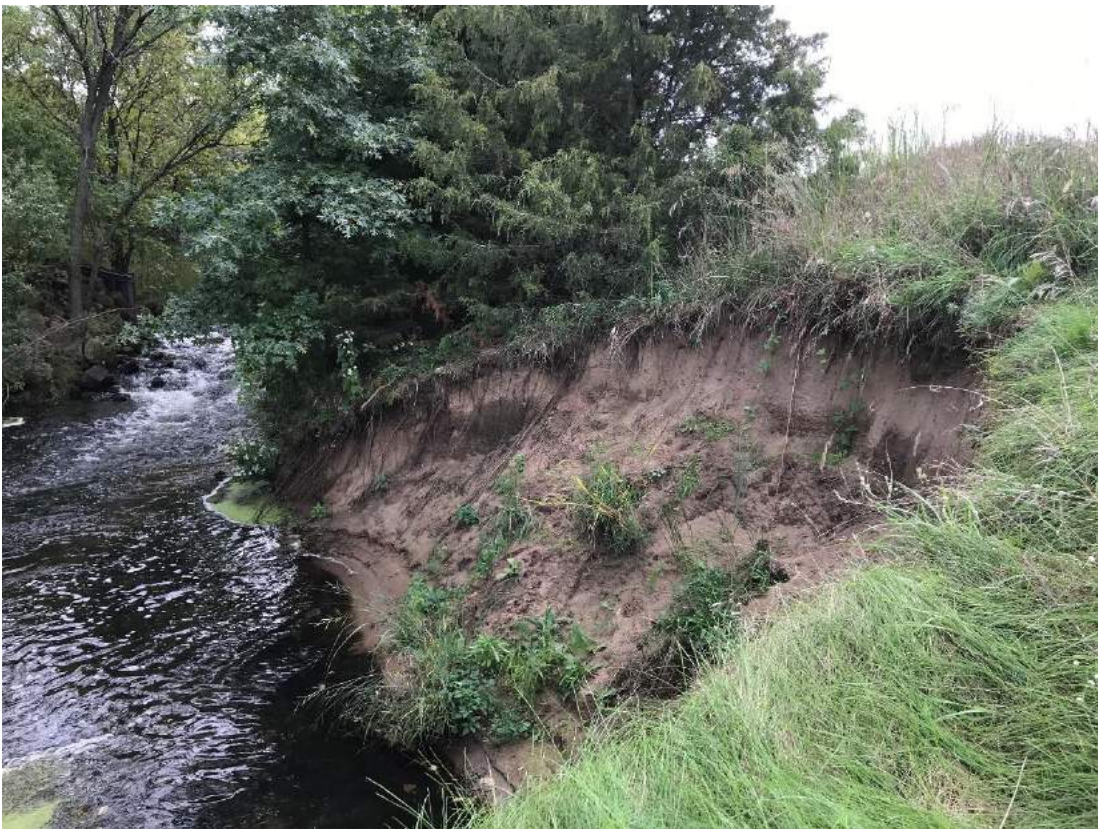
Figure 38. Large bank collapse upstream of Quarry Lake Park in Segment 7A

- Continue inspections in 2020 and monitor FEMA funded bank repairs when completed

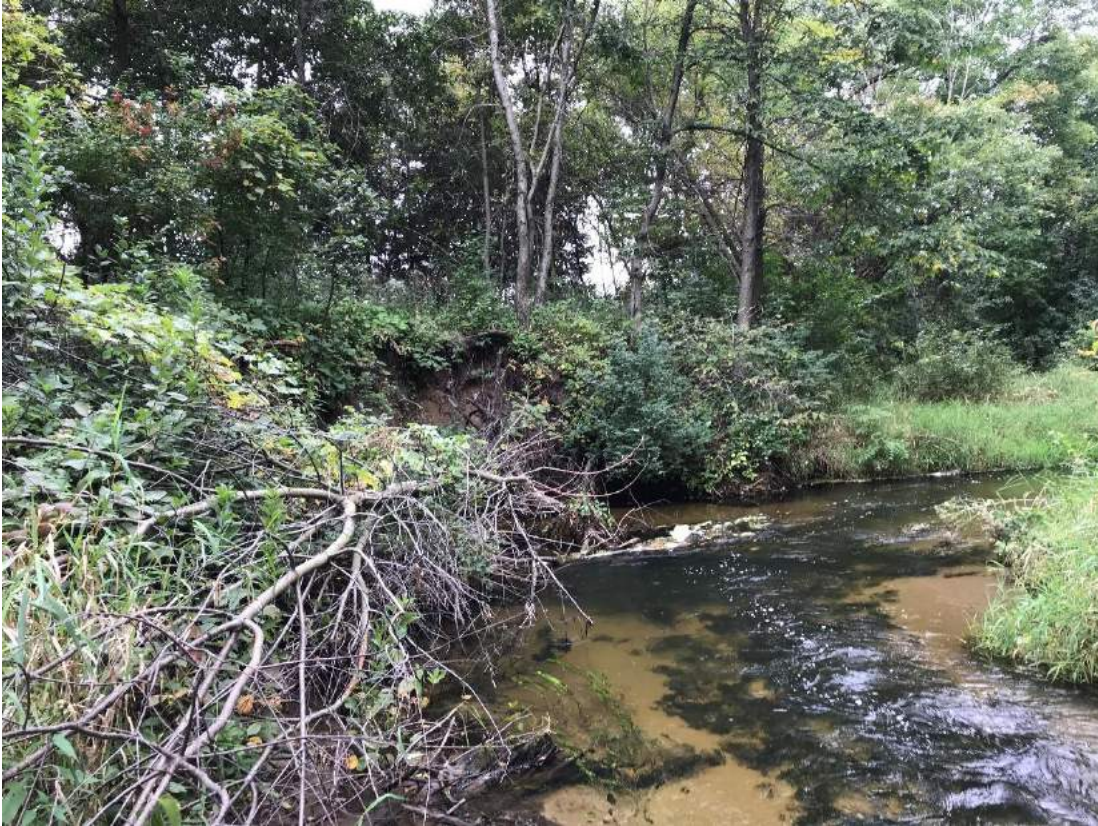
Figure 39. Bank erosion and fallen tree in the wooded reach of Segment 7A

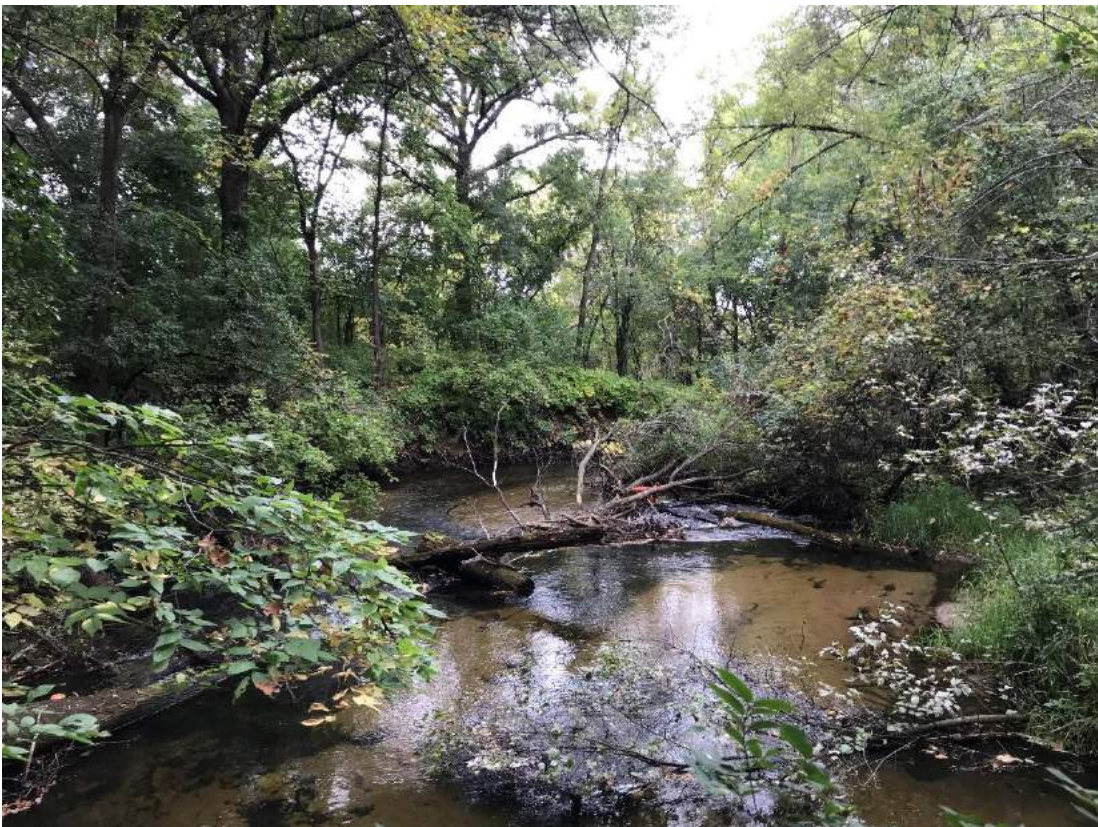
Figure 40. Fallen tree within the channel of Segment 7B

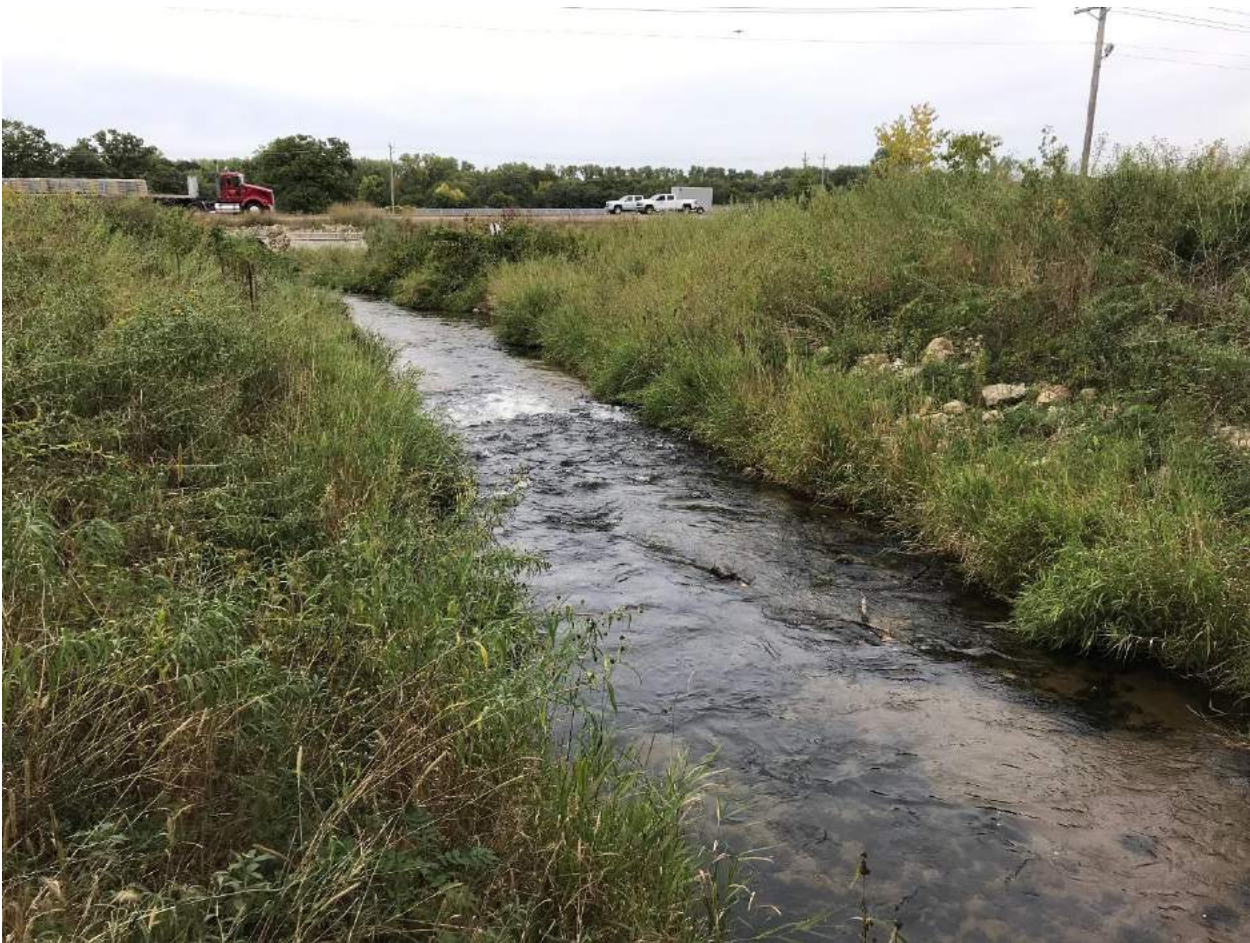
Figure 41. Channel condition of Segment 7B just upstream of Highway 101

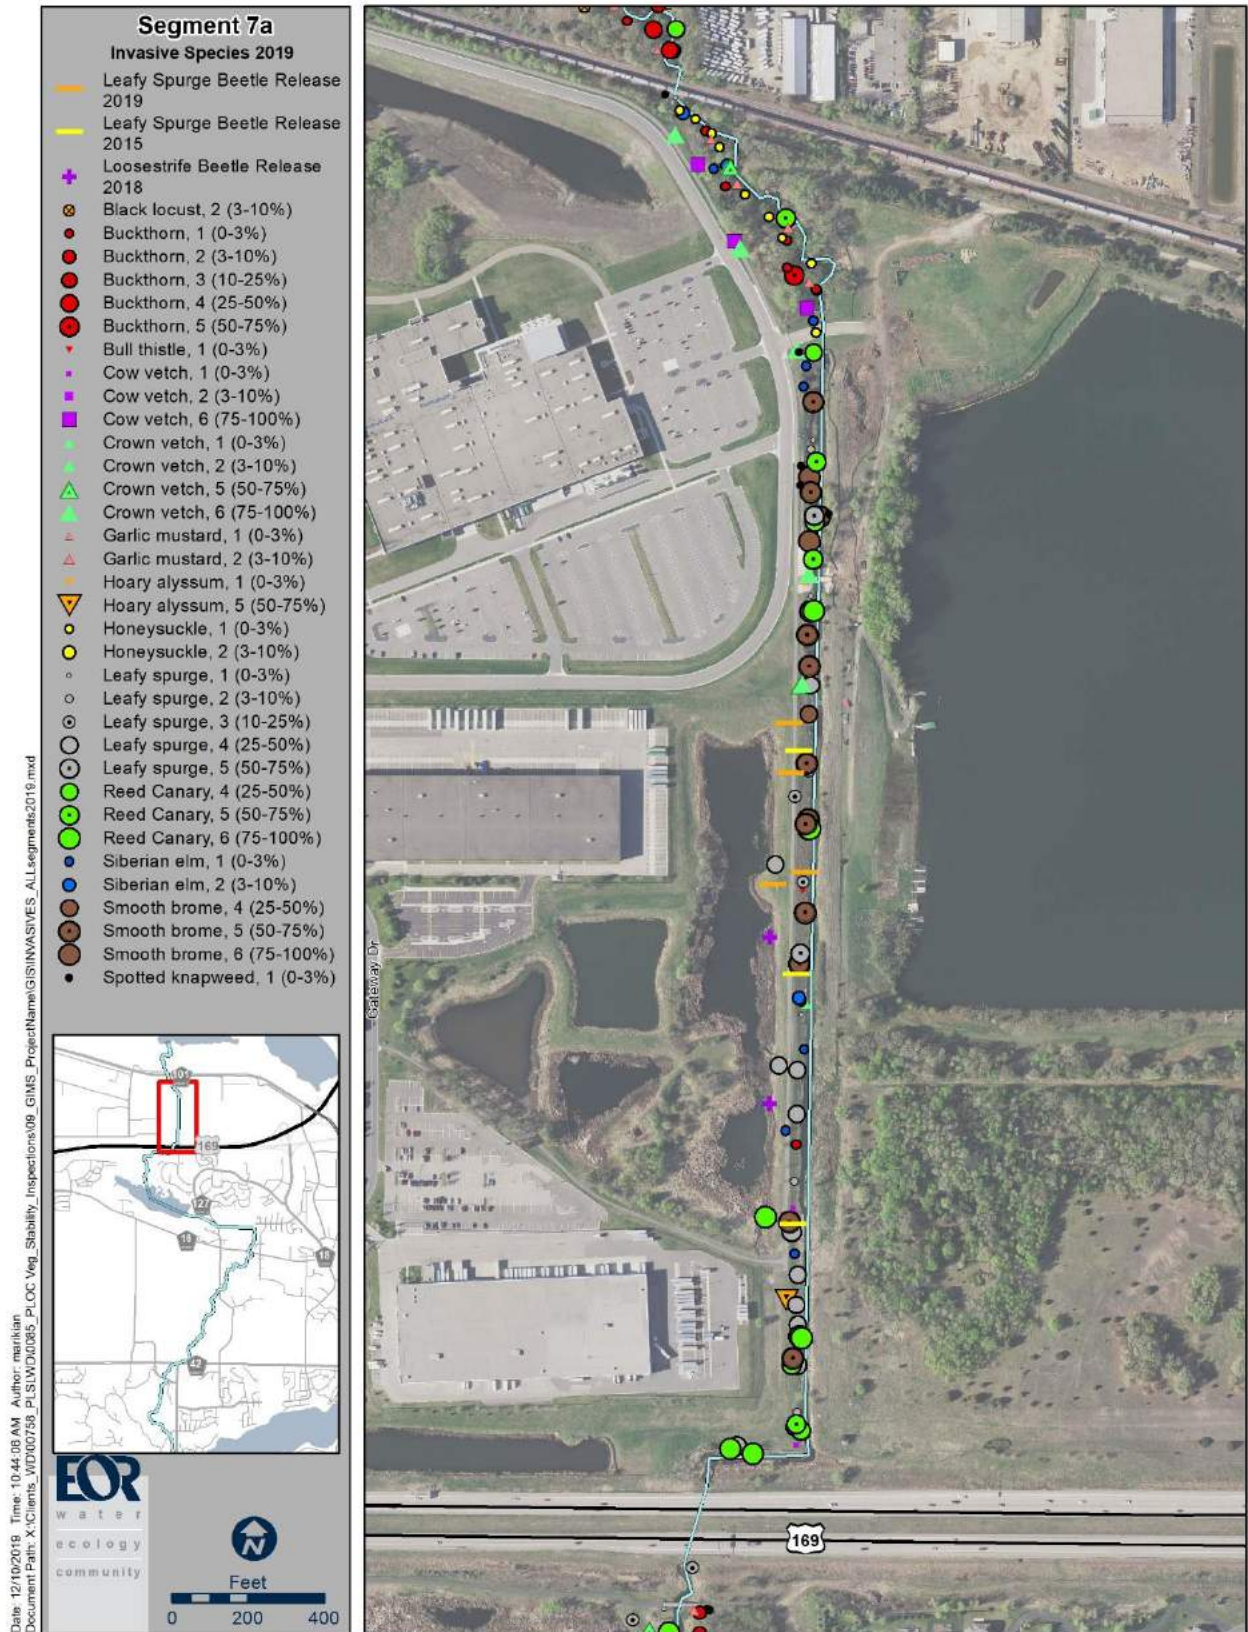
No purple loosestrife plants were found in the areas where management was conducted in 2017; however, it is recommended the area should be monitored again in the summer of 2020 and any new plants should be promptly removed before flowers develop. A significant decline in the population of purple loosestrife was observed in the wetland complex located immediately west of Segment 7A. Purple loosestrife beetles and weevils were released in this wetland by PLSLWD staff in July 2018, and it's possible the beetles have limited the growth and development of the plants in 2019. AES staff found only a few loosestrife plants during their reconnaissance work in July 2019. In addition, PLSLWD and EOR staff collected over a 1,000 leafy spurge flea beetles from a site just west of Deans Lake in late June 2019. Most of the flea beetles collected were *Aphthona lacertosa*, but some *Aphthona nigricutis* beetles were also collected. The beetles were released in four separate locations to more widely distribute the beetles in areas with the densest populations of leafy spurge.

The proliferation of the invasive species crown vetch (*Coronilla varia*) that was documented in 2016 continues to spread along the segment. Extensive populations occur along Innovation Road and the Quarry Lake Park crossing. Common buckthorn and bush honeysuckle saplings were found in areas previously managed. Continued foliar spray treatments will be needed to reduce the population of the saplings in this segment. Figure 42 and Figure 43 show the locations and areal coverages of previously identified invasive species in this segment.

Figure 42. Invasive species and associated areal coverages (in parenthesis) along Segment 7A

- Scout and treat for purple loosestrife in areas previously managed. Conduct the work in early July to prevent plants from maturing and producing seed
- Scout and treat for woody invasive species in areas not addressed by the proposed FEMA bank repair work
- Collect and distribute additional leafy spurge flea beetles in areas containing dense populations of leafy spurge
- Hand-pull invasive species (primarily spotted knapweed, vetch, and hoary alyssum) in areas containing rare plants, especially where four-point evening primrose has been documented

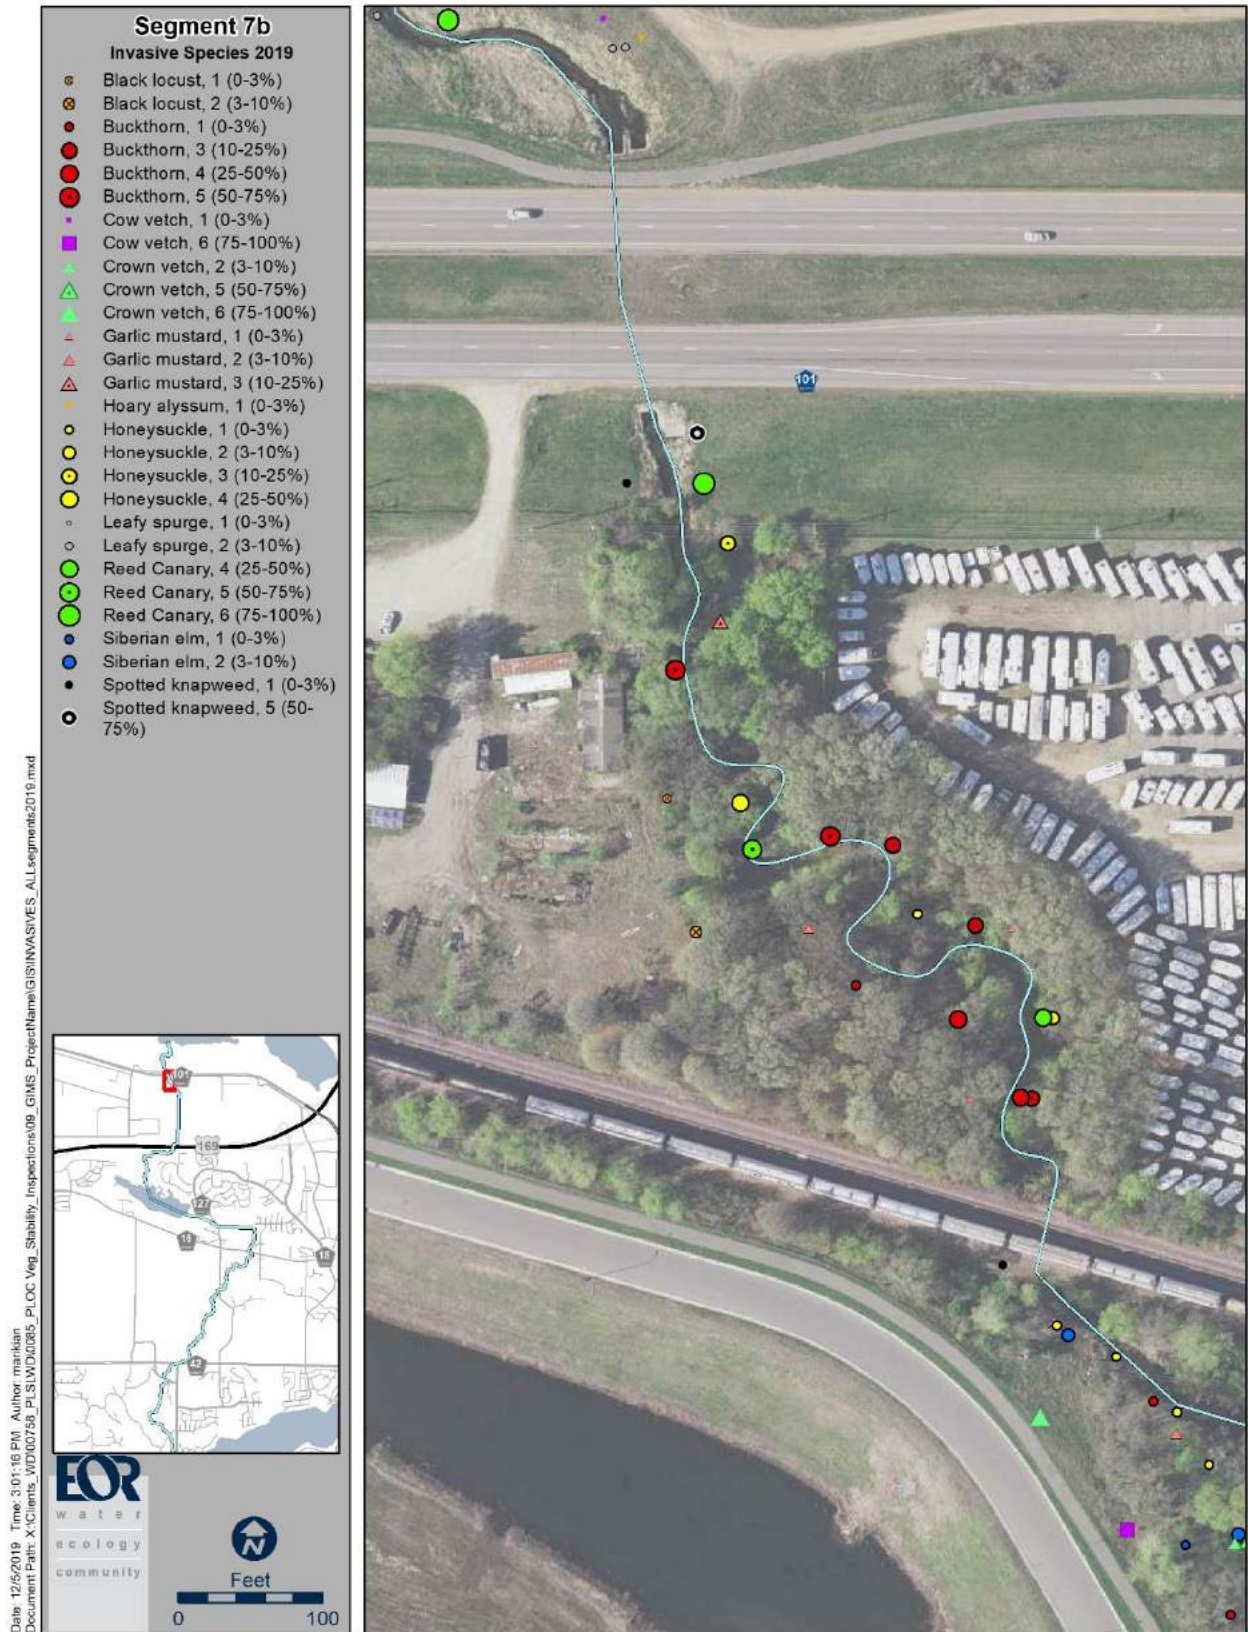
Figure 43. Invasive species and associated areal coverages (in parenthesis) along Segment 7B
