2019 PRIOR LAKE OUTLET SYSTEM ANNUAL OPERATIONS REPORT

Written by: Jaime Rockney
PLSLWD Water Resources Specialist
February 2020

PRIOR LAKE-SPRING LAKE
WATERSHED DISTRICT

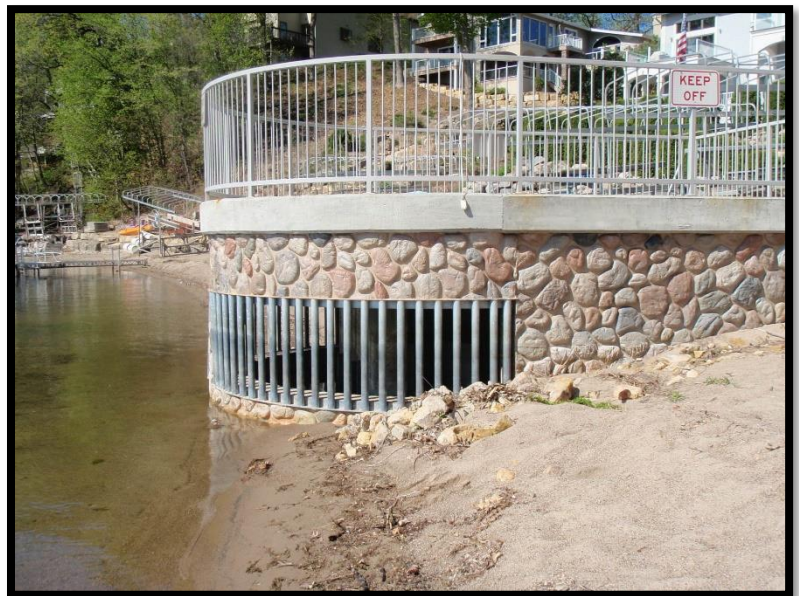
FIGURE 1 OUTLET STRUCTURE

Given these conditions, a replacement structure was pursued by the District and installed in 2010 (Figure 1). The new design has increased the efficiency of discharging water by allowing the outlet pipe to reach capacity sooner. It also provides safer conditions for staff during inspections and maintenance and is self-operating which reduces overall operations and maintenance costs. A schematic of the outlet structure is provided in Attachment A.

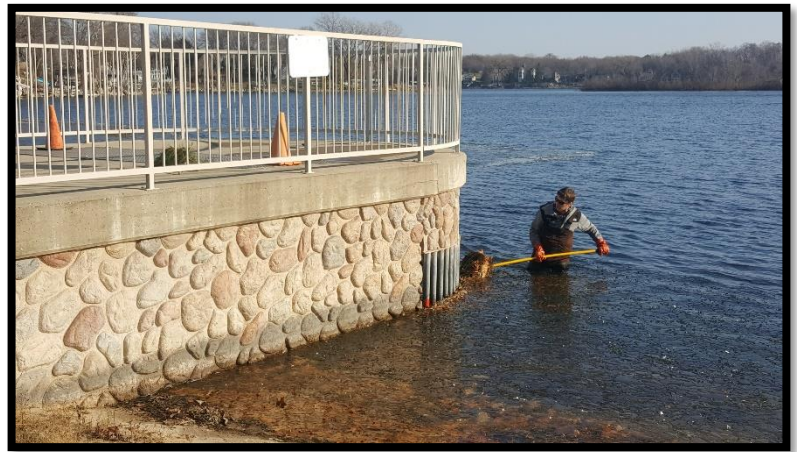
FIGURE 2 REMOVING VEGETATION FROM OUTLET STRUCTURE

The new structure requires minimal maintenance to operate. Once Prior Lake reaches 902.45', water starts spilling over the accordion shaped weir located inside the trash rack. Maintenance includes visual inspections, greasing gates, and removing debris from the trash rack. Removing vegetation and other debris from the trash rack is the most time-consuming and labor-intensive task (Figure 2). When the structure is operating (Prior Lake is greater than 902.45'), the structure will be inspected no less than once a week, and as much as twice per day, depending on the lake level and amount of vegetation getting caught on the trash rack. Inspections and debris removal are typically conducted by PLSLWD staff. During times when water is high and large amounts of vegetation are getting caught on the track rack, the City of Prior Lake staff have helped remove vegetation to ensure the Outlet Structure was not blocked.

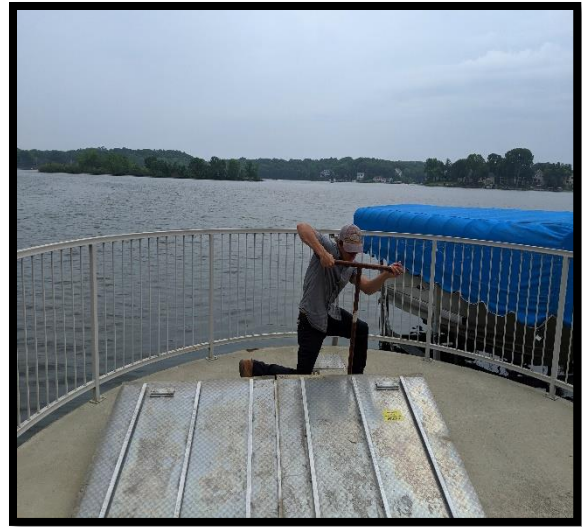
FIGURE 3 – OPENING THE LOW-FLOW GATE

At certain lake levels, the low-flow gate allows more water through the outlet structure, resulting in the lake level lowering more quickly and creating more storage (see Attachment C). To reduce the risk of flooding, the District opened the low-flow gate on March 5 due to anticipated high lake levels. To reduce ice dams along the channel after opening the low-flow gate, the low-flow gate of the outlet structure was only opened 10 rotations of the gate. This allowed the water to melt some of the ice in the channel before fully opening the low-flow gate on March 19. The low-flow gate remained open until July 9 (see Figure 3). The low-flow gate was opened again on October 2 and wasn't closed until December 19 when the lake level neared 902.0', at which the permit requires it be closed.

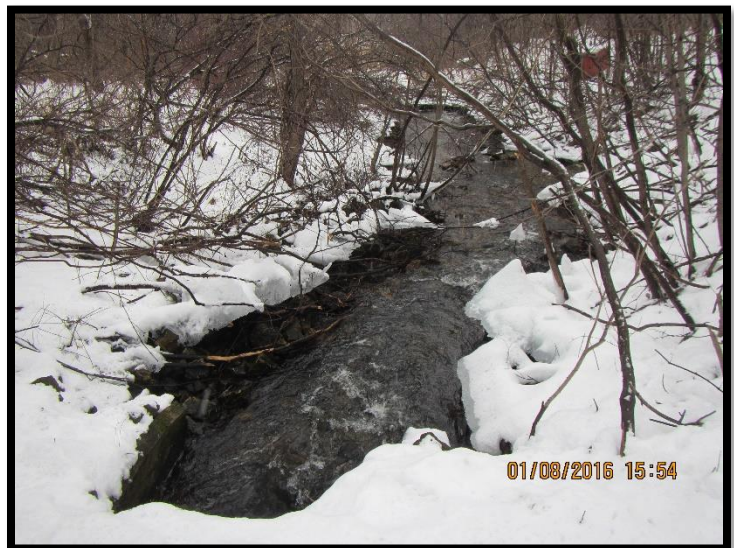
FIGURE 4 THE “DAYLIGHT”: BEGINNING OF THE OUTLET CHANNEL

In general, the lake outfall pipe is in good to fair condition and the pipe will be televised again in 2020.

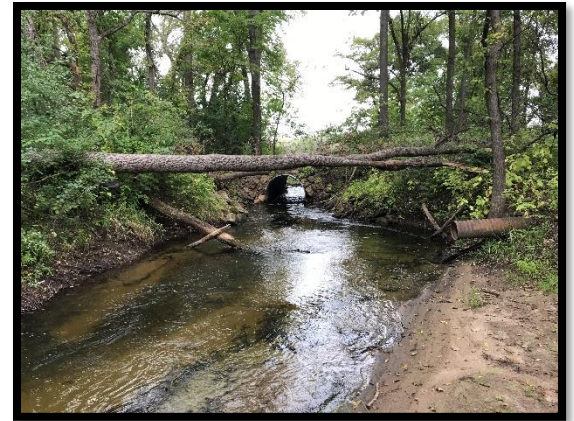
**FIGURE 9 DEBRIS IN SEGMENT 8 ON
SEPTEMBER 24, 2019**

The PLOC was assessed on foot from Segment 1 to Segment 7 on May 16, July 12, and September 24, 2019. Segment 8, which is under management by the United States Fish & Wildlife Service, was not assessed. For the spring and fall assessments, a series of photographs were taken in each segment to characterize the condition of the outlet channel, assess any new areas of bank erosion, and document any obstructions to flow such as fallen trees, debris piles, or culvert blockages.

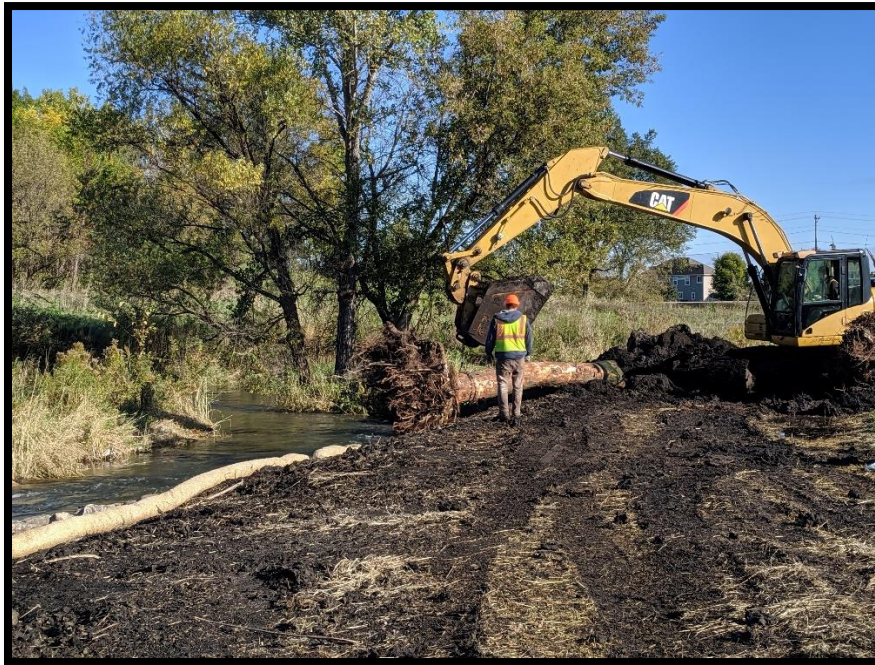
FIGURE 10 INSTALLING ROOT WAD FOR BANK EROSION REPAIR IN SEGMENT 4

The Prior Lake Outlet Channel incurred substantial damage during the 2014 flood, including downed trees, accumulated woody debris, sediment accumulation, culvert damage and over 2.8 miles of bank erosion. In 2015, most of the tree and woody debris removal work was completed and one of the culverts (KiciYapi) was repaired by the Shakopee Mdewakanton Sioux Community. Removal of the remaining trees and woody debris, culvert repairs (Gonyea and Kes Field Crossing), and Pike Lake Park stream crossing repair work was completed in 2016. The sediment delta was excavated in spring of 2018.

Due to permit and engineering design delays, the Bank Erosion project didn't begin until 2019, however, the flood damage repair was fully complete in the fall of 2019. The Federal Emergency Management Administration (FEMA) has approved federal funding to cover 75% of the costs of the 2014 flood damage to the PLOC. The State of Minnesota will pay the remaining 25%.

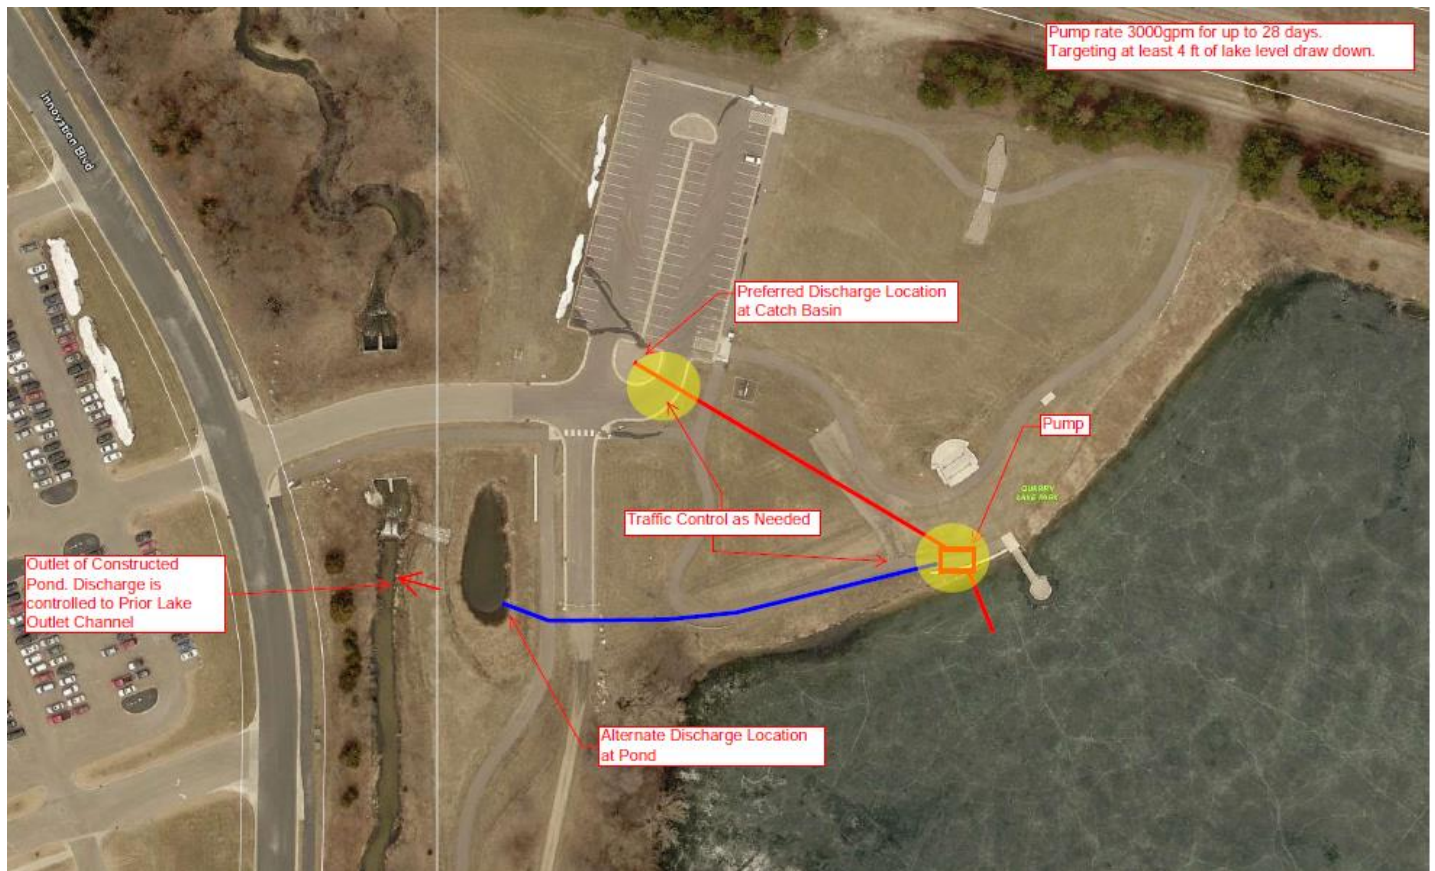
FIGURE 13 QUARRY LAKE DRAWDOWN PLAN

Quarry Lake is located along the east side of the Outlet Channel in Segment 7. It has experienced rising water levels over the years, especially in 2019, which caused erosion along the banks. Pumps were installed in Quarry Lake, which pulled the water out and through a filter which then flowed to the Outlet Channel. See Figure 13 for drawdown plan and Figure 12 for pictures of pumping procedure.
