Project Name	PLOC Channel & Vegetation Inspections	Date	1/05/2021
To / Contact info	Jaime Rockney		
Cc / Contact info	Carl Almer		
From / Contact info	Mike Majeski		
Regarding	Channel and Vegetation Inspections – 2020 Summary

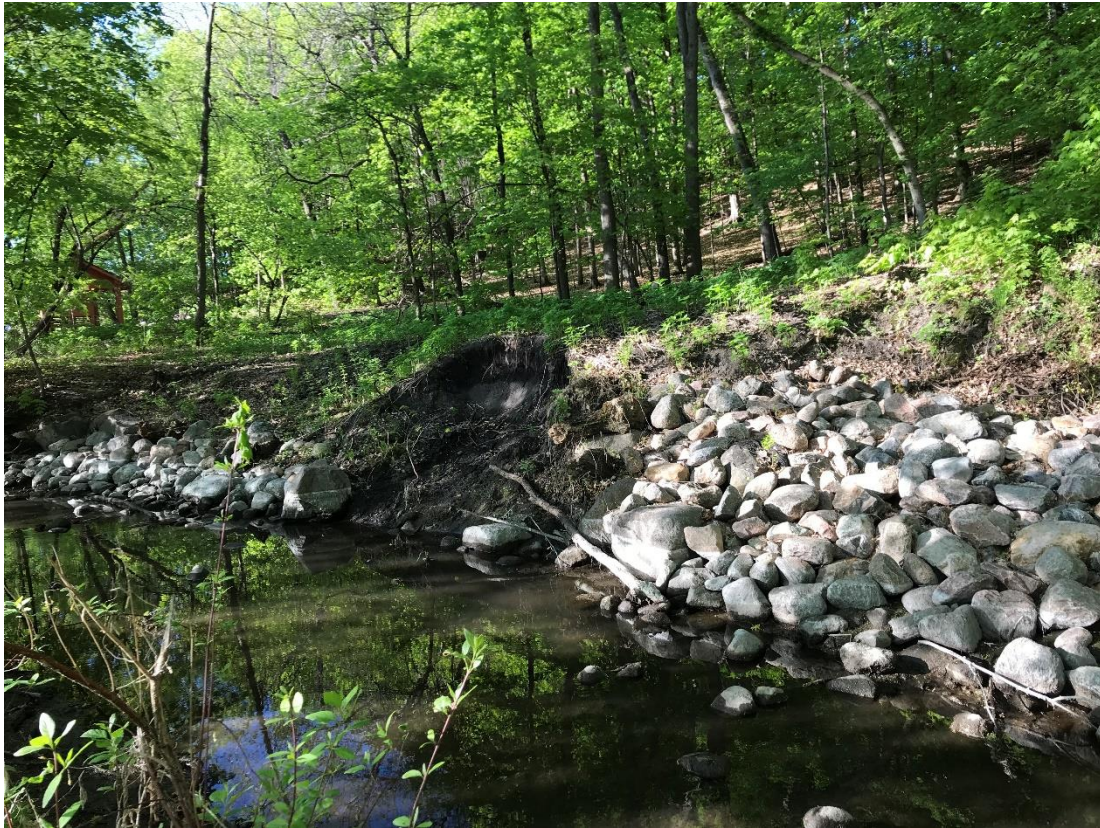
FEMA-funded bank repairs completed in 2019 included repair of boulder cross vanes, two bridge abutments near Jeffers Elementary School, and installation of boulder toe along previously eroded stream banks. However, the repaired cross vanes were not keyed into the bank sufficiently, resulting in flows around the sides of the vanes during high flow events. Downstream of the walking bridge, a 10-foot gap in the installed boulder toe has resulted in toe erosion and sloughing of the upper bank (Figure 1). There appears to be sufficient rock in the immediate vicinity to repair this bank without the need to import additional rock. In addition, bank erosion continues to occur along the right bank just upstream of the walking path at Fountain Hills Road (Figure 2). It is recommended the boulder toe rock be extended to the walking path culvert. Downstream of the walking path, the boulder cross vane has failed and has caused bank erosion along the right bank (Figure 3). It is recommended the cross vane be rebuilt with the low point of the cross vane in the center of the channel and the right wing of the vane keyed into the right bank a minimum of 3 feet to prevent flows from bypassing the vane.

Figure 1. Gap in boulder toe near Jeffers Pond Elementary School

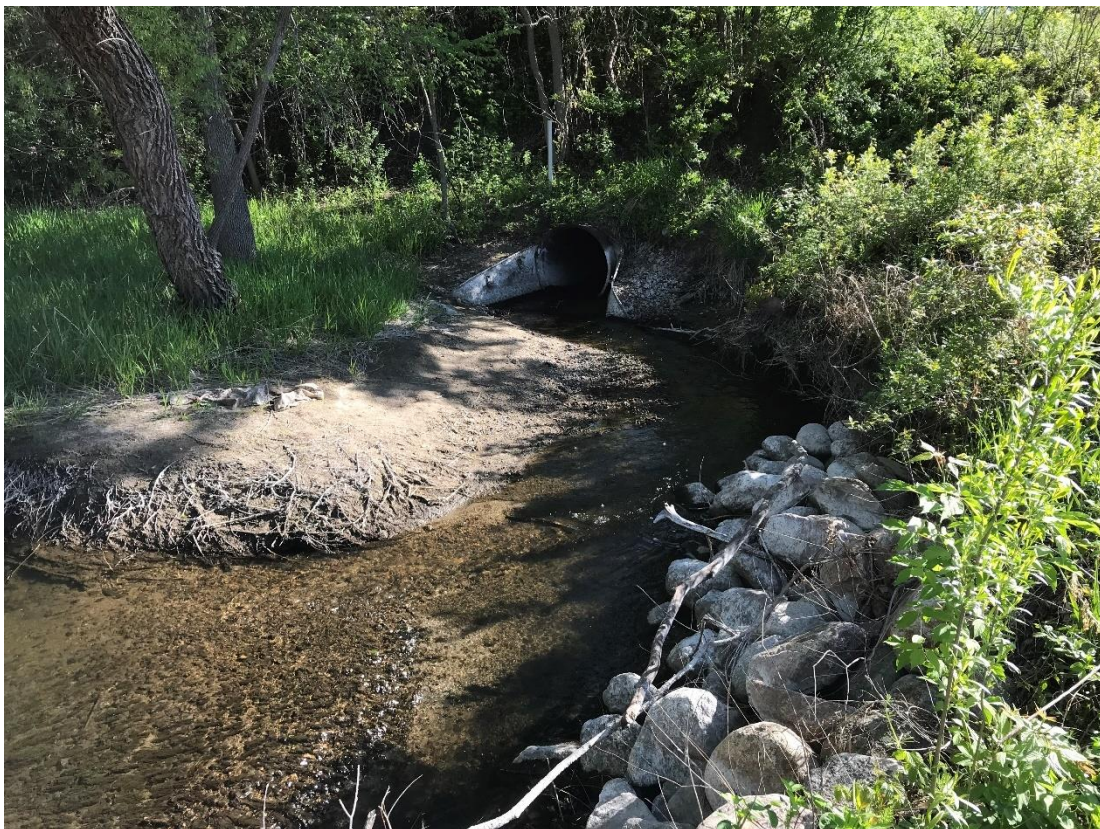
Figure 2. Bank erosion along right bank downstream of installed boulder toe

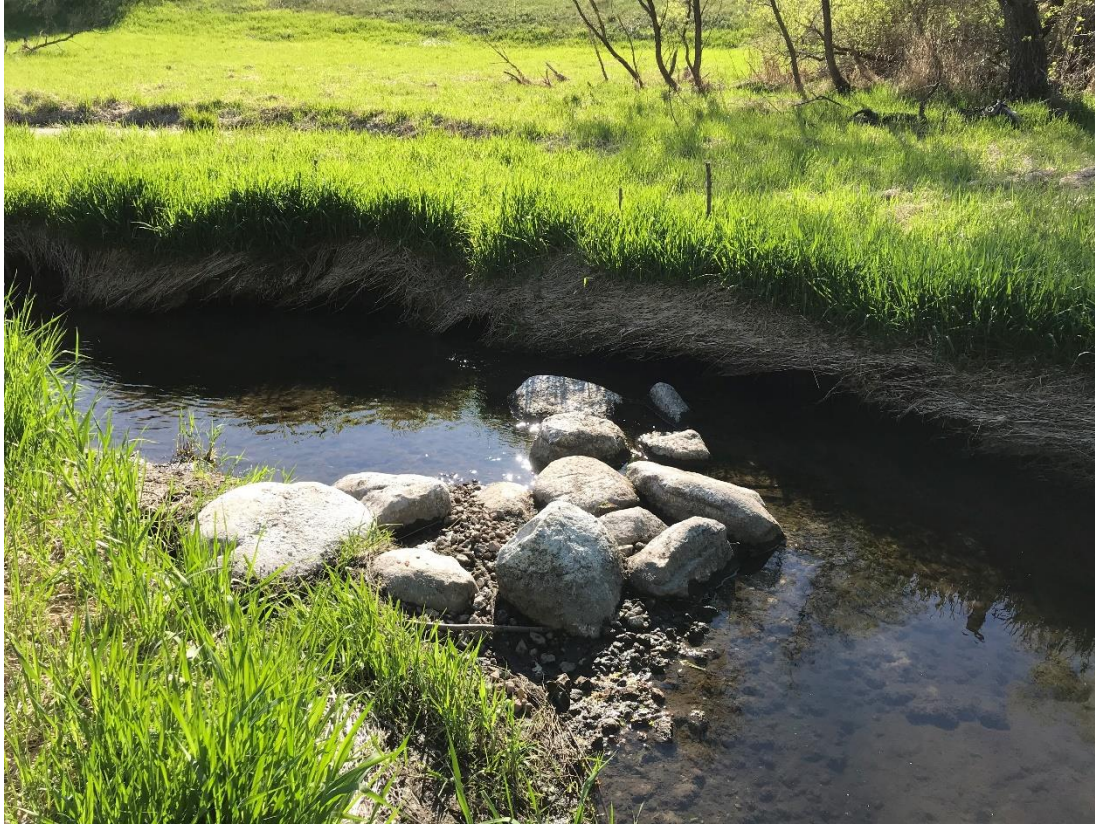
Figure 3. Failed cross vane downstream of the walking path, upstream of Fountain Hills Road

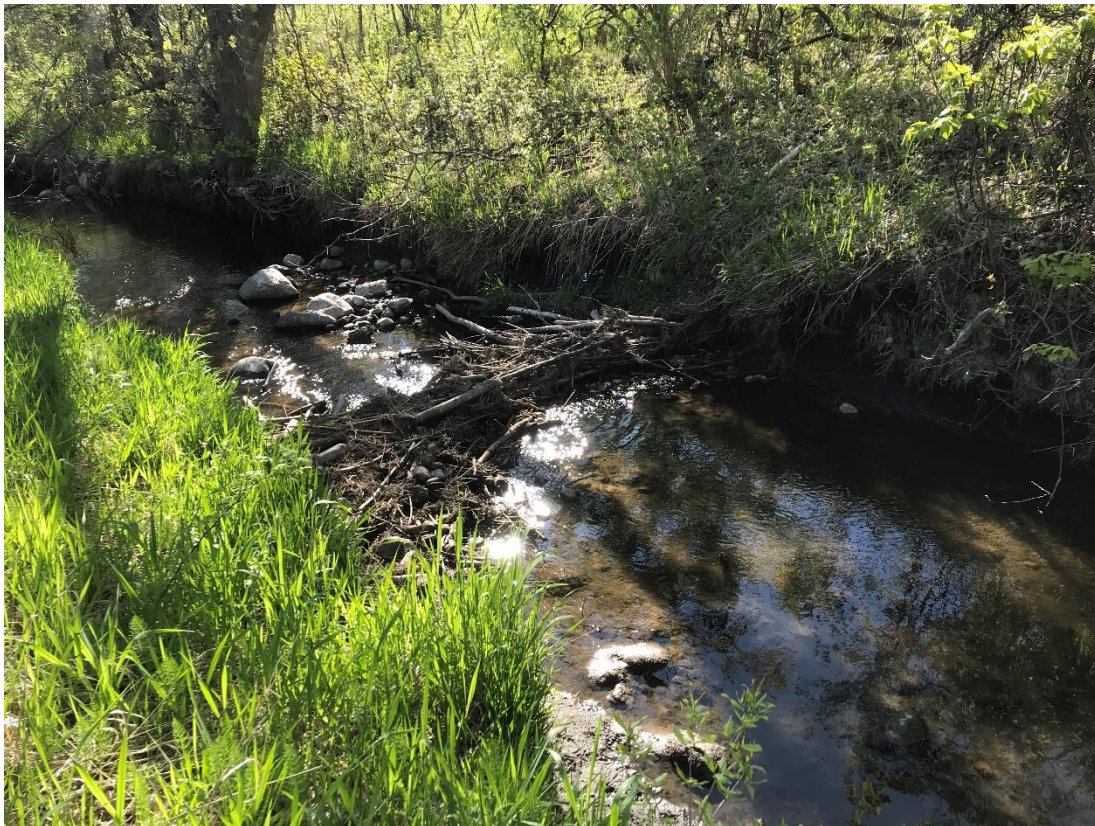
Minor channel obstructions were observed in the same areas identified in previous surveys including several large tree trunks and branches found lying across and within the channel in the wooded area just upstream of County Road 42, and a small beaver dam located just downstream of Fountain Hills Road (Figure 4).

Figure 4. Beaver dam in channel downstream of Fountain Hills Road

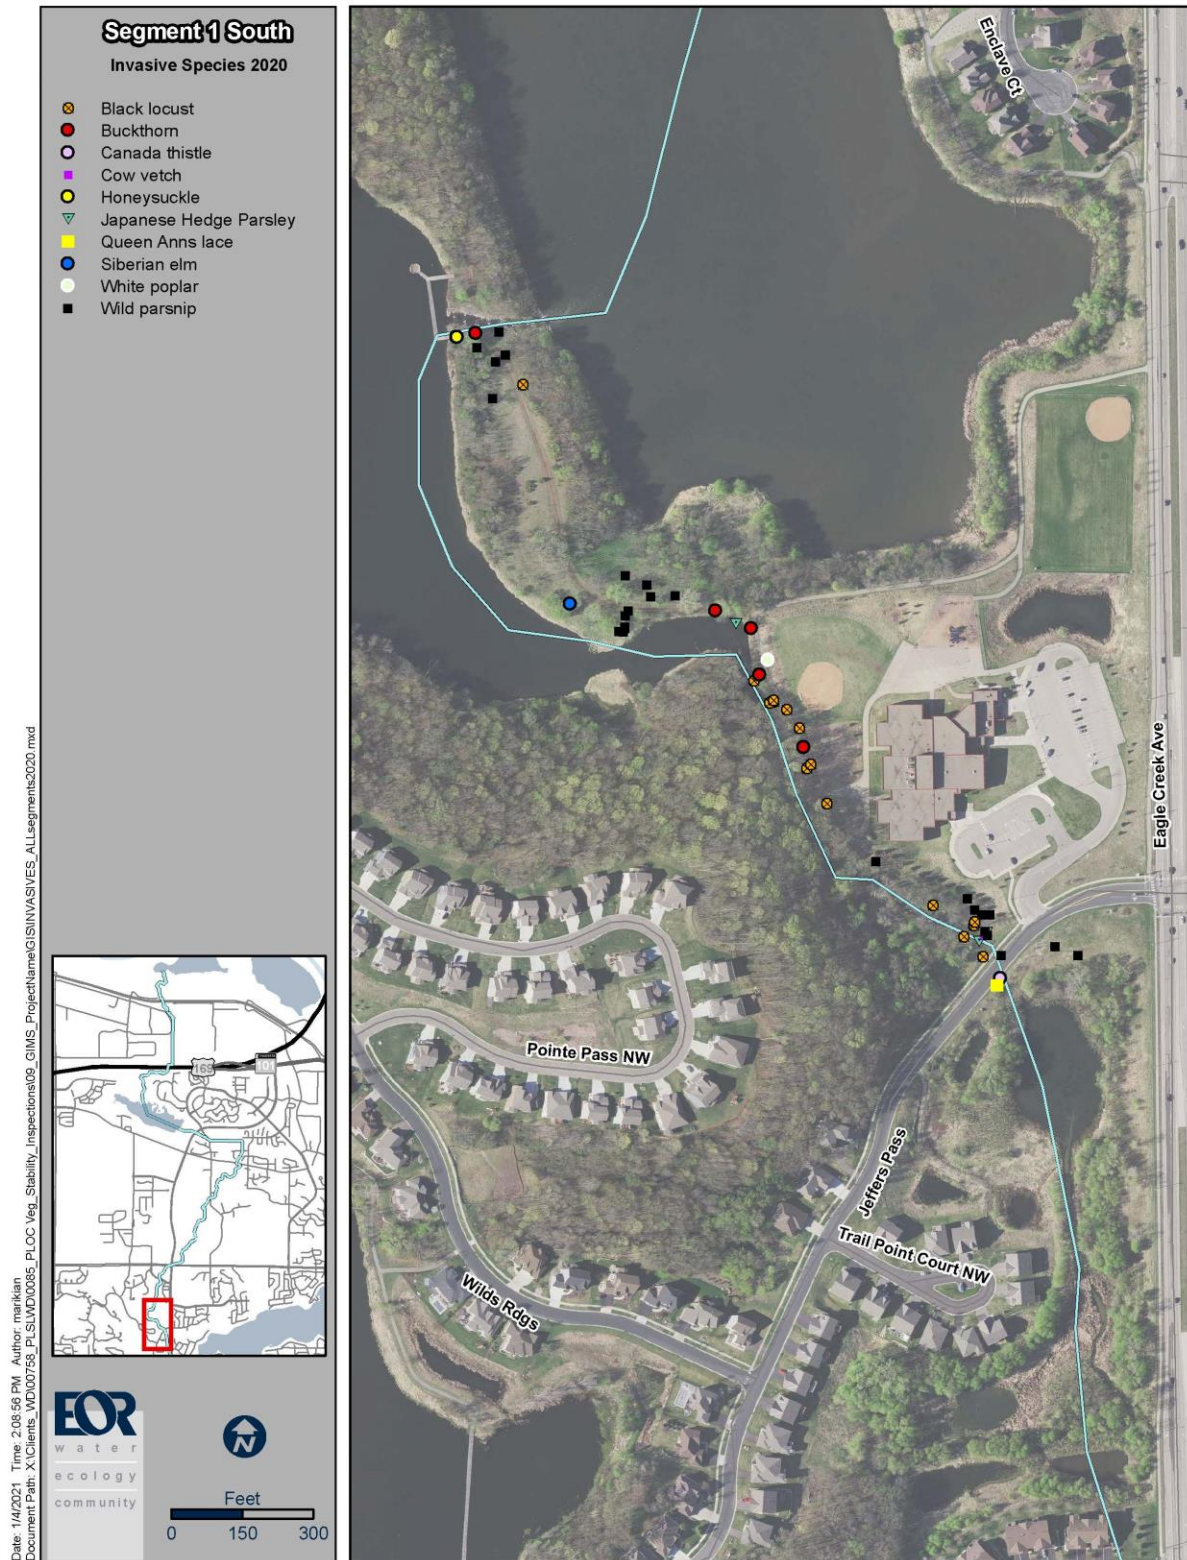
Several black locust (*Robinia pseudoacacia*) saplings continue to grow along the paved walking path west of Jeffers Pond Elementary School. Patches of wild parsnip persist in the areas managed in 2019 including the grassy area southwest of the intersection of Jeffers Pass NW and Eagle Creek Avenue, the area north of Fountain Hills Road, and in the grassy opening northeast of Chickadee Landing on Jeffers Pond Elementary property. In addition, Japanese hedge parsley (*Torilis japonica*) was discovered just north of Jeffers Pass during the July inspection. AES treated the wild parsnip in June & July, and hand-cut and removed Japanese hedge parsley seed heads in September. The patches of wild parsnip and Japanese hedge parsley should be closely monitored in the spring/early summer of 2021 to determine if any new plants exist in the area. Any young plants located should be treated with herbicide with follow-up inspections and treatments conducted in early July to prevent the plants from maturing and producing seed. Figure 5 and

Figure 5. Target invasive species along Segment 1 (South half)

- Foliar spray/ cut stump treatment of black locust and white poplar near Jeffers Pond Elementary School
- Request removal of remaining large Siberian elm tree near Chickadee Landing
- Scout and treat target invasive species, especially wild parsnip, Japanese hedge parsley, and Queen Anne's lace. Conduct the work in June & July to prevent plants from maturing and producing seed

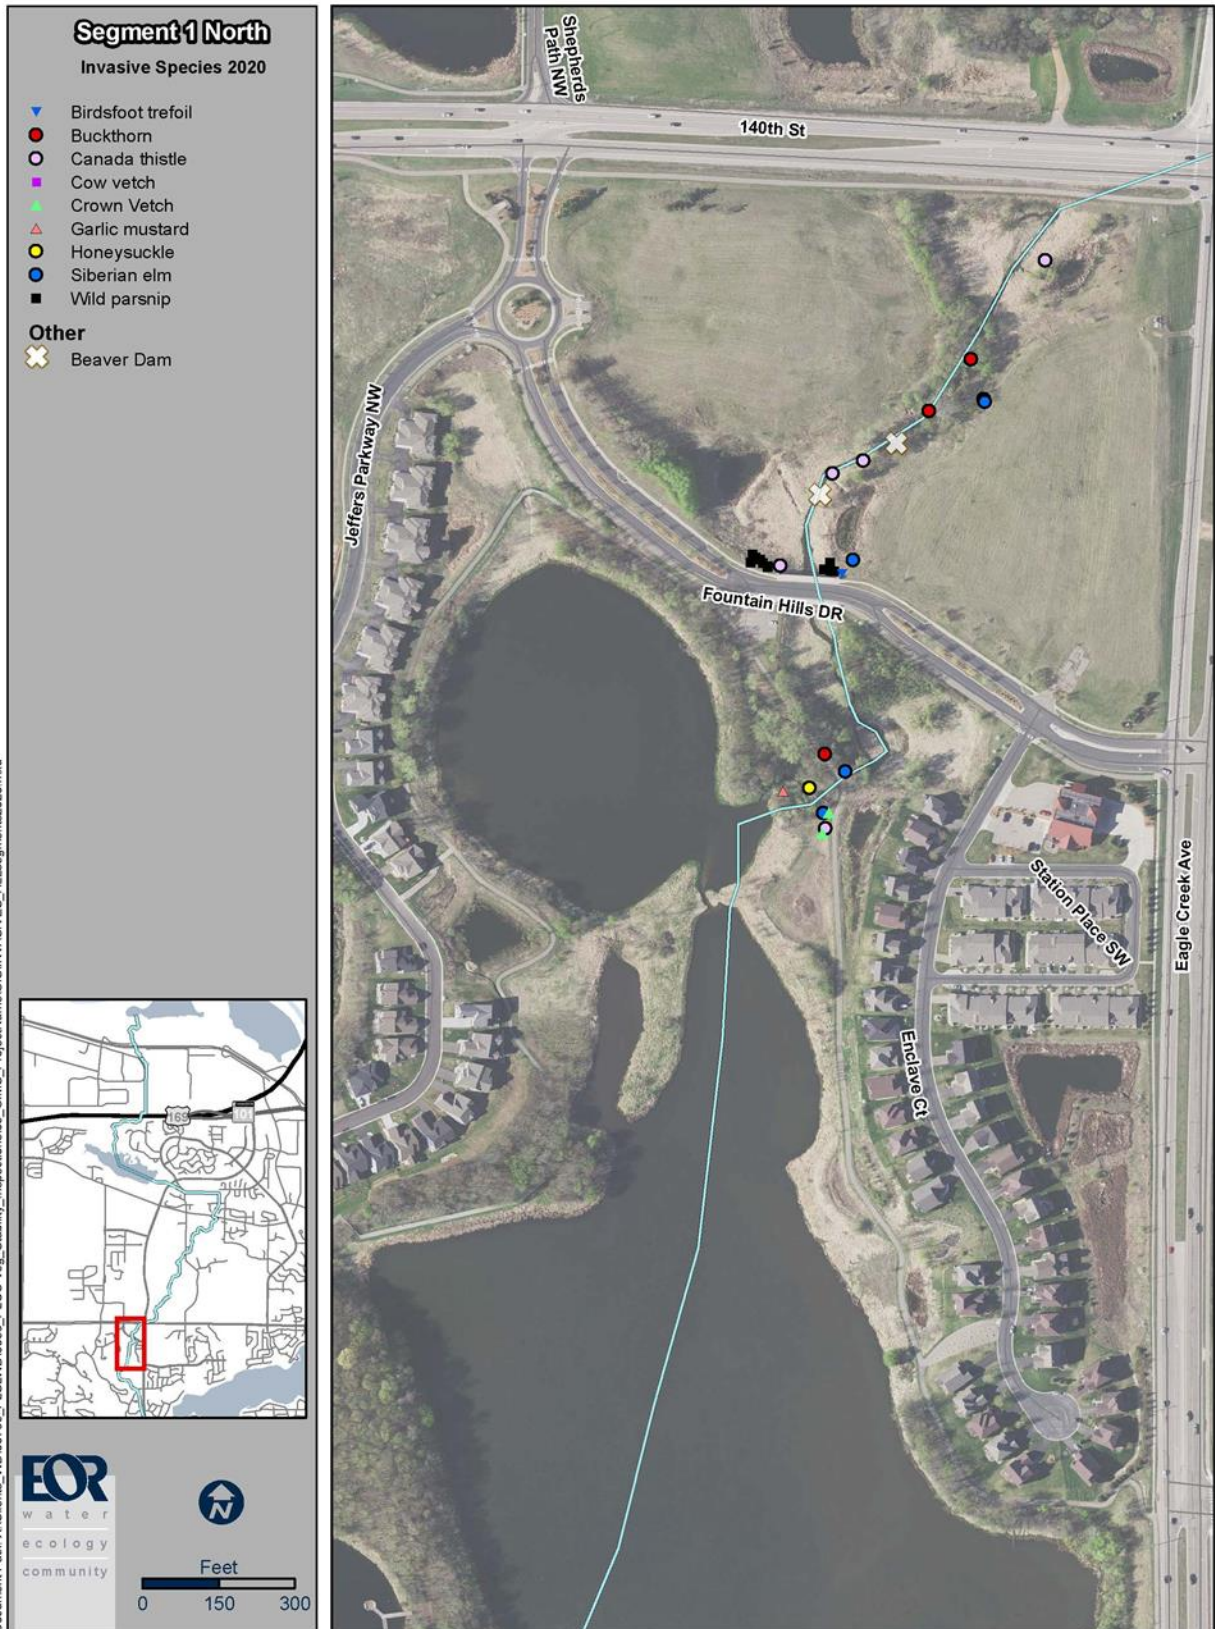
Figure 6. Target invasive species along Segment 1 (North half)

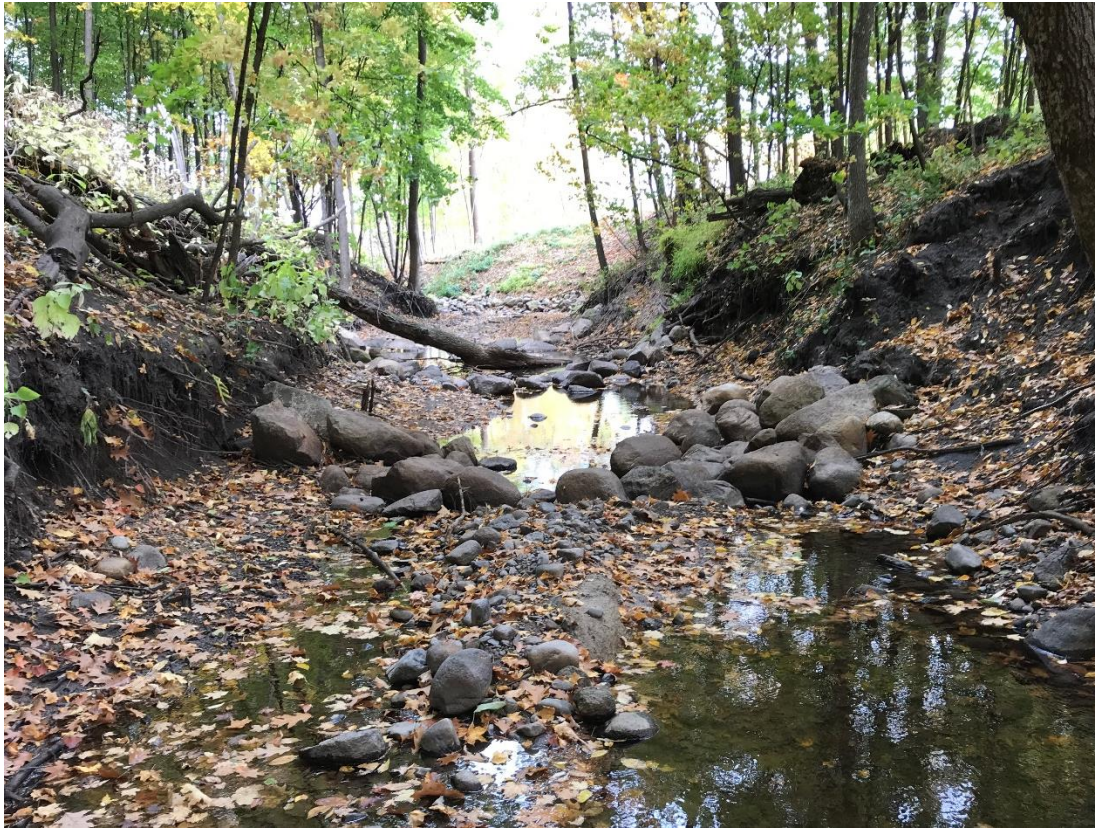
Numerous stream banks within this segment have been repaired since 2018 through the FEMA bank repair project (Figures 7-9). The primary bank stabilization practice implemented was the placement of boulder toe along the sides of the channel. Boulder cross vanes were also installed in several locations, but two cross vanes are beginning to fail due to flows around the edges of the vane wings (Figure 10). The bank repairs have reduced toe erosion throughout the segment, but some banks continue to erode in areas where bank repair activities have not occurred (Figures 11-12). It is recommended the large sediment delta at the inlet to Pike Lake be removed now that most of the channel banks in this segment have been repaired (Figure 13).

Figure 10. Cross vane beginning to fail, note the gap between the left side of the vane and the bank

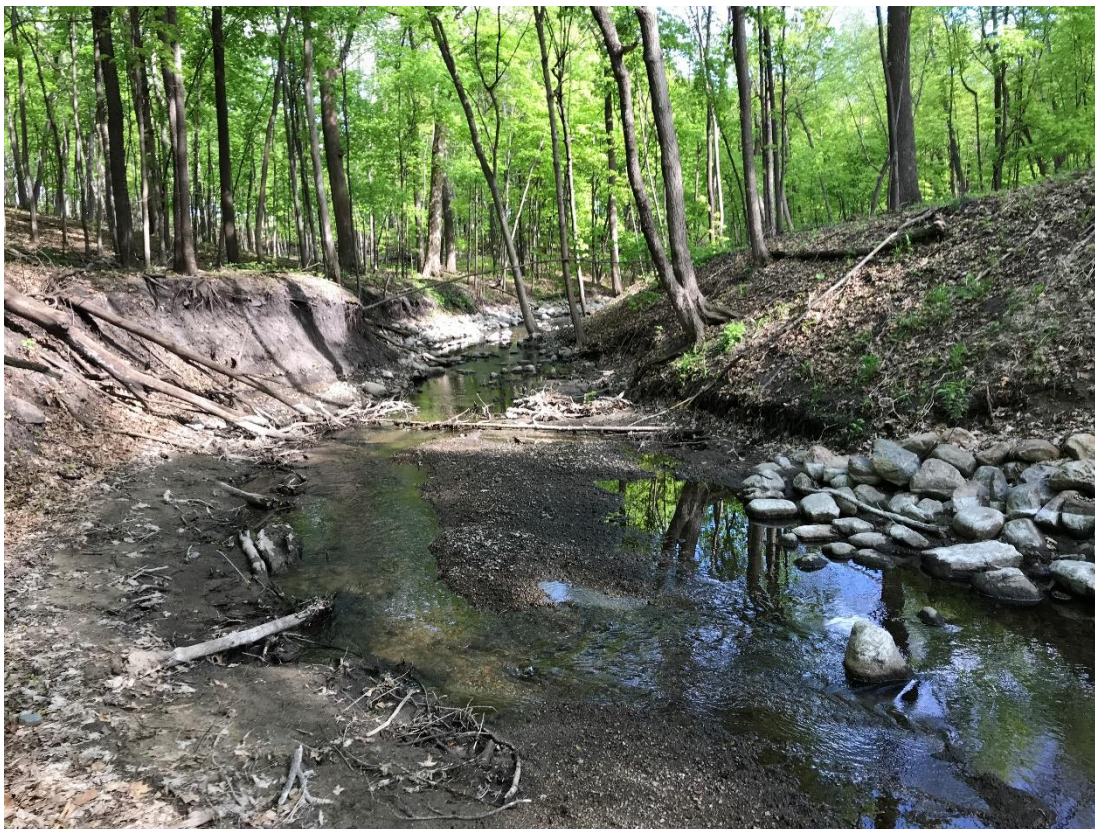
Figure 11. Bank erosion in areas where no bank repair work was conducted

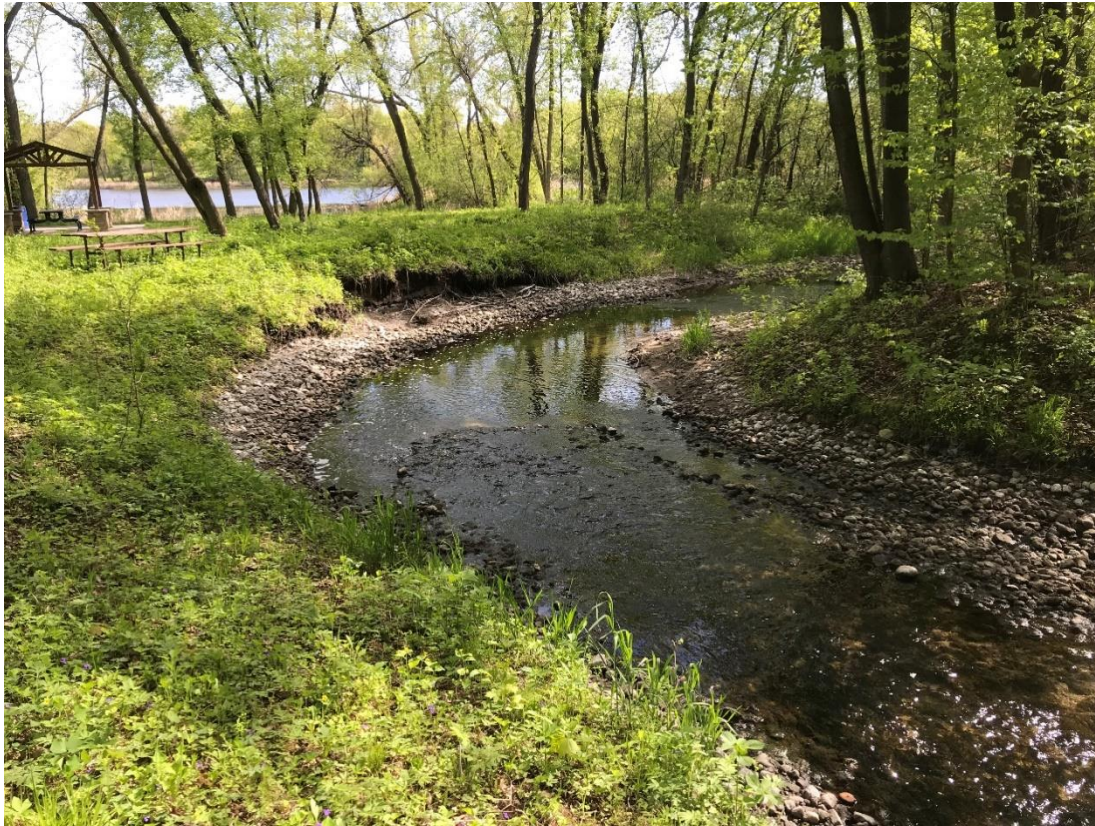
Figure 12. Bank erosion in areas where no bank repair work was conducted

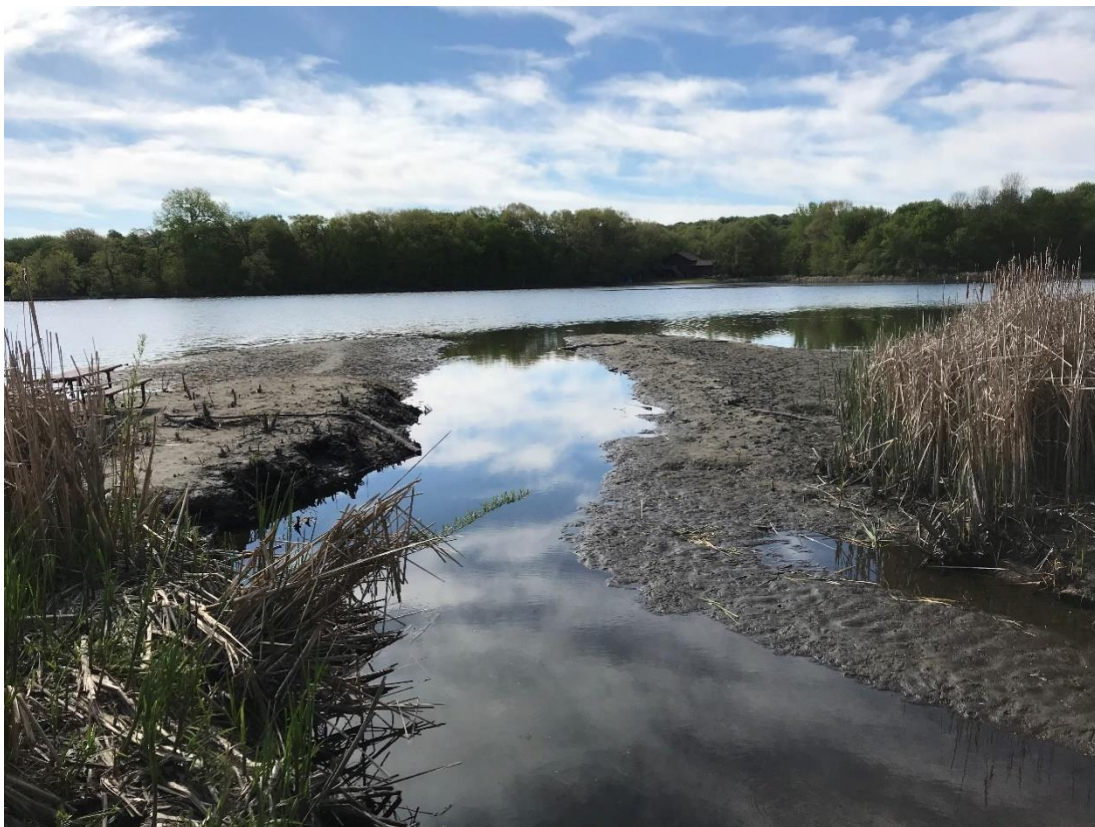
Figure 13. Sediment delta at the inlet to Pike Lake

- Continue inspections in 2021 and monitor FEMA-funded bank repair work
- Remove the sediment delta at the outlet of Segment 2 in Pike Lake

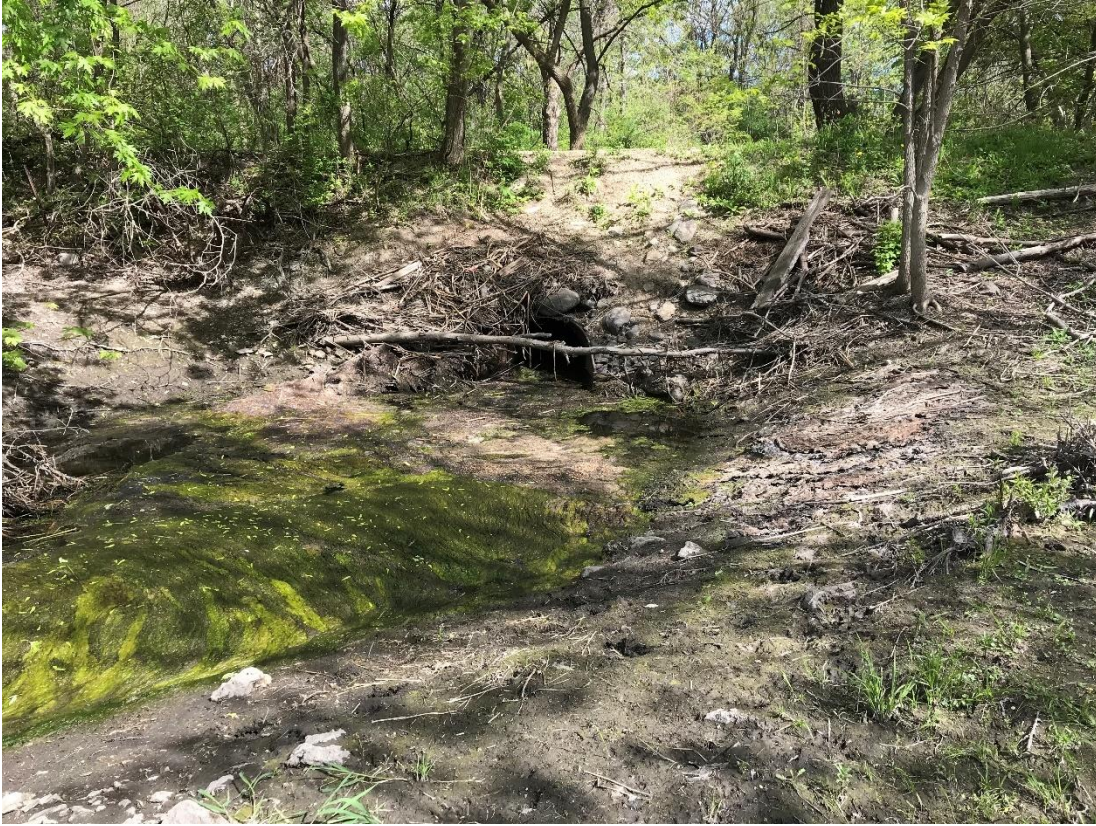
Numerous stream banks within this segment were repaired in 2019, including the two road embankment slumps along the upstream end of the Kici Yapi property (Figures 15-16). The primary bank stabilization practice implemented was the placement of boulder toe along the sides of the channel (Figures 17-18). Boulder cross vanes were also installed in several locations to concentrate flows to the center of the channel (Figure 19). No major channel obstructions were found; however, a minor culvert blockage was observed at the upstream end of the private driveway crossing during the May inspection but was removed by the September inspection (Figure 20Error! Reference source not found.). Bank erosion continues to occur downstream of the private driveway crossing (Figure 21).

Figure 20. Partial culvert blockage at the private driveway crossing upstream of Pike Lake Road (May)

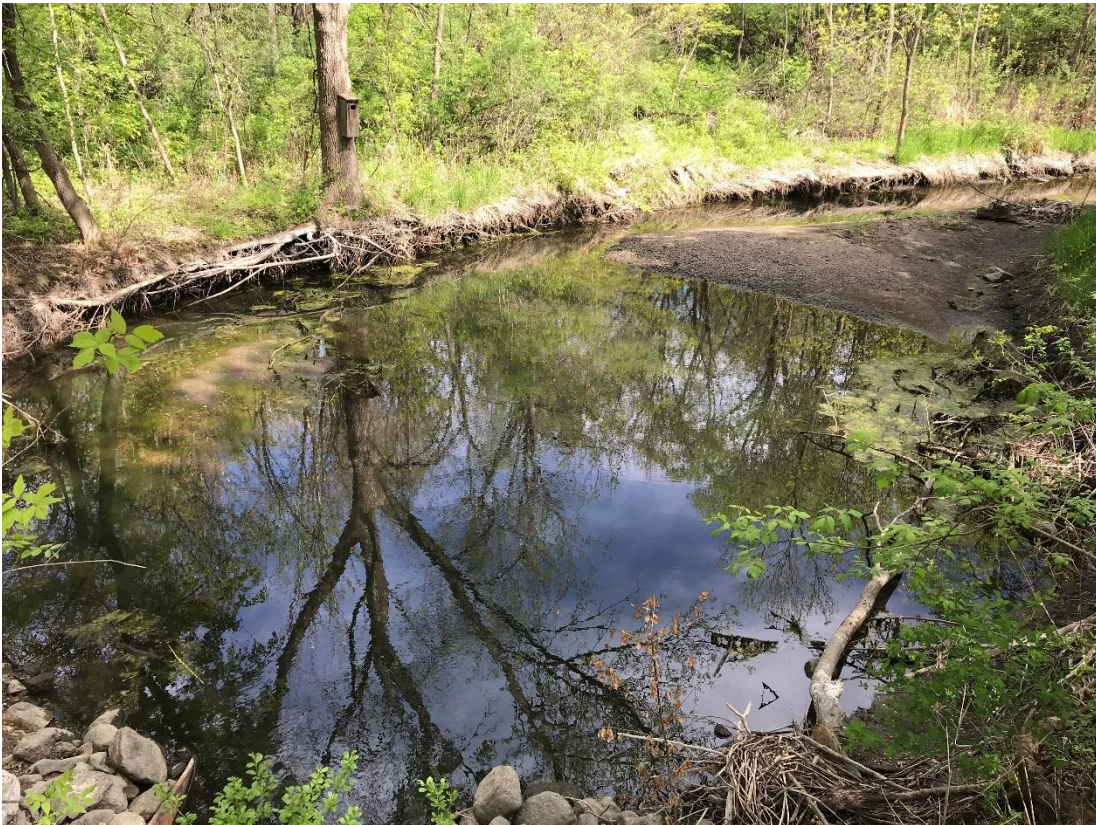
Figure 21. Bank erosion downstream of the private driveway crossing upstream of Pike Lake Road

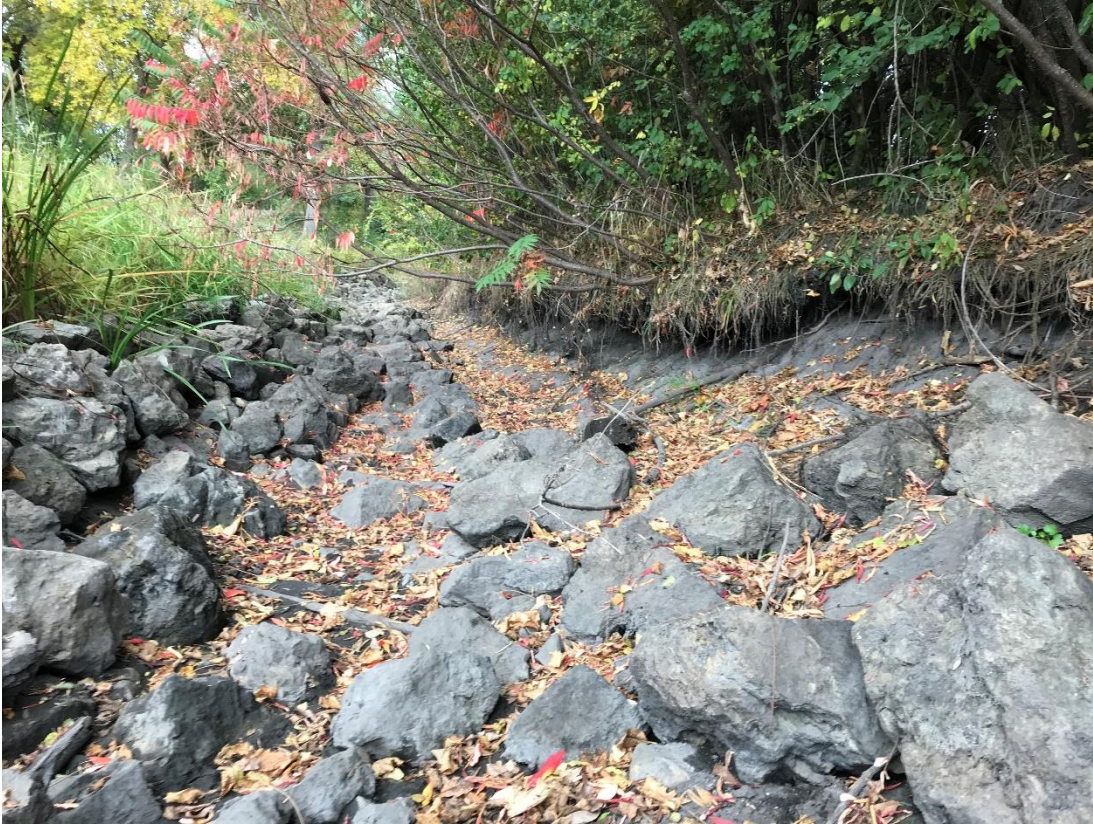
The restored channel at the upstream end of Segment 4A is stable but would benefit from repositioning of the existing riprap in the channel. There appears to be a sufficient volume of riprap along the south side of the channel to address the minor toe erosion along the north bank (Figure 23). Most of the previously documented eroded channel banks have been repaired in 2019 by the FEMA-funded project. Bank stabilization practices implemented included boulder toe, rock grade control structures and riffles, and installation of rootwads (Figures 24-25). Bank erosion continues to occur in areas where no bank stabilization work has been conducted (Figure 26). At the far downstream end of Segment 4A, the rootwads installed to stabilize the right bank have caused localized bank erosion upstream and downstream of the rootwads (Figure 27). The erosion appears to be the result of limited toe stabilization between the rootwads and eddy currents during high flow events. It is presumed this area will be repaired under warranty in 2021.

Figure 23. Toe erosion along the north bank of Segment 4A downstream of Pike Lake Road

- Re-position existing riprap along restored channel in Segment 4A
- Continue inspections in 2021 and monitor FEMA-funded bank repairs

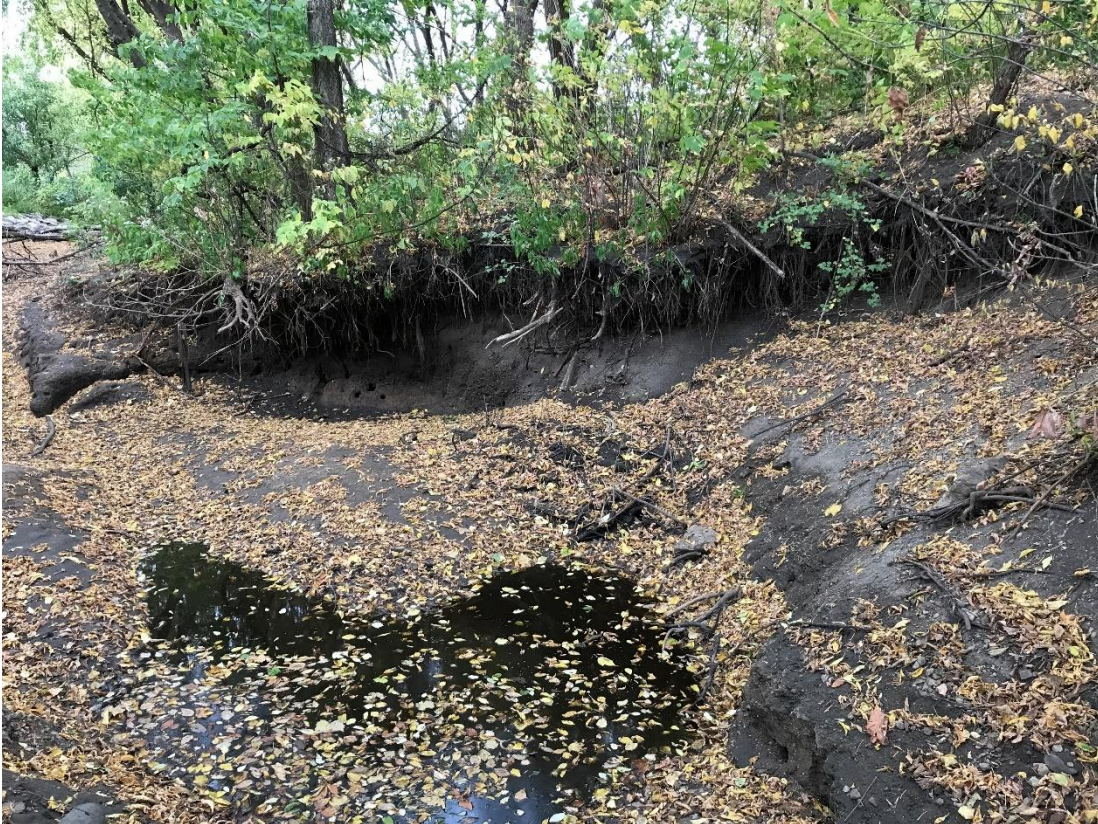
Figure 26. Continued bank erosion within the middle reach of Segment 4A

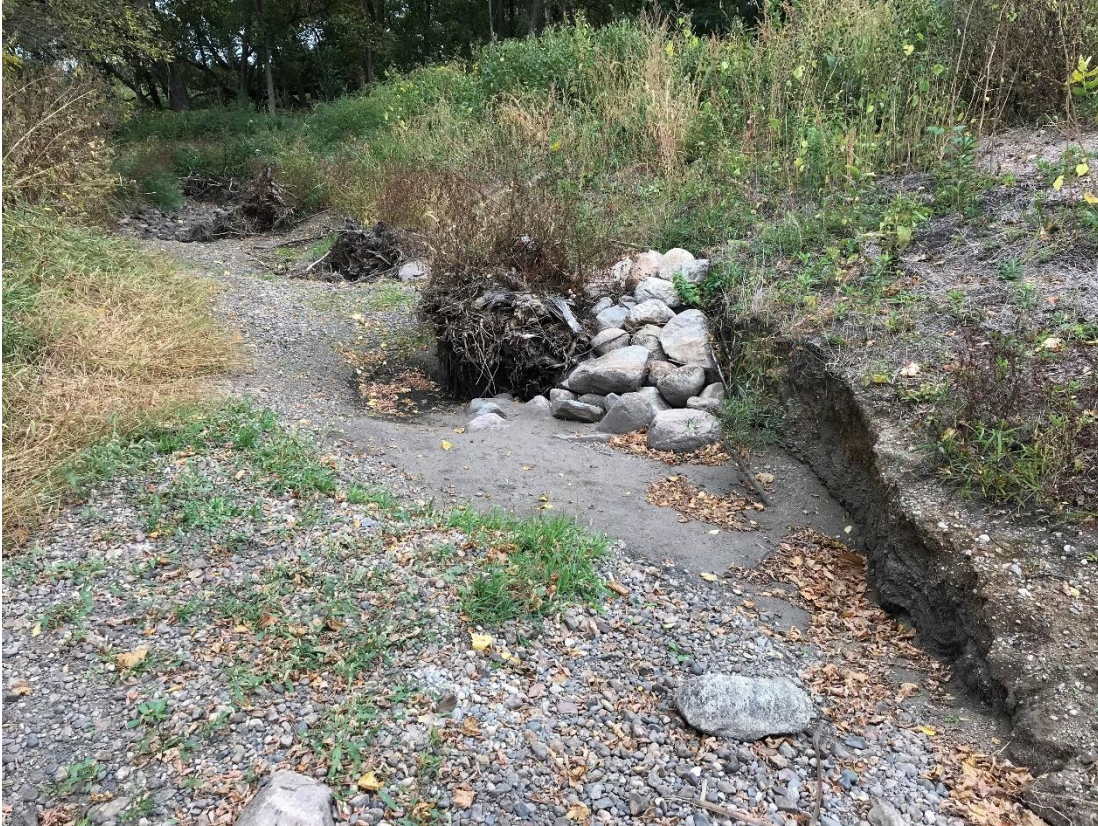
Figure 27. Rootwads and bank erosion at the downstream end of Segment 4A

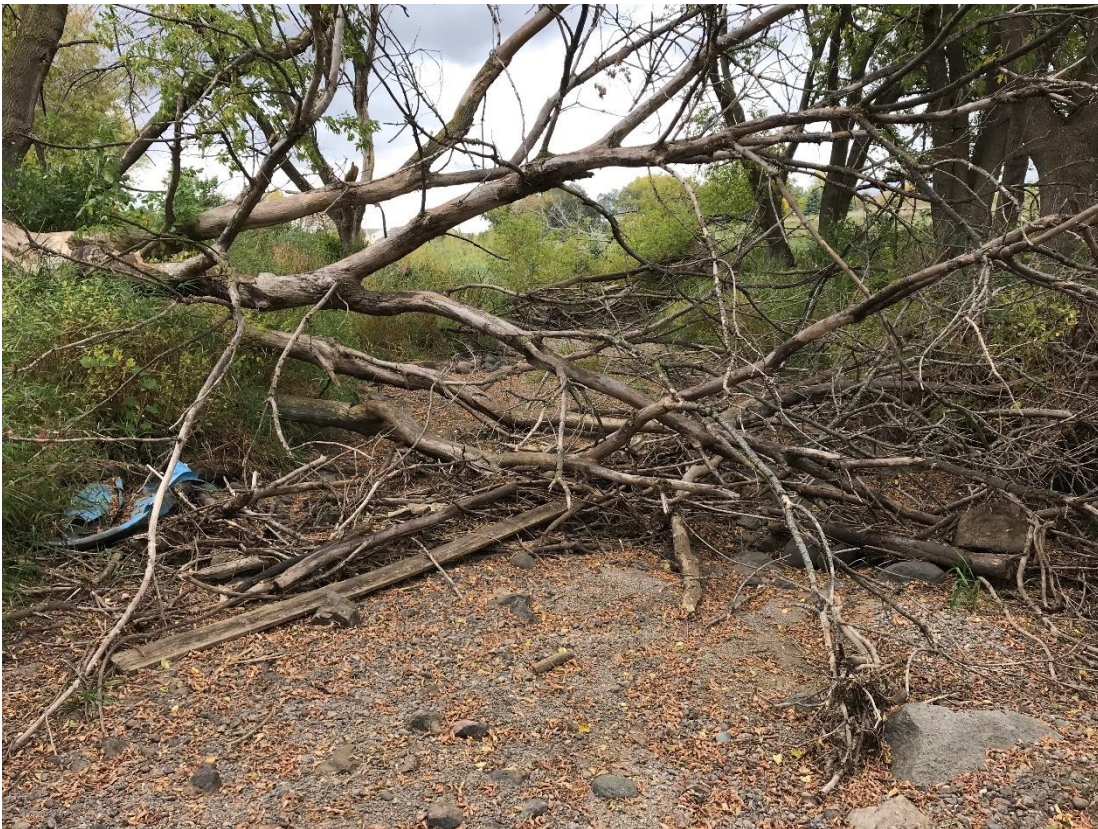
In Segment 4B, a large box elder tree has fallen across the channel at the upstream end of the segment and is beginning to collect debris (Figure 28). It is recommended this tree be removed before spring 2021 to prevent potential bank erosion during high flow events. The rootwads installed at the upstream end of the pasture appear stable with vegetation becoming well established on the restored bank (Figure 29). However, the rootwads installed at the downstream end of Segment 4B have erosion issues similar to the rootwads installed at the downstream end of Segment 4A that have erosion occurring between the rootwads (Figure 30). It is presumed this area will also be repaired under warranty in 2021. Interesting, groundwater seepage has increased in the middle of the pasture reach of Segment 4B. The seepage has significantly softened the bank soils, which now have the consistency of muck (Figure 31). These soft bank soils will likely erode if high flows continue through the outlet channel.

Figure 28. Fallen box elder tree over the channel at the upstream end of the pasture in Segment 4B

- Remove fallen trees within the channel between the Gonyea culvert and the pasture in Segment 4B

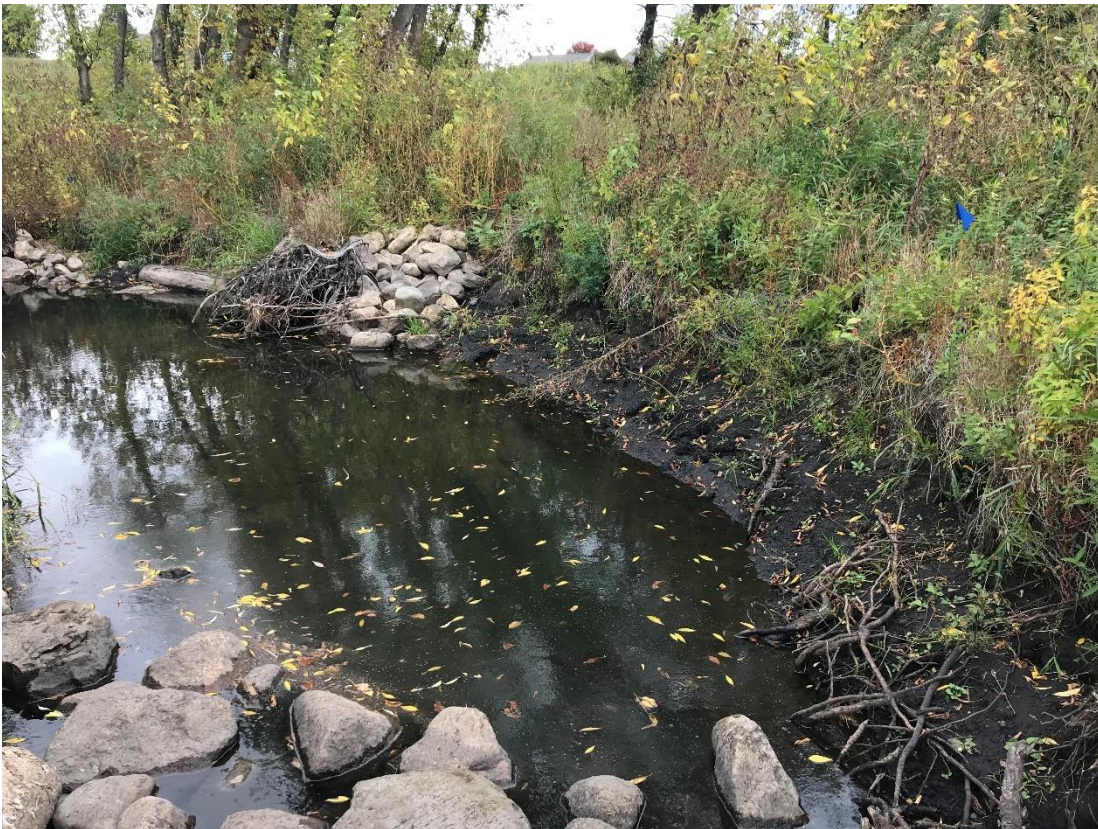
Figure 30. Rootwads and bank erosion at the downstream end of Segment 4B

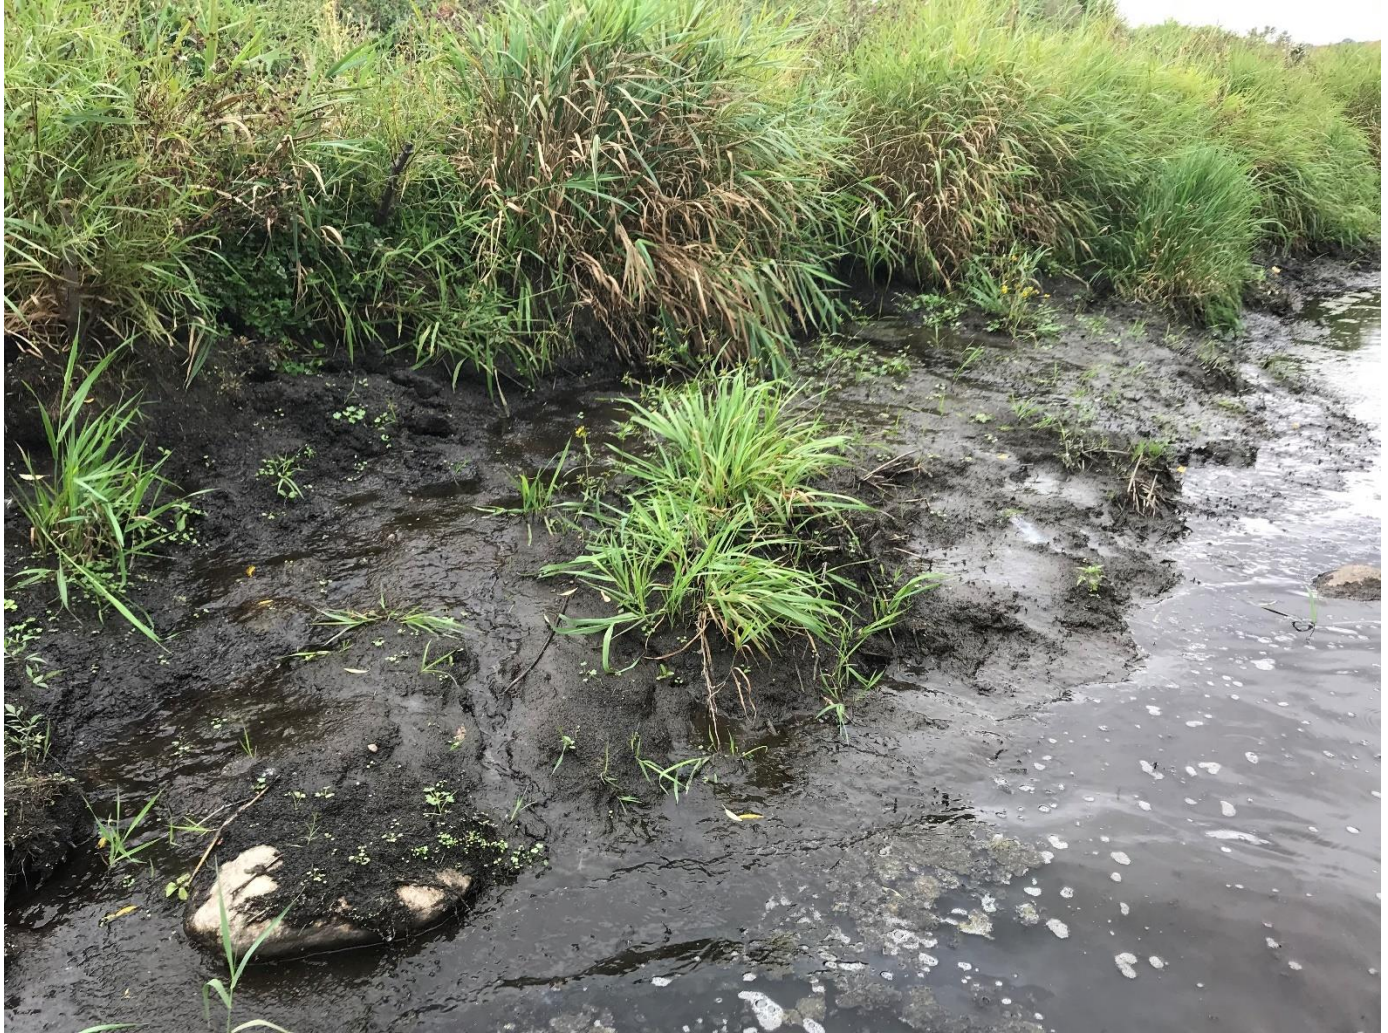
Figure 31. Groundwater seepage along the south bank of the pasture reach in Segment 4B

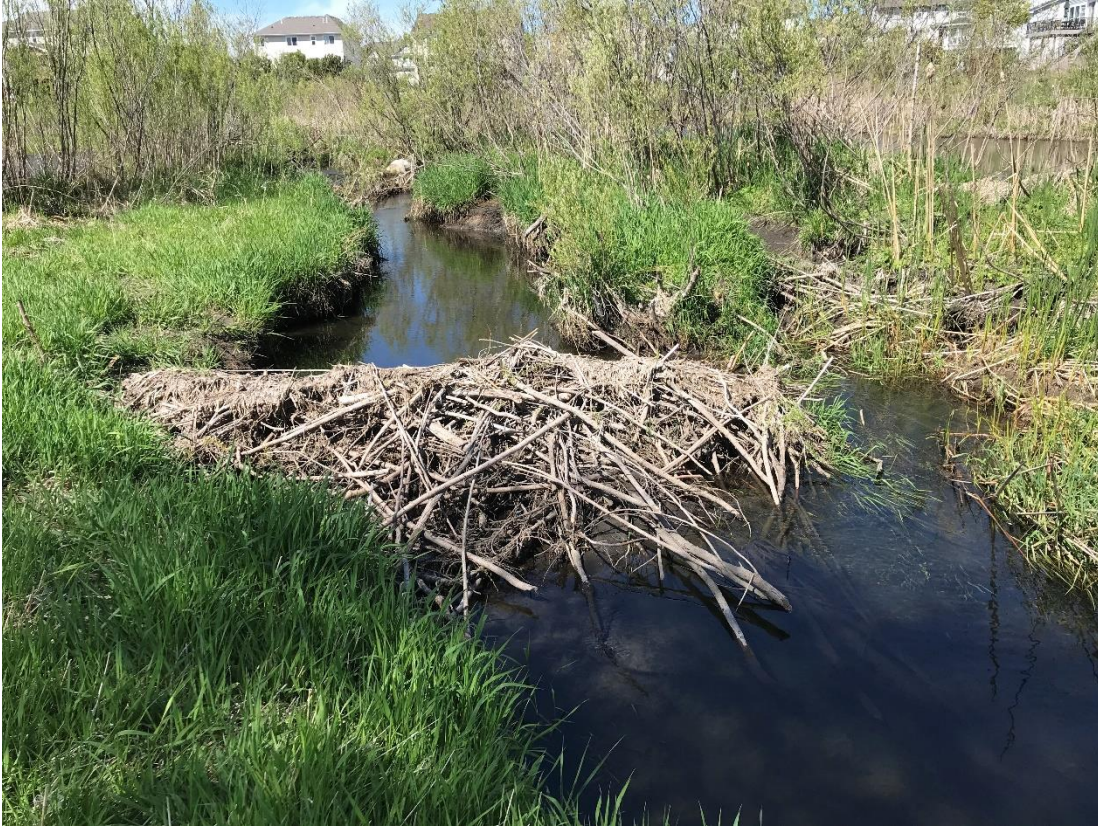
In Segment 5A, two beaver dams were found in the channel between the stormwater ponds. One of the dams has partially failed with water flowing around the side of the dam (Figure 34). Several muskrat tunnels also exist between the stormwater ponds and the PLOC. The tunnels occur under the earthen berm that divides the PLOC from the stormwater ponds and are functioning like culverts which have largely drained the east pond (Figure 35). In Segment 5B, a partial culvert obstruction was found at the upstream end of the twin culverts where the channel bends 90-degrees to the west (Figure 36). In addition, several fallen trees were found lying across and within the channel which are partially affecting flow (Figure 37). The channel banks throughout this segment are in fair condition with reed canary grass (*Phalaris arundinacea*) and tree roots providing ample surface protection in most areas. However, stream banks that were damaged by previous flood events continue to erode. Beaver activity has increased significantly this year in Segment 5B with six beaver dams found. The largest dam occurs just upstream of Pike Lake Road which has an approximate 1-foot surface water drop over the dam (Figure 38). The sediment delta continues to advance downstream of Pike Lake Road in Segment 5C (Figure 39).

Figure 34. Beaver dam in Segment 5A, note the blowout around the side of the dam
