Project Name	PLOC Channel & Vegetation Inspections	Date	1/05/2021
To / Contact info	Jaime Rockney		
Cc / Contact info	Carl Almer		
From / Contact info	Mike Majeski		
Regarding	Channel and Vegetation Inspections – 2020 Summary

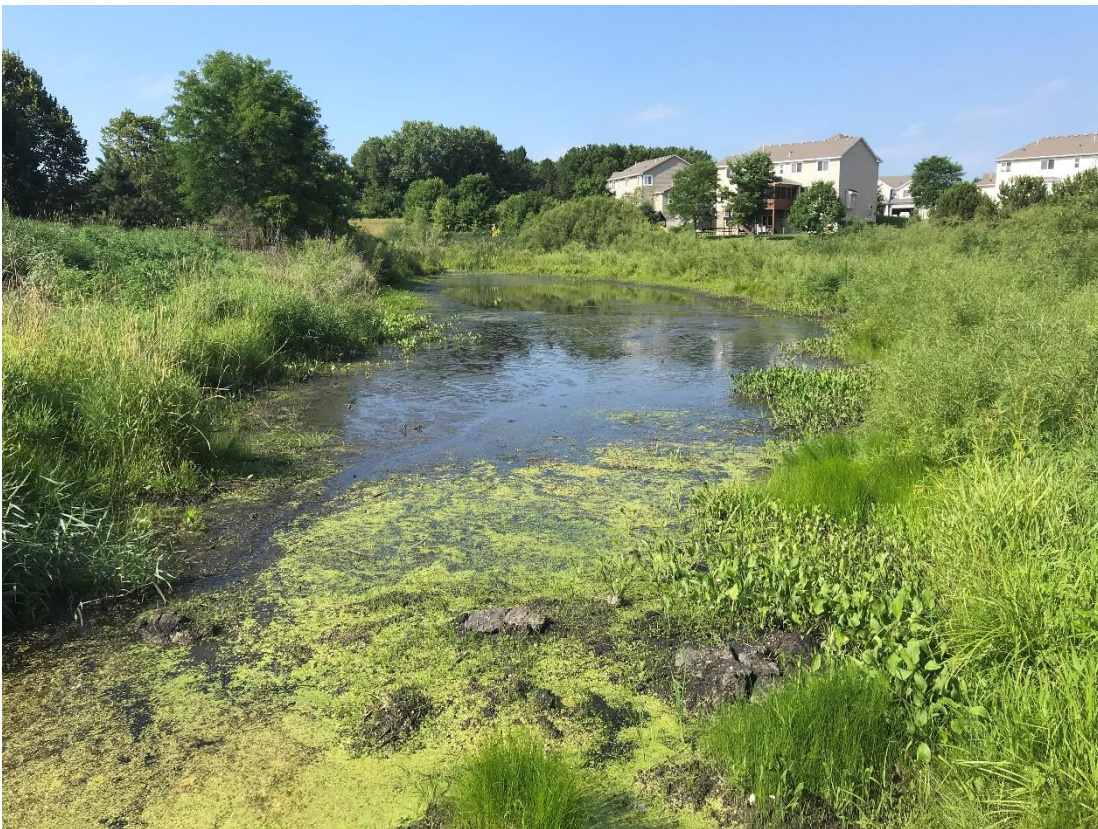
In Segment 5A, two beaver dams were found in the channel between the stormwater ponds. One of the dams has partially failed with water flowing around the side of the dam (Figure 34). Several muskrat tunnels also exist between the stormwater ponds and the PLOC. The tunnels occur under the earthen berm that divides the PLOC from the stormwater ponds and are functioning like culverts which have largely drained the east pond (Figure 35). In Segment 5B, a partial culvert obstruction was found at the upstream end of the twin culverts where the channel bends 90-degrees to the west (Figure 36). In addition, several fallen trees were found lying across and within the channel which are partially affecting flow (Figure 37). The channel banks throughout this segment are in fair condition with reed canary grass (*Phalaris arundinacea*) and tree roots providing ample surface protection in most areas. However, stream banks that were damaged by previous flood events continue to erode. Beaver activity has increased significantly this year in Segment 5B with six beaver dams found. The largest dam occurs just upstream of Pike Lake Road which has an approximate 1-foot surface water drop over the dam (Figure 38). The sediment delta continues to advance downstream of Pike Lake Road in Segment 5C (Figure 39).

Figure 35. Low surface water elevation in the east stormwater pond due to muskrat drainage tunnels

- Continue inspections in 2021
- Repair the earthen berm to restore the normal surface water elevation in the east stormwater pond

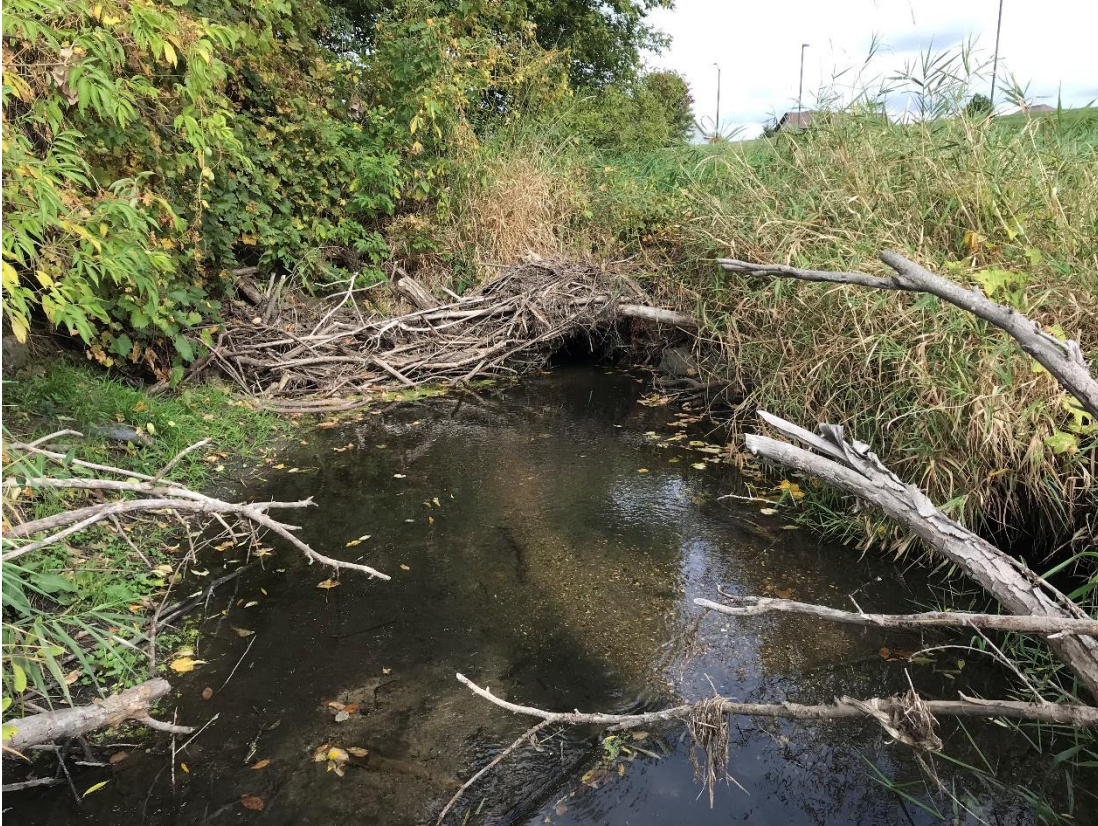
Figure 36. Culvert obstruction at the twin 90-degree culverts in Segment 5B

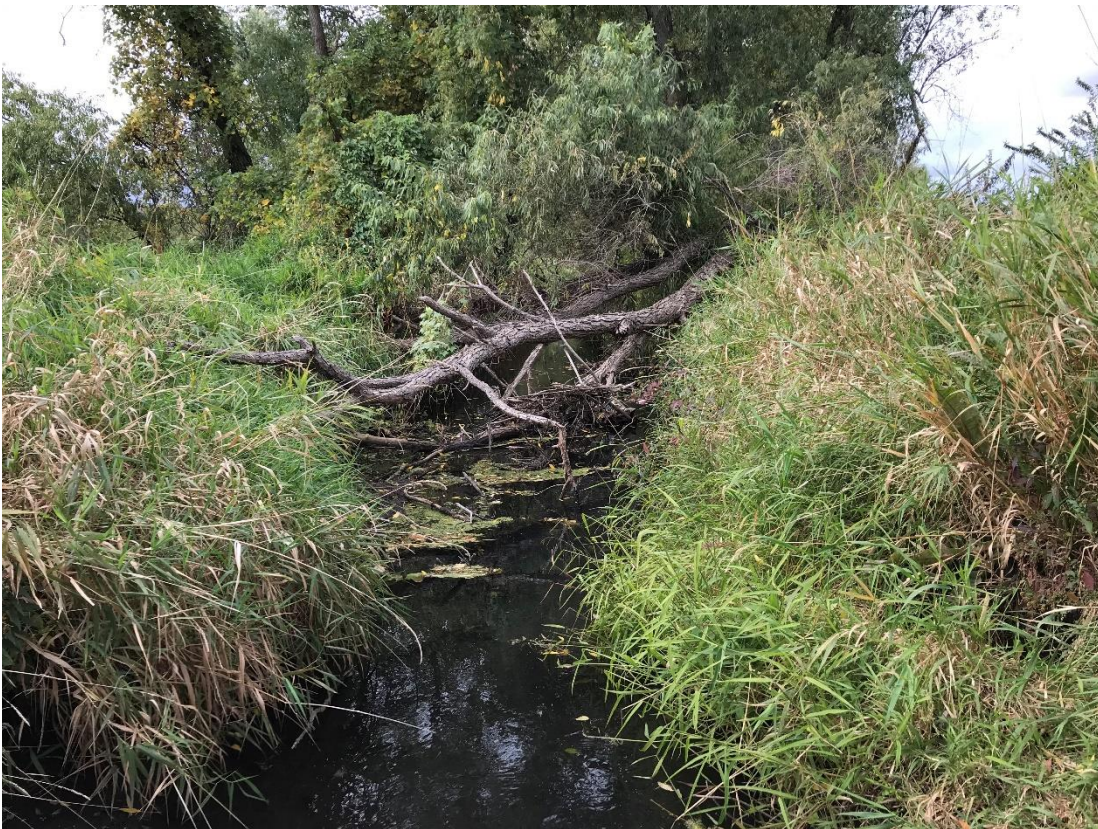
Figure 37. Several fallen trees over the channel in Segment 5B

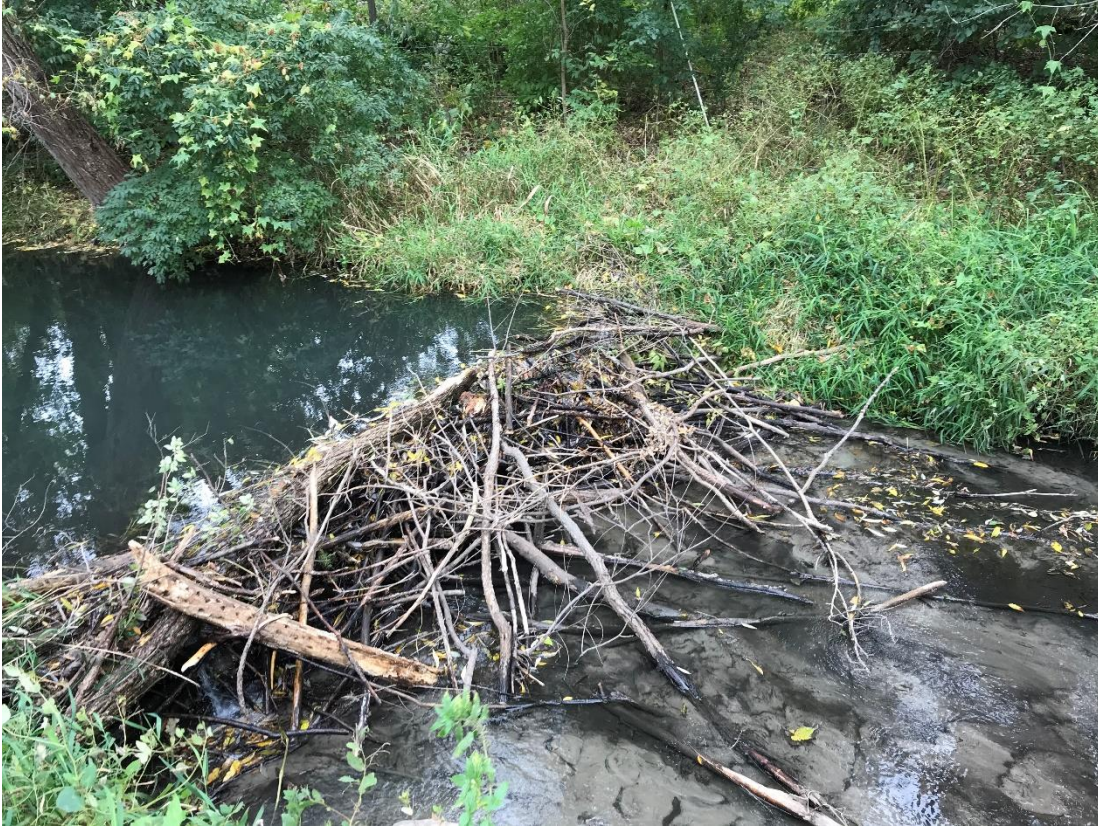
Figure 38. Large beaver dam near the downstream end of Segment 5B

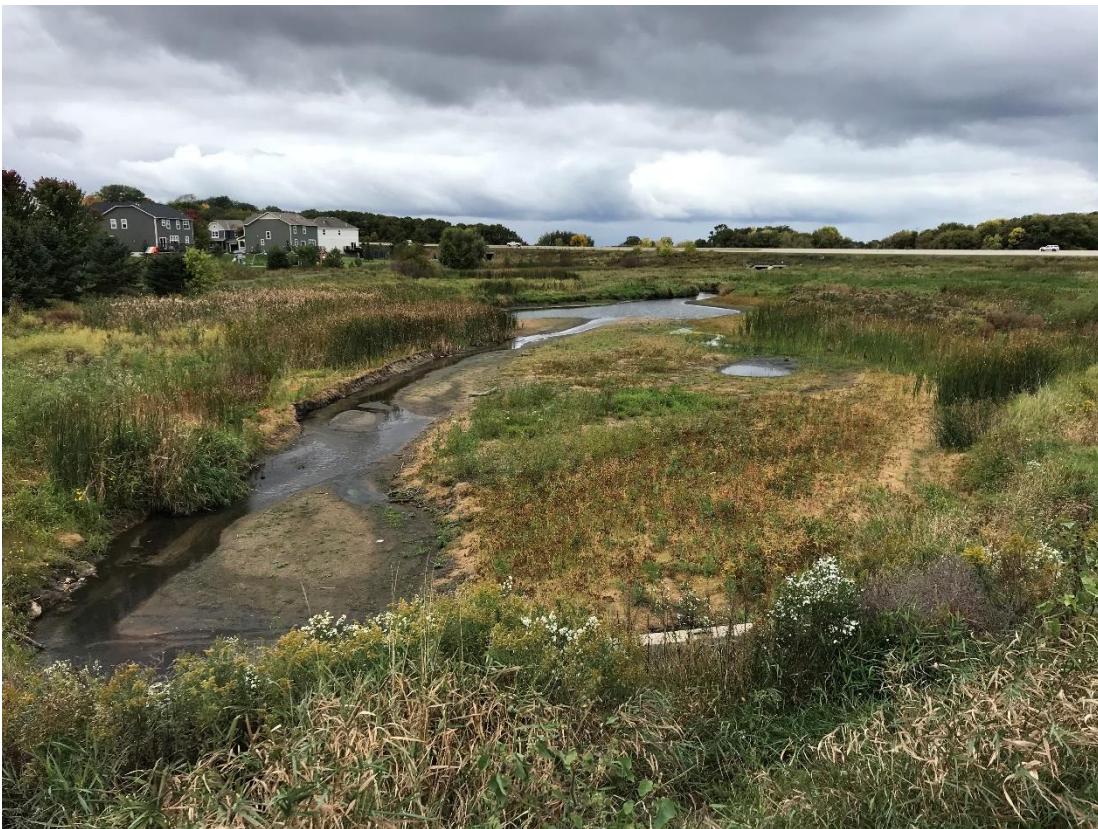
Figure 39. Sediment delta located downstream of Pike Lake Road in Segment 5C

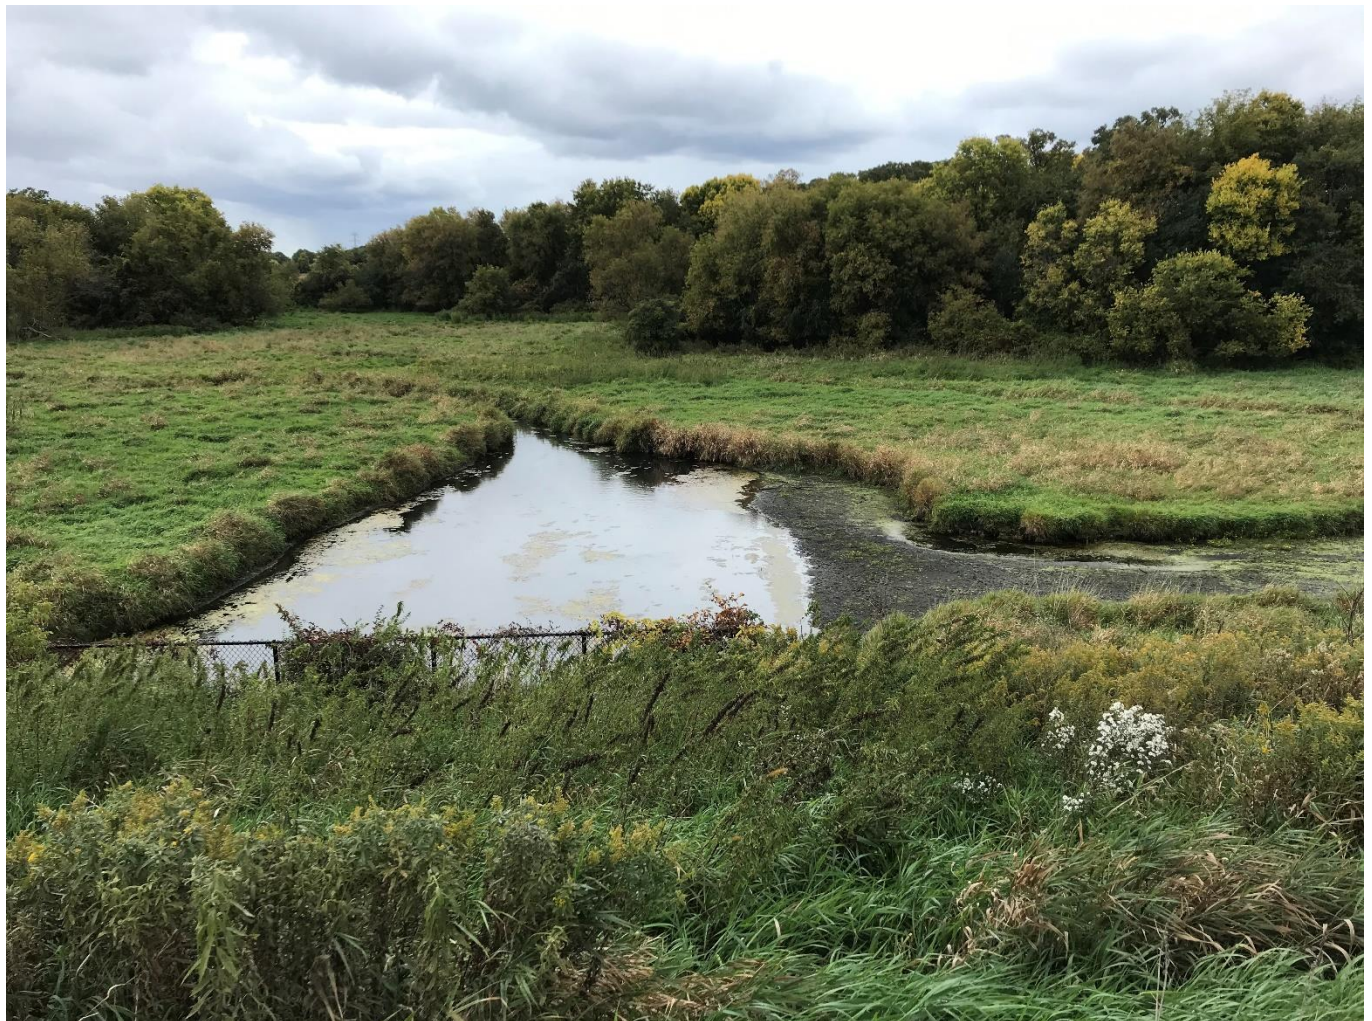
The sediment delta at the inlet to the Deans Lake bypass channel documented in 2018 continues to expand. The sediment delta bridges the entire mouth of the bypass channel and directs low flows into Deans Lake (Figure 43). Although the bypass channel still functions during high flow events through the PLOC, it is recommended the sediment delta be removed to increase flows through the bypass channel and reduce nutrient loading to Deans Lake. No other channel obstructions were found in this segment. The Deans Lake weir appears to be in good condition and was free of debris at the time of the surveys. The channel banks throughout this segment are well vegetated and show little evidence of bank erosion (Figure 44 and Figure 45Figure 45).

Figure 43. Channel downstream of County Road 21 & sediment delta in bypass channel

- Remove the sediment delta at the upstream end of the Deans Lake bypass channel located downstream of County Road 21. Continue inspections in 2021
