2020 PRIOR LAKE OUTLET SYSTEM ANNUAL OPERATIONS REPORT

PRIOR LAKE-SPRING LAKE
WATERSHED DISTRICT

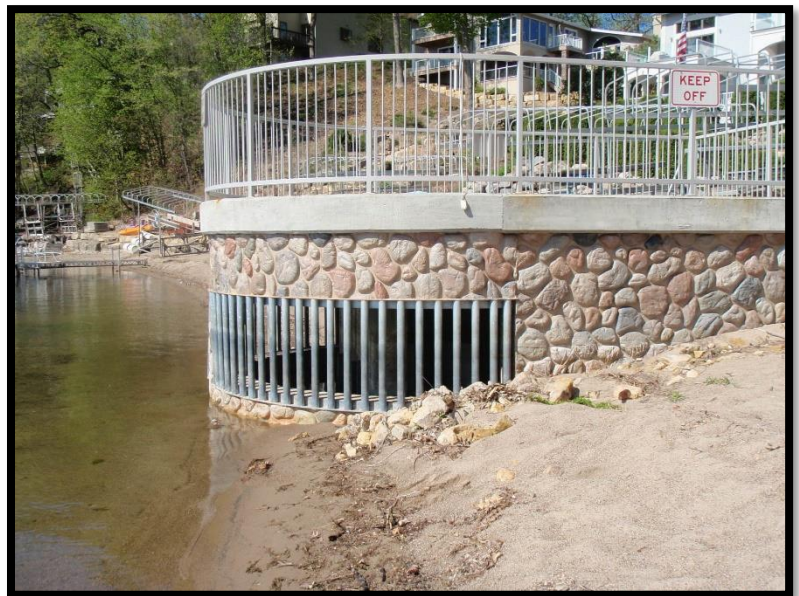
FIGURE 1 OUTLET STRUCTURE

Given these conditions, a replacement structure was pursued by the District and installed in 2010 (Figure 1). The new design has increased the efficiency of discharging water by allowing the outlet pipe to reach capacity sooner. It also provides safer conditions for staff during inspections and maintenance and is self-operating which reduces overall operations and maintenance costs. A schematic of the outlet structure is provided in Attachment A.

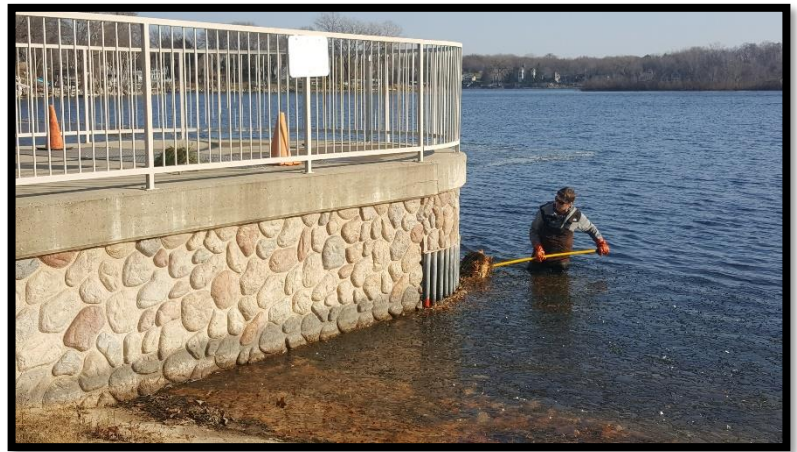
FIGURE 2 REMOVING VEGETATION FROM OUTLET STRUCTURE

The new structure requires minimal maintenance to operate. Once Prior Lake reaches 902.5', water starts spilling over the accordion shaped weir located inside the trash rack. Maintenance includes visual inspections, greasing gates, and removing debris from the trash rack. Removing vegetation and other debris from the trash rack is the most time-consuming and labor-intensive task (Figure 2). When the structure is operating (Prior Lake is greater than 902.45'), the structure will be inspected no less than once a week, and as much as twice per day, depending on the lake level and amount of vegetation getting caught on the trash rack. Inspections and debris removal are typically conducted by PLSLWD staff. During times when water is high and large amounts of vegetation are getting caught on the track rack, the City of Prior Lake staff have helped remove vegetation to ensure the Outlet Structure was not blocked.

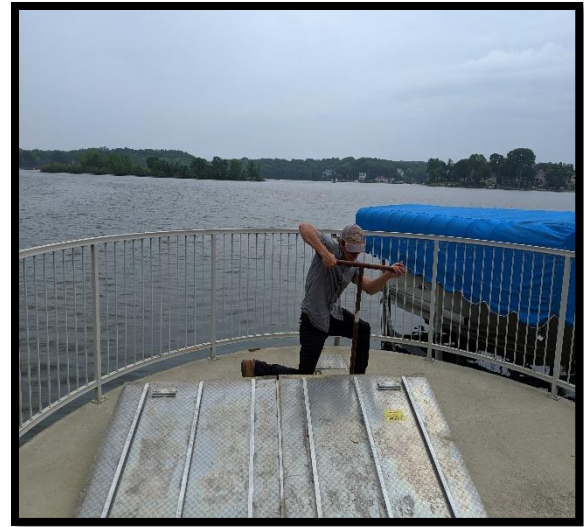
FIGURE 3 – OPENING THE LOW-FLOW GATE

At certain lake levels, the low-flow gate allows more water through the outlet structure, resulting in the lake level lowering more quickly and creating more storage (see Attachment C). To reduce the risk of flooding, the District opened the low-flow gate on March 2 due to anticipated high lake levels. To reduce ice dams along the channel after opening the low-flow gate, the low-flow gate of the outlet structure was only opened 10 rotations of the gate. This allowed the water to melt some of the ice in the channel. On March 4, the gate was opened half-way before fully opening the low-flow gate on March 19. The low-flow gate remained open until April 29 (see Figure 3).

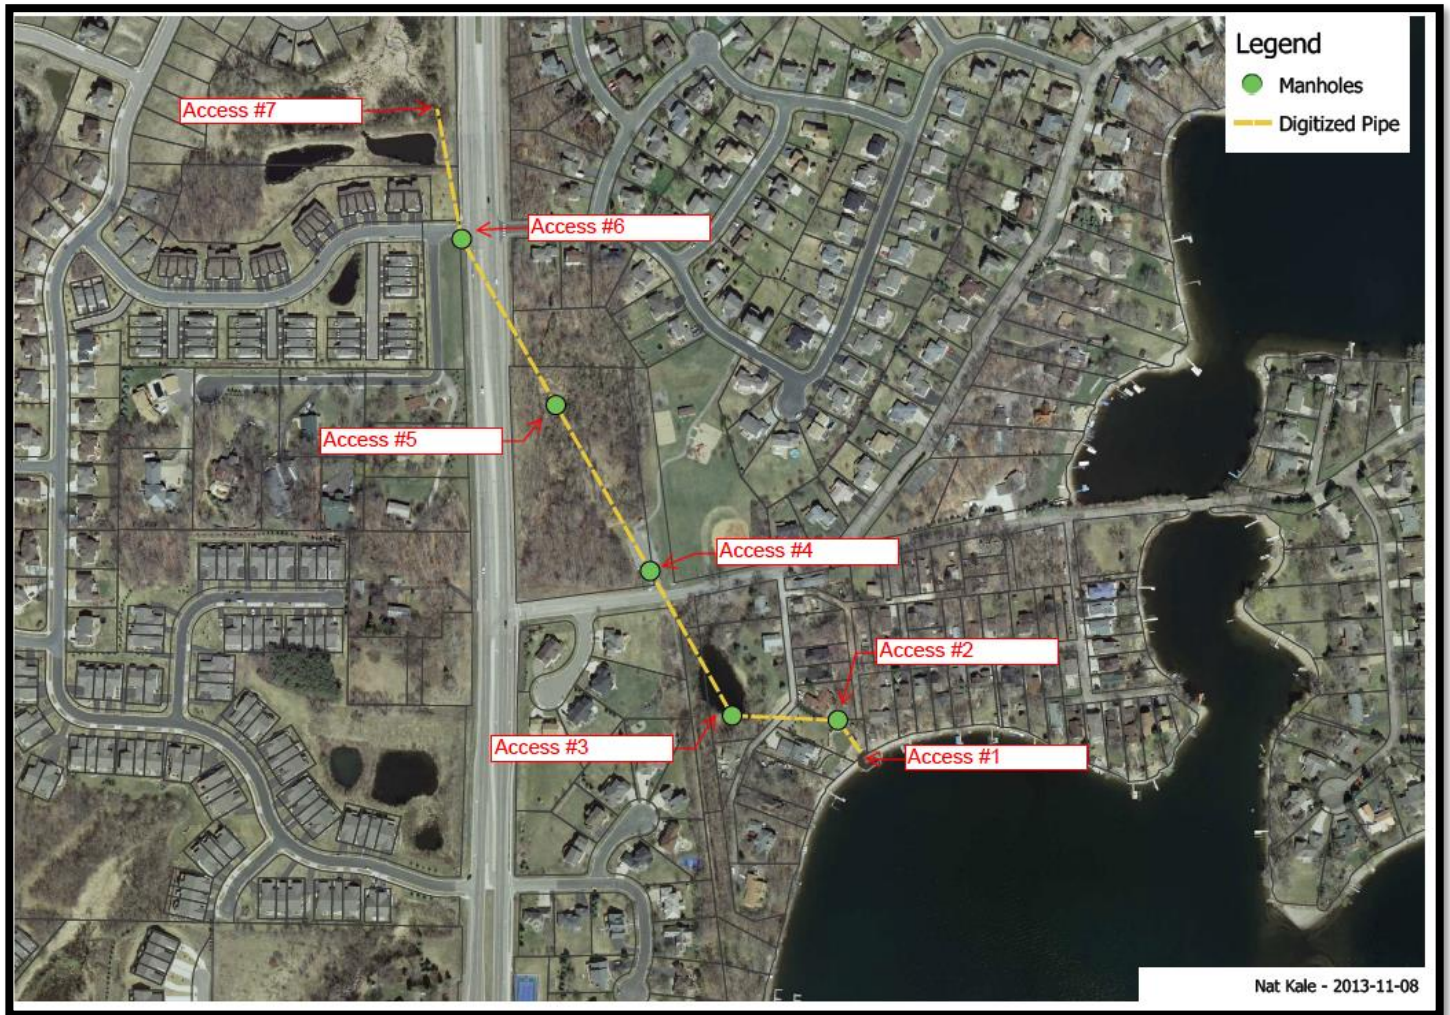
FIGURE 5 MAP OF OUTLET PIPE

The Outlet Pipe leads from the Outlet Structure to the beginning, or “daylight,” of the outlet channel (Figure 4). It is buried underground for approximately 2075 feet, with 5 manholes and 7 access points (Figure 5).

In 2020, American Environmental televised the pipe revealing the lake outlet pipe is in good to fair condition, but multiple cracks and fractures were found in some segments. Several options will be weighed to decide the best course of action. Some of these options include sealing the joints that fail pressure tests, lining the pipe, a combination of those two, or pipe bursting.

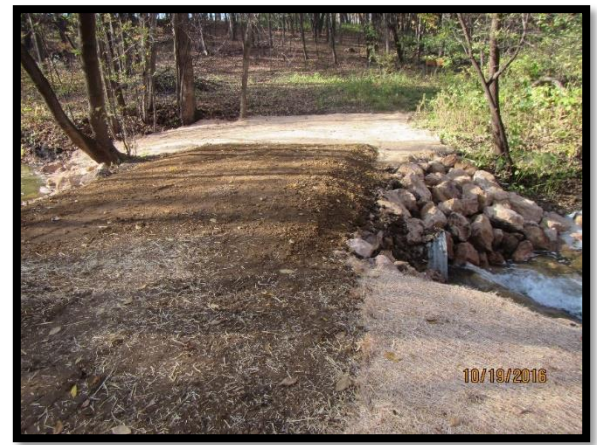
FIGURE 6 KES FIELD CROSSING REPAIR IN 2016

- Kes Field Crossing culvert (Figure 6), Gonyea culvert, and Pike Lake Park stream crossing repaired by Nadeau Companies.
 - The remaining downed trees and woody debris were removed by WHR.
