Project Name | PLOC Channel & Vegetation Inspections**Date** | 12/30/2021**To / Contact info** | Jaime Rockney, Water Resources Project Manager**Cc / Contact info** | Carl Almer**From / Contact info** | Mike Majeski**Regarding** | Channel and Vegetation Inspections – 2021 Summary

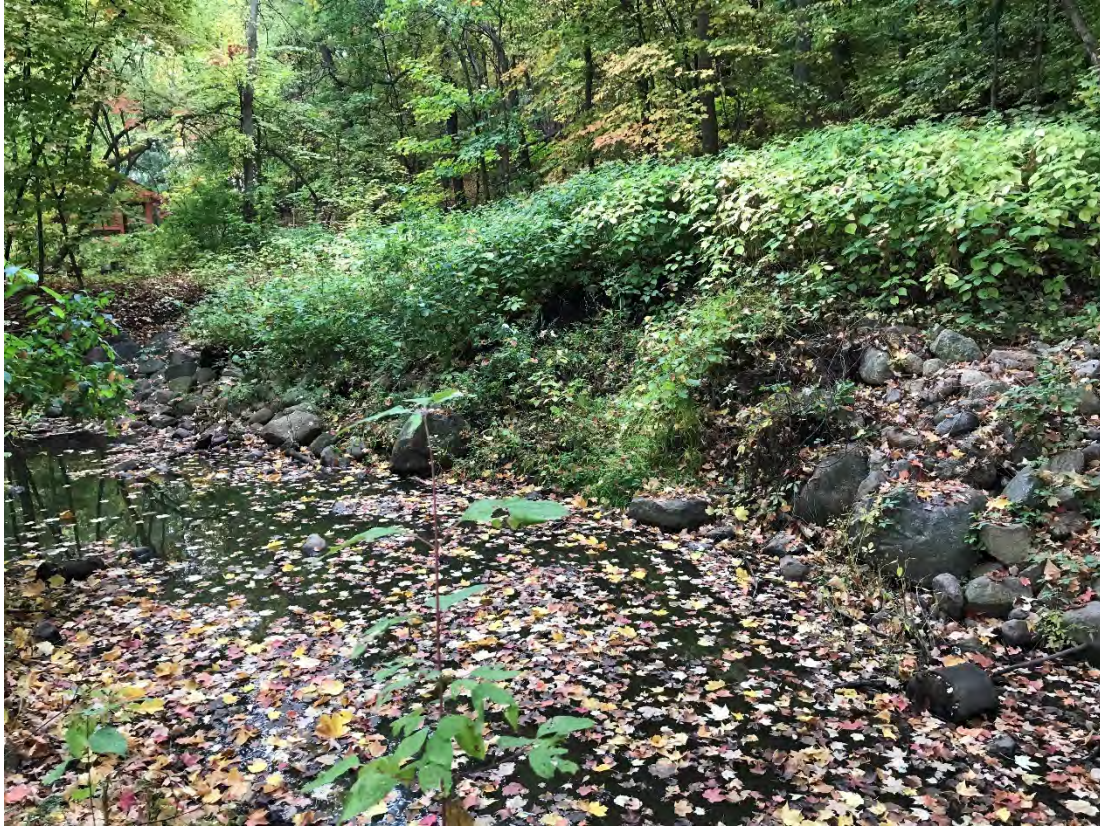
Similar conditions exist to the 2020 channel inspection and include erosion issues associated with the placement of rock to repair failed cross vanes near Jeffers Pond Elementary School. Self-healing of a previously eroded bank was noted downstream of the walking bridge at Jeffers Pond Elementary School and can be attributed to very low flows in the outlet channel throughout the year (Figure 1). A bank repair plan is currently being developed to extend boulder toe rock along the right bank just upstream of the walking path at Fountain Hills Road where erosion was previously documented. Downstream of Fountain Hills Road, bank erosion continues in the wooded reach where undercut banks are exposed (Figure 2, Figure 3). Minor channel obstructions were observed in the same areas identified in previous surveys including several down trees lying across and within the channel in the wooded area upstream of County Road 42 (Figure 4). The beaver dams observed in this reach in 2020 appear inactive and were not holding back any water during the inspections.

Figure 1. Self-healing of a bank where a gap in boulder toe occurs near Jeffers Pond Elementary School

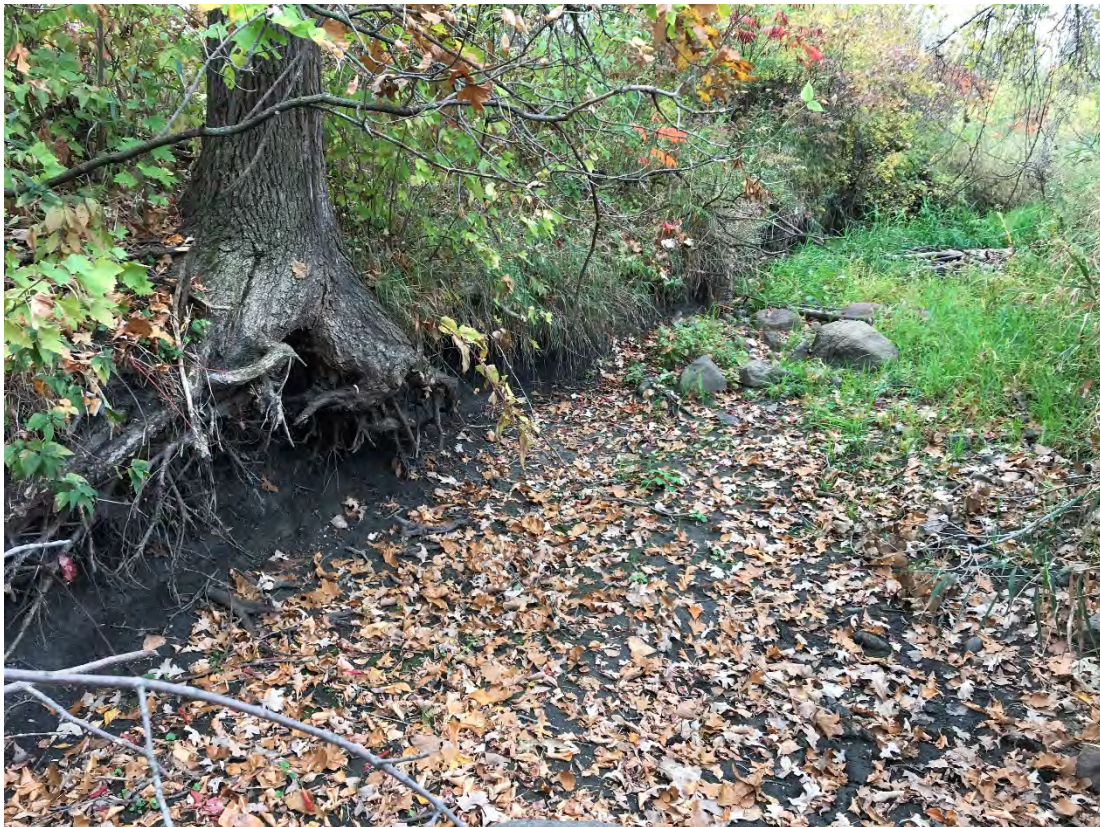
Figure 2. Bank erosion downstream of Fountain Hills Road

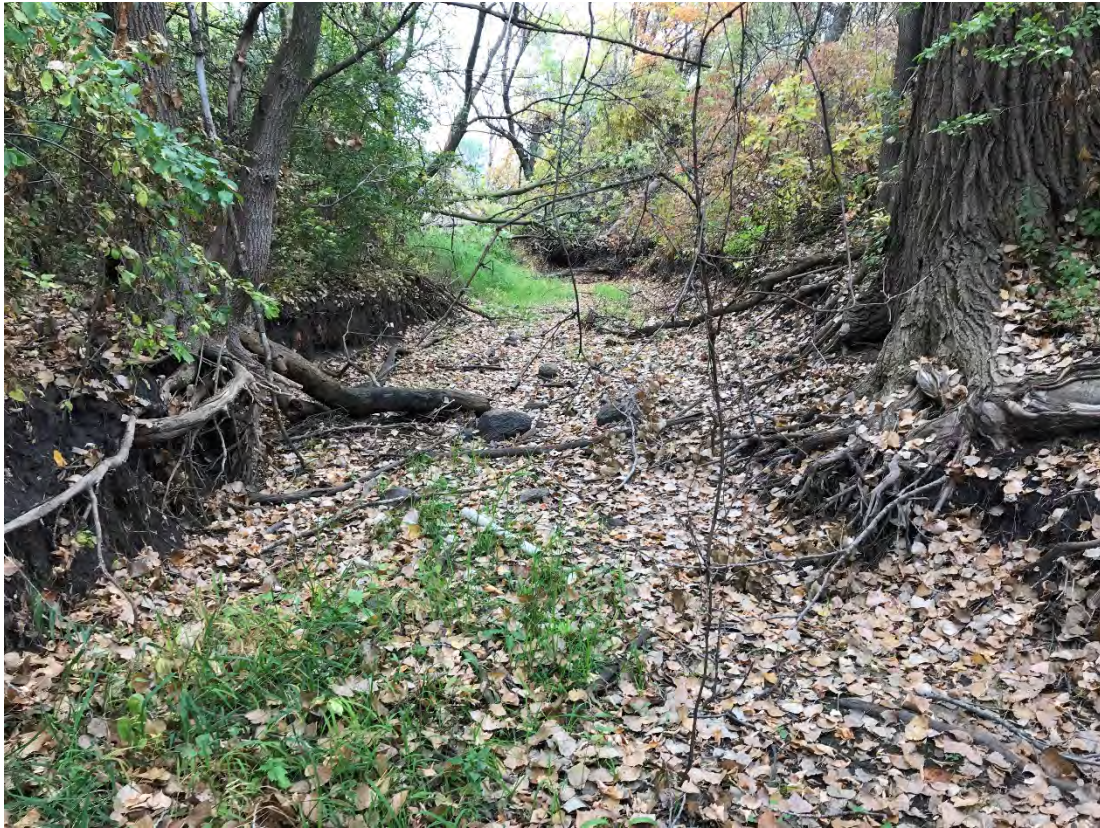
Figure 3. Bank erosion downstream of Fountain Hills Road

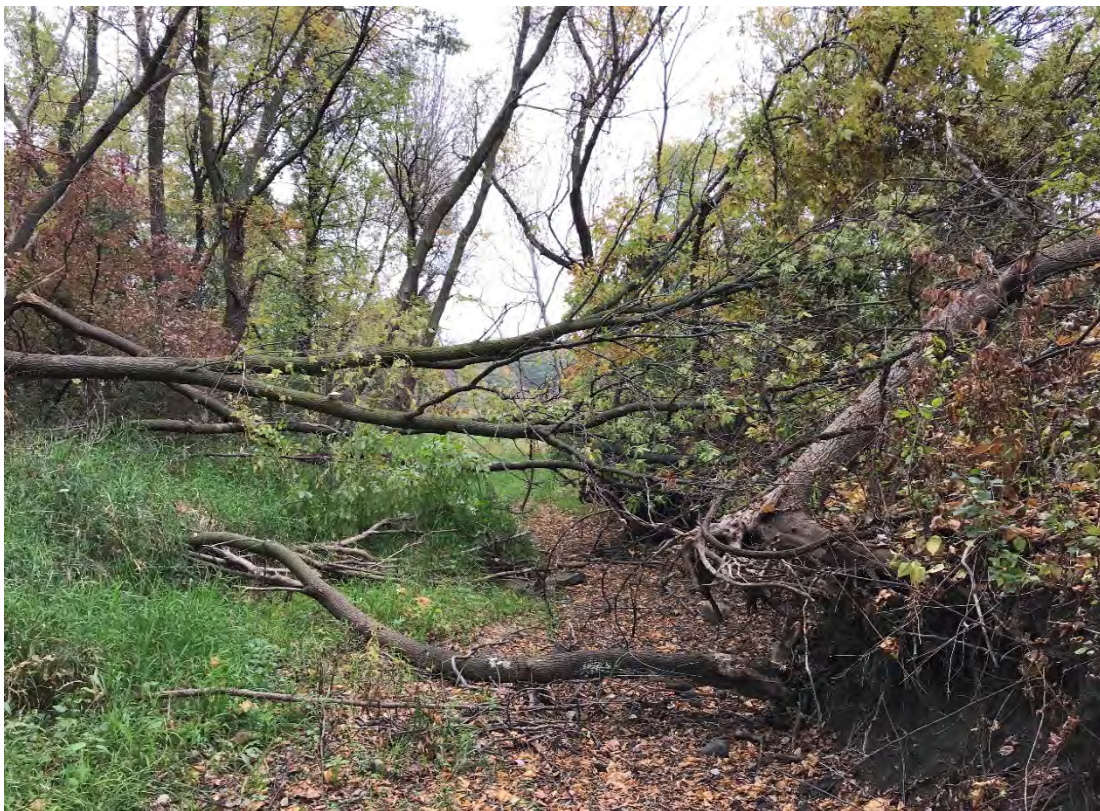
Figure 4. Down trees in channel downstream of Fountain Hills Road

- Continue inspections in 2022 and monitor stability of bank repair areas
- Remove fallen trees within the channel upstream of CR 42 (unless tree removal is part of future bank repair work)
- Remove blown-out culvert located upstream of CR 42 (old field crossing culvert) to reduce potential for channel obstruction during high flows

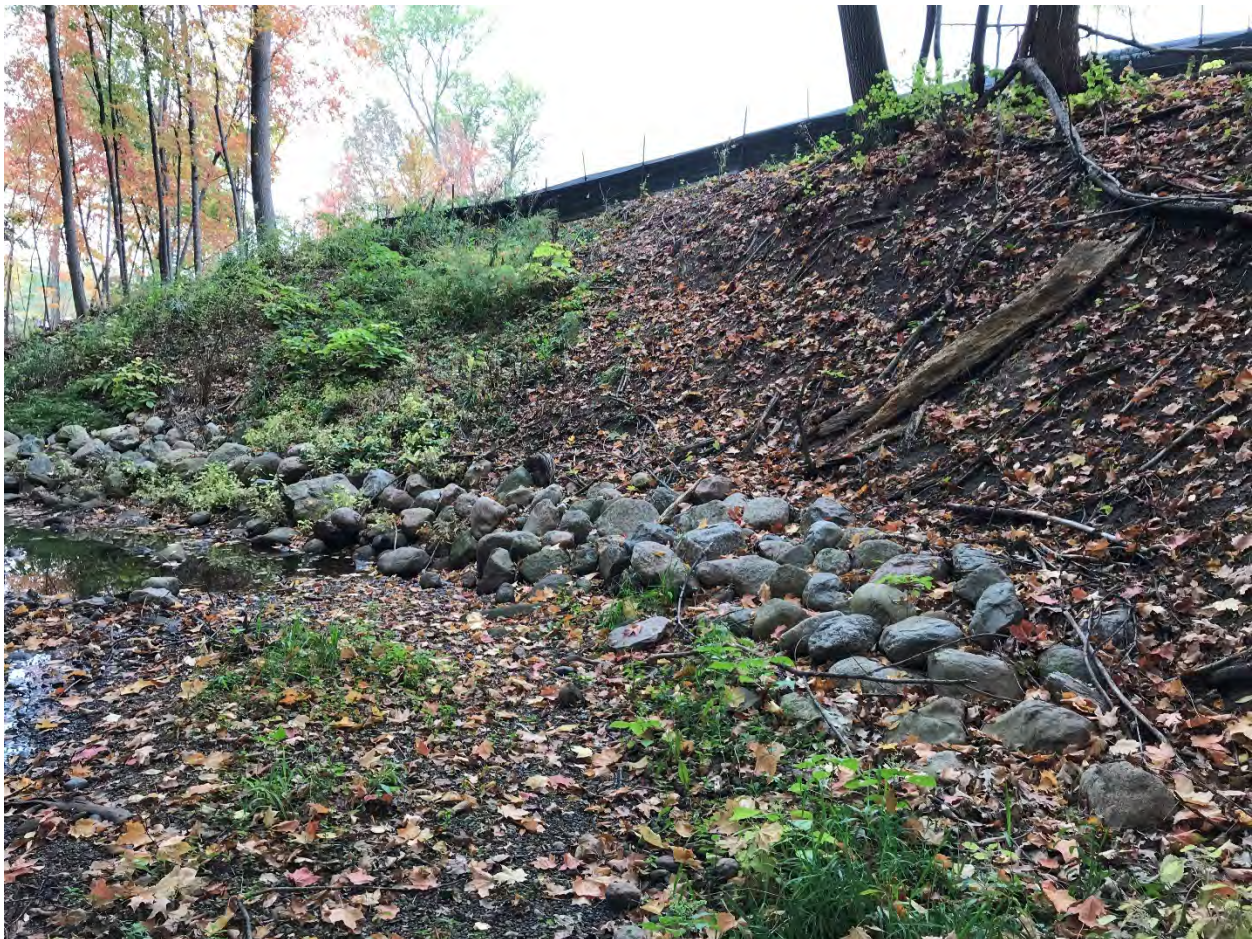
Numerous stream banks within this segment have been repaired since 2018 through the FEMA bank repair project (Figure 7). The primary bank stabilization practices implemented include placement of boulder toe along the sides of the channel and installation of rock cross vanes. Several rock cross vanes have erosion occurring around the edges of the vane wings (Figure 8). The bank repairs have reduced toe erosion throughout the segment, but bank erosion continues in areas where bank repair activities have not occurred (Figures 9-10). Following recent residential development in this reach, new culvert outfalls now occur in the channel (Figure 11). Significant tree loss has occurred because of the new development in this segment, and recent windfall adjacent to the development was observed during the October inspection (Figure 12, Figure 13). It is recommended the large sediment delta at the inlet to Pike Lake be removed now that most of the channel banks in this segment have been stabilized (Figure 14).

Figure 7. Boulder toe bank stabilization from the FEMA project

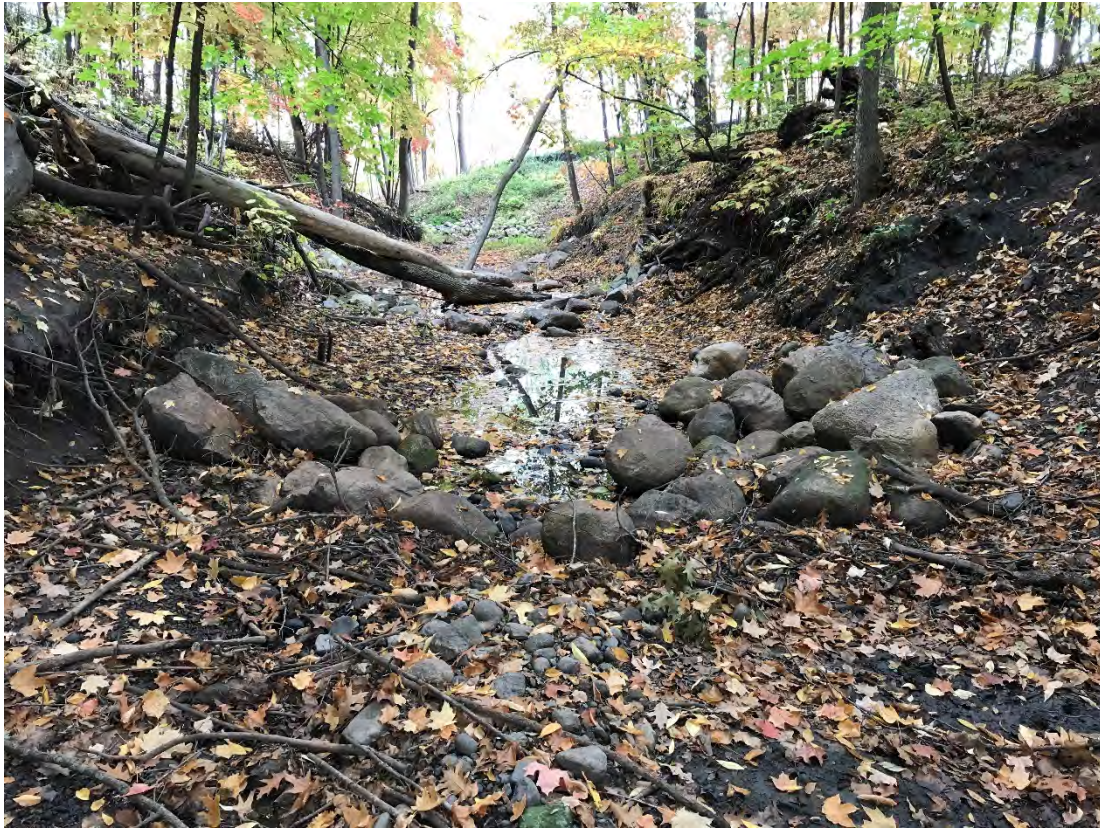
Figure 8. Erosion around the wings of installed rock cross vanes

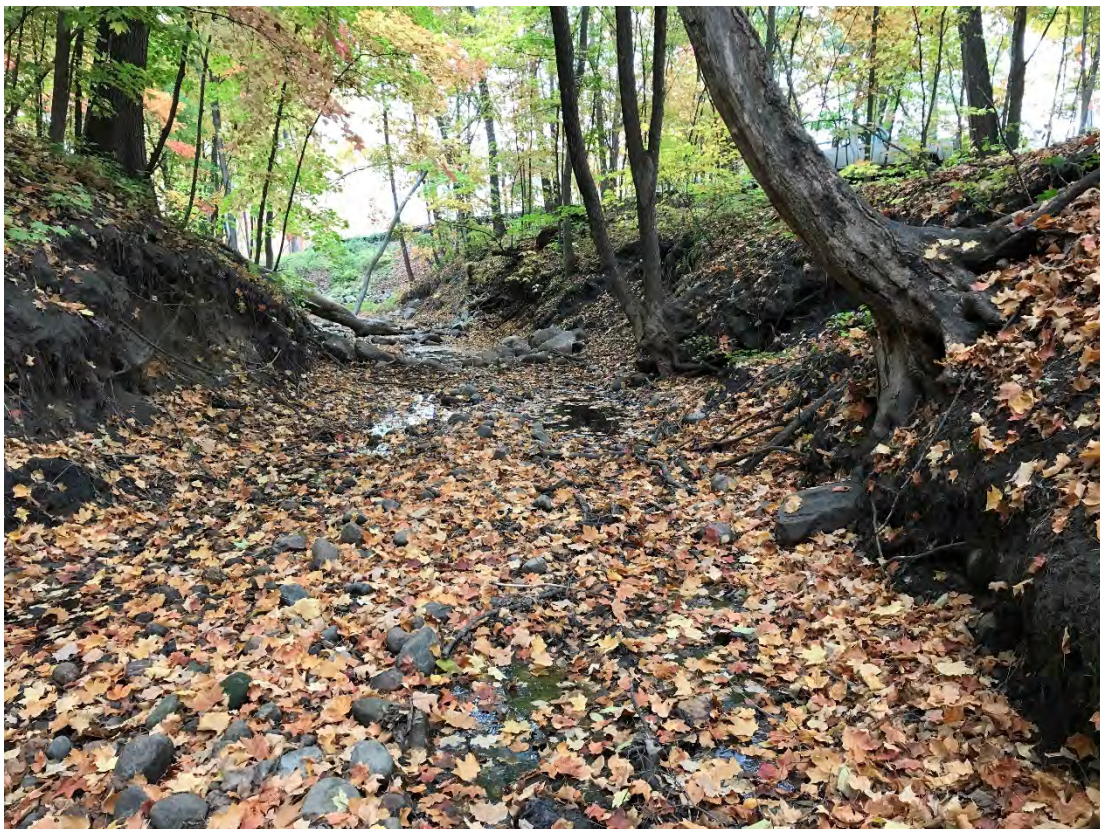
Figure 9. Bank erosion in areas where no bank repair work was conducted

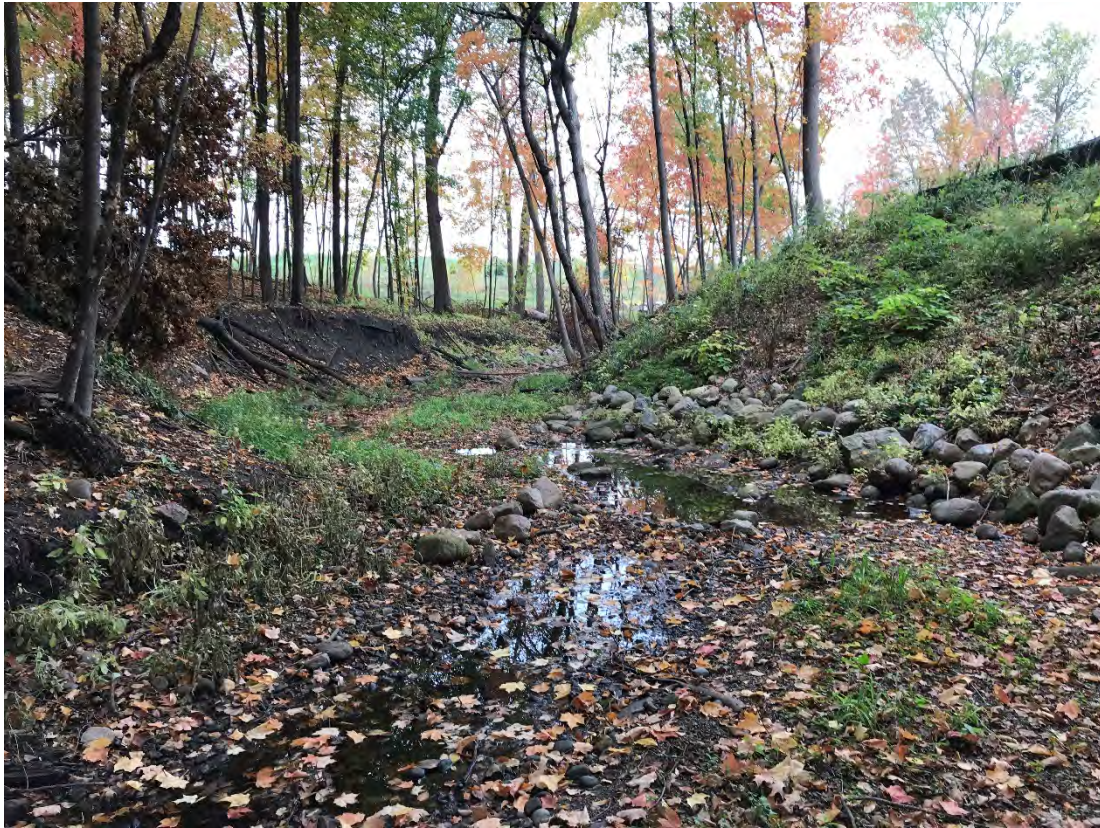
Figure 10. Bank erosion (left bank) where no bank repair work was conducted

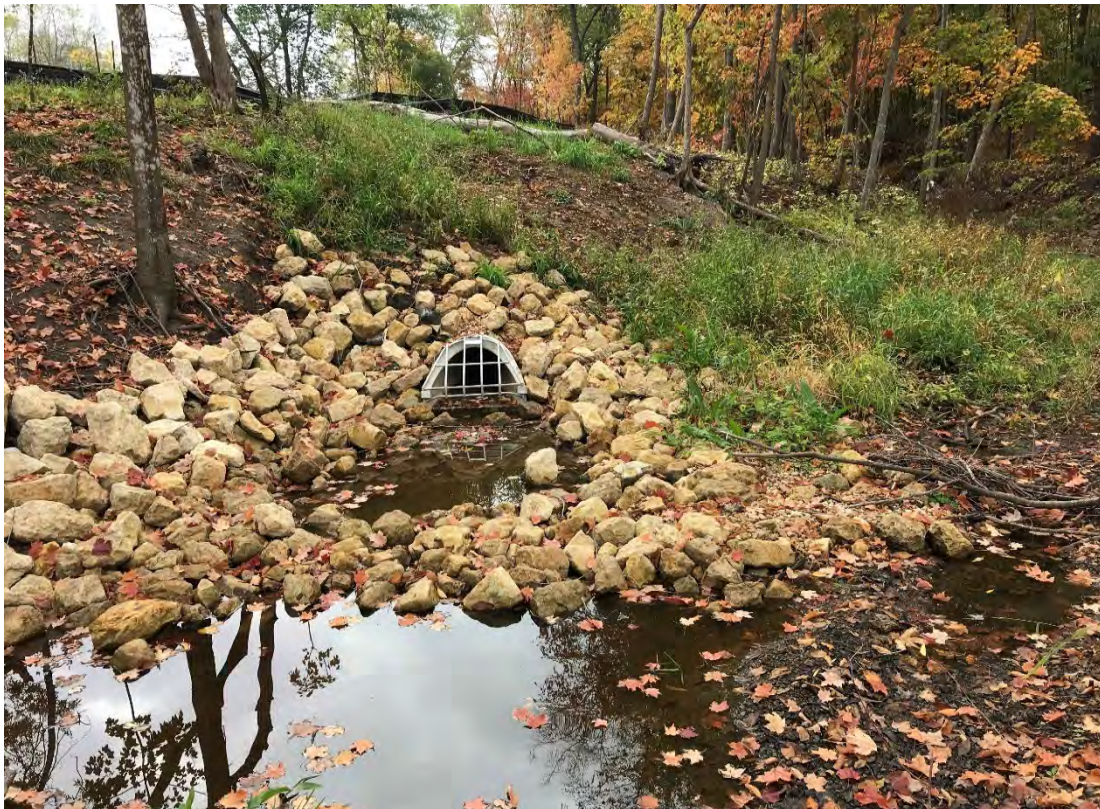
Figure 11. New culvert outfall within the developed reach of Segment 2

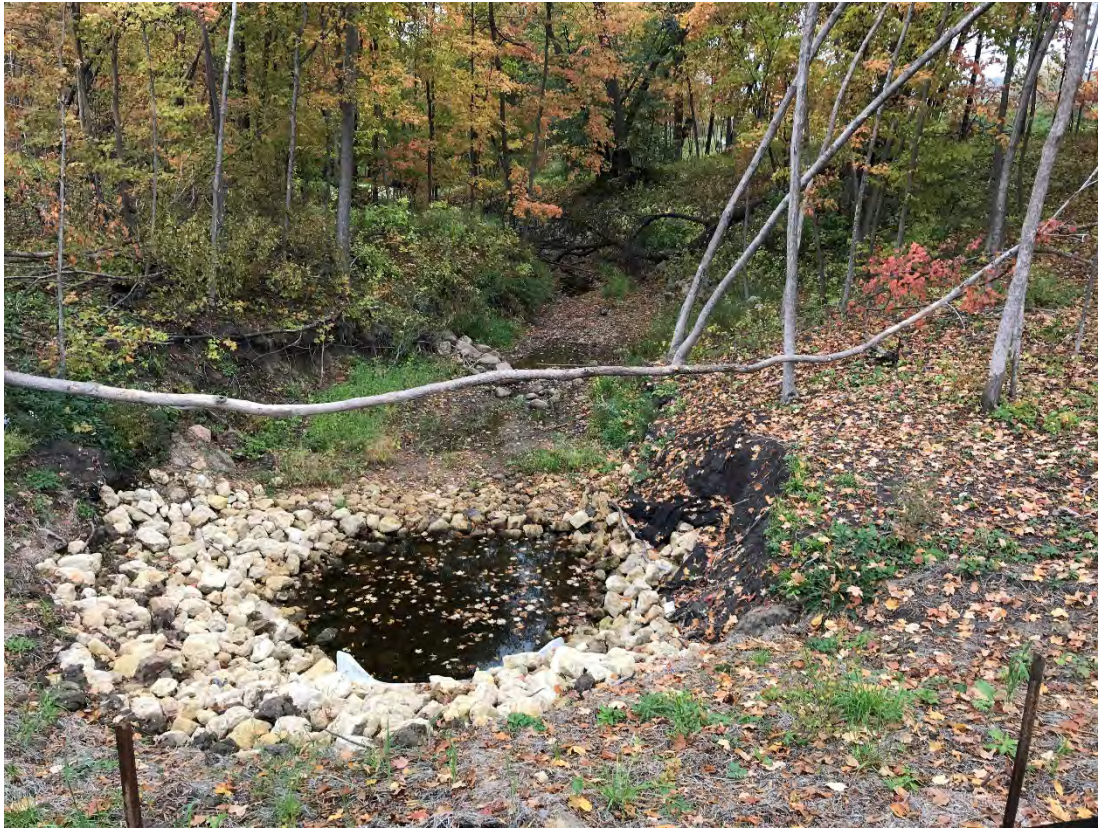
Figure 12. Recent down trees within the developed reach of Segment 2

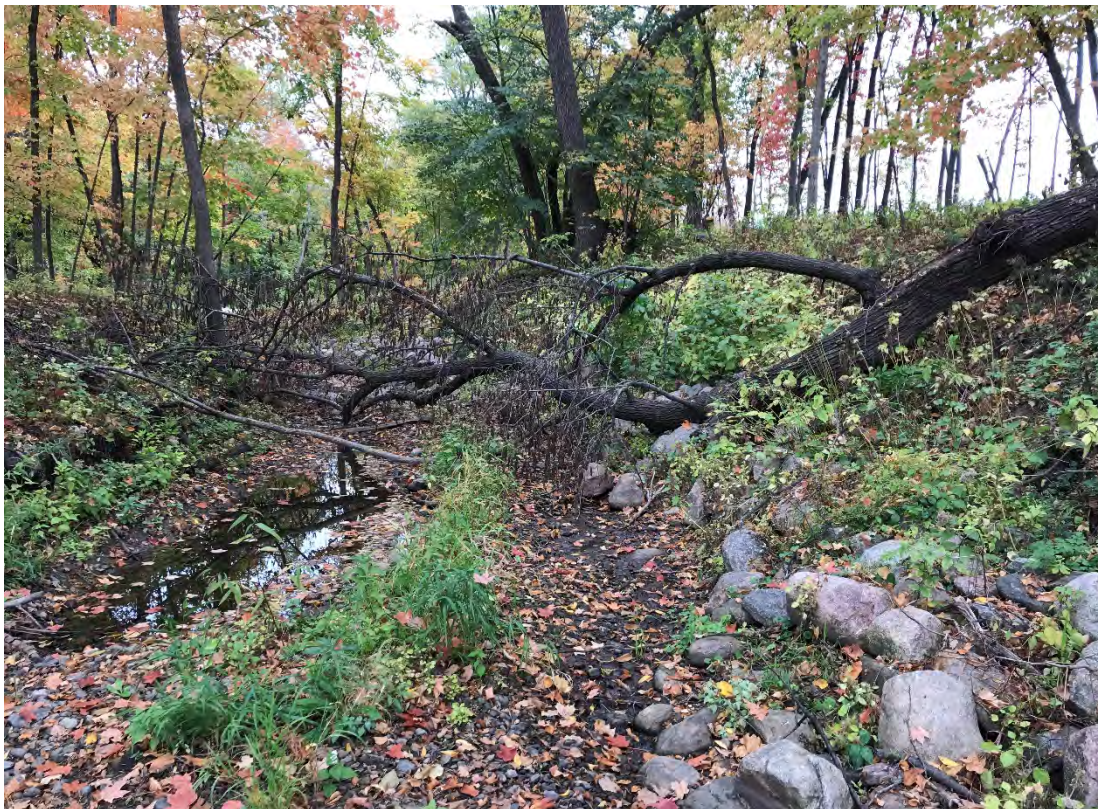
Figure 13. Recent down trees within the developed reach of Segment 2

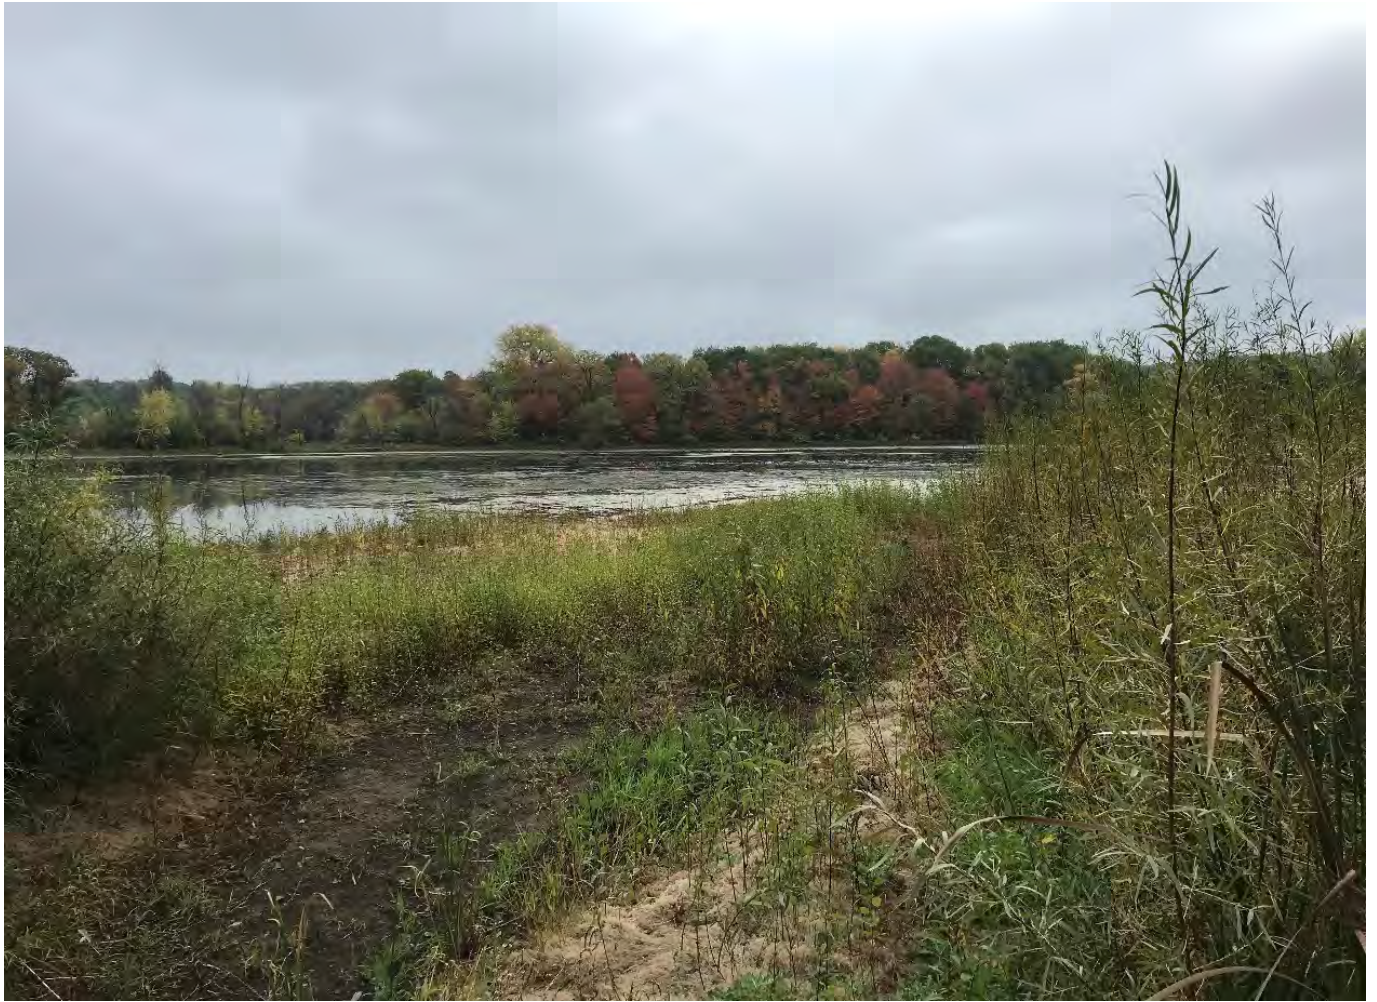
Figure 14. Sediment delta at the inlet to Pike Lake

- Continue inspections in 2022 and monitor stability of bank repair areas
- Remove the sediment delta at the outlet of Segment 2 in Pike Lake

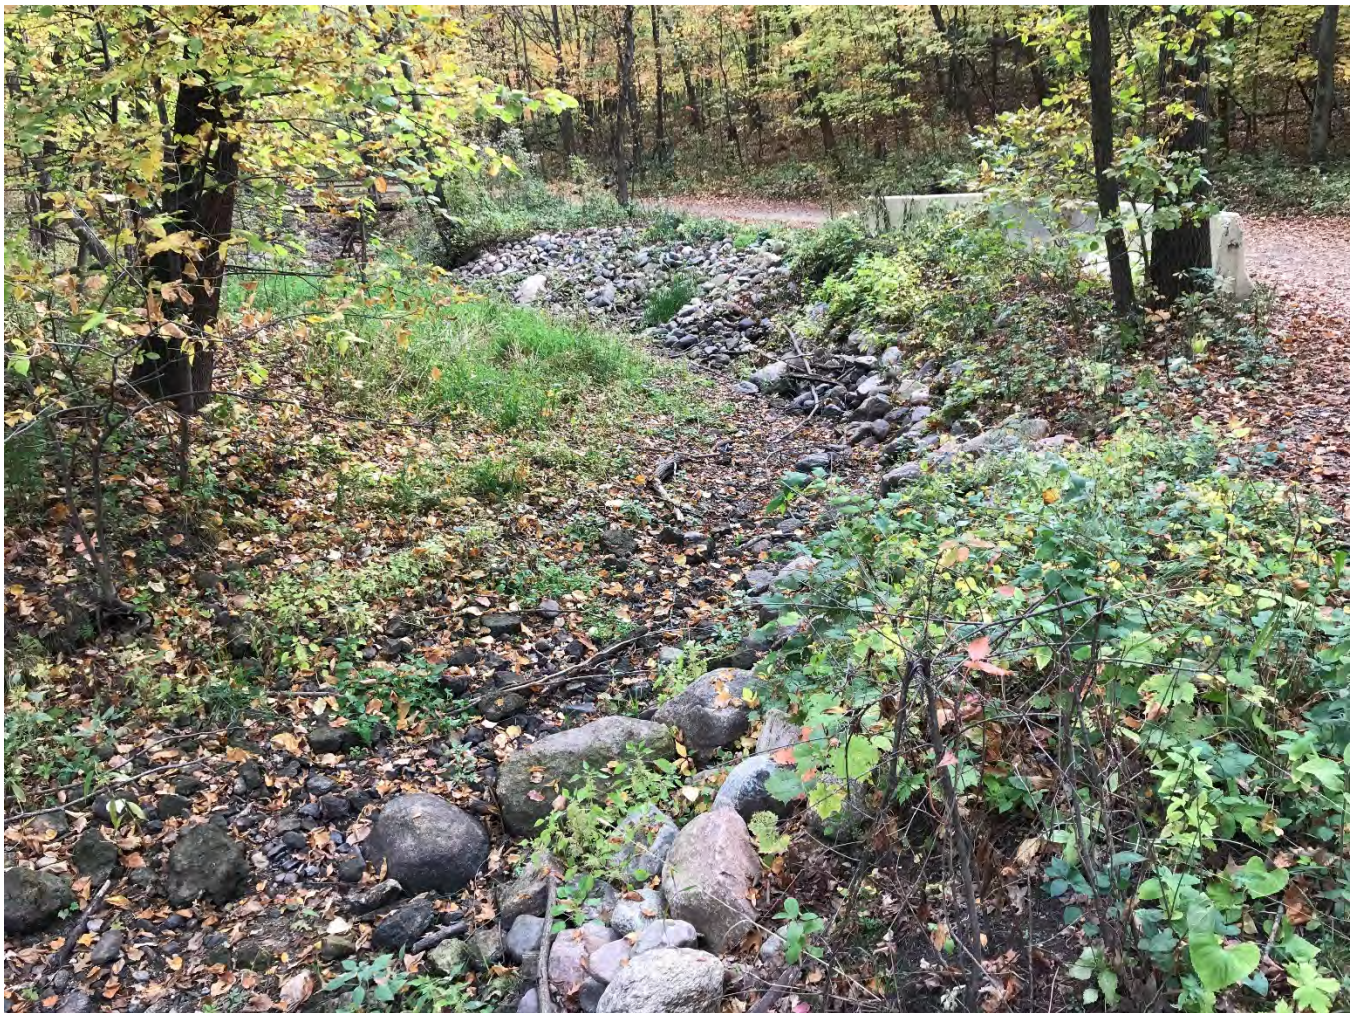
Numerous stream banks within this segment were repaired in 2019, including the two road embankment slumps along the upstream end of the Kici Yapi property (Figure 16, Figure 17). The primary bank stabilization practice implemented was the placement of boulder toe along the sides of the channel (Figure 18, Figure 19). Boulder cross vanes were also installed in several locations for grade control and to concentrate flows to the center of the channel (Figure 20). No major channel obstructions were found. The private driveway culvert upstream of Pike Lake Trail was removed and the crossing has been abandoned; an open channel now occurs where the culvert existed (Figure 21). With limited flow during 2021, significant riparian vegetation growth has occurred in the channel and adjacent banks (Figure 22).

Figure 16. Bank stabilization along the gravel road of the Kici Yapi property

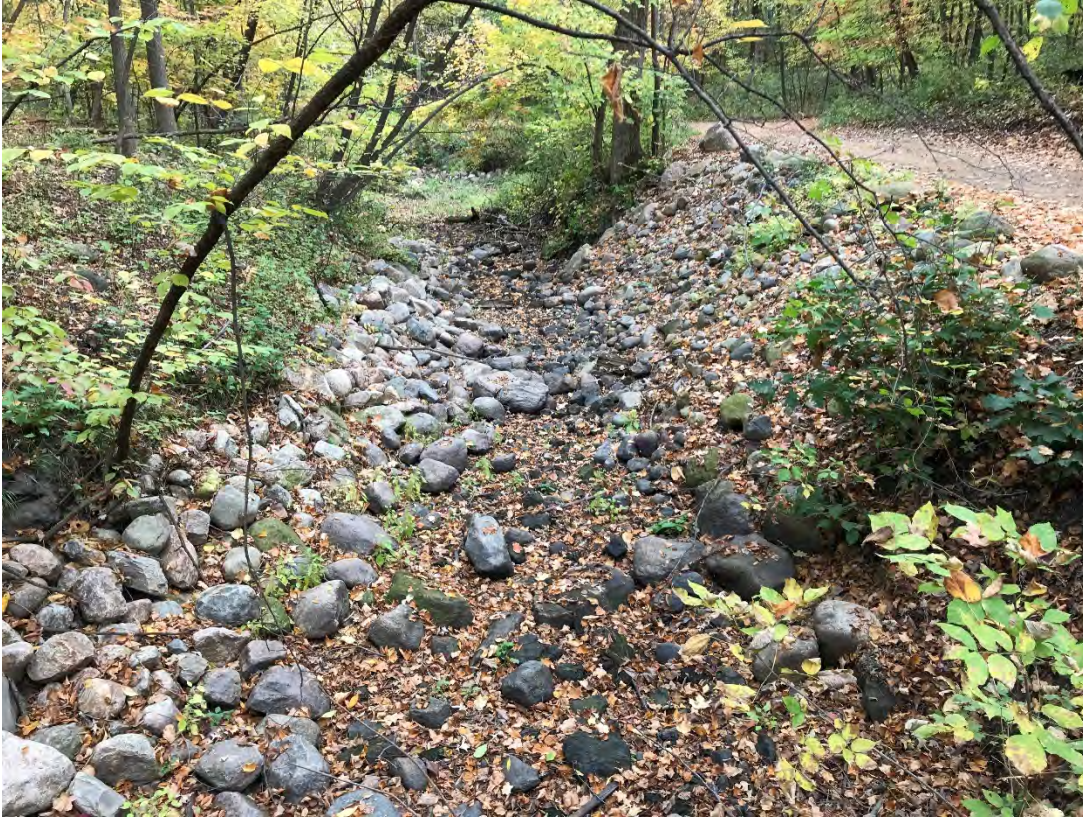
Figure 17. Bank stabilization along the gravel road of the Kici Yapi property

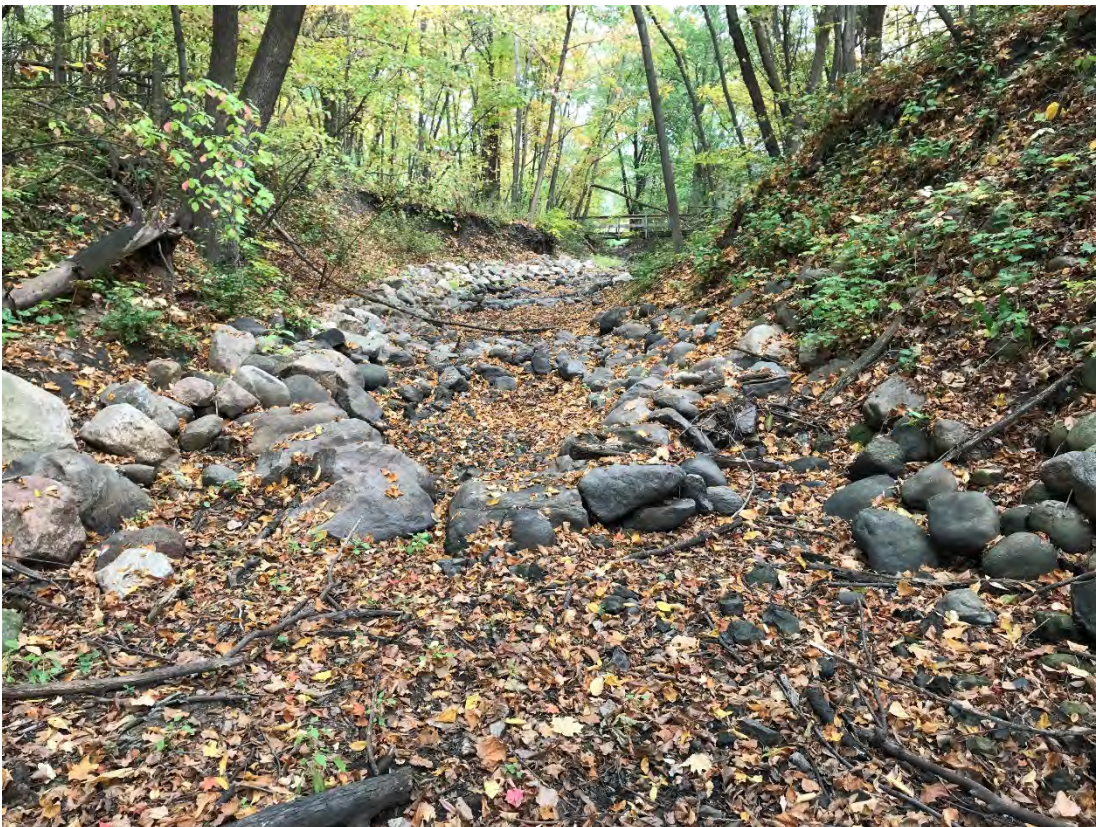
Figure 18. Bank stabilization within the middle reach of the Kici Yapi property

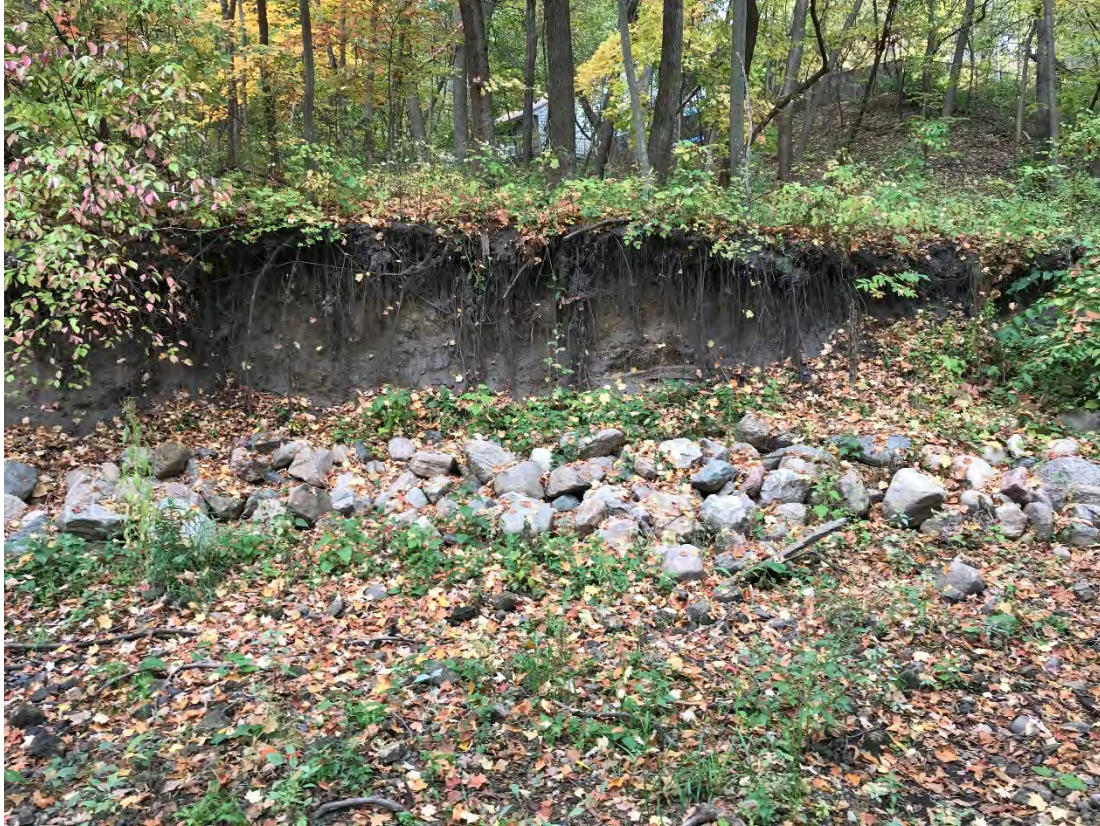
Figure 19. Bank stabilization within the middle reach of the Kici Yapi property

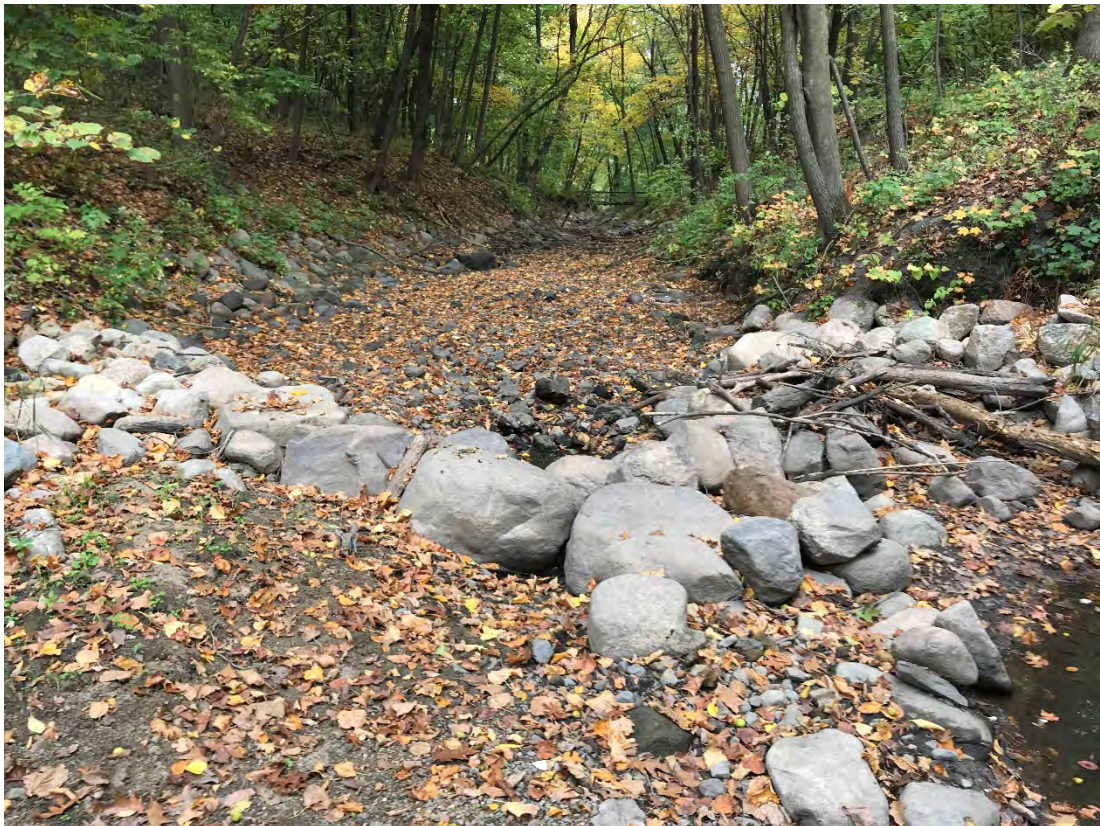
Figure 20. Boulder cross vane within the middle reach of the Kici Yapi property

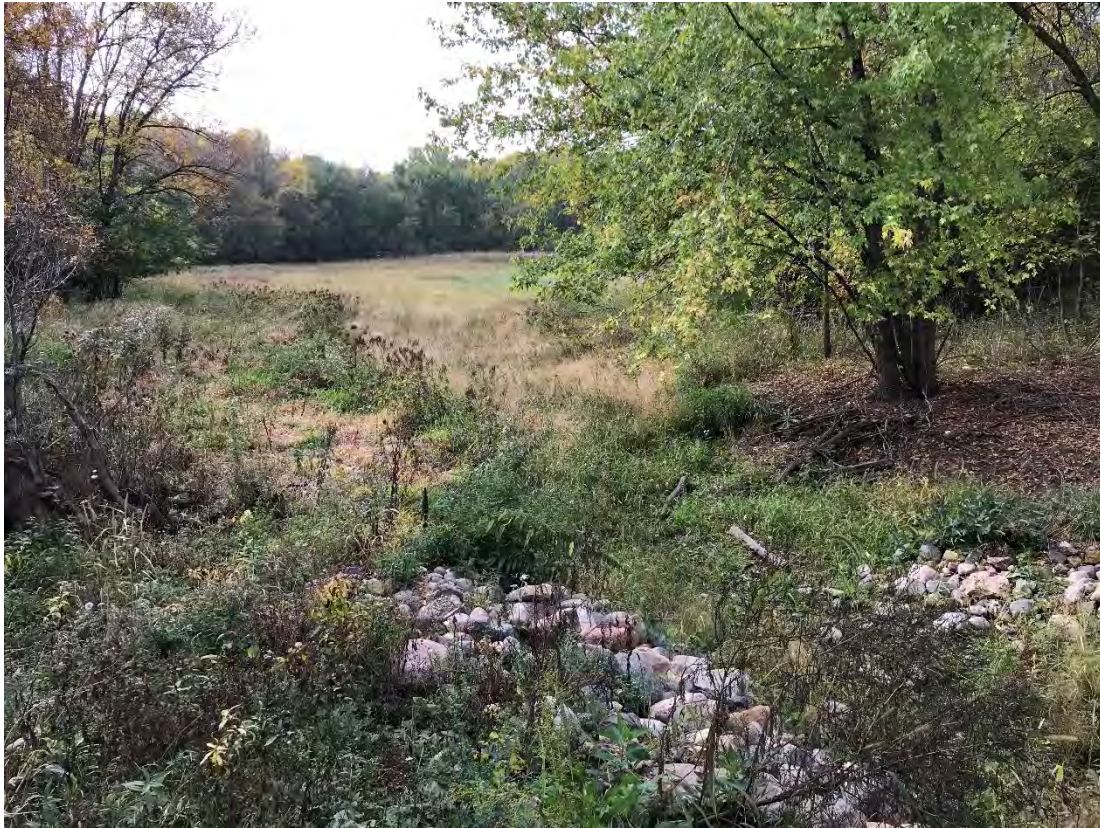
Figure 21. Old private driveway crossing upstream of Pike Lake Trail (now open channel)

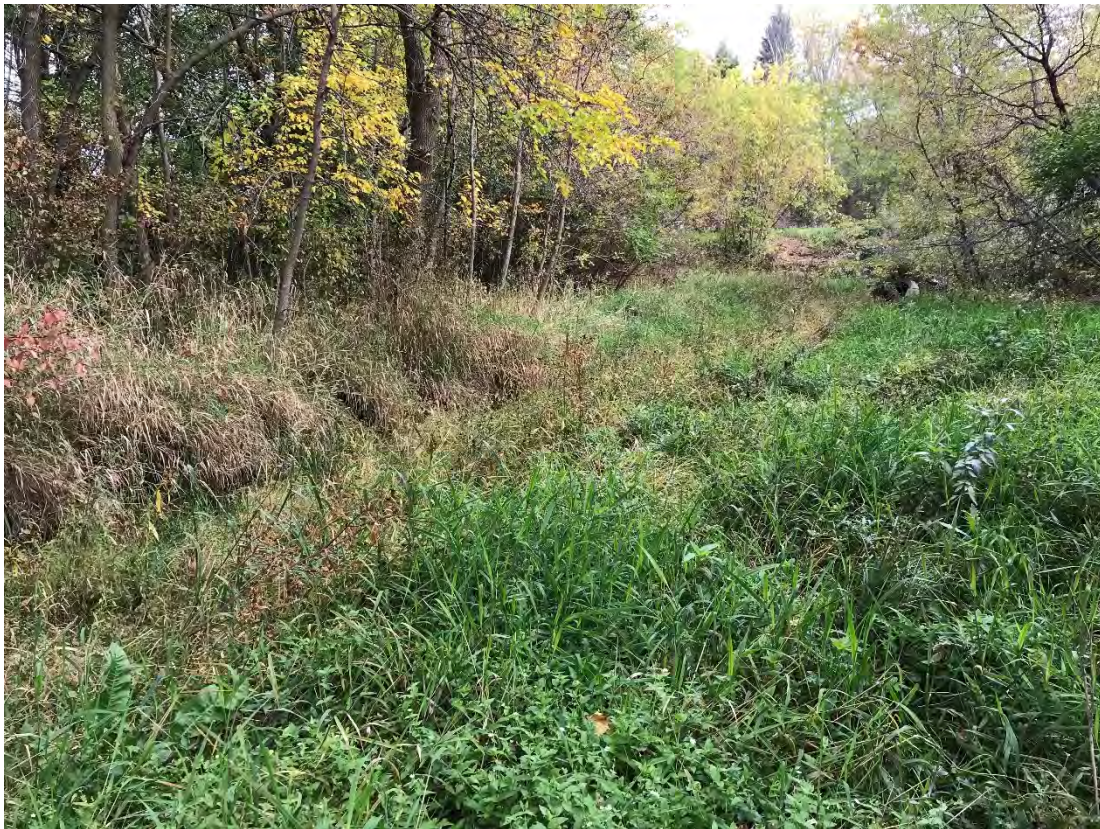
Figure 22. Channel condition downstream of the private driveway crossing upstream of Pike Lake Trail

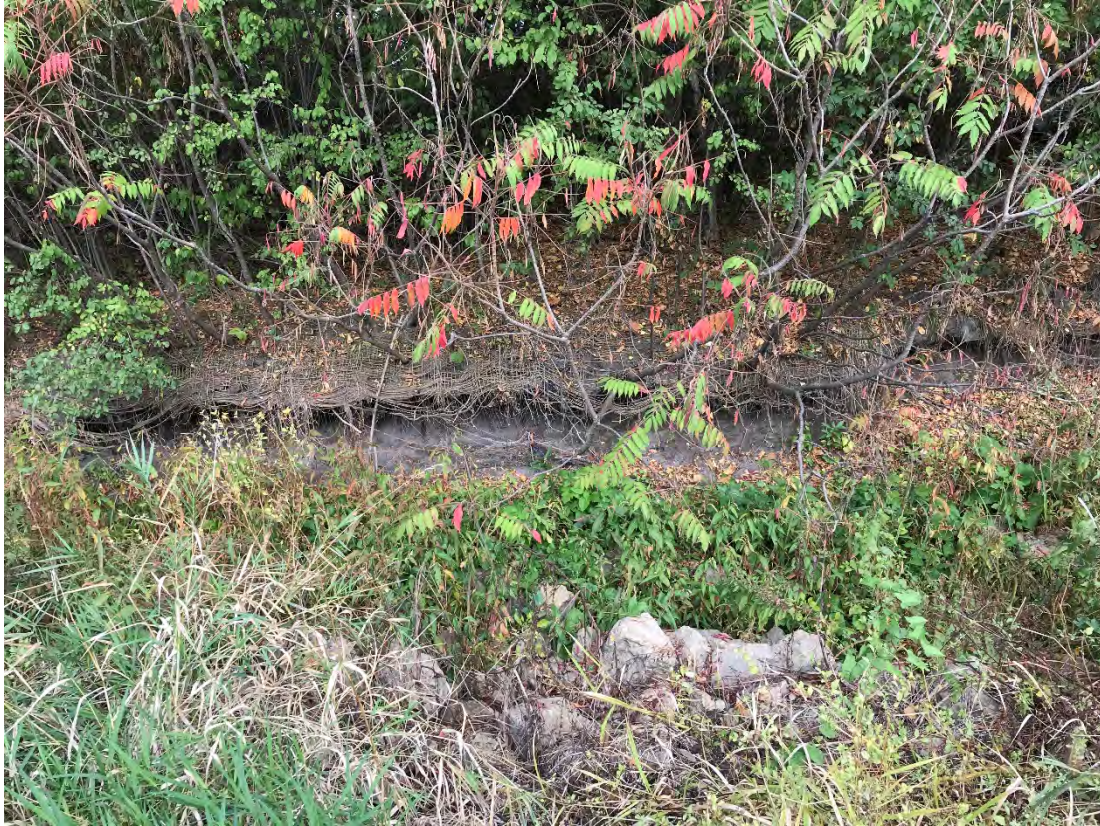
In Segment 4A, a bank repair plan is currently being developed to stabilize eroding stream banks between Pike Lake Trail and the wooded area just north of the Gonyea culvert (Figure 24, Figure 25, Figure 26). At the Gonyea culvert crossing, sediment build-up has occurred at the upstream end of the culvert due to erosion of the active construction crossing for the new residential development (Figure 27). This sediment should be removed before spring snow melt in 2022.

Figure 24. Toe erosion along the north bank downstream of Pike Lake Trail (to be repaired in 2022)

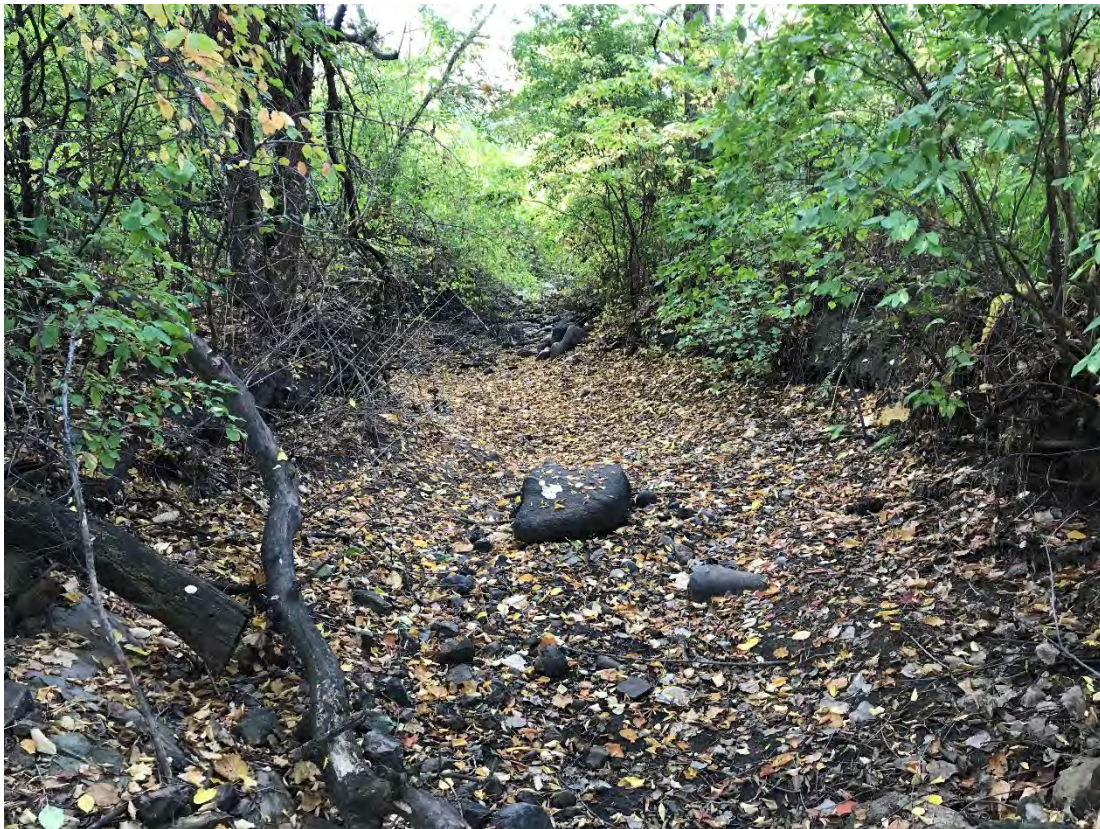
Figure 25. Channel banks to be stabilized in 2022 (upstream of Jackson Trail).

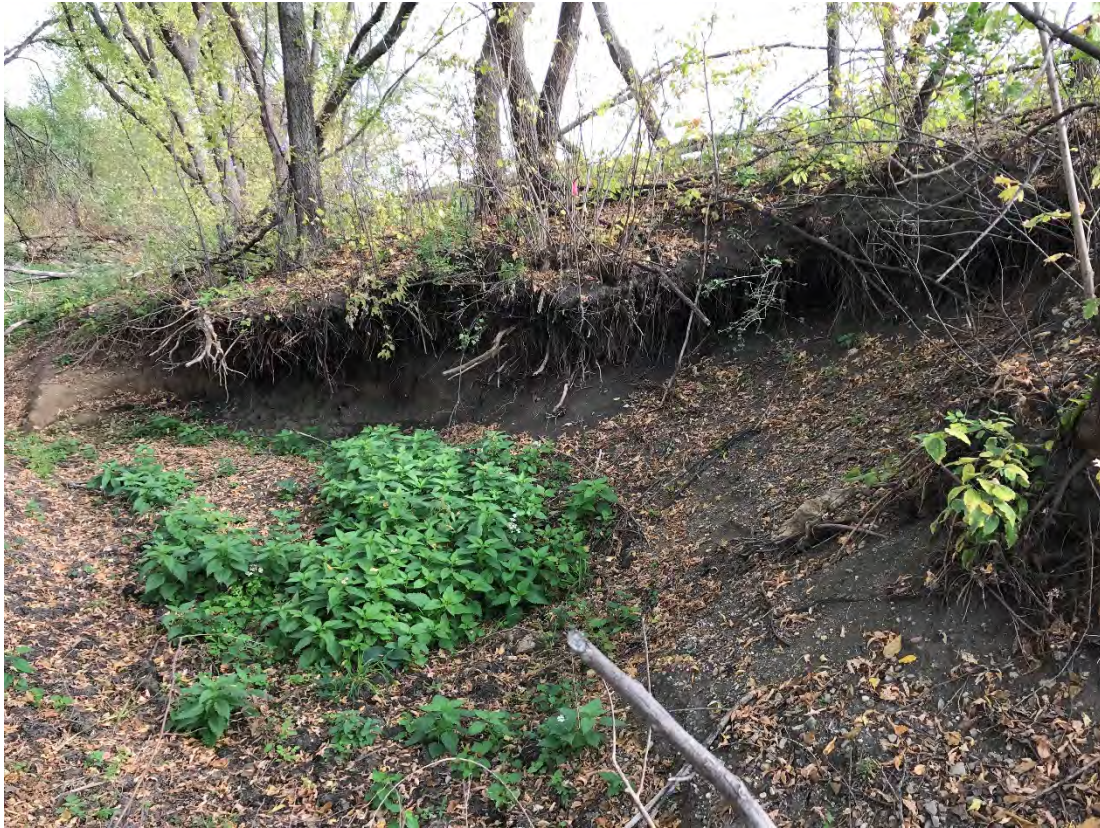
Figure 26. Channel banks to be stabilized in 2022 (downstream of Gonyea culvert).
