Project Name | PLOC Channel & Vegetation Inspections**Date** | 12/30/2021**To / Contact info** | Jaime Rockney, Water Resources Project Manager**Cc / Contact info** | Carl Almer**From / Contact info** | Mike Majeski**Regarding** | Channel and Vegetation Inspections – 2021 Summary

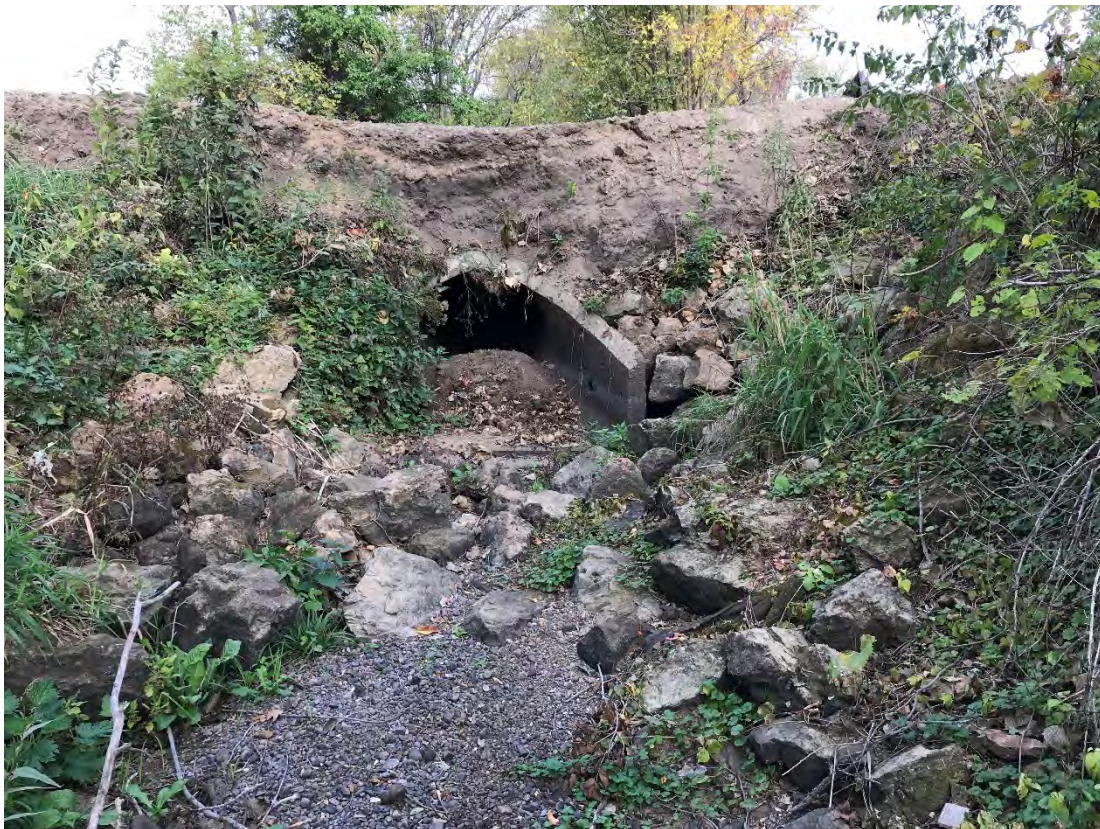
In Segment 4A, a bank repair plan is currently being developed to stabilize eroding stream banks between Pike Lake Trail and the wooded area just north of the Gonyea culvert (Figure 24, Figure 25, Figure 26). At the Gonyea culvert crossing, sediment build-up has occurred at the upstream end of the culvert due to erosion of the active construction crossing for the new residential development (Figure 27). This sediment should be removed before spring snow melt in 2022.

Figure 27. Sediment build-up at the upstream end of the Gonyea culvert

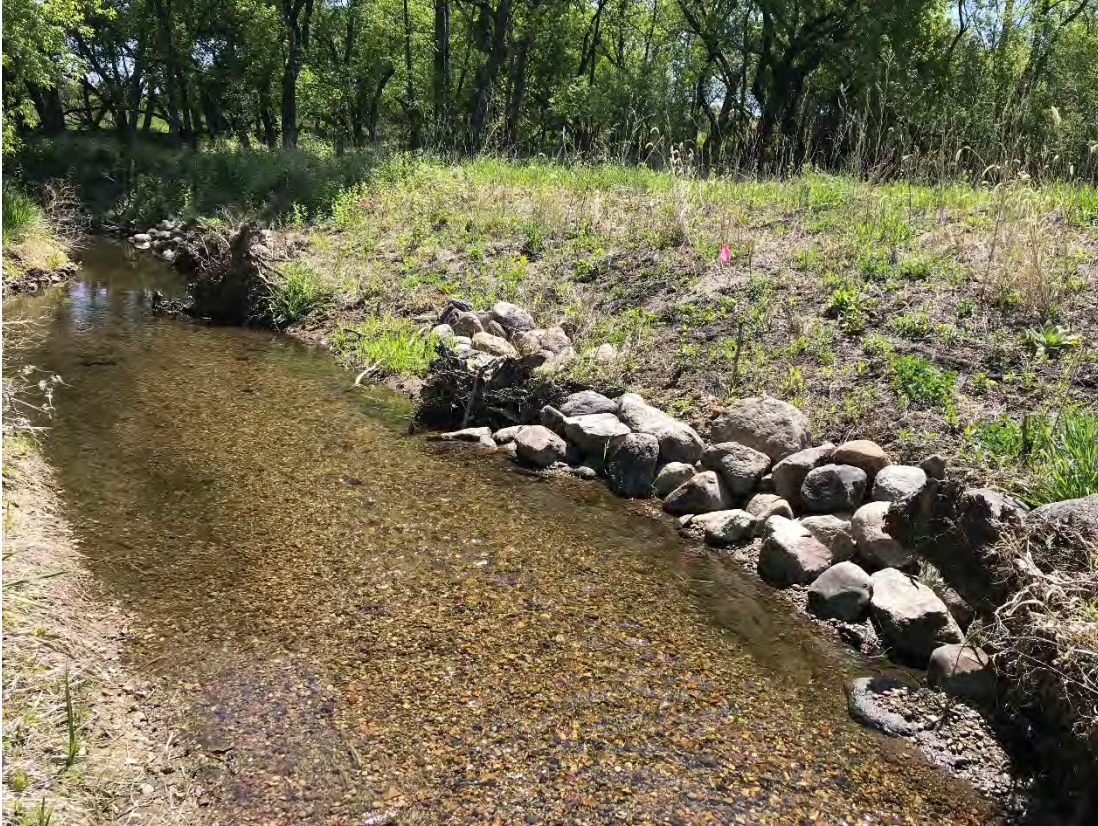
In Segment 4B, the stream banks stabilized by the FEMA-funded project were repaired in 2020/2021 and appeared to be in good condition with vegetation becoming established (Figure 28, Figure 29, Figure 30). In addition, a large box elder tree that had fallen across the channel at the upstream end of the segment is still present as of October 2021 (Figure 31). It is recommended this tree be removed to prevent the formation of a debris jam that could cause bank erosion during high flow events.

Figure 28. Repaired bank at the downstream end of Segment 4A

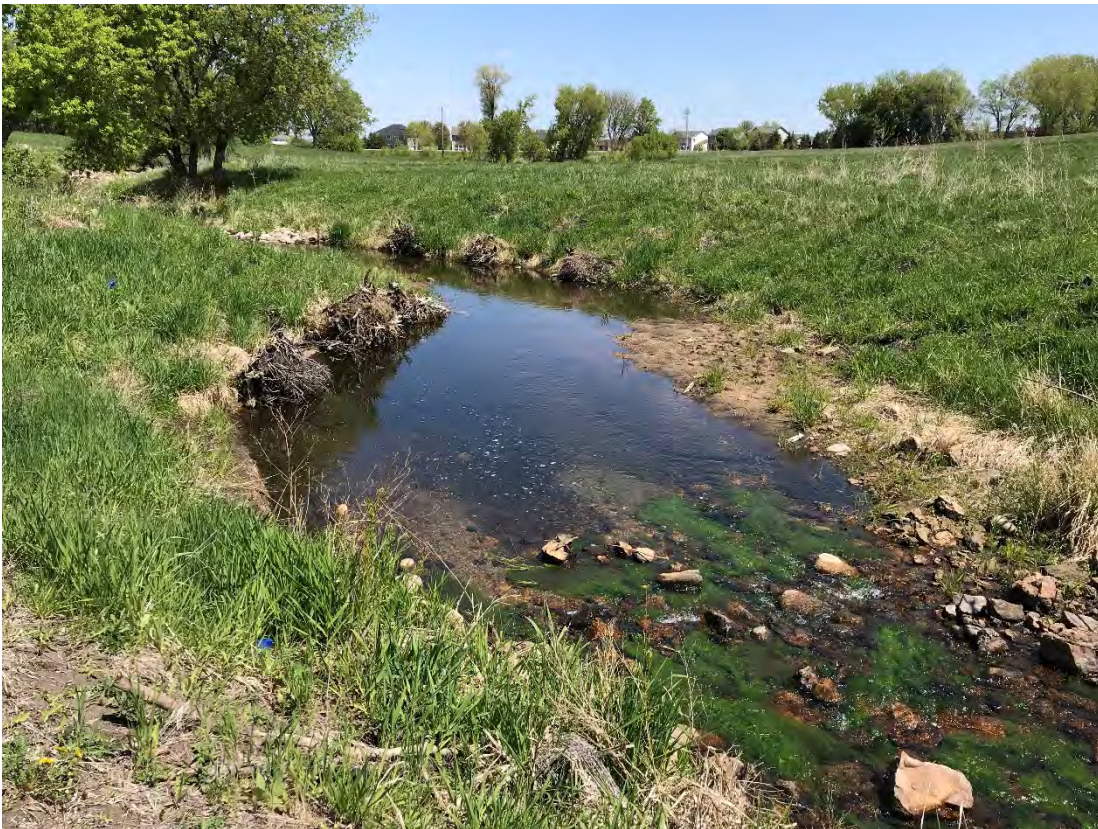
Figure 29. Repaired bank at the upstream end of Segment 4B

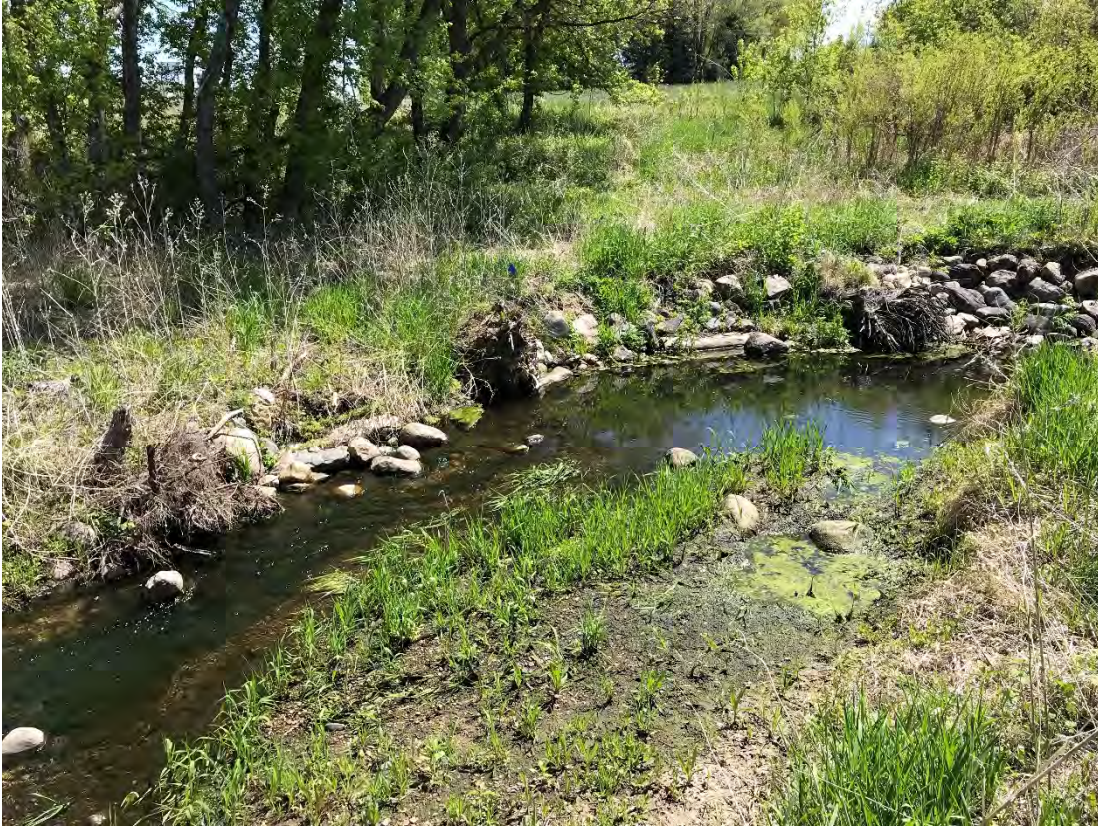
Figure 30. Repaired bank at the downstream end of Segment 4B

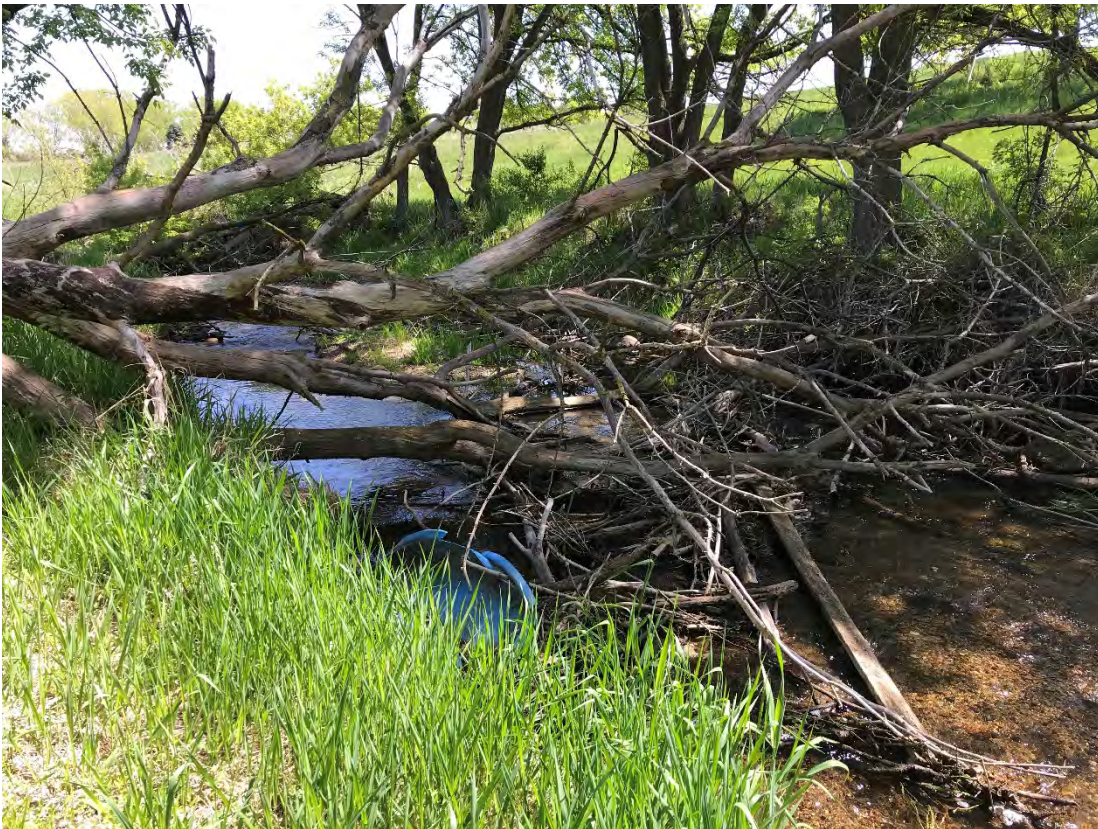
Figure 31. Fallen box elder tree over the channel at the upstream end of Segment 4B

- Continue inspections in 2022 and monitor stability of bank repair areas
- Remove fallen trees within the channel at upstream end of Segment 4B

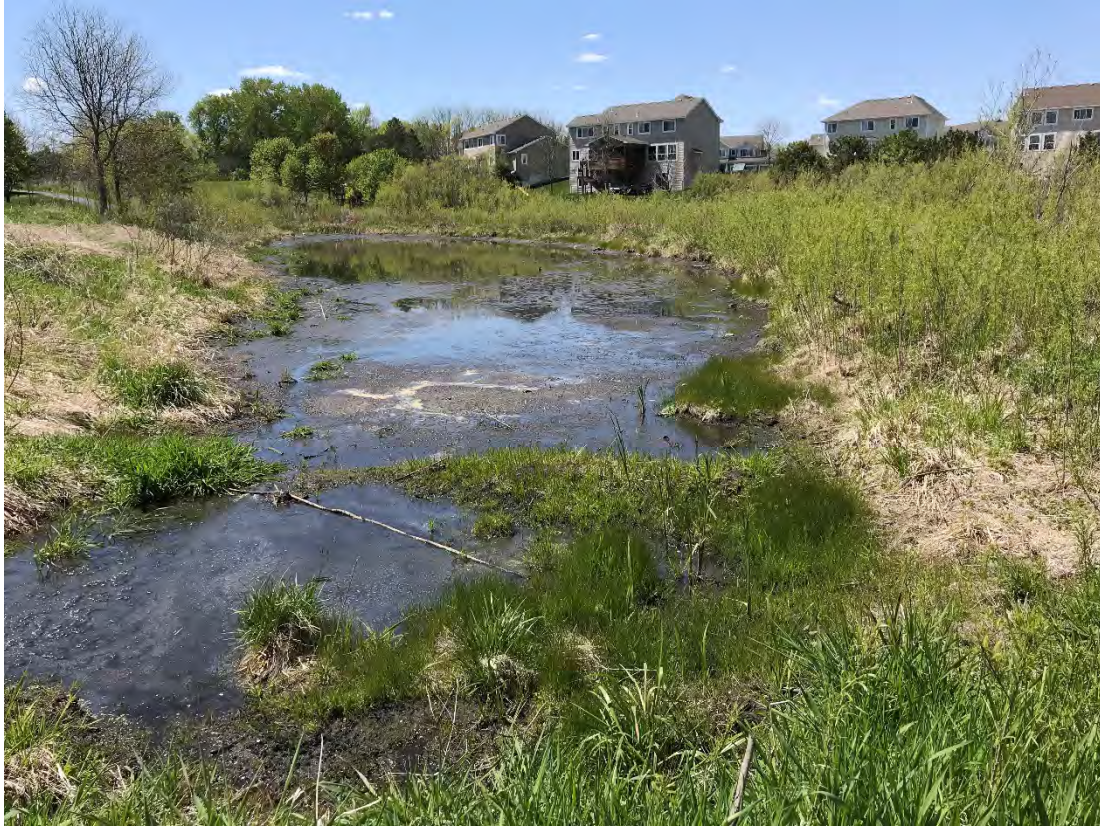
As documented during previous inspections, muskrat tunnels exist between the stormwater ponds and the PLOC between County Road 16 and Oak Ridge Trail. The tunnels occur under the earthen berm that divides the PLOC from the stormwater ponds and are functioning like culverts which have largely drained the east pond (Figure 34). Due to the degraded nature of the earthen berm and banks between the stormwater ponds, a channel modification plan is currently being developed to increase wetland storage and flood capacity of the wetland system between County Road 16 and Oak Ridge Trail.

Figure 34. Drained stormwater pond due to muskrat tunnels under the berm along the PLOC

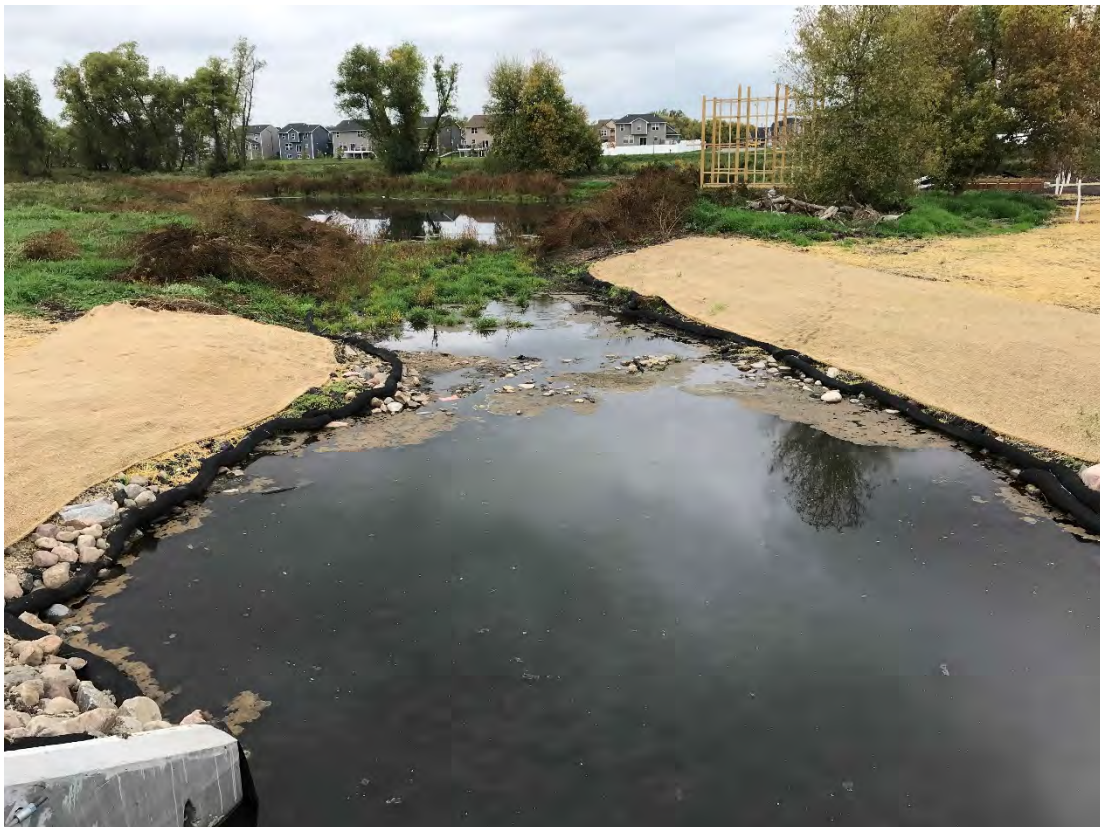
In Segment 5B, a new outlet channel has been constructed through the existing floodplain and will be the primary flow path of the PLOC through the segment (Figure 35). The old channel is still in place and serves as a stormwater conveyance for existing residential developments to the east. With the new channel in operation, the degraded culverts along the old channel have been replaced (Figure 36), and the down trees and beaver dams found in 2020 have been removed (Figure 37, Figure 38). Downstream of Pike Lake Road in Segment 5C, the sediment delta continues to accumulate sediment (Figure 39). A dredging project is currently under development to remove the accumulated sediment from the pond.

Figure 35. Inlet to the new outlet channel in Segment 5B

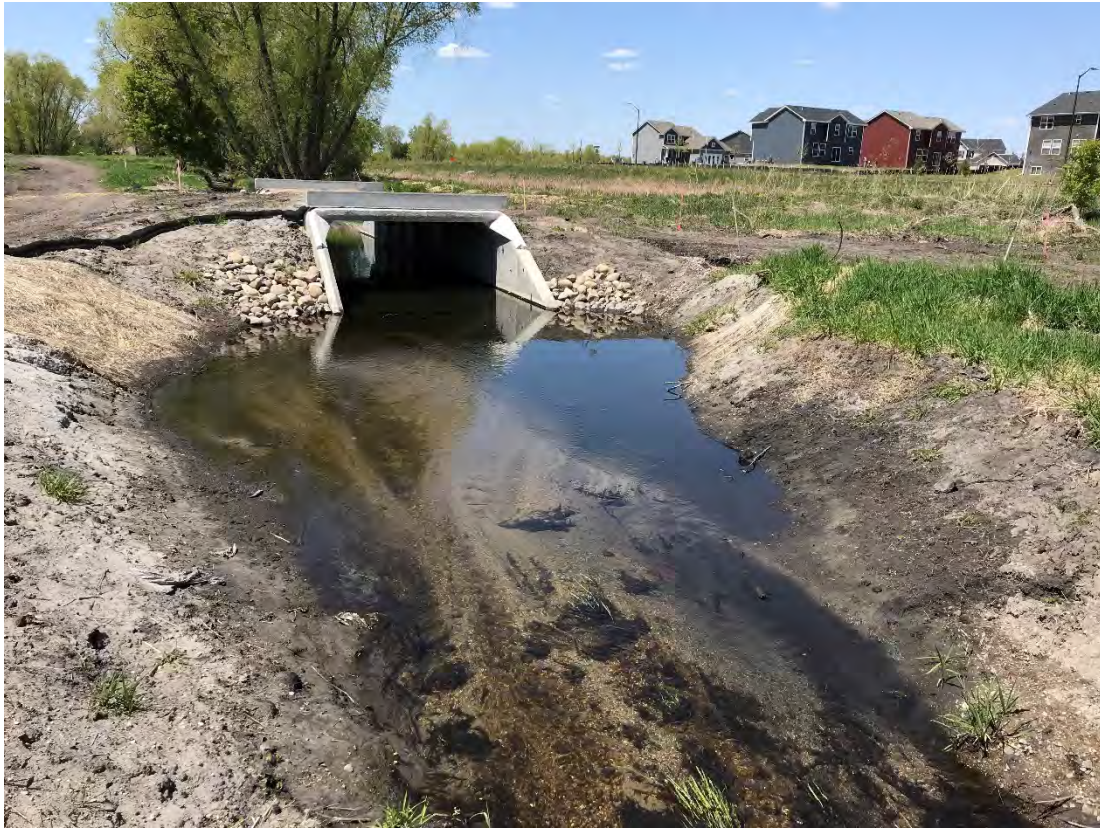
Figure 36. New box culvert installed within the old channel in Segment 5B

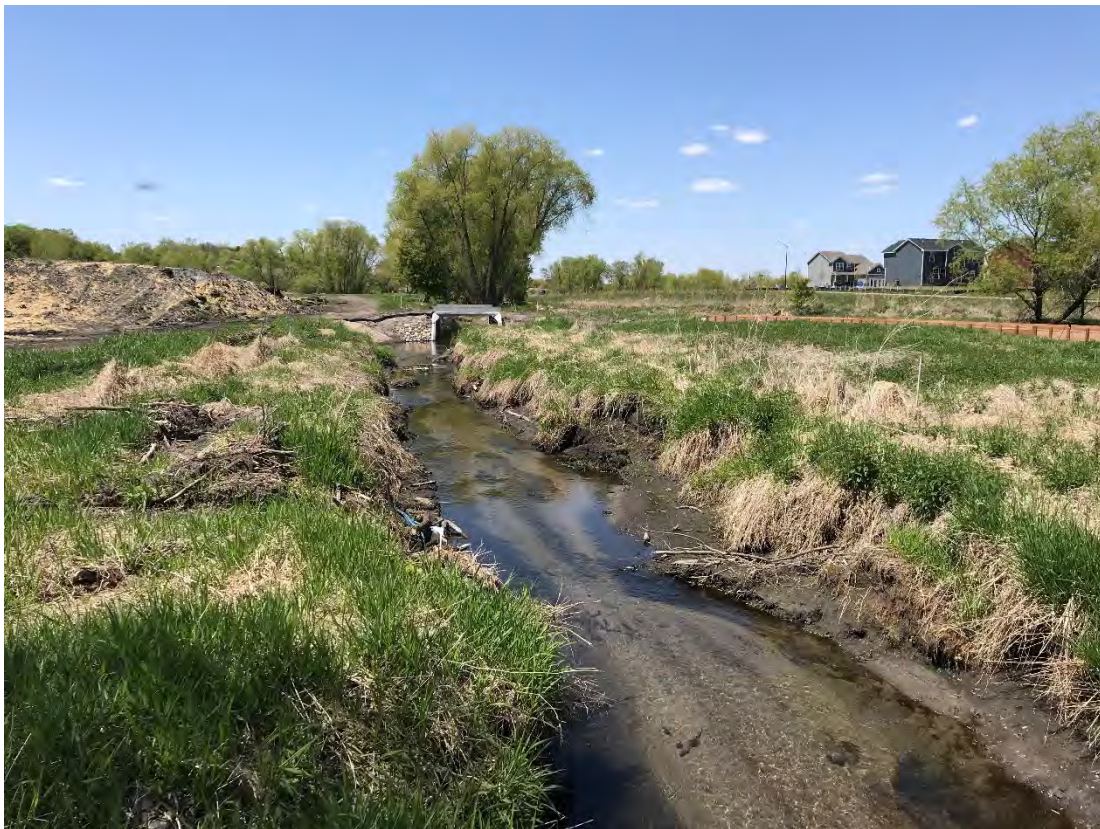
Figure 37. Tree and beaver dam removal from the old channel in Segment 5B

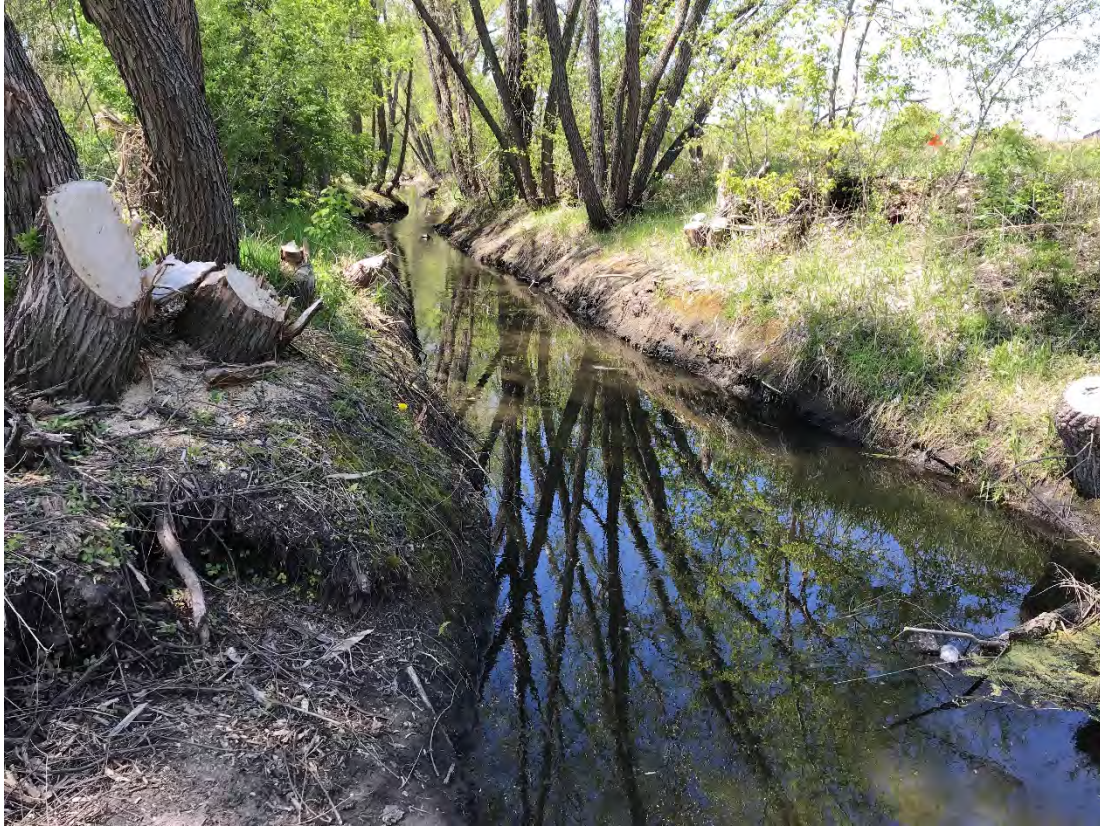
Figure 38. Tree removal along the old channel in Segment 5B

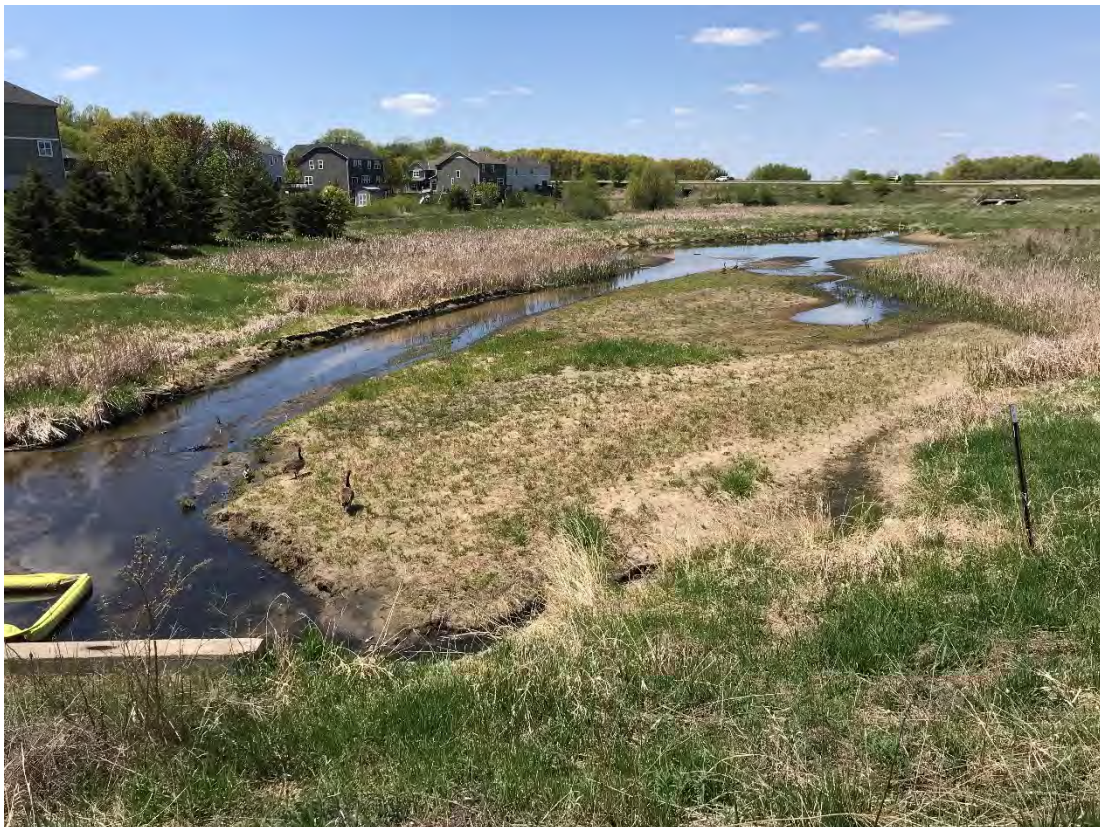
Figure 39. Sediment delta located downstream of Pike Lake Road in Segment 5C

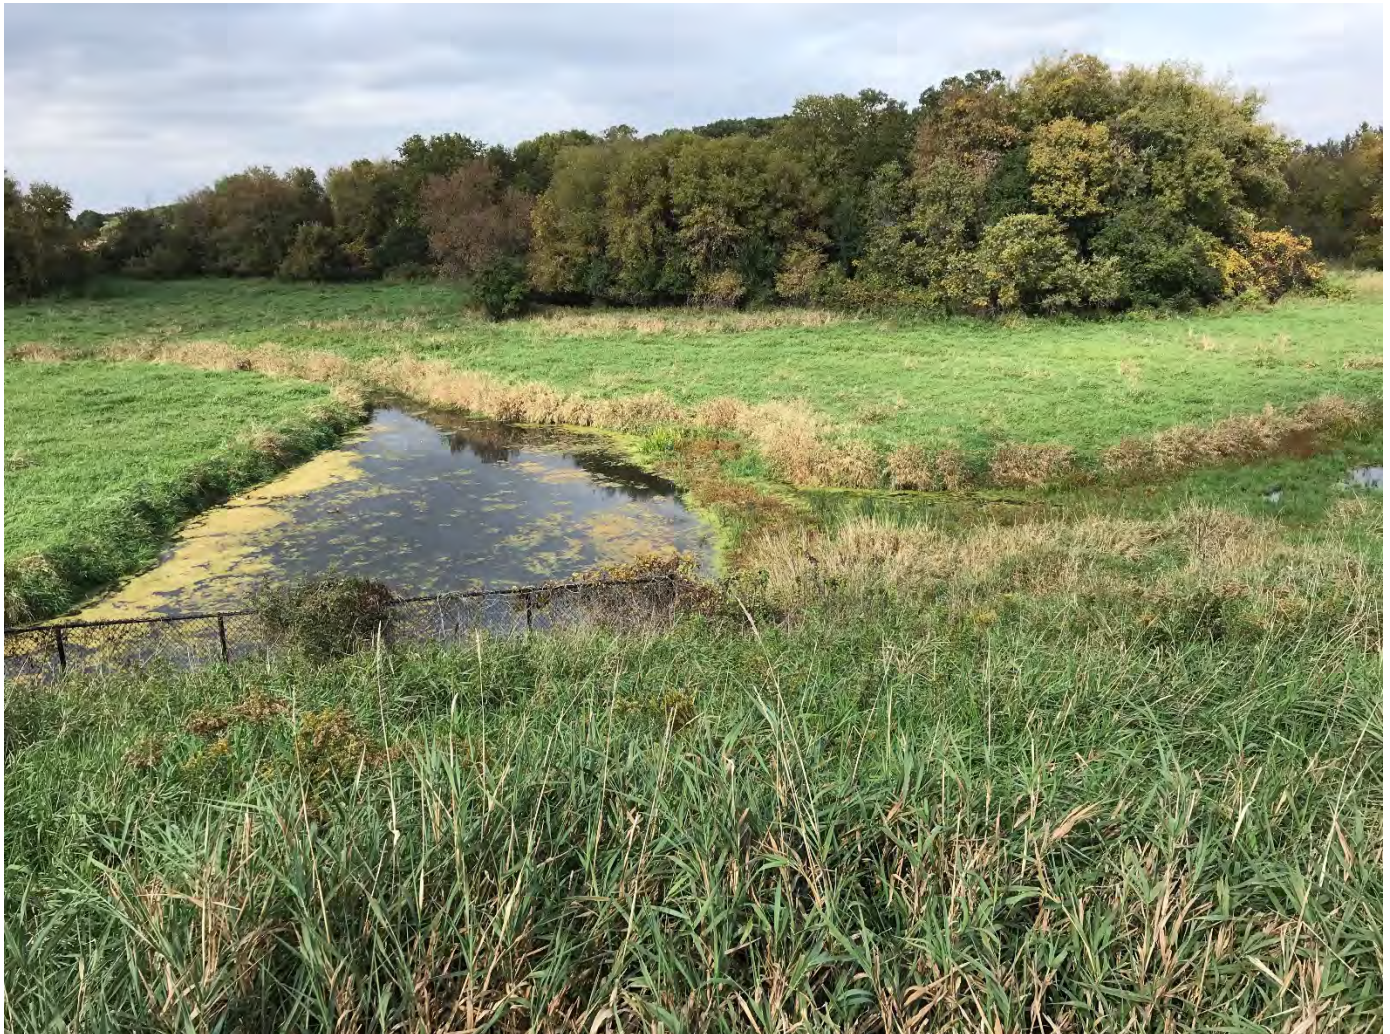
The sediment delta at the inlet to the Deans Lake bypass channel documented in 2018 has now become vegetated with wetland plants. The sediment delta bridges the entire mouth of the bypass channel and directs low flows into Deans Lake (Figure 42). Although the bypass channel still functions during high flow events through the PLOC, it is recommended the sediment delta be removed to increase flows through the bypass channel and reduce nutrient loading to Deans Lake. No other channel obstructions were found in this segment. The Deans Lake weir appears to be in good condition and was free of debris at the time of the surveys. The channel banks throughout this segment are well vegetated and show little evidence of bank erosion (Figure 43, Figure 44).

Figure 42. Channel downstream of County Road 21 & sediment delta in bypass channel

- Remove the sediment delta at the upstream end of the Deans Lake bypass channel located immediately downstream of CR 21. Continue inspections in 2022

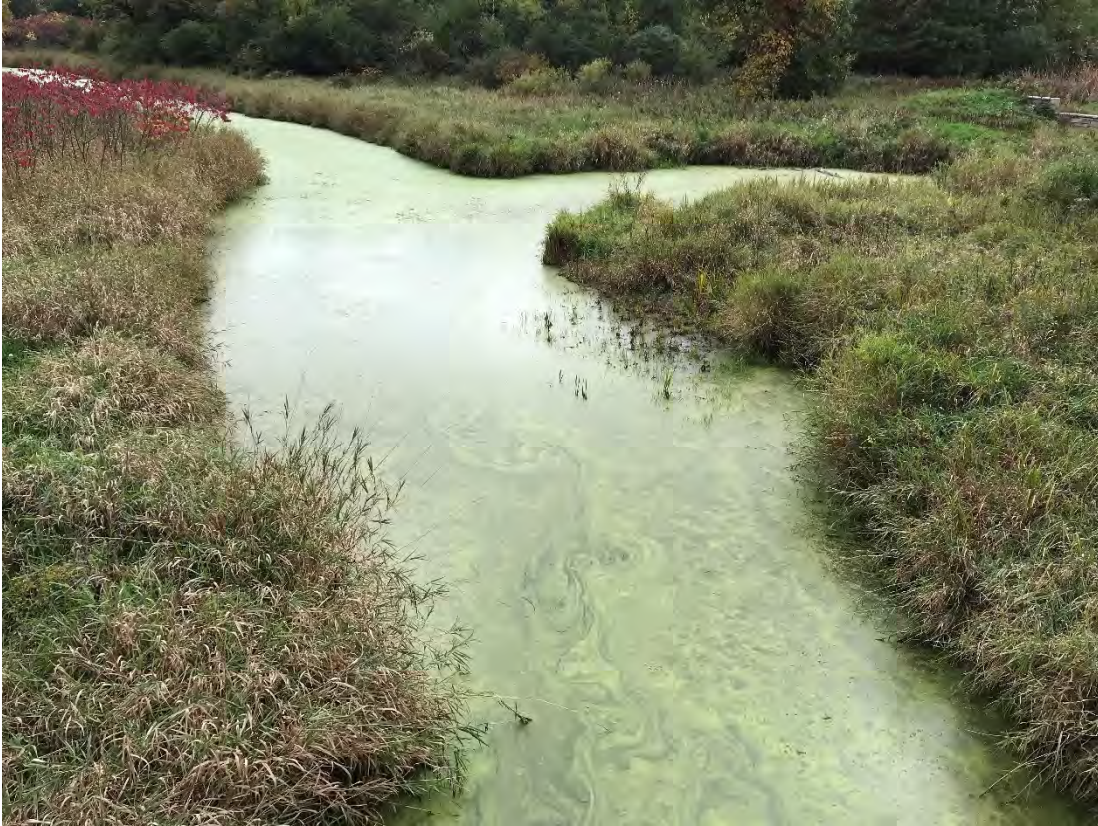
Figure 43. Stable, vegetated stream banks downstream of the Deans Lake weir

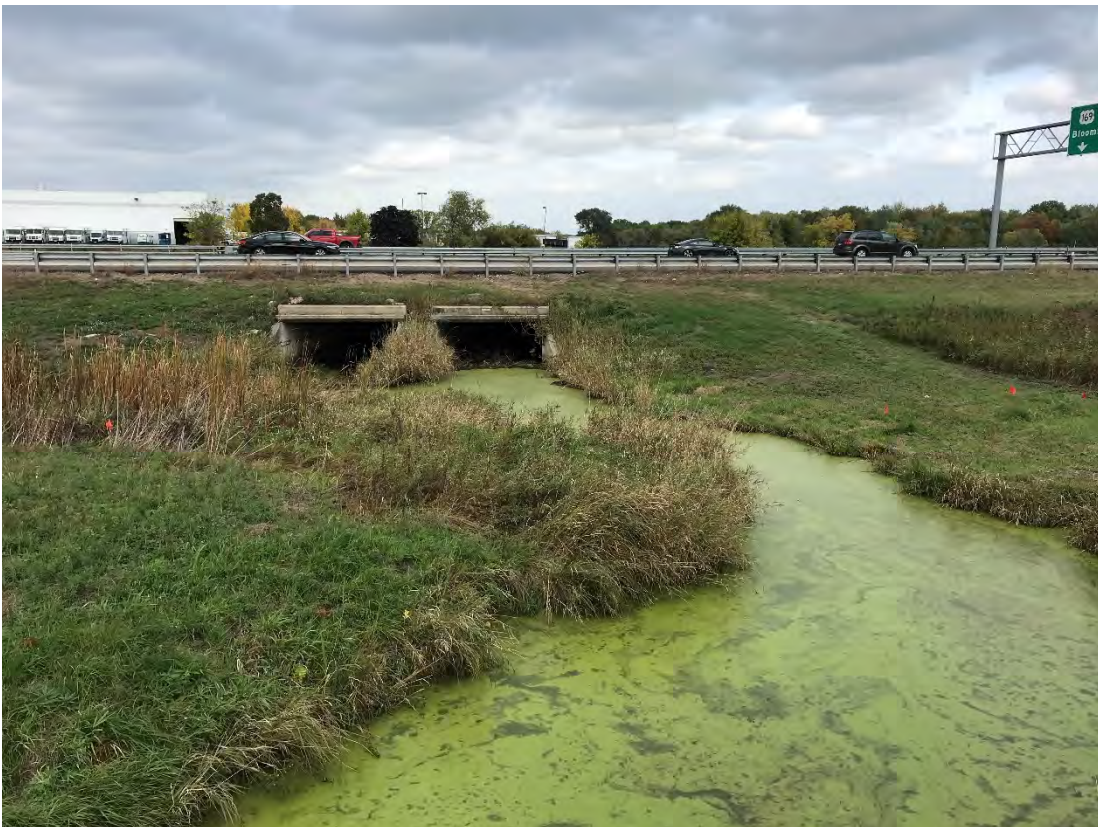
Figure 44. Stable, vegetated stream banks upstream of Highway 169

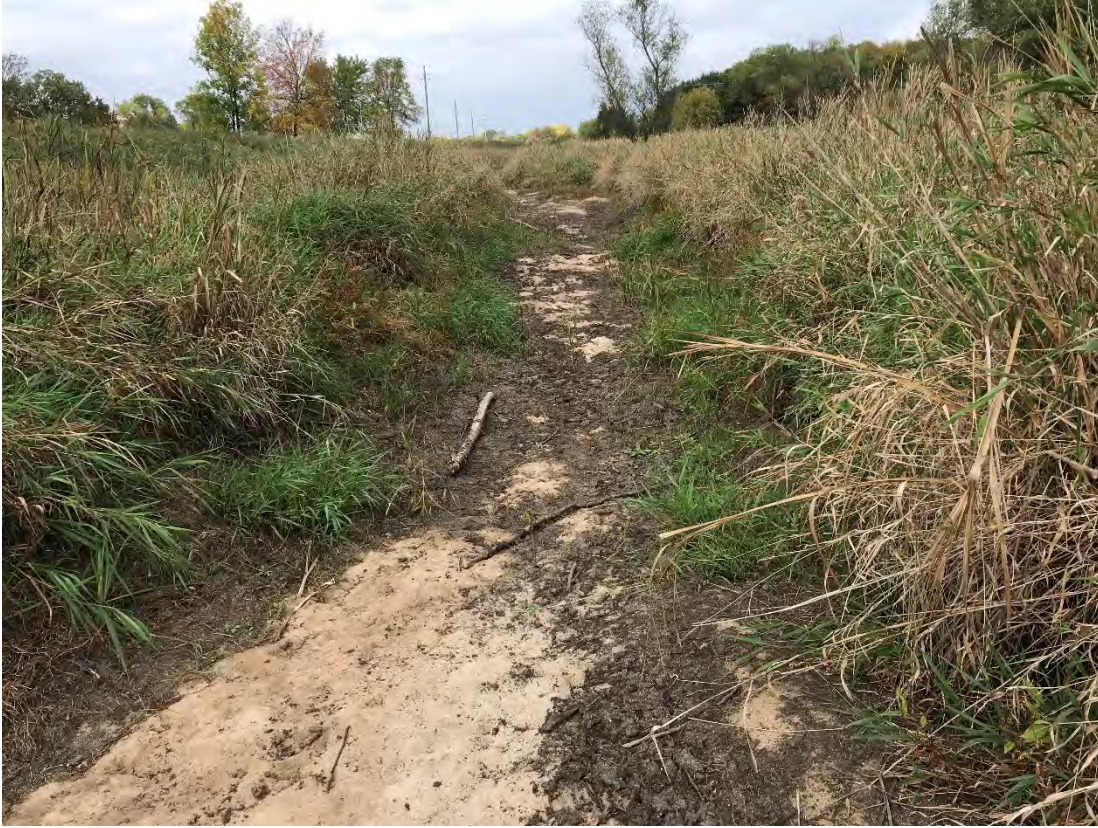
The channel banks downstream of Highway 169 are well vegetated and show little evidence of bank erosion (Figure 46). The sheet pile weirs within the reach were mostly free of debris during the inspections but are showing considerable rust and corrosion. Due to low flows in the channel throughout 2021, significant vegetation growth has occurred along the channel bottom (Figure 47). The beaver dams found in 2020 were no longer active.

Figure 46. Vegetated stream banks in the upper reach of Segment 7A

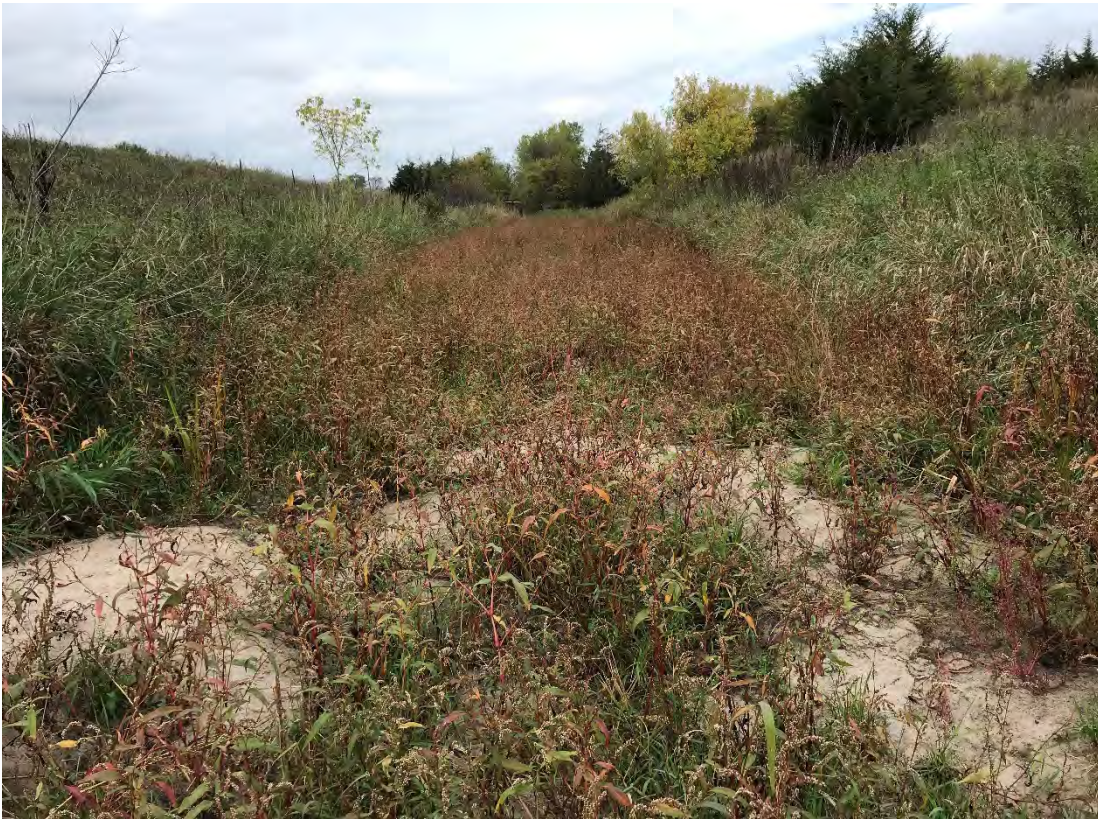
Figure 47. Vegetation growth along the bottom of the outlet channel in Segment 7A

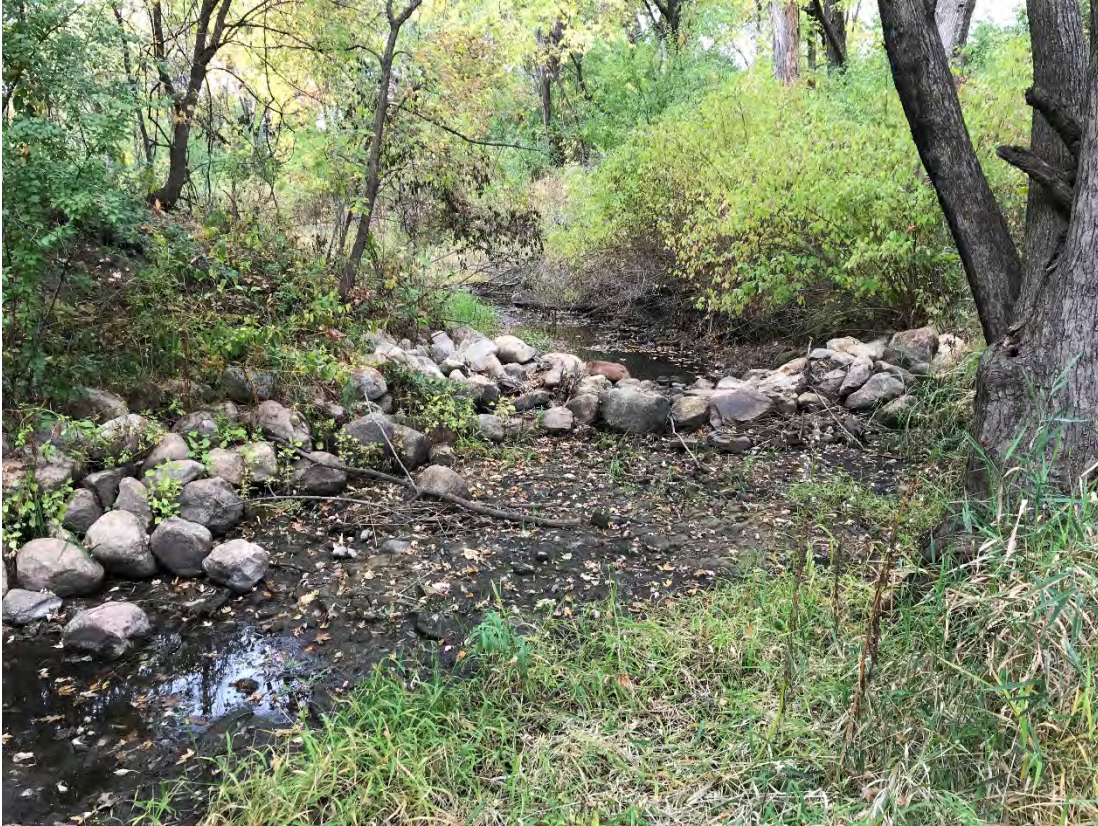
The stream banks repaired in Segment 7A and 7B in 2019 appeared stable with vegetation developing in areas where the tree canopy was thinned. With toe stabilization in place, the eroded banks are beginning to self-heal, though the vertical banks will continue to erode until a stable bank slope becomes established (Figure 48, Figure 49, Figure 50). A few large trees have fallen into the channel immediately upstream of the railroad crossing and should be removed to prevent potential blockage of the railroad culvert (Figure 51).

Figure 48. Self-healing stream banks in Segment 7A

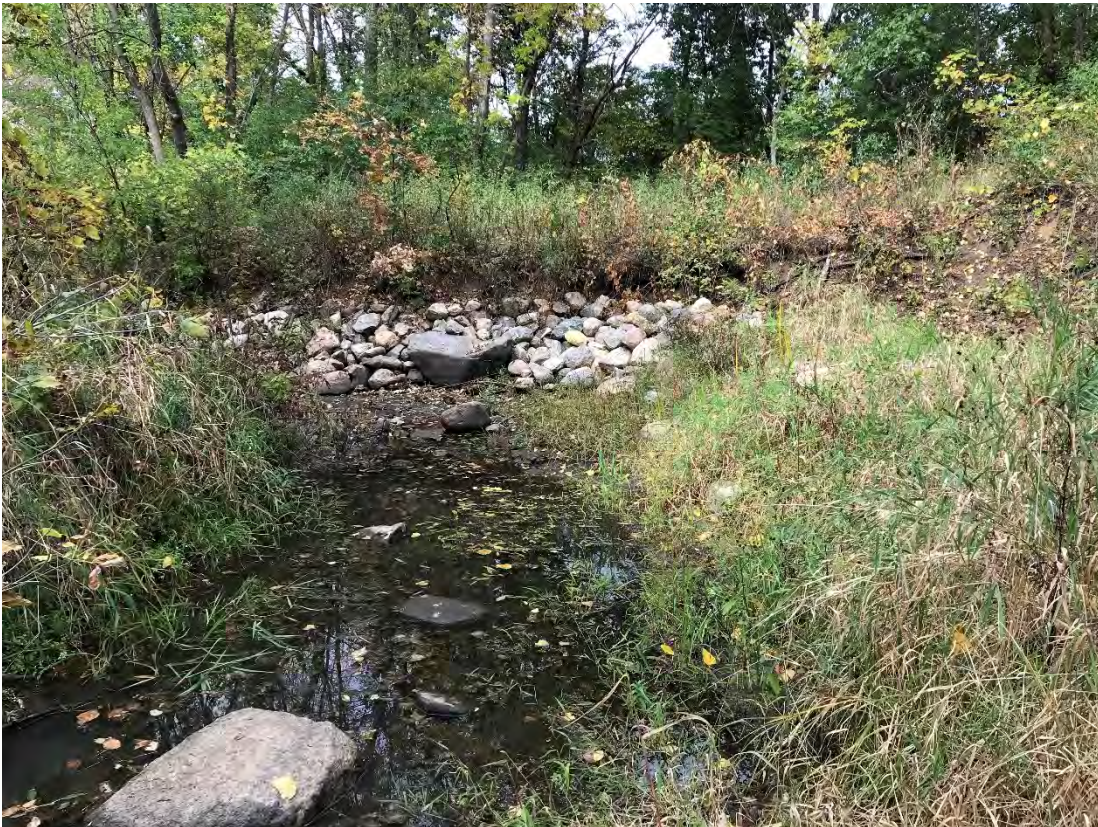
Figure 49. Self-healing stream banks in Segment 7A

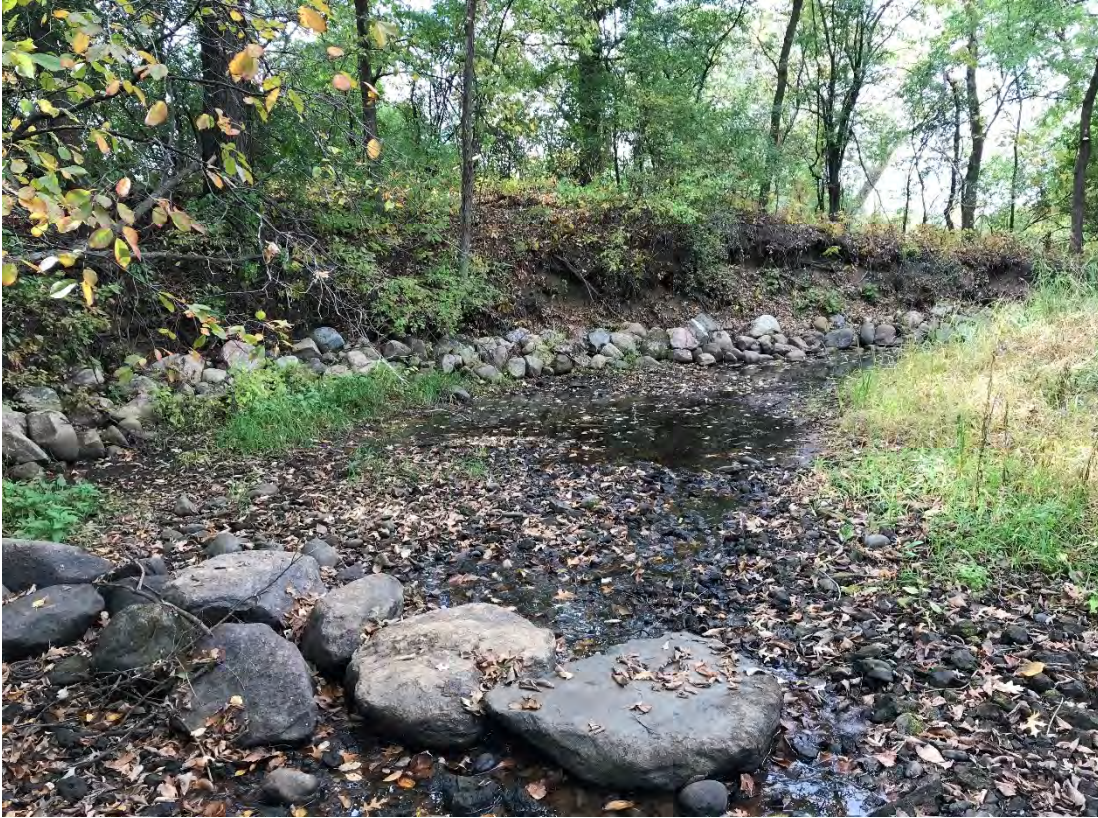
Figure 50. Self-healing stream banks in Segment 7B

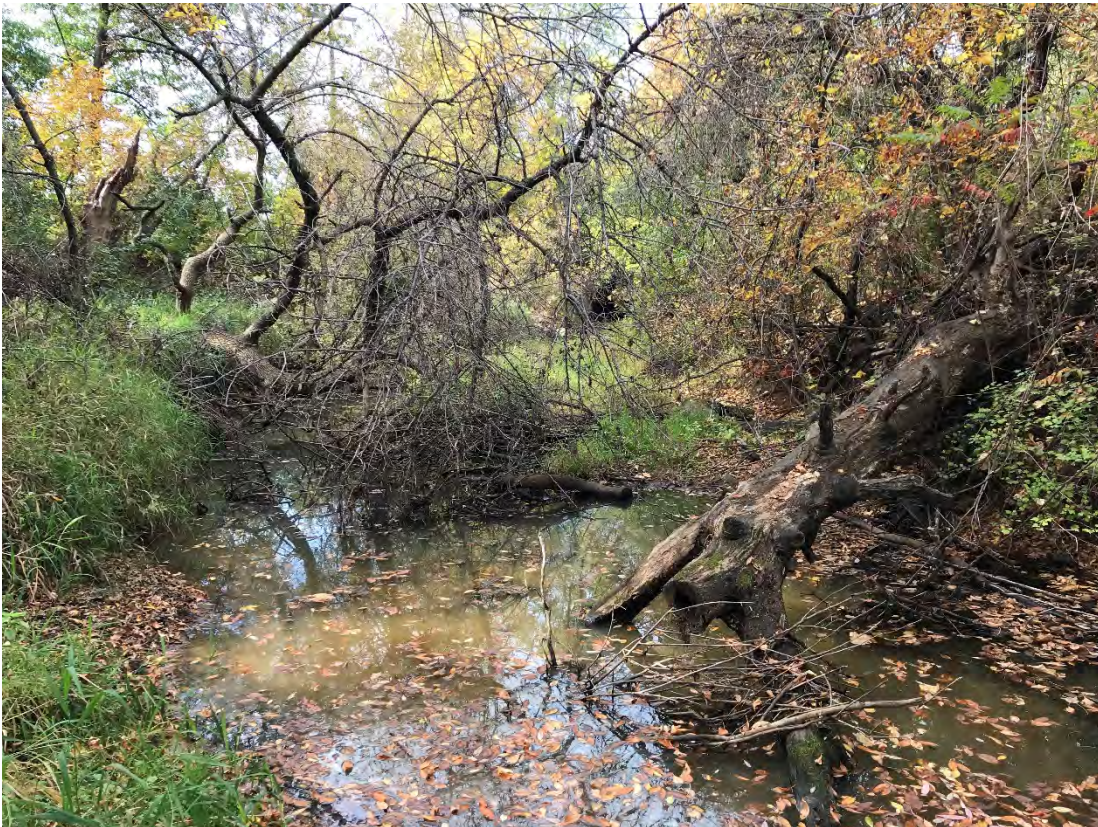
Figure 51. Down trees in the channel just upstream of the railroad culvert in Segment 7A
