2021 PRIOR LAKE OUTLET SYSTEM ANNUAL OPERATIONS REPORT

PRIOR LAKE-SPRING LAKE
WATERSHED DISTRICT

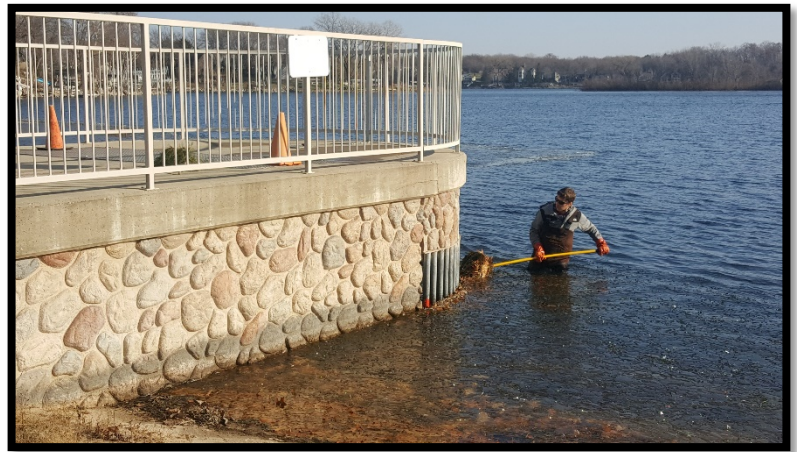
FIGURE 2 REMOVING VEGETATION FROM OUTLET STRUCTURE

The new structure requires minimal maintenance to operate. Once Prior Lake reaches 902.5', water starts spilling over the accordion shaped weir located inside the trash rack. Maintenance includes visual inspections, greasing gates, and removing debris from the trash rack. Removing vegetation and other debris from the trash rack is the most time-consuming and labor-intensive task (Figure 2). When the structure is operating (Prior Lake is greater than 902.45'), the structure will be inspected no less than once a week, and as much as twice per day, depending on the lake level and amount of vegetation getting caught on the trash rack. Inspections and debris removal are typically conducted by PLSLWD staff. During times when water is high and large amounts of vegetation are getting caught on the track rack, the City of Prior Lake staff have helped remove vegetation to ensure the Outlet Structure was not blocked.

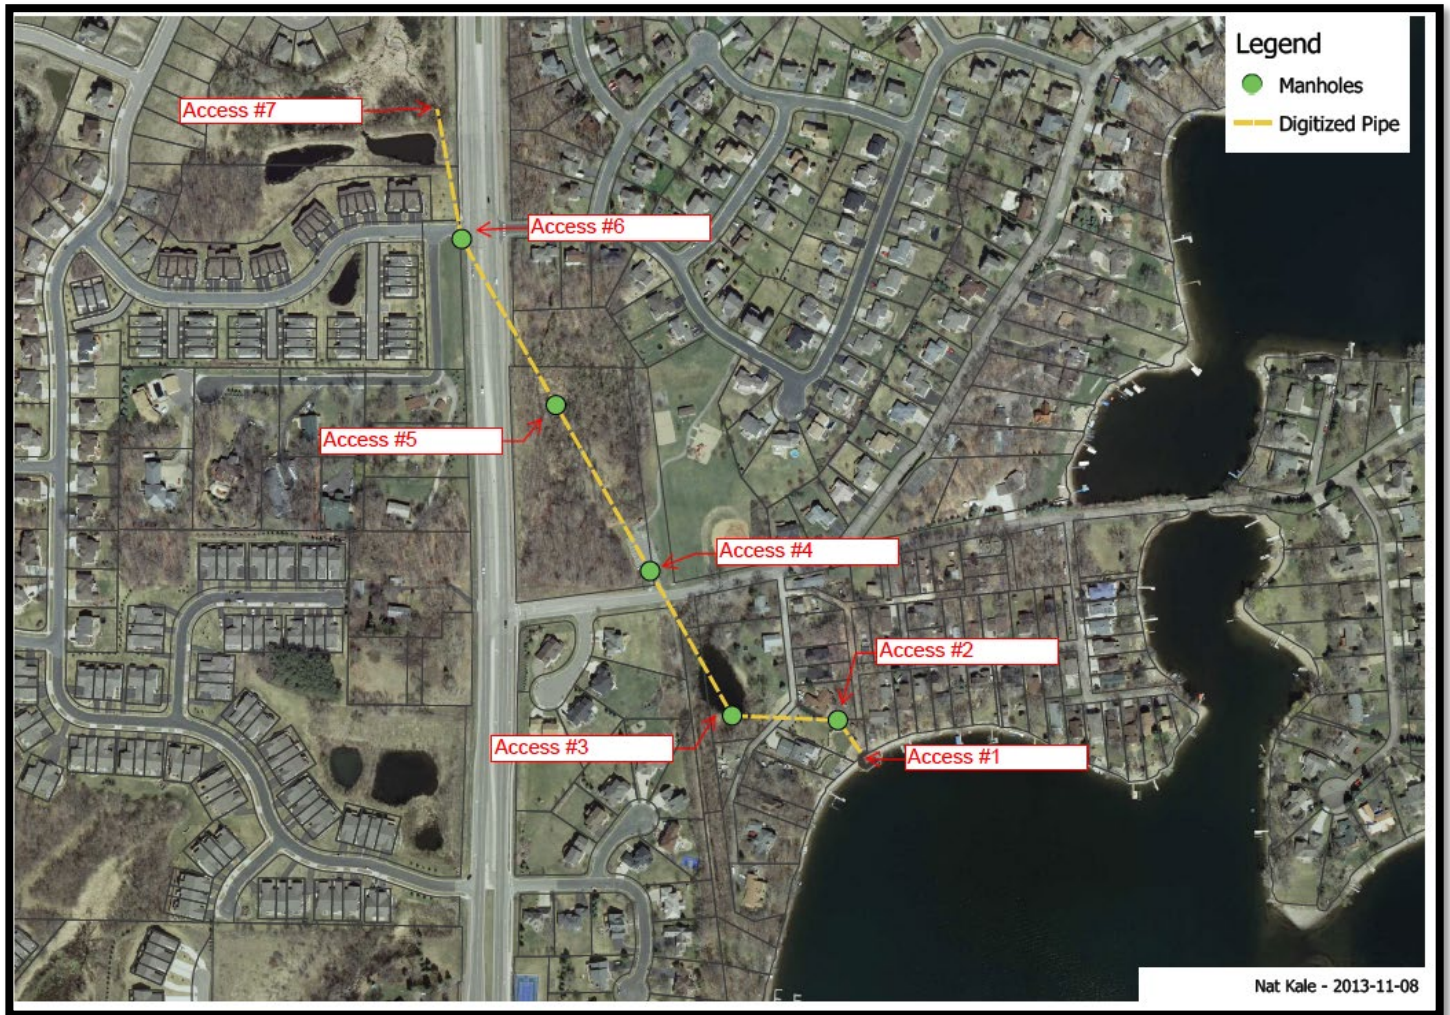
FIGURE 5 MAP OF OUTLET PIPE

In 2020, American Environmental televised the pipe revealing the lake outlet pipe is in good to fair condition, but multiple cracks and fractures were found in some segments. Several options will be weighed to decide the best course of action. Some of these options include sealing the joints that fail pressure tests, lining the pipe, a combination of those two, or pipe bursting. The outlet pipe will be televised and assed in 2022.

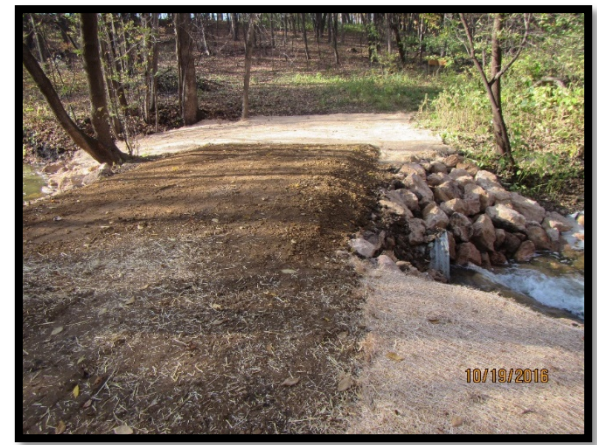
FIGURE 6 KES FIELD CROSSING REPAIR IN 2016

- Kes Field Crossing culvert (Figure 6), Gonyea culvert, and Pike Lake Park stream crossing repaired by Nadeau Companies.
 - The remaining downed trees and woody debris were removed by WHR.

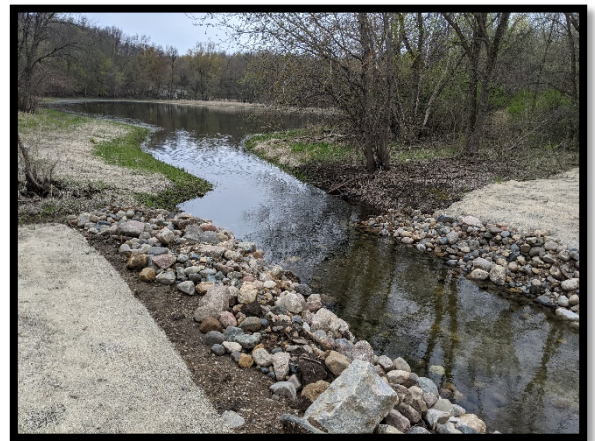
FIGURE 7 STRAUSS DRIVEWAY AND CULVERT REMOVAL IN 2021

- Driveway and culvert removed in connection with Permit 20.02 Strauss Driveway (Figure 7)
- Kes field road culvert removed in connection with the Pike Lake Landing Development
- Installed carp tracking PIT tag reading stations at the Daylight pond and at the inlet of Pike Lake
- Conducted trap netting fish surveys in Upper and Lower Jeffers Ponds.
- Security cameras maintained at outlet structure
- Vegetation maintenance

- Permit #20.02 *Pike Lake Culvert*: Culvert replaced; the District has completed final inspection is in the process of closing out the permit.
- Permit #20.04 *Strauss Driveway*: Culvert and driveway have been removed creating an open channel. The permit is still open awaiting final vegetation establishment.
