2022 PRIOR LAKE OUTLET SYSTEM ANNUAL OPERATIONS REPORT

PRIOR LAKE-SPRING LAKE
WATERSHED DISTRICT

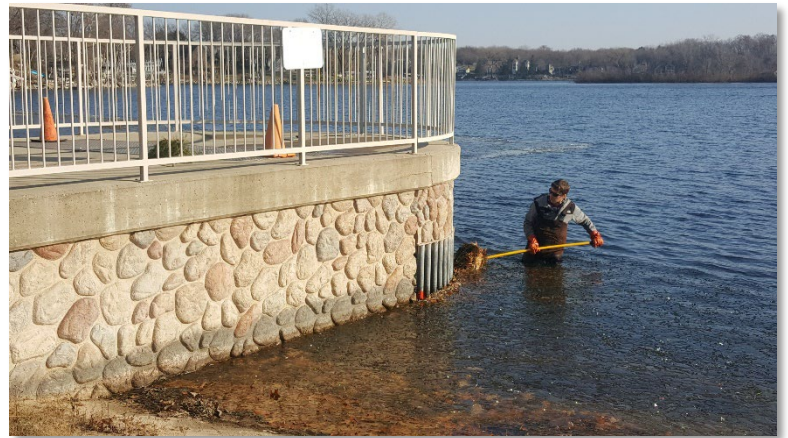
FIGURE 2 - REMOVING VEGETATION FROM OUTLET STRUCTURE

The new structure requires minimal maintenance to operate. Once Prior Lake reaches 902.5', water starts spilling over the accordion shaped weir located inside the trash rack. Maintenance includes visual inspections, greasing gates, and removing debris from the trash rack. Removing vegetation and other debris from the trash rack is the most time-consuming and labor-intensive task (Figure 2). When the structure is operating (Prior Lake is greater than 902.45'), the structure will be inspected no less than once a week, and as much as twice per day, depending on the lake level and amount of vegetation getting caught on the trash rack. Inspections and debris removal are typically conducted by PLSLWD staff. During times when water is high and large amounts of vegetation are getting caught on the track rack, the City of Prior Lake staff have helped remove vegetation to ensure the Outlet Structure was not blocked.

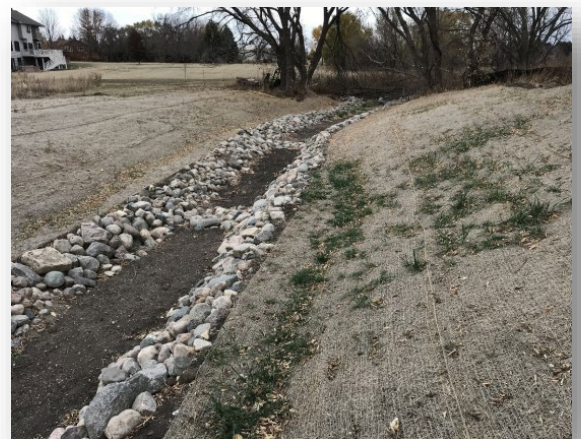
FIGURE 6 - SEGMENT 4 RESTORATION IN 2022

No easements were amended in 2022. In the 2022 upper segment 4 restoration site, the channel had drifted to the edge of the easement. Bank stabilization work was carefully completed with the use of temporary easements allowing contractors to align the channel back into current easement boundaries. There are still many locations along the channel that need easements or alignment amendments, but the Cooperators have generally accepted that we won't pursue easement purchases or amendments until the landowner changes hands or development occurs. A spreadsheet exists in the PLSLWD files that describes each potential easement purchase or amendment.

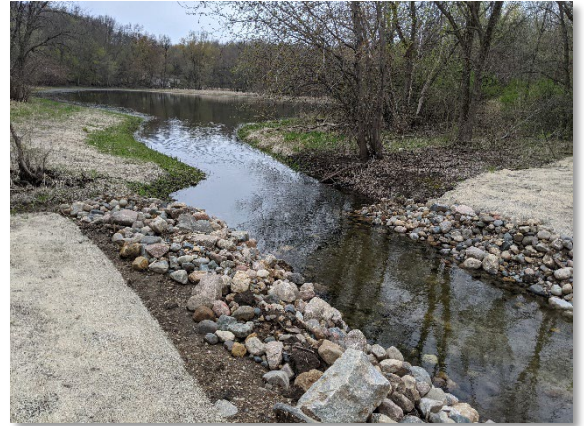
FIGURE 7 - STRAUSS DRIVEWAY AND CULVERT REMOVAL IN 2021

- Permit #20.02 *Pike Lake Culvert*: Culvert replaced; status closed.
- Permit #20.04 *Strauss Driveway*: Culvert and driveway have been removed creating an open channel. The permit is still open awaiting final vegetation establishment.

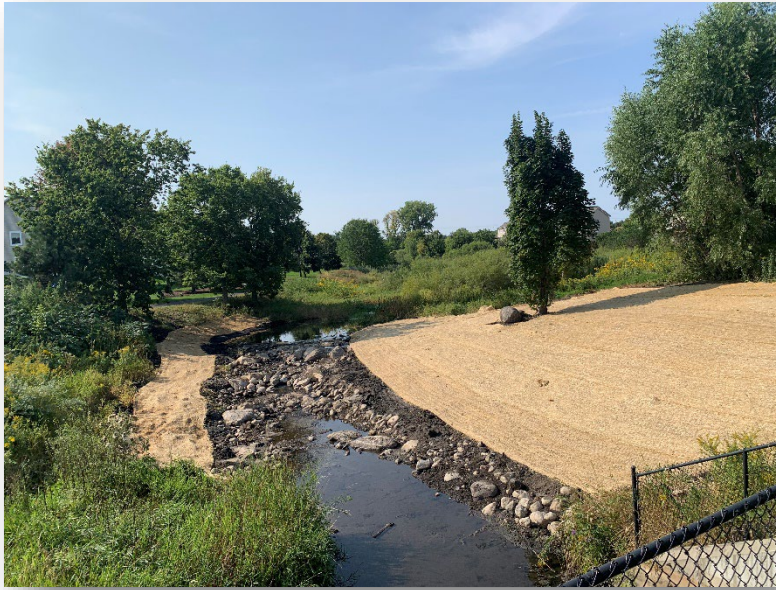
FIGURE 8 SEGMENT 5A STABILIZATION

- Boulder weirs installed in downstream end of segment 5a including a clay core to retain in upstream wetland.

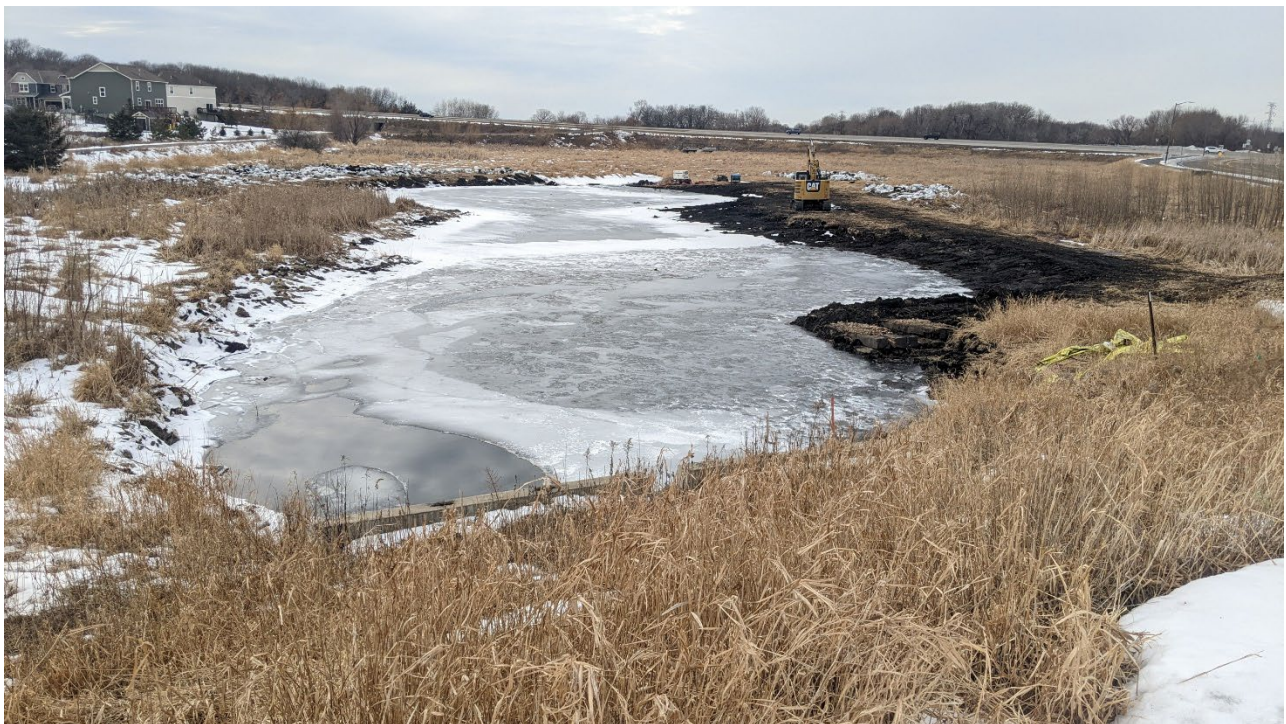
FIGURE 9 PIKE LAKE ROAD POND SEDIMENT REMOVAL

- Construction of a new outlet channel was completed, and new culverts were installed in segment 5b.
- In February, the Pike Lake Pond sediment project in segment 5c included wetland excavation, dewatering, erosion and sediment control, and vegetation restoration. Approximately 1,673 cubic yards of sediment were removed from this desiltation basin.
