## **Fish Lake, Scott County, Curlyleaf Pondweed Assessment for 2010**

**Assessment Date: April 27, 2010**

**Prior Lake/Spring Lake Watershed District  
Prior Lake, Minnesota**

**Steve McComas  
Blue Water Science  
St. Paul, MN 55116**

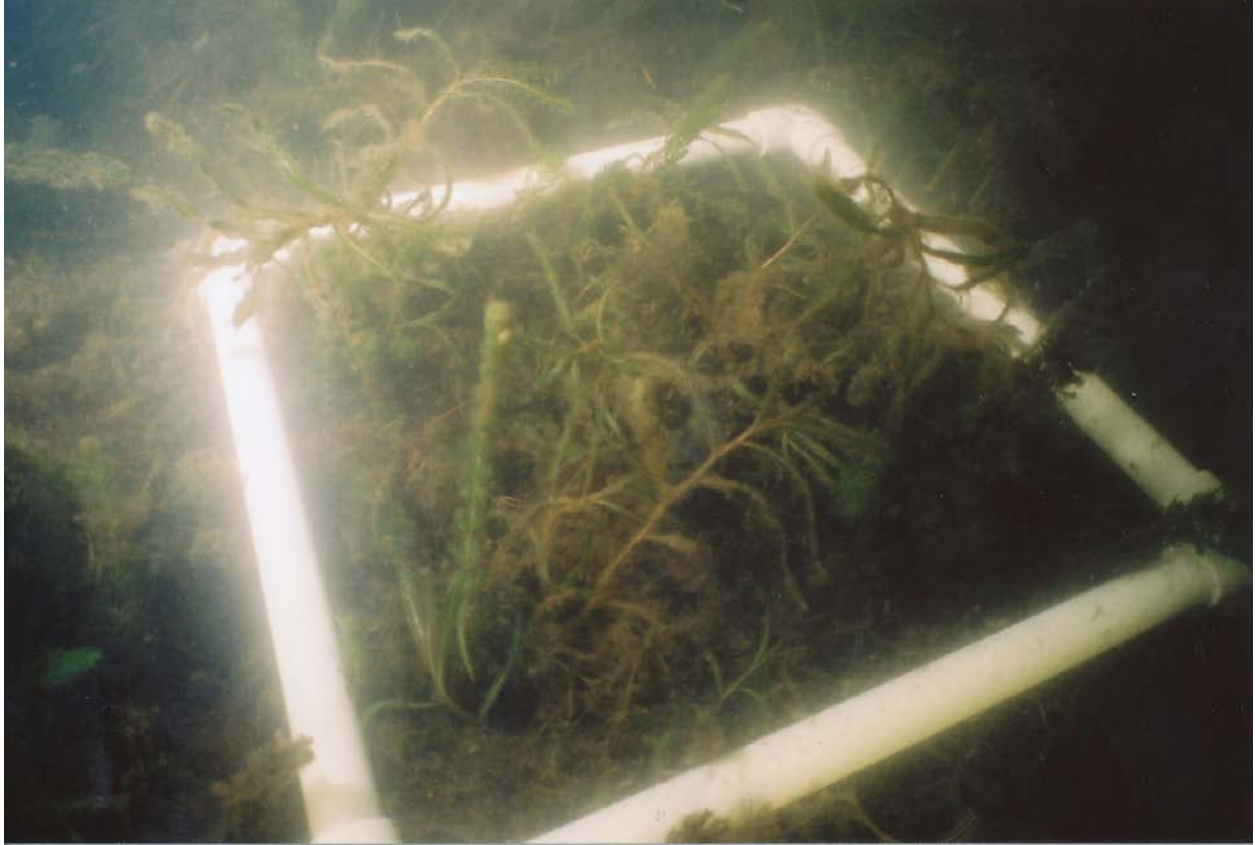
Curlyleaf Pondweed in a Sampling Quadrat in Fish Lake on April 27, 2010

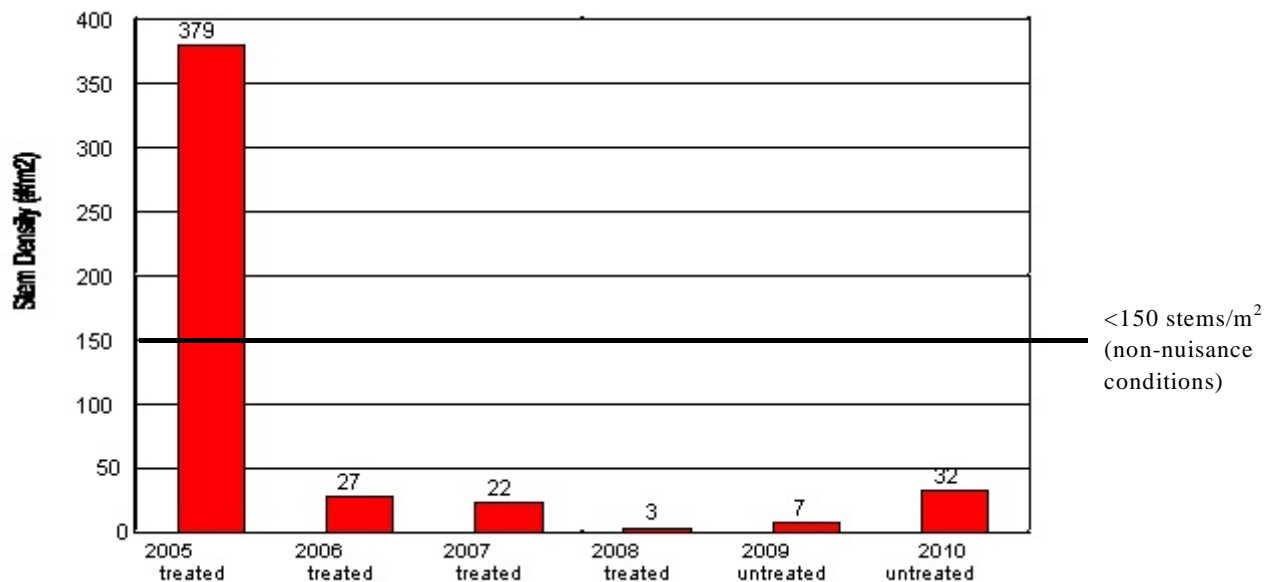
**Figure 3. Curlyleaf stem densities for early season monitoring (using scuba diving) for 2005-2010.**

Curlyleaf stem densities were determined by scuba diving at a location between sample sites 4-5 (Figure 1). Ten quadrat samples were taken at this location. The results for 2010 show curlyleaf was found at low stem densities (Table 2) but has increased slightly since 2008 (Figure 3). These stem densities were higher compared to densities found in 2008, but are still very low compared to pre-treatment stem densities from 2005 (Figure 3).

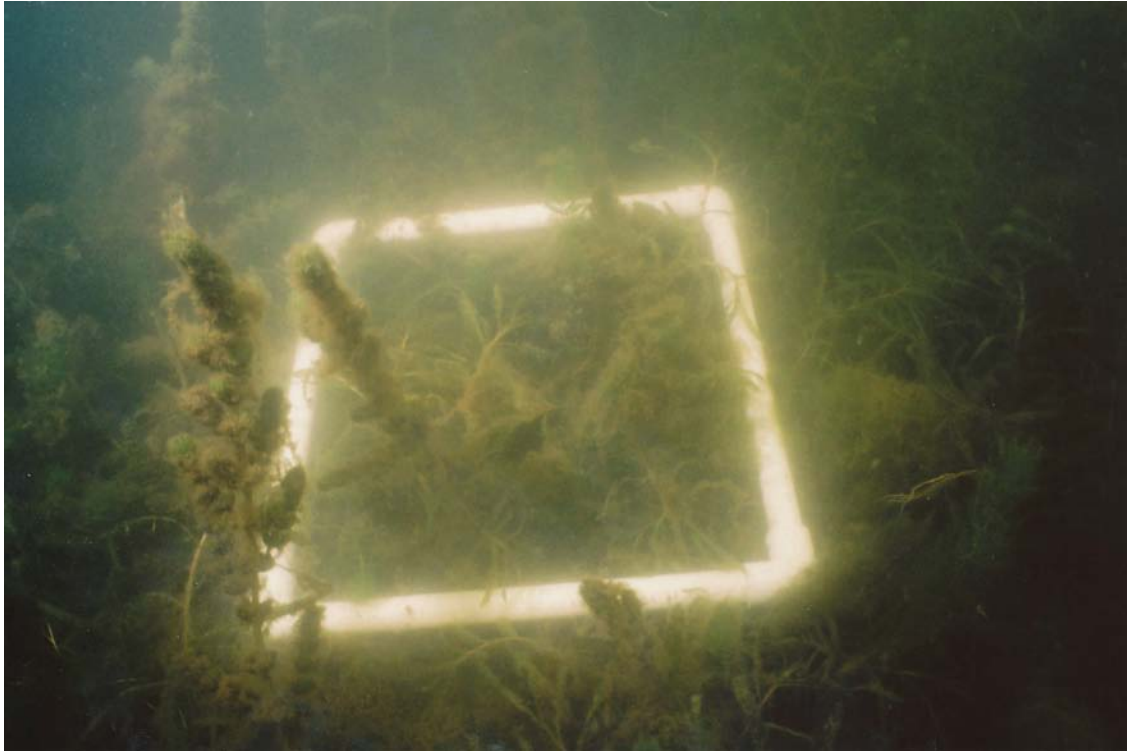
[top] The white frame is a quadrat sampler. All stems within the quadrat are counted. Curlyleaf was sparse at the sample sites monitored by scuba diving.

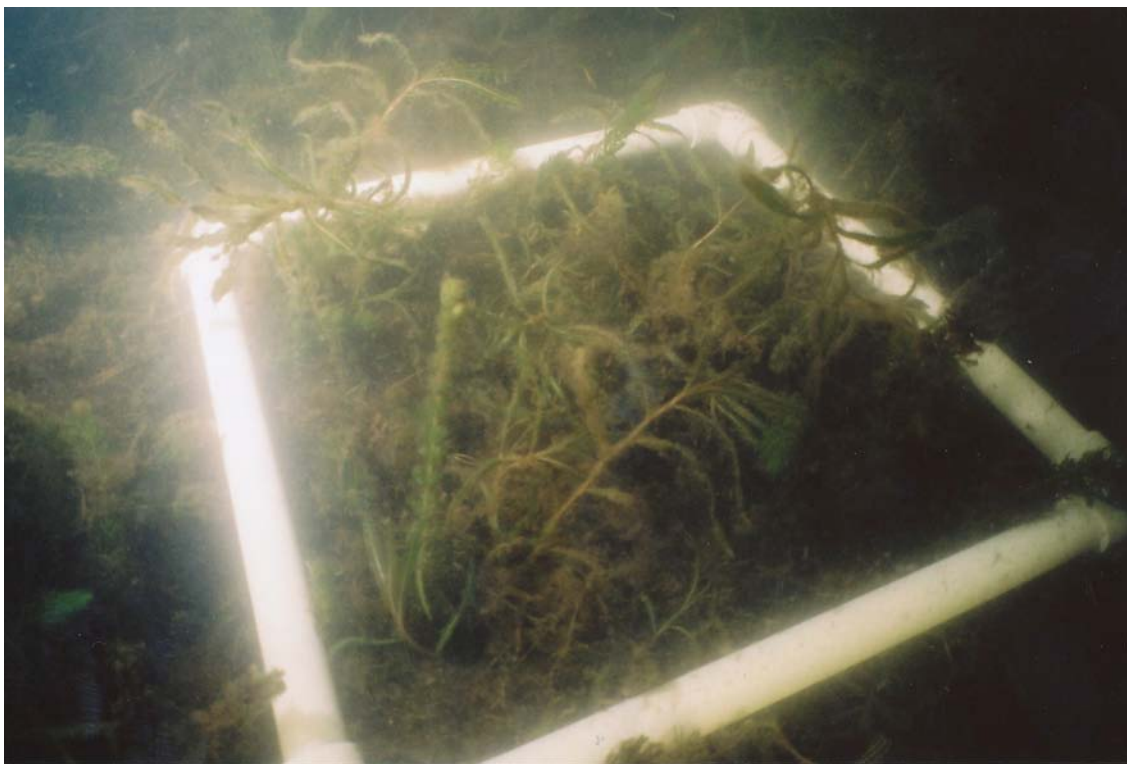
[bottom] Curlyleaf pondweed and coontail were found together at 7 out of 10 quadrat samples at Site 4.

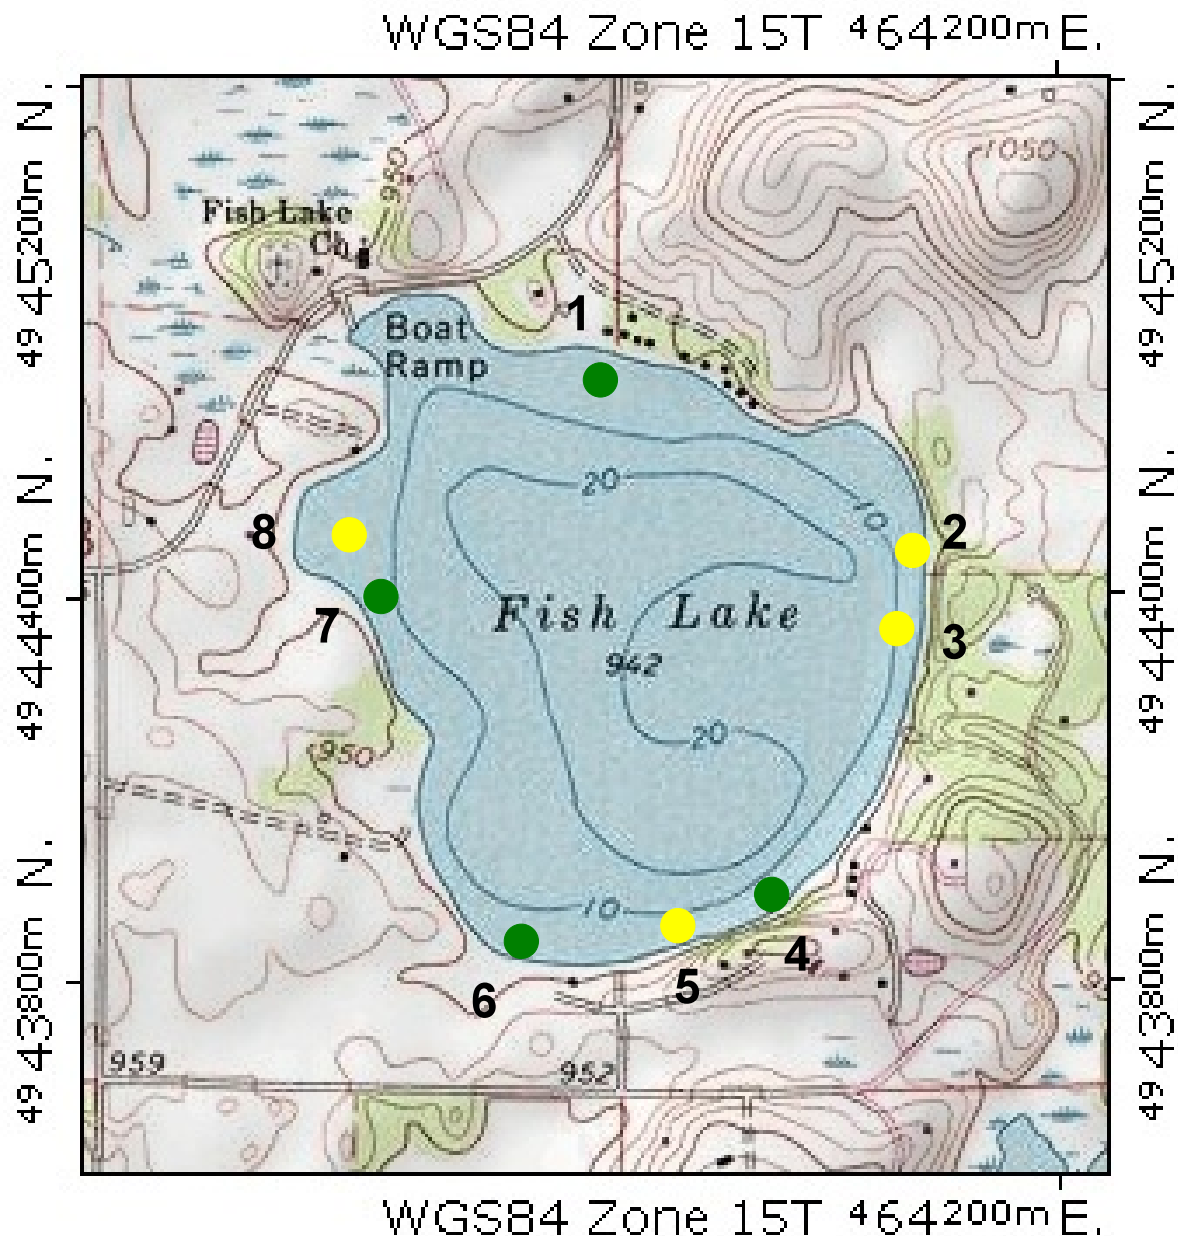
Figure 4. Sediment sample locations are shown with a circle. The circle color indicates the potential for nuisance curlyleaf pondweed growth to occur at that site. Key: green = light; yellow = moderate; red = heavy potential.

**Sediment Characteristics:** A Fish Lake sediment survey was conducted on September 1, 2006. Lake sediment sampling results from 2006 have been used to predict lake bottom areas that have the potential to support nuisance curlyleaf pondweed plant growth. Based on the key sediment parameters of pH, sediment bulk density, organic matter, and the Fe:Mn ratio (McComas, unpublished), the predicted growth characteristics of curlyleaf pondweed are shown in Figure 4.

Curlyleaf pondweed growth is predicted to produce mostly light to moderate growth at sample locations in Fish Lake (Figure 4)(a key to growth characteristics is shown on the next page) .

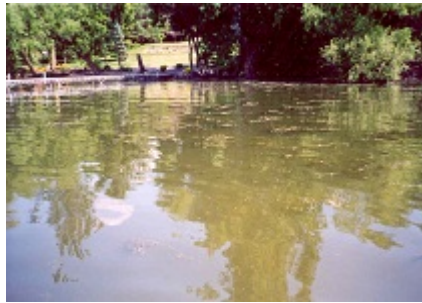
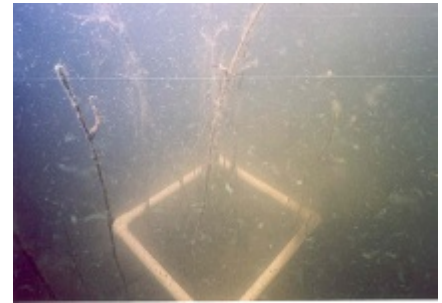
## Light Growth Conditions

Plants rarely reach the surface.

Navigation and recreational activities are not generally hindered.

Stem density: 0 - 160 stems/m<sup>2</sup>  
Biomass: 0 - 50 g-dry wt/m<sup>2</sup>  
Estimated TP loading: <1.7 lbs/ac

*MnDNR rake sample density equivalent for light growth conditions: 1, 2, or 3.*

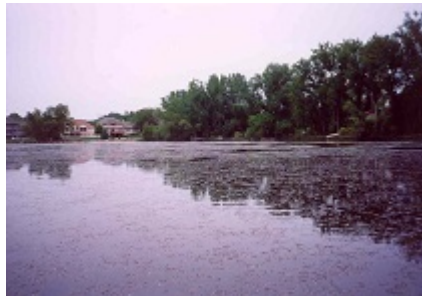
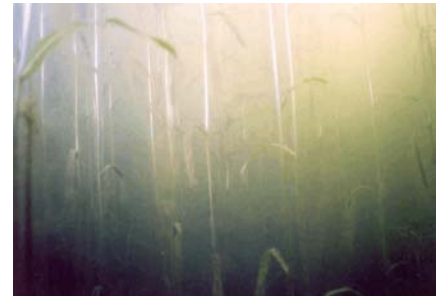
## Moderate Growth Conditions

Broken surface canopy conditions.

Navigation and recreational activities may be hindered.

Lake users may opt for control.

Stem density: 100 - 280 stems/m<sup>2</sup>  
Biomass: 50 - 85 g-dry wt/m<sup>2</sup>  
Estimated TP loading: 2.2 - 3.8 lbs/ac

*MnDNR rake sample density equivalent for moderate growth conditions: 2, 3 or sometimes, 4.*

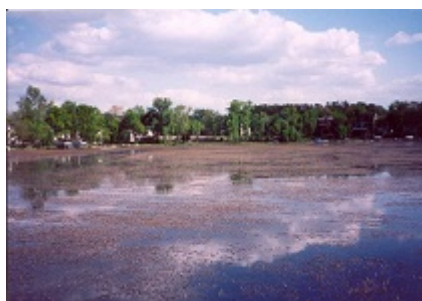
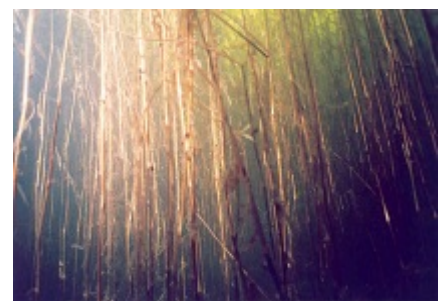
## Heavy Growth Conditions

Solid or near solid surface canopy conditions.

Navigation and recreational activities are severely limited.

Control is necessary for navigation and/or recreation.

Stem density: 400+ stems/m<sup>2</sup>  
Biomass: >300 g-dry wt/m<sup>2</sup>  
Estimated TP loading: >6.7 lbs/ac

*MnDNR rake sample density has a scale from 1 to 4. For certain growth conditions where plants top out at the surface, the scale has been extended: 4.5 is equivalent to a near solid surface canopy and a 5 is equivalent to a solid surface canopy. Heavy growth conditions have rake densities of a 4 (early to mid-season with the potential to reach the surface), 4.5, or 5.*
