Upper and Lower Prior Lakes, Scott County, Early Season Curlyleaf Pondweed Assessment for 2010

Assessment Dates: April 27 (57°F) and June 2, 2010 (75°F)

Prepared for:
Prior Lake/Spring Lake Watershed District
Prior Lake, Minnesota

Prepared by:
Steve McComas
Blue Water Science
St. Paul, MN 55116

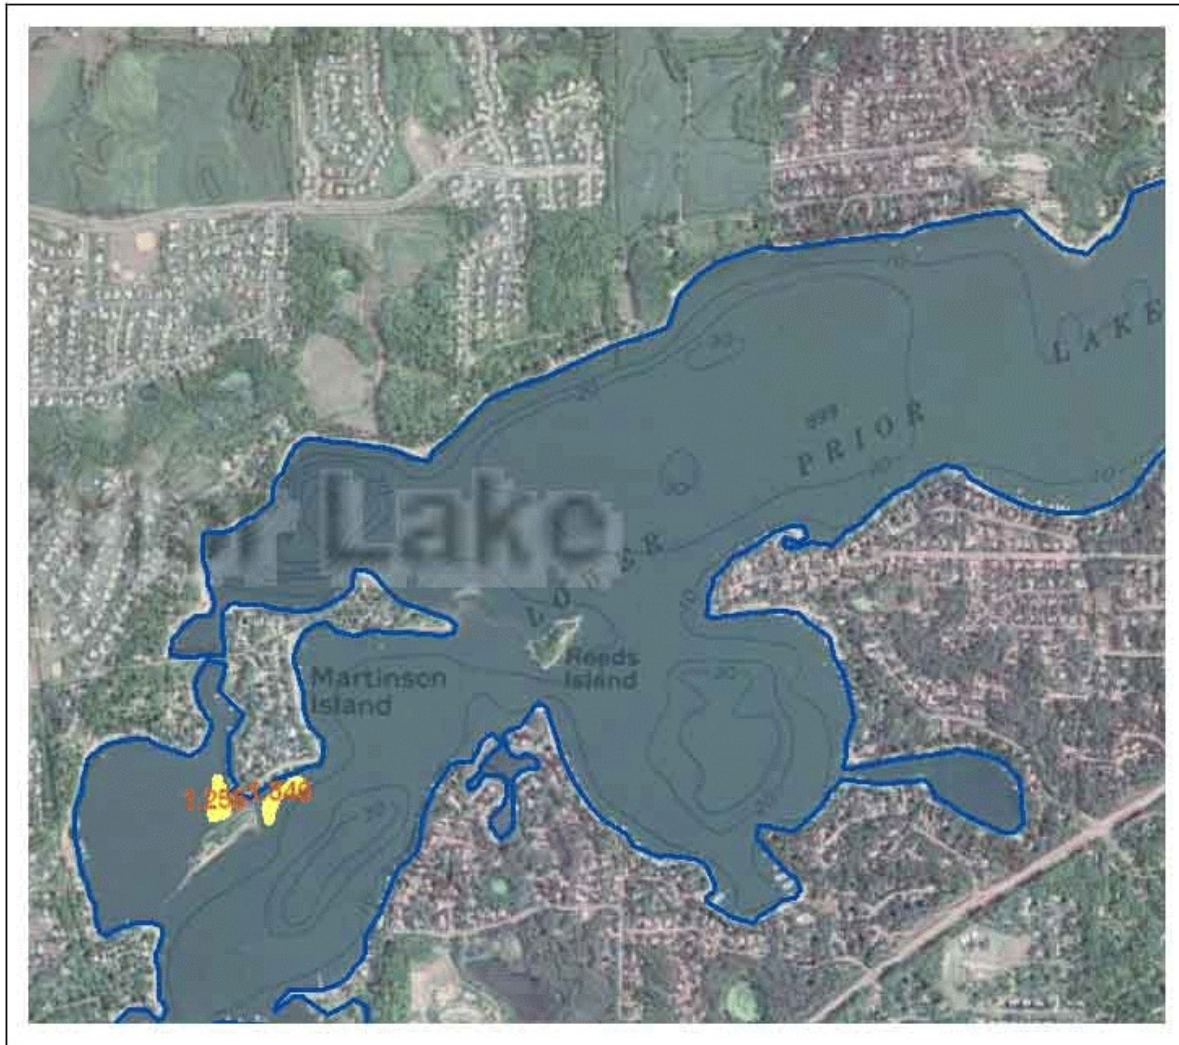
Site 12, left side CLP area: 1.3 ac
Site 11, right side CLP area: 1.6 ac
(site numbers refer to areas in Table 1 and labeled areas on maps in the summary)

Figure 1. Potential treatment areas for Lower Prior Lake based on the April 27, 2010 assessment.

Recommendations for 2011: For Lower Prior, the Martinson Island area had heavy growth in 2009 and 2010. Between the channel and open water areas about 5 to 10 acres of curlyleaf could be considered for treatment.

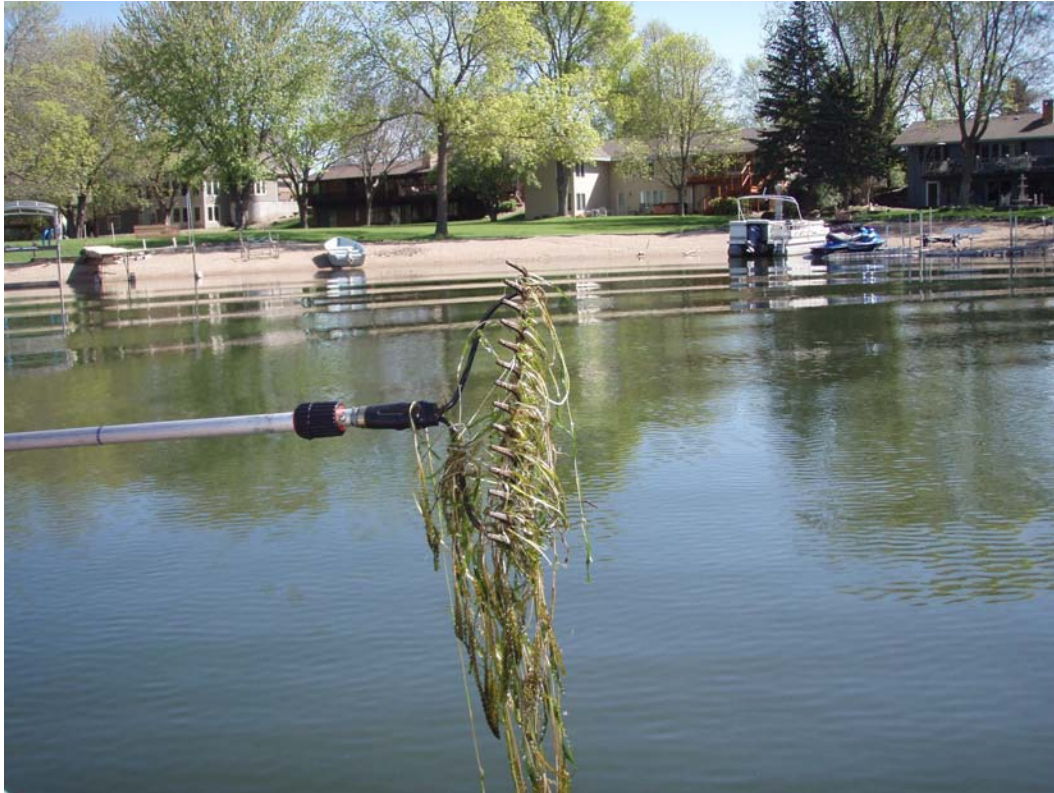
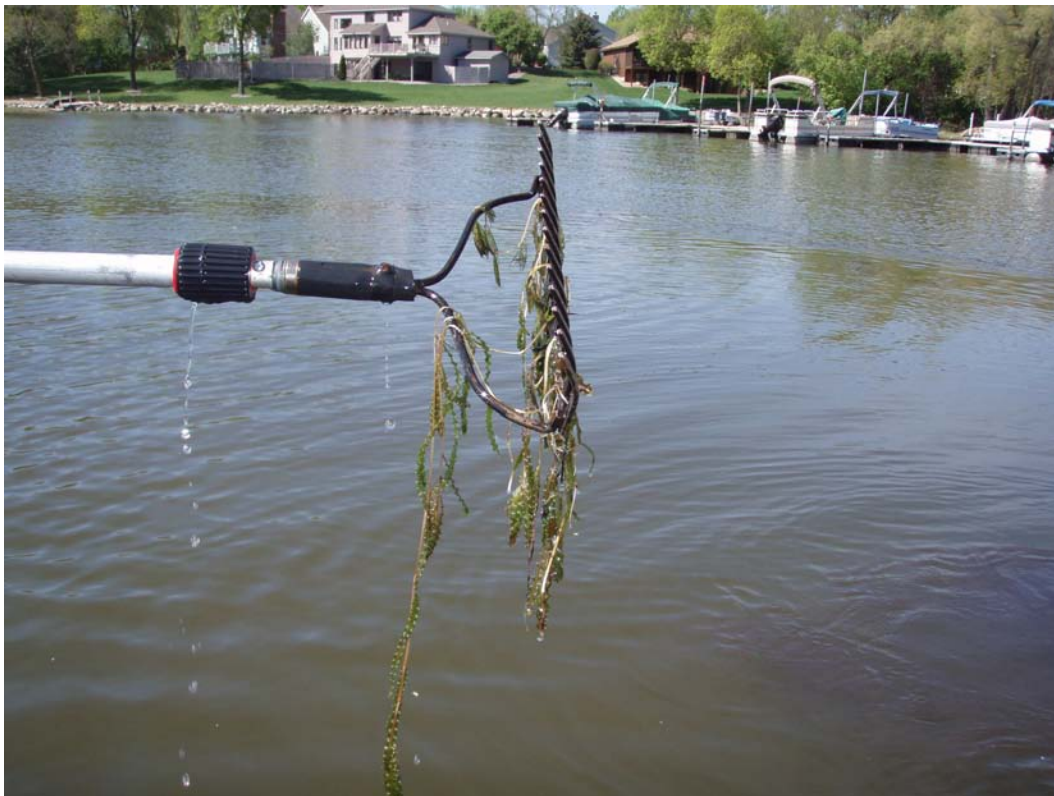
Figure 3. Curlyleaf pondweed was found around Prior Lake on April 27, 2010. Here curlyleaf was at a density of a “3” [top photo] and at a density of a “2” [bottom photo]. Typical curlyleaf density of a “2” found in Lower Prior.

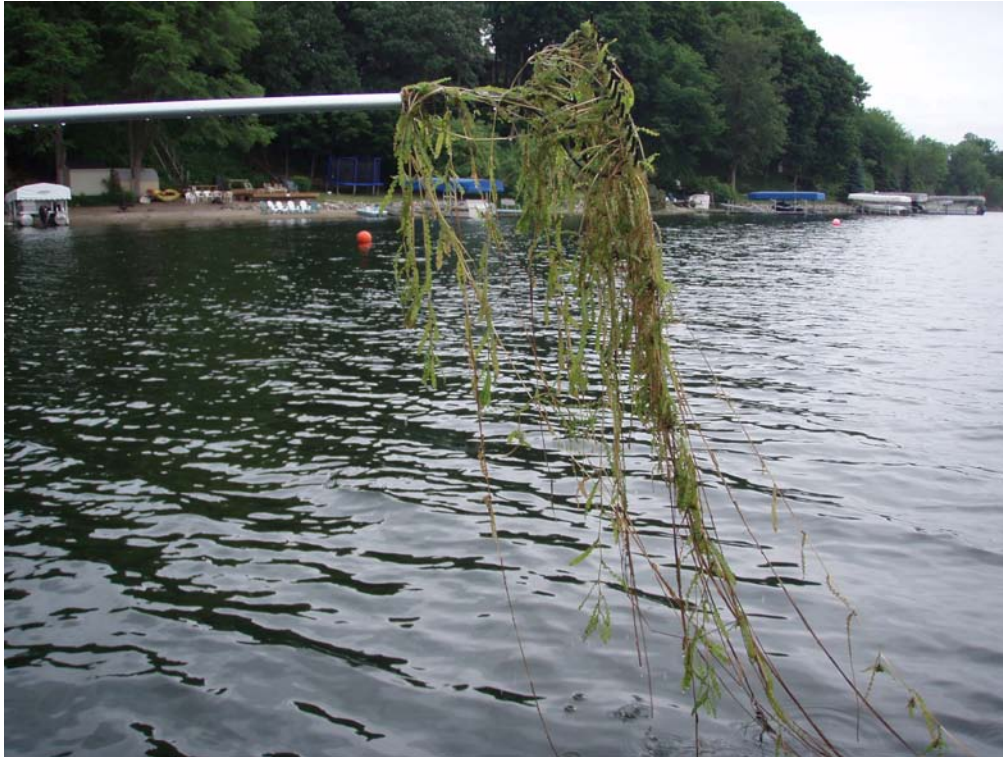
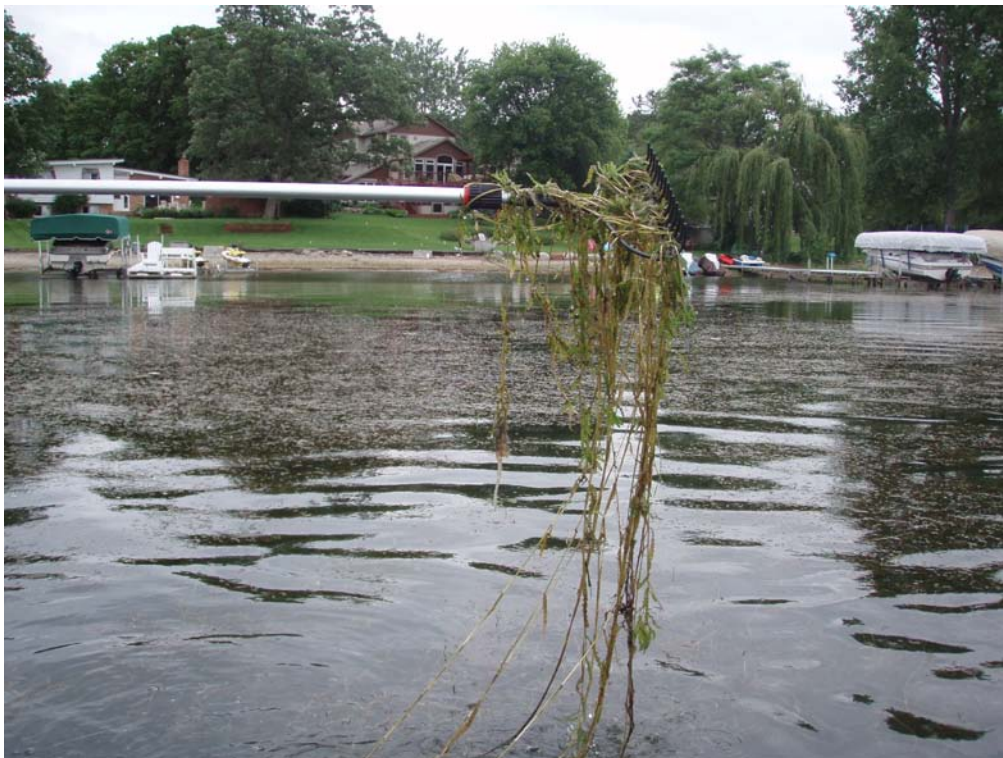
Figure 4. Curlyleaf pondweed was found around Prior Lake on June 2, 2010. Here curlyleaf was at a density of a “3” [top photo] and at a density of a “4” [bottom photo]. Here curlyleaf is at a density of a “5”.

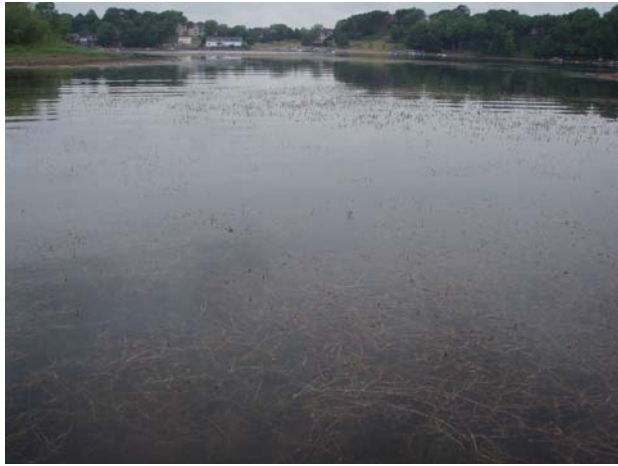
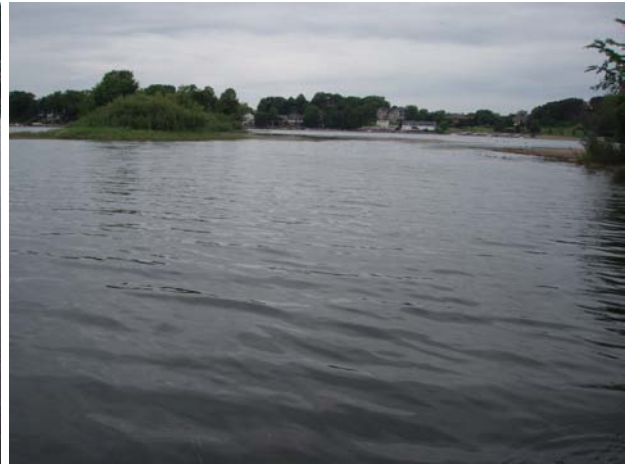
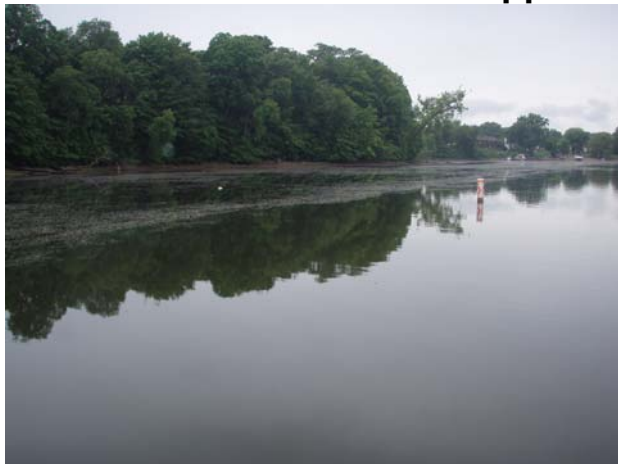
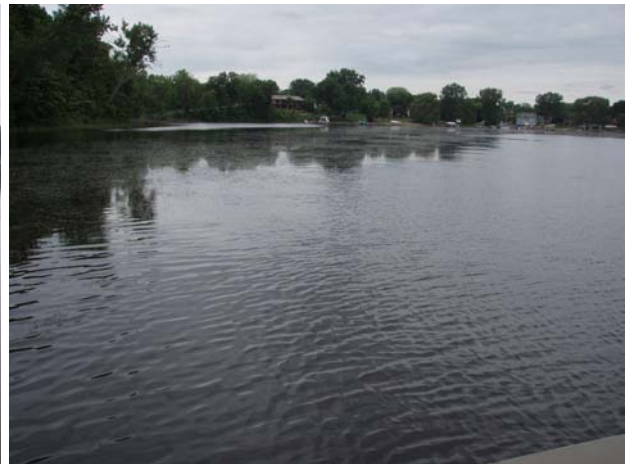
Figure 5. [top and middle] Lower and Upper Prior Lakes conditions in June 2009 and 2010. [bottom] Curlyleaf conditions in June 2009 and 2010 based on June assessments. Black = no curlyleaf; green = light growth; yellow = moderate growth; and red = heavy growth.

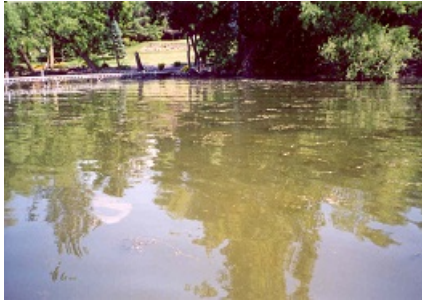
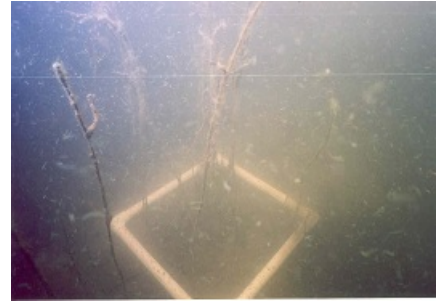
Light Growth Conditions

Plants rarely reach the surface.

Navigation and recreational activities are not generally hindered.

Stem density: 0 - 160 stems/m²
Biomass: 0 - 50 g-dry wt/m²
Estimated TP loading: <1.7 lbs/ac

MnDNR rake sample density equivalent for light growth conditions: 1, 2, or 3.

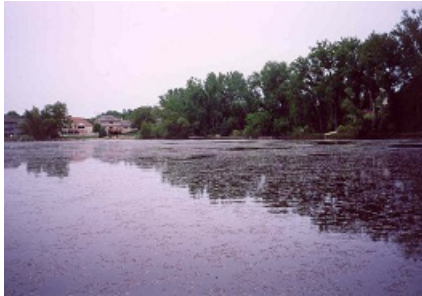
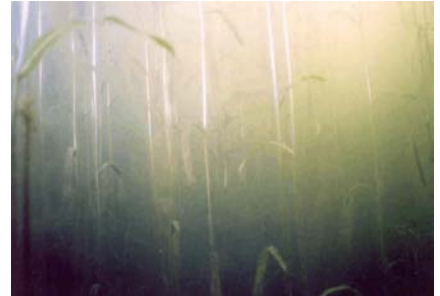
Moderate Growth Conditions

Broken surface canopy conditions.

Navigation and recreational activities may be hindered.

Stem density: 100 - 280 stems/m²
Biomass: 50 - 85 g-dry wt/m²
Estimated TP loading: 2.2 - 3.8 lbs/ac

MnDNR rake sample density equivalent for moderate growth conditions: 2, 3 or sometimes, 4.

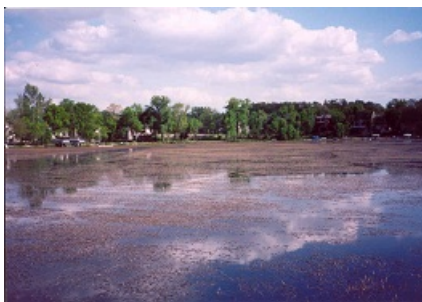
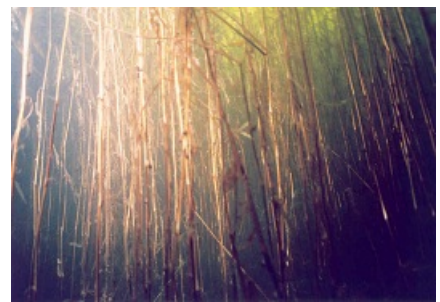
Heavy Growth Conditions

Solid or near solid surface canopy conditions.

Navigation and recreational activities are severely limited.

Stem density: 400+ stems/m²
Biomass: >300 g-dry wt/m²
Estimated TP loading: >6.7 lbs/ac

MnDNR rake sample density has a scale from 1 to 4. For certain growth conditions where plants top out at the surface, the scale has been extended: 4.5 is equivalent to a near solid surface canopy and a 5 is equivalent to a solid surface canopy. Heavy growth conditions have rake densities of a 4 (early to mid-season with the potential to reach the surface), 4.5, or 5.

Control is necessary for navigation and/or recreation.
