# Aquatic Vegetation Density Mapping – BioBase 2015 Report

June 2016

PRIOR LAKE - SPRING LAKE

WATERSHED DISTRICT

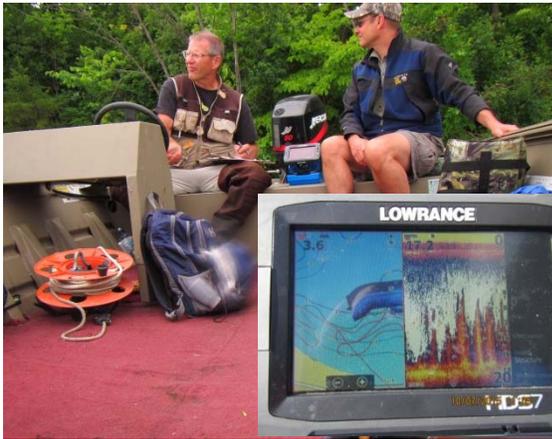
Figure 1 BioBase equipment being used by volunteers

BioBase uses sonar to detect and record aquatic vegetation density, lake bottom hardness, and bathymetry (contours of lake bottom). Vegetation density is determined by the percent of the water column (the vertical space between the lake bottom and the water surface) that is filled with plants. An area that has plant growth from the lake bottom to the lake surface has 100% vegetation density, while an area of the lake with no vegetation has 0% density.

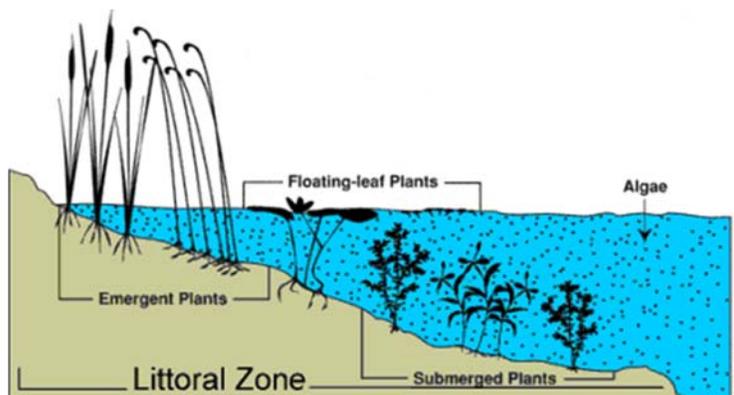
Figure 2 Shows the different areas and plants of the littoral zone.

The relationship between water depth and aquatic plant life is called the Littoral Zone. As described by the DNR “the shallow transition zone between dry land and the open water area of the lake. In Minnesota waters, the littoral zone extends from the shore to a depth of about 15 feet, depending on water clarity. “The width of the littoral zone will vary . . . places where the slope of the lake bottom is steep, the littoral area may be narrow . . . if the lake is shallow and the bottom slopes gradually, the littoral area may extend hundreds of feet into the lake (Where Aquatic Plants Grow).” See Figure 2.

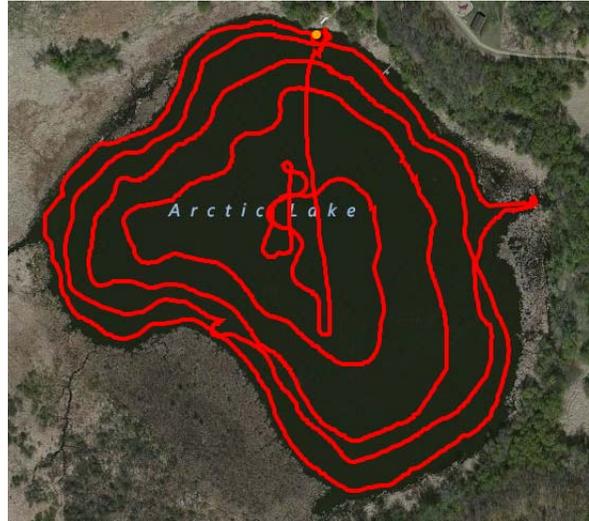
Figure 3 Tracks recorded by Biobase Software

The equipment used consists of a Lowrance depth finder, a transducer (sonar), and structure scan (structure scan is optional but used to aid in vegetation identification). When collecting data on the lakes, the staff member drives a boat less than 5mph in order for the sonar to record data. The sonar collects data from about 150ft out from either side of the boat, so driving near the ends of the docks is generally close enough to map the vegetation all the way up to the shoreline. Laps or “tracks” are then made moving farther and farther into deeper water.

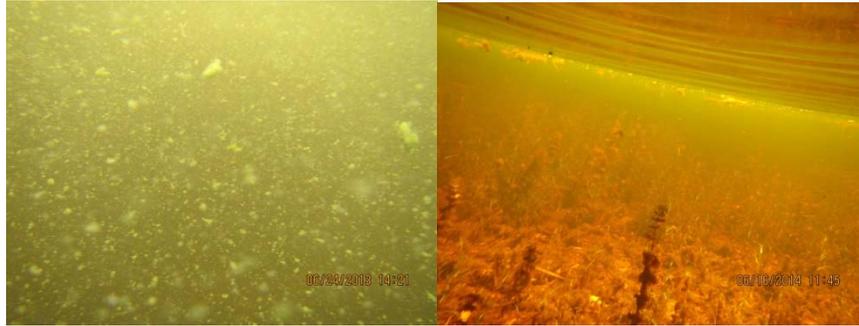
**Figure 4 Spring Lake before the Alum treatment on the left (taken 6/24/13) and after the treatment (taken on 6/15/14) on the right**

Water quality can also be affected by the amount of vegetation. Spring Lake was treated with Aluminum Sulfate in October 2013, which increased the clarity of the lake. After a few more years of monitoring vegetation density, we should be able to determine if better clarity will lead to more plant growth. Historically, Spring Lake vegetation did not grow in depths greater than approximately 8 feet. A typical lake with good water clarity could have plant growth as deep as 16 feet. It will be interesting to see how the Alum Treatment affects vegetation growth, if at all.

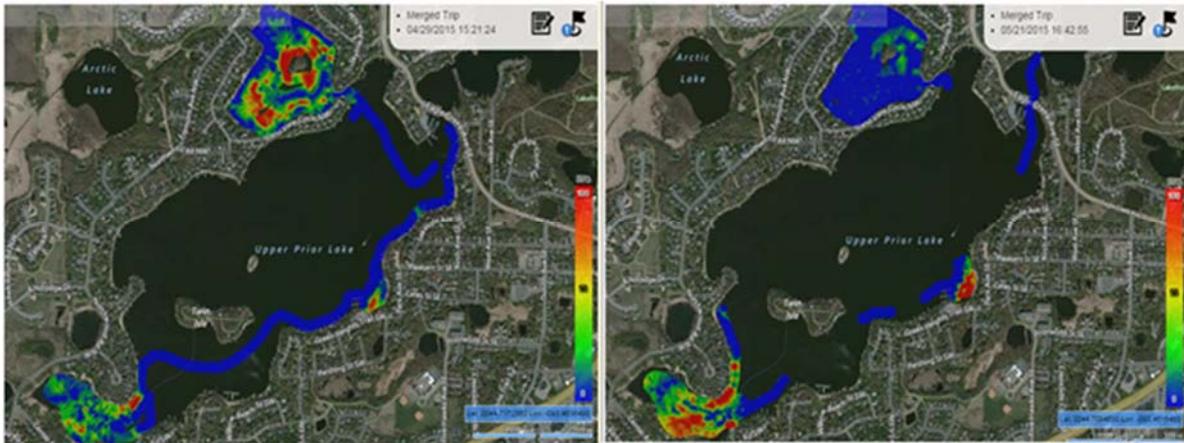
Figure 6 Curlyleaf presence before (4/29/15 - left) and after treatment (5/21/15 - right).

In the example in Figure 6, the areas showing presence of vegetation were dominated by CLP. This was confirmed by vegetation surveys conducted by Blue Water Science. CLP was treated in all three areas, however, treatment success varied, as is seen in the maps. The bay (Crystal Bay) in the top of the map was very effective while the two locations on the south central and southwest part of the lake were less effective and CLP flourished. Based upon the evidence created by these maps, the PLSLWD was able to receive a credit from the contractor for inadequate Curlyleaf pondweed treatment in 2015, which was used for 2016 treatments.

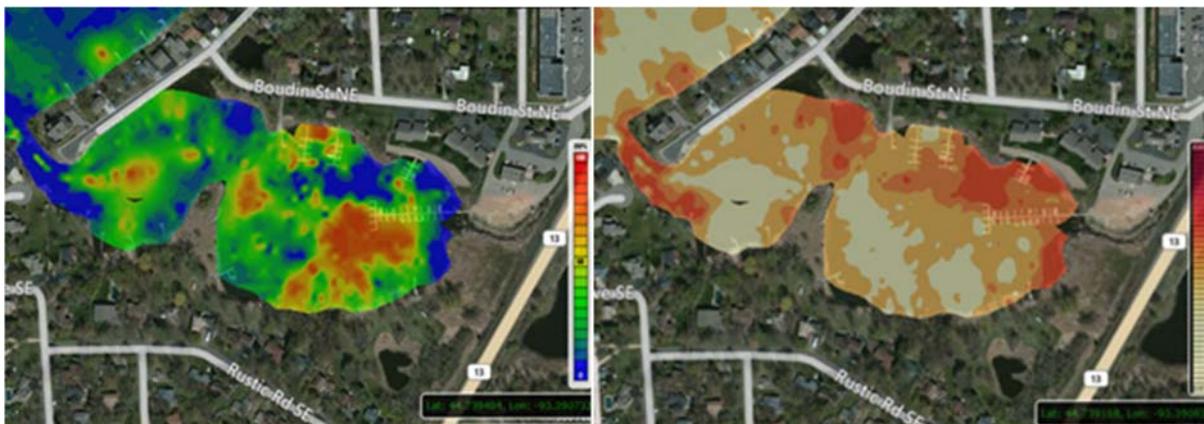
Figure 7 Where there is a lack of vegetation (blue) the bottom of the lake is harder (dark orange/red).

Mapping bottom hardness or substrate composition of a lake is also potentially useful as it may help explain part of the water clarity issues in our local lakes. When looking at the bottom hardness of this close up view of a bay in Lower Prior Lake in Figure 7, it is noticeable that where the lake bottom is harder, there is less vegetation. All bottom hardness maps are located in Appendix C *Note: bottom hardness is measured light – dark corresponding as soft – hard, and vegetation is blue – red corresponds as 0 – 100% density.*

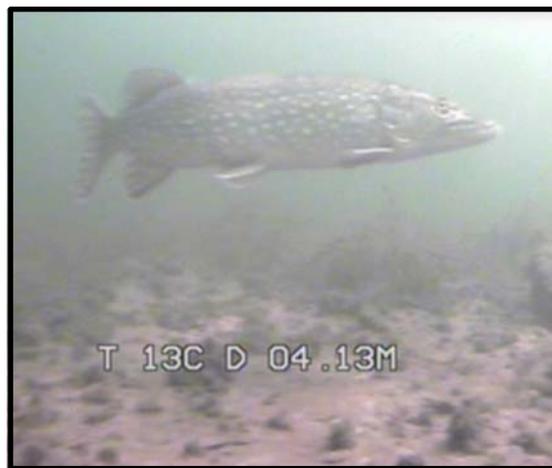
**Figure 8**  
**The lake bottom in the photo has a high hardness value (0.4) and little vegetation.**

Plants have a difficult time growing in lakes with hard bottoms (sandy or rocky). An example of this is found in Mr. Valley’s article *Composition Algorithm Improved*, in Figure 8. The bottom hardness is a 0.4 in the data recorded, but an underwater photo was taken at that point during the monitoring to see what the bottom looks like at that point. As can be seen, there is some vegetation there but it is sparse and small due to the lack of soft substrate to grow in.

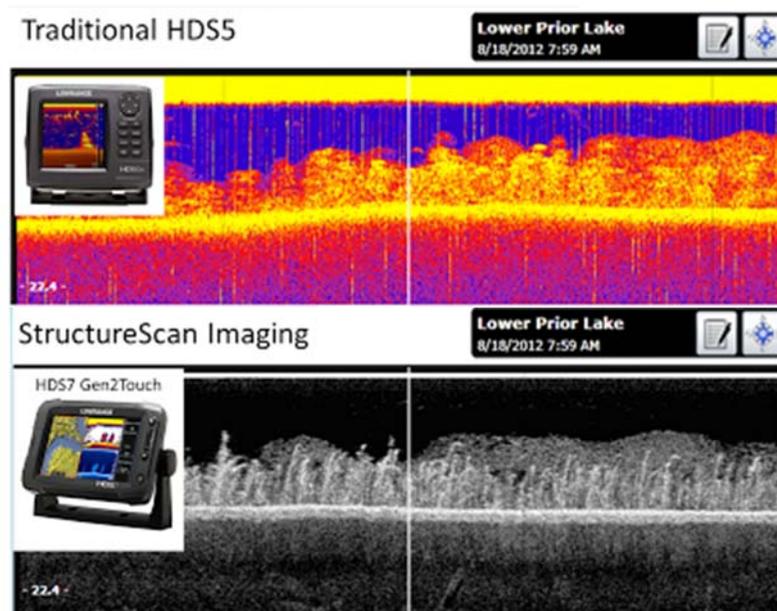
Figure 9 Eurasian Water Milfoil and a school of fish using the regular transducer image (above) and the structure scan image (below). Images courtesy of Ray Valley.

In addition to the sonar transducer, the structure scan equipment takes “ultra-sound-like” pictures of vegetation that allows for better visual clarity when looking at vegetation images. This can be helpful when determining plant type. See Figure 9.

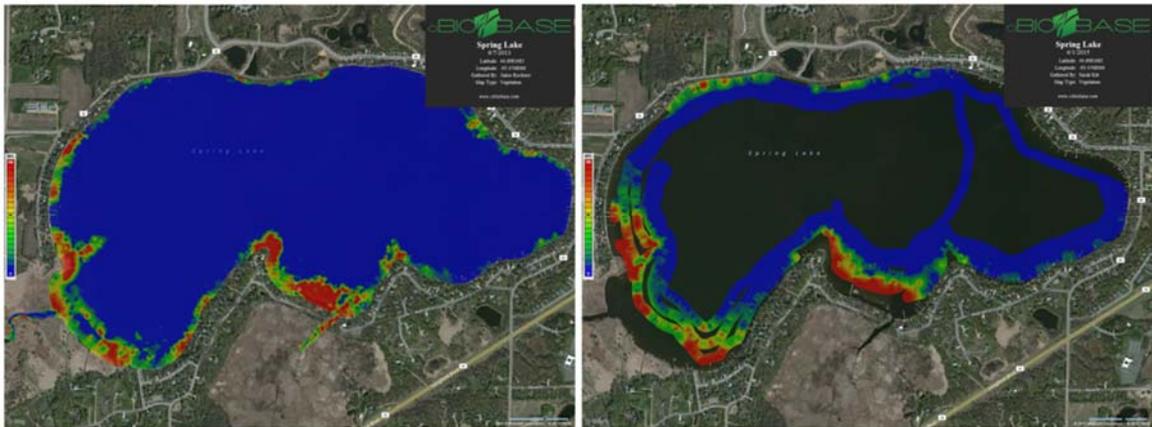
Figure 15 Summer 2013 on the left and summer 2015 on the right.

Projects like the Alum treatment conducted in October 2013 could possibly give plants a chance to grow in deeper areas if sunlight can now penetrate farther into the water. By comparing the summer season between 2013 and 2015, Figure 15, it is easy to see that the vegetation has started growing in deeper water and showing up in places it was absent before. PLSLWD will continue to observe how deep the vegetation grows, with hopes that it will continue to grow deeper. The Alum treatment may help kick-start the process of vegetation growing in enough density to restore the natural process of plants filtering out nutrients in the water for better clarity.

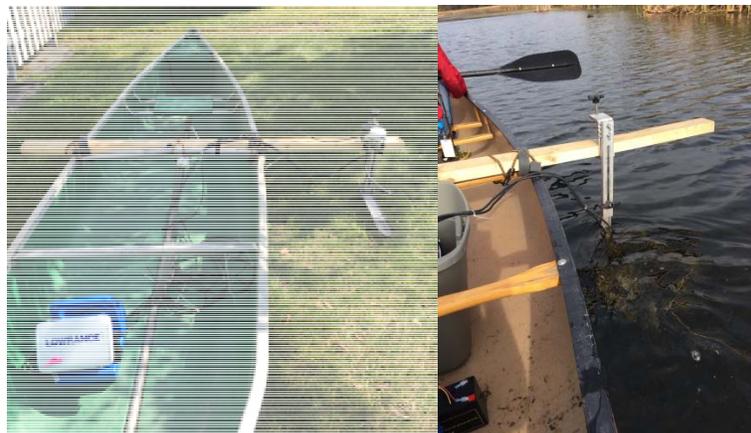
**Figure 19 Canoe set up**

Buck Lake was challenging to map as there was no public access or motorized boats allowed on the lake. Lakeshore owners supplied a canoe and the sonar equipment was attached to the canoe in order to complete this task, making the first attempt at mapping by canoe in 2015. The strategy proved fairly successful and will be used again in the future (see Figure 19). As more data is collected, PLSLWD will be able to better interpret the health of Buck Lake.
