PIKE LAKE-WEST: 2024 Water Quality Report Card

PIKE LAKE-EAST: Water Quality Story

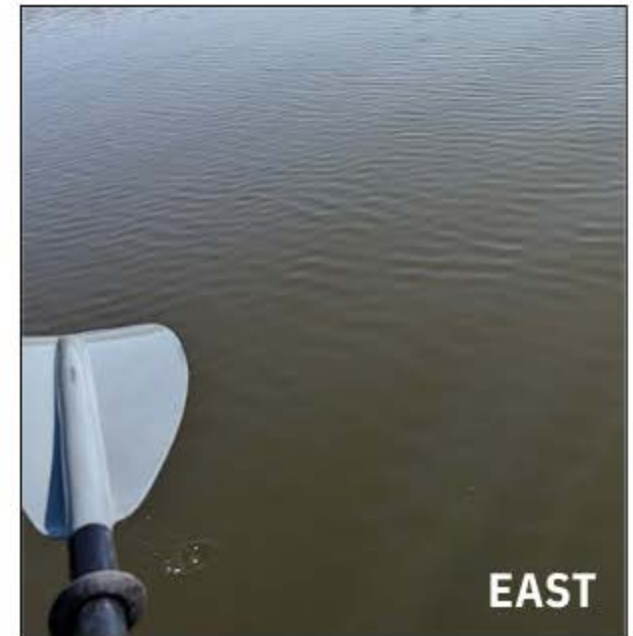
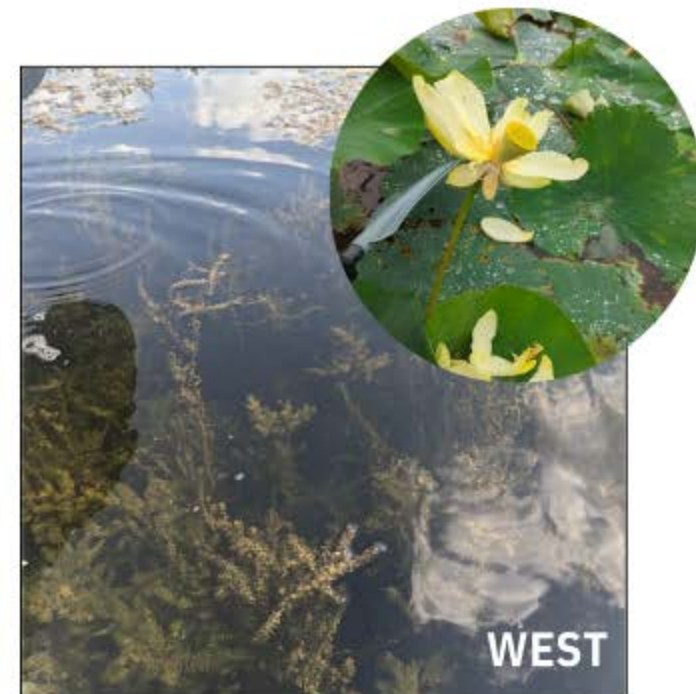
This lake highlights how water external influences shape water quality. Despite similar depth, sediment composition, size, and surrounding land use, the east and west bays differ dramatically. Separated by a short channel and an island, their contrasting conditions are even visible from aerial photographs.

The western bay benefits from clean water flowing in from Lower Prior Lake via the Prior Lake Outlet Channel (PLOC), which exits from the same bay toward the Minnesota River. This consistent flush of high-quality water helps keep the bay clear, allowing aquatic plants to thrive and compete with algae. During droughts, reduced PLOC flow diminishes water quality in the western bay.

The eastern bay, on the other hand, remains largely stagnant, receiving primarily nutrient-rich runoff. This fosters frequent algal blooms, which outcompete plants and further degrade the water quality.
