PIKE LAKE-EAST: 2024 Water Quality Report Card

PIKE LAKE-EAST: Water Quality Story

The Basin Difference Explained

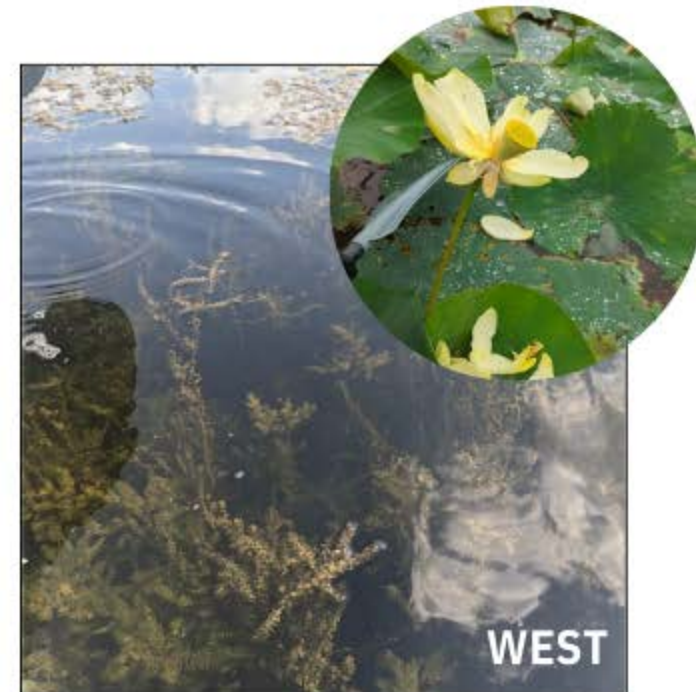
This lake highlights how water external influences shape water quality. Despite similar depth, sediment composition, size, and surrounding land use, the east and west bays differ dramatically. Separated by a short channel and an island, their contrasting conditions are even visible from aerial photographs.

The western bay benefits from clean water flowing in from Lower Prior Lake via the Prior Lake Outlet Channel (PLOC), which exits from the same bay toward the Minnesota River. This consistent flush of high-quality water helps keep the bay clear, allowing aquatic plants to thrive and compete with algae. During droughts, reduced PLOC flow diminishes water quality in the western bay.

The eastern bay, on the other hand, remains largely stagnant, receiving primarily nutrient-rich runoff. This fosters frequent algal blooms, which outcompete plants and further degrade the water quality.
