# **Aquatic Plant Point-Intercept Survey for Buck Lake, Scott County, Minnesota**

[Plant Survey Conducted August 31, 2016]

Prepared for:
Prior Lake-Spring Lake
Watershed District

Prepared by: Steve McComas Jo Stuckert Blue Water Science

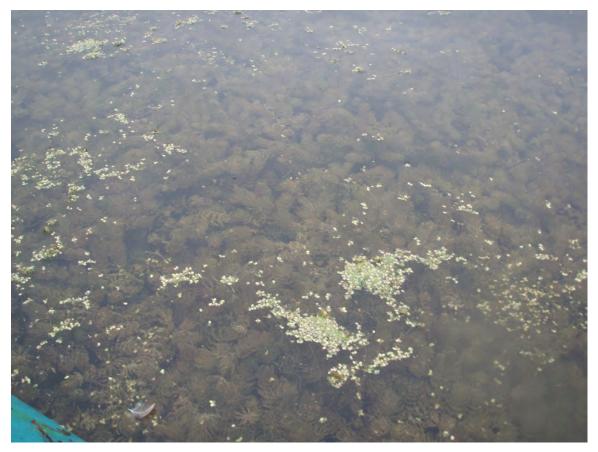
Figure S1. Coontail was dominant in Buck Lake in 2010 and 2016. This picture shows coontail conditions in 2010.

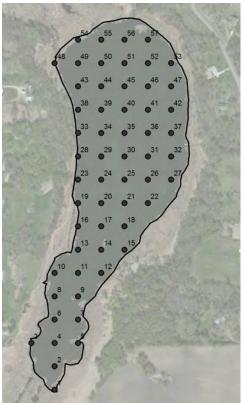
An aquatic plant point-intercept survey of Buck Lake was conducted by Blue Water Science on August 31, 2016 and 57 points were sampled. Sample points were placed 50 meters apart on a grid that covered the lake (Figure 1). At each sample point, a sampling rake was lowered into the water and a plant sample was taken. The plant species were recorded and the density of each species was assigned. Densities were based on the coverage on the teeth of the rake. Density ratings were from 1 to 5 with 1 being sparse and 5 being a nuisance. Based on these sample

Figure 1. Sample location map for the aquatic plant survey conducted on Buck Lake.

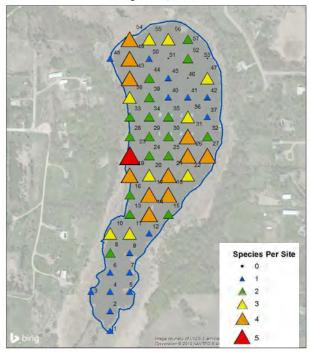
Buck Lake Species Richness August 31, 2016

Figure 2. Species richness map for Buck Lake, 2016.

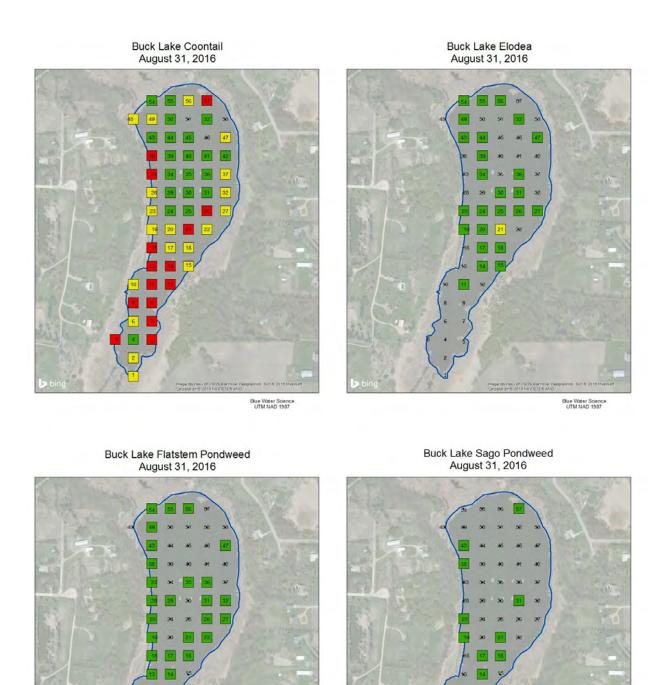
Figure 3. Buck Lake distribution and abundance maps for coontail (top-left), elodea (top-right), flatstem pondweed (bottom-left), and sago pondweed (bottom-right).

Key: green = light growth, yellow = moderate growth, and red = heavy growth.

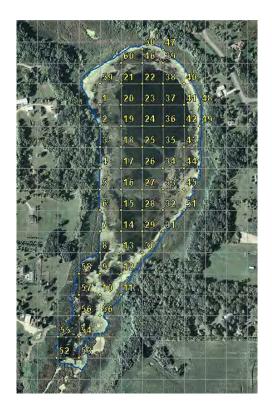
Figure 1. [top] Sample site map used on September 16, 2010.
[right] Coontail was the dominant plant in Buck Lake.

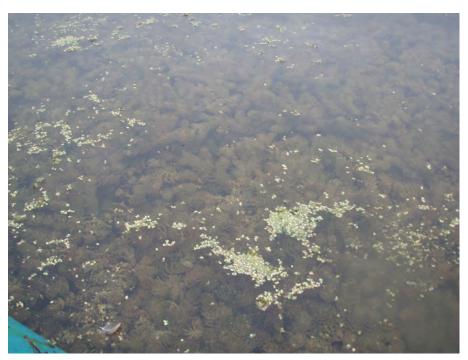
Figure 3. Buck Lake has fairly good water clarity, especially in areas with thick coontail growth. Duckweed (shown floating on the water) was common as well.

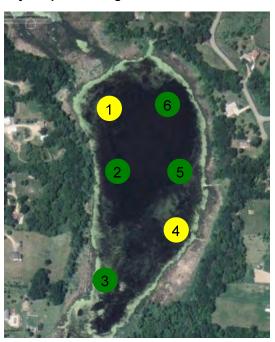
Curlyleaf pondweed growth is predicted to produce mostly low to moderate nuisance growth (where plants top out) at only several locations (Figure 4).

Figure 4. Curlyleaf pondweed growth is predicted to be light to moderate based on lake sediment characteristics. Green circles = light growth and yellow circles = moderate growth.

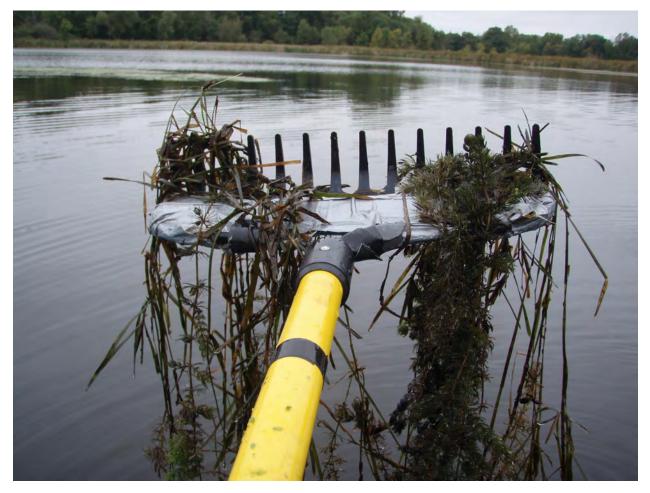
Figure 6. Flatstem pondweed and coontail were both common plants found in Buck Lake in 2010. Coontail was more abundant than flatstem.
