Aquatic Plant Point Intercept Surveys for Pike Lake, Scott County, Minnesota

[Early Season Plant Survey Conducted June 10, 2019]
[Late Season Plant Survey Conducted August 6, 2019]

Prepared for:
Prior Lake/Spring Lake
Watershed District

Prepared by:
Steve McComas
Jo Stuckert
Blue Water Science

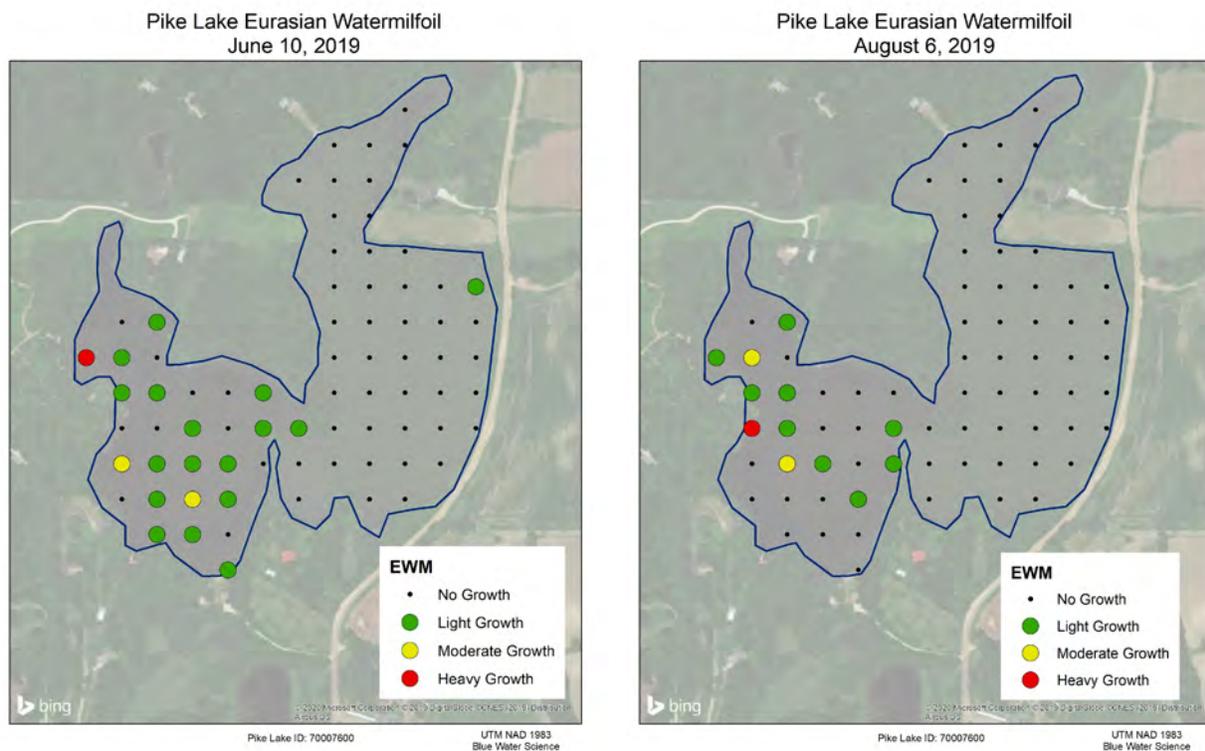
Figure S1. Pike Lake Eurasian watermilfoil growth on June 10, 2019 (left) and Eurasian watermilfoil growth on August 6, 2019 (right). Key: Green = light growth, yellow = moderate growth, and red = heavy growth.

Pike Lake plant survey results indicated a low diversity of submerged aquatic plants with four species of submerged plants found in the survey spring survey and only two species found in the summer survey. Coontail was the dominant aquatic plant in both the June and August surveys. EWM was reduced in abundance and occurrence in 2019 compared to previous years (Figure S1).

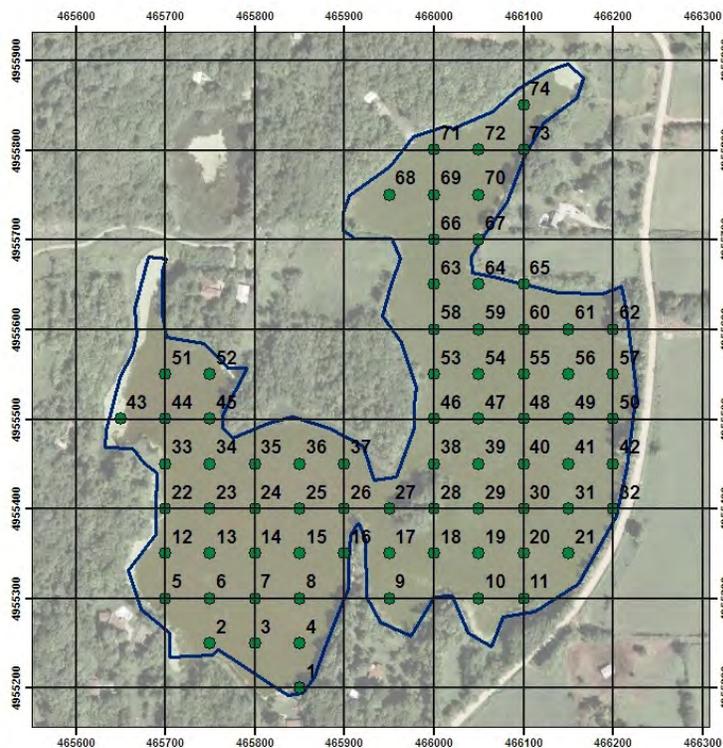
Figure 1. Sample grid map for the aquatic plant survey conducted on Pike Lake.

Aquatic plant point intercept surveys of Pike Lake were conducted by Blue Water Science. A total 74 points were sampled and points were spaced 50 meters apart on a grid that covered the lake (Figure 1). At each sample point, a sampling rake was lowered into the water and a plant sample was taken. The plant species were recorded and the density of each species was assigned. Densities were based on the coverage on the teeth of the rake. Density ratings ranged from 1 to 3 with 1 being sparse and 3 being heavy growth.

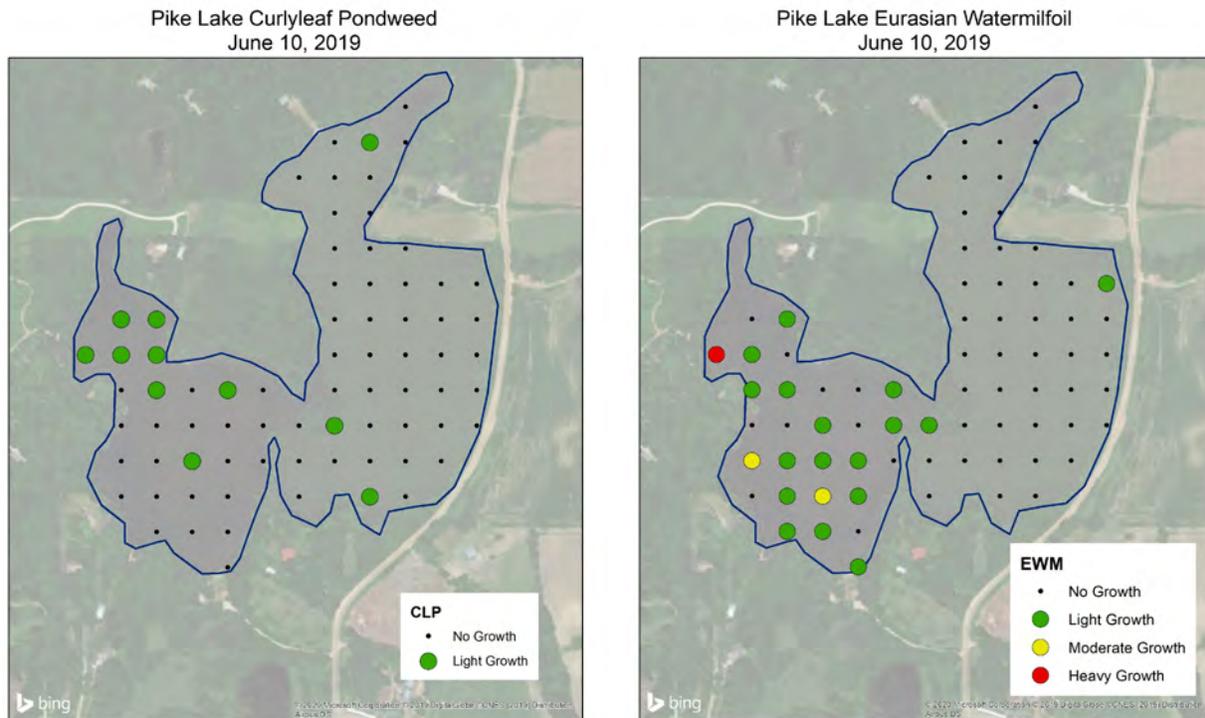
Figure 2. [left] Curlyleaf pondweed coverage on June 10, 2019. [right] Eurasian watermilfoil coverage on June 10, 2019.

Results of the early-summer/spring aquatic plant survey conducted on June 10, 2019 found two native submerged plant species and two non-native plant species were present in Pike Lake (Table 1). Coverage of curlyleaf and coontail found in the June survey are shown in Figure 2. Eurasian watermilfoil growth was light to moderate, EWM was reduced compared to previous years at this time. Curlyleaf pondweed was found at light densities scattered around Pike Lake while coontail was the dominant aquatic plant and was found at 29 sites (Figure 3).

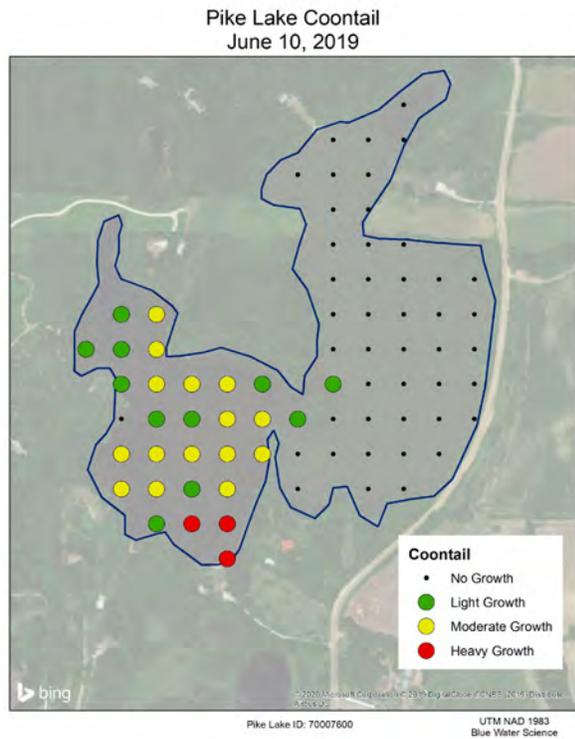
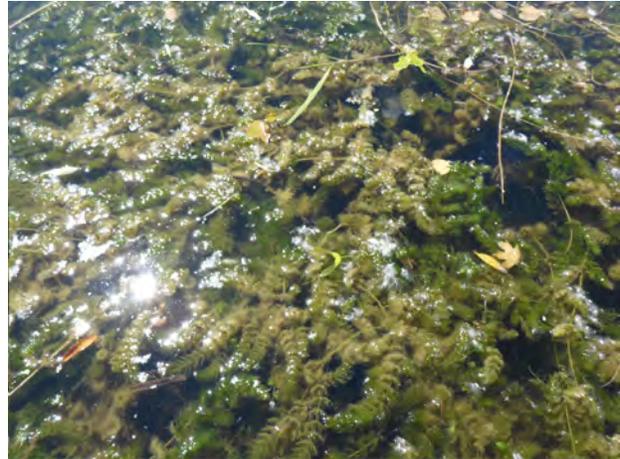
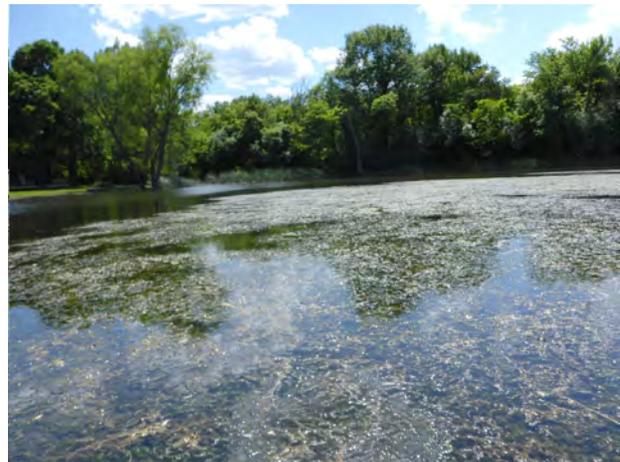
Figure 3. [left] Coontail distribution and abundance on June 10, 2019. [right] Coontail growing to the lake surface in the western basin on June 10, 2019. Key: Green shading = light growth, yellow shading = moderate growth, and red shading = heavy growth.

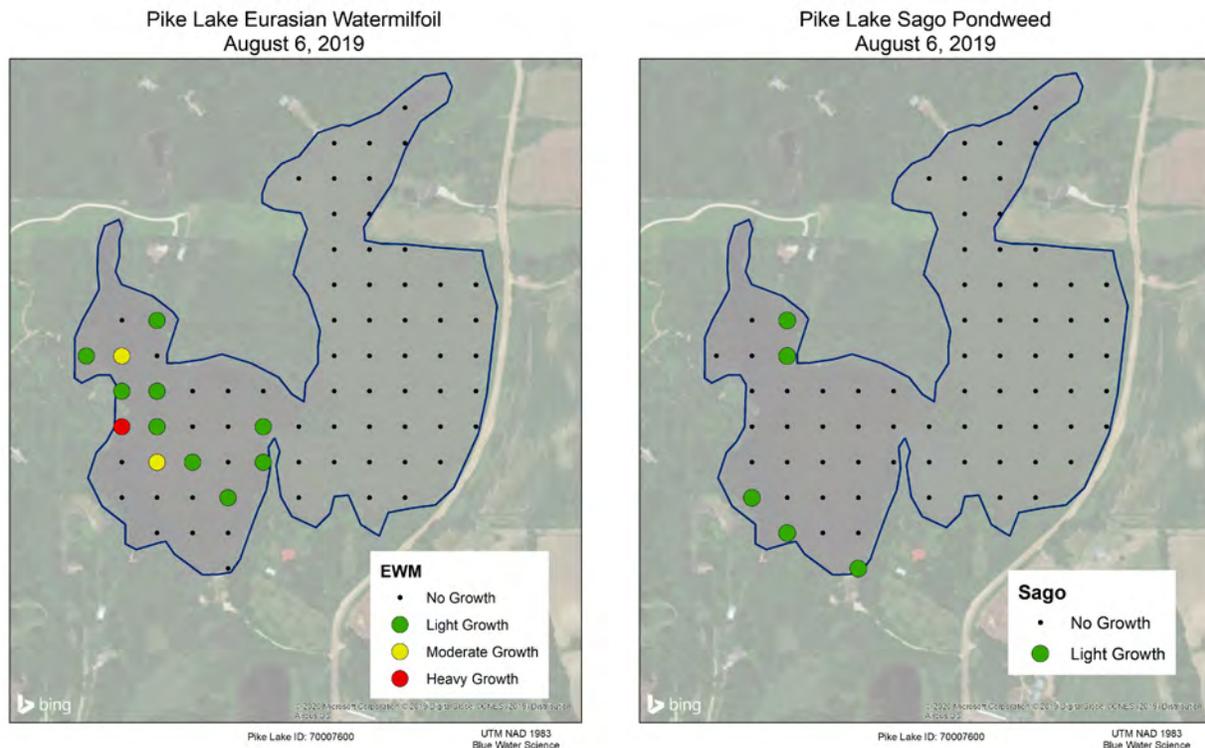
Figure 4. [left] Eurasian Watermilfoil growth and [right] sago pondweed for Pike Lake on August 6, 2019.

Results of the summer aquatic plant survey conducted on August 6, 2019 found two native submerged plant species and one non-native plant species were present. Plant growth in August was restricted to water depths of 5-6 feet or less in Pike Lake (Table 3 and Figure 4). Coontail was growing abundantly in the shallower west basin of Pike Lake (Figure 5). Coverage of coontail found in the August survey is shown in Figure 5. Eurasian watermilfoil was found 12 sites around Pike Lake, mostly in the shallow western basin (Figure 4). Eurasian watermilfoil growth was reduced compared to previous years, coontail was the dominant aquatic plant, often growing near the surface.

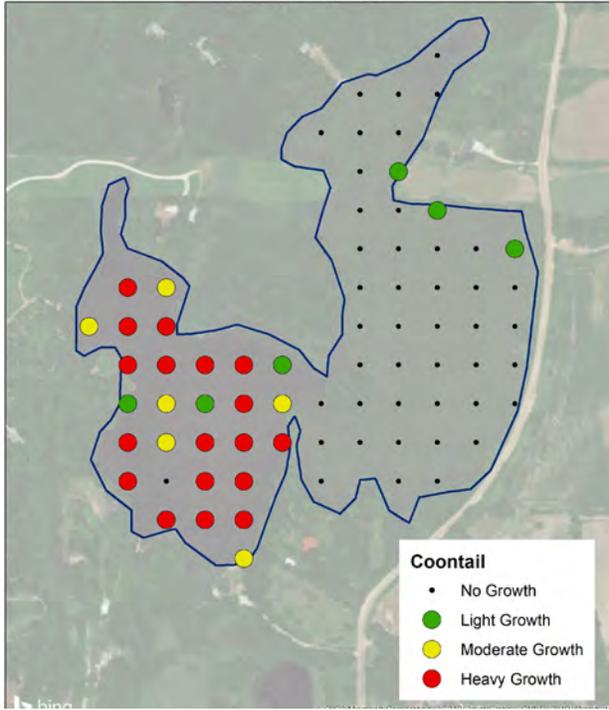
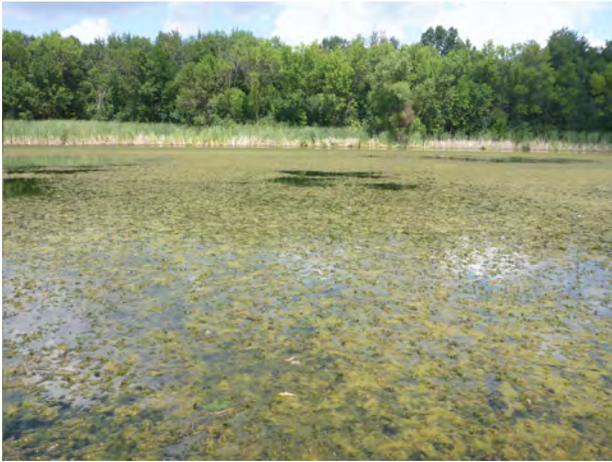
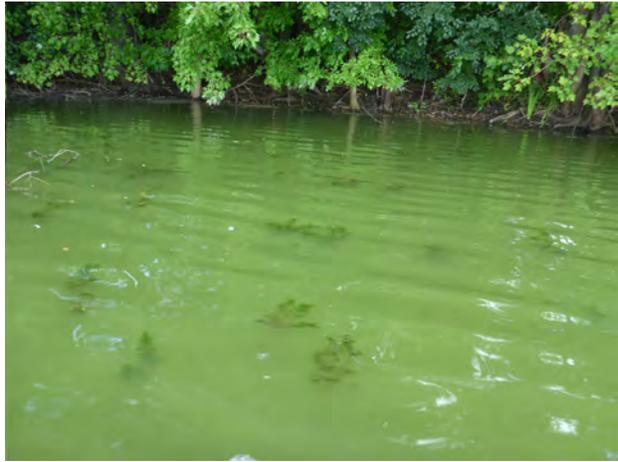
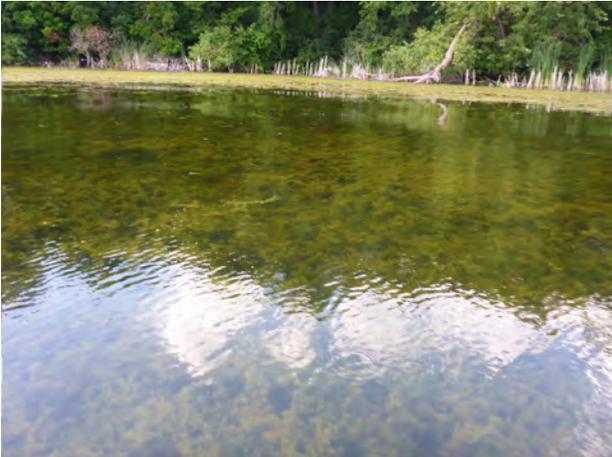
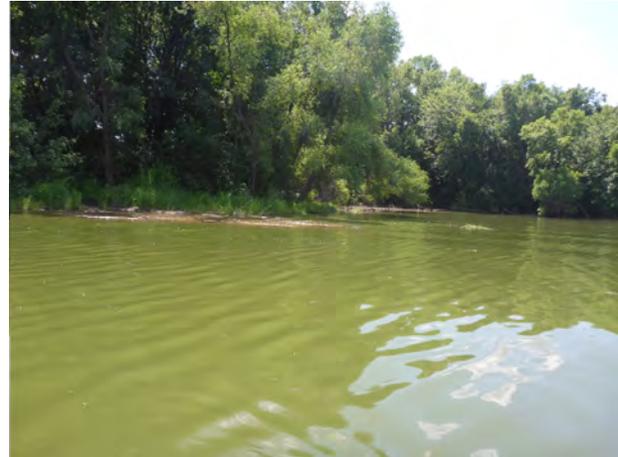
Pike Lake Coontail
August 6, 2019

Figure 5. August 6, 2019 Pike Lake coontail growth: West basin (left) vs East Basin (right).

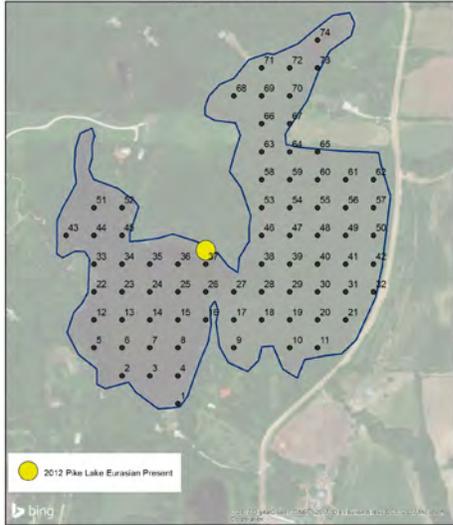
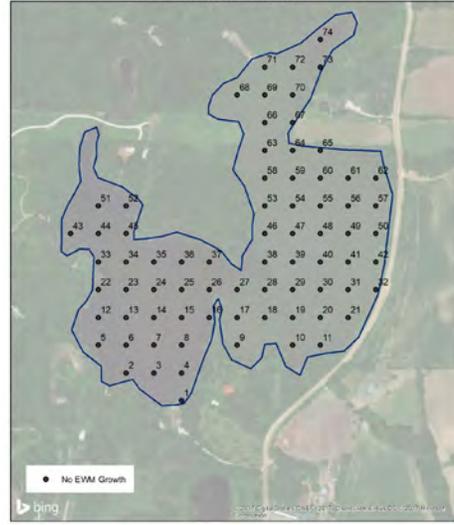
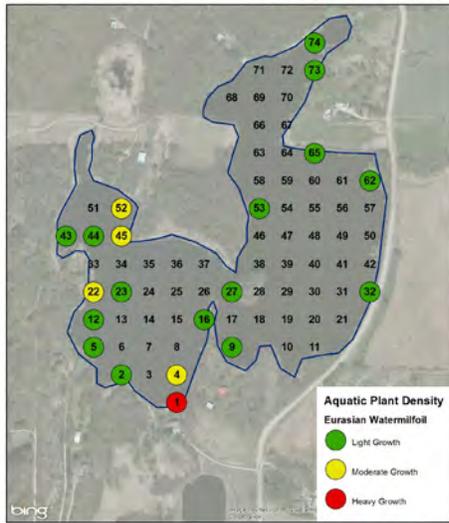
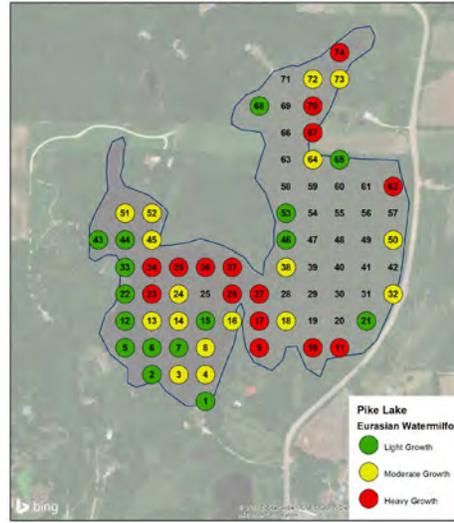
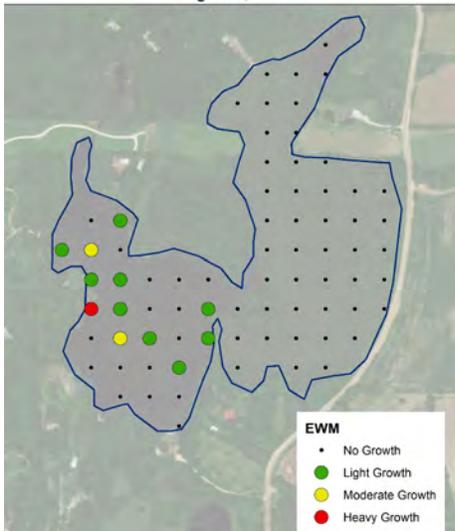
Figure 6. Eurasian watermilfoil distribution and abundance from 2012 - 2019 (no surveys conducted in 2014, 2016, and 2018). Key: Green = light growth, yellow = moderate growth, red = heavy growth, and black = no growth.

Initially, Eurasian watermilfoil was first found only at one spot in the west basin in 2012 but results from previous surveys indicate Eurasian watermilfoil has expanded its range. In 2015 Eurasian watermilfoil had expanded its range from 2012 and was growing sparsely around Pike Lake at 23% of sample sites. In 2017 Eurasian watermilfoil grew more widespread and more abundantly, found at 65% of sample sites. In 2019 Eurasian watermilfoil was reduced in abundance and occurrence compared to previous years but still present in the western basin, EWM was found at 16% of sample sites (Table 5 and Figure 6).

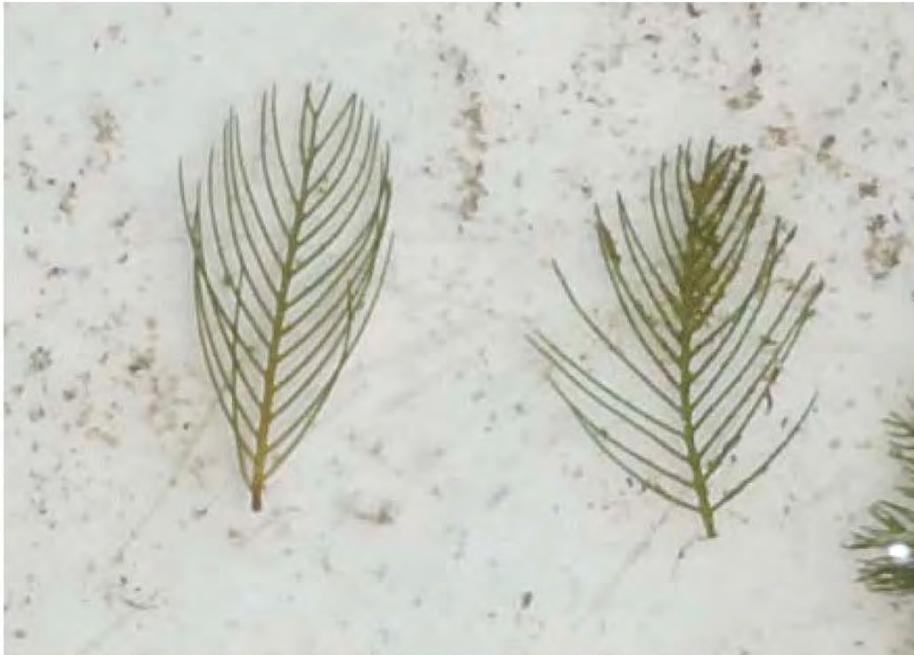
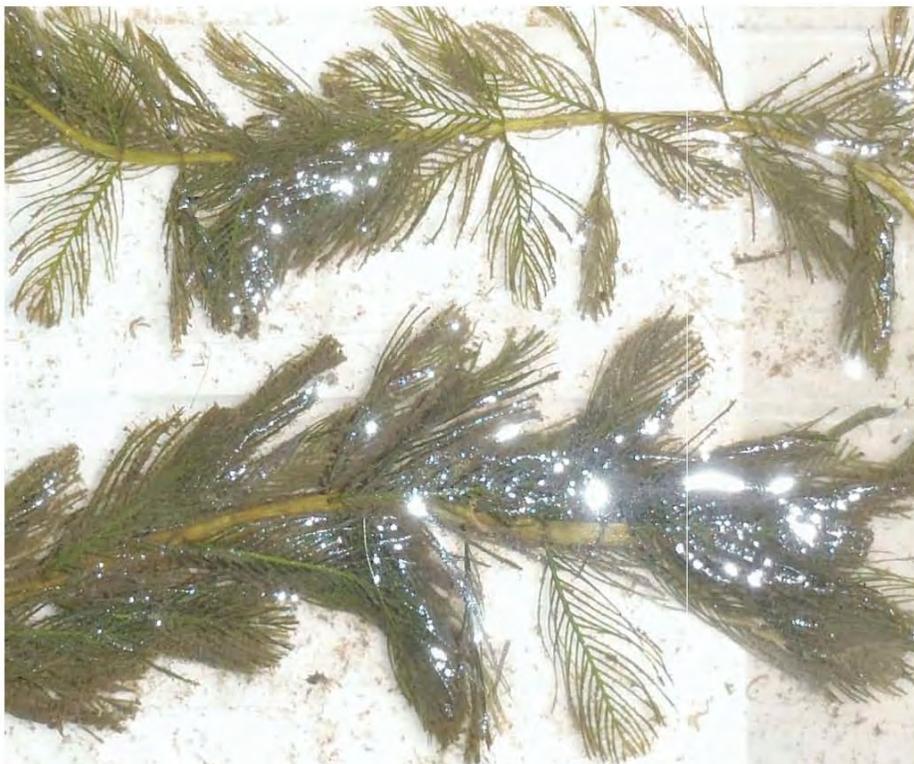
Suspected Eurasian watermilfoil, *Myriophyllum spicatum*, observation

Collected by:
Steve McComas,
Blue Water
Science

August 6, 2012

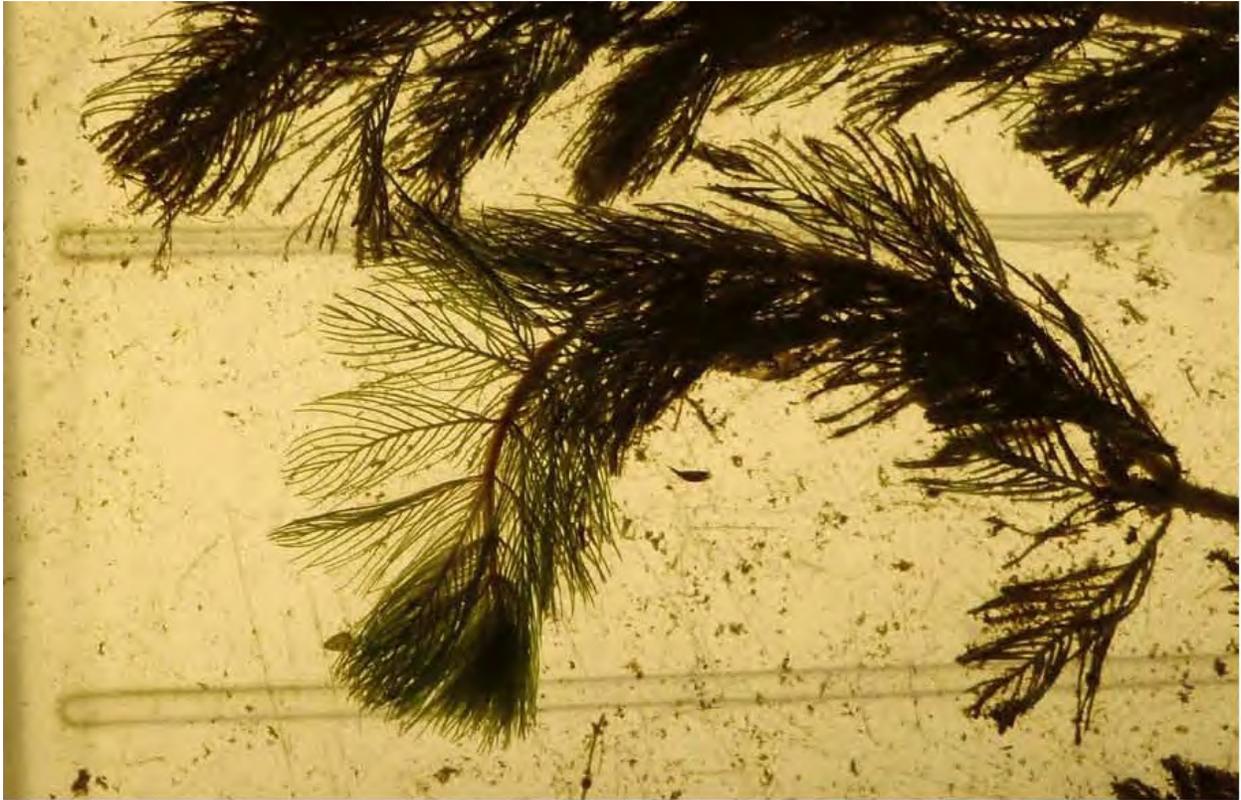
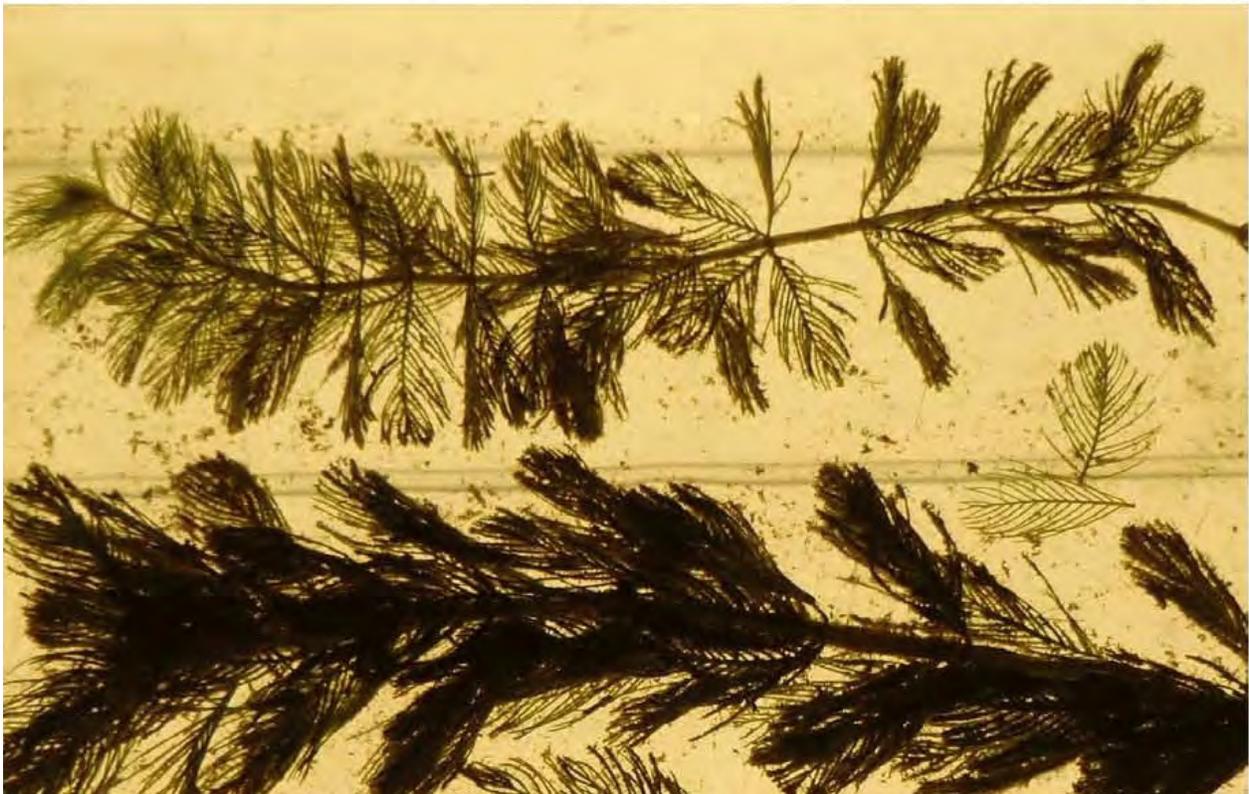
Eurasian watermilfoil collected in Pike Lake on August 6, 2012.

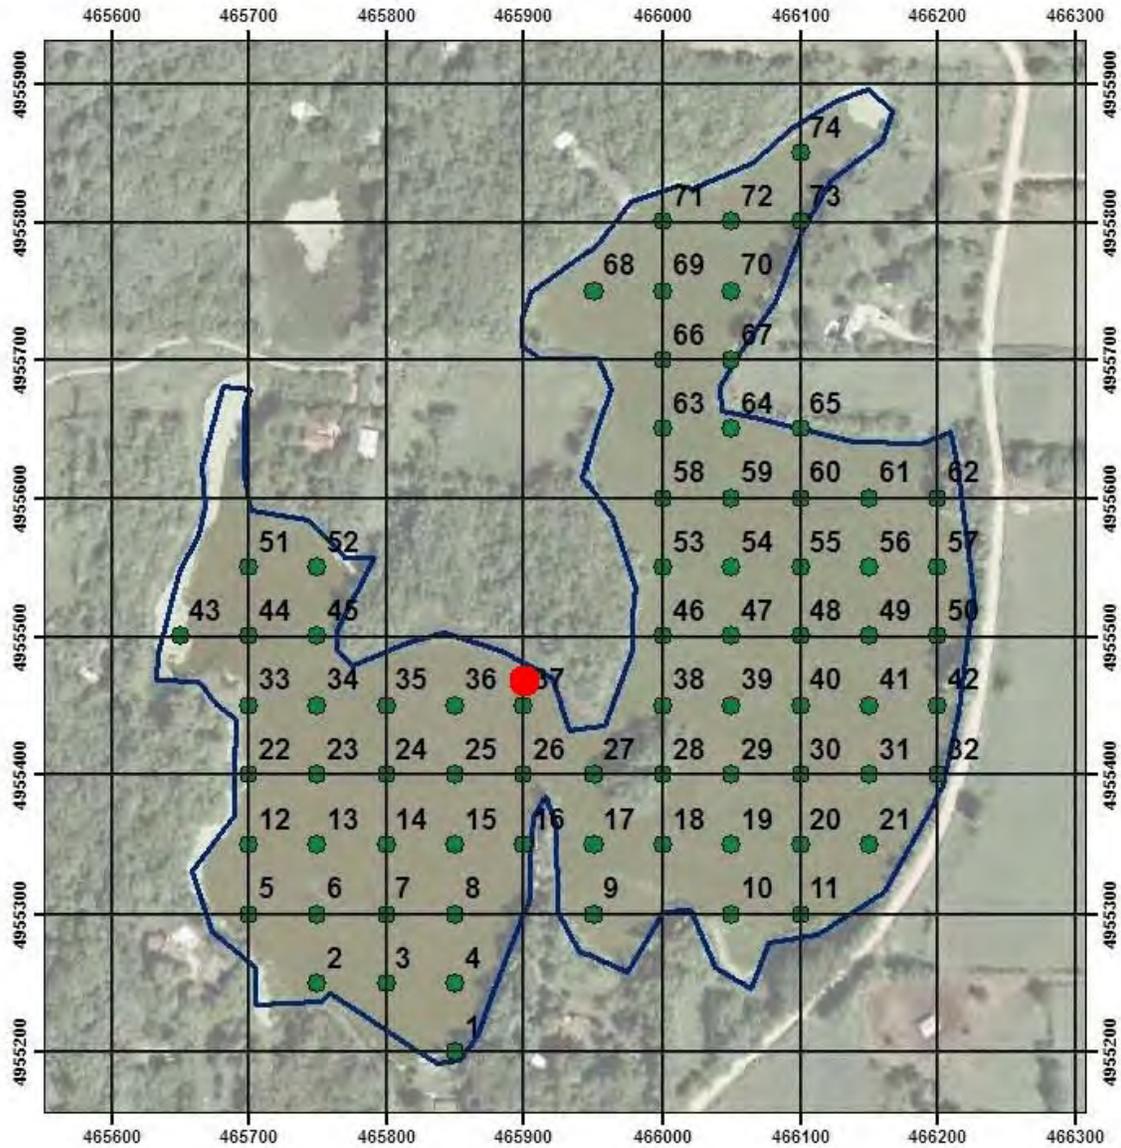
Red dot indicates location of suspected Eurasian watermilfoil occurrence.

Eurasian Watermilfoil Was Collected from a Site North of Point 37 in Pike Lake in 2012
