Curlyleaf Pondweed Assessment and Aquatic Plant Point Intercept Survey for Buck Lake, Scott County, Minnesota

[Curlyleaf Pondweed Assessment June 10, 2019] [Point Intercept Plant Survey Conducted August 6, 2019]

Prepared for:
Prior Lake-Spring Lake
Watershed District

Prepared by: Steve McComas Jo Stuckert Blue Water Science

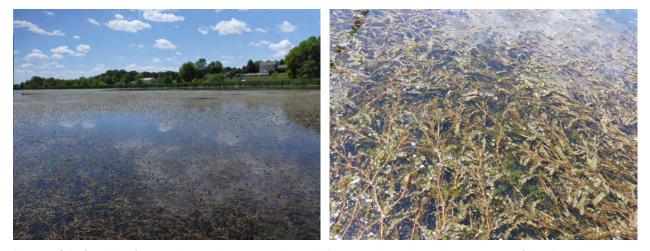
Figure S1. Curlyleaf growth was heavy in June 2019, growing throughout most of the basin.

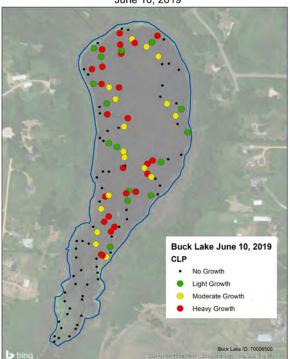
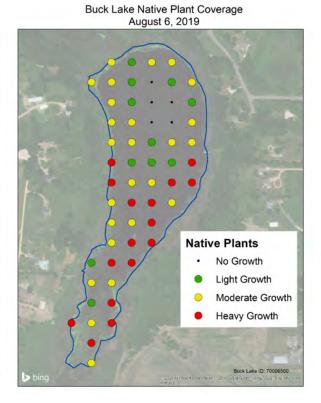
The CLP assessment on June 10, 2019 found abundant CLP in much of Buck Lake except for the southern end (Figures S1 and S2). Coontail was also widespread but at light to moderate growth.

Figure S2. [left] In the June CLP assessment using a meander survey, CLP was widespread with fairly abundant growth.

[right] In the August point intercept survey, plant were widespread with a range of light to heavy growth. Coontail was the dominant plant.

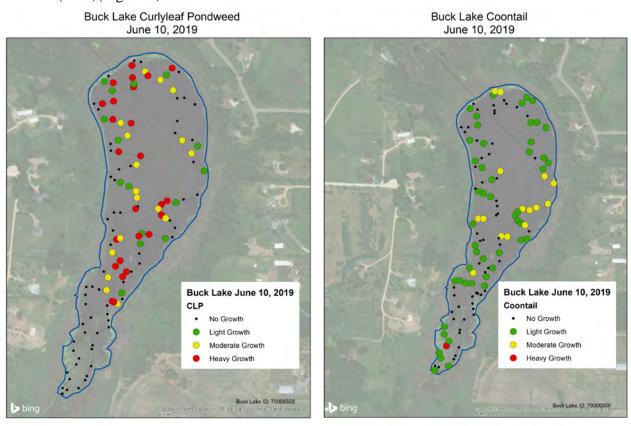
Curlyleaf Pondweed Assessment: June 10, 2019: A meander survey was conducted on June 10, 2019 to assess the status of CLP. A total of 121 sites were sampled and CLP was found at 57 sites (47%)(Figure 2) Coontail was also common, but less abundant and was found at 65 sites (54%)(Figure 2).

Figure 2. [left[Curlyleaf pondweed growth on June 10, 2019. CLP was growing abundantly and throughout most of the lake. [right] Coontail growth on June 10, 2019.

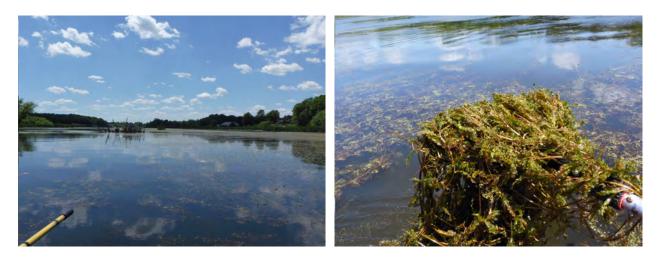
Figure 3. Pictures from the June 10, 2019 CLP assessment meander survey.

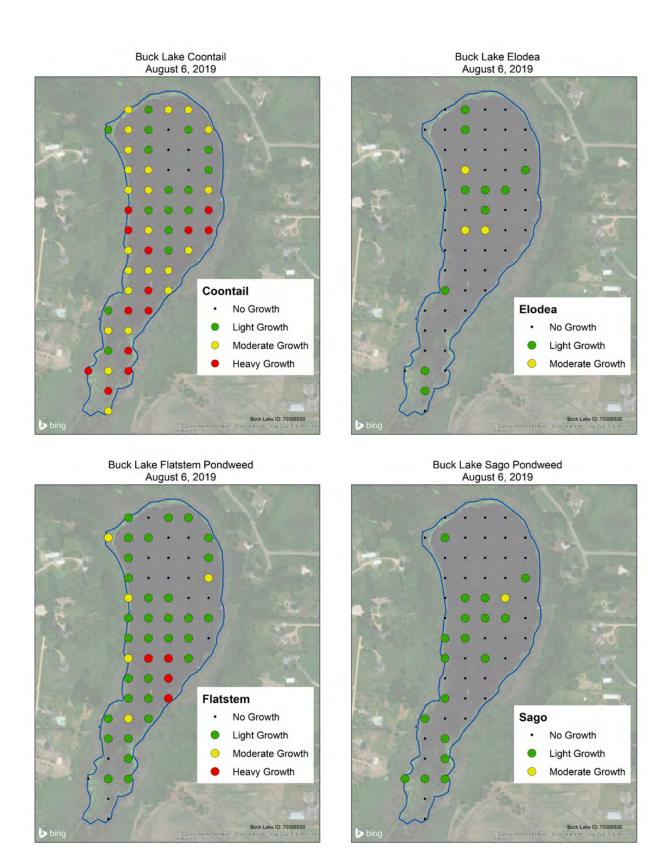
Figure 6. Buck Lake distribution and abundance maps for coontail (top-left), elodea (top-right), flatstem pondweed (bottom-left), and sago pondweed (bottom-right).

Key: green = light growth, yellow = moderate growth, and red = heavy growth.

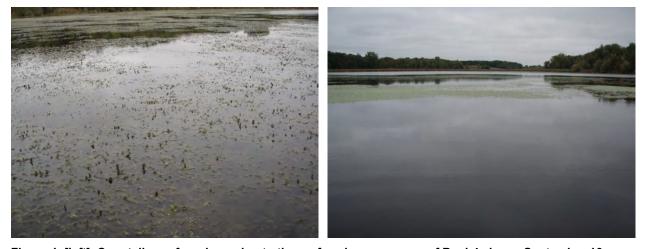
Figure 1. [left] Coontail was found growing to the surface in some areas of Buck Lake on September 16, 2010.

[right] Buck Lake plant conditions on September 16, 2010. Some plants were growing to the surface.

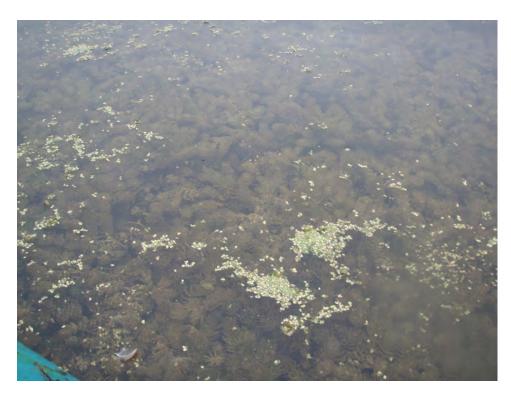
Figure 2. Buck Lake has fairly good water clarity, especially in areas with thick coontail growth. Duckweed (shown floating on the water) was common as well.
