Aquatic Plant Point Intercept Survey for Arctic Lake, Scott County, Minnesota

[Plant Survey Conducted July 12, 2019]

Prepared for:
Prior Lake-Spring Lake
Watershed District

Prepared by: Steve McComas Jo Stuckert Blue Water Science

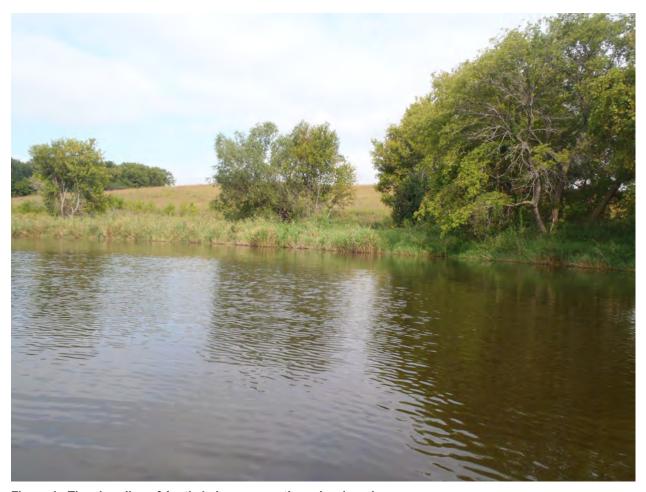
Figure 1. The shoreline of Arctic Lake was mostly undeveloped.

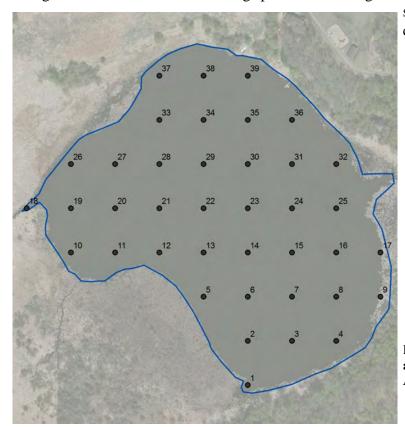
An aquatic plant point-intercept survey of Arctic Lake was conducted by Blue Water Science on July 12, 2019 and all points were sampled. Sample points were placed 50 meters apart on a grid that covered the lake (Figure 1). At each sample point, a sampling rake was lowered into the water and a plant sample was taken. The plant species were recorded and the density of each species was assigned. Densities were based on the coverage on the teeth of the rake. Density ratings were from 1 to 3 with 1 being sparse and 3 being a nuisance. Based on these sample

Figure 1. Sample location map for the aquatic plant survey conducted on Arctic Lake.

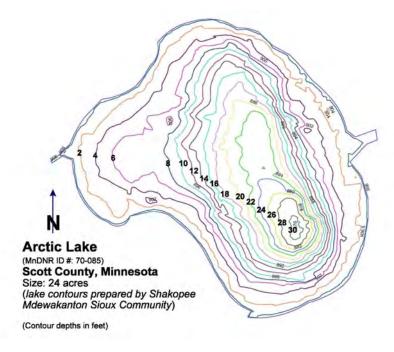
Results of the summer aquatic plant survey conducted on July 12, 2019 found sago pondweed at one site (Table 1). No other plants were observed in the lake. Arctic Lake water levels drop off relatively quickly after 8 feet (Figure 2). There is a narrow shelf where water depth is shallow enough to allow plants to establish under current conditions. Carp were observed jumping out of the water indicating the presence of numerous adult carp in the lake.

Figure 2. Arctic Lake contour map.

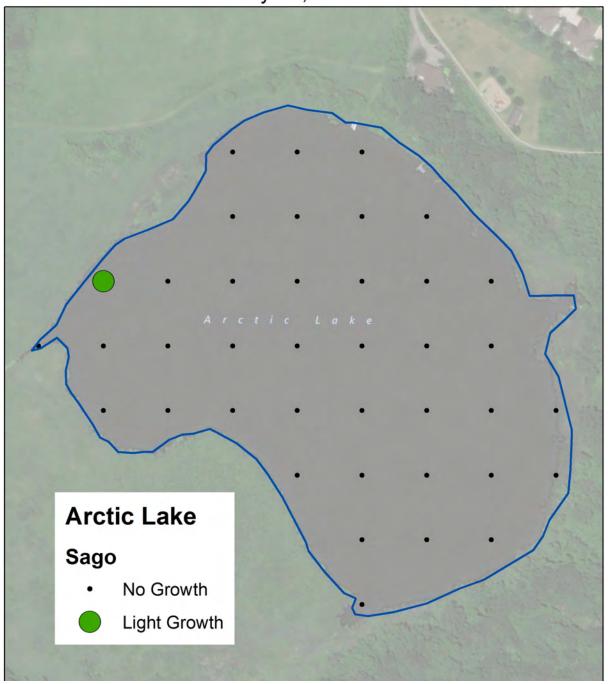
Arctic Lake Sago Pondweed July 12, 2019

Figure 3. Sago pondweed growth in Arctic Lake. Sago was the only aquatic plant observed in Arctic Lake on July 12, 2019.
