# Joint PLSLWD Board and Citizen Advisory Committee Annual Tour

**May 29, 2025**  
**4:00 PM to 6:00 PM**

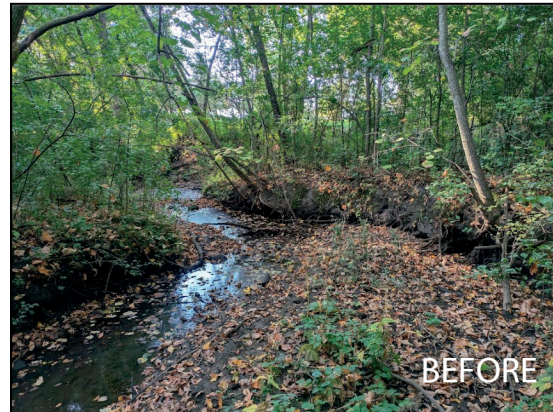
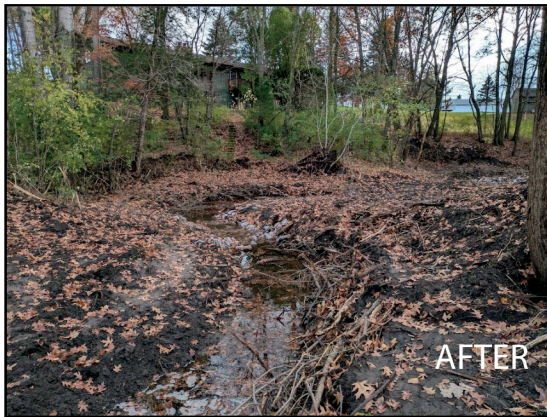
- Streambank was washed out and eroded, contributing sediment and nutrients
- Streambank vegetation was primarily buckthorn, creating poor habitat and soil health/stability
- 2 willing landowners
- \$75,000 in Clean Water Funding

- 1,300 feet of streambank restored
- Stabilization will reduce 56 tons of soil, sediment, and phosphorus from entering Buck Lake each year

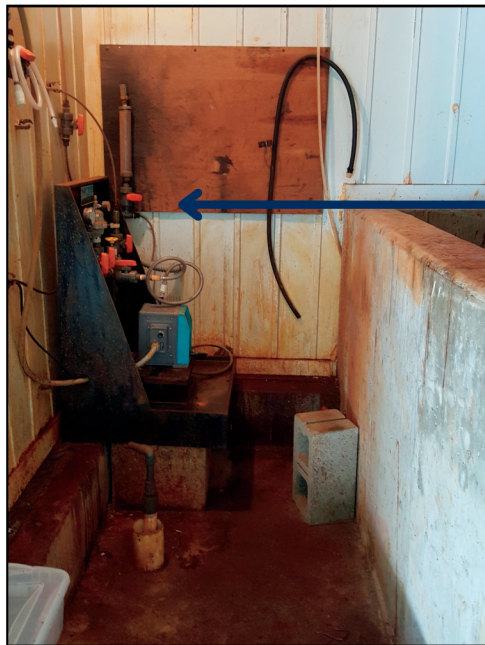
Old pump and skid

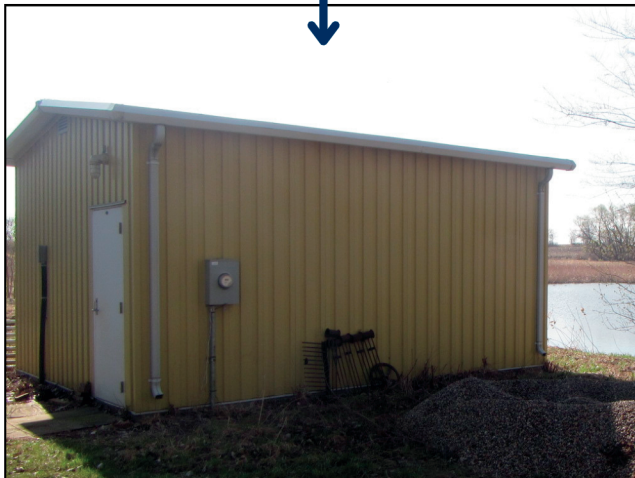
Building was built around the tank, preventing easy tank replacement

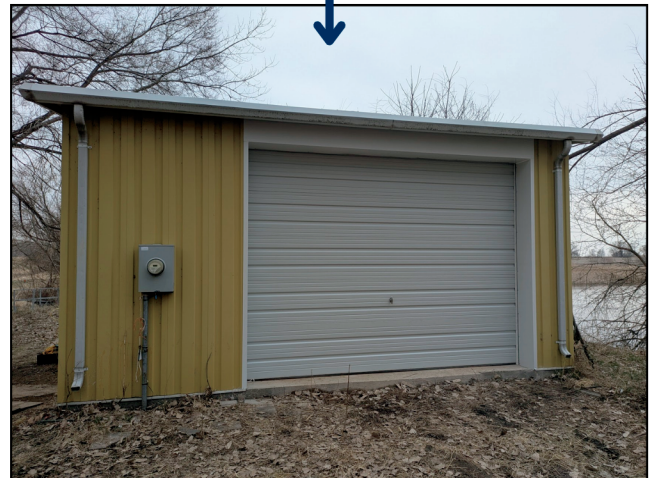
Garage door added to replace tank and for ease of access

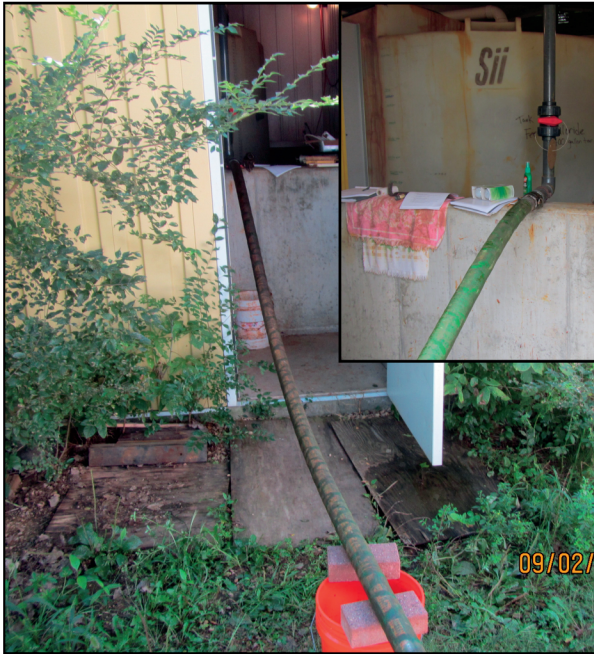
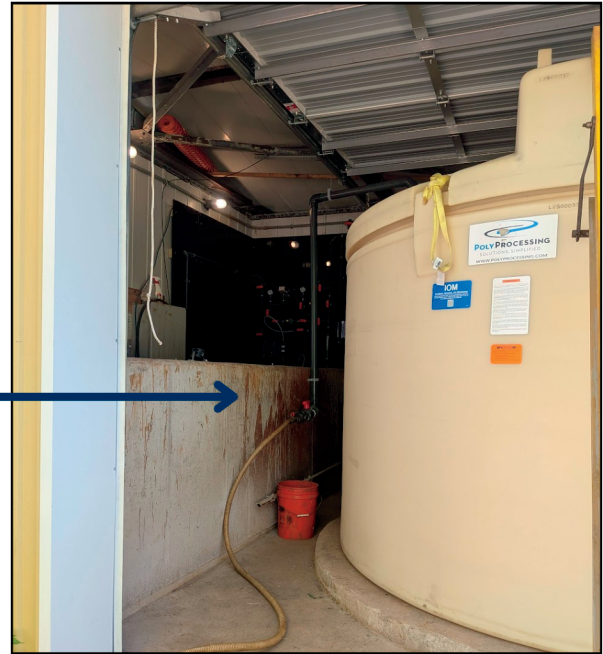
New tank provides double-walled containment and piping placement has been adjusted to safely refill tank.

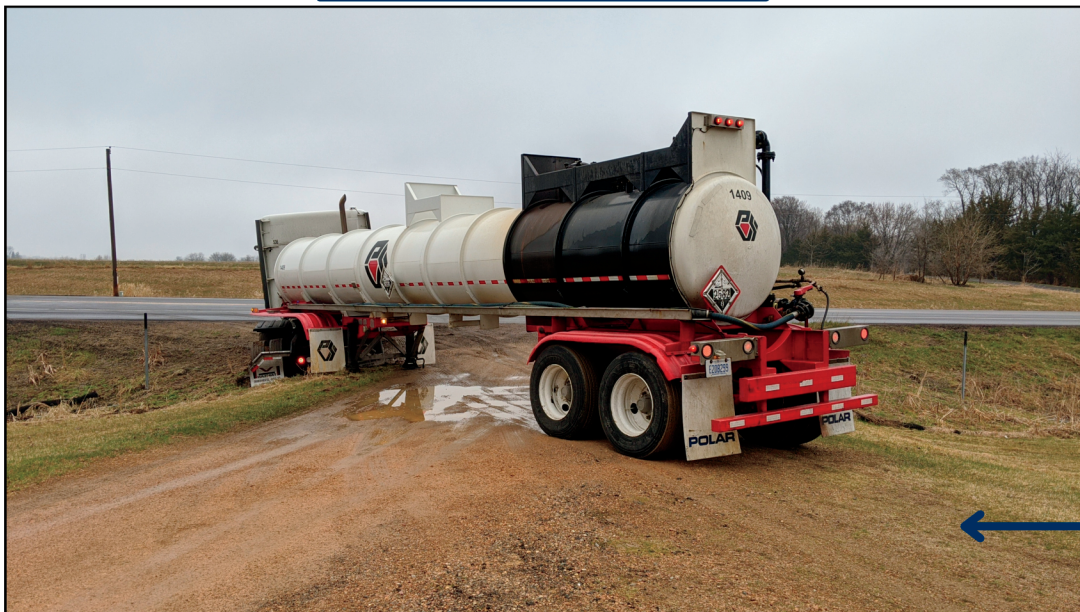
Driveway modifications will improve safety and reduce lawn damage during ferric chloride deliveries.

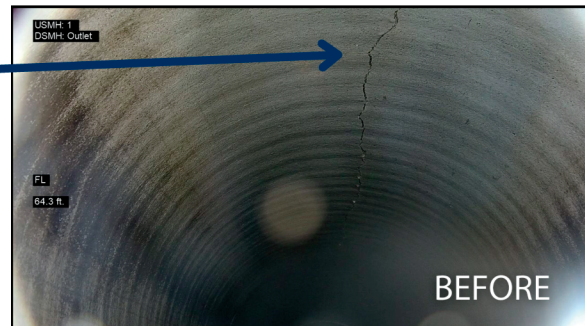
Longitudinal crack

- Cured-in-Place Pipe lining "CIPP" will extend lifespan by 50 years
- Completed without excavation and minimal lane closures

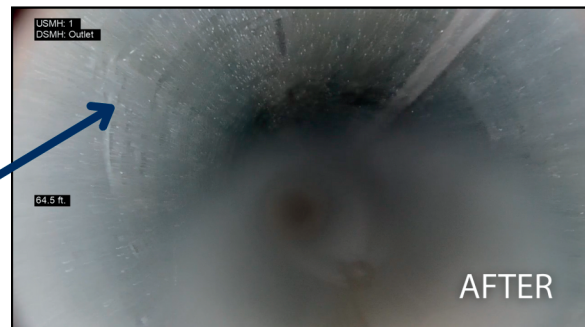
Lining creates smooth surface for faster water exit
