Upper and Lower Prior Lakes, Scott County, Curlyleaf Pondweed Assessment for 2011

Assessment Dates: May 10 (55°F) and June 13, 2011 (71°F)

Prepared for:
Prior Lake/Spring Lake
Watershed District
Prior Lake, Minnesota

Prepared by:
Steve McComas
Blue Water Science
St. Paul, MN 55116

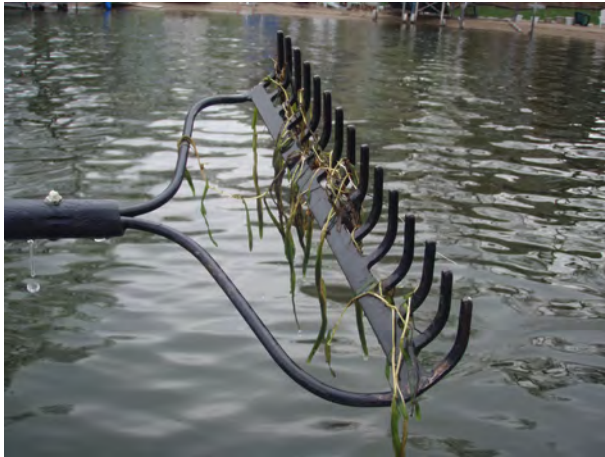
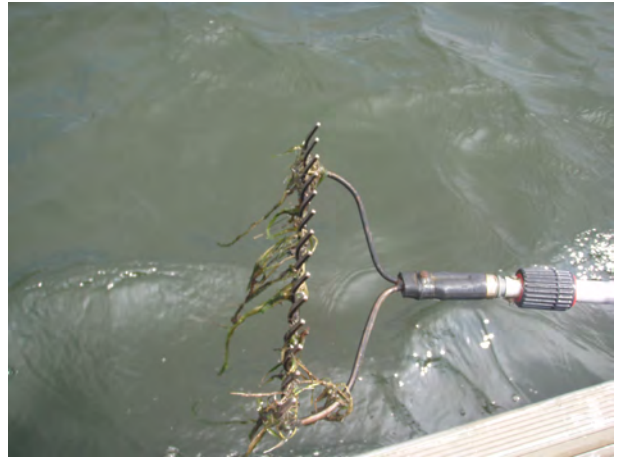
May 10, 2011

Figure 3. Curlyleaf pondweed was found around Prior Lake on May 10, 2011. Here curlyleaf was at a density of a “1” [top photo] and at a density of a “3” [bottom photo].

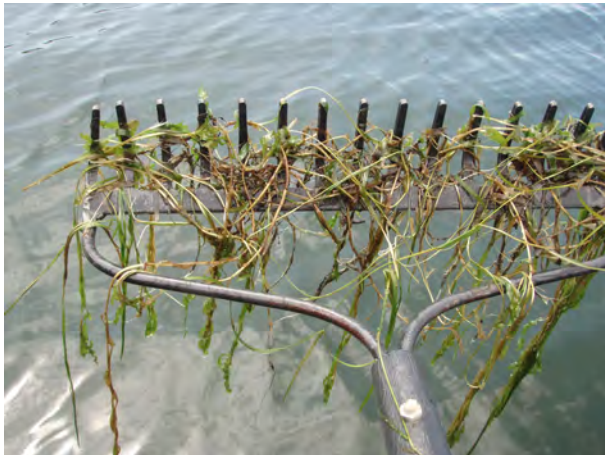
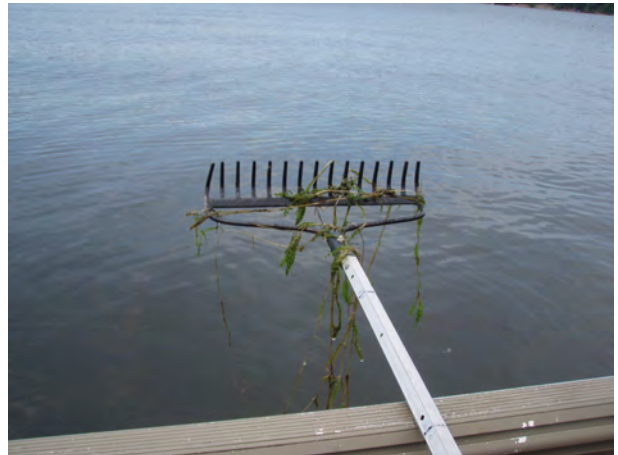
June 13, 2011

Figure 4. Curlyleaf pondweed was found around Prior Lake on June 13, 2011. Here curlyleaf was at a density of a “1” [top photo] and at a density of a “3” [bottom photo].

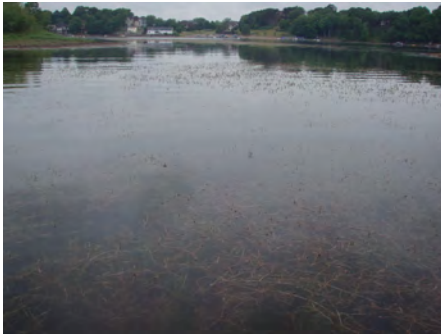
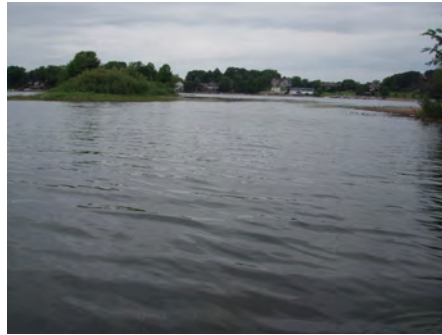
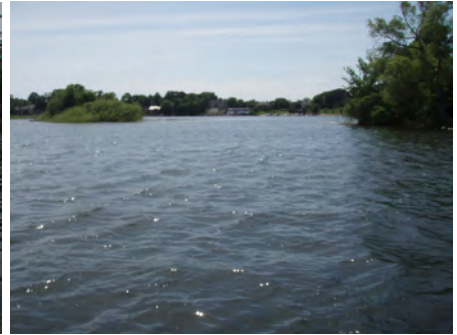
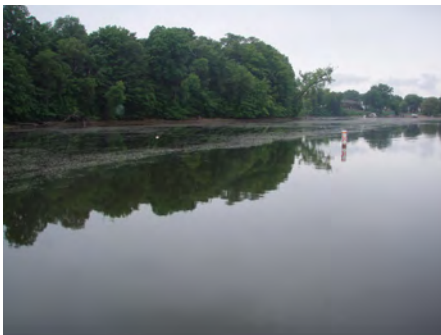
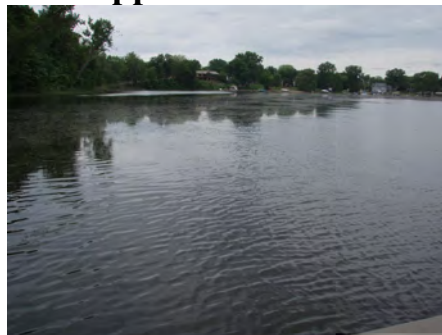
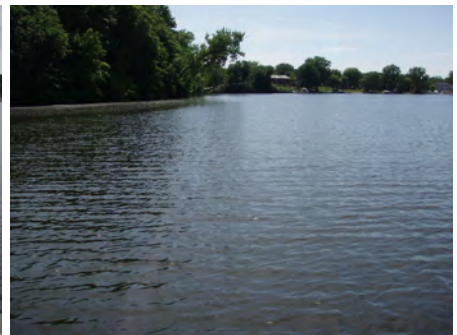
Figure 5. [top and middle] Lower and Upper Prior Lakes conditions in June 2009, 2010, and 2011. [bottom] Curlyleaf conditions in June 2009 and 2010 based on June assessments. Black = no curlyleaf; green = light growth; yellow = moderate growth; and red = heavy growth.

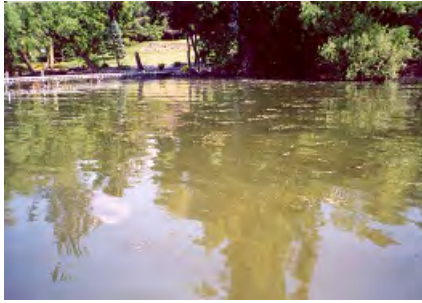
Light Growth Conditions

Plants rarely reach the surface.

Navigation and recreational activities are not generally hindered.

MnDNR rake sample density equivalent for light growth conditions: 1, 2, or 3.

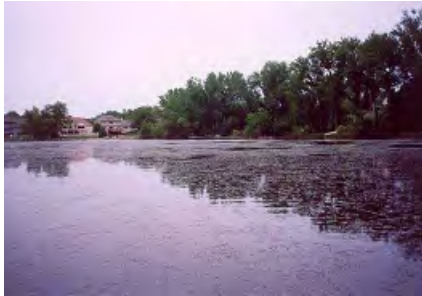
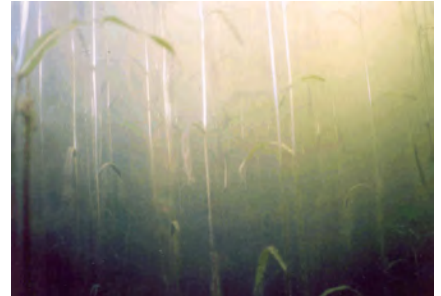
Moderate Growth Conditions

Broken surface canopy conditions.

Navigation and recreational activities may be hindered.

MnDNR rake sample density equivalent for moderate growth conditions: 2, 3 or sometimes, 4.

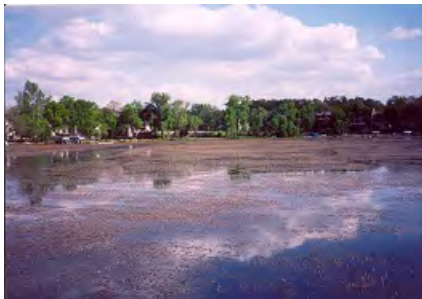
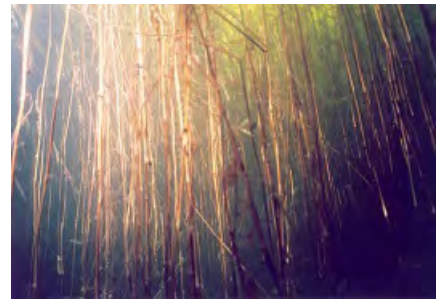
Heavy Growth Conditions

Solid or near solid surface canopy conditions.

Navigation and recreational activities are severely limited.

MnDNR rake sample density has a scale from 1 to 4. For certain growth conditions where plants top out at the surface, the scale has been extended: 4.5 is equivalent to a near solid surface canopy and a 5 is equivalent to a solid surface canopy. Heavy growth conditions have rake densities of a 4 (early to mid-season with the potential to reach the surface), 4.5, or 5.
