# **Lower Prior Lake Diagnostic Study and Implementation Plan**

**Prior Lake-Spring Lake Watershed District**

**April 10, 2013**

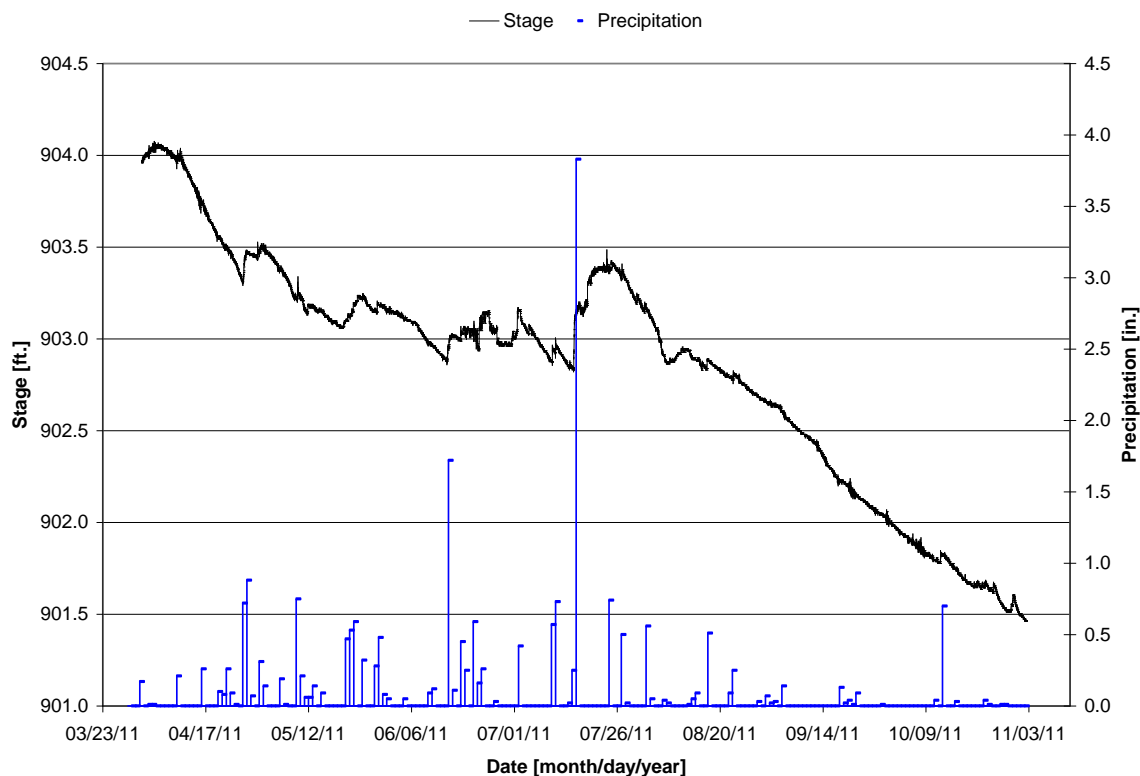
**Figure 28. Lower Prior Lake outlet stage**

Continuous stage data collected at the Prior Lake outlet; precipitation data from the MN Climatology Network (BYRG at 114N 22W Sec4)

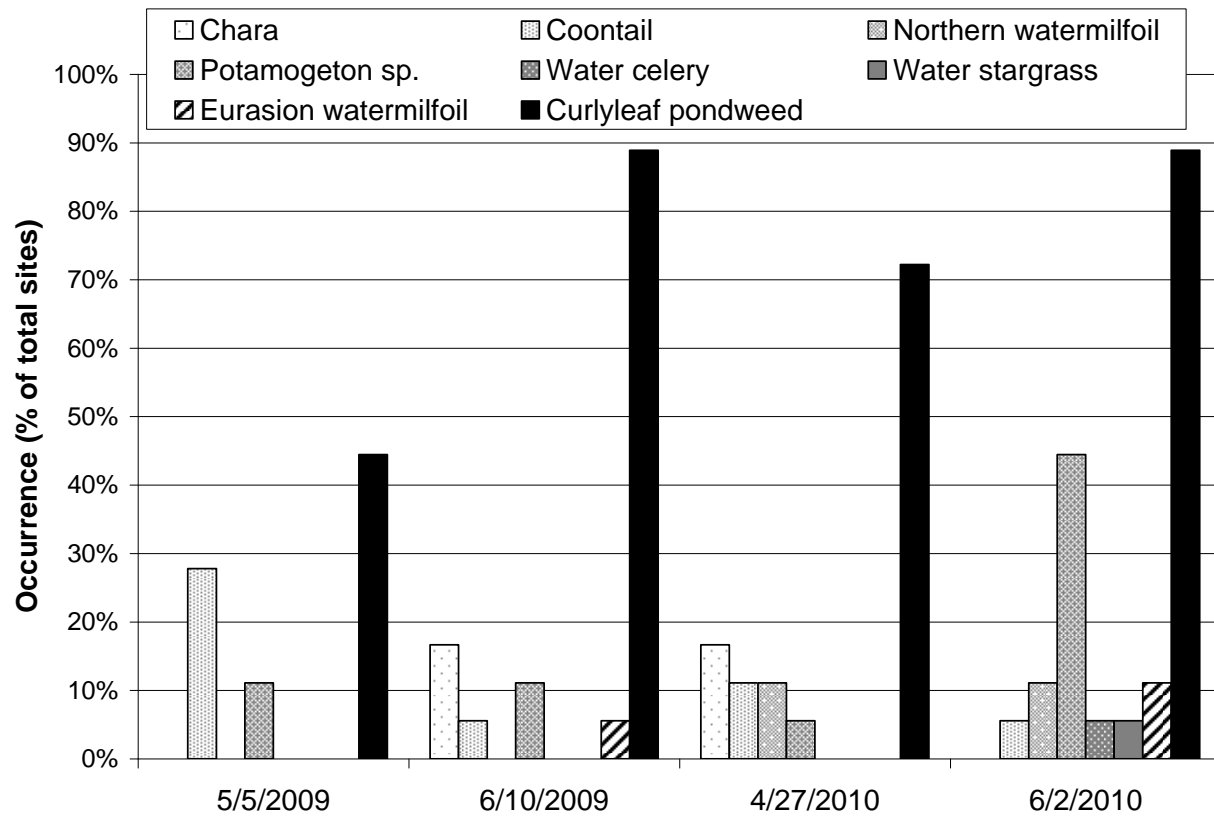
Figure 30. Macrophyte abundance as % occurrence of total sites, 2009-2010.

In the two most recent June surveys, curly-leaf pondweed was found in at least half of the surveyed sites and at low to medium densities (Figure 30 and Figure 32). Eurasian watermilfoil (another invasive aquatic plant, thought to have less effect on phosphorus concentrations) has been present in Lower Prior Lake since 1991. In recent macrophyte surveys (2002-2008), Eurasian watermilfoil occurrence declined throughout the lake while the density per site remained variable (Figure 29 and Figure 31).

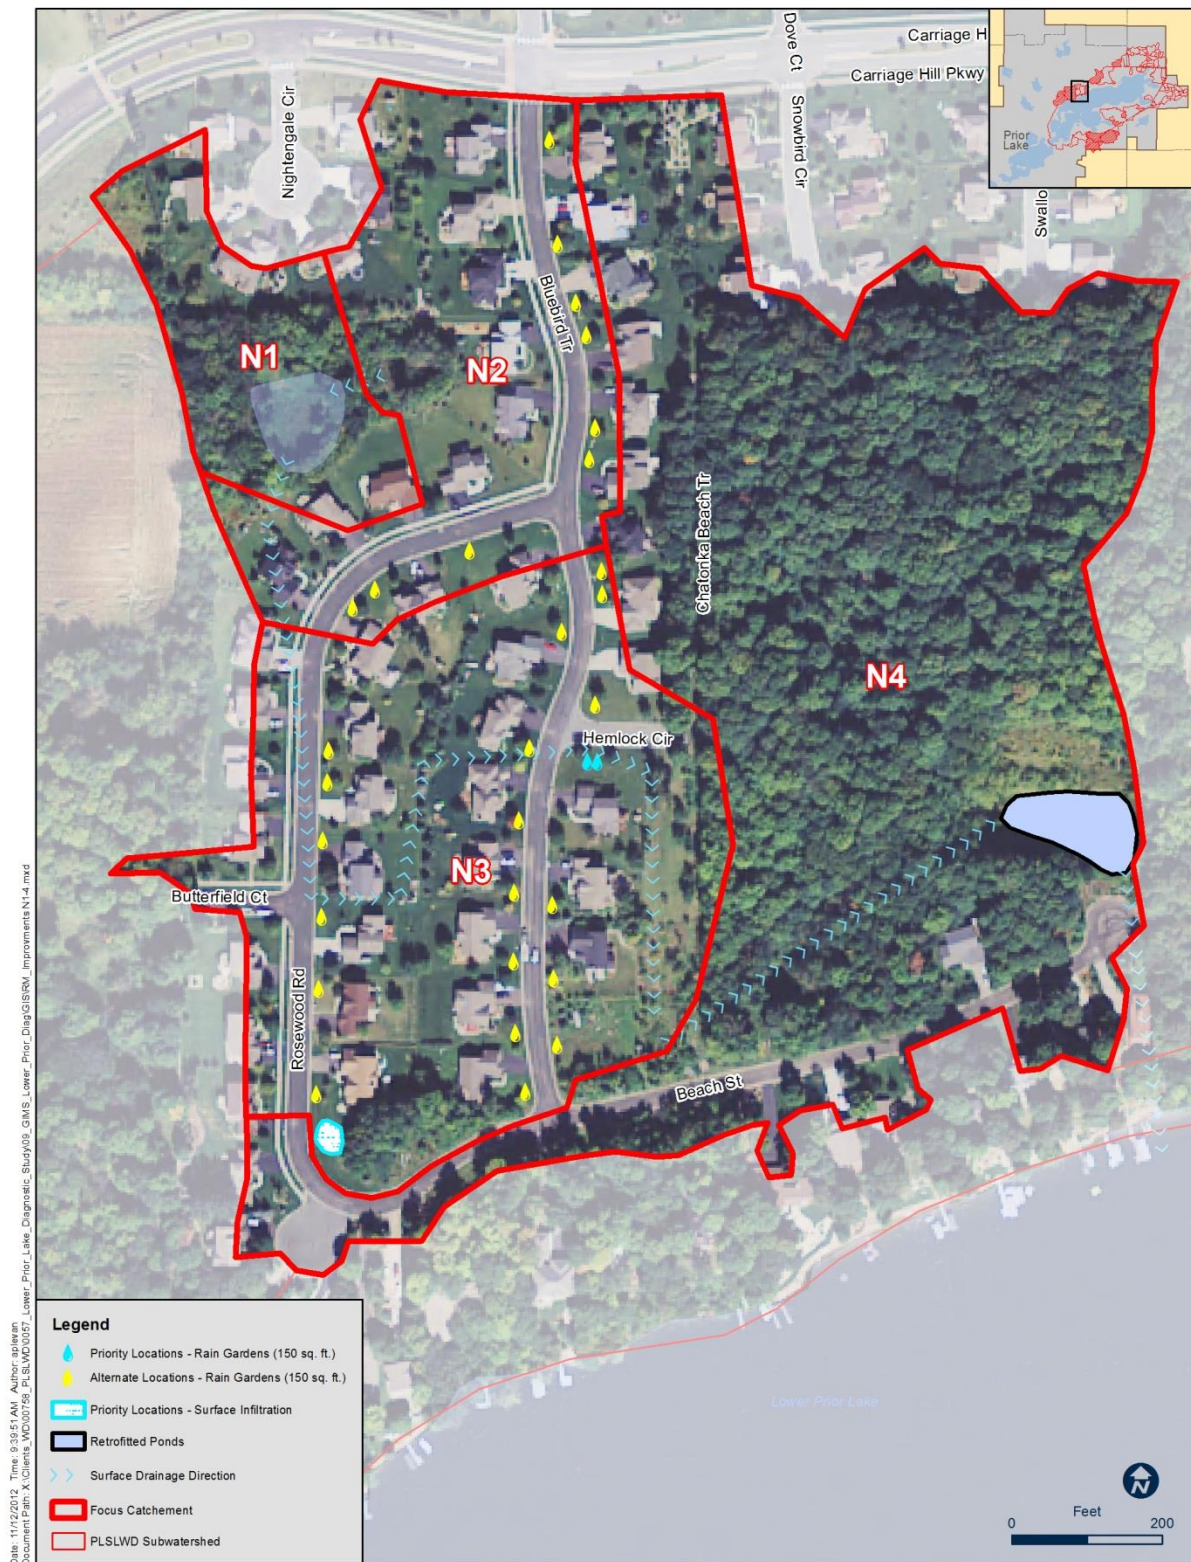
**Figure 37. BMP retrofit opportunities in Lower Prior Lake subwatersheds N1, N2, N3, and N4**

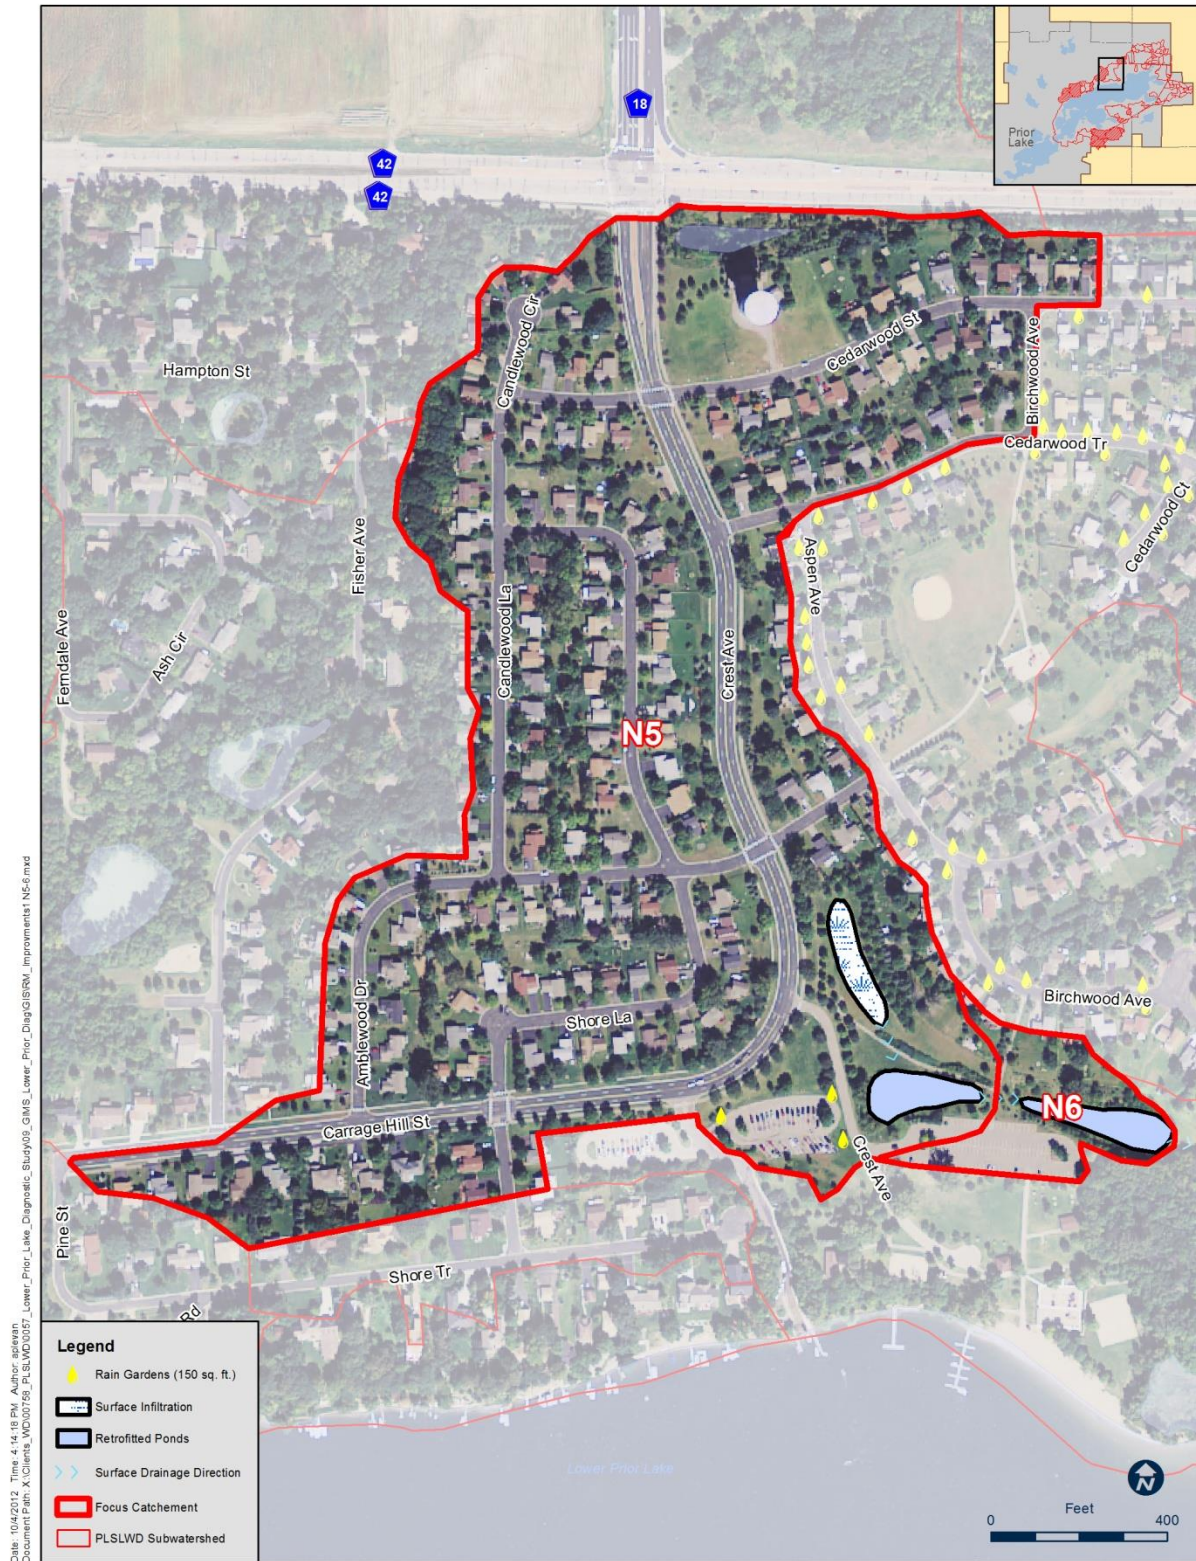
Figure 38. BMP retrofit opportunities in Lower Prior Lake subwatersheds N5 and N6

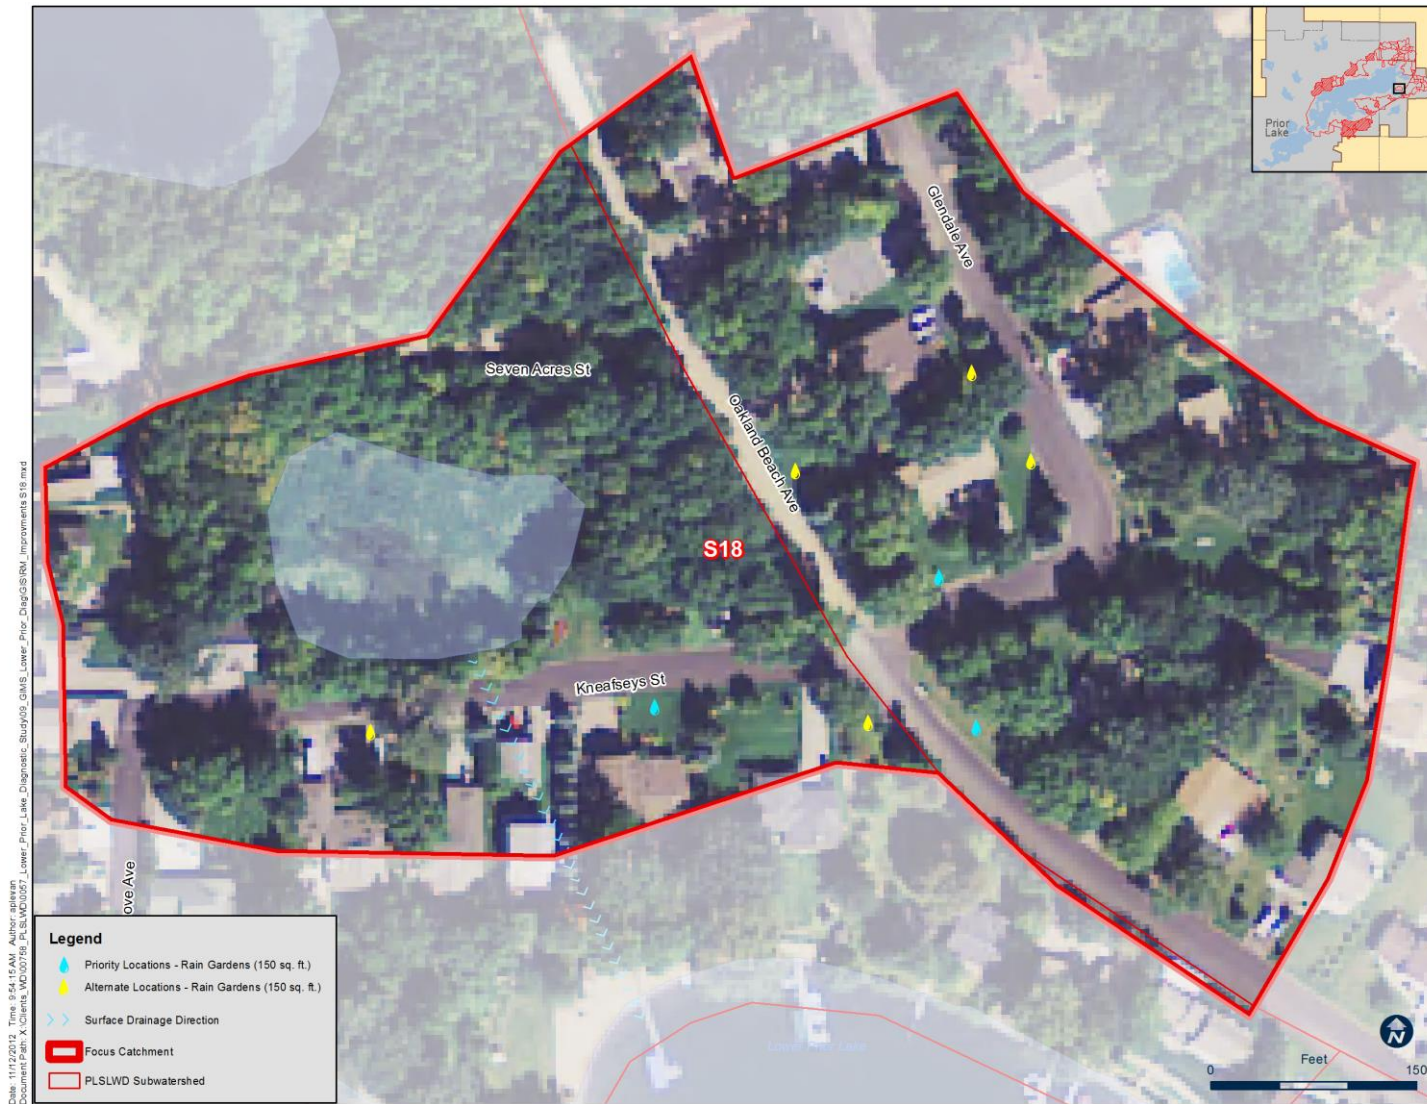
Figure 41. BMP retrofit opportunities in Lower Prior Lake subwatershed S18

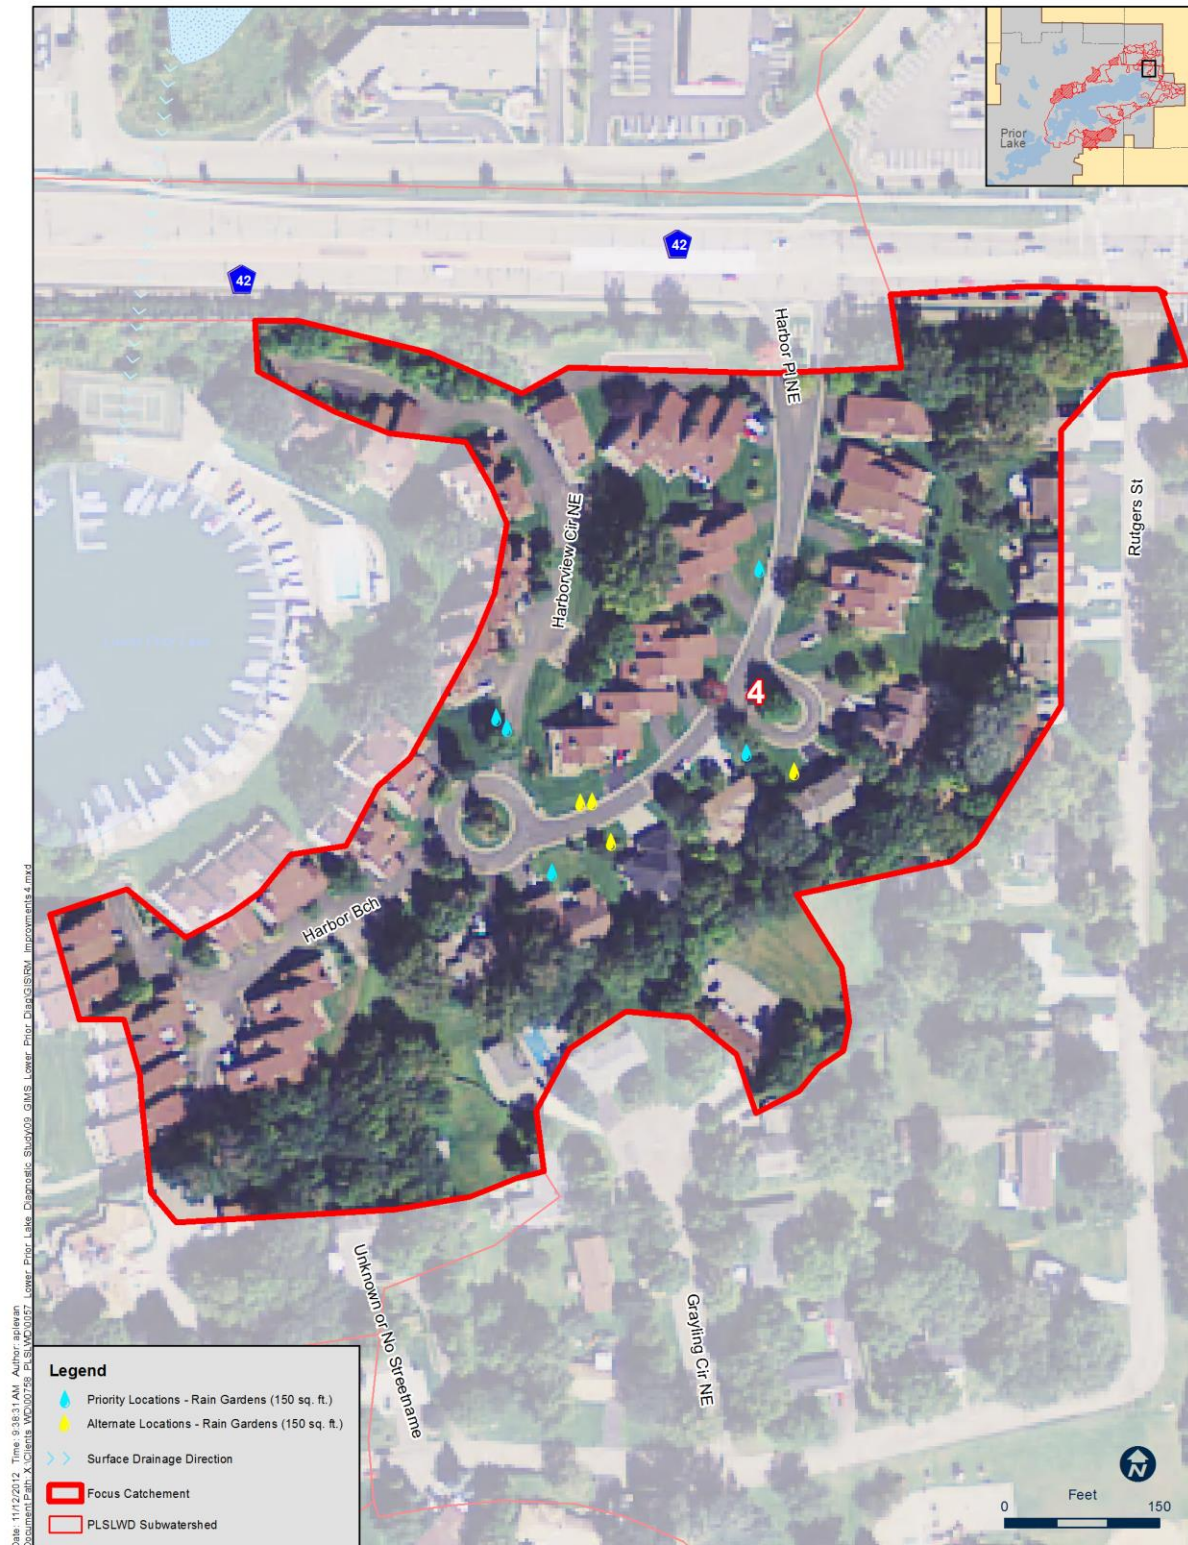
**Figure 43. BMP retrofit opportunities in Lower Prior Lake subwatershed 4**

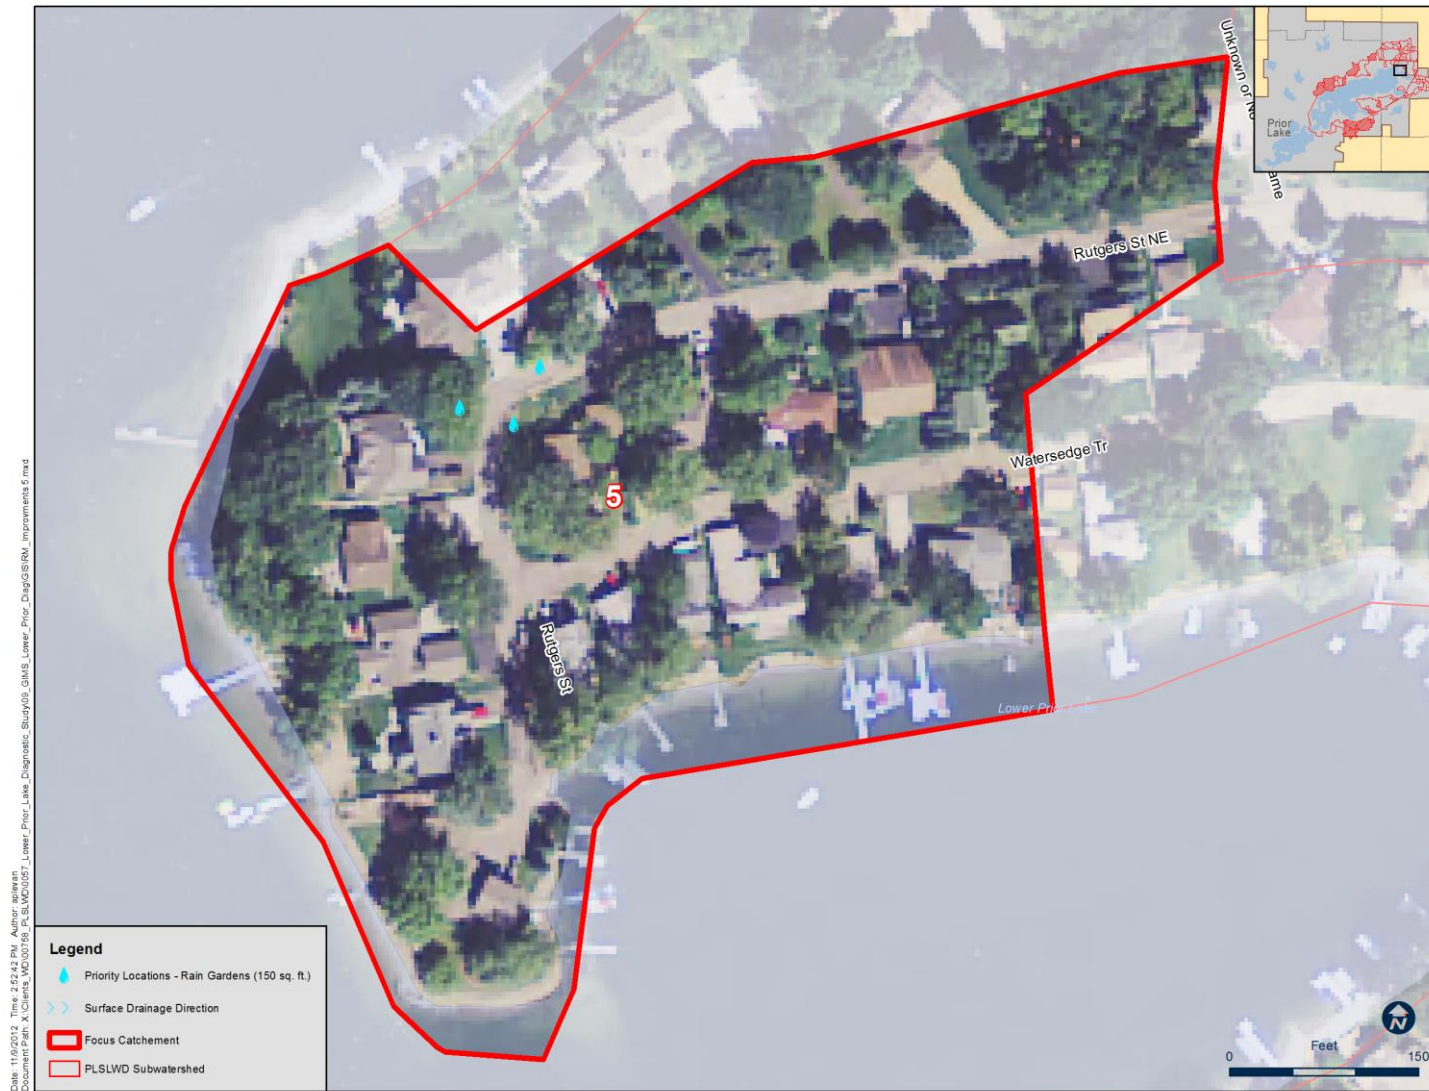
**Figure 44. BMP retrofit opportunities in Lower Prior Lake subwatershed 5**

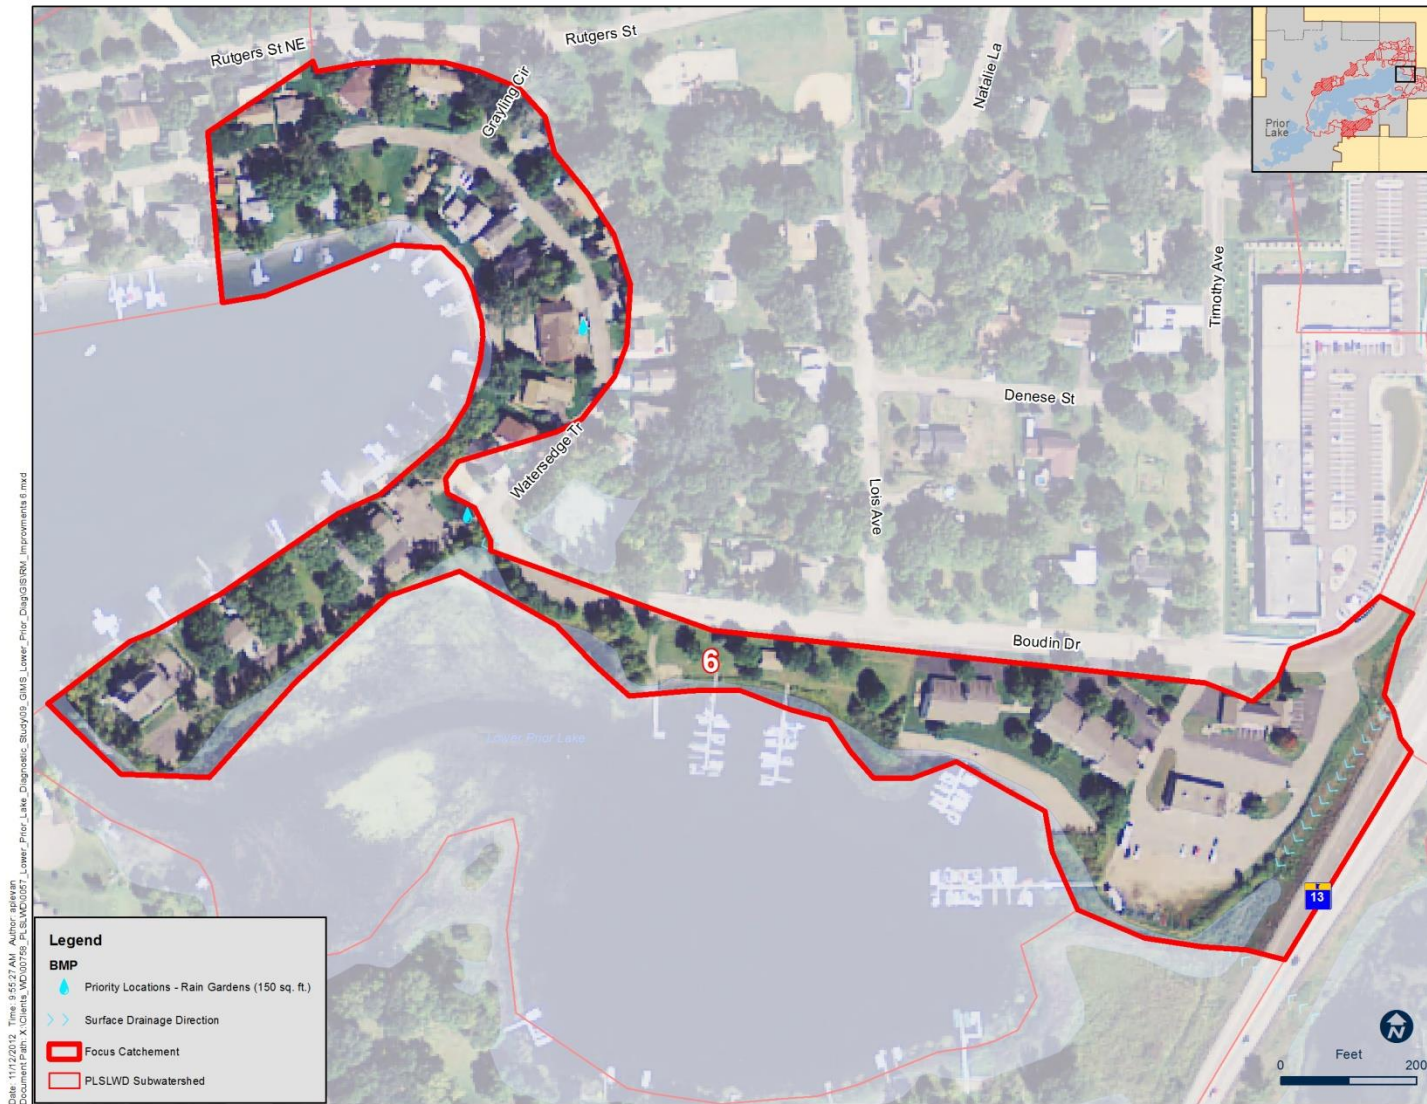
Figure 45. BMP retrofit opportunities in Lower Prior Lake subwatershed 6

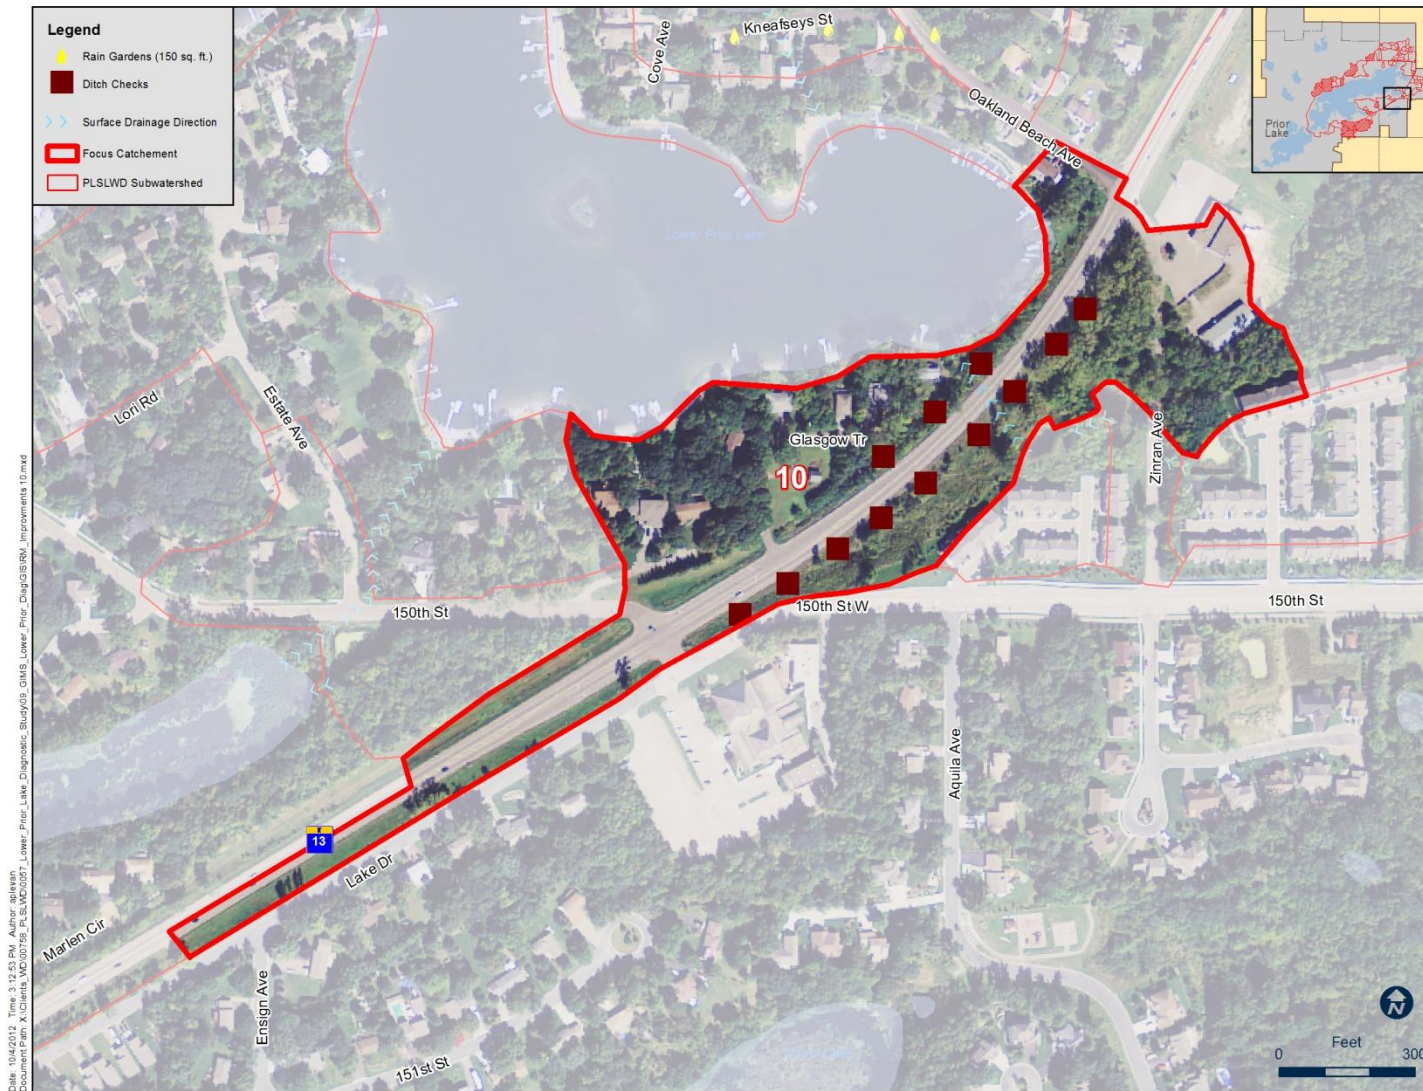
**Figure 47. BMP retrofit opportunities in Lower Prior Lake subwatershed 10**

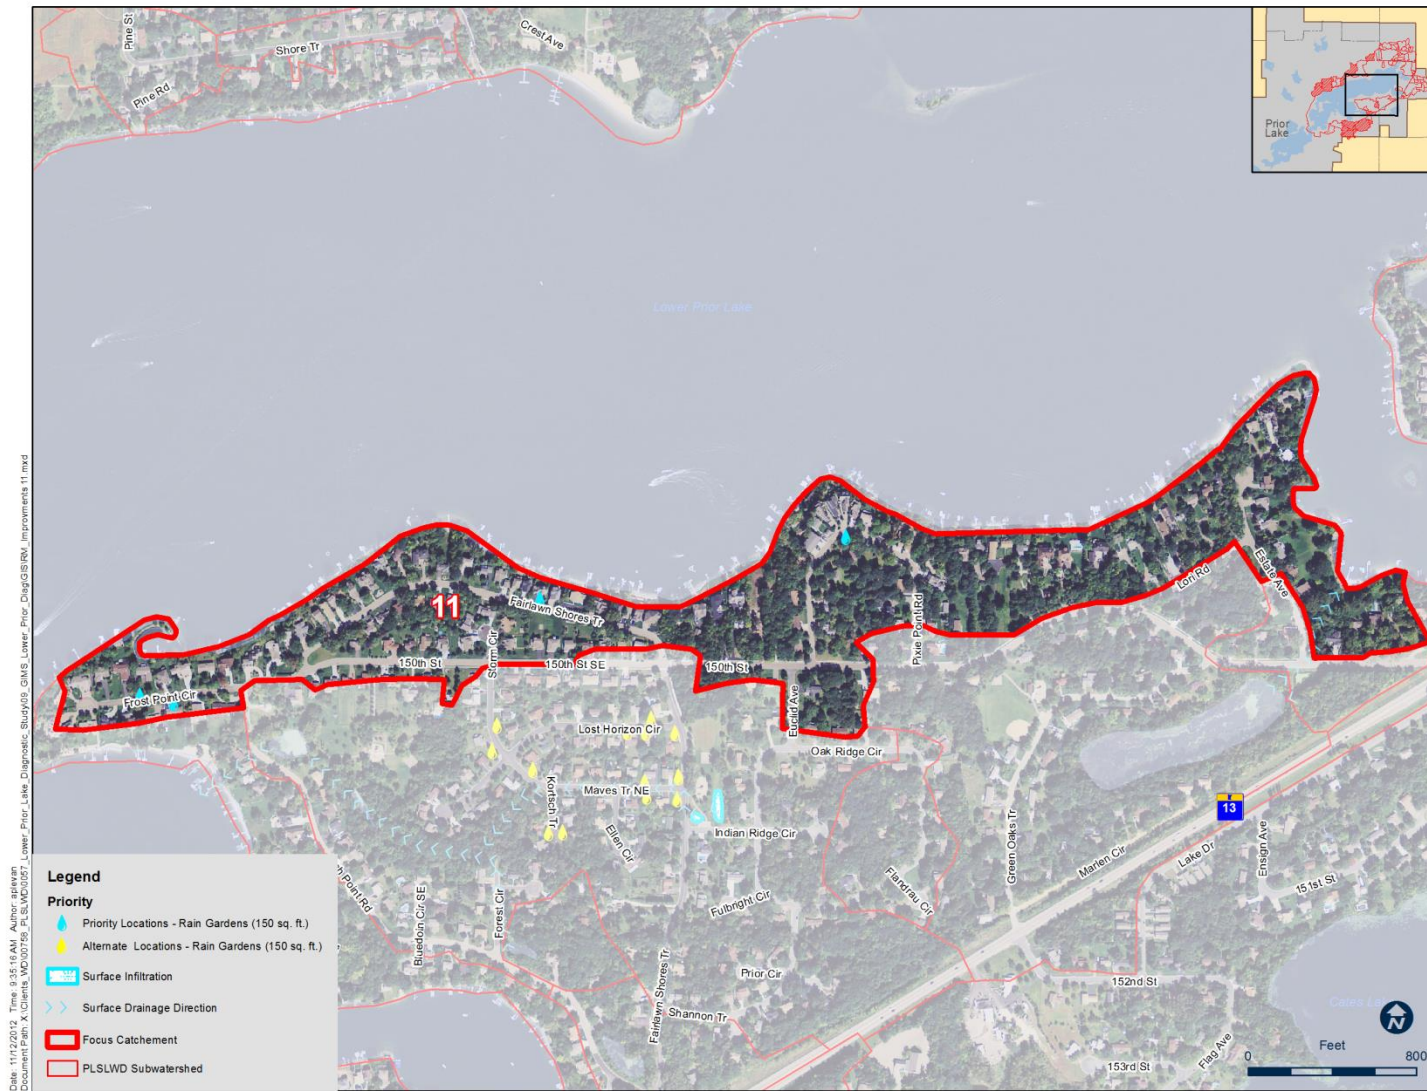
Figure 48. BMP retrofit opportunities in Lower Prior Lake subwatershed 11

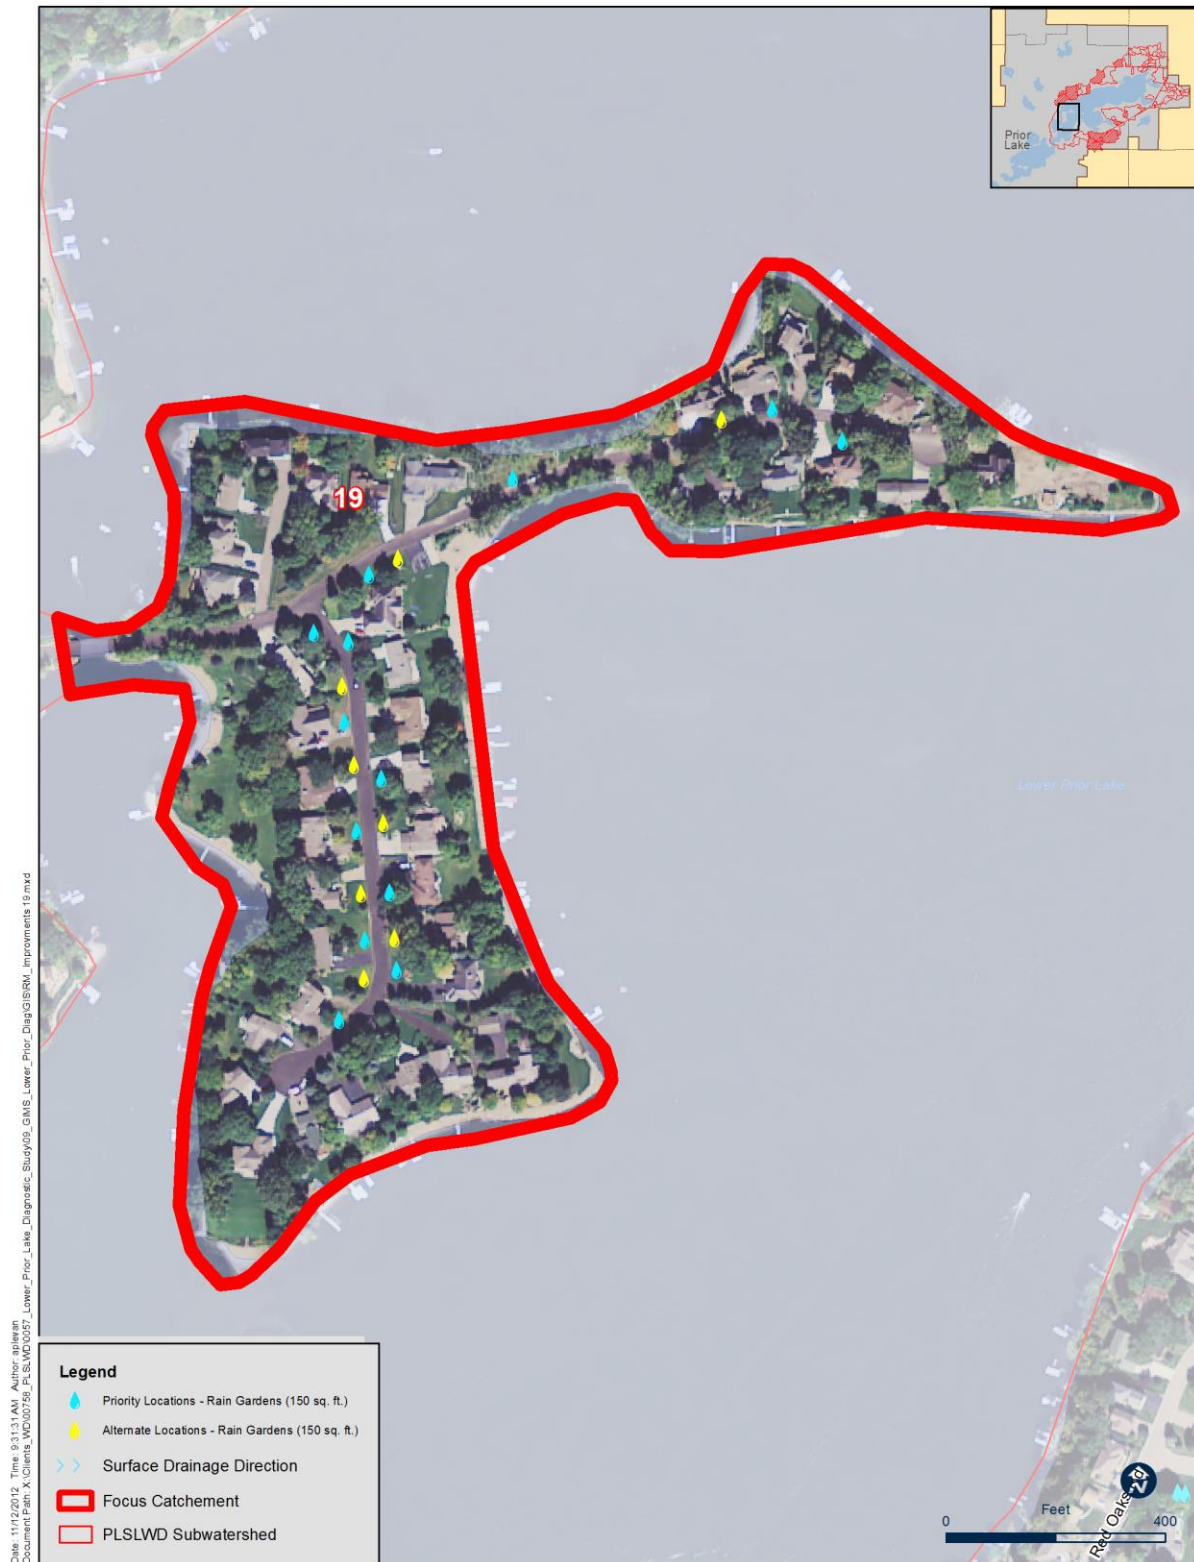
**Figure 52. BMP retrofit opportunities in Lower Prior Lake subwatershed 19**

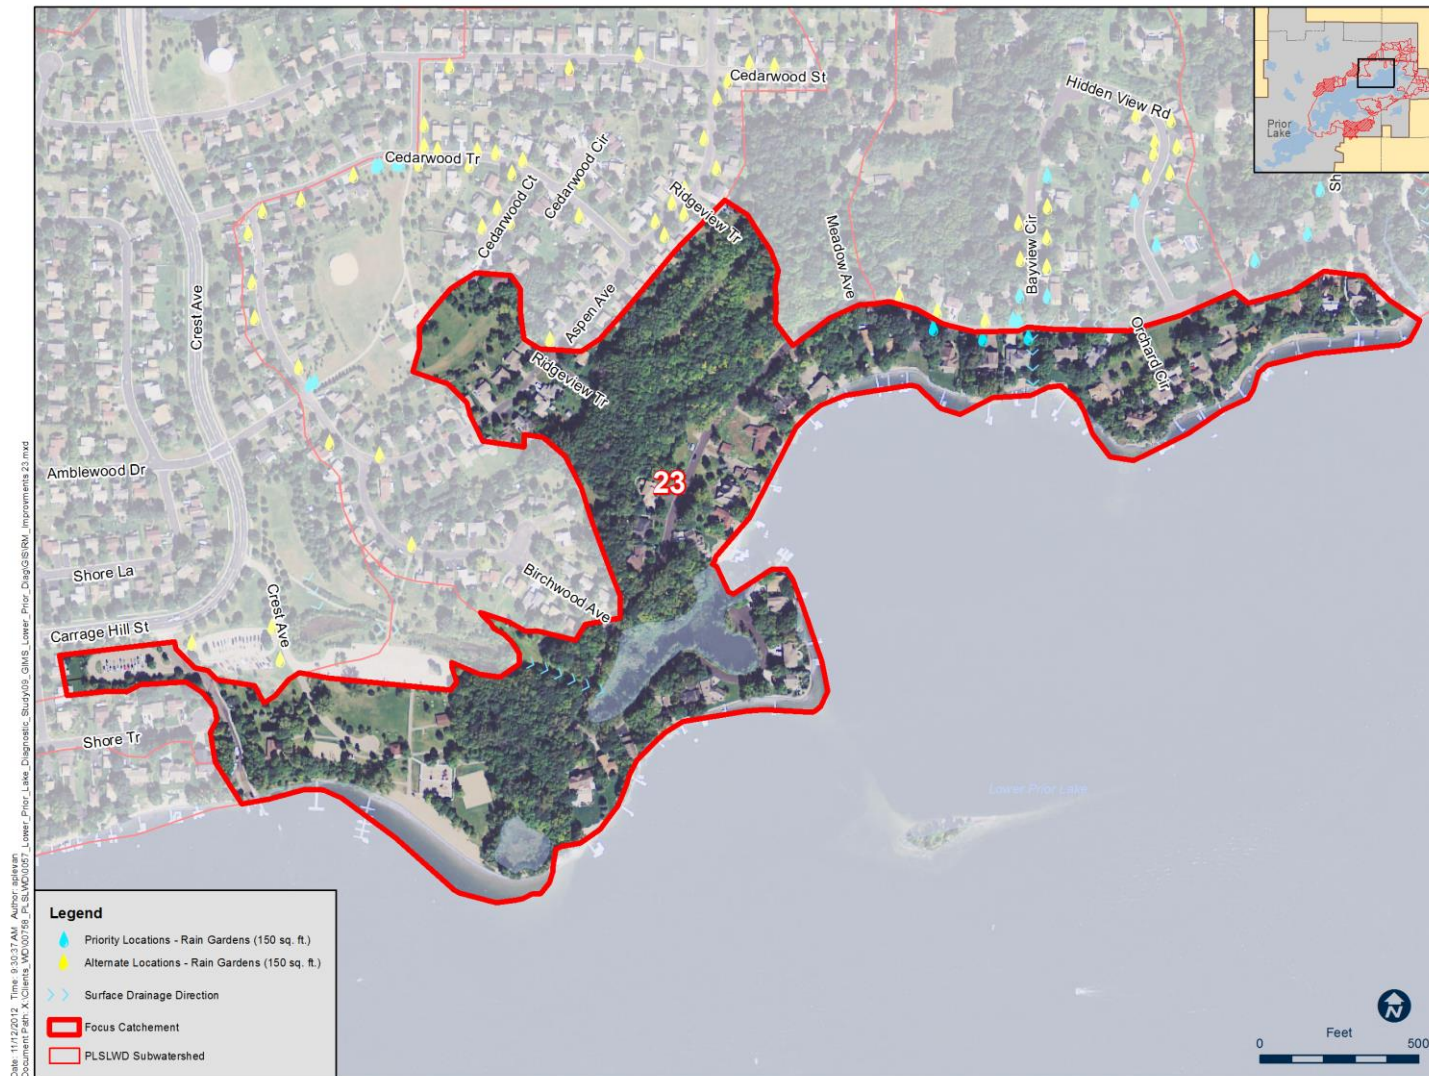
**Figure 53. BMP retrofit opportunities in Lower Prior Lake subwatershed 23**
