Fish Lake, Scott County, Curlyleaf Pondweed Assessment for 2013

Assessment Dates: May 23 and June 13, 2013

Prior Lake/Spring Lake Watershed District Prior Lake, Minnesota

Prepared by: Steve McComas Blue Water Science St. Paul, MN 55116

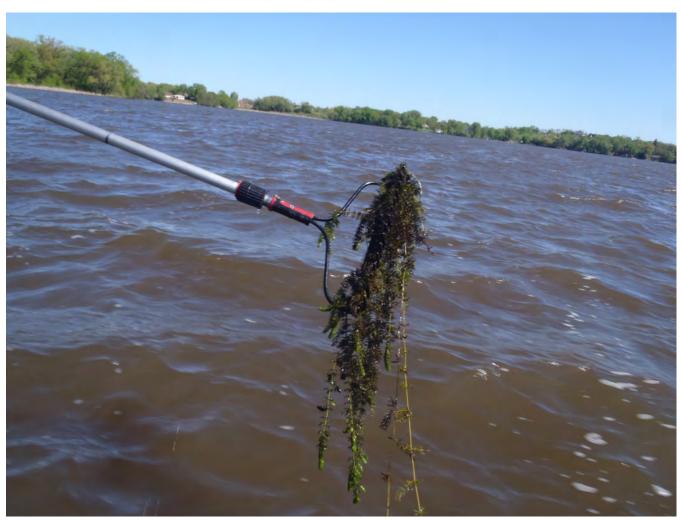
Aquatic Plants in Fish Lake, Scott County, MN, on May 23, 2013

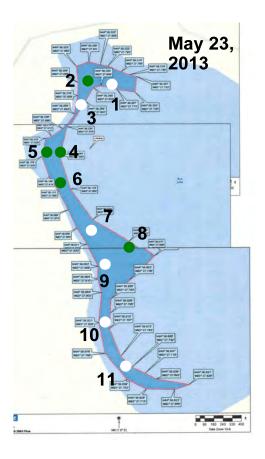
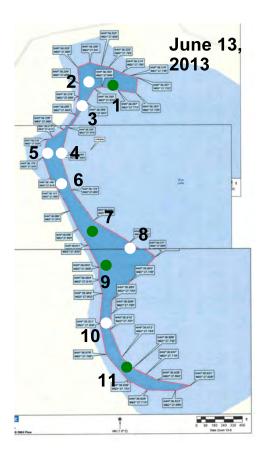
Figure S-1. [left] Eleven sites within an area that was treated from 2005-2008 (dark blue shading) were monitored on May 23, 2013 and curlyleaf was detected at five sites at low densities (green dots). White dots indicate no curlyleaf pondweed observed.

[right] In June, the same sites were monitored and curlyleaf was detected at four sites. Green dots indicates were curlyleaf pondweed was observed.

Overview: Two curlyleaf pondweed (CLP) assessments were conducted in Fish Lake within the 15.5 acre area that was treated with an endothall herbicide from 2005-2008 (shaded dark blue in Figure S-1). The first assessment was on May 23 and the second was on June 13, 2013. In the first assessment on May 23, 2013 curlyleaf pondweed was found at 5 out of the 11 sites monitored. However, CLP growth was light and no herbicide treatments were conducted. On the second assessment, curlyleaf abundance did not significantly increase, but rather remained about the same as in the May survey. Overall curlyleaf growth has been mostly light to moderate in the last few years and that was also the case for 2013. No herbicides have been used in the 15.5 acre area from 2009 through 2013.

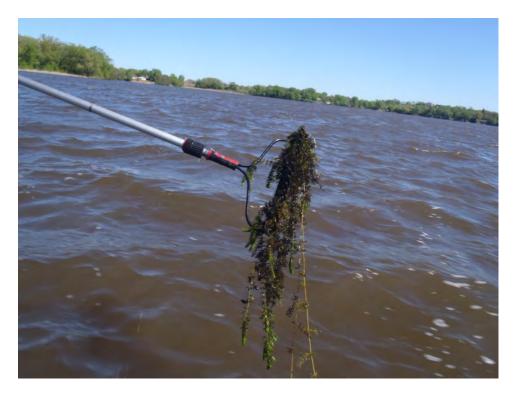
Figure S-2. Aquatic plants on a sample rake on May 23, 2013.

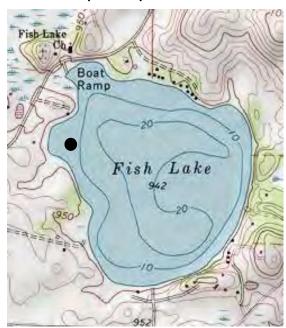
Figure S-3. Underwater monitoring site (shown with a black dot).

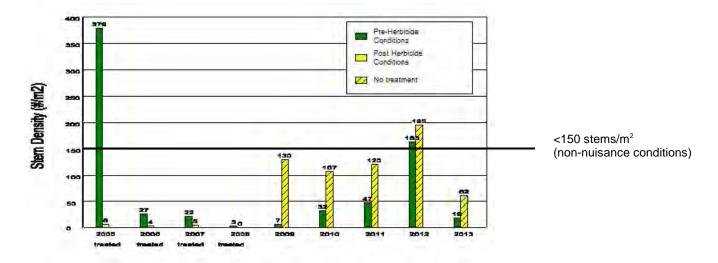
Figure S-4. Average of Fish Lake curlyleaf pondweed stem densities for early season and late season conditions in 2005 through 2013 at a 6.0-foot water depth at the monitoring site shown in Figure S-3.

Curlyleaf Pondweed Stem Densities at Site 4 from 2005 - 2013: Curlyleaf has been monitored at the same site on early and late season dates from 2005 through 2013 (Figure S-3). Curlyleaf stem densities were initially high on April 18, 2005. Curlyleaf was treated within this site for four years (2005-2008). No herbicide was used in 2009 through 2013. The early season stem density was 19 stems/m² on May 23, 2013, which was lower compared to Years 2009-2012. The next sample date on June 13, 2013, curlyleaf stem density increased to 62 stems/m² (Table S-2 and Figure S-4).

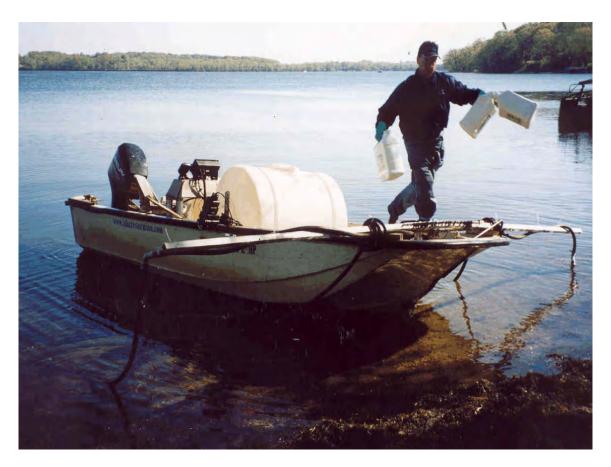
Figure 1. Herbicides were applied to a 15-acre area from 2005 through 2008. No herbicides were applied in 2009 through 2013.

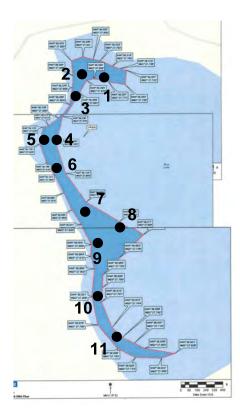
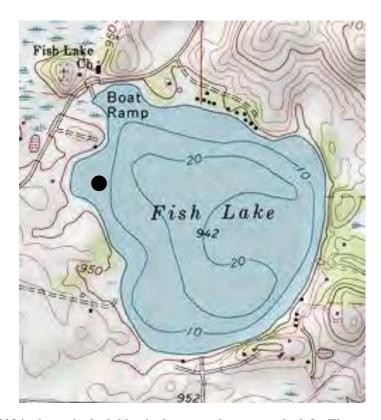
Figure 2. [left[The area treated from 2005-2008 is shown in dark blue is shown on the map to the left. The black dots shows the individual sample sites in the treatment area. Eleven sites were samples on May 23 and June 13, 2013

[right] Stem density determinations (10 samples) were collected from one site within an area treated from 2005-2013. Stem densities were determined using scuba diving and a 0.1 m² quadrat.

Aquatic Plant Distribution Surveys: In 2013, eleven sites within a former treatment area were monitored with a rake sampler. At each sampling site, water depth, plant species, and abundance of the plant species were recorded (Figure 2).

Curlyleaf Stem Density Methods: In 2013, one site (4-7 feet) was sampled on two sample dates. At the site, a total of ten curlyleaf stem density samples were taken sampling an area of a 0.10 m² (Figure 3). The stem density samples were randomly collected along a 50 meter transect line that ran parallel to the shoreline at each station. Other plant species were also counted if present.

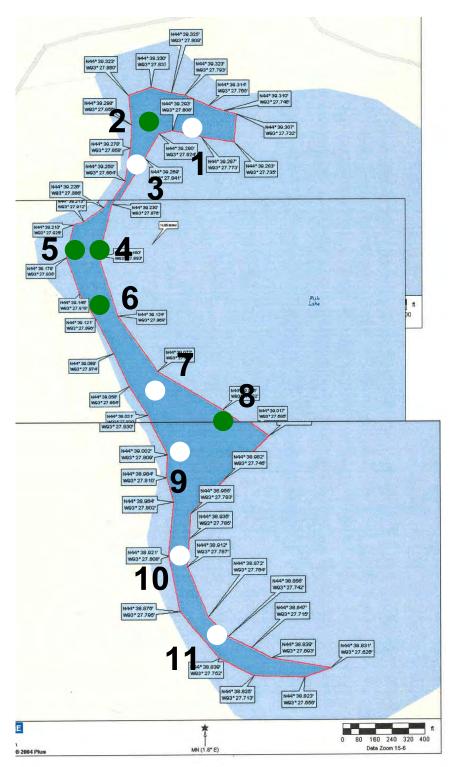
Figure 4. Curlyleaf delineation in Fish Lake on May 23, 2013. White dots = no curlyleaf pondweed and green dots = light growth. The darker blue shading in the nearshore area represents the 15.5 acre area that was treated with herbicides from 2005 through 2008. No herbicides were applied in 2009 through 2013.

A total of 11 sites were monitored with rake sampling on May 23, 2013 in areas that previously had been treated for four consecutive years with an endothal herbicide (Figure 4). Curlyleaf was found at 5 sample sites out of the 11 that were monitored (Table 1). In May, curlyleaf was present in the treated area but was sparse in density and in distribution. No herbicide treatments were conducted.

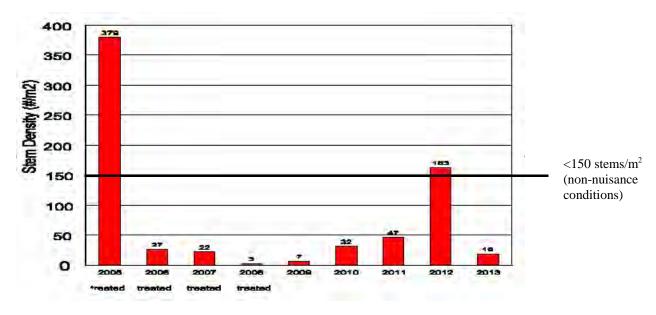
Figure 5. Curlyleaf stem densities for early season monitoring for 2005-2013.

Curlyleaf stem densities were determined at a location between sample sites 4-5 (location is shown in Figure 1). Ten quadrat samples were taken at this location. The results for 2013 show curlyleaf was found at light to moderate stem densities (Table 2). CLP stem densities were less in 2013 compared to 2012 (Figure 5).

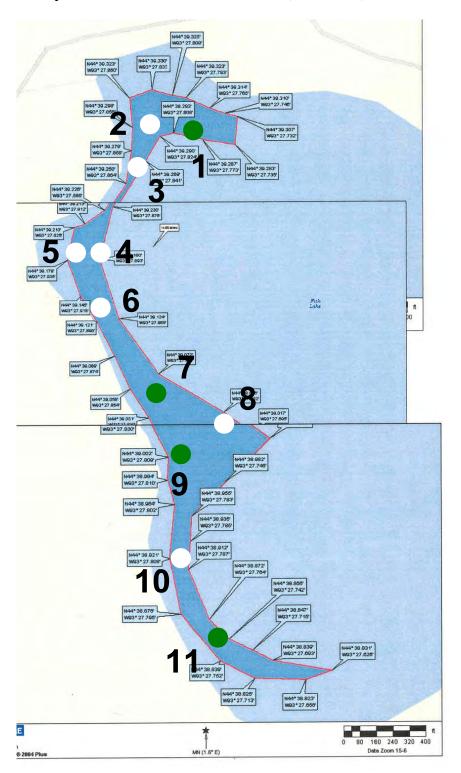
Figure 7. Curlyleaf delineation in Fish Lake on June 13, 2013. White dots = no curlyleaf pondweed and green dots = light growth. The darker blue shading in the nearshore area represents the 15.5 acre area that was treated with herbicides from 2005 through 2008. No herbicides were applied in 2009 through 2013.

A total of 11 sites were re-sampled with rake sampling on June 13, 2013 in the area that previously had been treated for four consecutive years in 2005-2008 with an endothall herbicide. There was no herbicide use in 2013. Curlyleaf was found at 4 out of 11 sample sites. Coontail was found at 11 out of 11 sample sites.

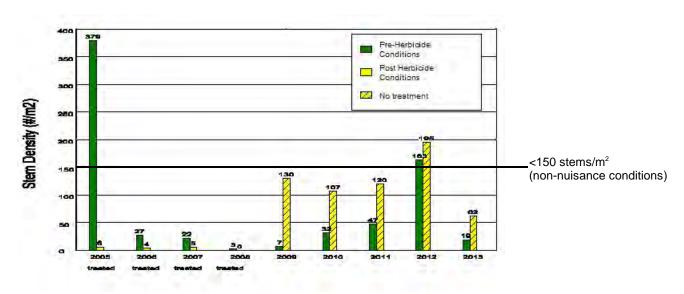
Figure 8. Average of Fish Lake curlyleaf pondweed stem densities for early season and late season conditions in 2005 through 2013 at a 6.0-foot water depth at the monitoring site shown in Figure S-3.

Curlyleaf Pondweed Stem Densities at Site 4: Curlyleaf has been monitored at the same site on early and late season dates from 2005 through 2013. Curlyleaf stem densities were initially high on April 18, 2005. Curlyleaf was treated within this site for four years (2005-2008). No herbicide was used in 2009 through 2013. The early season stem density was 19 stems/m² on May 23, 2013, which was lower compared to Years 2009-2012. The next sample date on June 13, 2013, curlyleaf stem density increased to 60 stems/m² (Table 5).

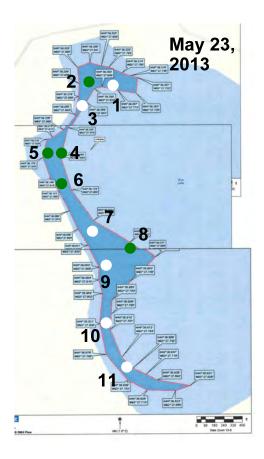
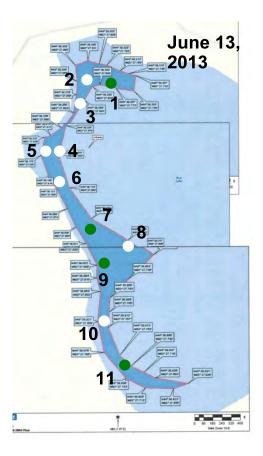
Figure 9. [left] Eleven sites within an area that was treated from 2005-2008 (dark blue shading) were monitored on May 23, 2013 and curlyleaf was detected at five sites at low densities (green dots). White dots indicate no curlyleaf pondweed observed.

[right] In June, the same sites were monitored and curlyleaf was detected at four sites. Green dots indicates were curlyleaf pondweed was observed.

Conclusions: Two curlyleaf pondweed (CLP) assessments were conducted in Fish Lake within the 15.5 acre area that was treated with an endothall herbicide from 2005-2008 (shaded dark blue in Figure 9). The first assessment was on May 23 and the second one was on June 13, 2013. In the first assessment in 2013 curlyleaf pondweed was found at 5 out of the 11 sites monitored. However, CLP growth was light and no herbicide treatments were conducted. On the second assessment, curlyleaf abundance had remain about the same as in the May survey. Overall curlyleaf growth has been mostly light to moderate in the last few years and that was also the case for 2013. No herbicides have been used in the 15.5 acre area in 2009 through 2013.
