# Aquatic Plant Point Intercept Survey for Haas Lake, Scott County, Minnesota

[Plant Survey Conducted August 18, 2022]

Prepared for:  
Prior Lake-Spring Lake  
Watershed District

Prepared by:  
Steve McComas  
Jo Stuckert  
Blue Water Science

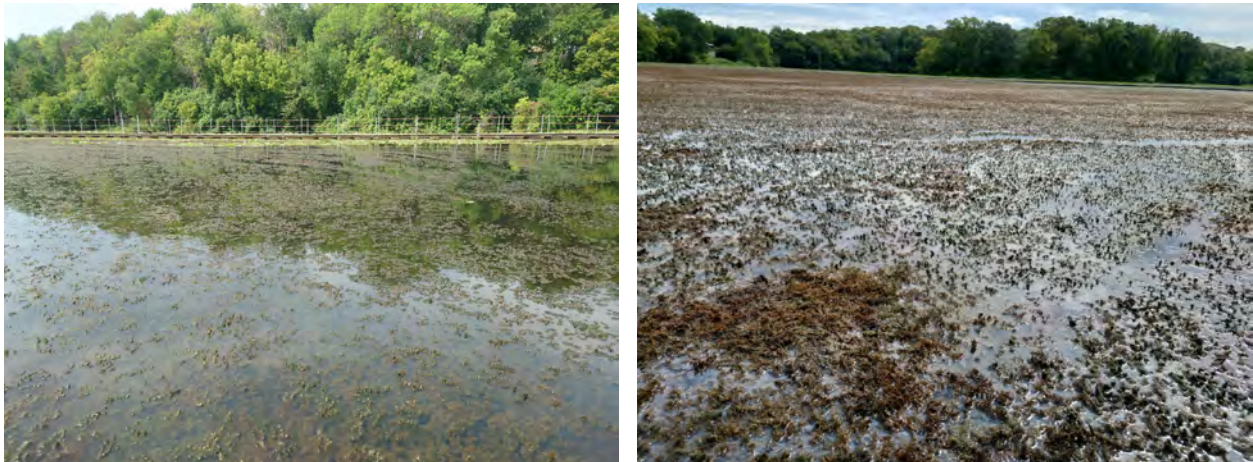
Results of the summer aquatic plant survey conducted on August 18, 2022 found 1 submerged plant species (Table 2)(Figure 3). Coontail was growing throughout the lake at mostly moderate to heavy growth. Coontail coverage was approximately 98% (48 out of 49 sites) of the lake area. White lilies were abundant and also growing throughout most of the lake.

**Figure 3. Coontail was common and abundant around Haas Lake.**

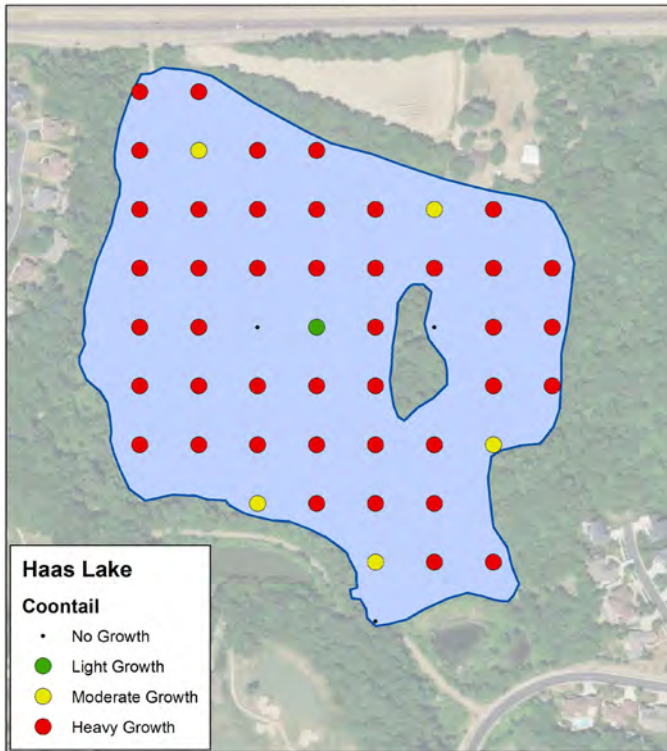
Maps of the distribution and abundance for each plant species are shown in Figure 4.

Haas Lake Coontail  
August 18, 2022

Haas Lake White Lily Growth  
August 18, 2022

Figure 4. Haas Lake aquatic plant coverage maps for white water lilies and coontail.

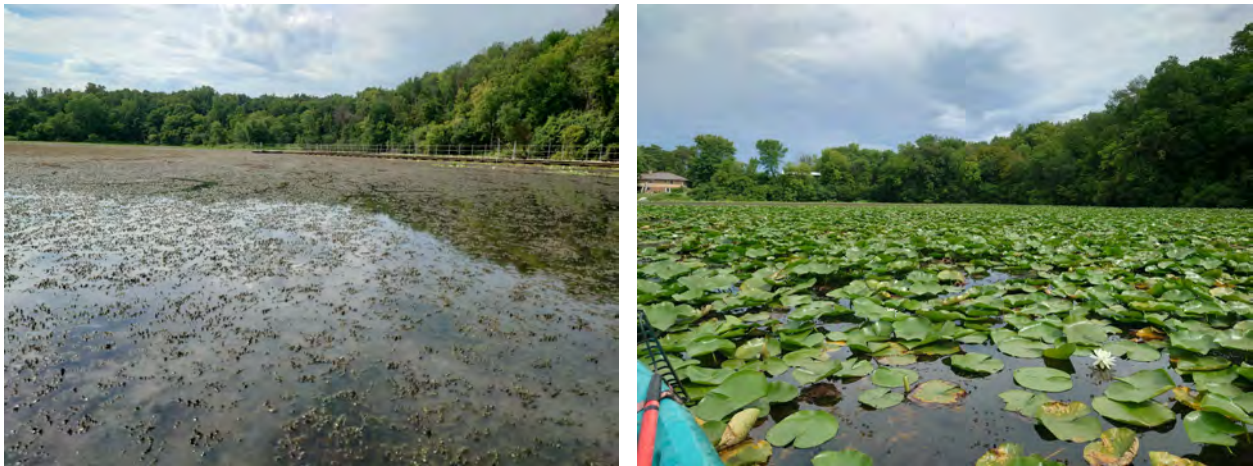
**Figure 5. The west side of Haas Lake was dominated by coontail while the east side was mostly dominated by white lilies.**

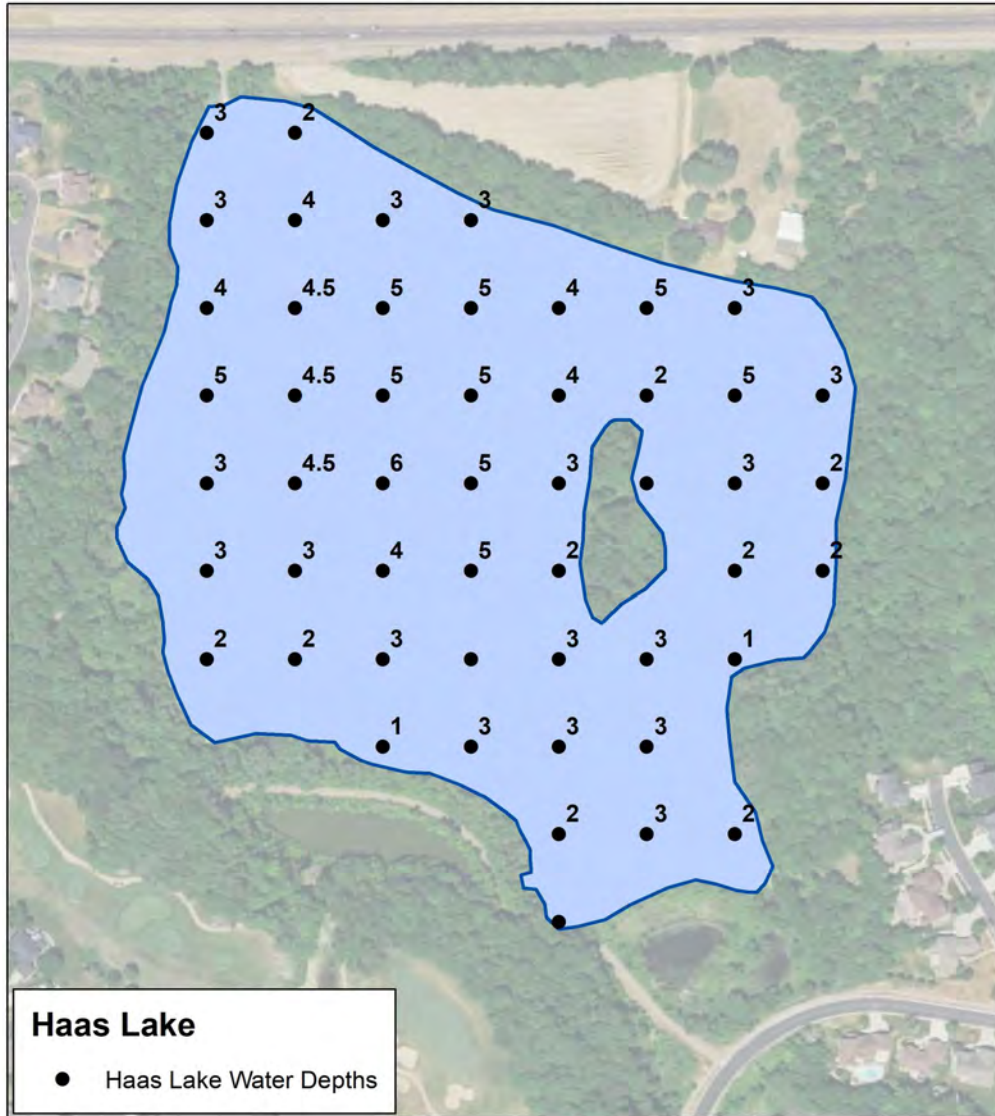
# Haas Lake Observed Water Depths August 18, 2022
