Aquatic Plant Point-Intercept Survey for Rice Lake, Scott County, Minnesota

[Plant Survey Conducted August 22, 2022]

Prepared for: Prior Lake-Spring Lake Watershed District

Prepared by: Steve McComas Jo Stuckert Blue Water Science

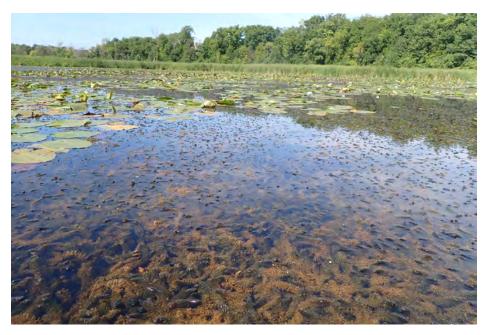
Figure 1. Coontail and White lilies are widespread in Rice Lake.

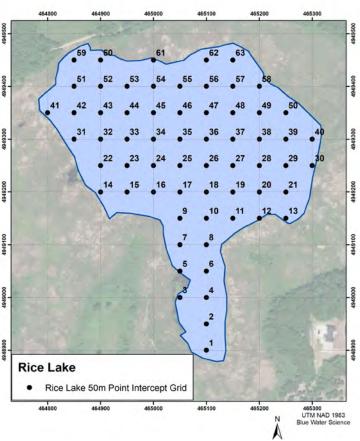
Rice Lake 50m Grid

An aquatic plant point-intercept survey of Rice Lake was conducted by Blue Water Science on August 22, 2022 and 63 points were sampled. Sample points were placed 50 meters apart on a grid that covered the lake (Figure 2). At each sample point, a sampling rake was lowered into the water and a plant sample was taken. The plant species were recorded and the density of each species was assigned. Densities were based on the coverage on the teeth of the rake. Density ratings were from 1 to 3 with 1 being sparse and 3 being a nuisance. Based on these sample sites, a plant distribution map was constructed.

Figure 2. Sample location map for the aquatic plant survey conducted on Rice Lake.

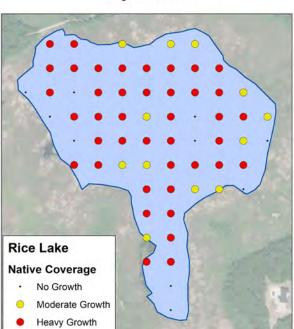
Aquatic plant coverage was approximately 95%. Distribution and abundance plant maps are shown in Figure 2.

Figure 3. Native plant coverage in Rice lake on August 22, 2022.

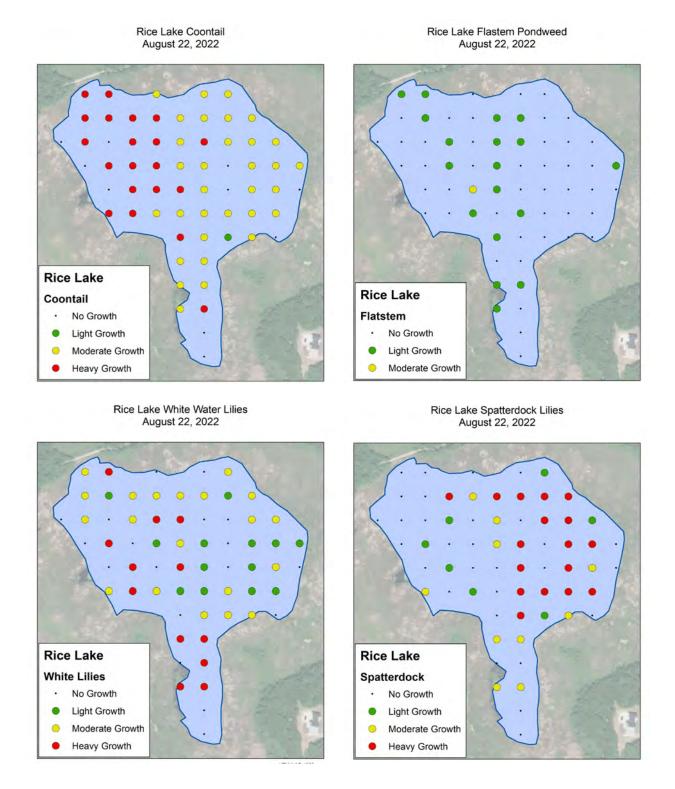
Results of the summer aquatic plant survey conducted on August 22, 2022 found two submerged plant species, coontail and flatstem pondweed (Table 2)(Figure 4).

Figure 4. Rice Lake aquatic plant coverage maps. For individual species maps: green = light growth, yellow = moderate growth, and red = heavy growth.

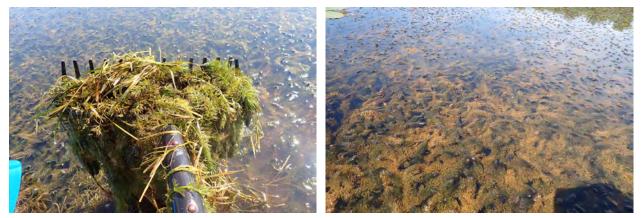
Figure 5. [left] A rake of heavy coontail growth with flatstem present. [right] Coontail topping out the at surface.

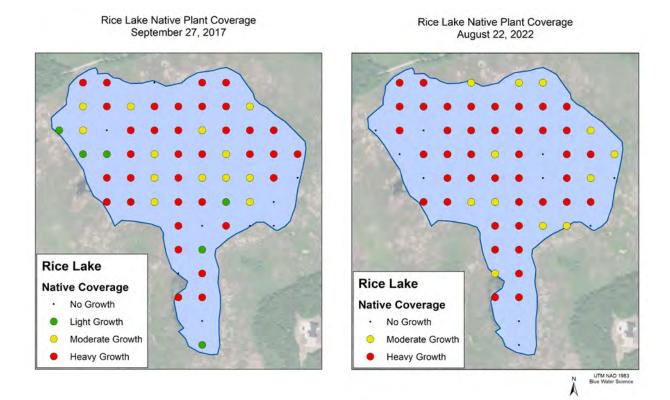
Table 4. Coontail was the dominant aquatic plant in both surveys. Only 2 submerged plant species were observed in 2022 compared to 5 in 2017.

Figure 6. Native plant coverage in Rice Lake in 2017(left) and native plant coverage in 2022 (right).
