Aquatic Plant Survey for Sutton Lake, Scott County, Minnesota, 2022

Visual Aquatic Plant Survey: September 1, 2022

Prepared for: Prior Lake-Spring Lake Watershed District

March 9, 2023

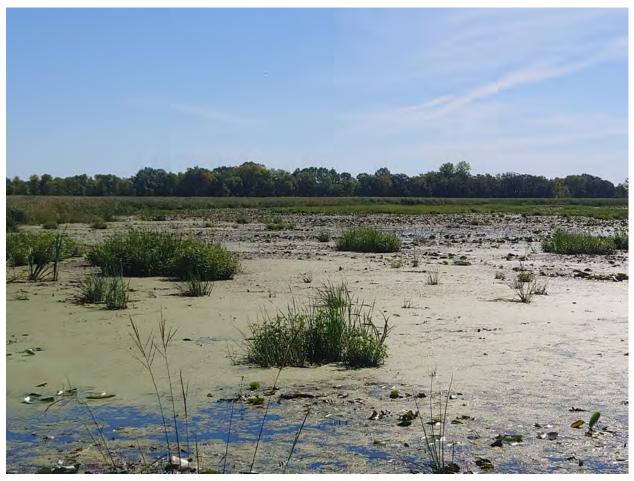
Water Lilies and Duckweed were abundant in Sutton Lake, September 2022

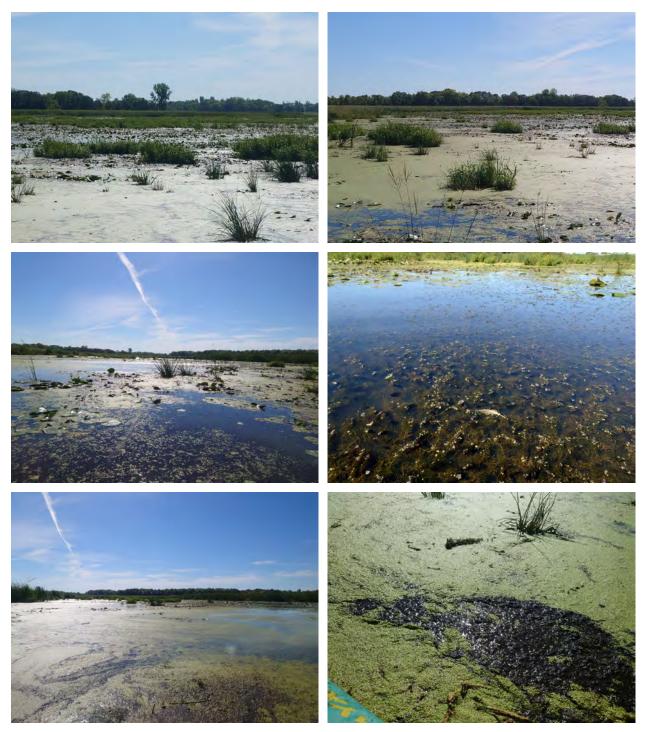
Figure 2. Emergent plants were common in Sutton Lake in 2022. Wild rice and bullrush were found in several locations on September 1, 2022. White water lilies were common while no spatterdock was observed. Coontail was present where water depth 3 inches or greater. Duckweed was growing throughout the basin.

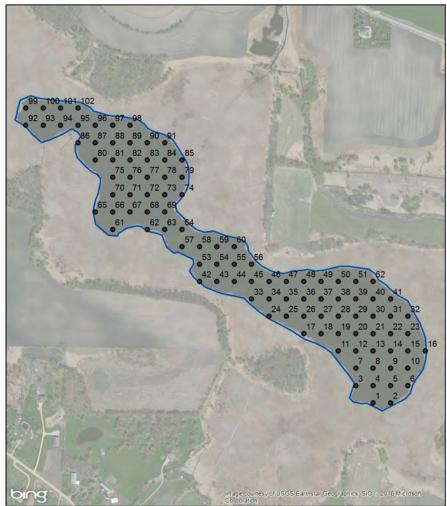
Figure 3. Sample locations for the point intercept aquatic plant survey.

Sutton Lake is located within in Scott County. An aquatic plant point intercept survey was attempted on the 64-acre lake on September 1, 2022. A sampling grid is shown in Figure 3.

However, drought conditions resulted in lake water depths of one to six inches. Soft sediments were up to two feet thick. Navigation by boat or by walking was not feasible. Therefore qualitative estimates were made along with visual observations.
