Project Name | PLOC Channel & Vegetation Inspections

Date | 12/7/2022

Regarding | Channel and Vegetation Inspections – 2022 Summary

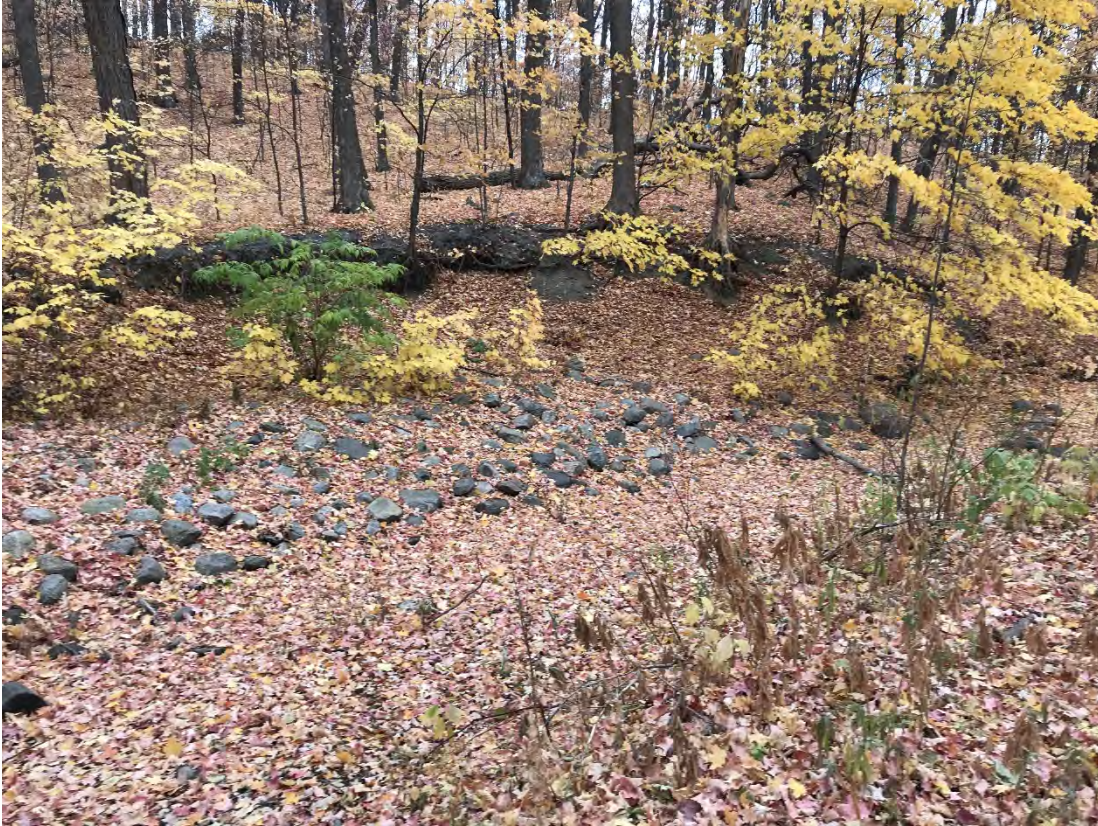
The low water levels in 2022 enabled greater establishment of riparian vegetation along the lower stream banks throughout the segment, and self-healing of previously eroded banks continue in areas where repairs were made near Jeffers Pond Elementary School (Figure 1). A small bank repair was completed during the summer of 2022 that extended boulder toe rock along the right bank just upstream of the walking path at Fountain Hills Road where erosion was previously documented (Figure 2). Downstream of Fountain Hills Road, bank erosion persists in the wooded reach where undercut banks are exposed, though the rate of bank erosion has been minimal over the last several years (Figure 3). Minor channel obstructions were observed in the same areas identified in previous surveys including several down trees lying across and within the channel in the wooded area upstream of County Road 42 (Figure 4). The trees and branches are currently not impeding flow but may catch debris during high flows. The beaver dams observed in this reach in 2020 appear inactive and were not holding back any water during the inspections completed in 2022.

Figure 1. Self-healing bank downstream of foot bridge near Jeffers Pond Elementary School

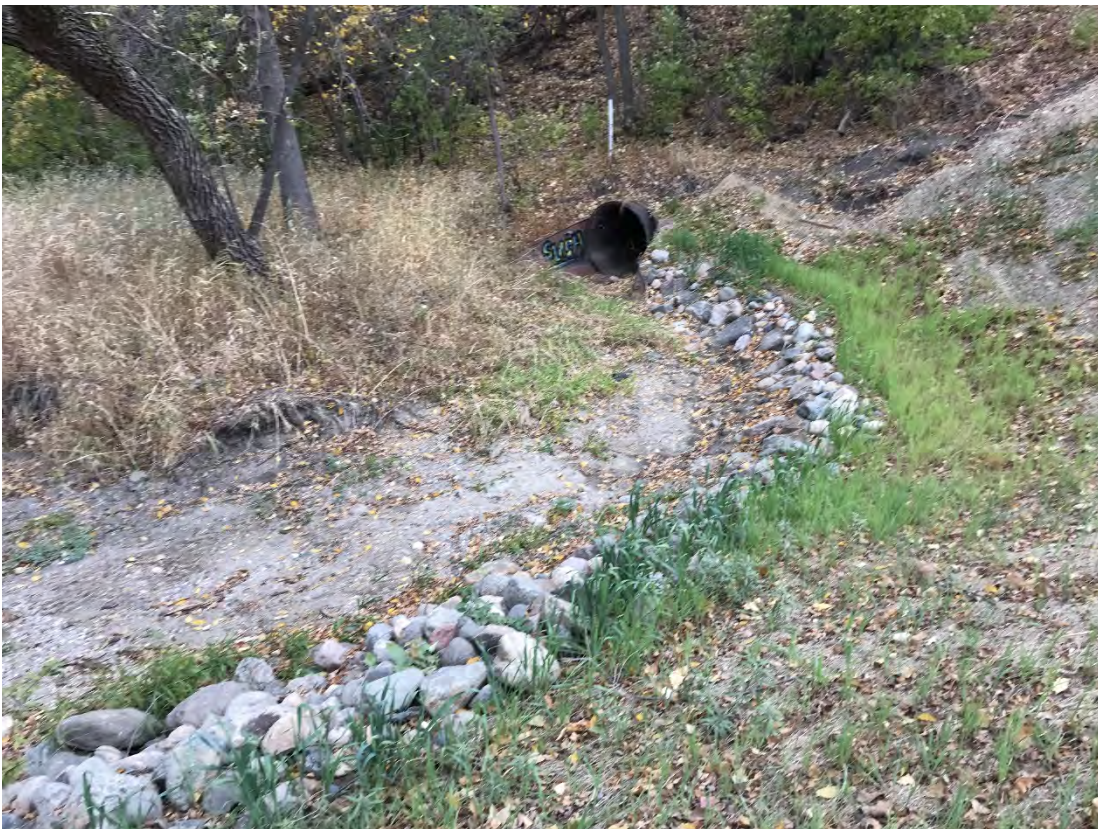
Figure 2. Bank repair upstream of Fountain Hills Road walking trail

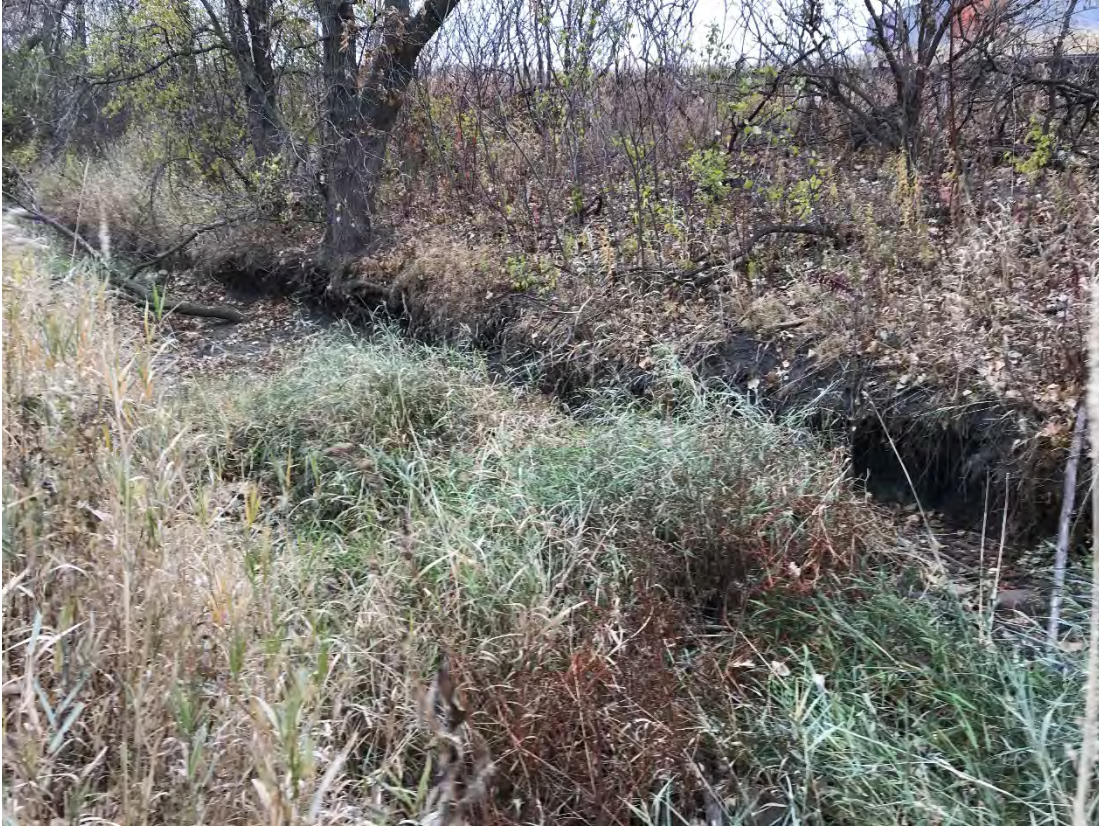
Figure 3. Bank erosion downstream of Fountain Hills Road

- Continue inspections in 2023 and monitor stability of bank repair areas.
- Stabilize eroding banks and remove fallen trees within the channel upstream of County Road 42.
- Remove blown-out field culvert upstream of County Road 42 (old field crossing culvert) if future bank stability work is planned in this area.

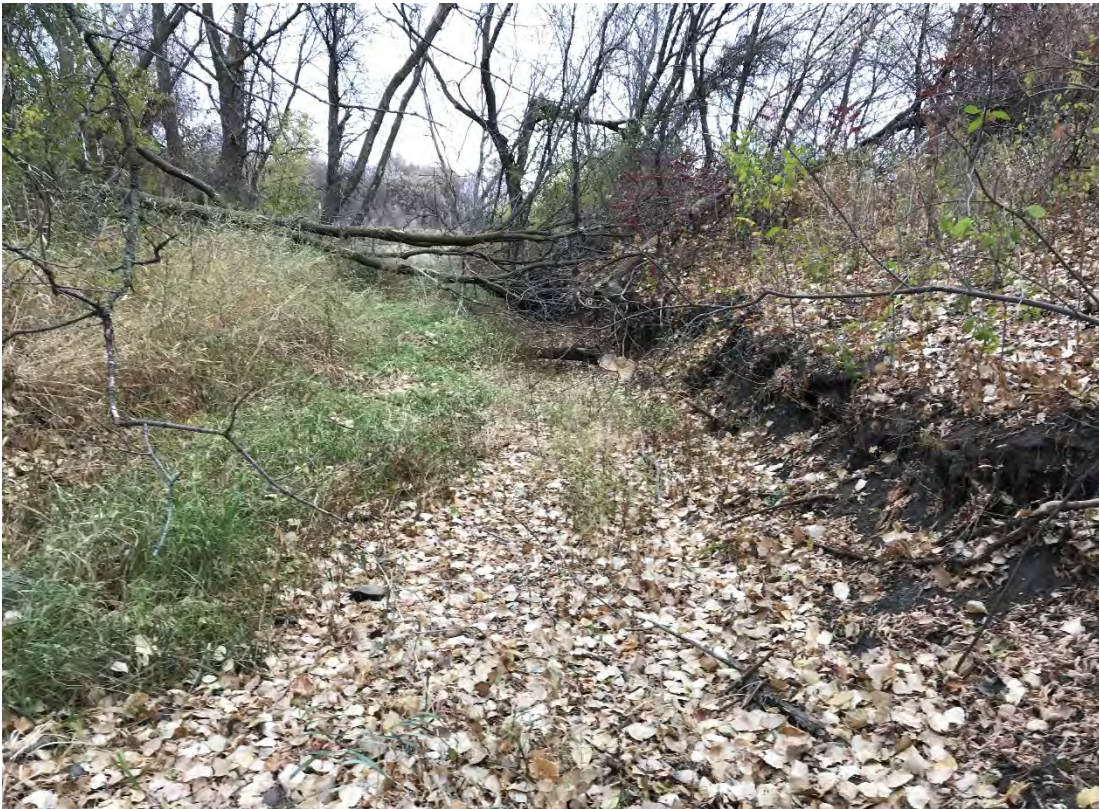
Figure 4. Down trees in channel downstream of Fountain Hills Road

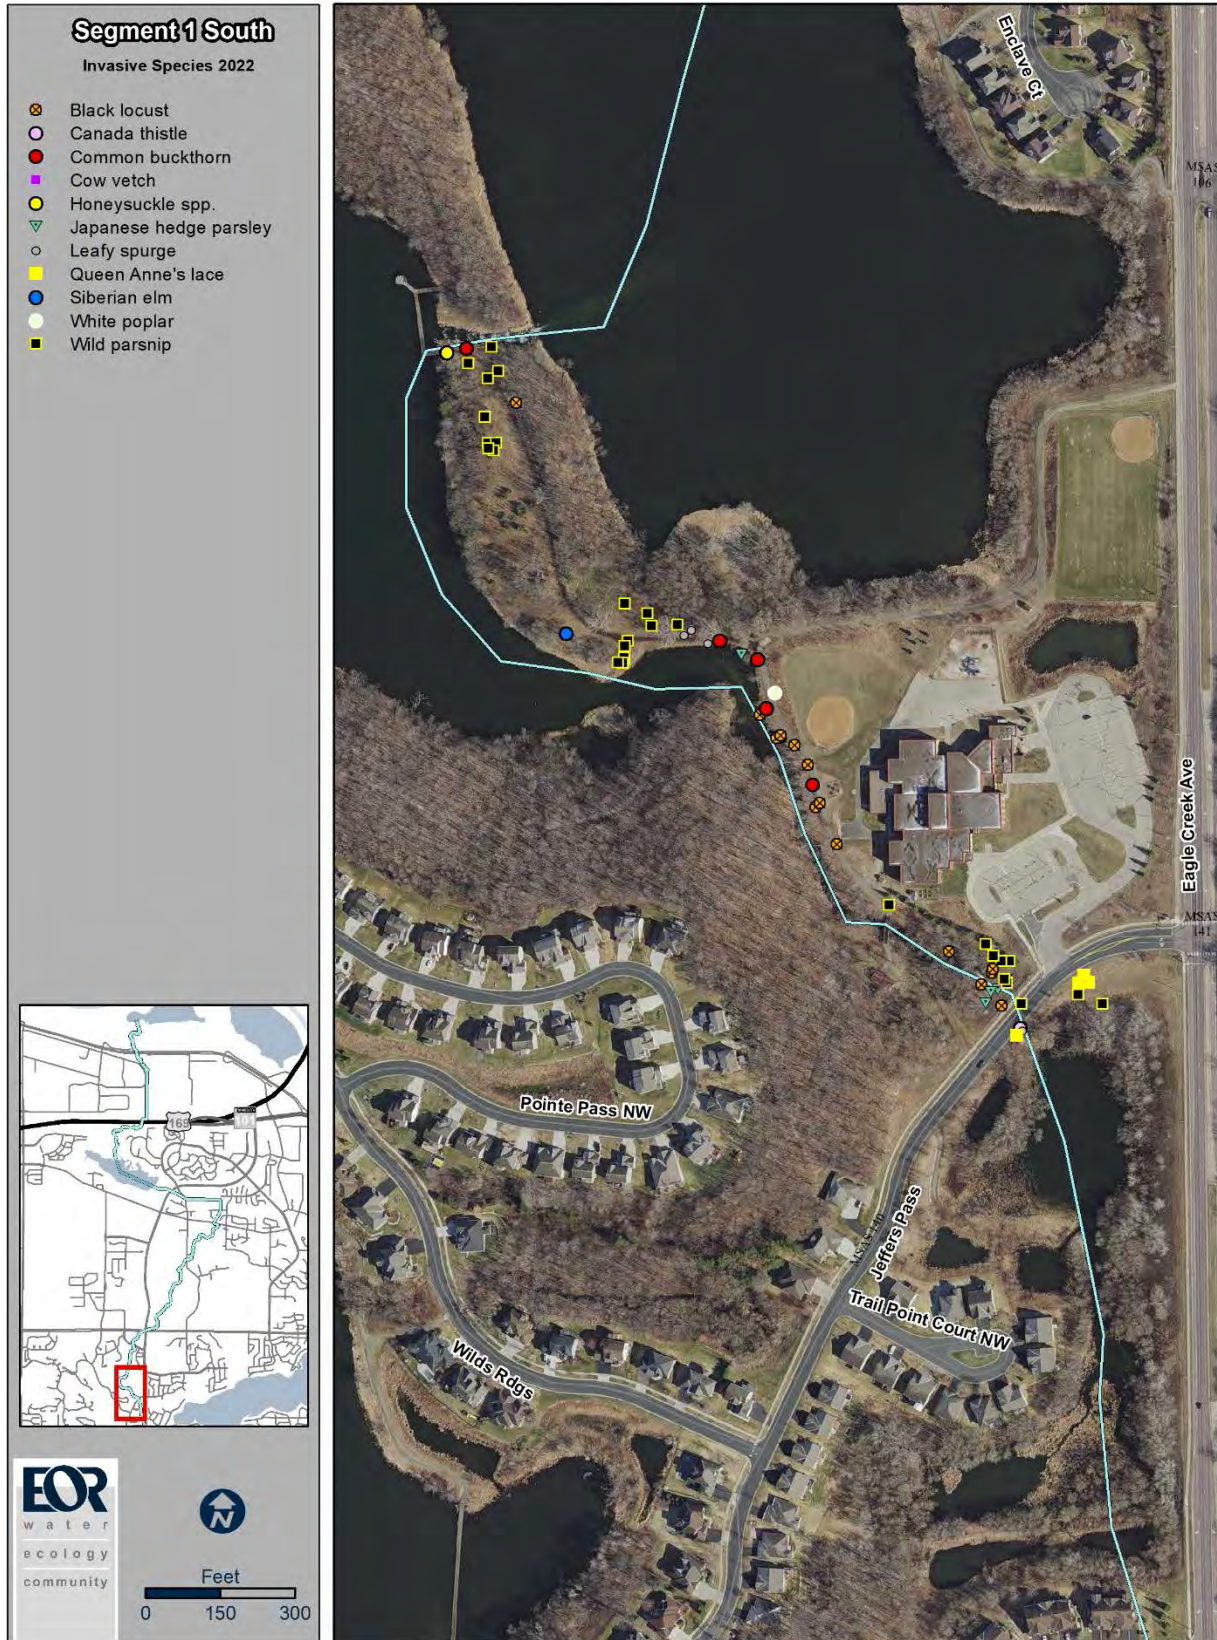
Several black locust (*Robinia pseudoacacia*) saplings were found along the paved walking path west of Jeffers Pond Elementary School. In addition, patches of wild parsnip were found in the areas managed in 2021, including the grassy area southwest of the intersection of Jeffers Pass NW and Eagle Creek Avenue, the north road slope along Fountain Hills Road, and in the grassy opening northeast of Chickadee Landing on Jeffers Pond Elementary School property. In addition, staff from NST found a new patch of wild parsnip downstream of Fountain Hills Road during their spring vegetation management trip. Japanese hedge parsley was observed again just downstream of Jeffers Pass NW. Monitoring and treatment for known invasive species, particularly wild parsnip, Japanese hedge parsley, and Queen Ann's lace should continue in 2023 to limit the spread of these species. Figure 5 and Figure 6 show the locations of target invasive species identified in this segment.

Figure 5. Target invasive species along Segment 1 (South half)

- Perform cut stump treatments / foliar spray of all woody invasive trees, shrubs, and saplings located within 30 feet from the top of the bank from Jeffers Pass NW to upper Jeffers Pond and from the outlet of Jeffers Pond to Fountain Hills Road.
- Scout and treat target herbaceous invasive species from Jeffers Pass NW to County Road 42 (excluding open water areas around upper and lower Jeffers Pond). Conduct one trip in mid-late May and a second trip in early July to prevent target invasive species from maturing and producing seed.

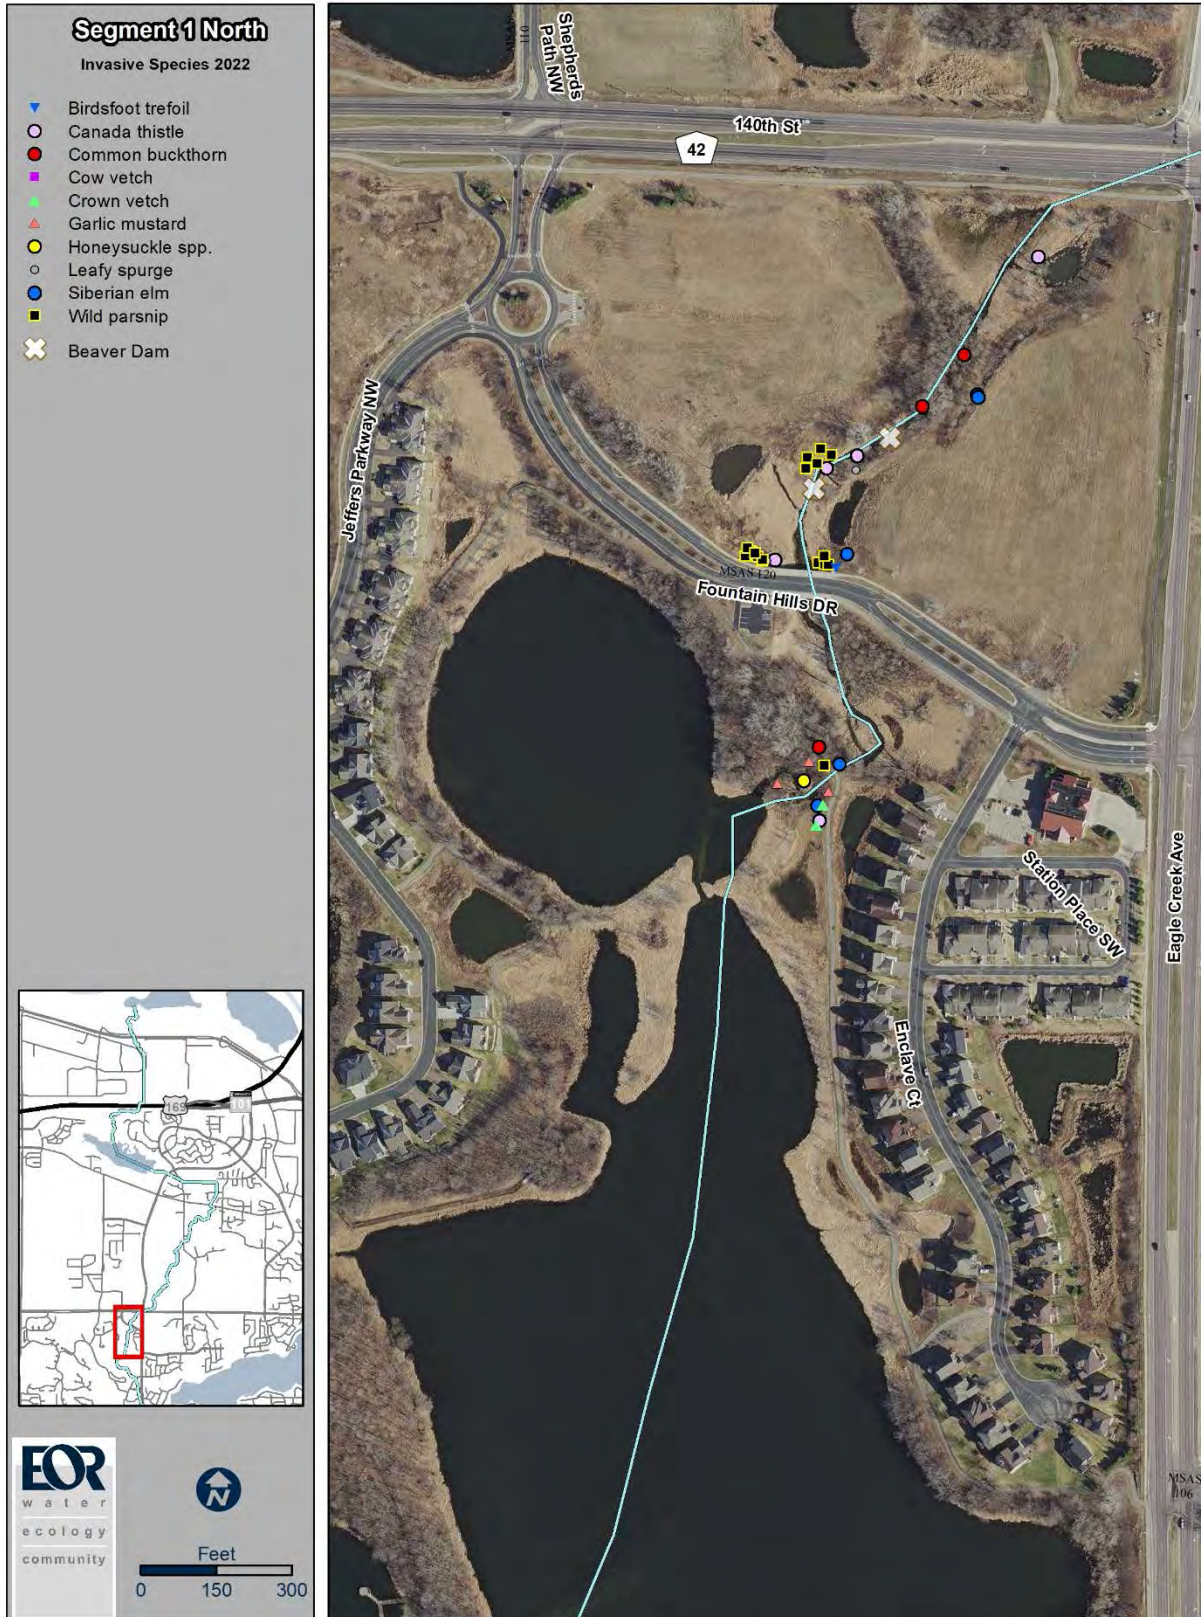
Figure 6. Target invasive species along Segment 1 (North half)

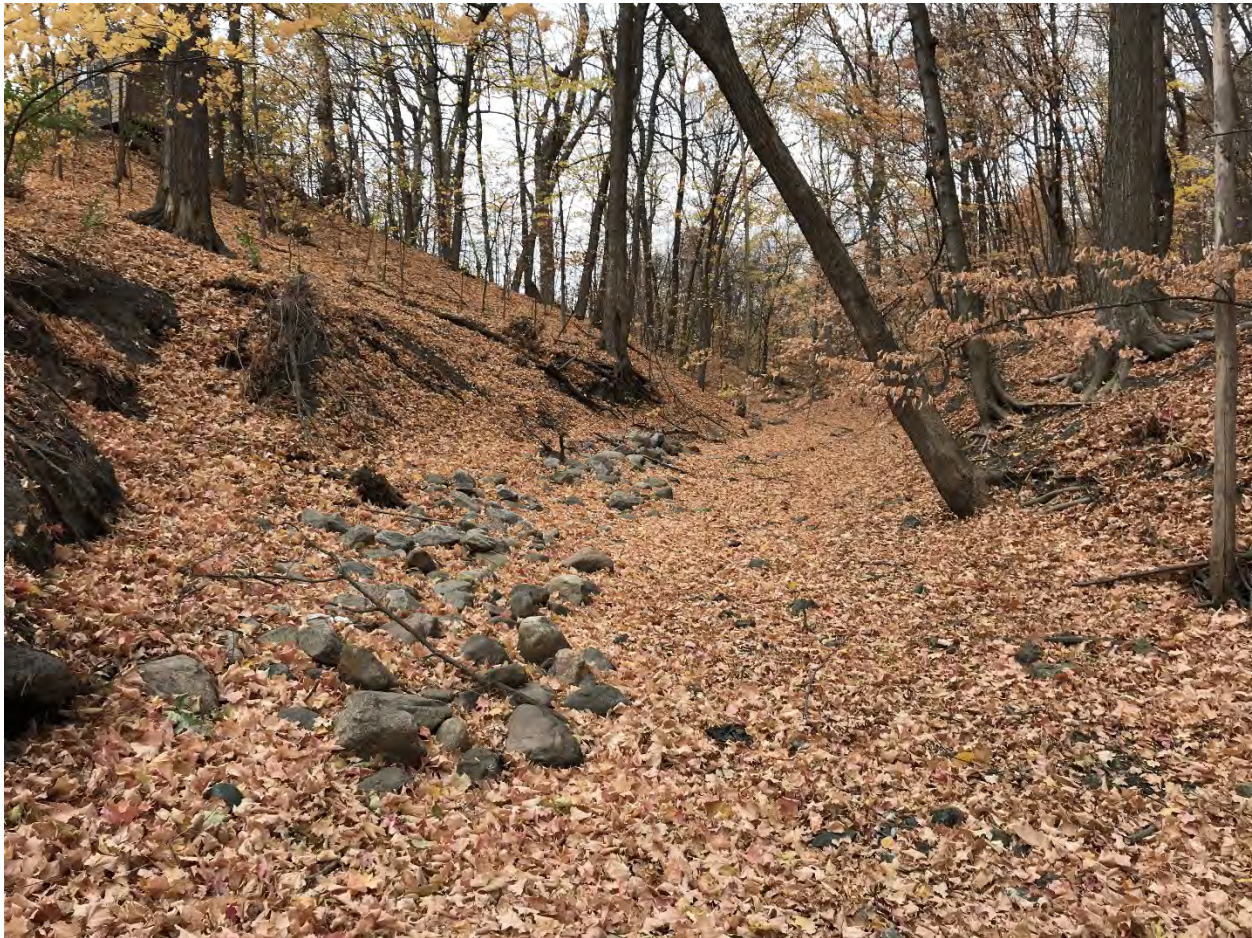
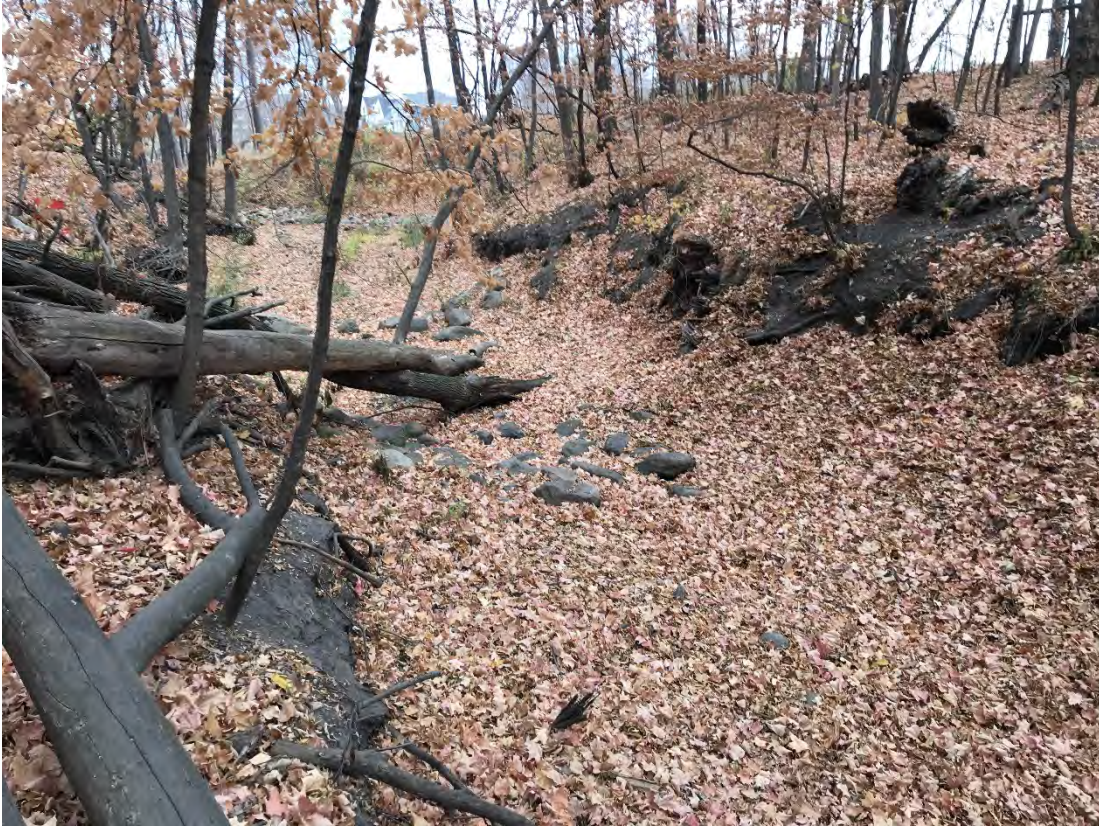
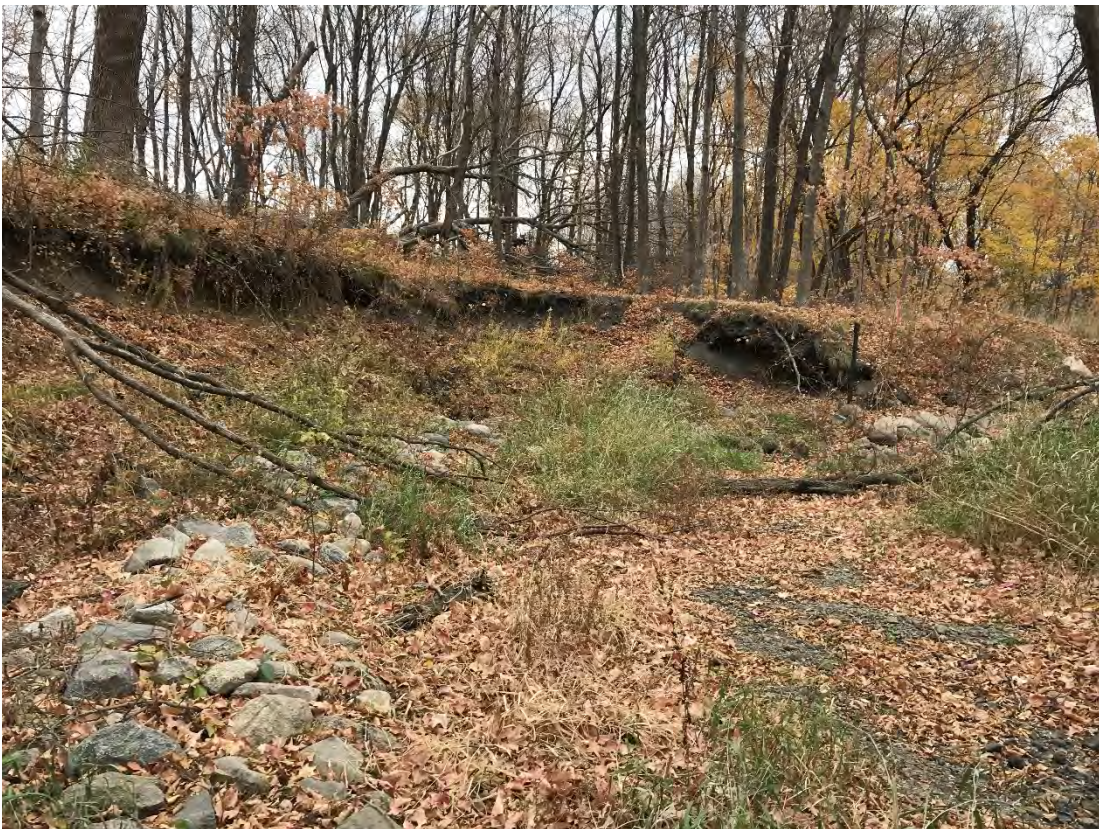
Numerous stream banks within this segment have been repaired since 2018 through the FEMA bank repair project. The primary bank stabilization practices implemented included placement of boulder toe along the sides of the channel and installation of rock cross vanes (Figure 7-Figure 9). Toe erosion has been minimized following the repair project, but surface erosion of the upper stream banks persists in areas with heavy shade (Figure 10). Following recent residential development in this reach, several new culverts have been installed within the channel and the culvert outfalls appeared stable (Figure 11). Tree loss has been significant as a result of the development, but the openings in the canopy have allowed herbaceous vegetation to become well established along the channel (Figure 12, Figure 13). Some leaning trees and down trees exist in this segment but are not currently impeding flow.

Figure 7. Boulder toe bank stabilization from the FEMA project

Figure 8. Boulder toe and cross vanes from the FEMA project

Figure 9. Boulder toe bank stabilization from the FEMA project

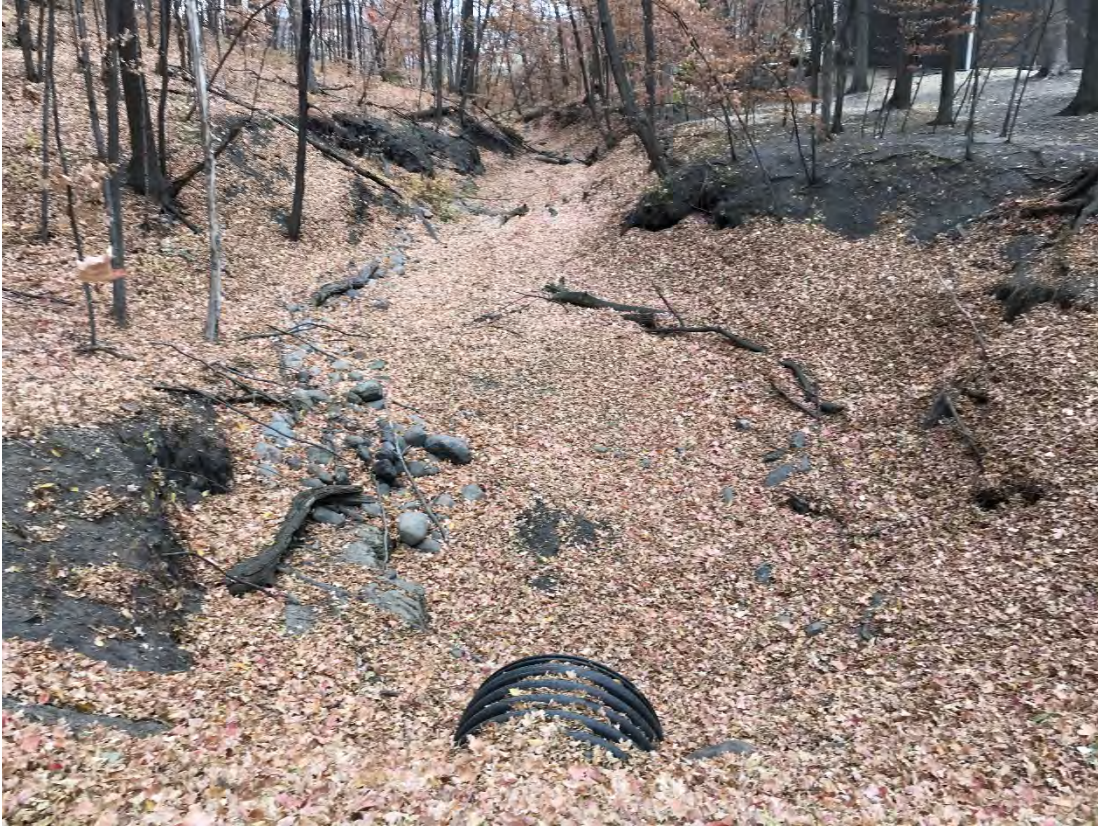
Figure 10. Upper bank surface erosion in areas with heavy shade

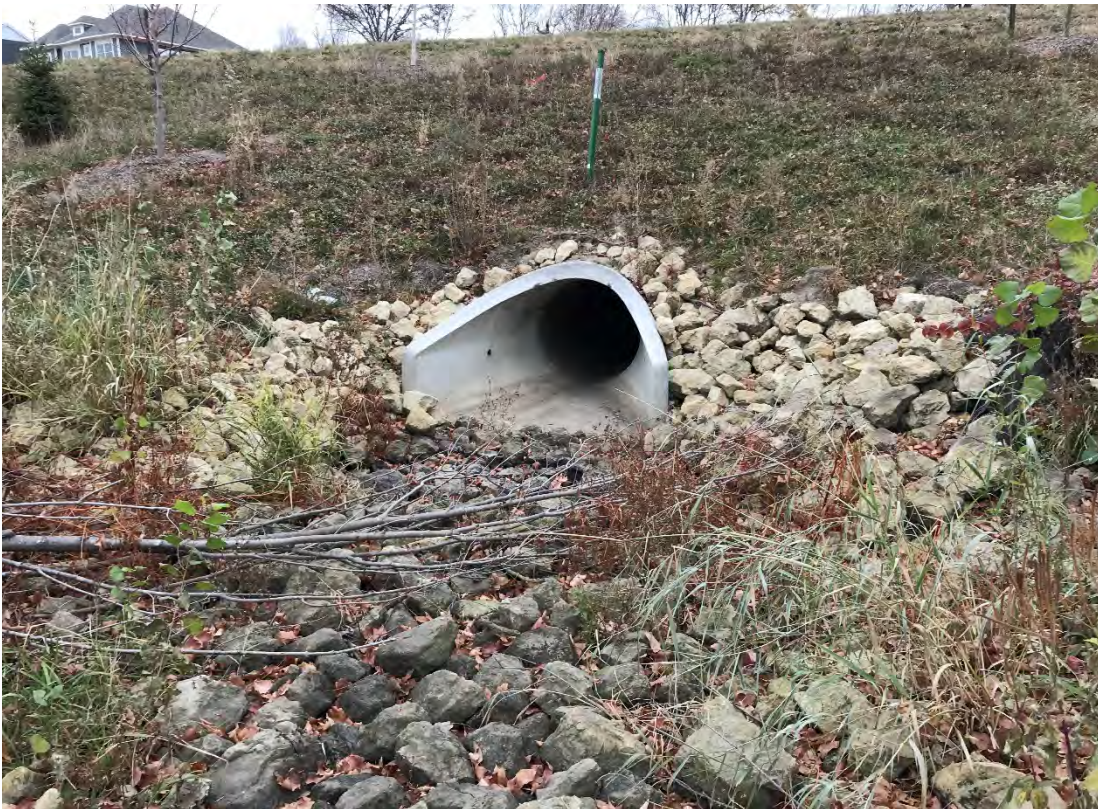
Figure 11. New culvert installed for a new road crossing (Marsh Drive NE)

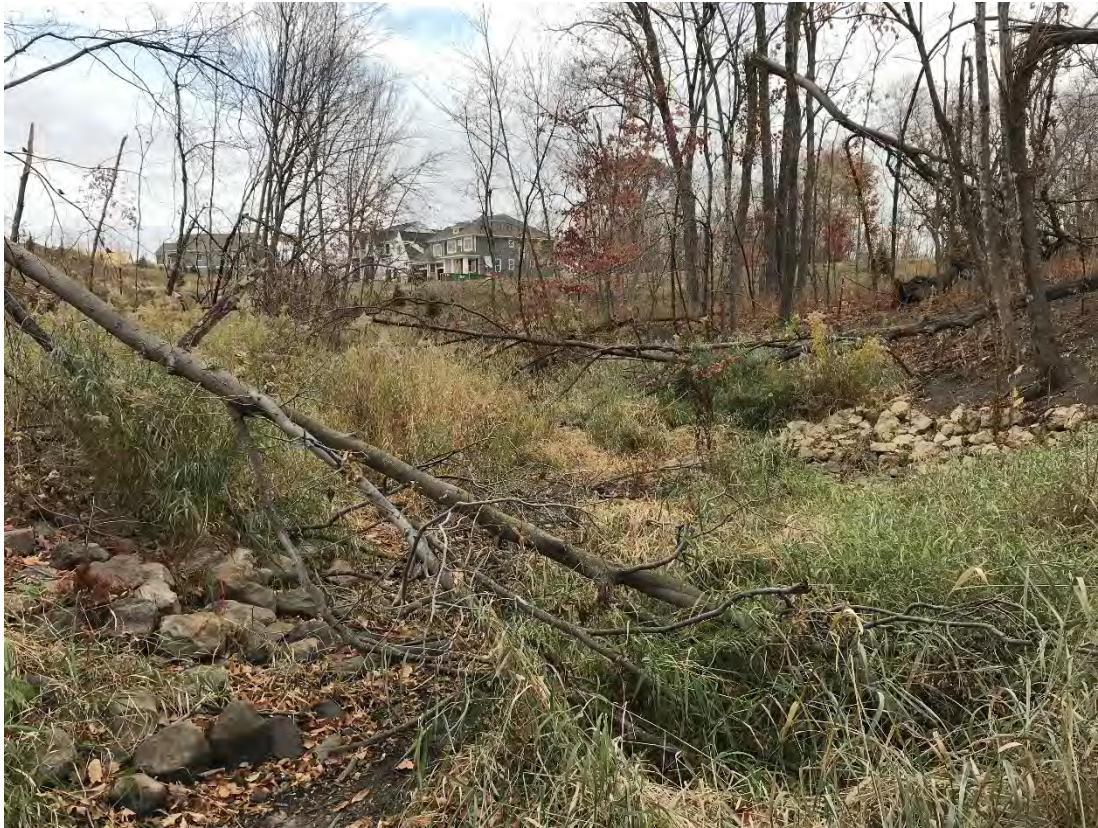
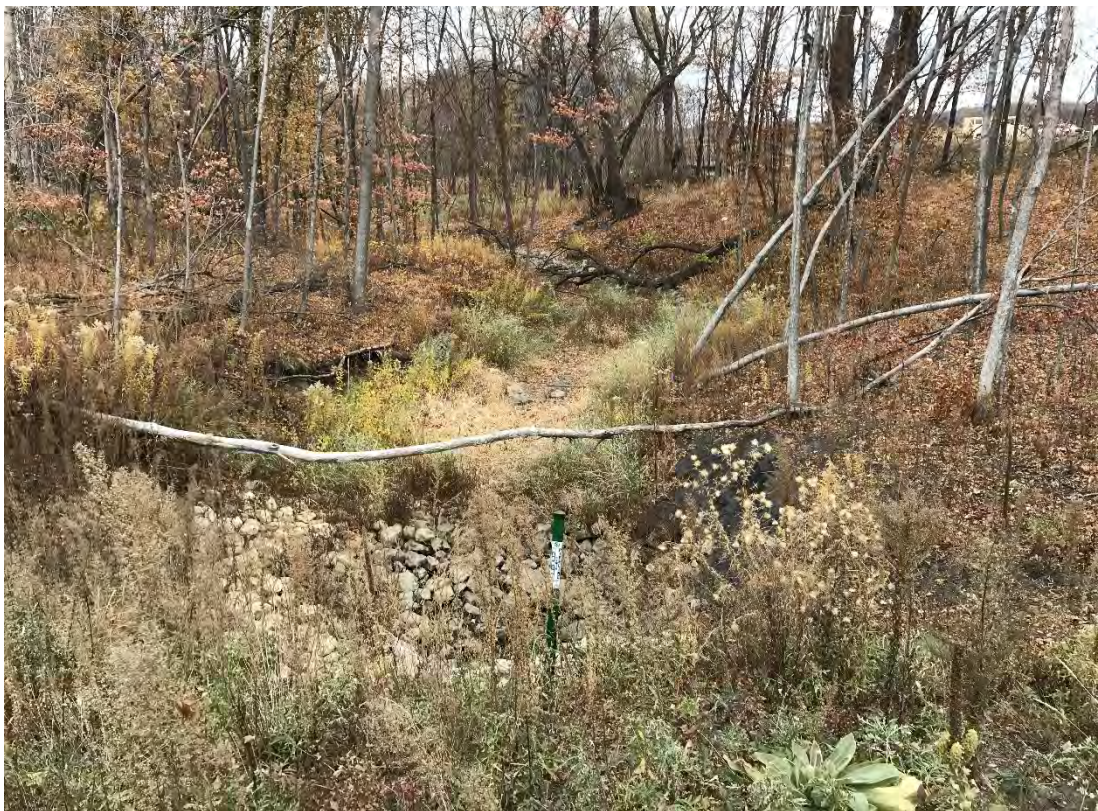
Figure 12. Open canopy and dense riparian vegetation along channel banks upstream of Marsh Drive NE

Figure 13. Open canopy and dense riparian vegetation downstream of Marsh Drive NE

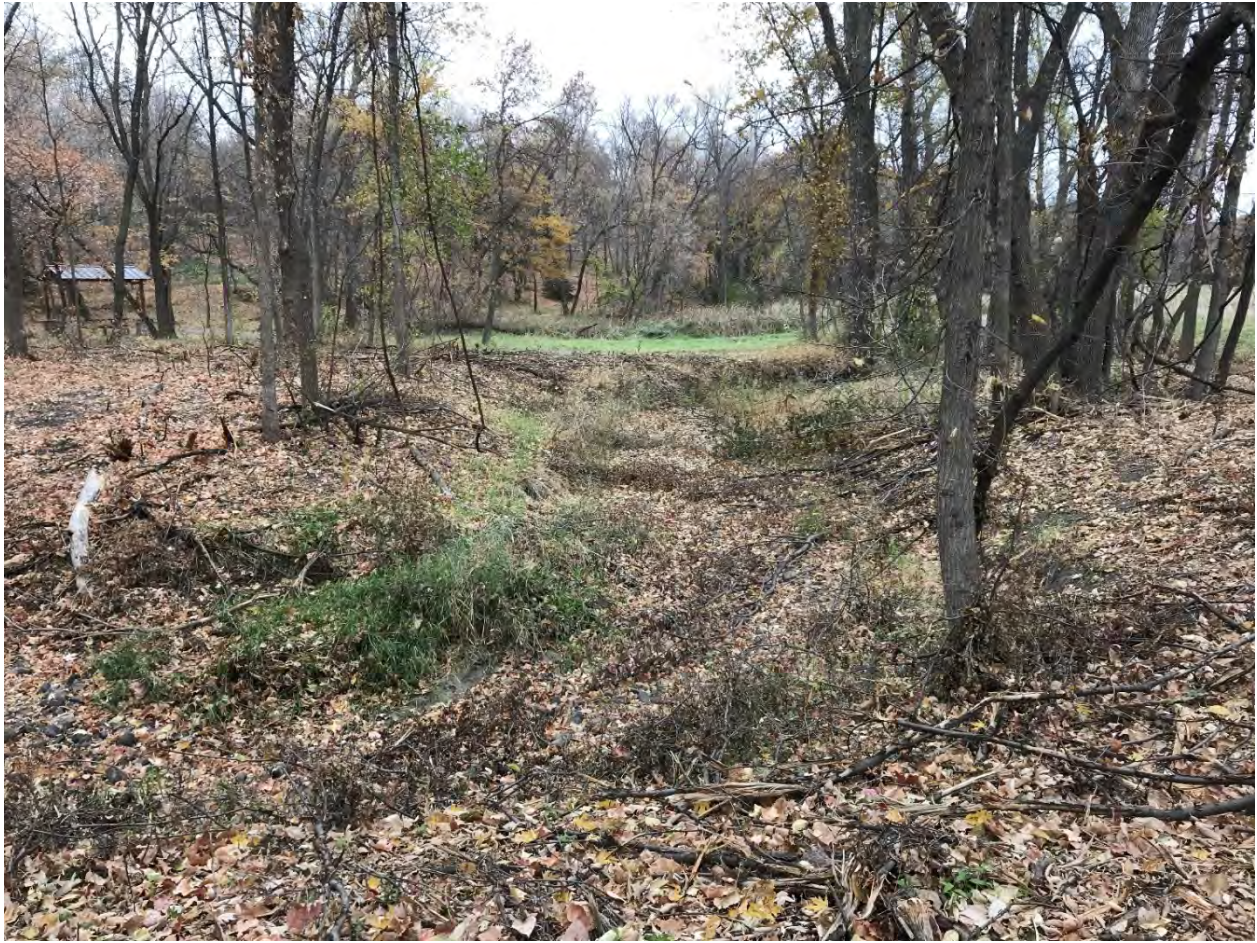
No new invasive species were found in this segment. In the fall of 2022, the City of Prior Lake conducted forestry mowing in Pike Lake Park to remove woody invasive species (Figure 14). Monitoring and treatment for garlic mustard, black locust, and common buckthorn should continue in 2023 to limit the spread of these species. Figure 15 shows the locations of target invasive species identified in this segment.

Figure 14. Forestry mowing of invasive species conducted along the PLOC in Pike Lake Park

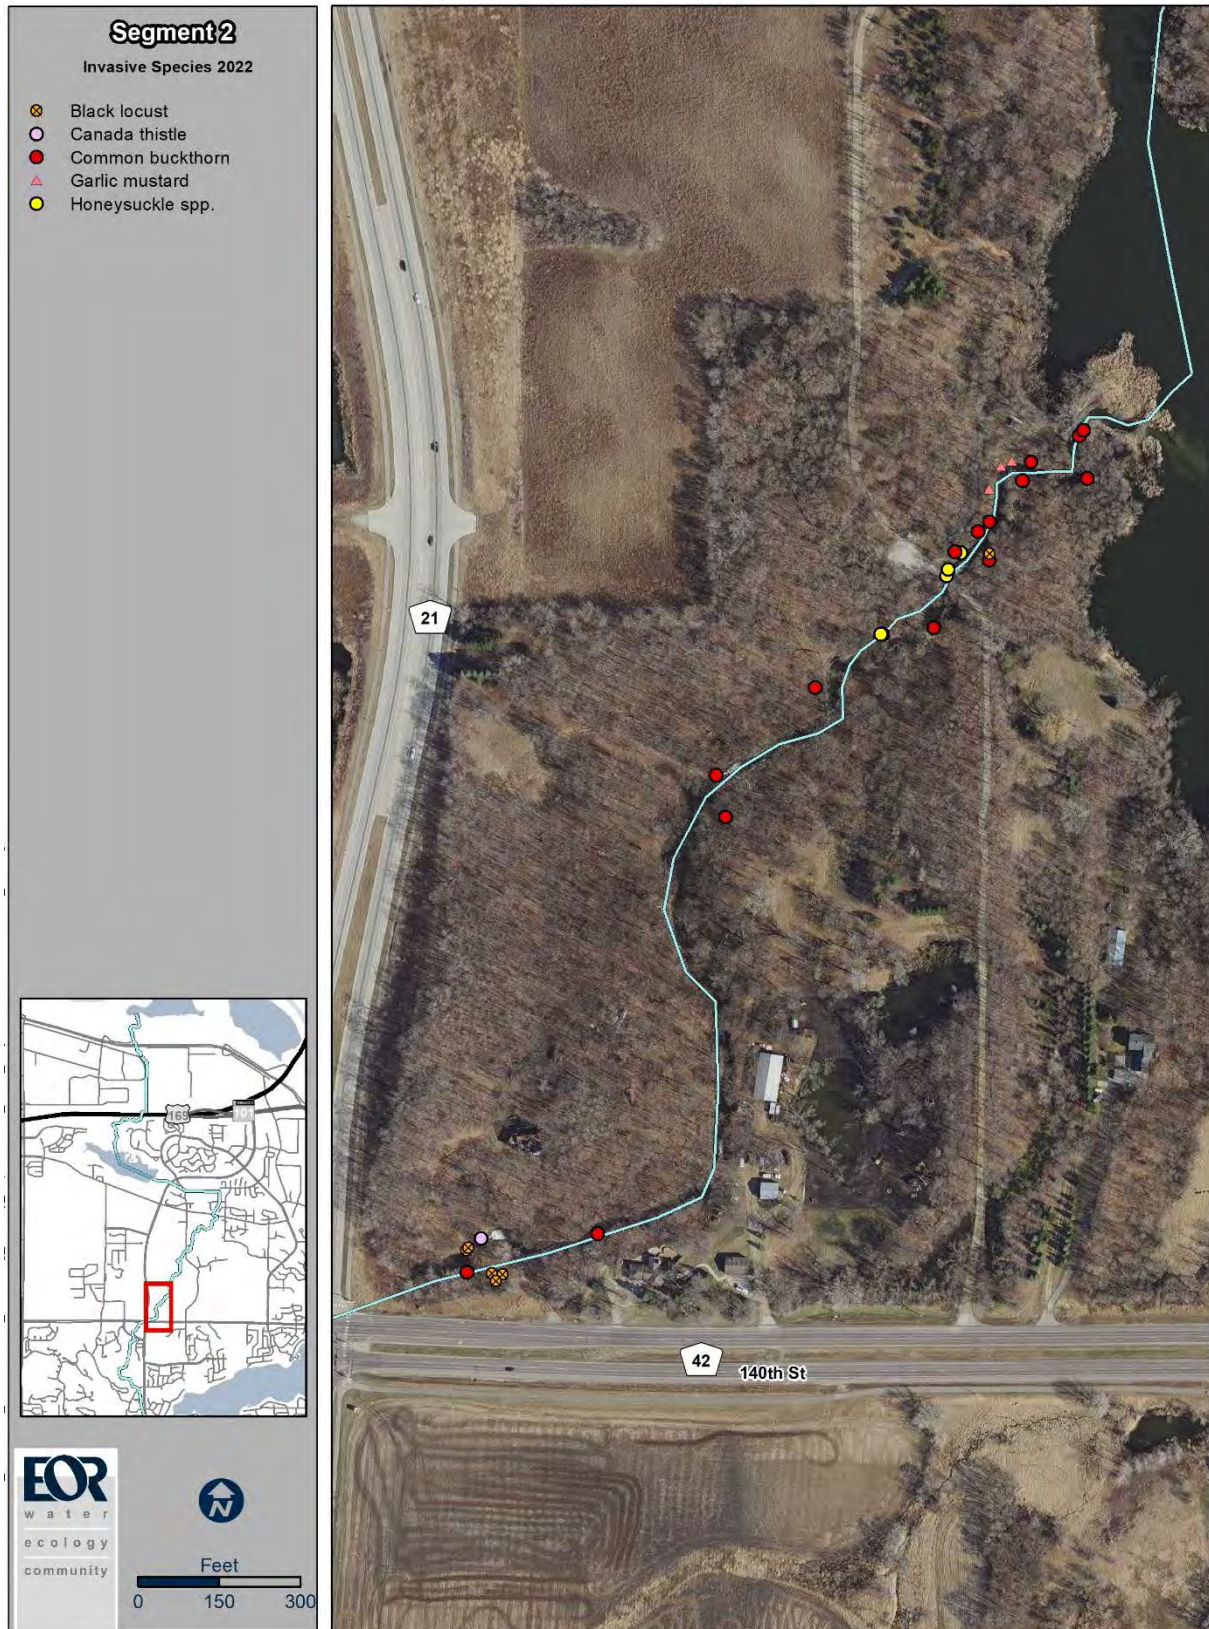
Figure 15. Target invasive species along Segment 2

- Perform cut stump treatments / foliar spray of all woody invasive trees, shrubs, and saplings located within 30 feet from the top of the bank from County Road 42 to Pike Lake.
- Scout and treat target herbaceous invasive species from County Road 42 to Pike Lake. Conduct one trip in mid-late May and a second trip in early July to prevent target invasive species from maturing and producing seed.

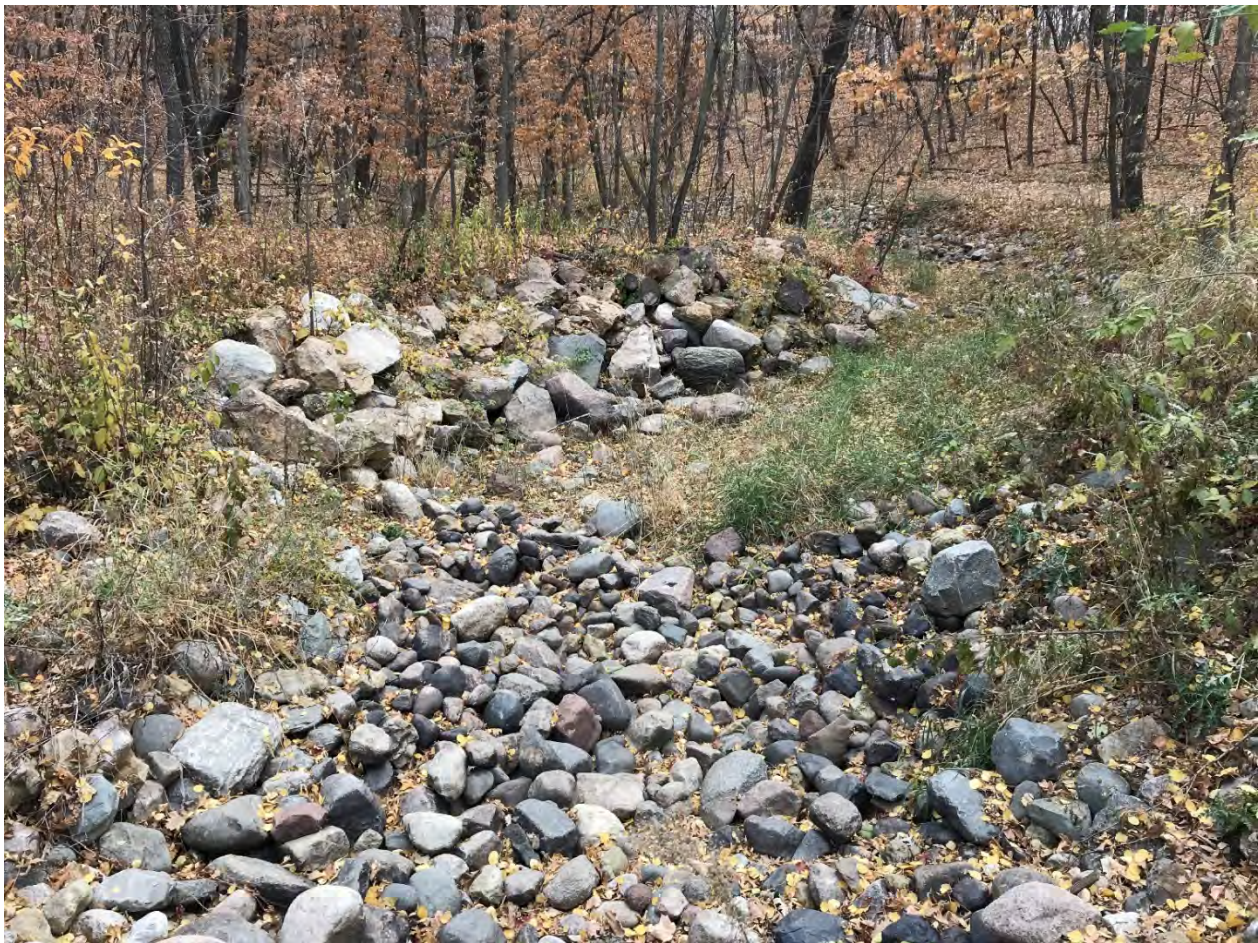
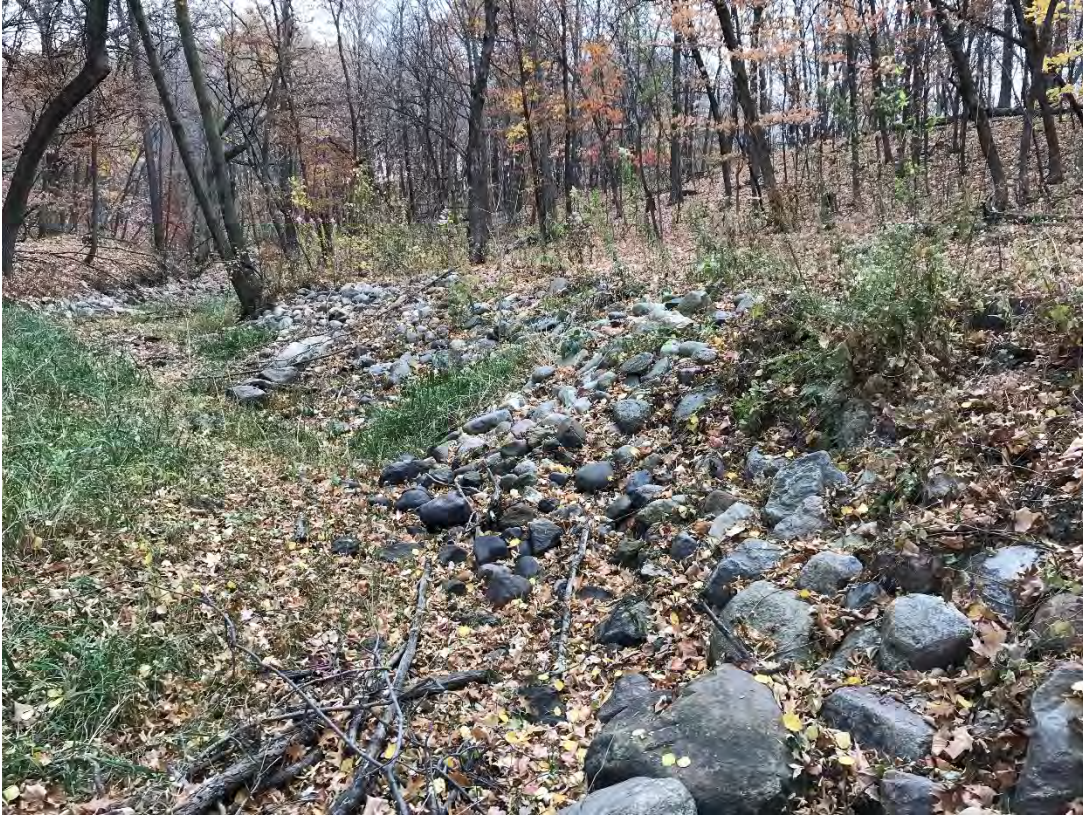
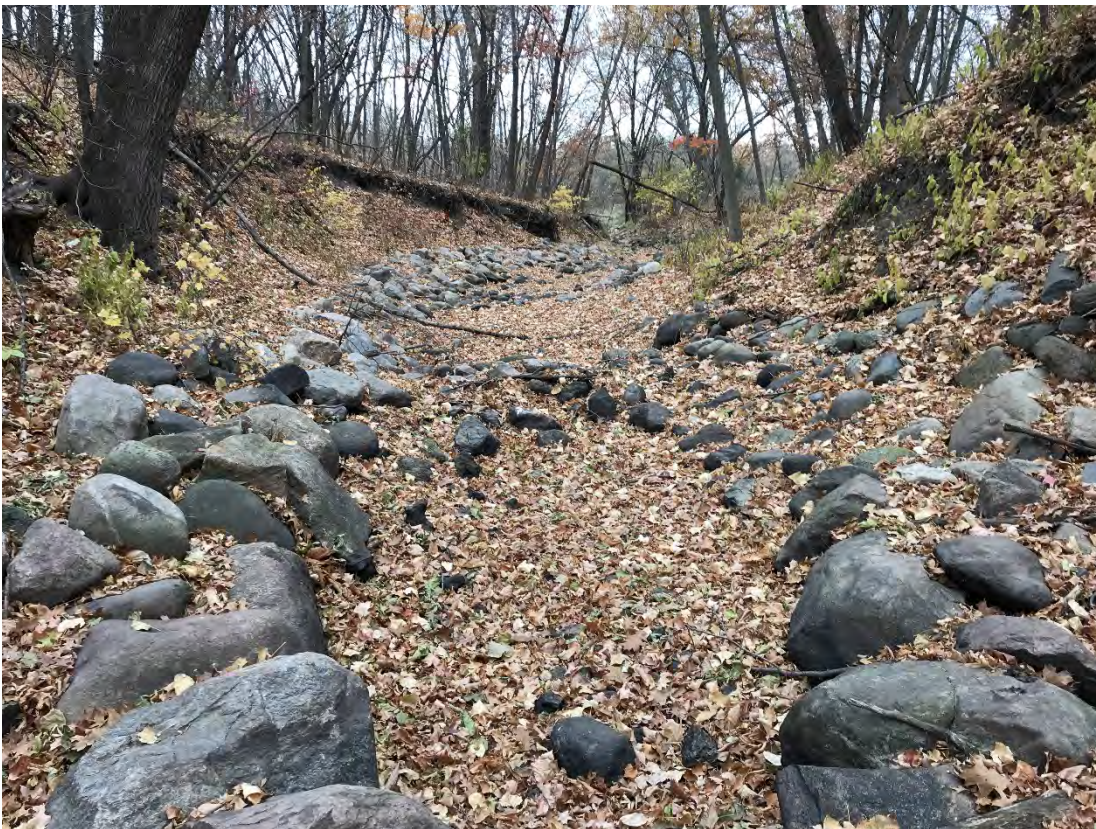
Numerous stream banks within this segment were repaired in 2019 using boulder toe stabilization (Figures 16-18). Boulder cross vanes were also installed in several locations for grade control and to concentrate flows to the center of the channel (Figure 19). The two wooden foot bridges in the Kici Yapi reach have been removed in 2022 (Figure 20). With limited flow during the growing season, riparian vegetation growth has occurred in the channel and adjacent banks (Figure 21, Figure 22).

Figure 16. Rock bank stabilization at the upstream end of the Kici Yapi reach

Figure 17. Bank stabilization along the gravel road in the Kici Yapi reach

Figure 18. Bank stabilization and grade control in the middle of the Kici Yapi reach

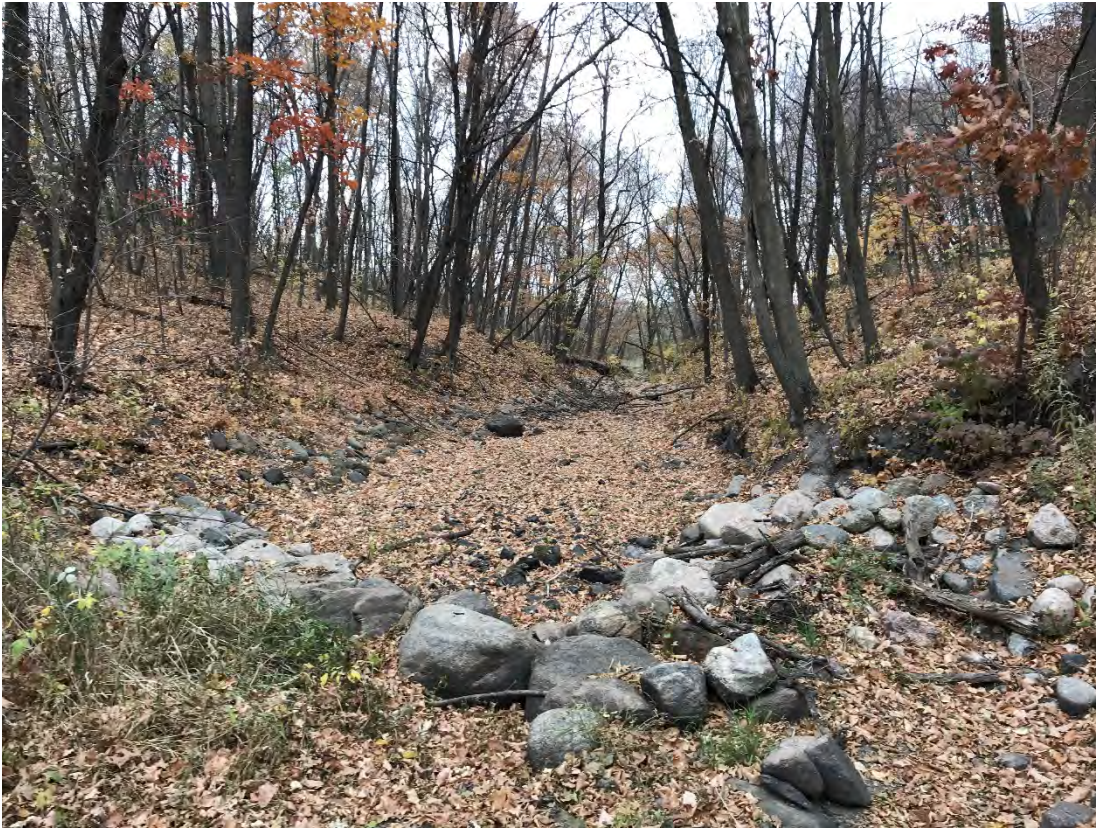
Figure 19. Rock cross vane in the Kici Yapi reach
