Project Name | PLOC Channel & Vegetation Inspections

Date | 12/7/2022

Regarding | Channel and Vegetation Inspections – 2022 Summary

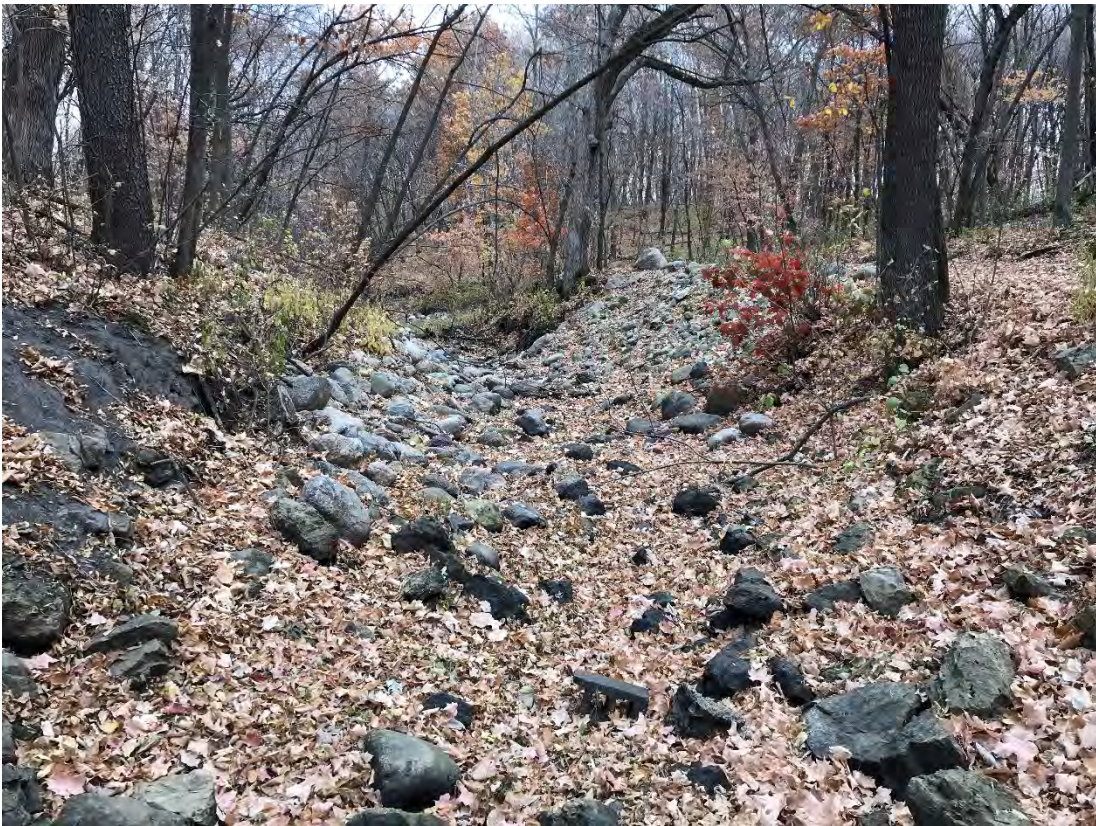
Numerous stream banks within this segment were repaired in 2019 using boulder toe stabilization (Figures 16-18). Boulder cross vanes were also installed in several locations for grade control and to concentrate flows to the center of the channel (Figure 19). The two wooden foot bridges in the Kici Yapi reach have been removed in 2022 (Figure 20). With limited flow during the growing season, riparian vegetation growth has occurred in the channel and adjacent banks (Figure 21, Figure 22).

Figure 20. Location of a former wooden bridge that was removed in 2022 in the Kici Yapi reach

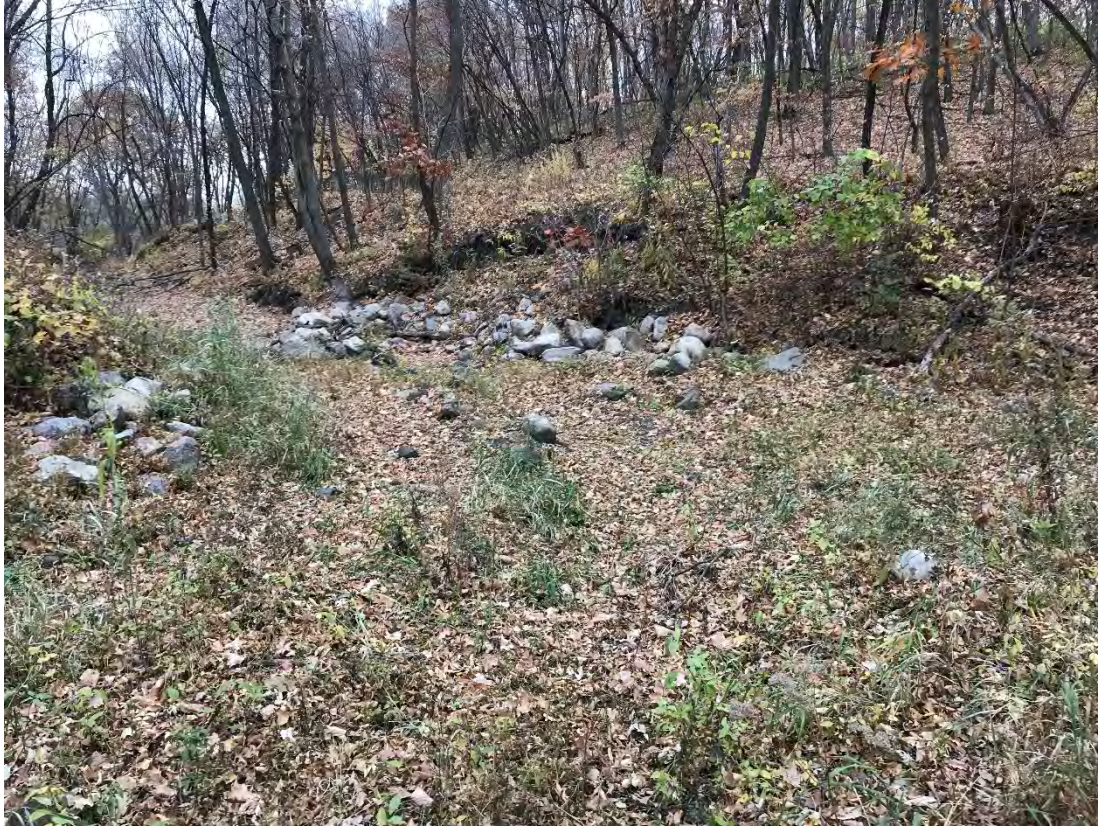
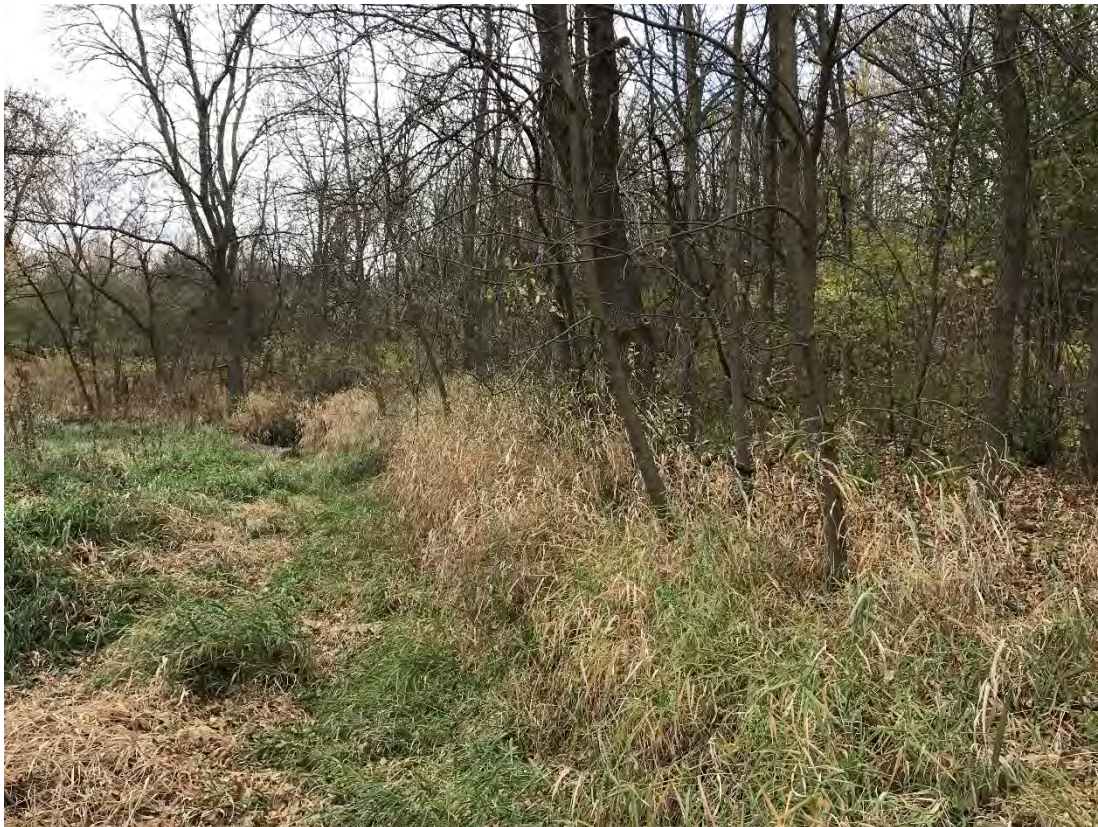
Figure 21. Vegetation establishment within the channel in the Kici Yapi reach

Figure 22. Dense vegetation within the channel upstream of Pike Lake Trail

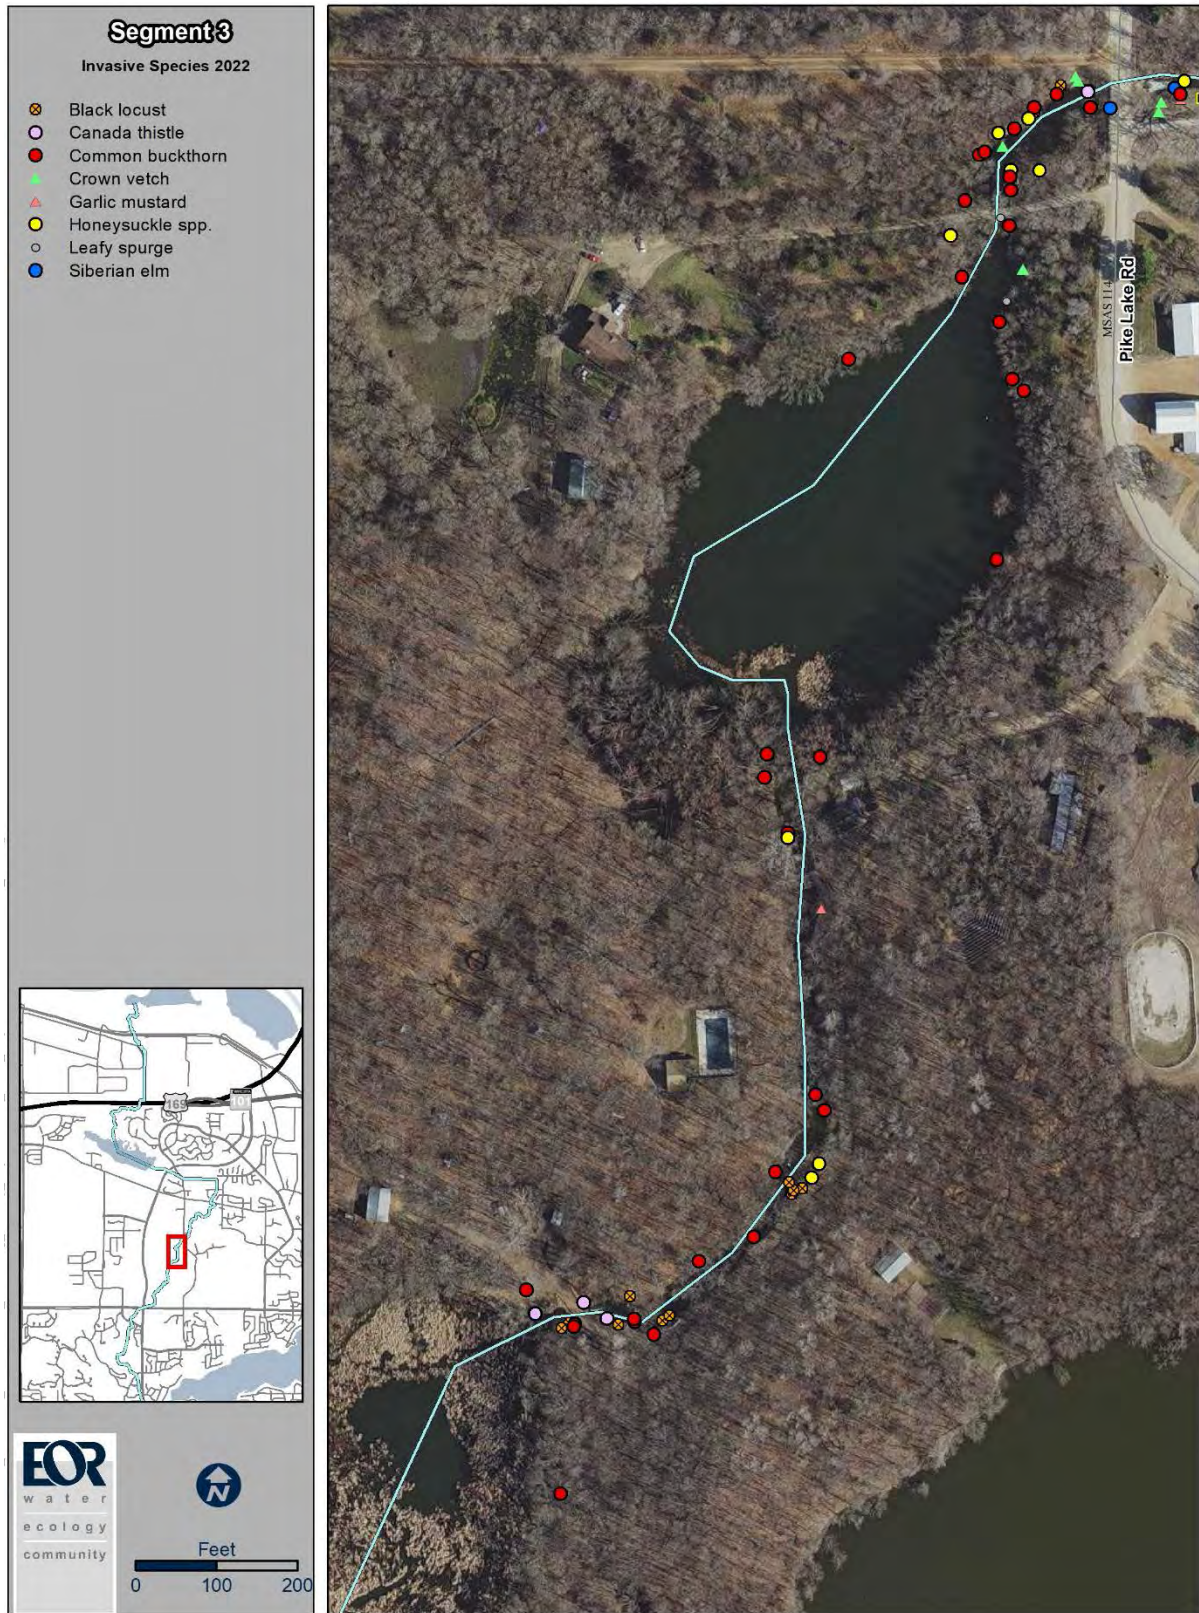
No new invasive species were found in this segment. Small saplings of black locust, common buckthorn (*Rhamnus cathartica*) and bush honeysuckle (*Lonicera spp.*) were observed in areas previously managed. Coordination with the Shakopee Mdewakanton Sioux Community is recommended to manage future populations of invasive species in this segment. Figure 23 shows the locations of target invasive species identified in this segment.

Figure 23. Target invasive species along Segment 3

- Perform cut stump treatments / foliar spray of all woody invasive trees, shrubs, and saplings located within 30 feet from the top of the bank from the outlet of Pike Lake to Pike Lake Trail, excluding the open water zone around the large wetland and the Kici Yapi reach.

- Coordinate with the Shakopee Mdewakanton Sioux Community to manage invasive species along the Kici Yapi reach.
- Scout and treat target herbaceous invasive species from outlet of Pike Lake to Pike Lake Trail, excluding the open water zone around the large wetland and the Kici Yapi reach. Conduct one trip in mid-late May and a second trip in early July to prevent target invasive species from maturing and producing seed.

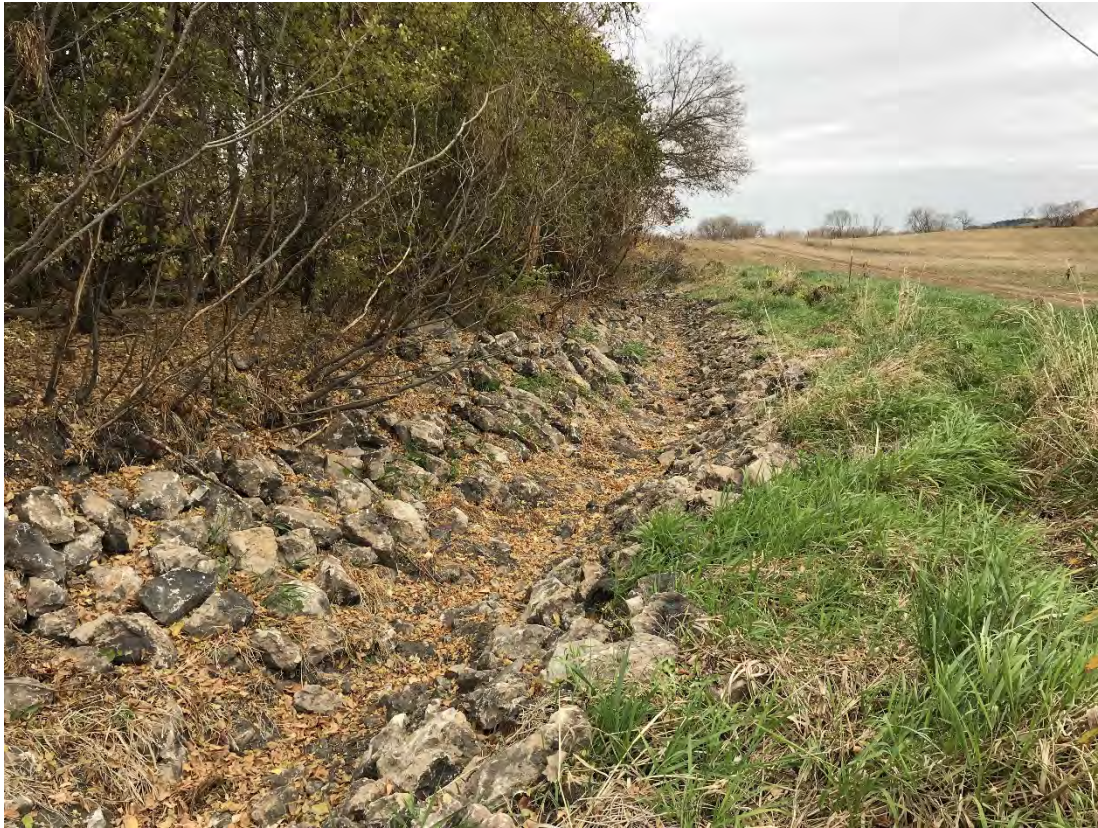
In Segment 4A, the stream banks were repaired in the summer of 2022 using boulder toe rock and grade control structures (Figure 24). Floodplain benches were also excavated to dissipate flood energy within the channel (Figure 25, Figure 26). The repairs included tree harvest to remove invasive species and allow access for bank grading to create floodplain benches. With limited flow during 2022, vegetation has become well established within the channel (Figure 27, Figure 28).

Figure 24. Repaired boulder toe downstream of Pike Lake Trail

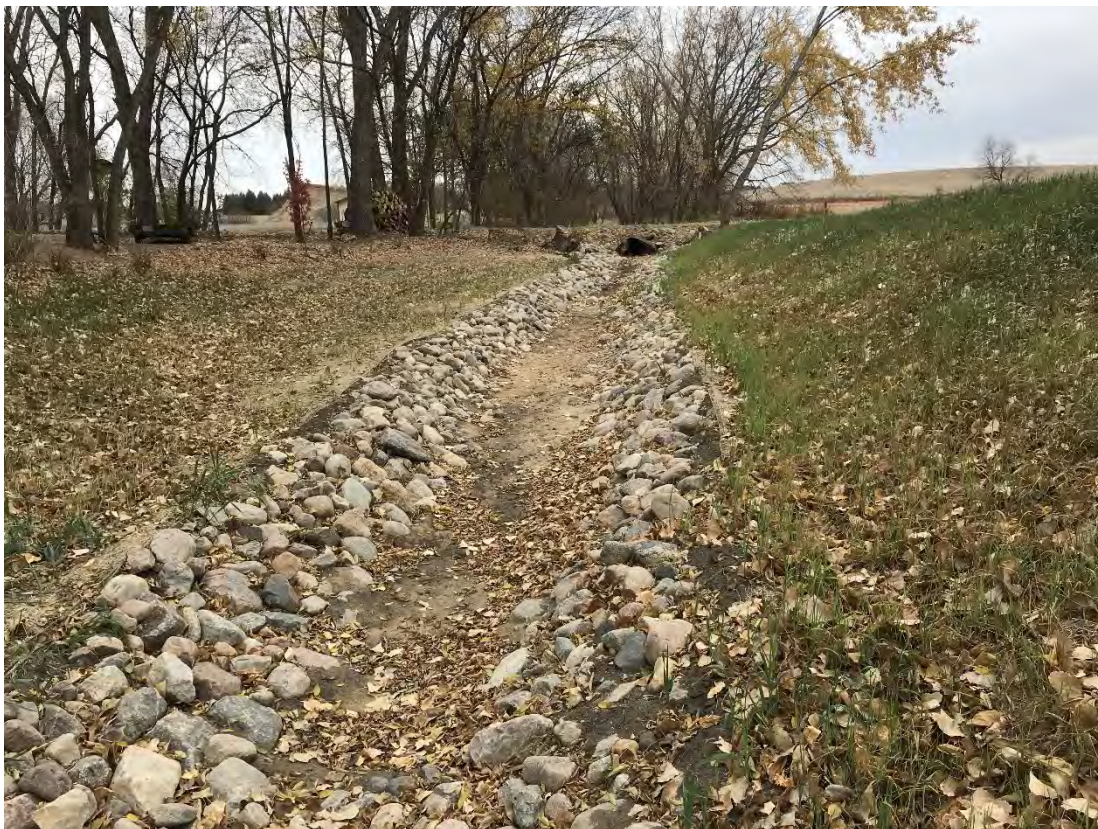
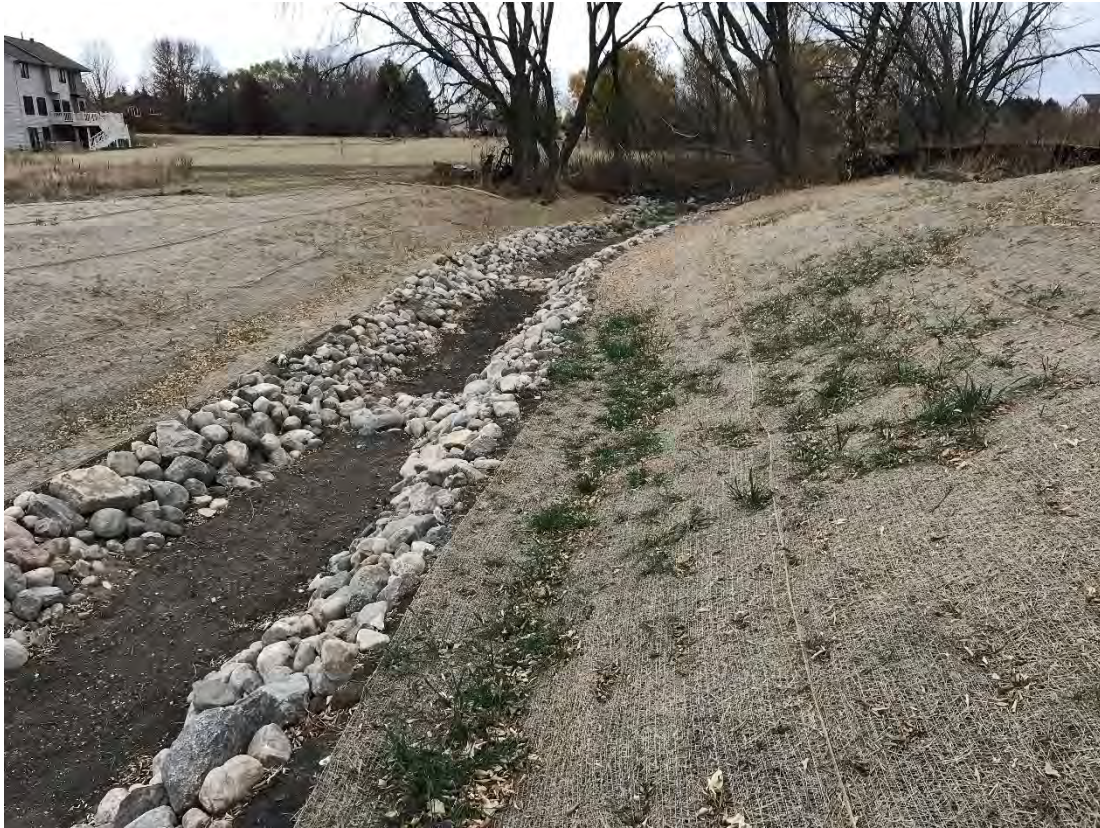
Figure 25. Repaired channel and floodplain bench upstream of Jackson Trail

Figure 26. Repaired channel and floodplain benches downstream of the Gonyea culvert

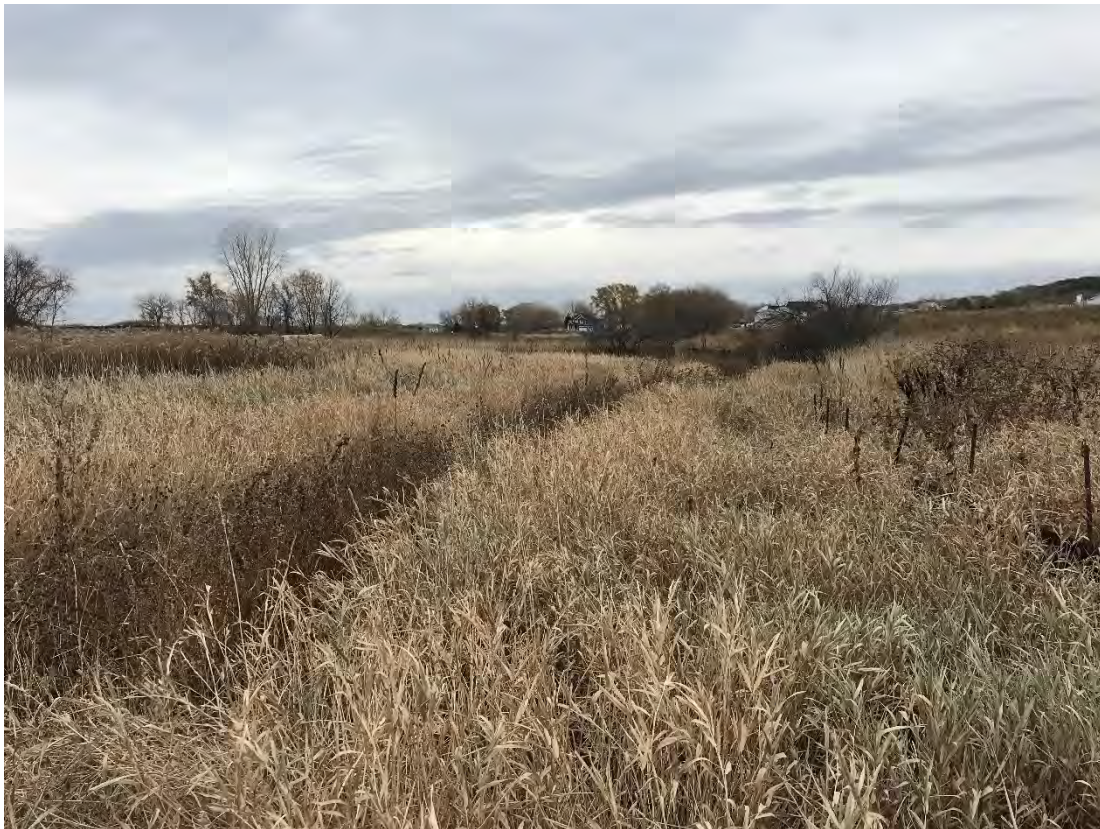
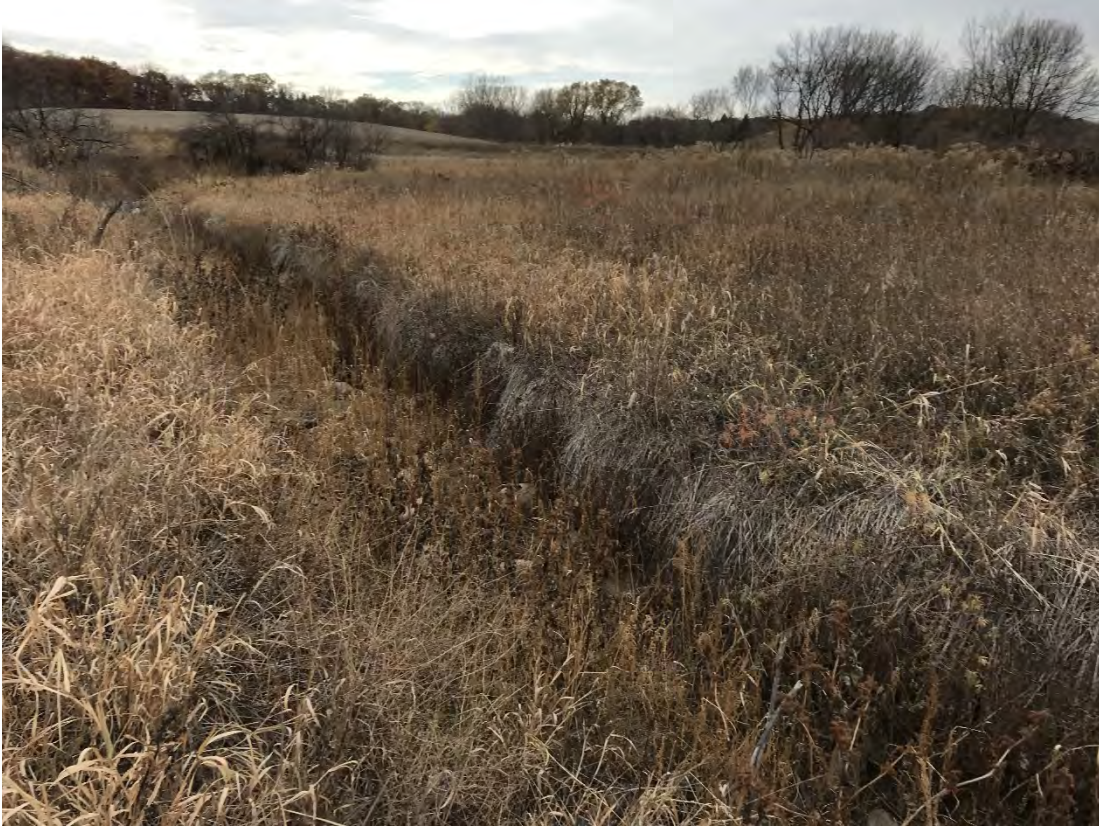
Figure 27. Dense vegetation within the PLOC channel in Segment 4A

Figure 28. Dense vegetation within the PLOC channel in Segment 4A

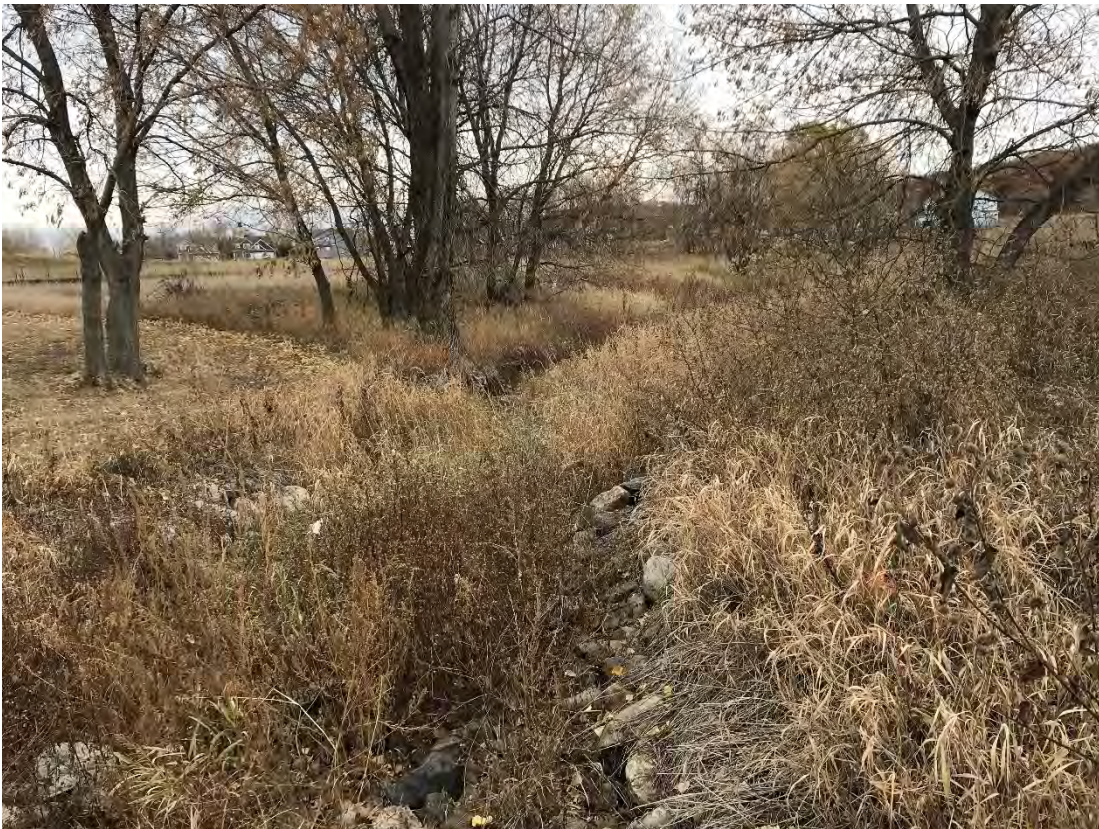
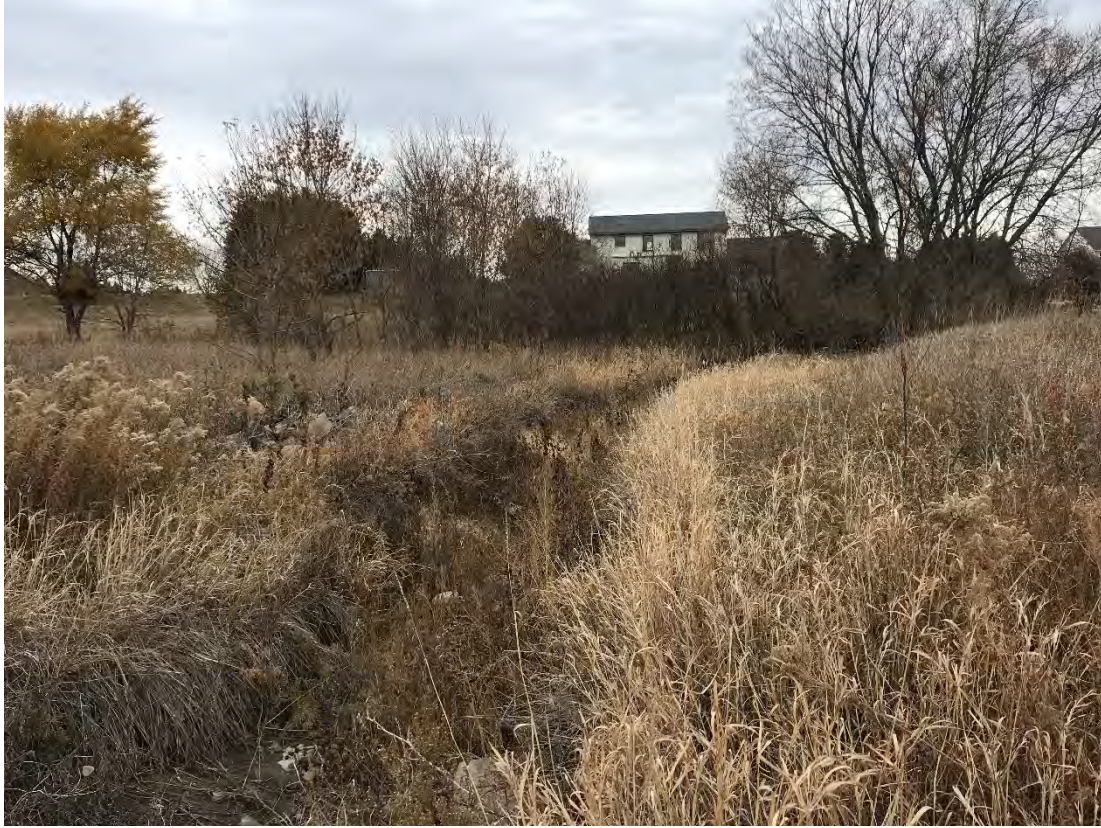
The stream banks stabilized by the FEMA-funded project that were repaired in 2021 were in good condition with dense riparian vegetation along the stream banks (Figure 29, Figure 30). A new box culvert was installed in the developed reach of Segment 4B, and the fallen trees documented in 2021 were removed for placement of the culvert (Figure 31).

Figure 29. FEMA bank repair area in Segment 4B with established vegetation

Figure 30. FEMA bank repair area in Segment 4B with established vegetation

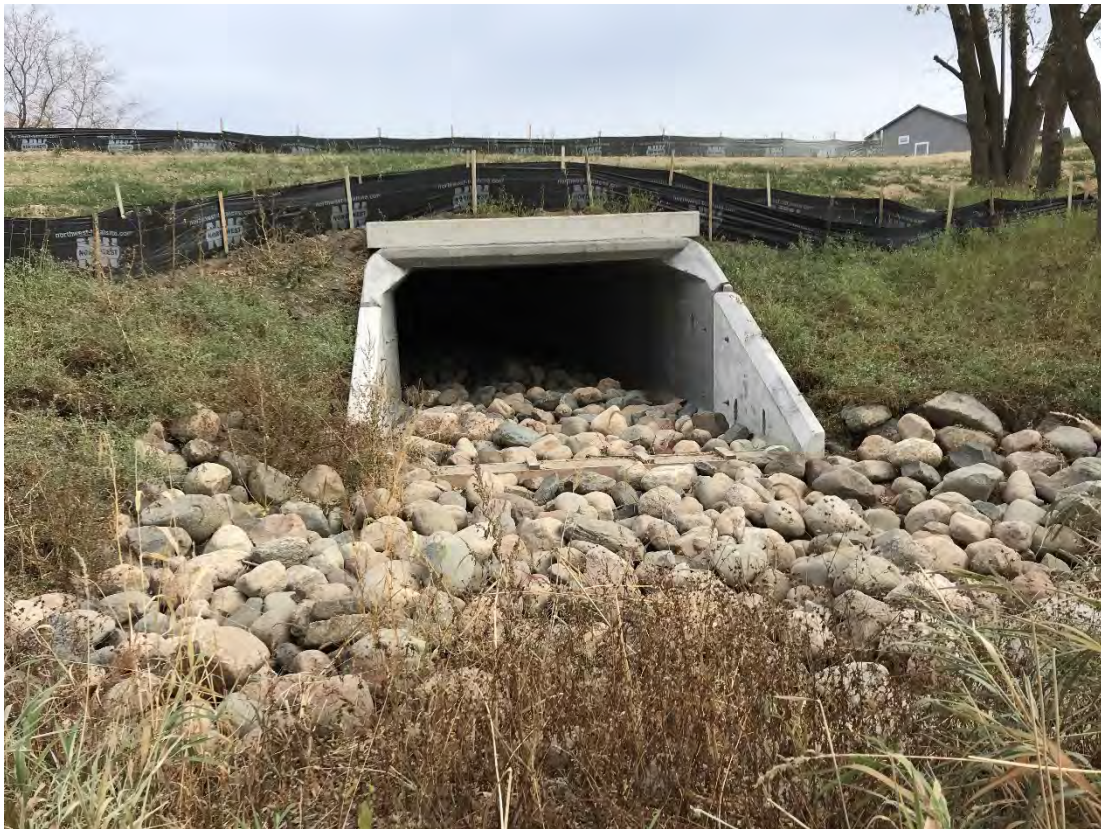
Figure 31. New box culvert and road crossing in Segment 4B

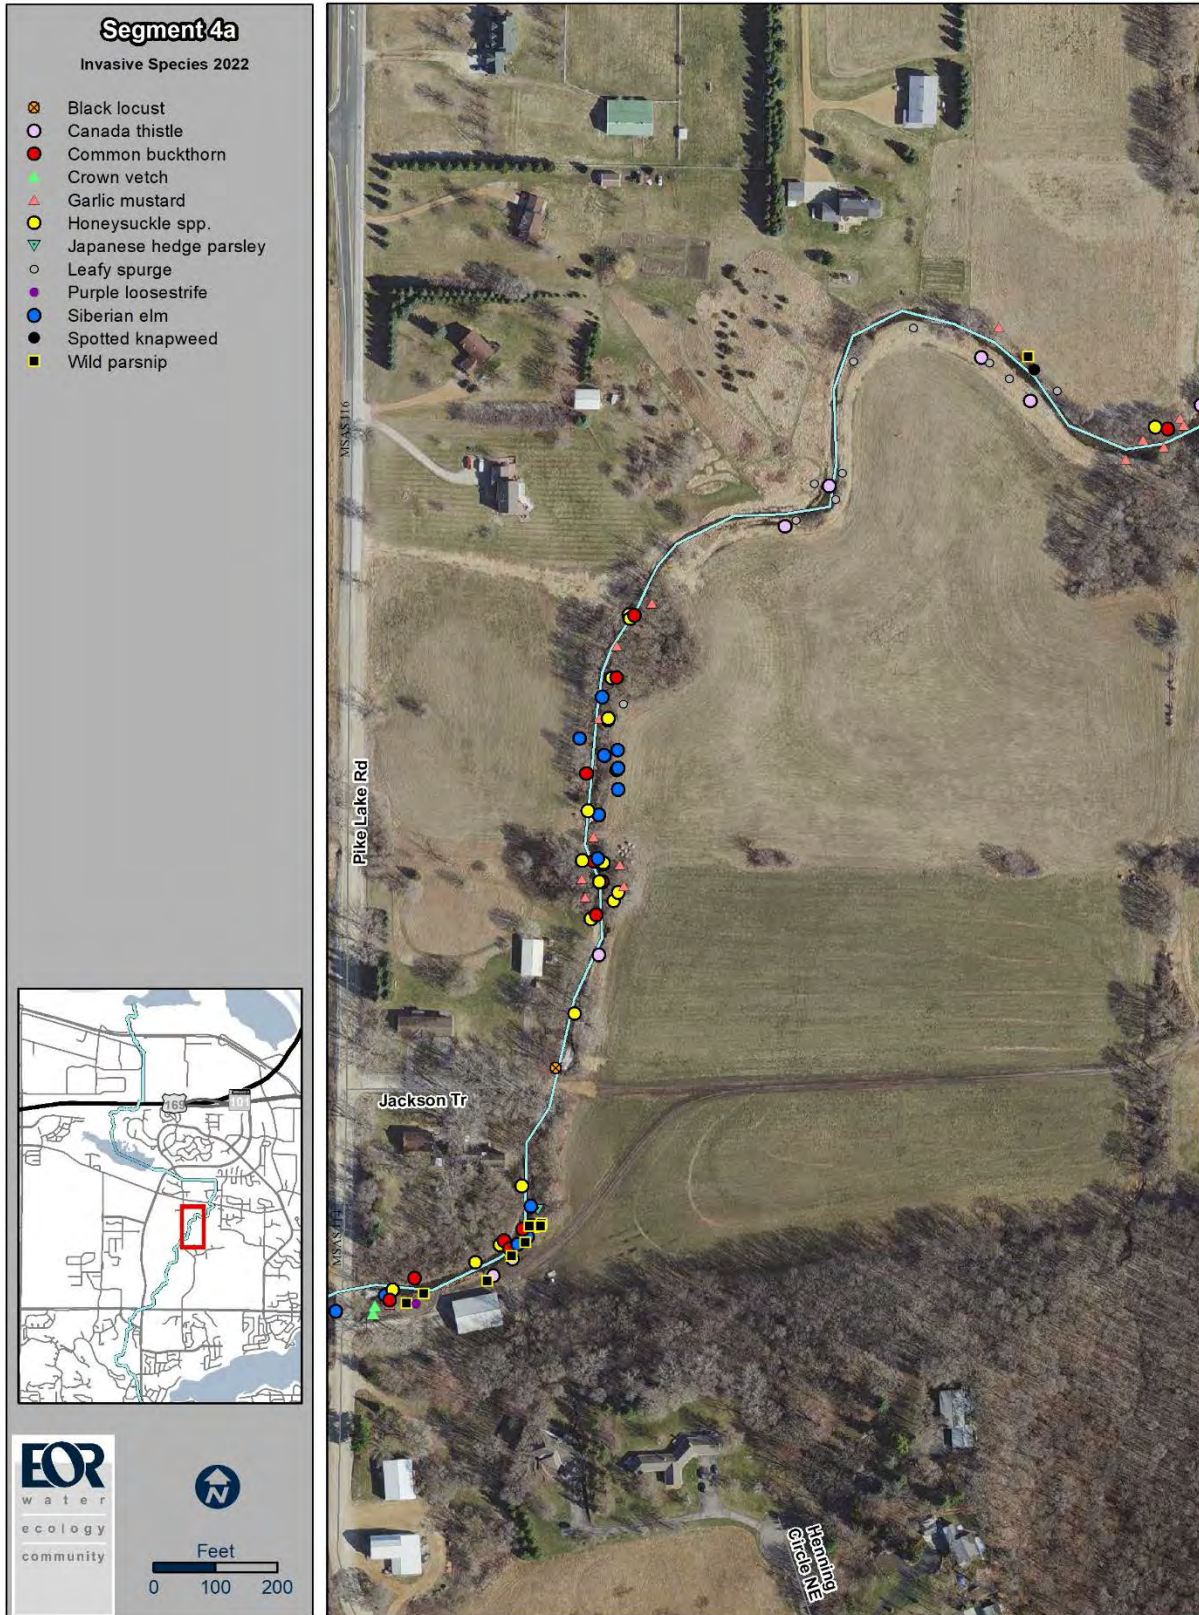
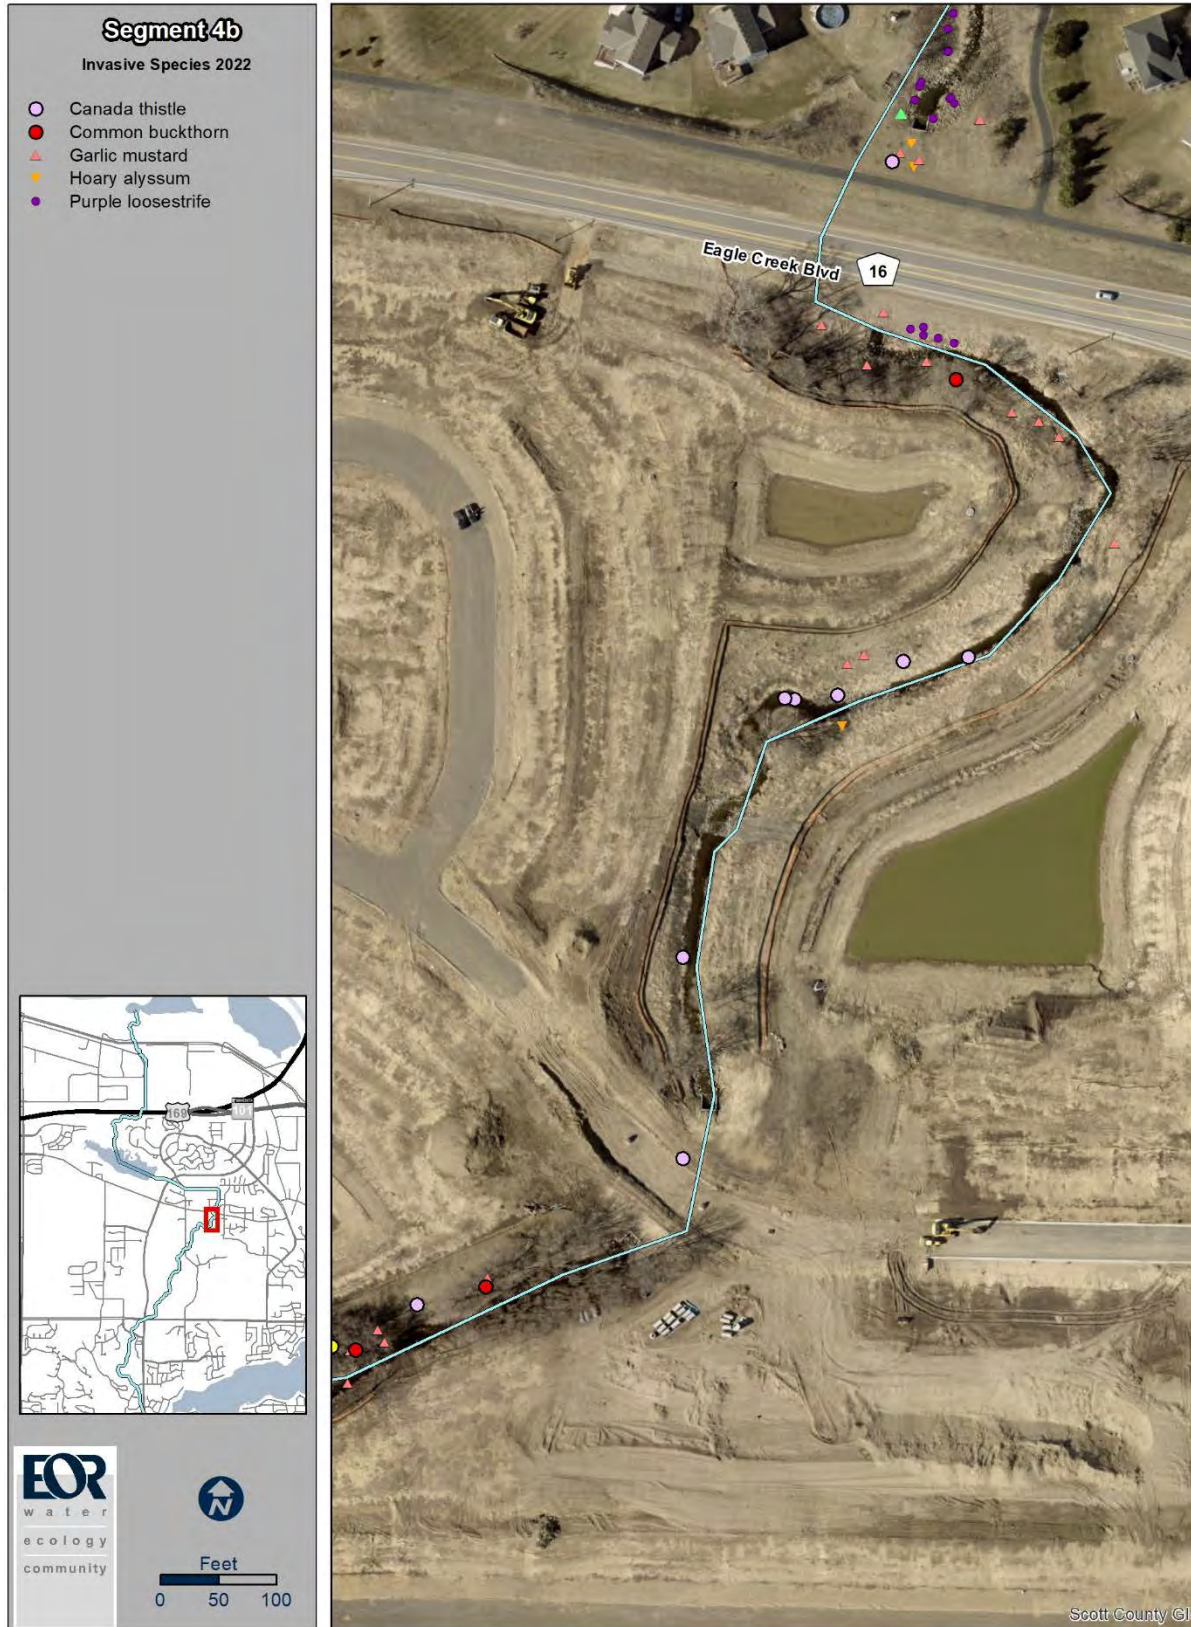
During the August vegetation inspection, one purple loosestrife plant was found at the upstream end of Segment 4A, and five purple loosestrife plants were found at the far downstream end of Segment 4B near County Road 16. Monitoring and treatment for known invasive species, particularly wild parsnip, garlic mustard, Japanese hedge parsley, and purple loosestrife should continue in 2023 to limit the spread of these species. Figure 32 and Figure 33 show the locations of target invasive species identified in this segment.

Figure 32. Target invasive species along Segment 4A

Figure 33. Target invasive species along Segment 4B

- Perform cut stump treatments / foliar spray of all woody invasive trees, shrubs, and saplings located within 30 feet from the top of the bank within the remaining wooded areas downstream of Jackson Trail to County Road 16.
- Scout and treat target herbaceous invasive species from Pike Lake Trail to County Road 16. Conduct one trip in mid-late May and a second trip in early July to prevent target invasive species from maturing and producing seed.

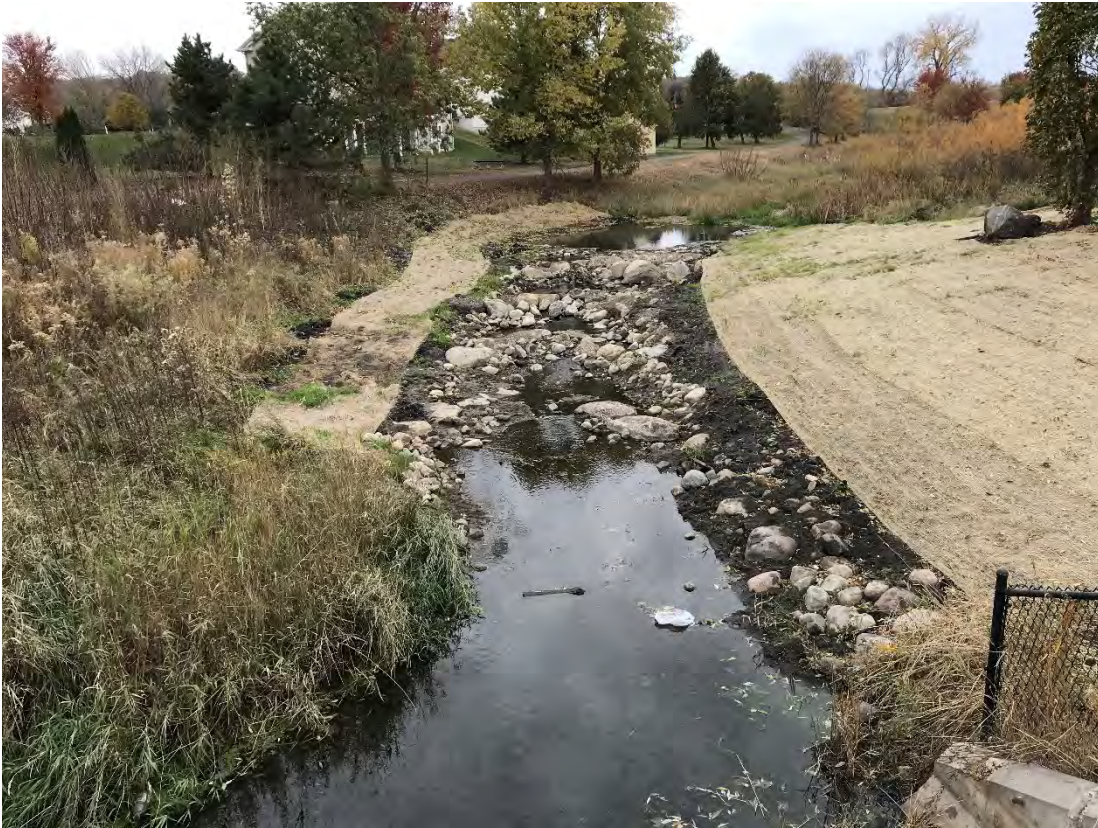
In the summer of 2022, boulder weirs were installed at the downstream end of Segment 5A to increase water storage and flood capacity of the wetland system between County Road 16 and Oak Ridge Trail (Figure 34). With the addition of the boulder weirs, the east and west stormwater ponds in Segment 5A are now equalized with the water level in the outlet channel (Figure 35).

Figure 34. Boulder weirs installed upstream of Oak Ridge Trail in Segment 5A

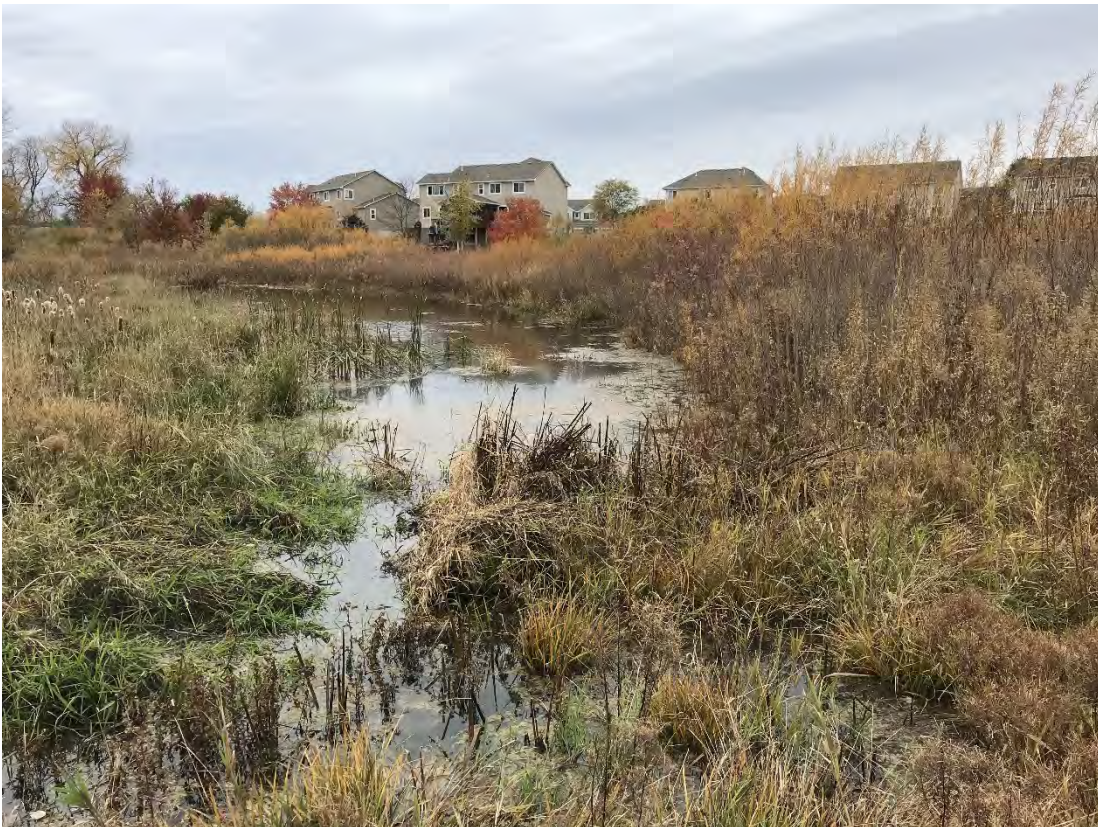
Figure 35. Equalized water levels in the west stormwater pond in Segment 5A

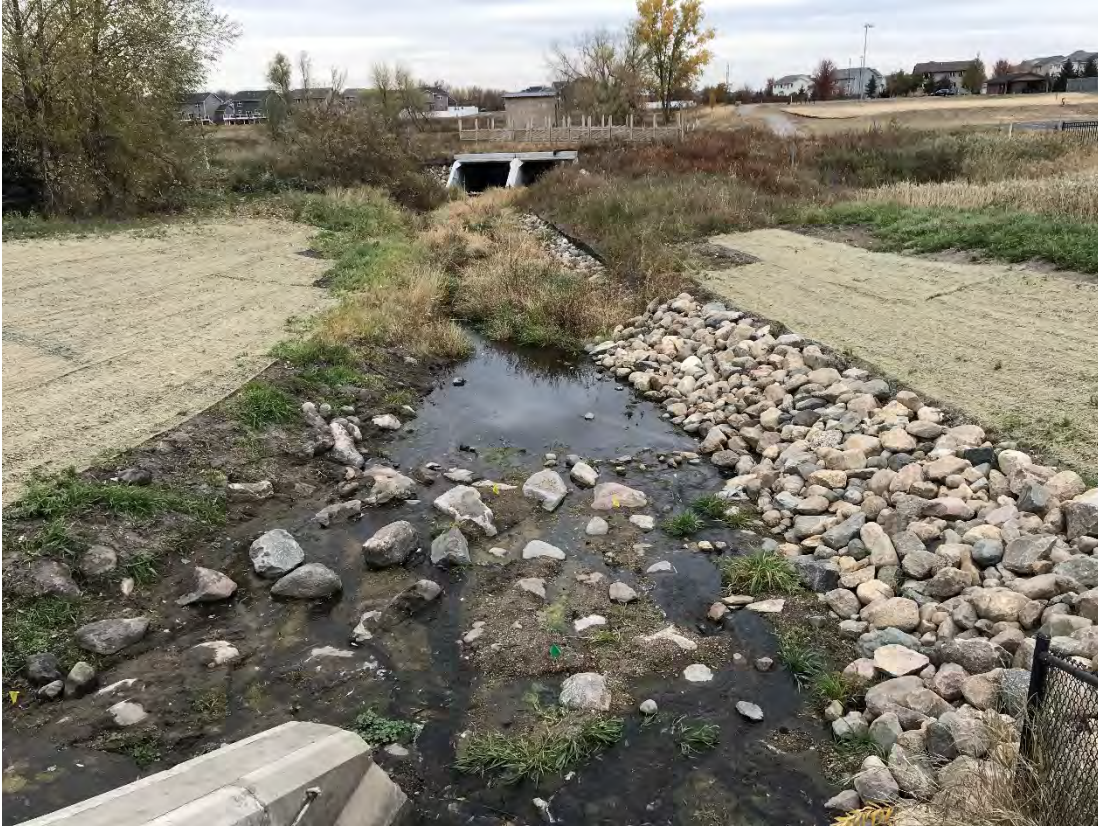
In Segment 5B, construction of the new outlet channel has been completed and new culverts have been installed along the new channel alignment (Figure 36). The new channel is stable and contains grade control structures (rock cross vanes), rootwads, and graded streambanks (Figure 37, Figure 38).

Figure 36. New box culvert installed at the upstream end of the new channel alignment in Segment 5B

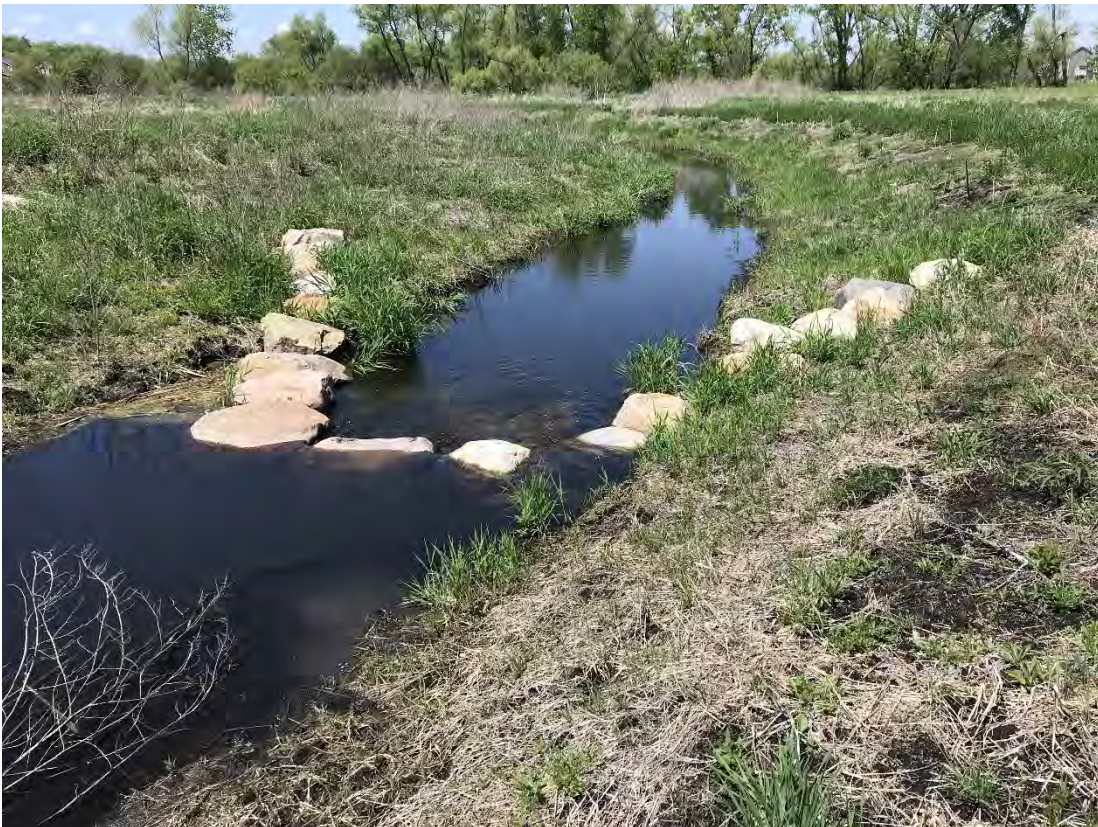
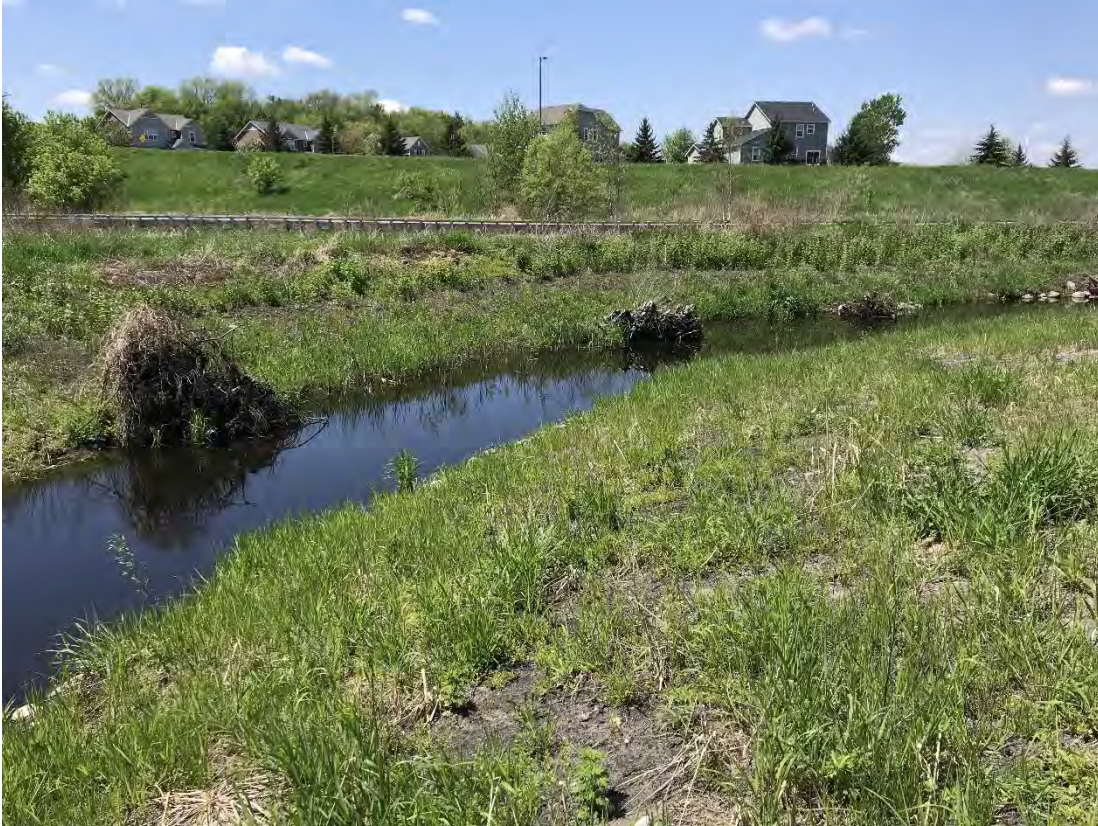
Figure 37. Boulder cross vane grade control installed in the new channel alignment in Segment 5B

Figure 38. Rootwads installed along the new channel alignment in Segment 5B

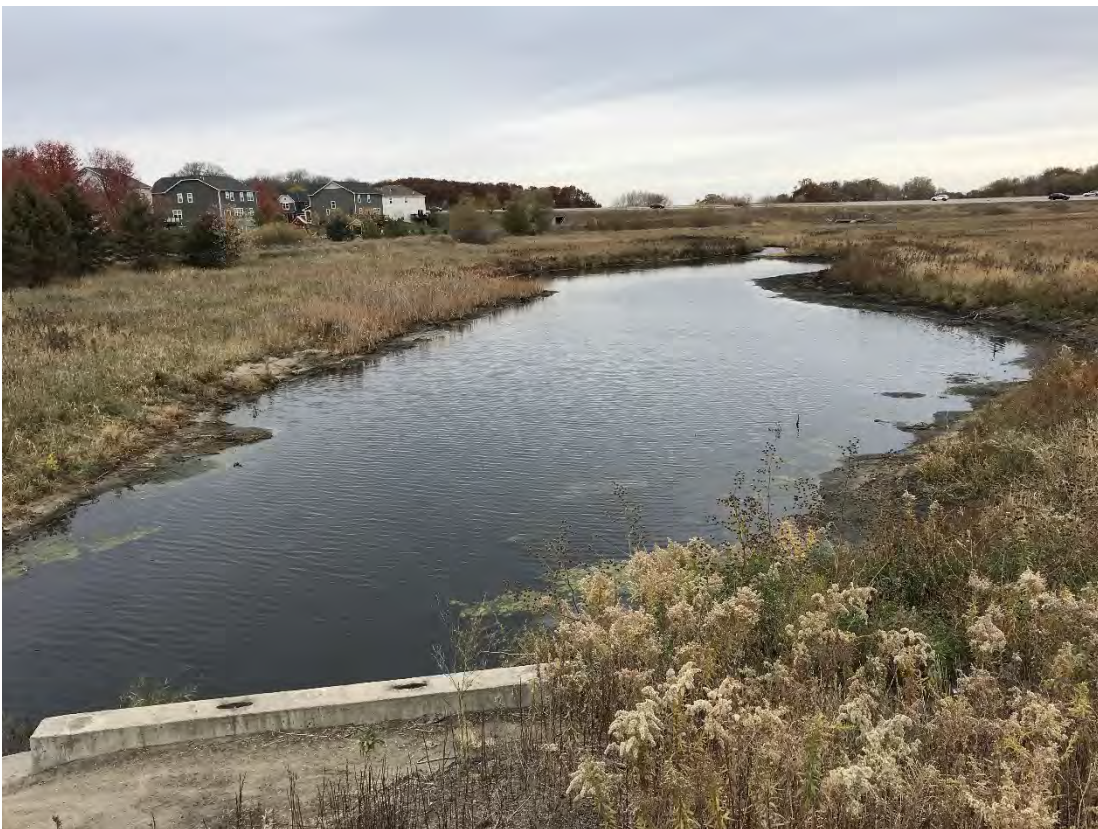
The sediment delta in Segment 5C downstream of Pike Lake Road was removed in early 2022 (Figure 39).

Figure 39. Open water pond downstream of Pike Lake Road in Segment 5C
