Project Name | PLOC Channel & Vegetation Inspections

Date | 12/7/2022

Regarding | Channel and Vegetation Inspections – 2022 Summary

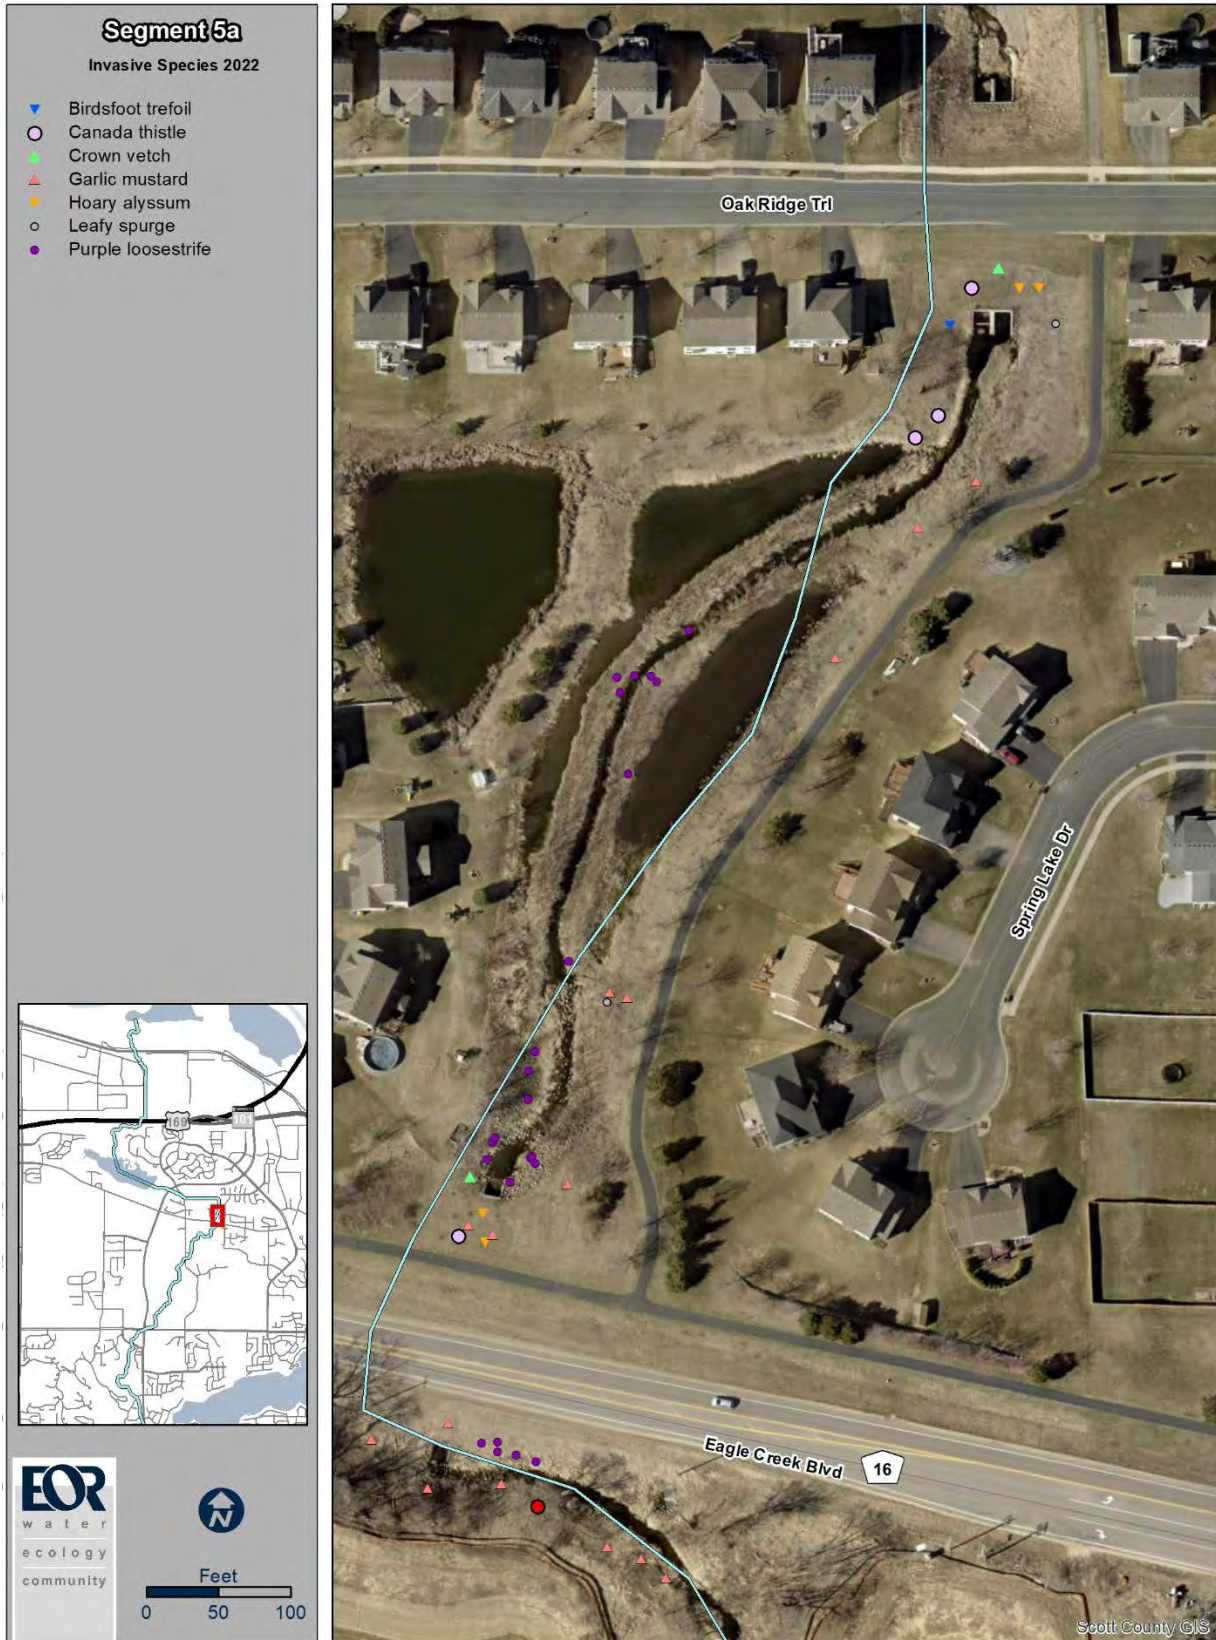
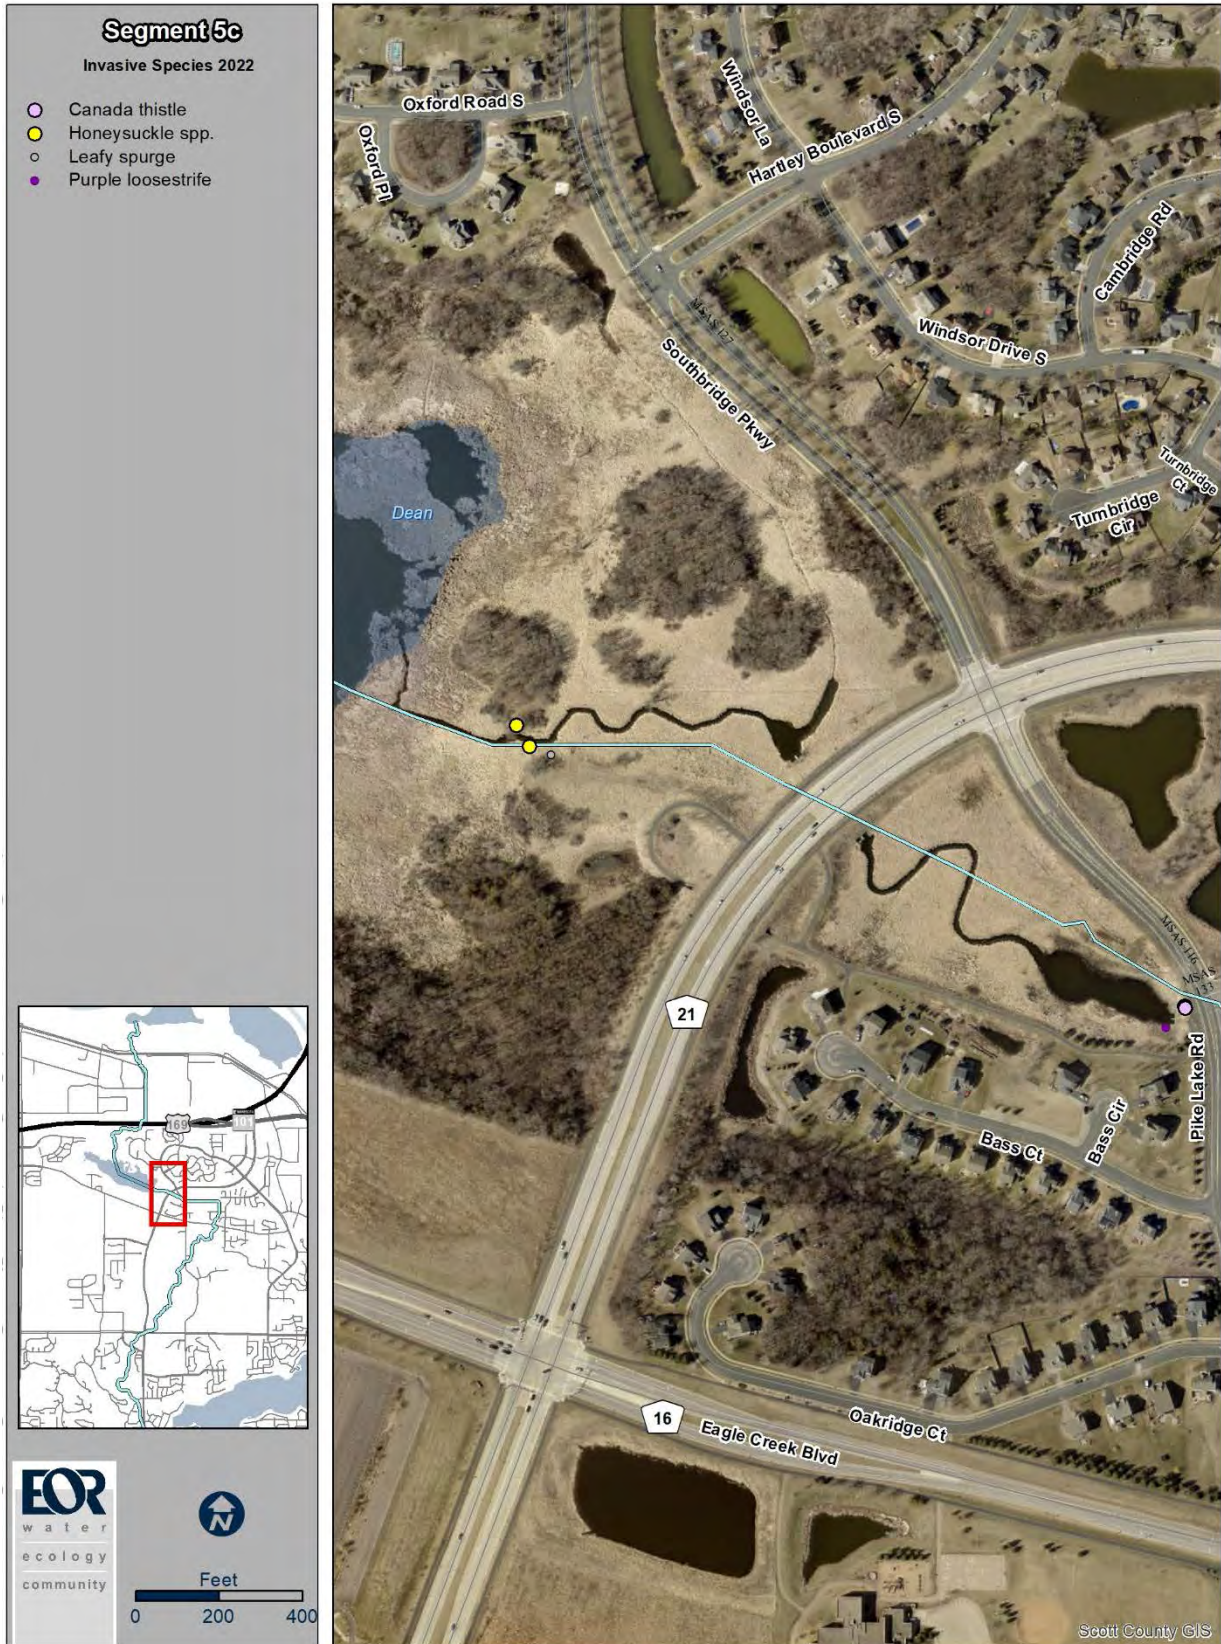
Small pockets of purple loosestrife were documented in Segment 5A downstream of the County Road 16 box culverts and one plant was found downstream of Oak Ridge Trail. In addition, several purple loosestrife plants were found within the abandoned ditch (old PLOC alignment) in Segment 5B. Since the ditch is no longer part of the PLOC, EOR coordinated with the City of Shakopee to treat the plants in the ditch, and their staff removed the plants in August 2022. Only one purple loosestrife plant was observed in Segment 5C in 2022. RES treated purple loosestrife in this area in 2021, and it appears the treatment was effective. Monitoring and treatment for known invasive species, particularly garlic mustard and purple loosestrife, should continue in 2023 to limit the spread of these species. Figure 40, Figure 41, and Figure 42 show the locations of target invasive species identified in this segment.

Figure 40. Target invasive species along Segment 5A

Figure 41. Target invasive species along Segment 5B

Figure 42. Target invasive species along Segment 5C

- Scout and treat for target herbaceous invasive species between County Road 16 to County Road 21, including the area around the sediment pond in Segment 5C. Conduct one trip in mid-late May and a second trip in early July to prevent target invasive species from maturing and producing seed.
- Coordinate with the City of Shakopee to scout and treat purple loosestrife in the abandoned ditch in Segment 5B.

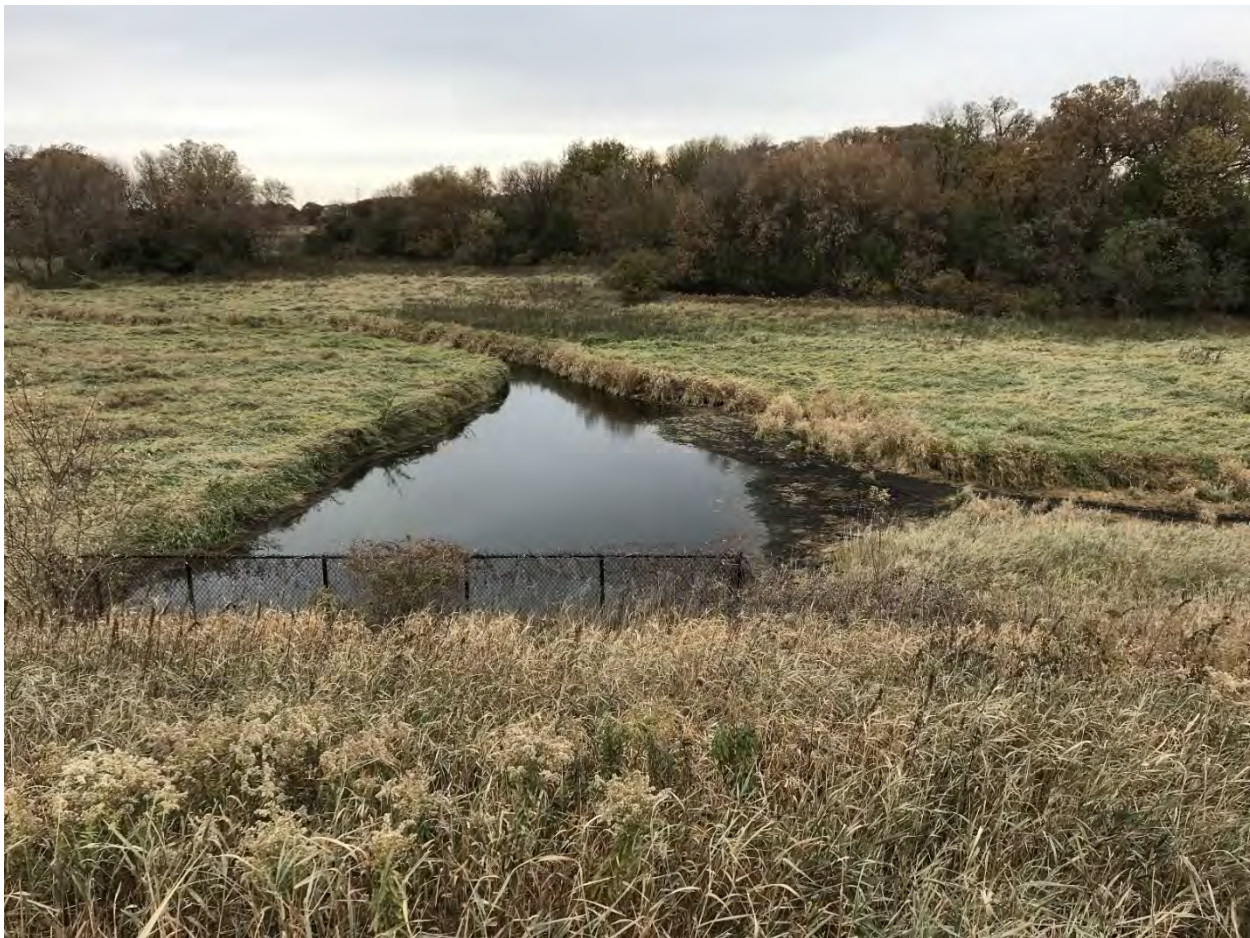
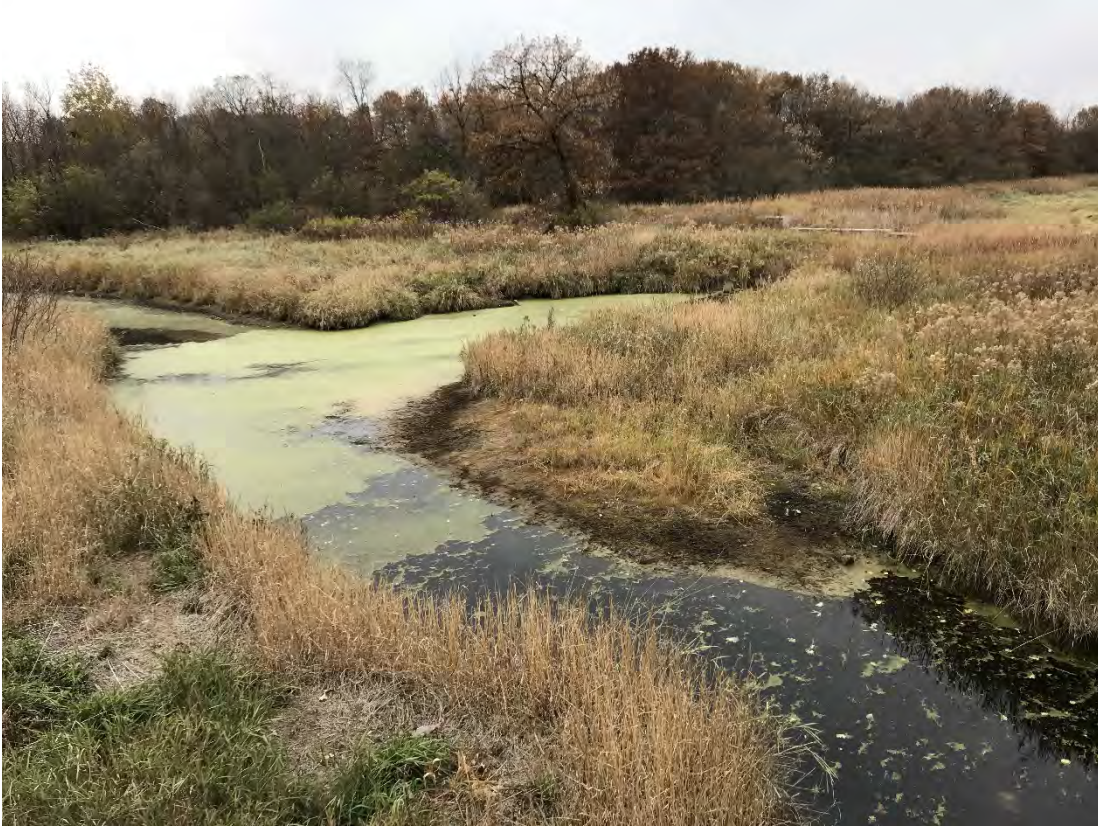
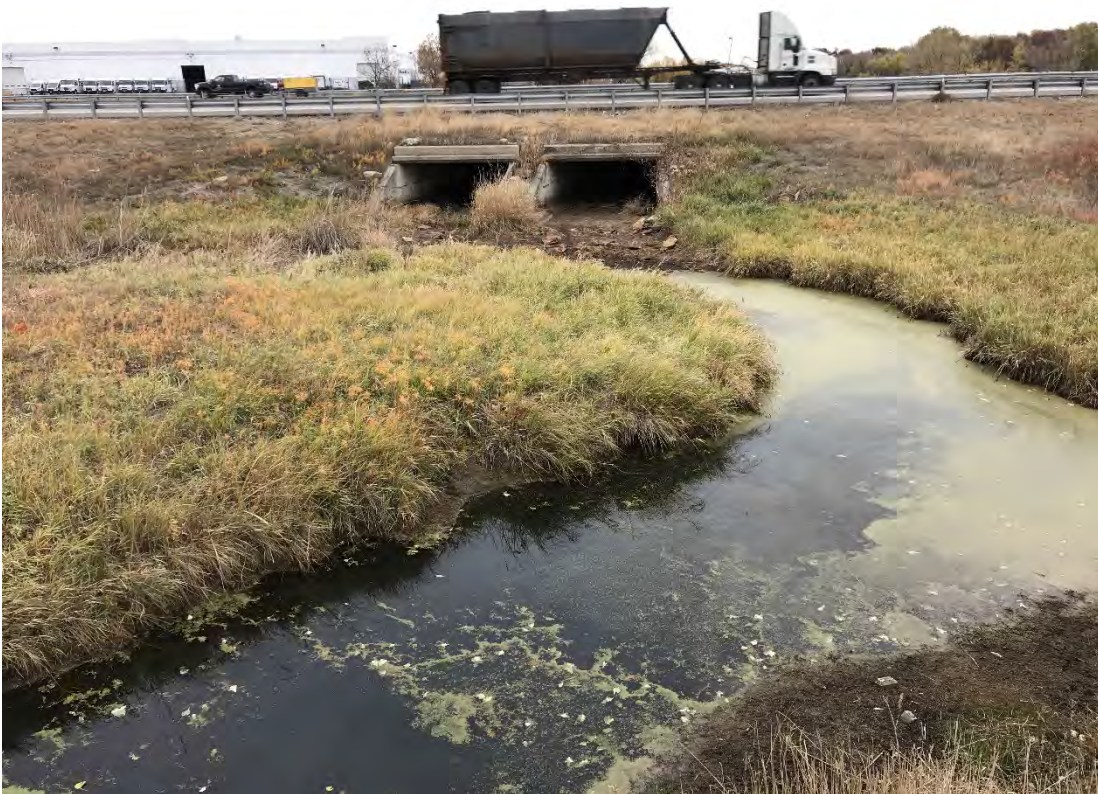
The Deans Lake bypass channel was dry during the fall survey and no water was present upstream of the Deans Lake weir (Figure 43, Figure 44). The Deans Lake weir appears to be in good condition and no debris was found at the weir outlet. The channel banks throughout this segment are well vegetated and show little evidence of bank erosion (Figure 45).

Figure 43. Channel downstream of County Road 21 & bypass channel

Figure 44. Stable, vegetated stream banks downstream of the Deans Lake weir

Figure 45. Stable, vegetated stream banks upstream of Highway 169

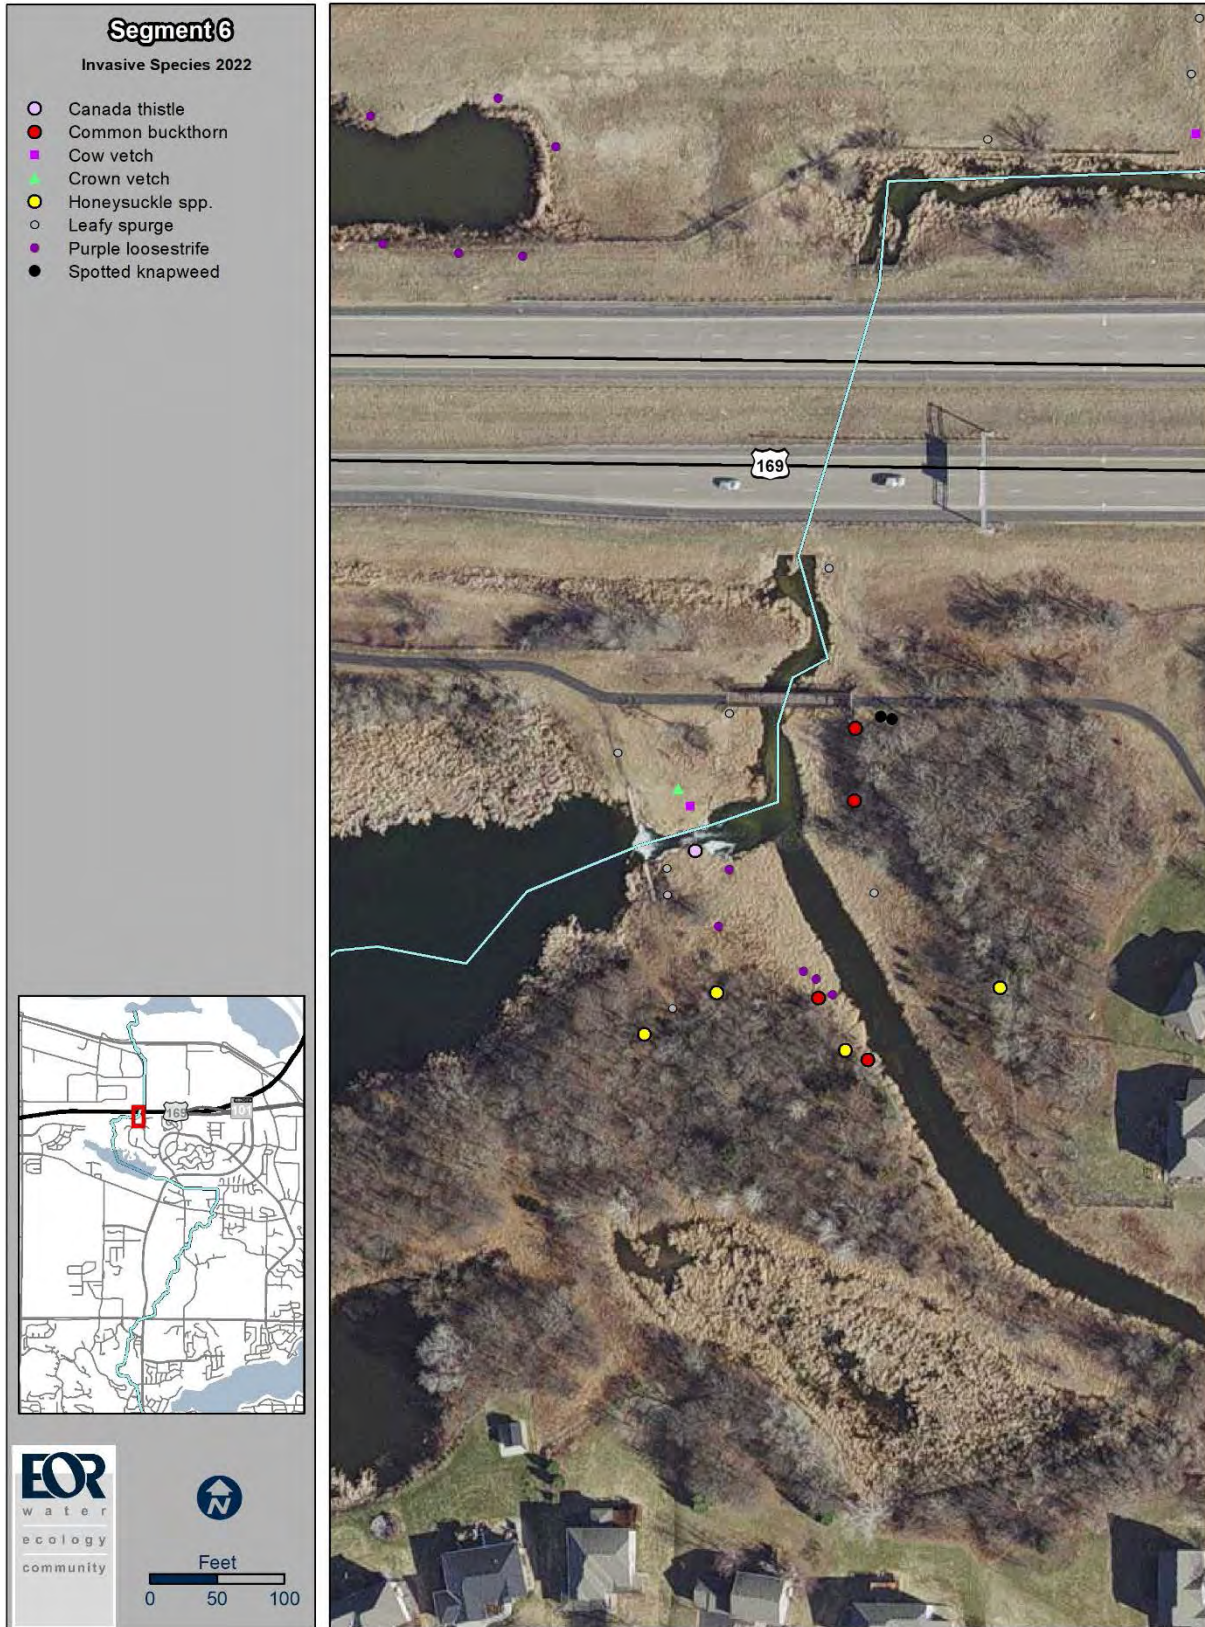
Several purple loosestrife plants were found downstream of the Deans Lake weir and were managed by NST staff in August 2022. Monitoring and treatment for known invasive species, particularly purple loosestrife, should continue in 2023 to limit the spread of these species. Figure 46 shows the locations of target invasive species identified in this segment.

Figure 46. Target invasive species along Segment 6

- Scout and treat for target herbaceous invasive species around the Deans Lake outlet. Conduct one trip in mid-late May and a second trip in early July to prevent target invasive species from maturing and producing seed.

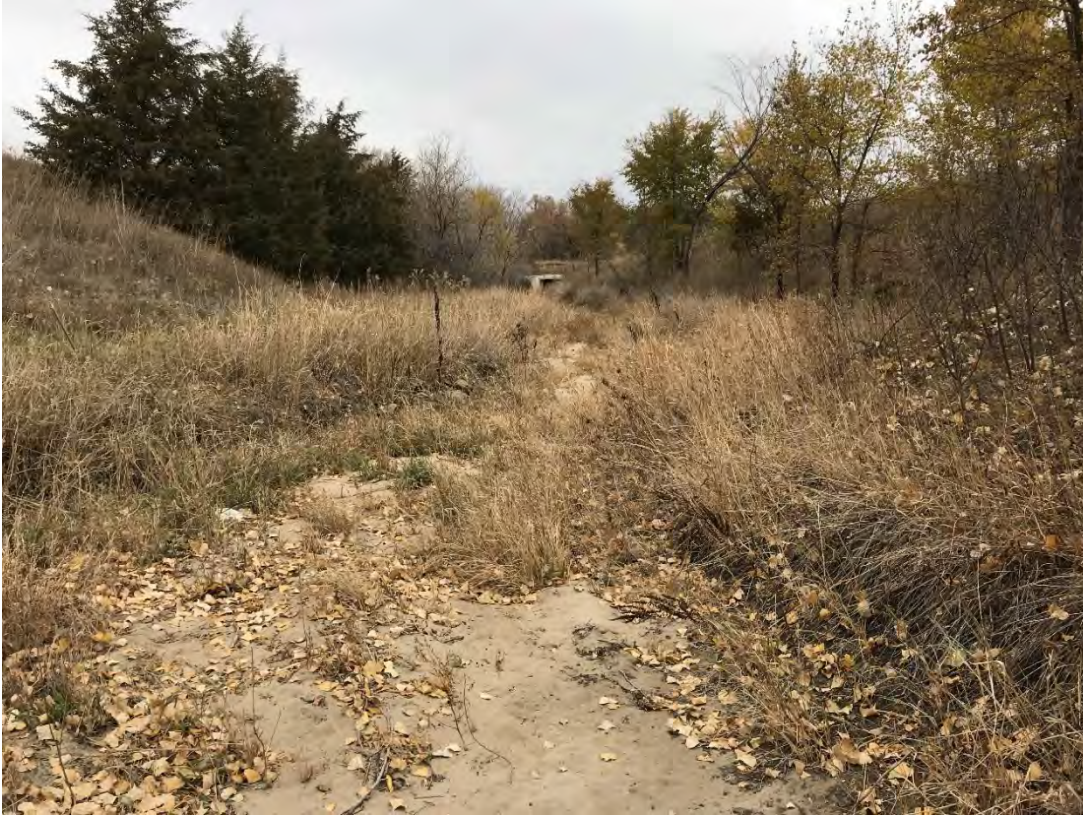
The channel banks in Segment 7A are well vegetated and show little evidence of bank erosion (Figure 47). The sheet pile weirs within the reach are very rusted but are still functional (Figure 48). Low flows and persistent drought conditions throughout 2021 and 2022 have resulted in vegetation establishment along the channel bottom and possible abandonment of the beaver dams documented in 2020.

Figure 47. Vegetated channel in Segment 7A

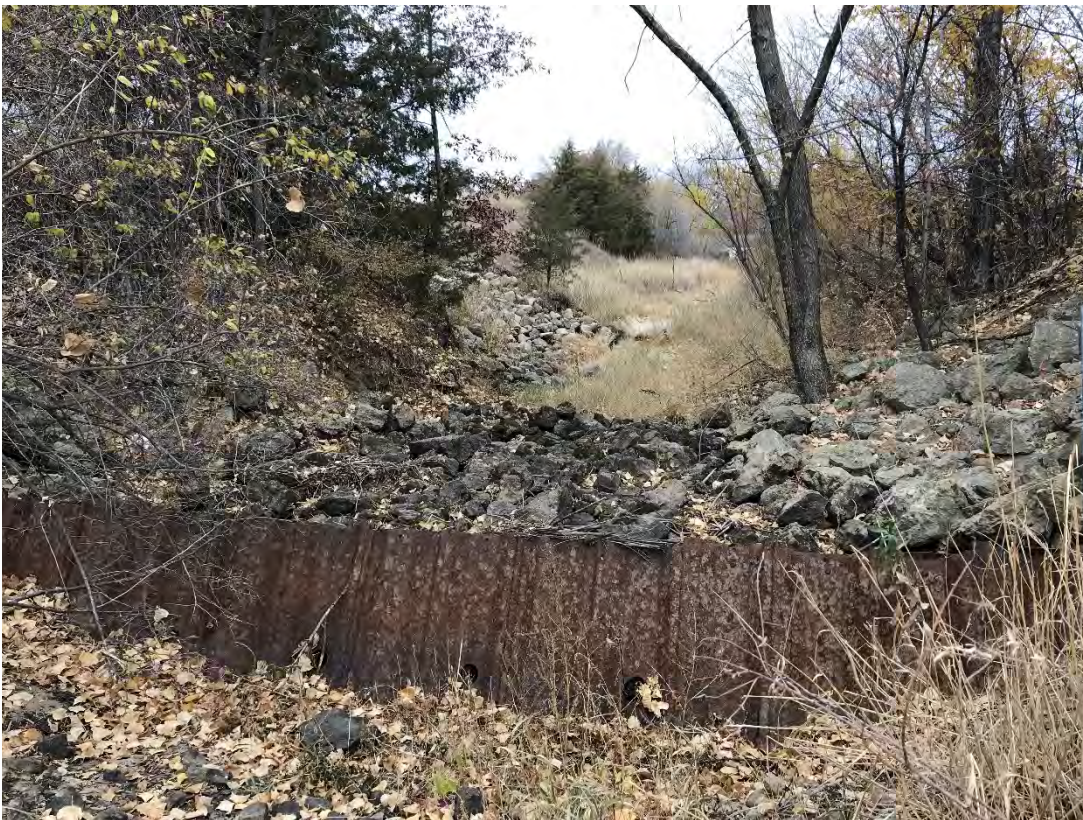
Figure 48. Corroded sheet pile weir in Segment 7A

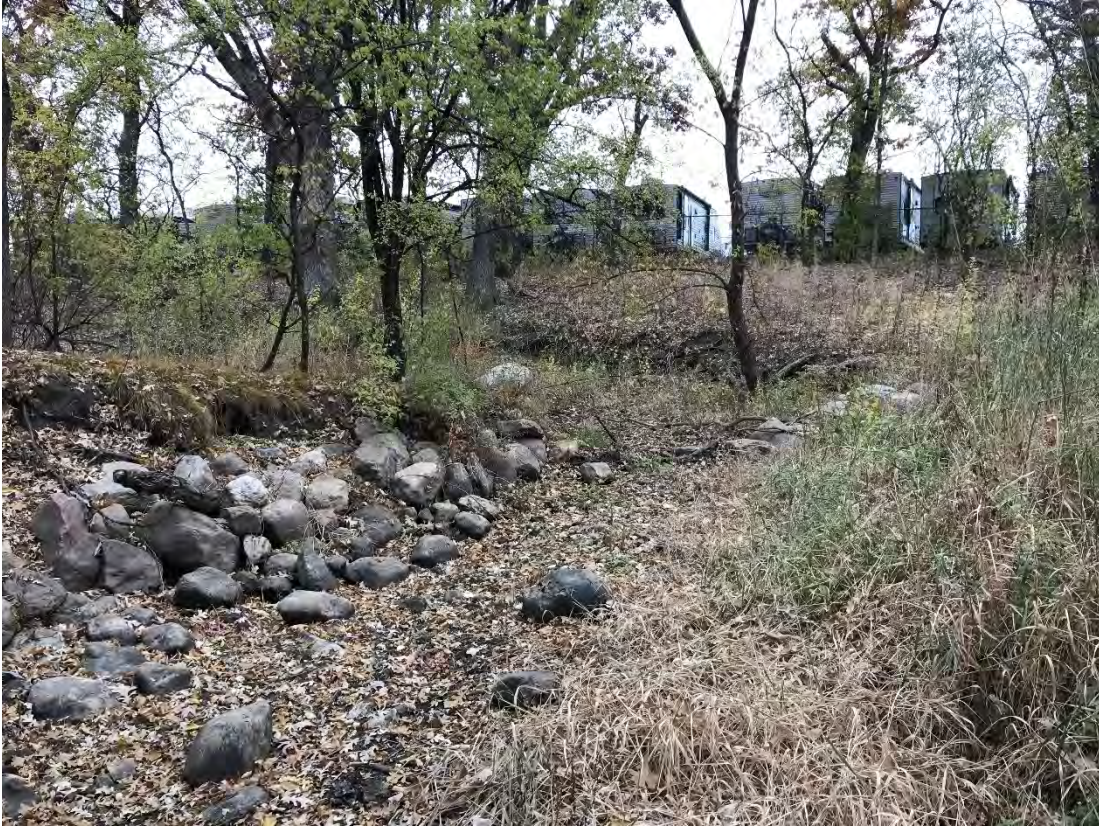
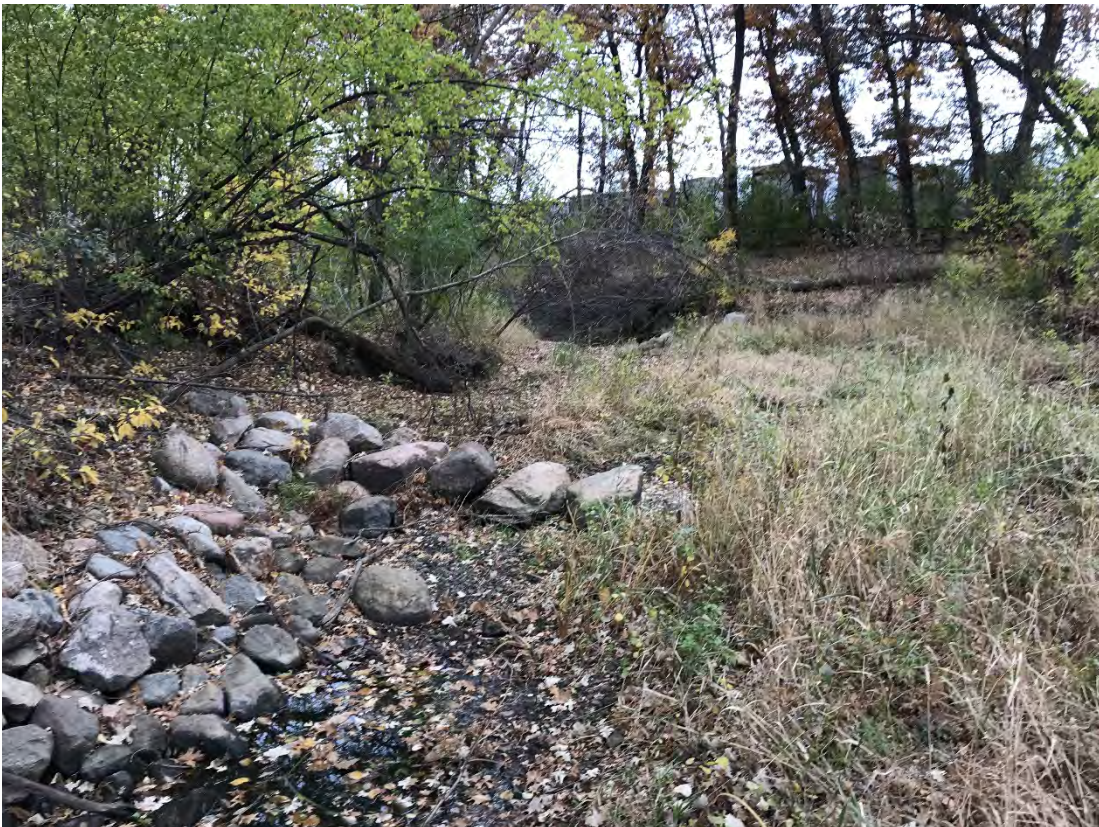
The stream banks repaired in 2019 along Segment 7A and 7B appear stable with vegetation fully established in areas where the tree canopy was thinned (Figure 49). Similar to Segment 7A, the low flows in Segment 7B have allowed vegetation to establish within the outlet channel (Figure 50). Down trees occur in the channel upstream of the railroad box culvert and recent windfall was also found in the wooded reach downstream of the railroad crossing, but the wood is not currently impeding flow (Figure 51, Figure 52).

Figure 49. Former bank repair area and vegetation establishment in Segment 7B

Figure 50. Vegetated channel in Segment 7B

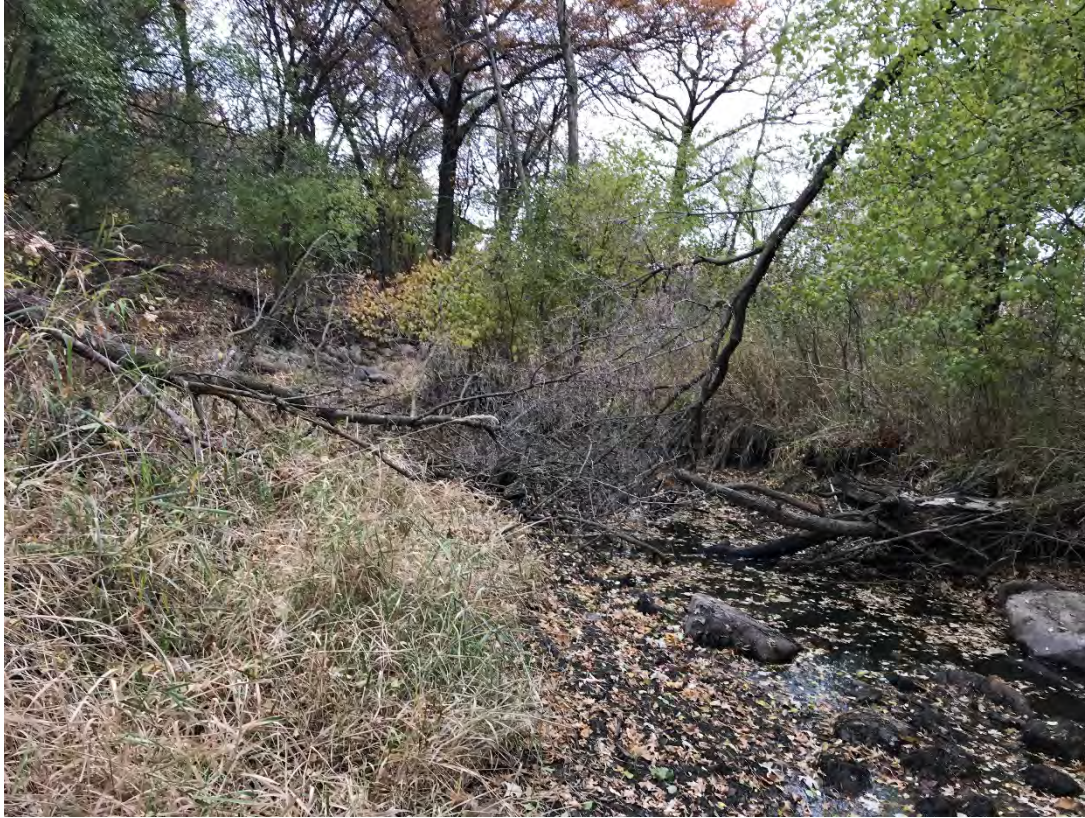
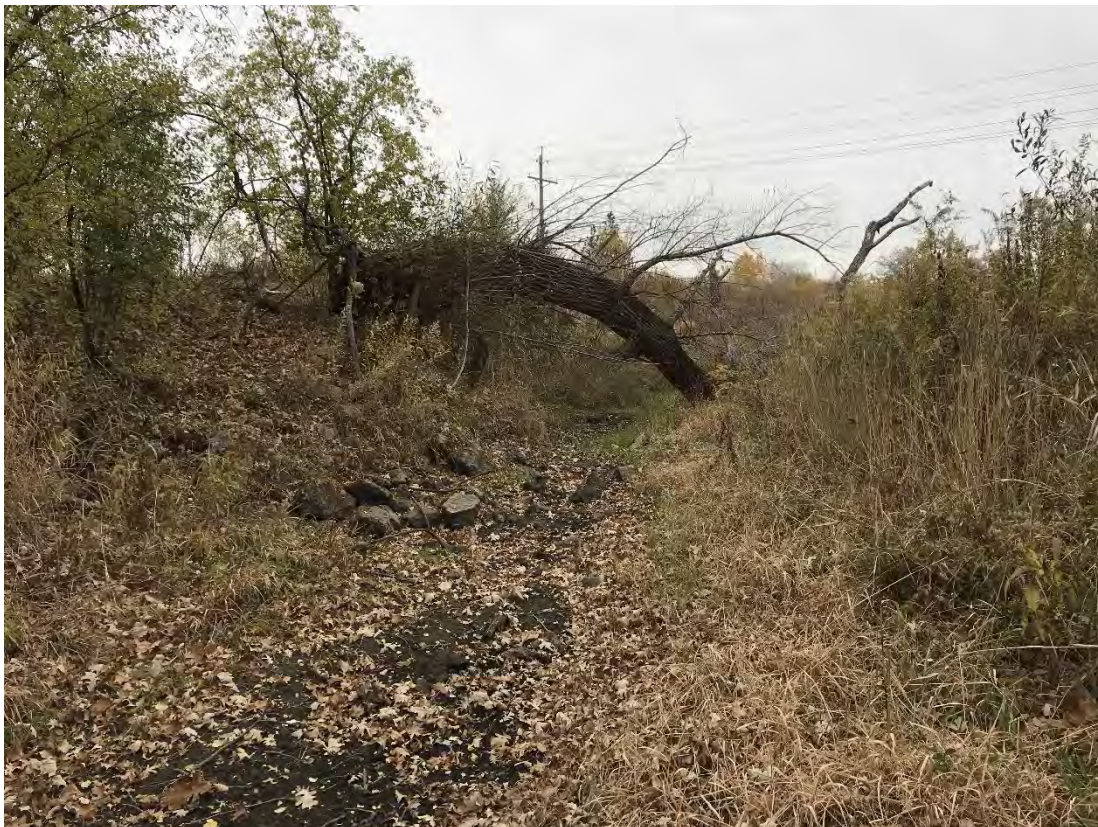
Figure 51. Recent windfall in Segment 7B

Figure 52. Down willow tree just upstream of Highway 101 in Segment 7B

- Continue inspections in 2023 and monitor stability of bank repair areas.
- Remove fallen trees within the channel upstream of the railroad crossing in Segment 7A and upstream of Highway 101 in Segment 7B.

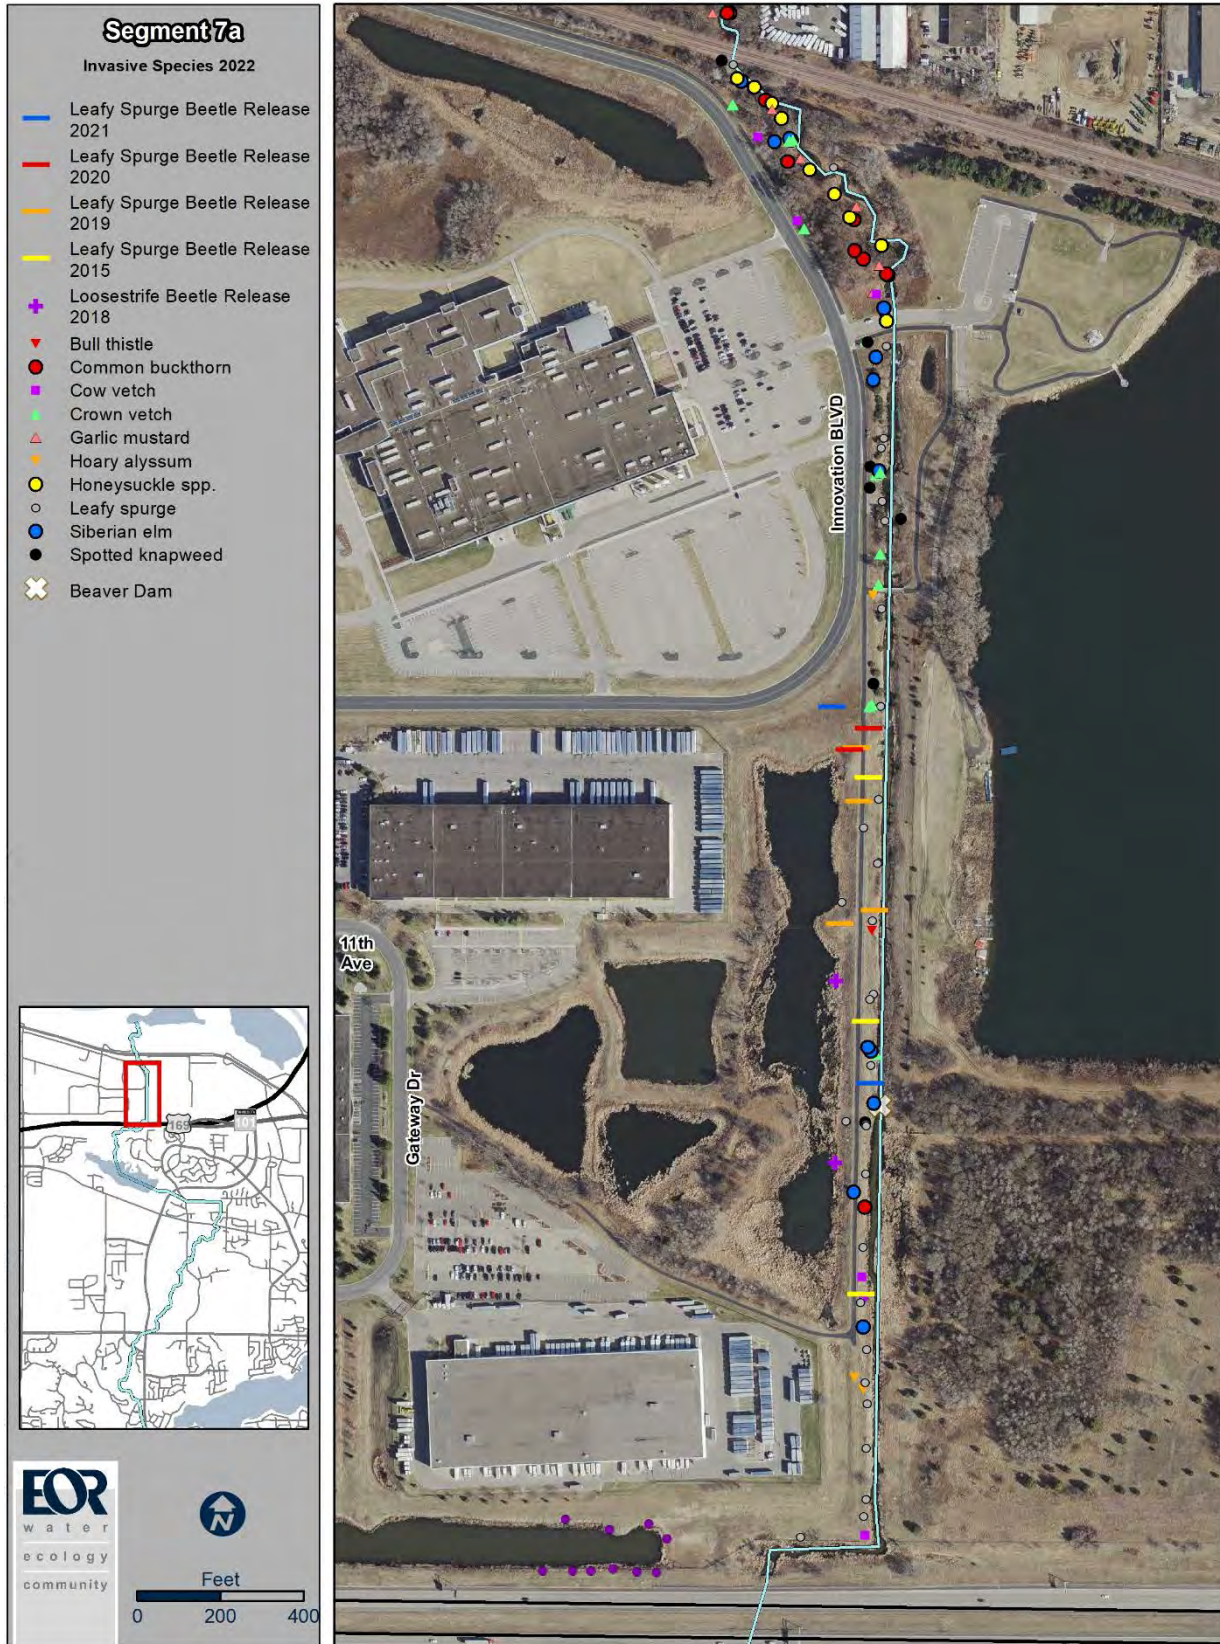
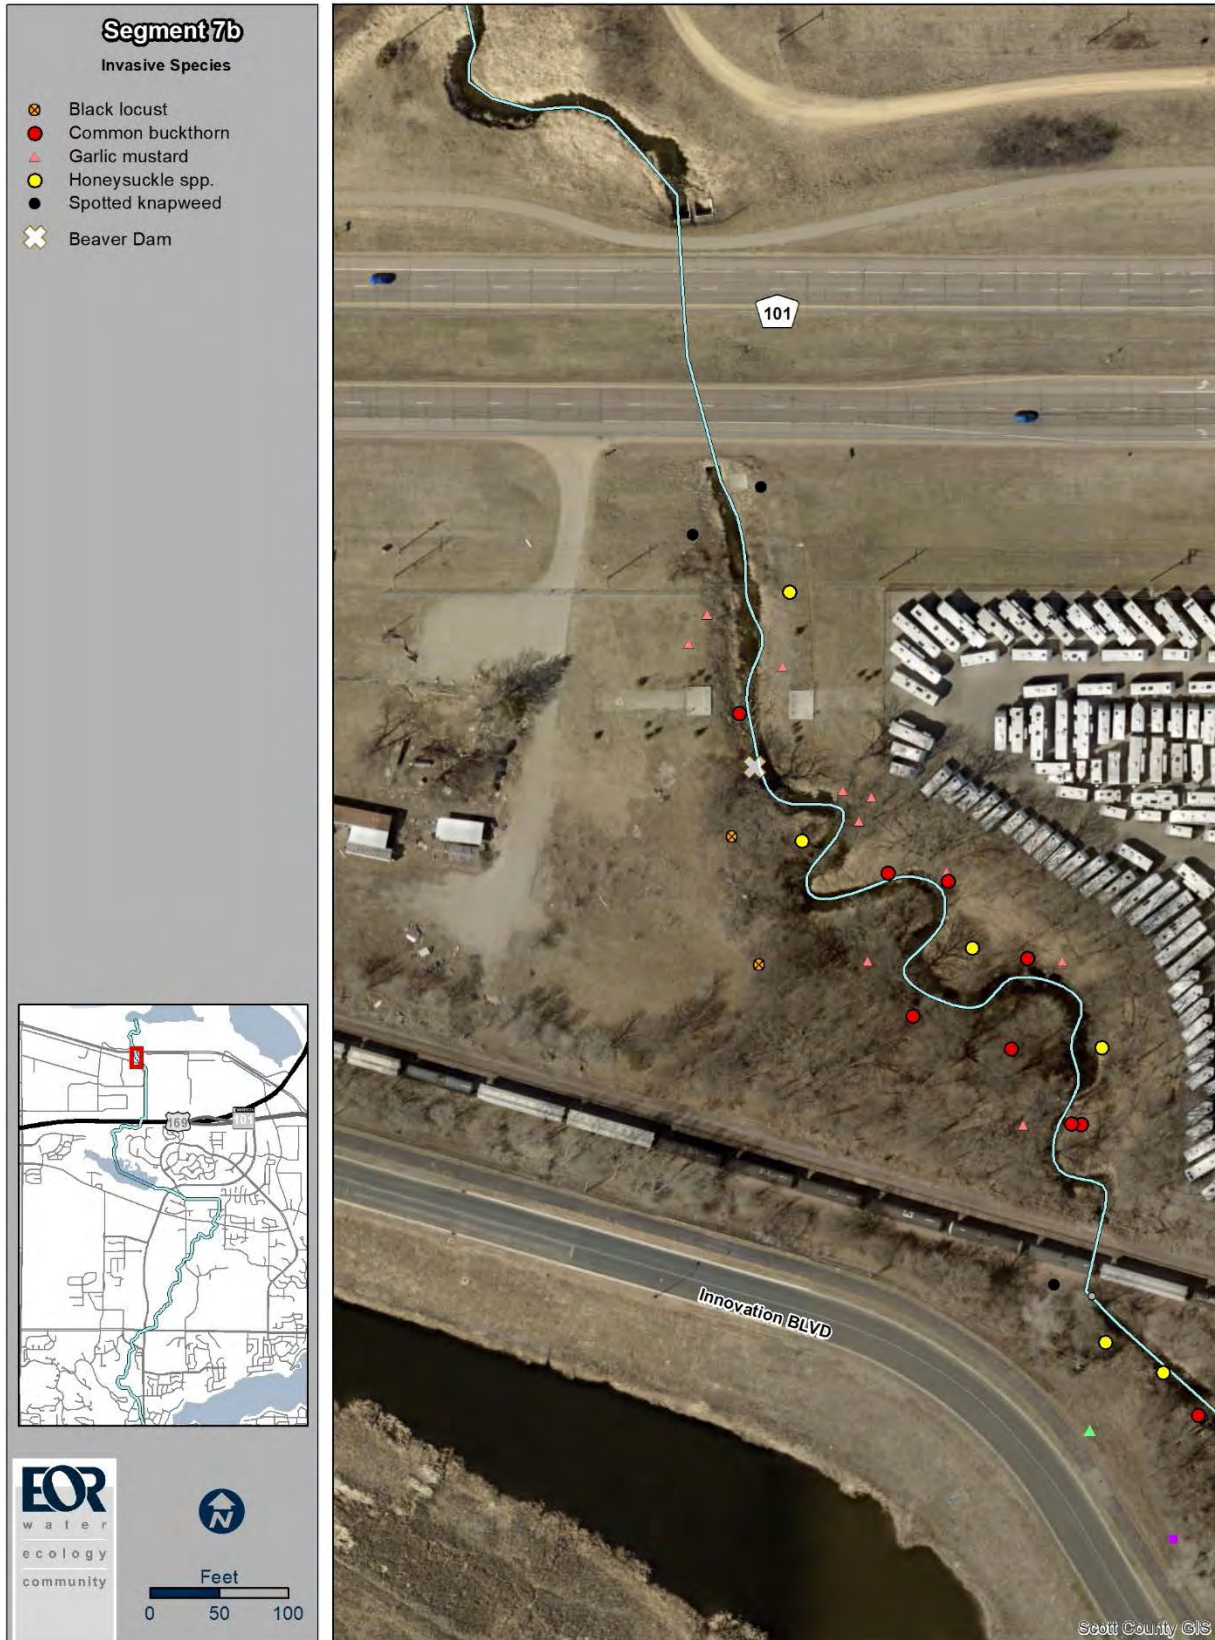
No purple loosestrife plants were found in the areas where the species was managed in 2021, and the spread of seeds from known populations was likely inhibited by drought conditions throughout the year. However, long term management of this species will be problematic until the source of seed from the western MNDOT stormwater pond can be controlled where numerous plants were observed in 2021 (see east-west linear pond at the bottom of Figure 53).

Monitoring and treatment of garlic mustard, common buckthorn, bush honeysuckle, and other invasives should continue within the wooded areas now that the streambank stabilization project has been completed. Managing for an open canopy along the channel will allow for further establishment of herbaceous vegetation and promote self-healing of the upper stream banks. Figure 53 and Figure 54 show the locations of target invasive species identified in this segment.

Figure 53. Target invasive species along Segment 7A

Figure 54. Target invasive species along Segment 7B

- Perform cut stump treatments / foliar spray of all woody invasive trees, shrubs, and saplings located within 30 feet from the top of the bank within the wooded areas of Segment 7A and Segment 7B.

- Scout and treat target herbaceous invasive species from Highway 169 to Highway 101. Also scout for and treat for purple loosestrife along the eastern edge of the large wetland complex in Segment 7A. Conduct one trip in mid-late May and a second trip in early July to prevent target invasive species from maturing and producing seed.

- Coordinate with MNDOT to manage purple loosestrife in the long east/west pond immediately north of Highway 169. The pond is in the MNDOT right-of-way and discharges directly to the PLOC. The purple loosestrife in the pond is a seed source to downstream wetlands along the PLOC.
