Prepared by: EOR

For the Prior Lake-Spring Lake Watershed District, April 2023

Sutton Lake Management Plan

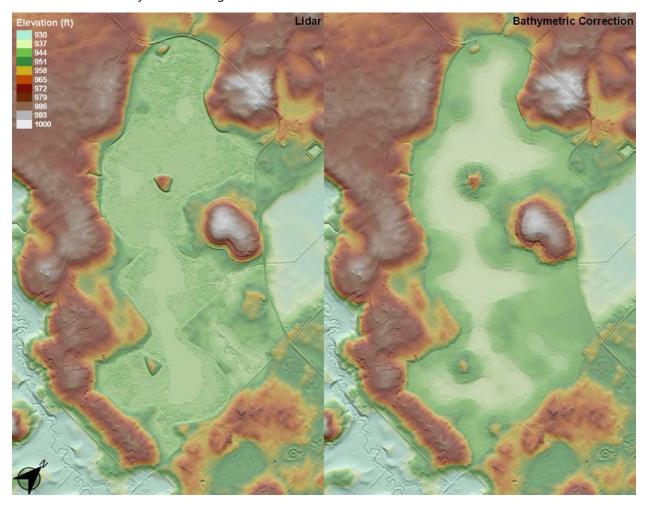
Figure 2. Left image is Lidar-derived digital elevation model (DEM). Right image is the corrected DEM with surveyed bathymetry data from open water areas and beneath the floating mat. Comparison of these two images illustrates the large area of cattail mat that is floating and the large volume of free water beneath the mat.

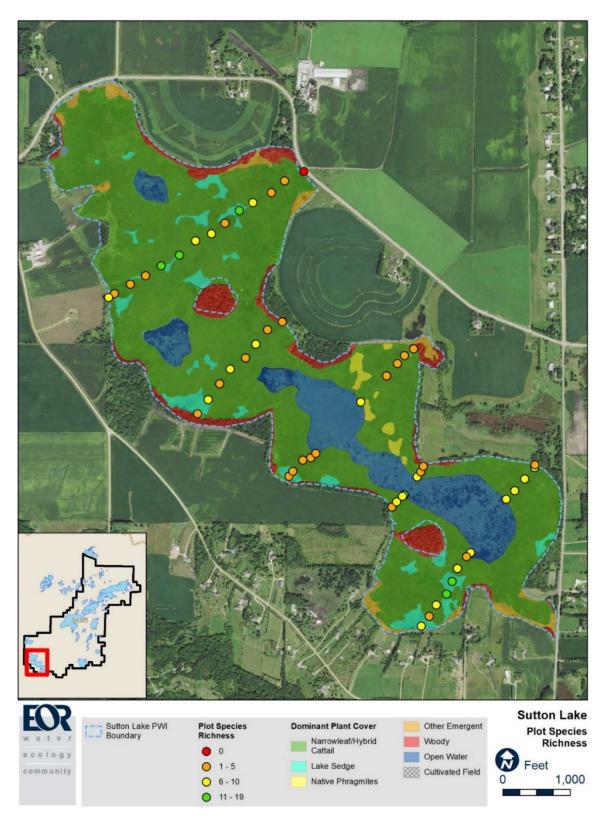
Figure 3. Vegetation sample plot locations from 2019 survey by EOR, with species richness for each plot.

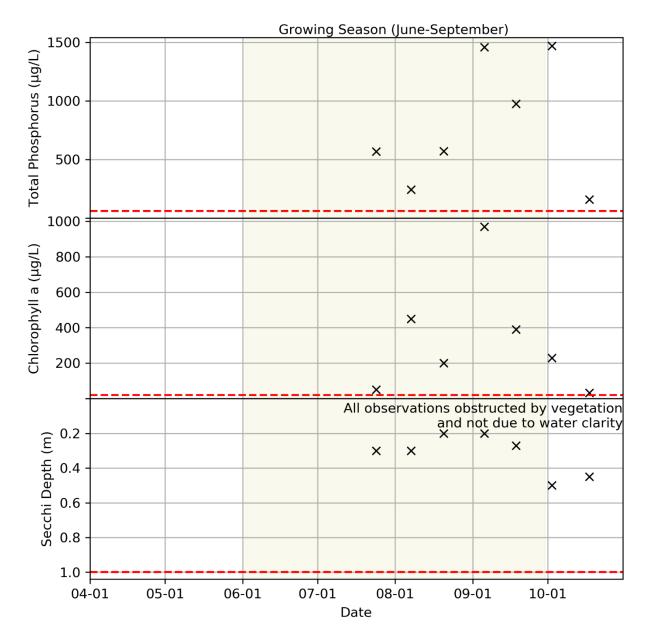
Figure 4. Sutton Lake 2020 Lake water quality observations. Red dashed lines are the water quality standards for shallow lakes in the North Central Hardwoods Ecoregion.

Water quality data at Sutton Lake was collected in 2020 by Citizen-Assisted Monitoring Program (CAMP) volunteers. Extremely high total phosphorus (TP) concentrations were observed, well above the 60 µg/L TP concentration standard for lakes in the North Central Hardwood Forest (NCHF) ecoregion. Further, chlorophyll-a (measurement of algae growth) concentrations far exceeded the 20 µg/L Chlorophyll-a standard (Figure 4). This information would seem to suggest that Sutton Lake is not in the ecologically preferred, clear water state. However, observers noted the physical condition of the water column as being crystal clear in four of the seven sampling events, with "some algae present" during three of the sampling events (Figure 5). This finding, coupled with the results from the 2018 aquatic plant survey, which found aquatic plants present at 100% of sampling locations, would suggest that aquatic plants are helping to maintain the preferred clear water state. Field observations by EOR during the 2019 natural resources inventory also suggest Sutton Lake is in a clear water state. Water quality data obtained in 2020 was likely to have been improperly collected.

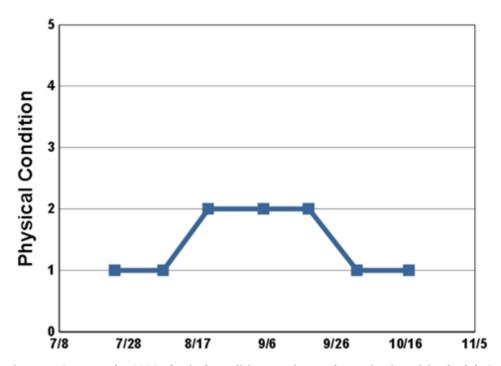
Figure 5. Sutton Lake 2020 physical condition. During each monitoring visit, the lake's physical condition, and was ranked on a 1-to-5 scale. 1 = Crystal Clear, 2 = Some Algae Present, 3 = Definite Algal Presence, 4 = High Algal Color, 5 = Severe Algal Bloom.

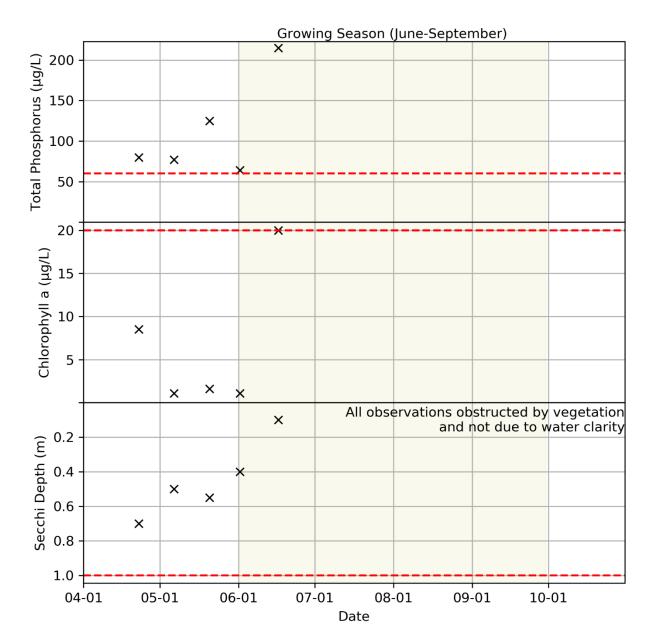
Figure 6. Sutton Lake 2021 Lake water quality observations. Red dashed lines are the water quality standards for shallow lakes in the North Central Hardwoods Ecoregion.

Water quality data at Sutton Lake was collected in 2021 by District staff in May and June. Elevated but reasonable TP concentrations were observed (Figure 6). Only two of the five samples were within the growing season of June through September. Both of the TP concentrations were above the shallow lake water quality standard, however, the chlorophyll-a concentrations were at or below the standard and the Secchi depth was uncertain. All the Secchi depth data were noted as being obstructed by dense vegetation. With uncertainty surrounding the response variables the state of the lake (i.e. turbid vs. clear) remains uncertain. More chlorophyll-a sampling (a measure of how much algae is present) is needed to determine the overall health of the lake with respect to water quality. Given the lake is so shallow, it is also recommended that Secchi disk measurements be substituted with physical, qualitative descriptions of the water column (e.g., clear, turbid, stained, etc.) to validate that the lake remains in the ecologically preferred, clear-water state.

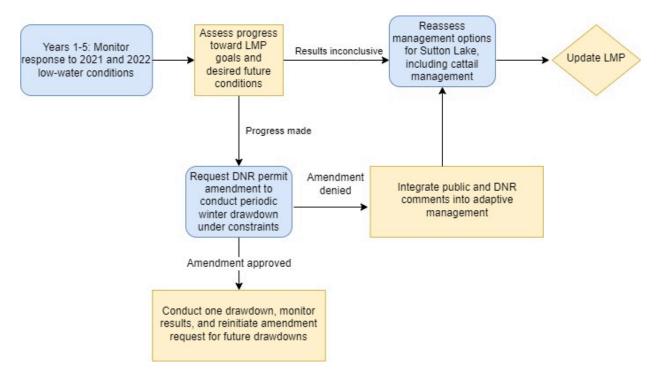
Figure 7. Sutton Lake Adaptive Management and Permitting Decision Matrix.

The implementation strategies, including recommended timelines and best management practices, provided in this lake management plan are the result of watershed and hydrologic/hydraulic modeling efforts, the latest science regarding lake management and aquatic plant management, and professional judgment. Multiple meetings and reviews were also completed with riparian landowners and DNR staff (Table 1). The proposed actions outlined are subject to adaptive management—an iterative approach of implementation, evaluation, and course correction that allows for implementation to proceed while accounting for uncertainty. The management approach to achieving the goals and objectives should be adapted as new monitoring data is collected and evaluated. Continued monitoring will inform and prioritize specific actions responding to hydrological, biological, and water quality monitoring conditions both within Sutton Lake and further downstream in the watershed. Management activities will be changed or refined to efficiently meet goals and objectives as identified in Sections 6.1 and 6.3. An adaptive management decision matrix is provided for Sutton Lake in Figure 7.

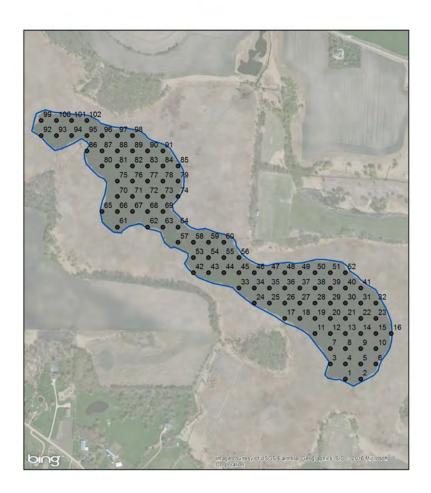
Sutton Lake 50m Grid 102Pts

Figure 1. Sample locations for the point-intercept aquatic plant survey.

Sutton Lake is located within in Scott County. An aquatic plant point intercept survey was conducted on the 64-acre lake on September 11, 2018. A sampling grid is shown in Figure 1.

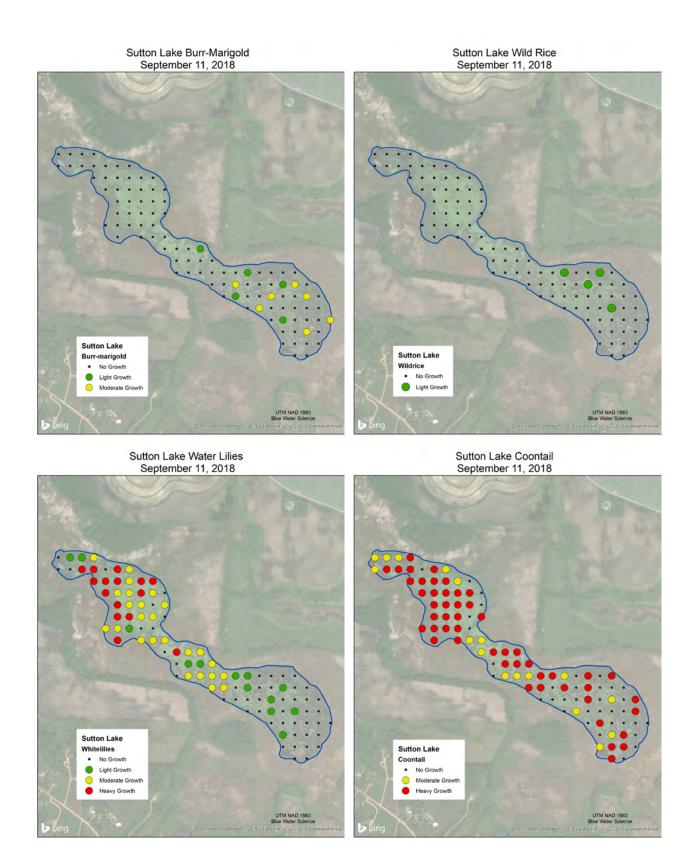
Figure 4. Distribution and abundance maps for September 11, 2018. [top-left] Bur-marigold. [top-right] Wild rice. [bottom-left] White water lilies. [bottom-right] Coontail. Key: green = light growth, yellow = moderate growth, and red = heavy growth.

Aquatic plants were abundant in Sutton Lake for the September 2018 point intercept plant survey. Coontail was the dominant plant in Sutton Lake. Bur-marigold, which is relatively rare in lakes, was found in Sutton Lake as well (Figure 3). A total of 4 submerged aquatic plants, 3 floatingleaf plants, and 2 emergent plants were identified (Figure 4 and Table 1).

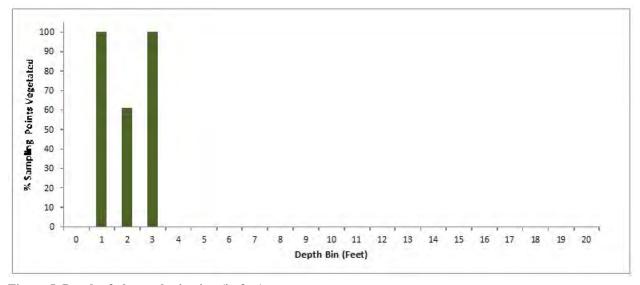
Figure 5. Depth of plant colonization (in feet).

Depth (feet)	Number of Points Sampled	Percent Sampling Points with Submerged Species Observed
0	0	0
1	8	100
2	82	61
3	12	100

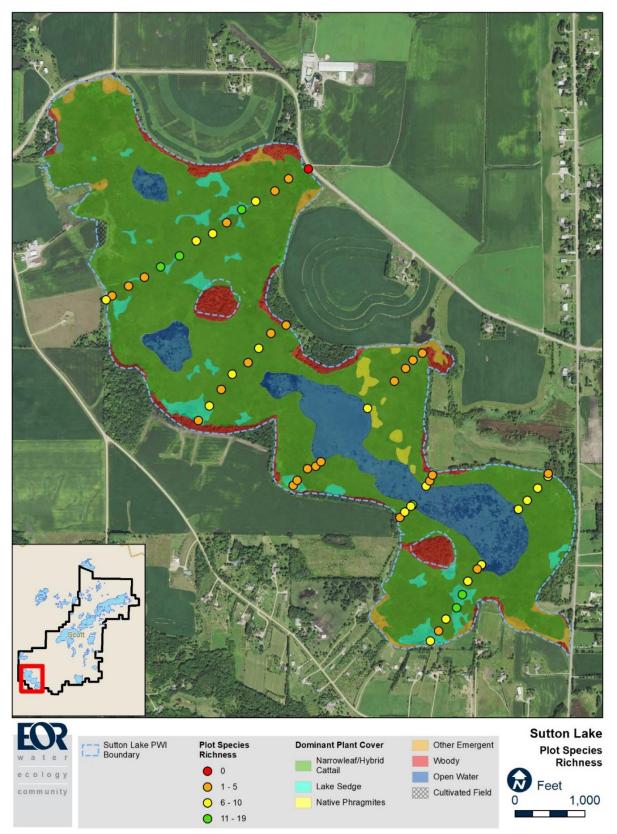
Figure 1. Vegetation sample plot locations with species richness for each plot.

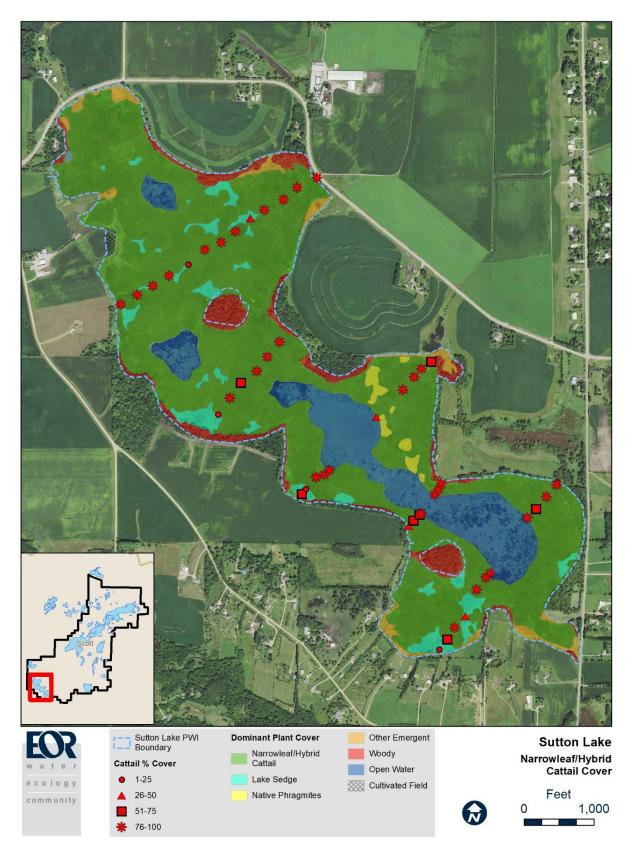
Figure 2. Narrowleaf/hybrid cattail cover at Sutton Lake.

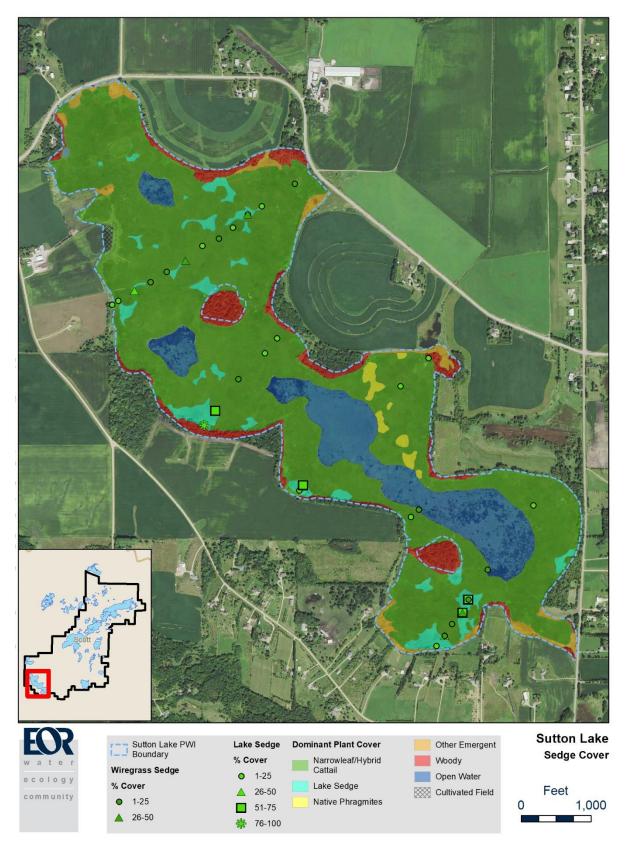
Figure 3. Lake sedge and wiregrass sedge cover at Sutton Lake.

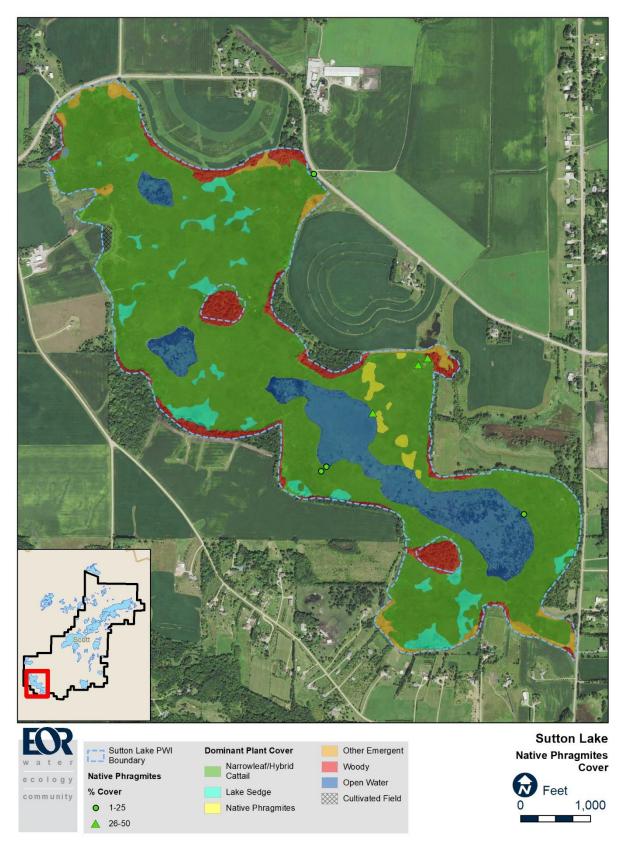
Figure 4. Native Phragmites cover at Sutton Lake.

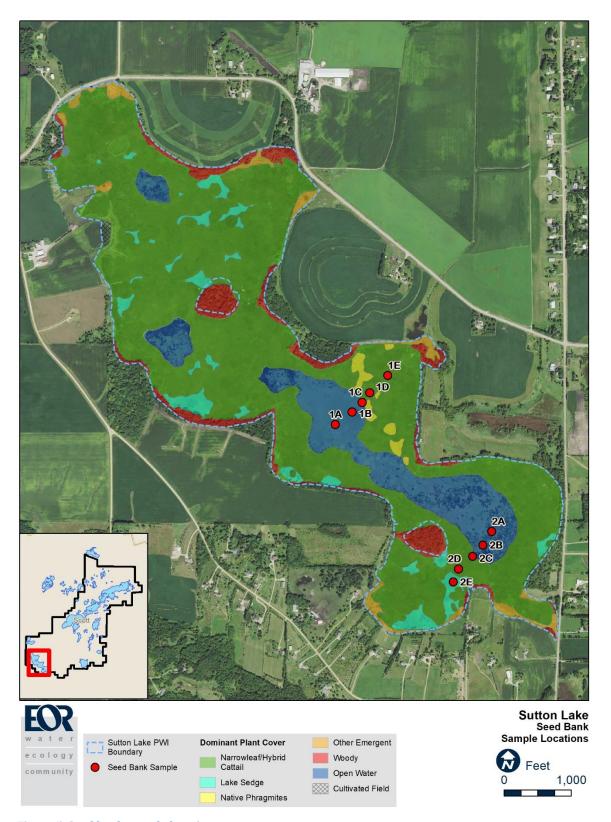
Figure 5. Seed bank sample locations.

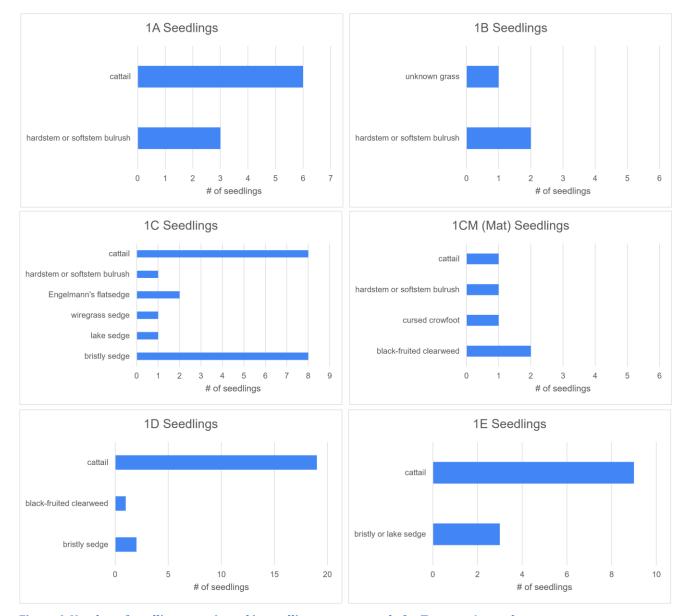
Figure 6. Number of seedlings germinated in seedling grow-out study for Transect 1 samples.

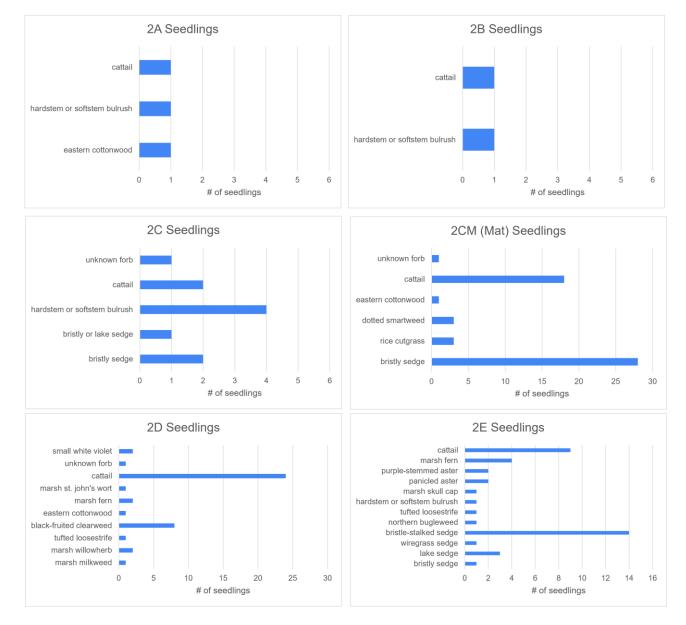
Figure 7. Number of seedlings germinated in seedling grow-out study for Transect 2 samples.

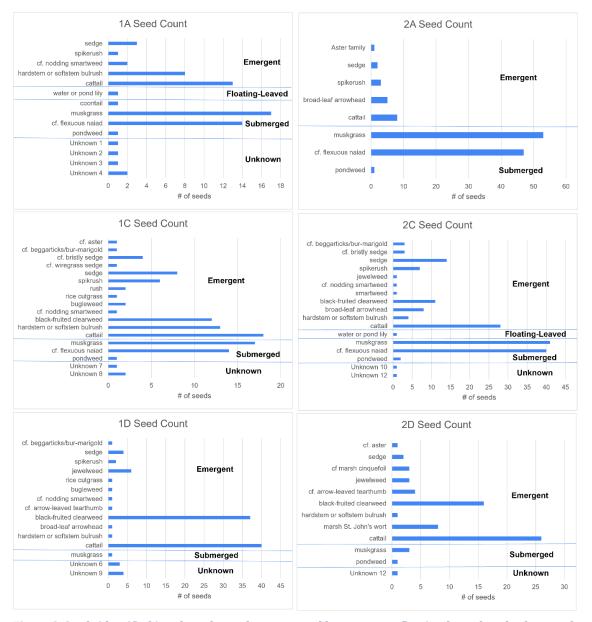
Figure 8. Seeds identified in selected samples, separated by emergent, floating-leaved, and submerged growth habits.

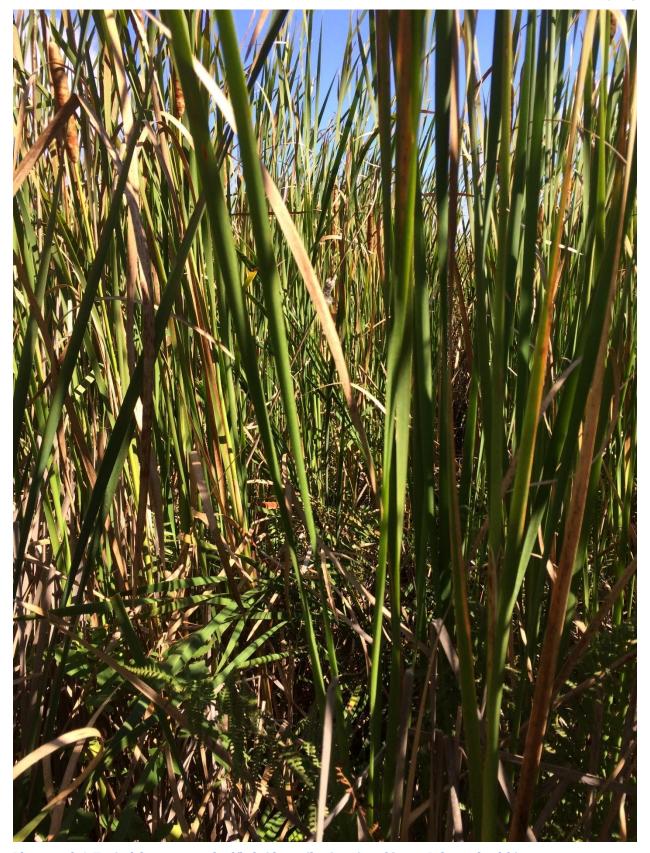
$Photograph \ 1. \ Typical \ dense \ narrowleaf/hybrid \ cattail \ at interior \ of \ Sutton \ Lake \ wetland \ fringe.$

Results from the vegetation survey suggest that the majority of Sutton Lake is dominated by the invasives narrowleaf or hybrid cattail (*Typha angustifolia T.* x *glauca*) (**Photograph 1**). Where cattail is dominant, its cover is typically greater than 75% and species richness is less than 11 (**Figure 1** and **Figure 2**). The native broadleaf cattail (*Typha latifolia*) was also observed but was rare.

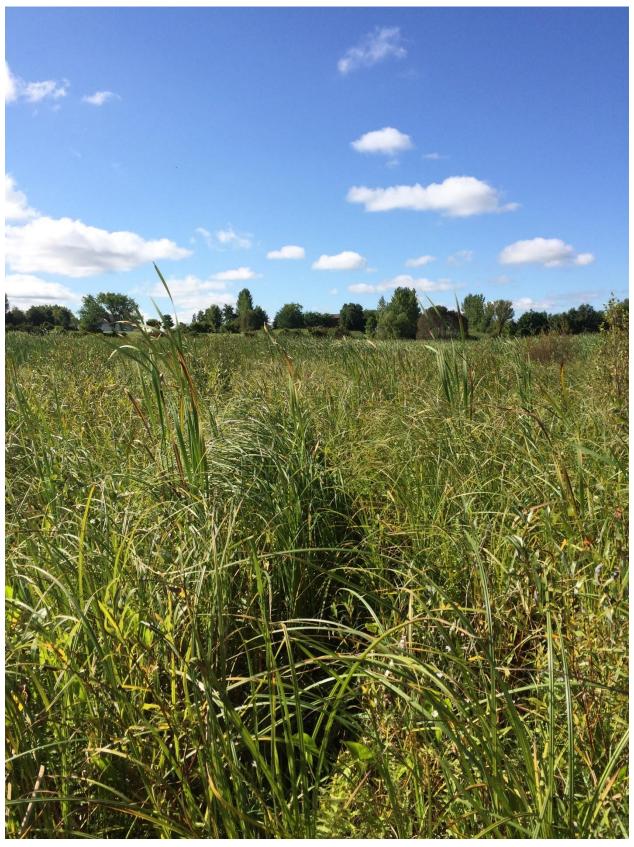
Photograph 2. Patch of sedge meadow floating mat within Sutton Lake wetland fringe.

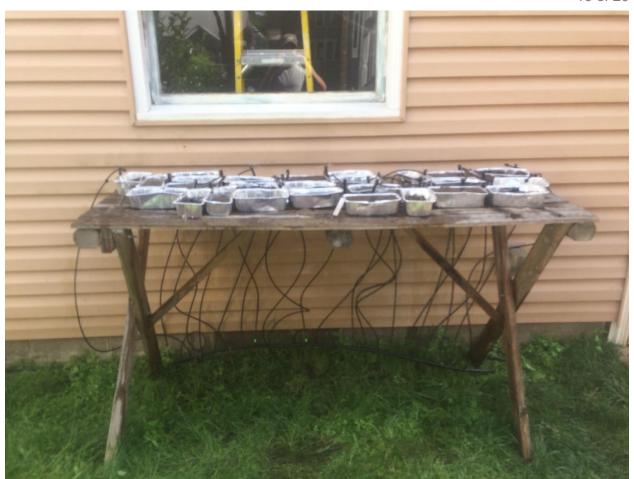
Photograph 3. Seedling grow-out study setup.

- 1) Seedling grow-out: Sediment samples were planted and maintained under moist to saturated conditions. Seedlings were identified upon emergence over three-months. These data indicate the identity of viable seeds in the seed bank that may germinate under moist/saturated conditions.
- 2) Seed identification: Seeds were extracted from samples following the end of the seedling grow-out by sieving remaining soils. Seeds were identified to finest taxonomic resolution feasible. These data indicate the identity of remaining seeds that did not germinate, due to non-viability or unsuitability of germination conditions (e.g., submerged aquatic plant species).

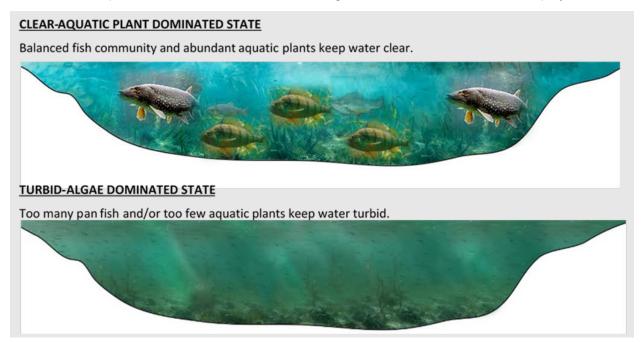
Figure 8. Clear and turbid water states in shallow lakes.

The result of this impact of biological components on the ecological interactions is that shallow lakes normally exhibit one of two ecologically alternative stable states (Figure 8): the turbid water, algaedominated state, and the clear water, aquatic plant-dominated state. The clear state is the most preferred, since algae communities are held in check by diverse and healthy zooplankton and fish communities. In addition, rooted plants stabilize the sediments, lessening the amount of sediment stirred up by the wind.

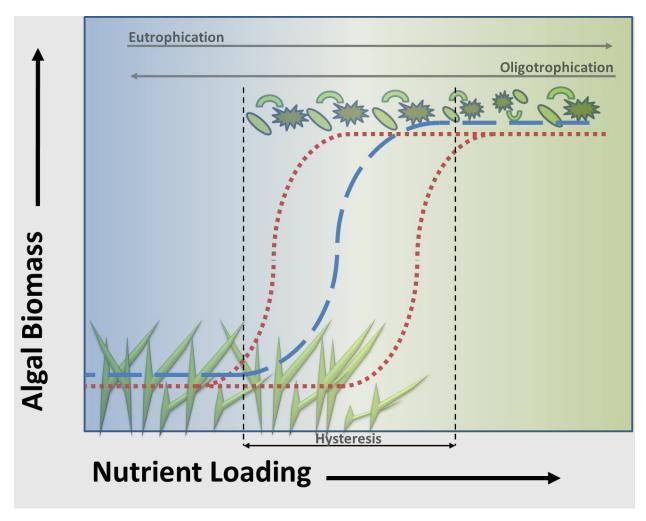
Figure 9. Trophic state shifts in shallow lakes in response to changes in nutrient loading

As shown in Figure 9, the transition in water quality of shallow lakes from clear to turbid is often abrupt. When shallow lakes have historically been in the clear water state and dominated by submerged aquatic

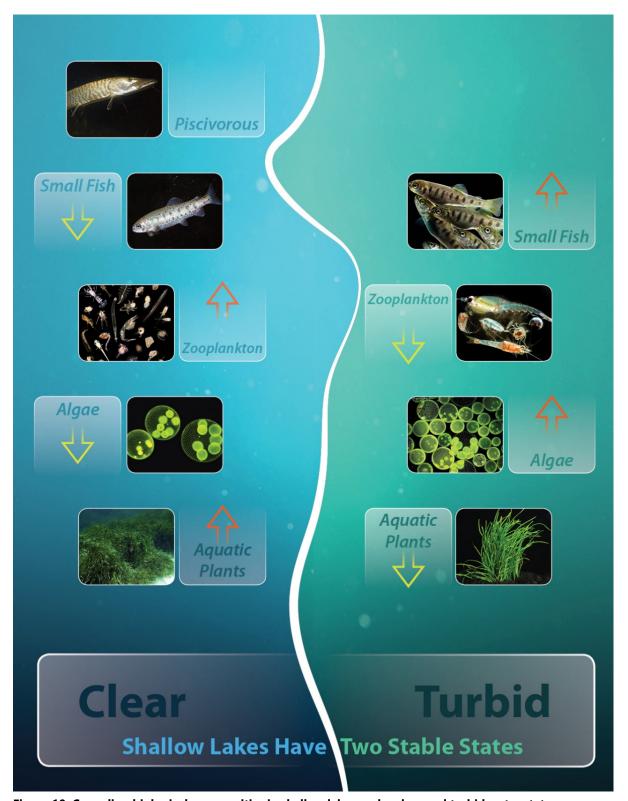
Figure 10. Cascading biological communities in shallow lakes under clear and turbid water states

vegetation, they are capable of assimilating large amounts of phosphorus loading without becoming dominated by algae. That is to say, they are stable in a clear-water state. They may experience some periods of turbid water conditions, but tend to revert to clear water conditions. However, as phosphorus loading increases, the stability of the clear-water state declines until the lake is stable in a turbid-water state. Consequently, drastic reductions in nutrients or changes in the biological community of a shallow lake are needed to promote a clear-water state (Figure 10).

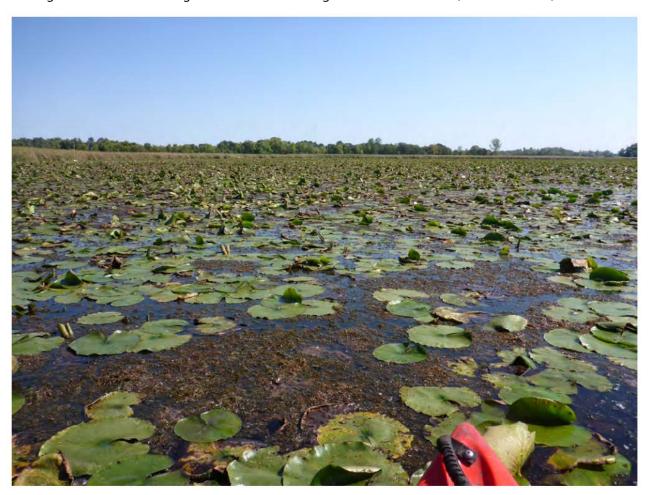
Figure 11. Sutton Lake September 2018 photo showing abundant water lilies and submergent aquatic vegetation exceeding 50% of the water column.

Dense aquatic canopies, that occupy at least 50% of the water column (e.g. Figure 11) can trigger diurnal fluxes in dissolved oxygen concentration in lakes. Recent research conducted on shallow lakes shows that when aquatic plants occupy more than 50% of the water depth, anoxia manifested before sunset and lasted until night-time surface cooling induced vertical mixing of the water column (Vilas et al. 2017).

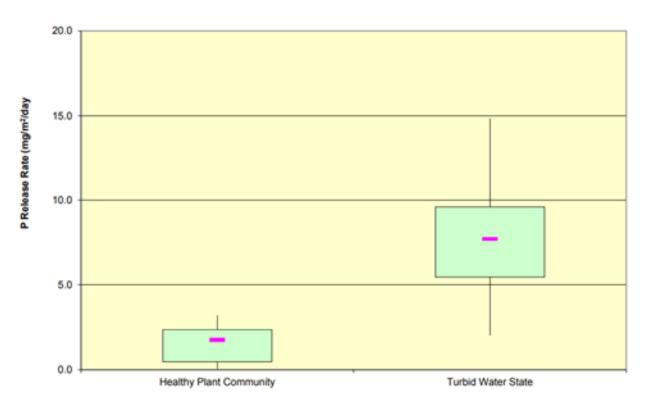
Figure 12. Comparison of anoxic phosphorus release rates in shallow lakes in the healthy aquatic plant dominated state versus the turbid water state. Red lines indicate the mean.

A study of 70 Minnesota Lakes found that the mean anoxic phosphorus release rate under anoxic conditions was higher in lakes in the turbid water state versus the healthy plant state (Figure 12; Bischoff and James 2012). This figure suggests that lakes with a healthy aquatic plant community have a lower release rate under anoxic conditions in comparison with lakes that are in the turbid water state with little or no aquatic
