2024 PRIOR LAKE OUTLET SYSTEM ANNUAL OPERATIONS REPORT

PRIOR LAKE-SPRING LAKE
WATERSHED DISTRICT

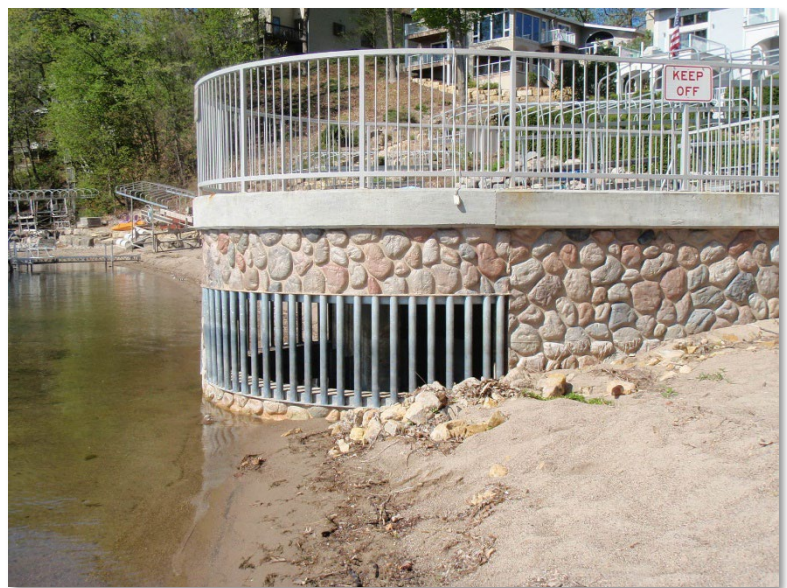
FIGURE 1 - OUTLET STRUCTURE

Given conditions, a replacement structure was pursued by the District and installed in 2010 (Figure 1). The new design has increased the efficiency of discharging water by allowing the outlet pipe to reach capacity sooner. It also provides safer conditions for staff during inspections and maintenance and is self-operating, which reduces overall operations and maintenance costs. A schematic of the outlet structure is provided in Attachment A.

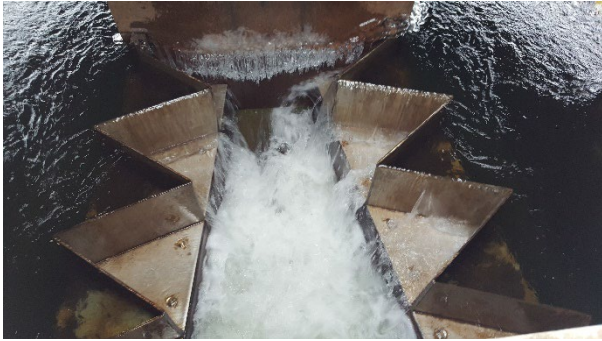
FIGURE 3 - LOW-FLOW GATE IN OPERATION

At certain lake levels, the low-flow gate allows more water through the outlet structure, resulting in the lake level lowering more quickly and creating more storage (see Attachment C). The low-flow gate was operated in 2024 due to rapid rise in water levels and consecutive rain events (Figure 3). The stage-discharge relationship curve is used to calculate flows and water quantities leaving Prior Lake.

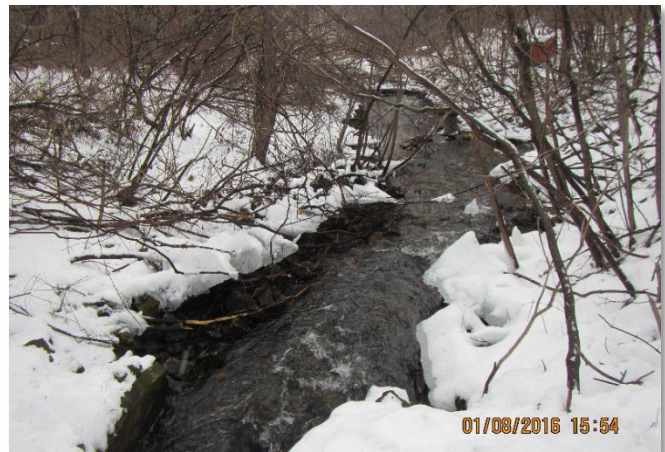
FIGURE 4 - THE "DAYLIGHT": BEGINNING OF THE OUTLET CHANNEL

The Outlet Pipe leads from the Outlet Structure to the beginning, or "daylight," of the outlet channel (Figure 4). It is buried underground for approximately 2075 feet, with 5 manholes and 7 access points (Figure 5).

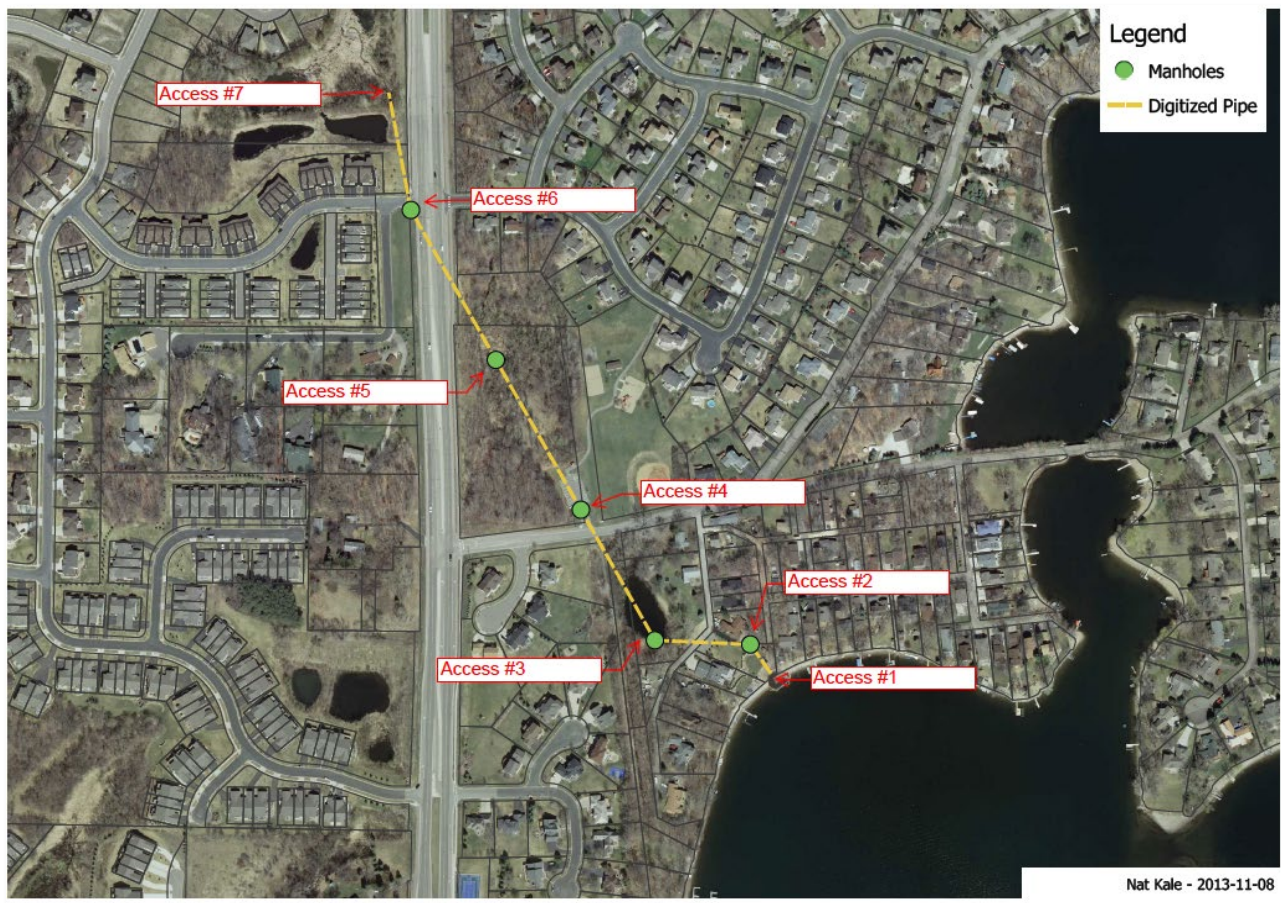
FIGURE 5 - MAP OF OUTLET PIPE

In 2020, American Environmental televised the pipe revealing the lake outfall pipe is in good to fair condition, but multiple cracks and fractures were found in some segments. Several options were weighed to decide the best course of action. Some of the options include sealing the joints that fail pressure tests, lining the pipe, a combination of those two, or pipe bursting.

In 2022, American Environmental televised the pipe and found that the pipe is still in good to fair condition. However, many small longitudinal cracks, light to medium leaks, and light to medium mineral deposits around joints (sign of infiltration) were observed throughout entire length of the pipe. The contractor suggested cured-in-place-pipe (CIPP) lining as a suggested fix for the current observed issues. The pipe review summary is shown in Attachment H.

The current pipe is over 40 feet deep in some places, with narrow easements that would not allow a full pipe replacement. Throughout 2023 and 2024, watershed District staff, partners, and dedicated residents from across the watershed were determined to find funding to extend the life of Prior Lake’s greatest line of defense against flooding. District staff and partners worked extensively to secure project funding, including lobbying for state bonding funds and applying for multiple grants. In August, the District was awarded a \$850,000 MPCA “Stormwater Resiliency Implementation” grant that would cover approximately 90% of the estimated project cost. Construction of a CIPP project is expected to begin in the winter of 2025-2026, extending the lifespan of the pipe by another 50 years.

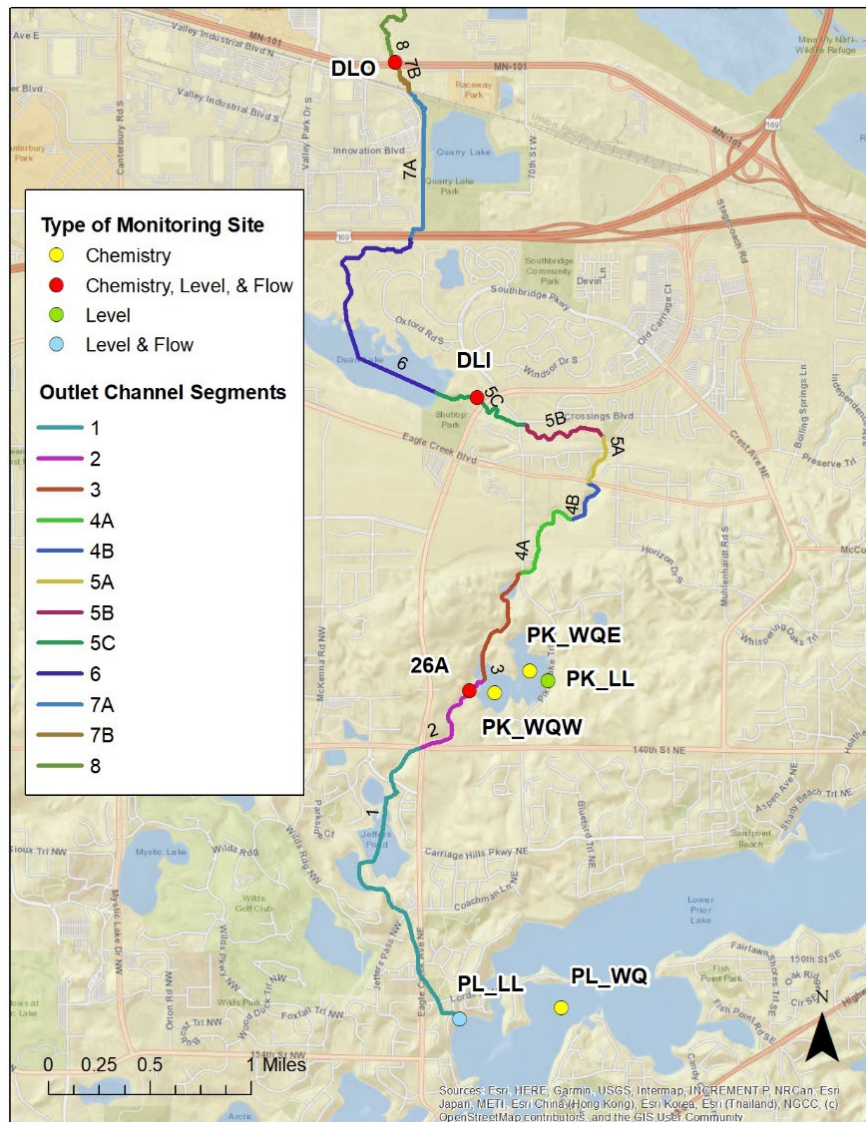
FIGURE 9 - PLOC MONITORING LOCATIONS

Monitoring along the outlet channel in 2024 consisted of water quantity (flow), water quality (chemistry), vegetation surveys, and erosion monitoring (Figure 9). A part of this monitoring is funded by the MOA cooperators, and some is done for other programs or entities. Figure 9 below shows the location and types of monitoring sites location along the channel.
