2014 PRIOR LAKE OUTLET SYSTEM ANNUAL OPERATIONS REPORT

February 2015

PRIOR LAKE - SPRING LAKE
WATERSHED DISTRICT

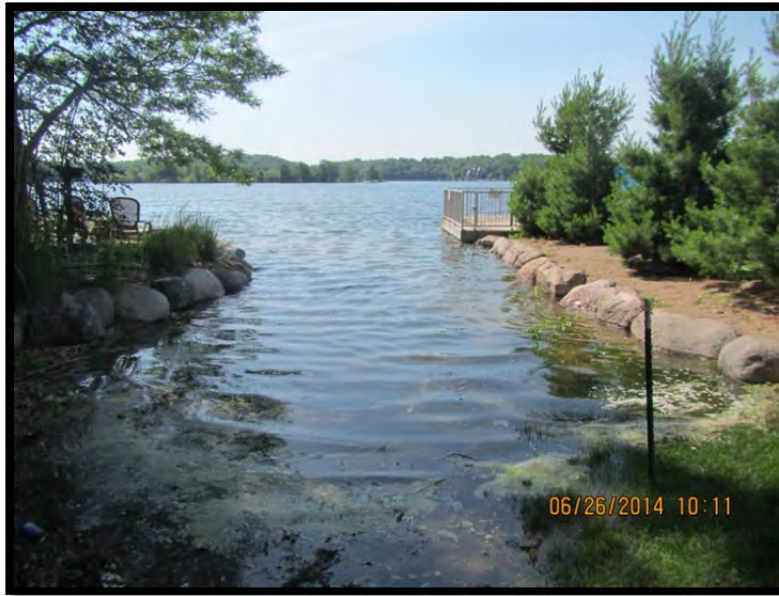
FIGURE 3 – OUTLET STRUCTURE DURING FLOOD IN 2014

In 2014, the extreme rainfalls (see Figure 1) created record flood conditions and caused the outlet structure and outlet channel to be engulfed with water for long periods of time. Prior Lake reached a record 906.16', which was the highest recorded lake level since 1915, when 907 feet was recorded.

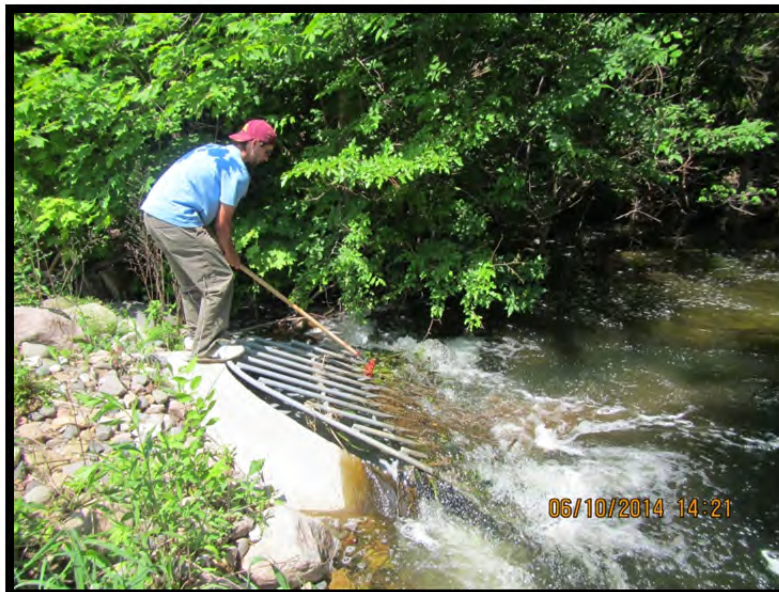
Removal of vegetation and debris from several culverts or grates throughout the year to ensure free flows was the primary extent of the additional maintenance that occurred (See Figure 19).

FIGURE 19 REMOVING VEGETATION FROM CULVERT GRATE AT CR42

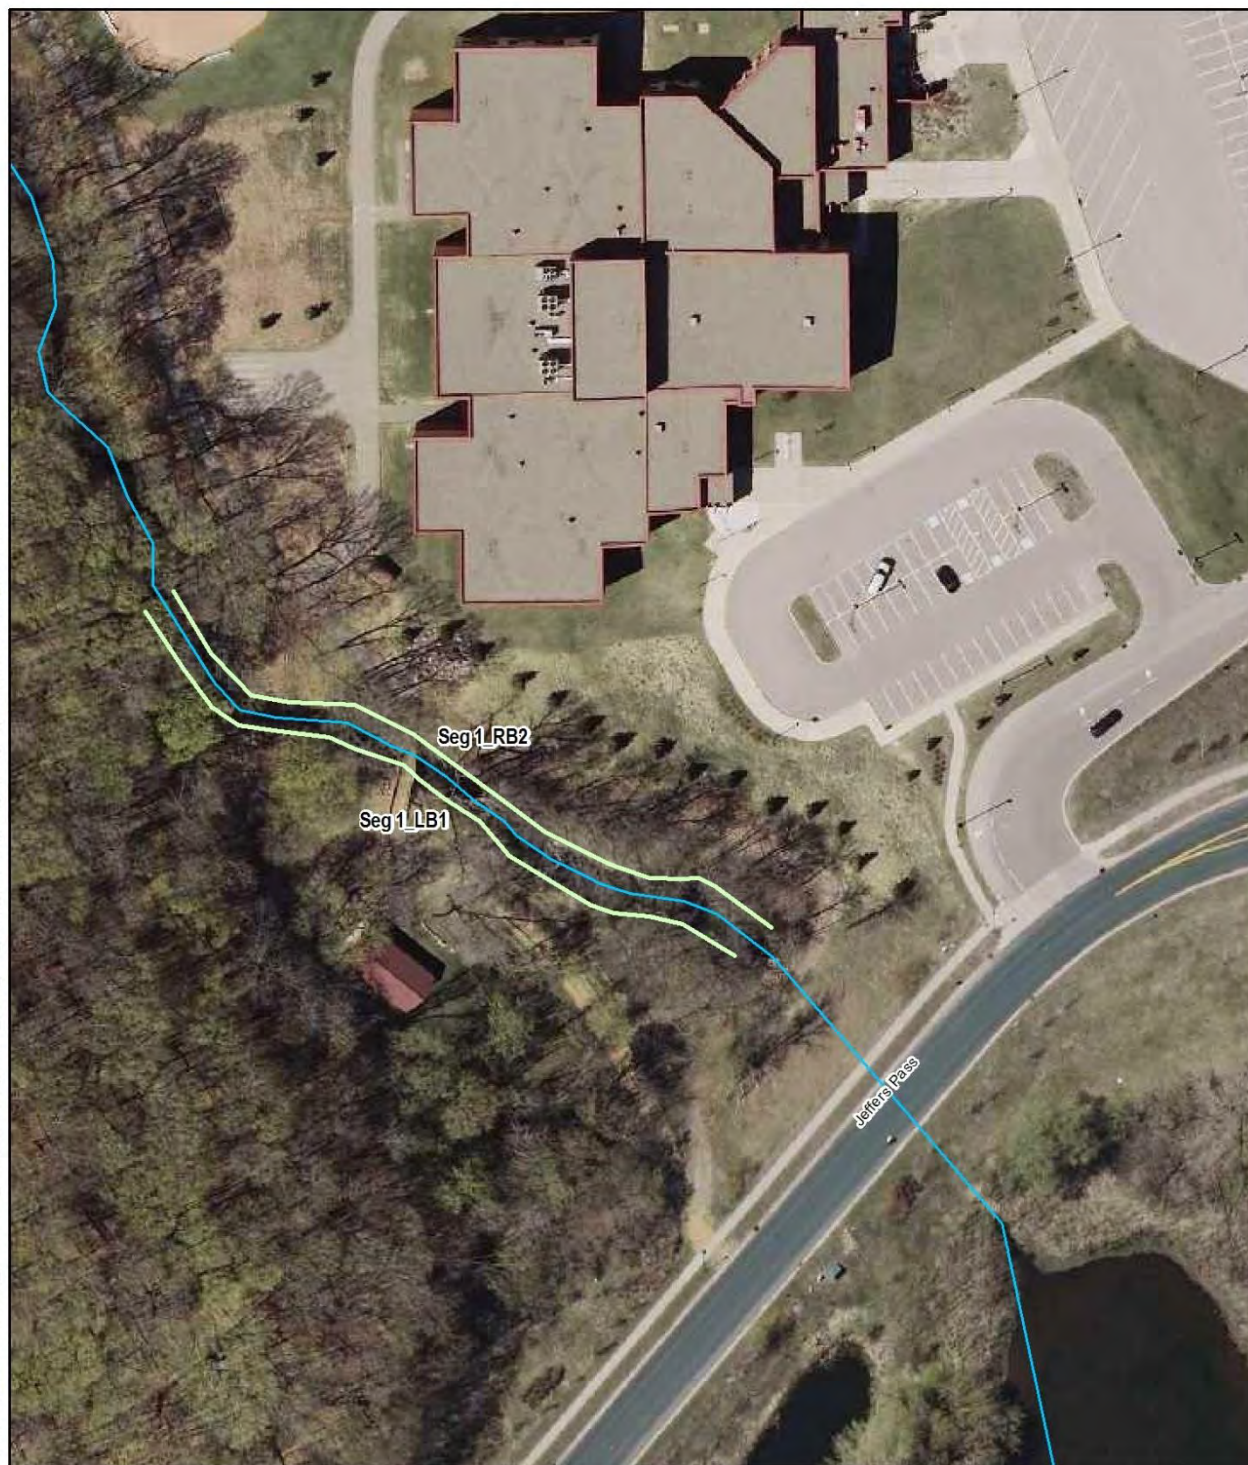
Figure 1. Segment 1 (Upper Reach) Bank Erosion Location.

Bank ID	Location	Length [ft.]	Average Height [ft.]	Max Height [ft.]	Priority Ranking	Preliminary Estimate of Probable Cost
Seg 1_LB1	Left Bank	370	2.0	2.5	Low	\$20,774
Seg 1_RB2	Right Bank	373	2.0	2.6	Low	\$20,942
Seg 1_RB3	Right Bank	34	2.4	2.8	Low	\$1,909
Seg 1_RB4	Right Bank	135	1.2	1.2	Low	\$7,580
Seg 1_RB5	Right Bank	63	1.3	1.8	Low	\$3,537
Seg 1_LB6	Left Bank	138	1.7	2.4	Low	\$7,748
Seg 1_RB7	Right Bank	381	2.1	3.0	Low	\$21,391
Seg 1_LB8	Left Bank	207	1.8	2.1	Low	\$11,622
Seg 1_LB9	Left Bank	33	2.8	2.8	Low	\$1,853
Seg 1_RB10	Right Bank	68	2.6	3.0	Low	\$3,818
Seg 1_RB11	Right Bank	68	2.1	2.5	Low	\$3,818
Seg 1_RB12	Right Bank	126	2.0	2.2	Low	\$7,074
Seg 1_LB13	Left Bank	121	2.2	3.0	Low	\$6,794
Seg 1_LB14	Left Bank	61	1.4	1.9	Low	\$3,425
Total Length		2178			Segment Total	\$122,284

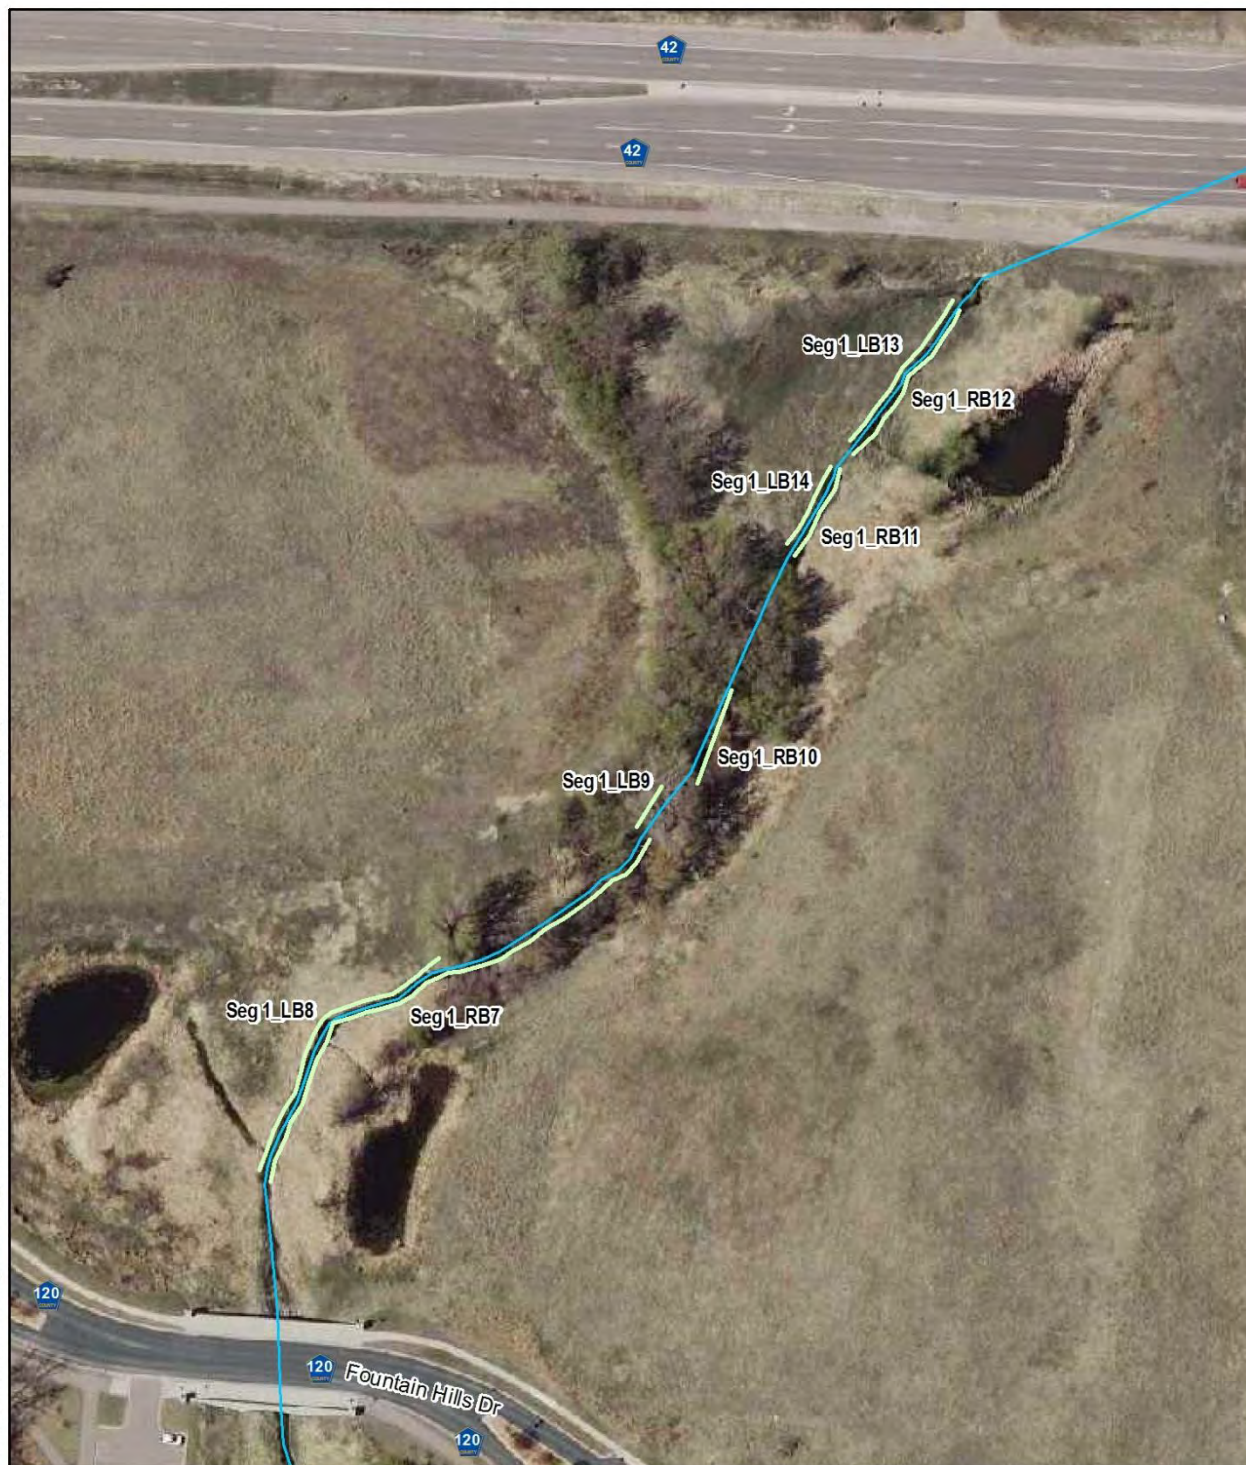
Figure 3. Segment 1 (Lower Reach) Bank Erosion Locations

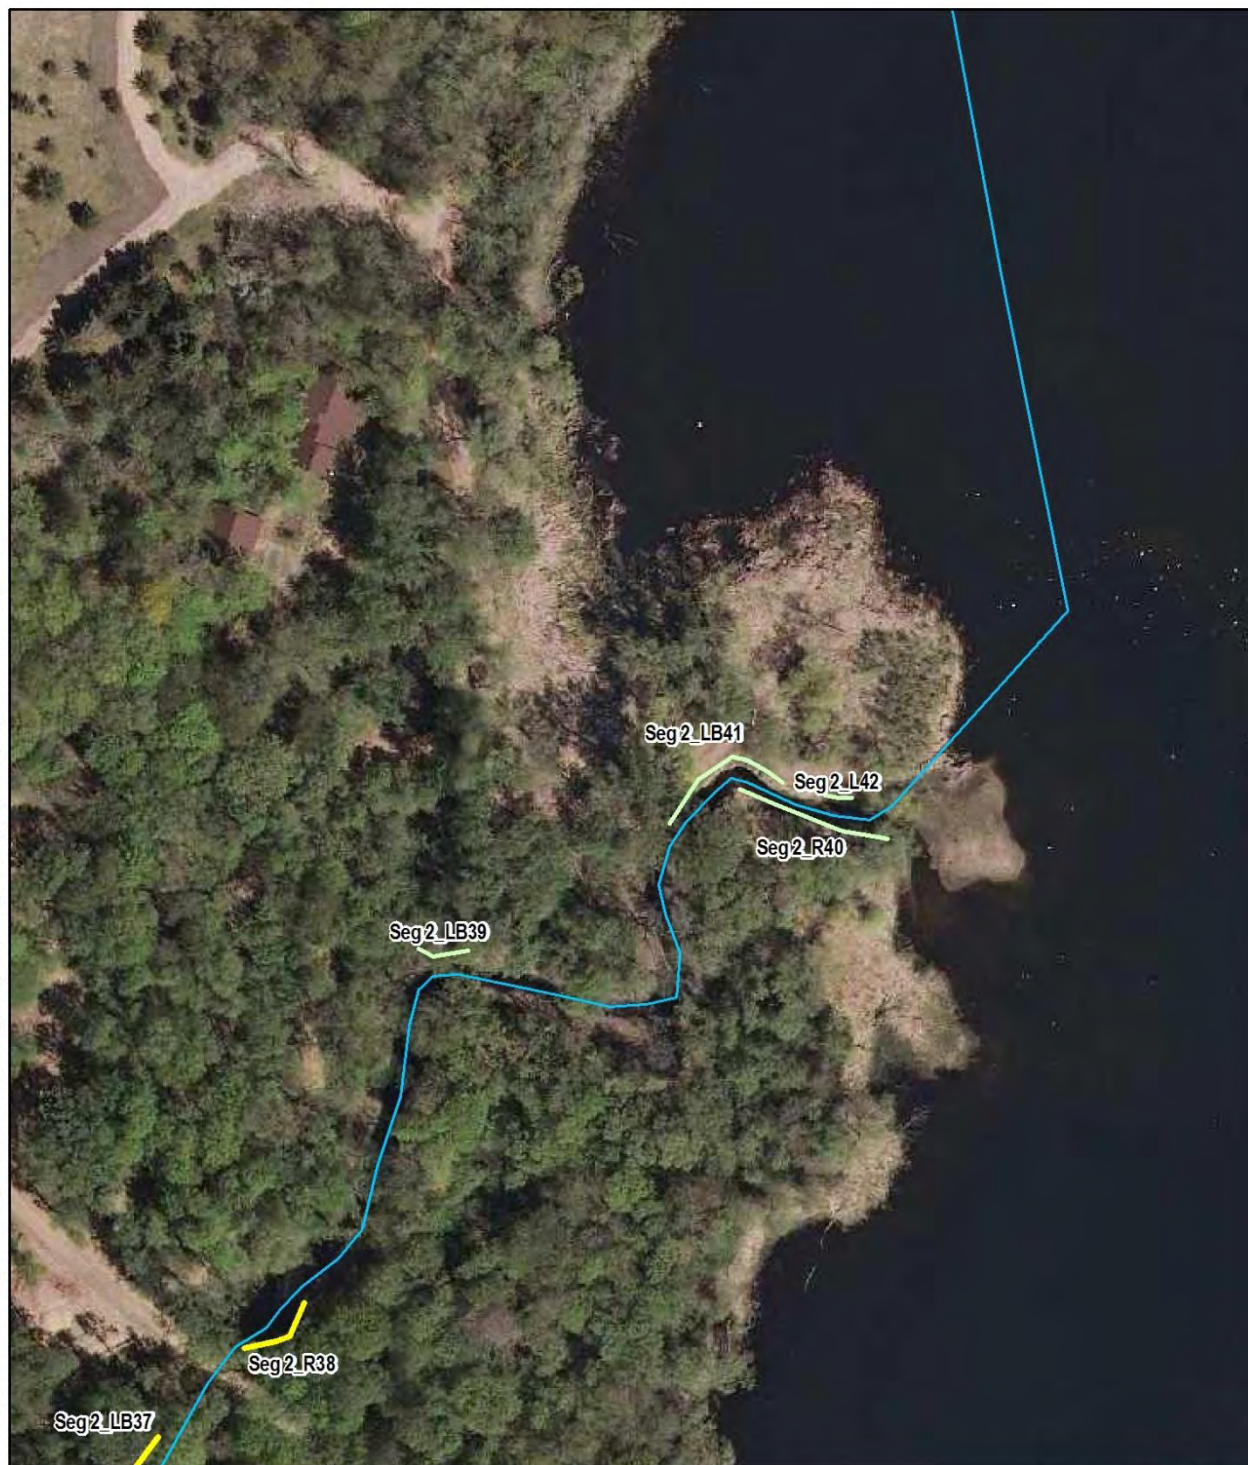
Figure 6. Segment 2 (Lower Reach) Bank Erosion Locations

Seg 2_LB33	Left Bank	104	4.7	9.5	High	\$6,468
Seg 2_R34	Right Bank	22	2.1	3.3	Moderate	\$1,382
Seg 2_RB35	Right Bank	15	1.5	2.5	Low	\$949
Seg 2_R36	Right Bank	84	2.3	3.3	Moderate	\$5,208
Seg 2_LB37	Left Bank	149	1.6	4.5	Moderate	\$9,265
Seg 2_R38	Right Bank	43	2.1	4.0	Moderate	\$2,696
Seg 2_LB39	Left Bank	27	1.0	1.8	Low	\$1,677
Seg 2_R40	Right Bank	82	1.8	2.8	Low	\$5,075
Seg 2_LB41	Left Bank	78	1.4	3.0	Low	\$4,854
Seg 2_L42	Left Bank	14	1.2	2.2	Low	\$882
Total Length		2037	Segment Total			\$126,714

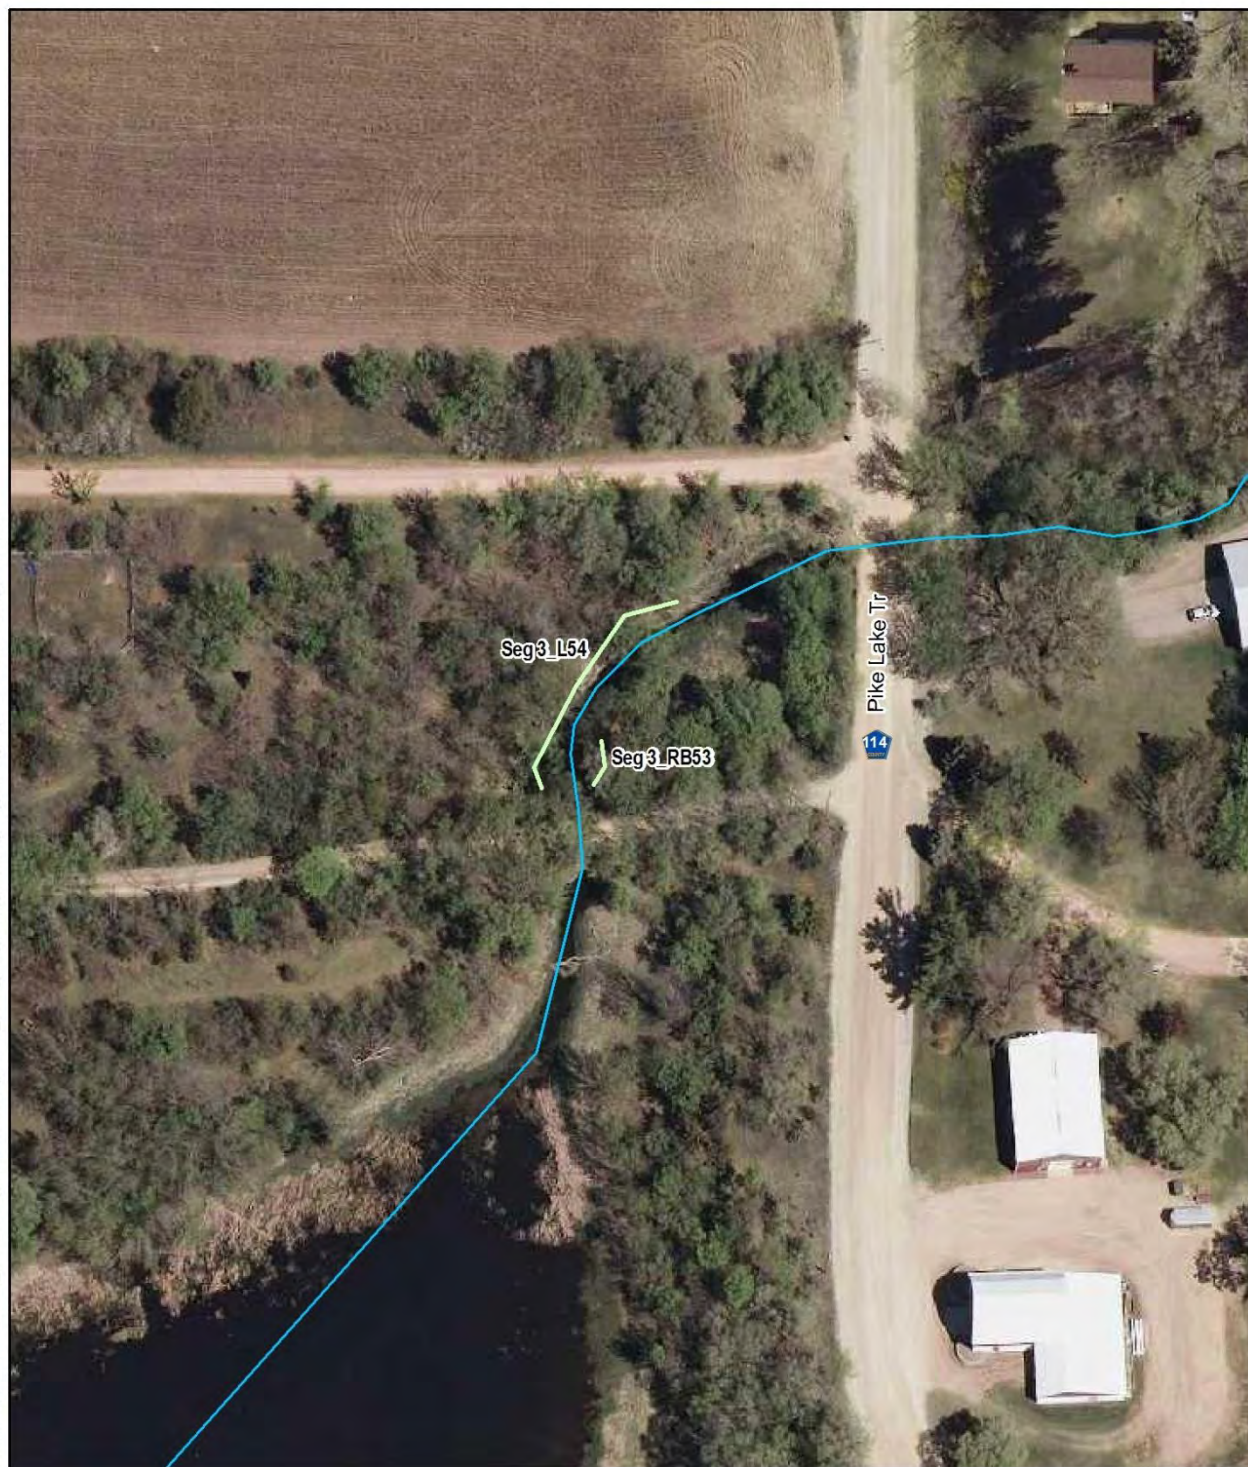
Bank ID	Location	Length [ft.]	Average Height [ft.]	Max Height [ft.]	Priority Ranking	Preliminary Estimate of Probable Cost
Seg 3_RB43	Right Bank	157	2.0	3.9	Moderate	\$9,646
Seg 3_L44	Left Bank	71	2.4	4.2	Moderate	\$4,396
Seg 3_LB45	Left Bank	83	1.6	2.7	Low	\$5,104
Seg 3_R46	Right Bank	108	1.5	2.9	Low	\$6,621
Seg 3_LB47	Left Bank	22	1.8	2.5	Low	\$1,339
Seg 3_L48	Left Bank	130	3.6	8.0	High	\$8,025
Seg 3_RB49	Right Bank	46	1.6	3.1	Low	\$2,802
Seg 3_L50	Left Bank	112	4.2	6.8	High	\$6,897
Seg 3_LB51	Left Bank	14	2.5	3.0	Low	\$889
Seg 3_R52	Right Bank	34	1.9	2.5	Low	\$2,082
Seg 3_RB53	Right Bank	24	1.4	2.3	Low	\$1,483
Seg 3_L54	Left Bank	132	1.8	2.8	Low	\$8,107
Total Length		932			Segment Total	\$57,390

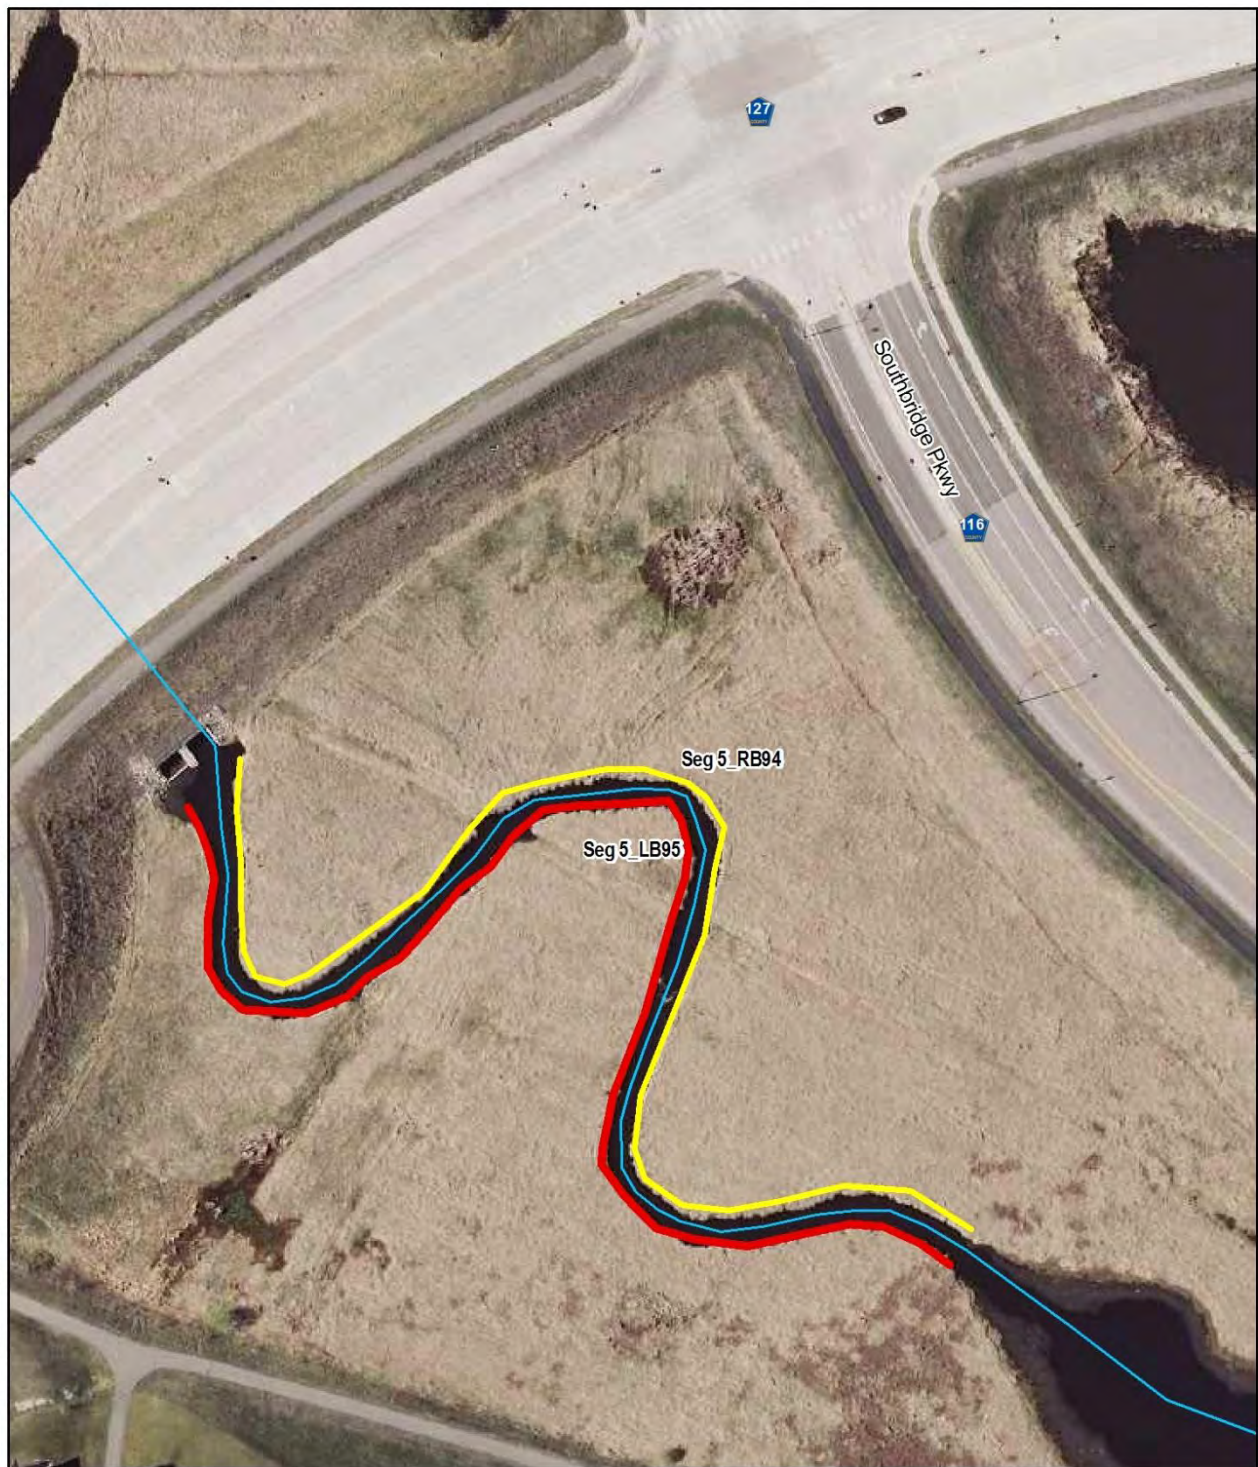
Seg 5_LB90	Left Bank	96	1.8	2.6	Low	\$5,464
Seg 5_RB91	Right Bank	49	1.8	2.2	Low	\$2,819
Seg 5_LB92	Left Bank	155	2.1	3.0	Low	\$8,811
Seg 5_RB93	Right Bank	133	1.8	2.0	Low	\$7,607
Seg 5_RB94	Right Bank	786	2.5	3.3	Moderate	\$44,823
Seg 5_LB95	Left Bank	783	2.9	5.0	High	\$44,631
Total Length		3930			Segment Total	\$224,022

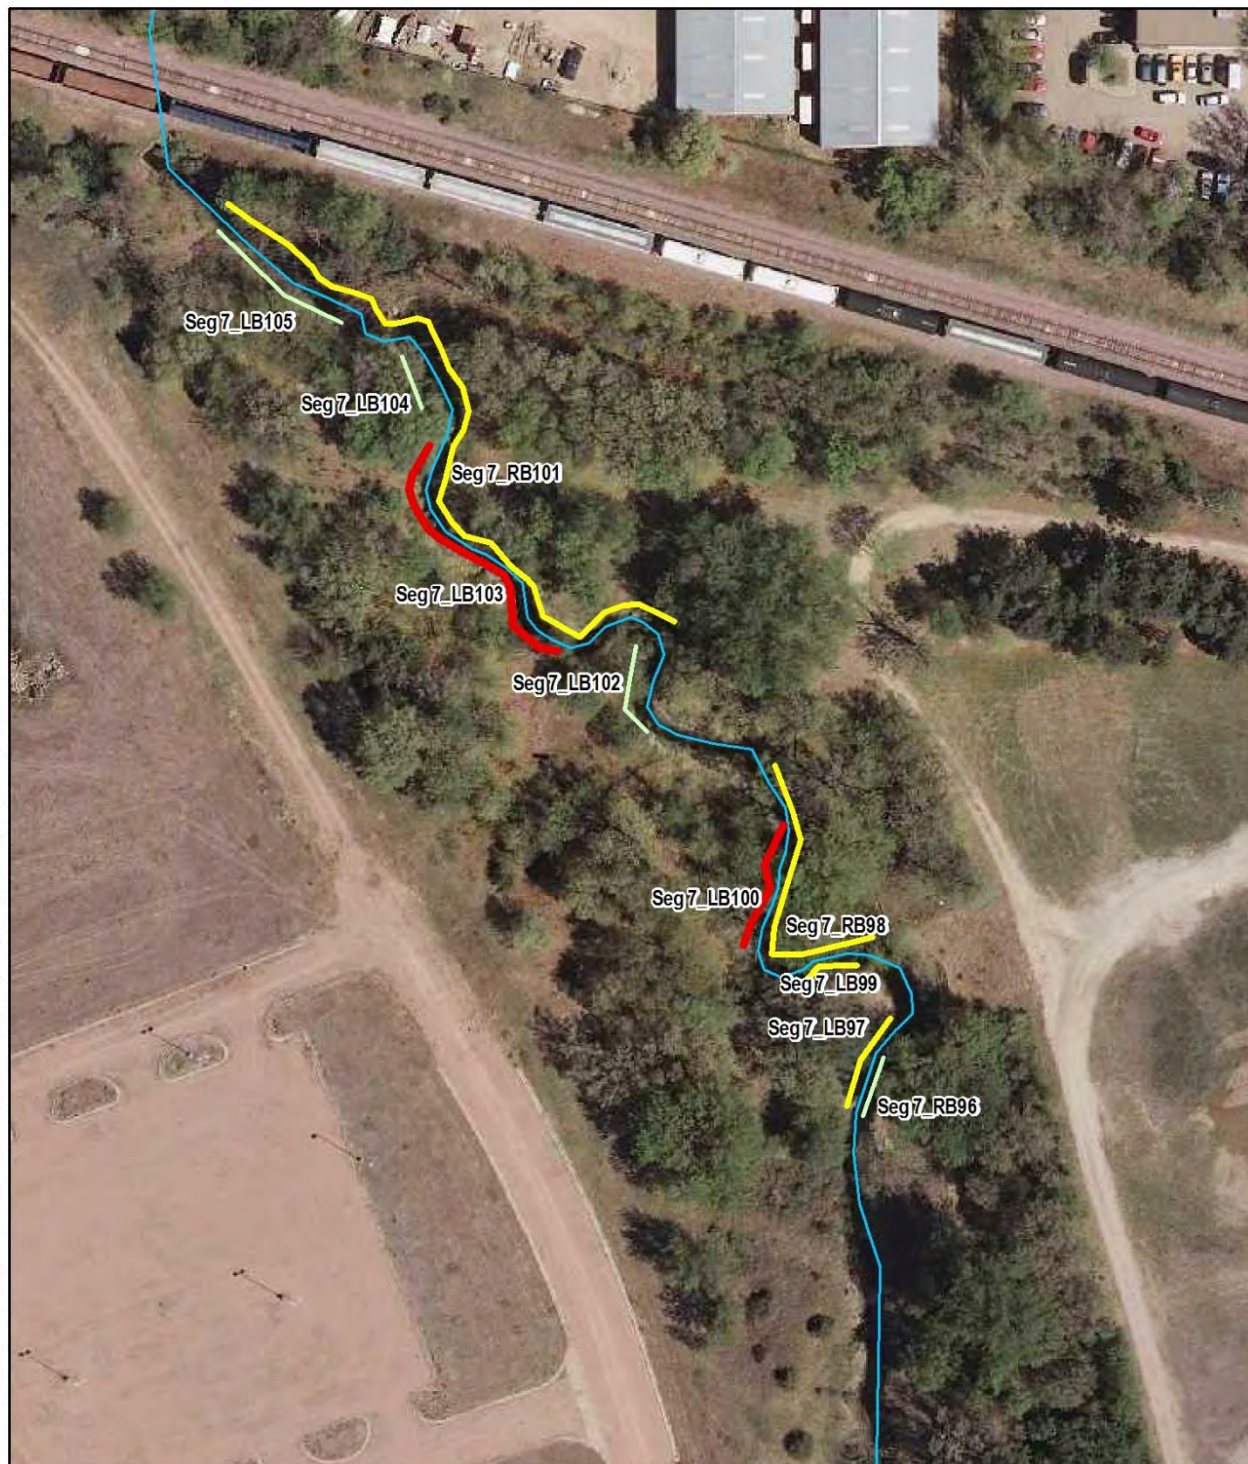
PLOC Bank Failure 2014 Inventory

Bank ID	Location	Length [ft.]	Average Height [ft.]	Max Height [ft.]	Priority Ranking	Preliminary Estimate of Probable Cost
Seg 6_RB131	Right Bank	974	2.2	3.0	Low	\$57,090
Seg 6_LB132	Left Bank	913	2.5	3.2	Moderate	\$53,489
Seg 6_LB133	Left Bank	120	2.0	3.0	Low	\$7,011
Total Length		2007			Segment Total	\$117,591

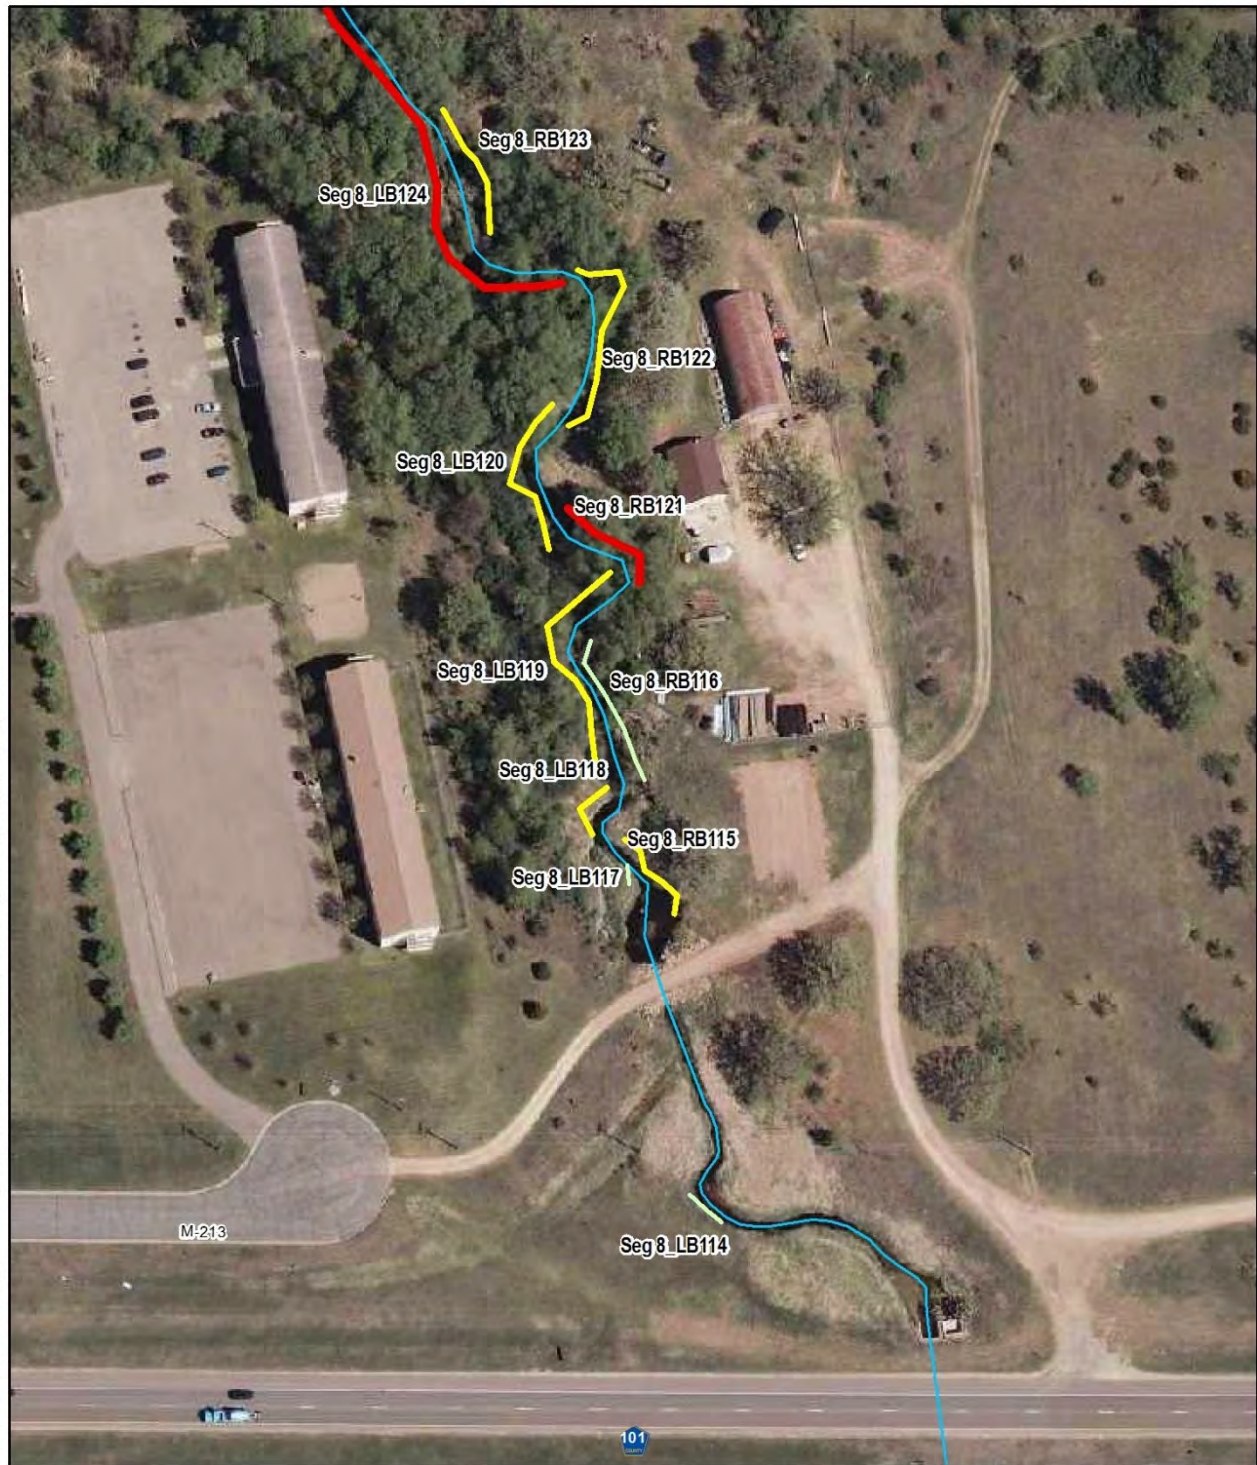
**PLOC Bank Failure
 2014 Inventory
 Segment 7 (Lower Reach)**

Seg 7_RB113	Right Bank	85	3.5	7.5	High	\$5,186
Seg 7_RB134	Right Bank	52	1.7	2.5	Low	\$3,212
Seg 7_RB135	Right Bank	122	1.8	2.5	Low	\$7,458
Total Length		1888	Segment Total			\$115,640

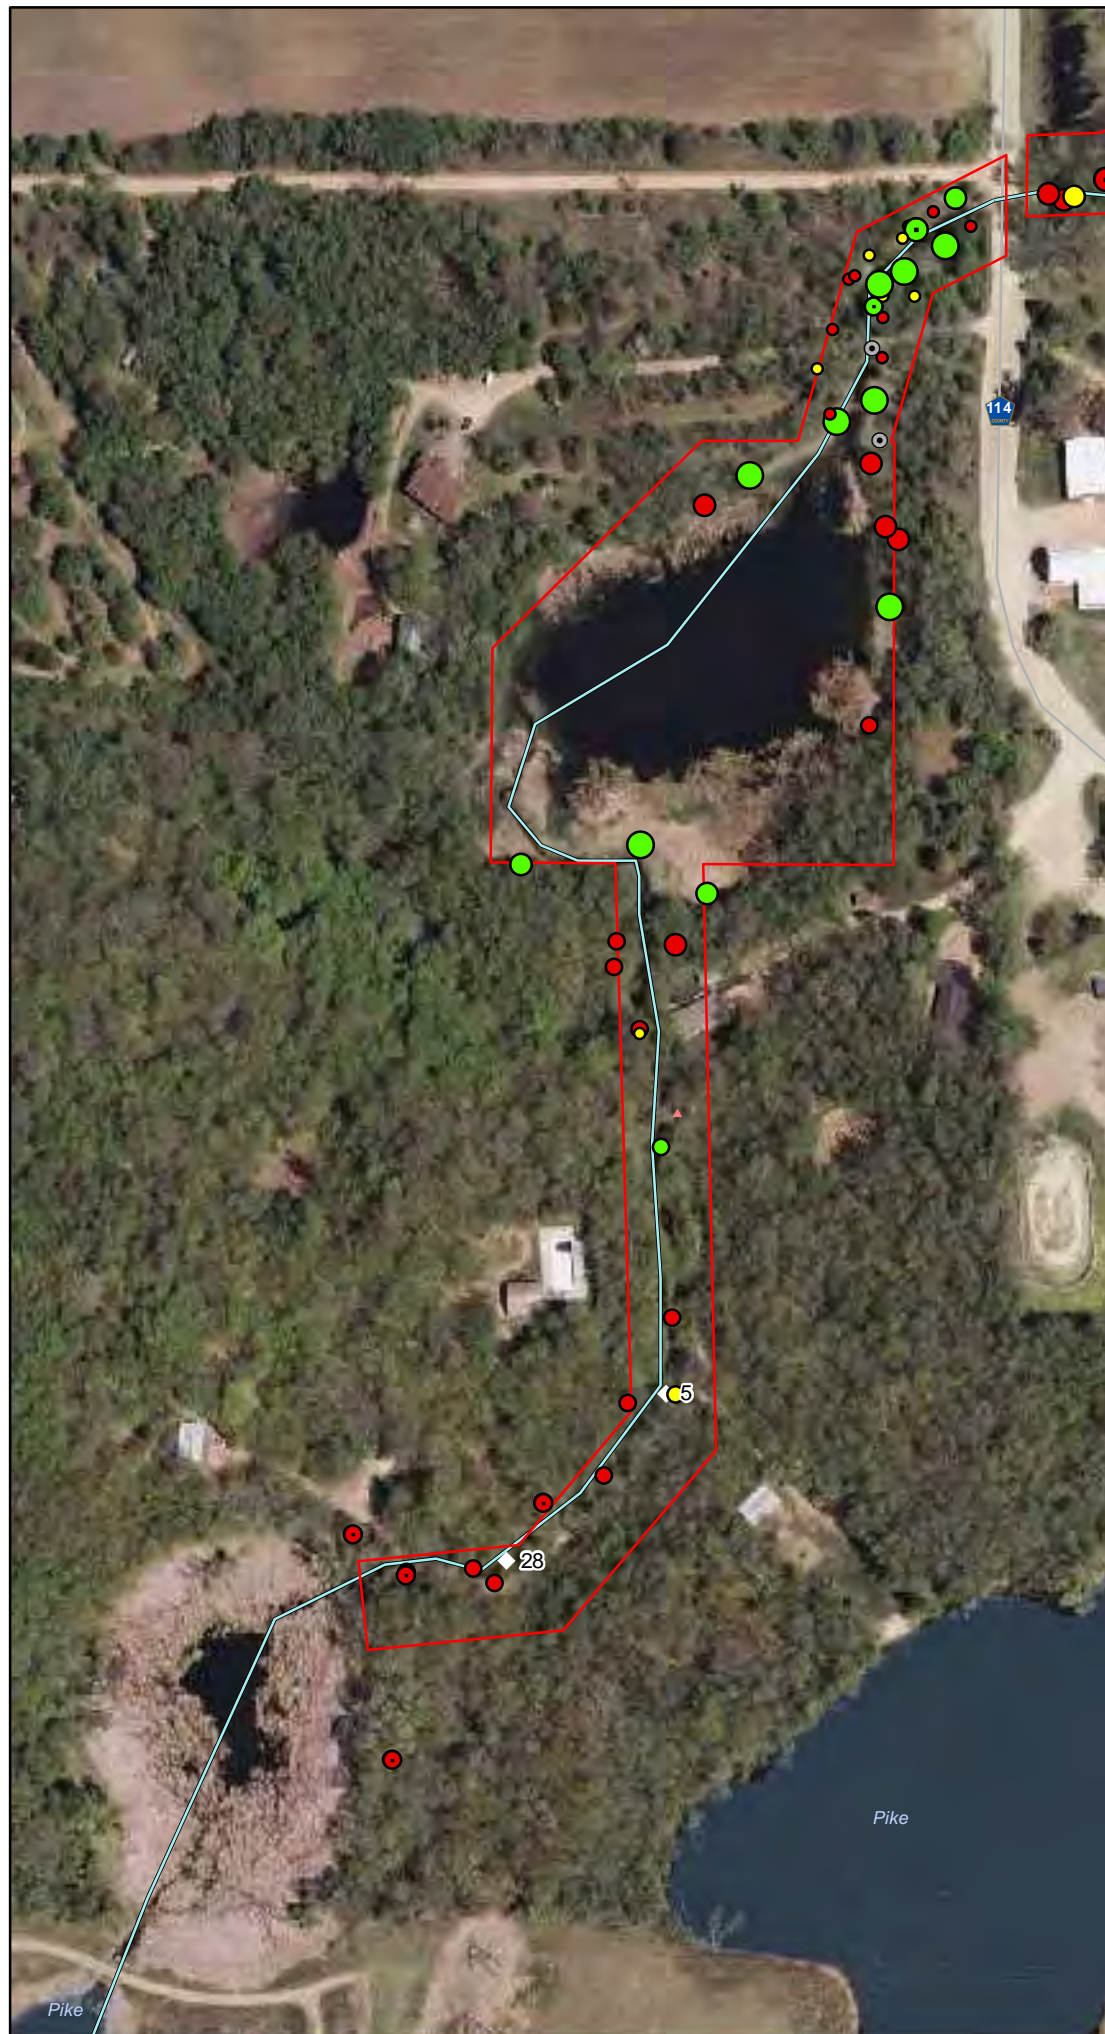
Segment 4a

Segment 4A: Occasional sucker growth from cut stumps of buckthorn and honeysuckle was observed. Re-growth of native herbaceous species has occurred so foliar spraying will be conducted during the fall. No re-growth of Siberian elm was observed. Dense stands of honeysuckle and buckthorn occur between Pike Lake Trail and Jackson Trail, as well as on the western easement between Jackson Trail and the Jackson field road crossing. These areas were not managed in 2012 due to conflicting easement information and property access.

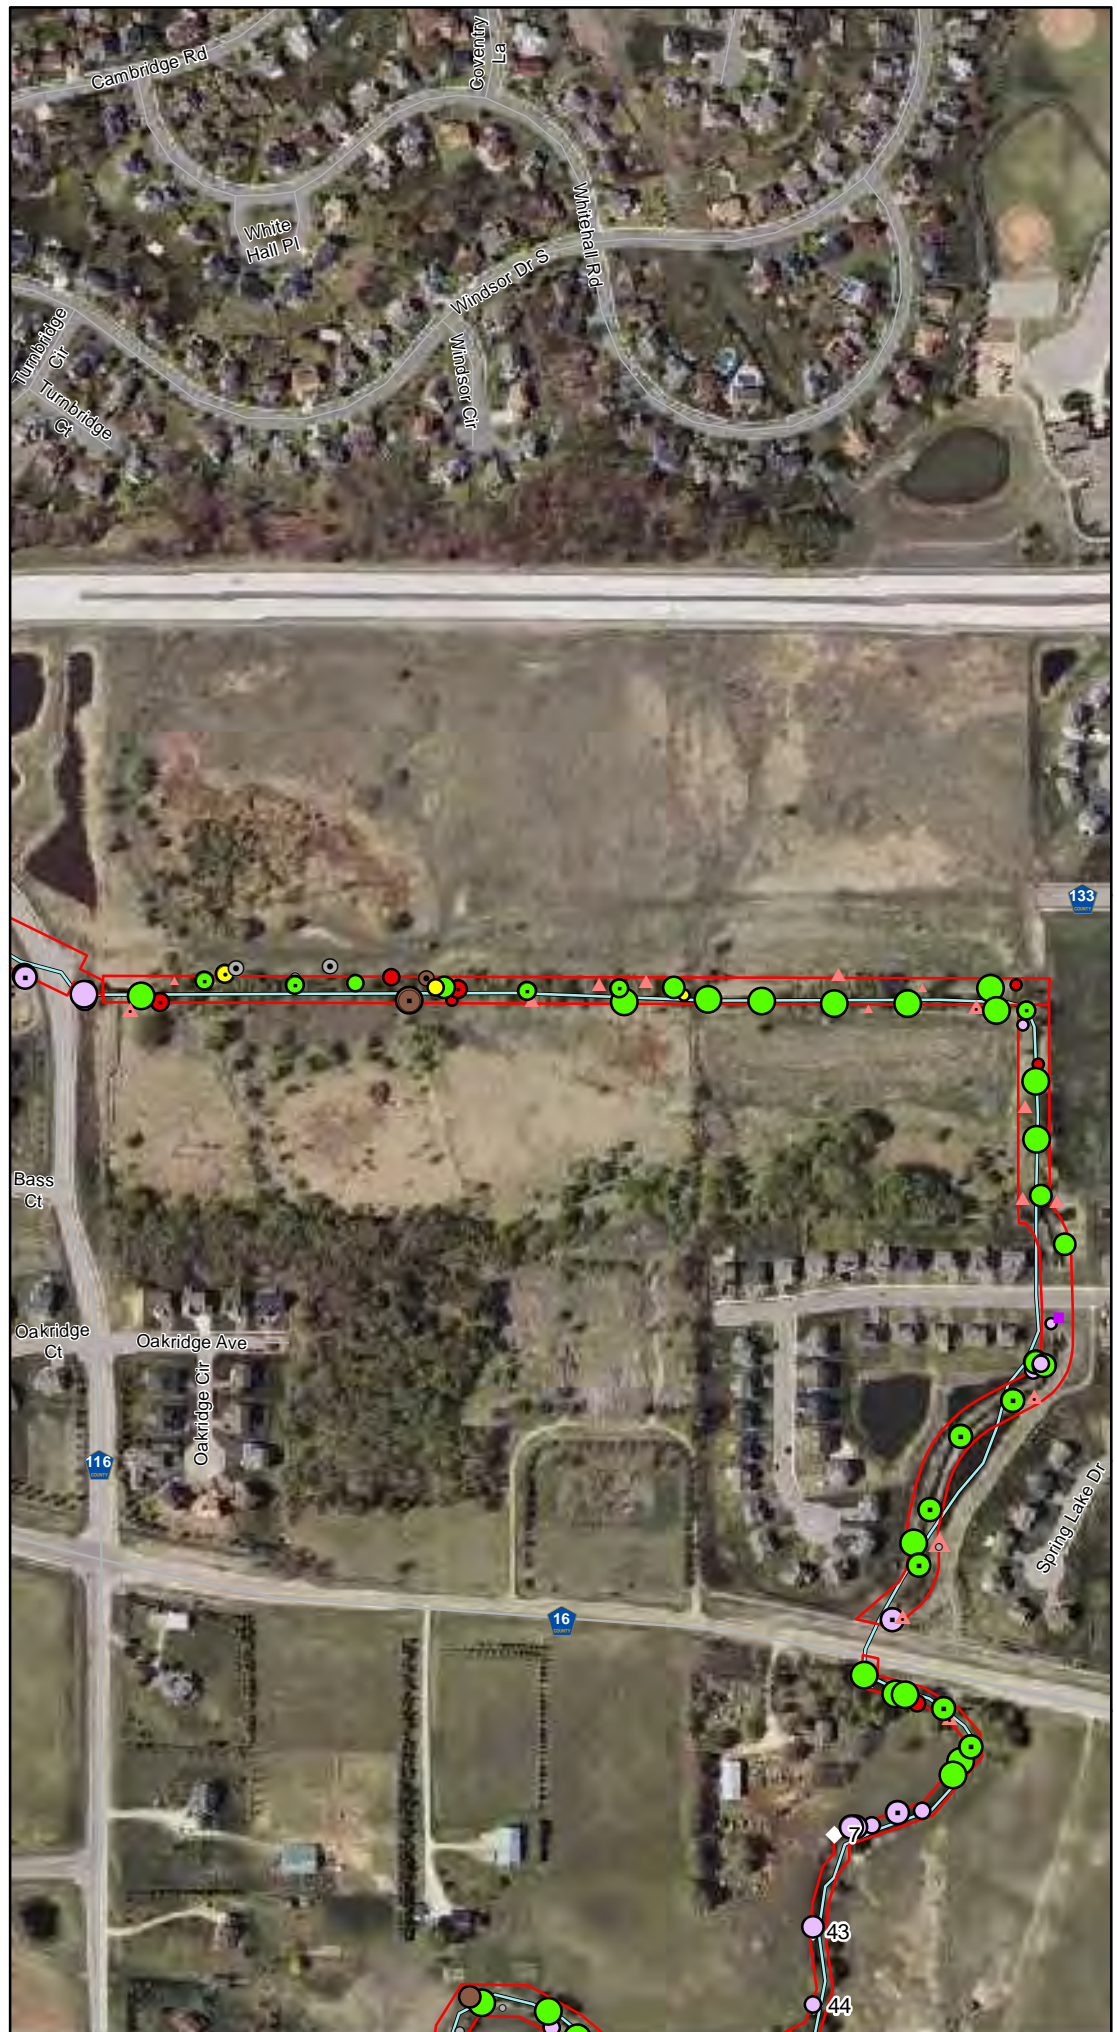
Segment 5c

Segment 5C: Slight sucker growth from cut stumps of buckthorn and honeysuckle was noted in the small treatment area immediately upstream of Dean's Lake.

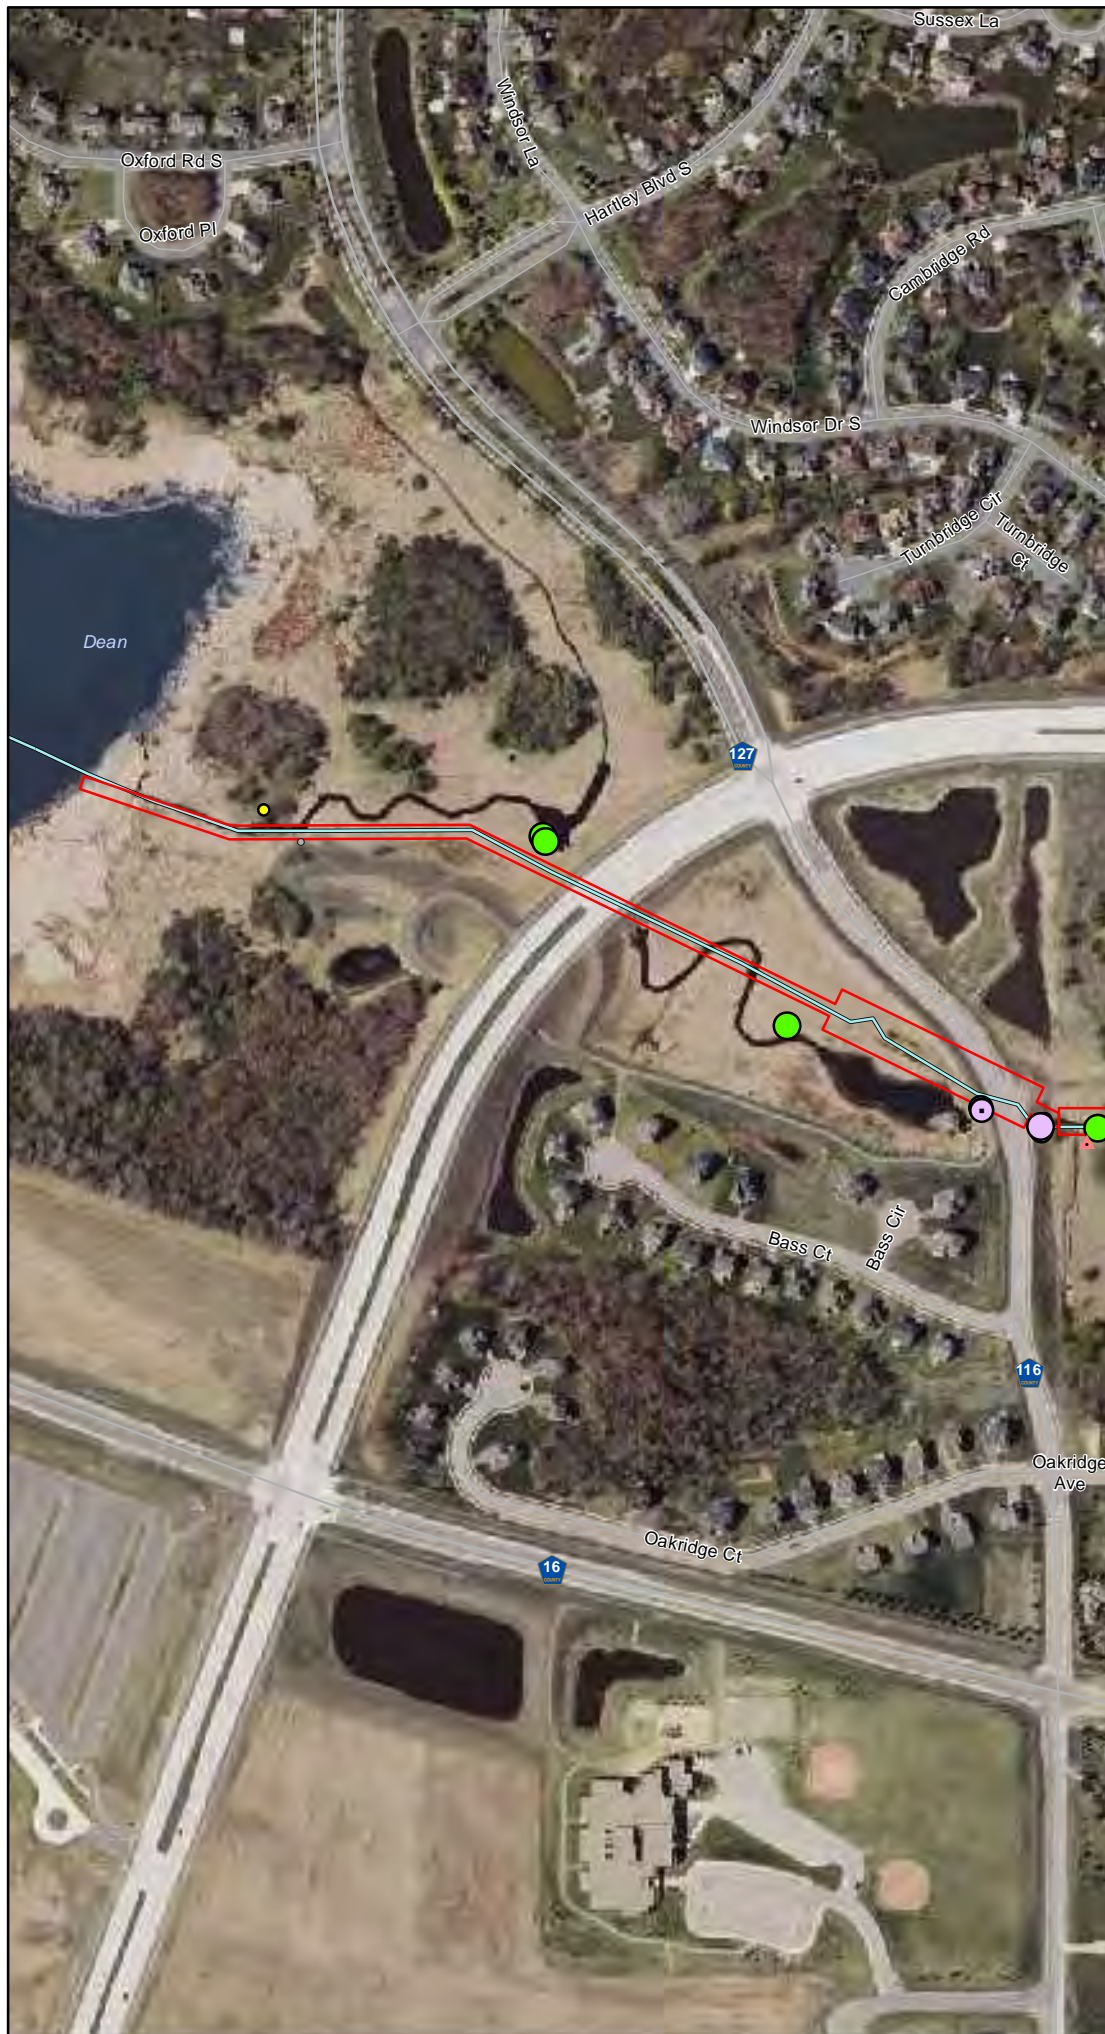
Segment 6

Segment 6: Buckthorn seedlings were observed in the treatment area on the east side of the Dean's Lake weir.
