2014 PRIOR LAKE OUTLET SYSTEM ANNUAL OPERATIONS REPORT

February 2015

PRIOR LAKE - SPRING LAKE
WATERSHED DISTRICT

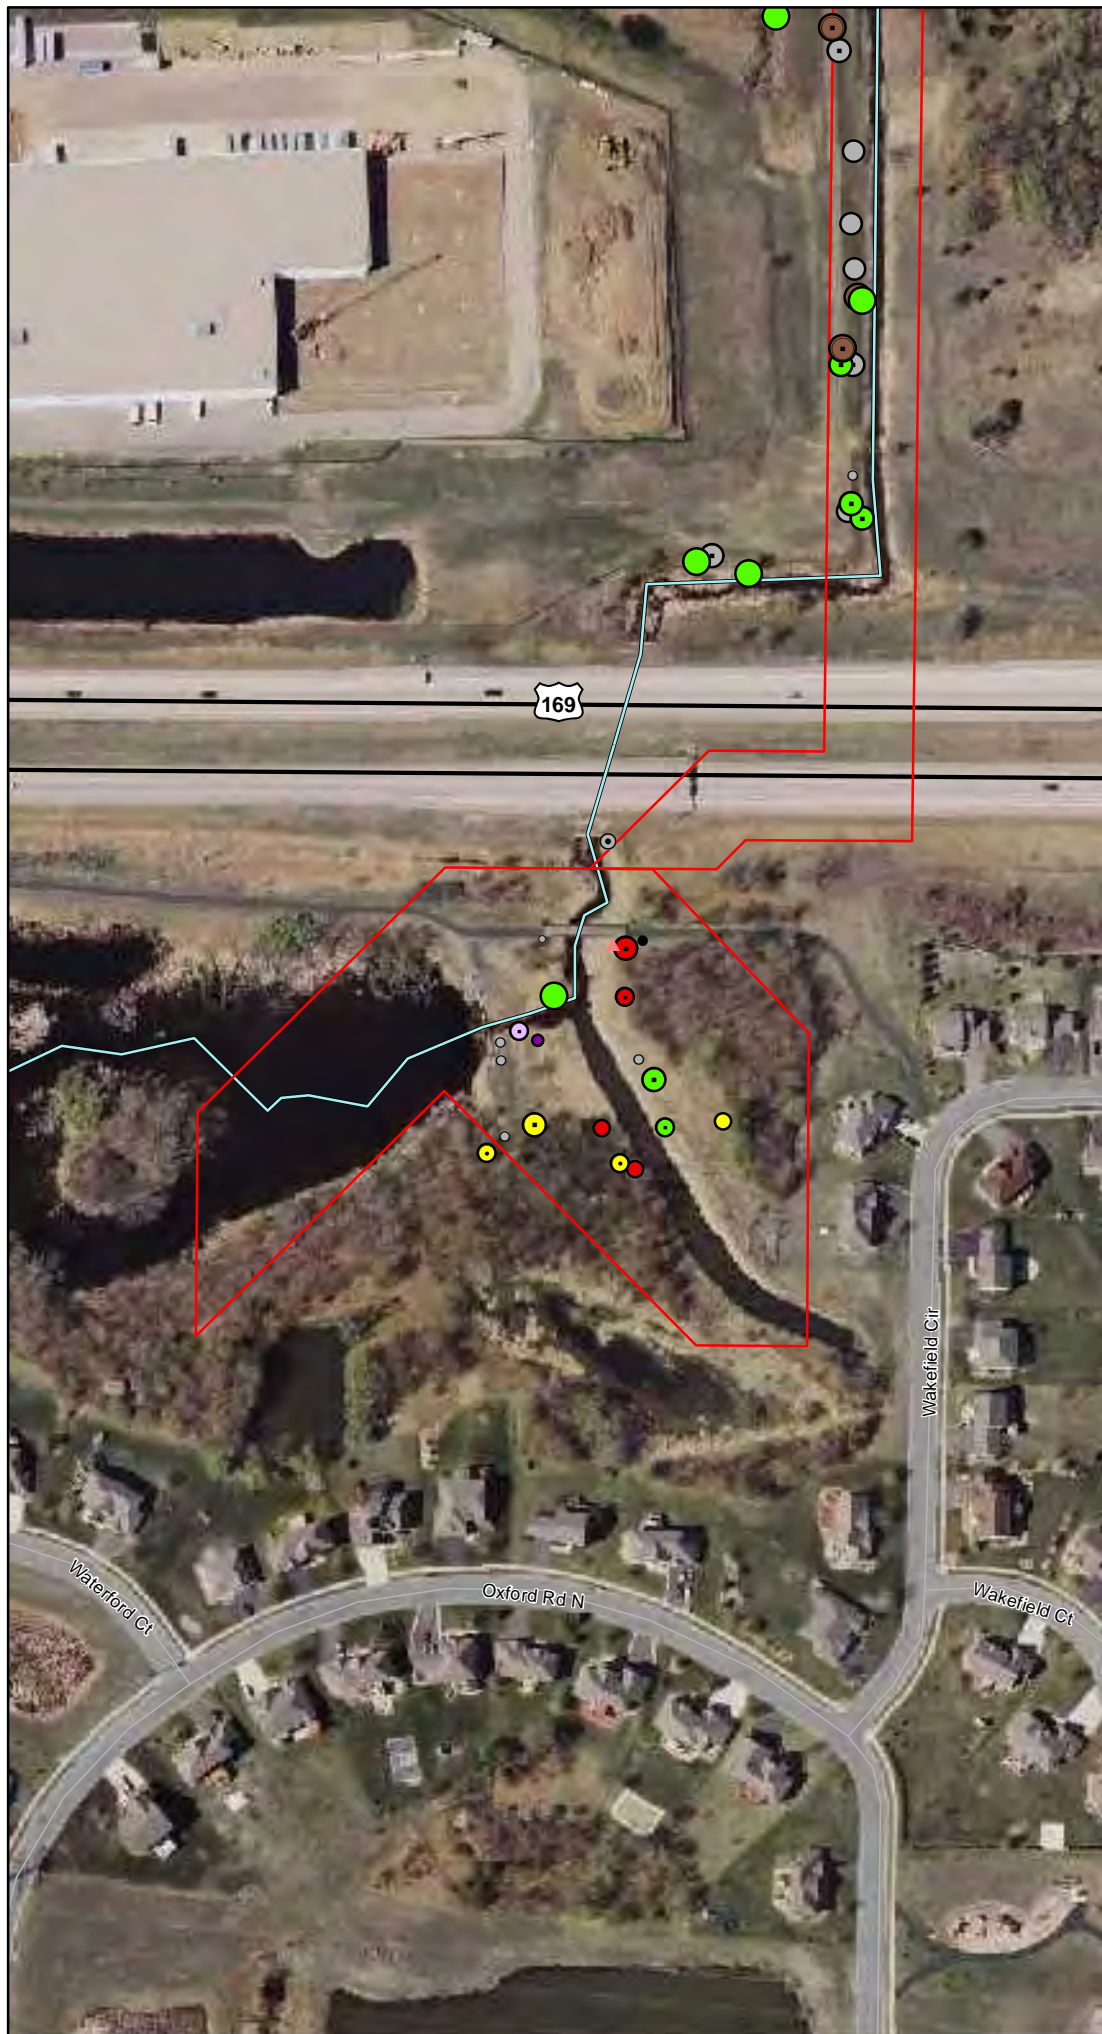
Segment 7a

Segment 7A: Occasional sucker growth from cut stumps of buckthorn and honeysuckle was observed. Re-growth of native herbaceous species has occurred so foliar spraying will be conducted during the fall. No re-growth of Siberian elm was observed.
