PRIOR LAKE - SPRING LAKE
WATERSHED DISTRICT

2015 Prior Lake Outlet System Annual Operations Report

2015 PRIOR LAKE OUTLET SYSTEM ANNUAL OPERATIONS REPORT

By: Jaime Rockney
PLSLWD Water Resources Specialist
February 2016

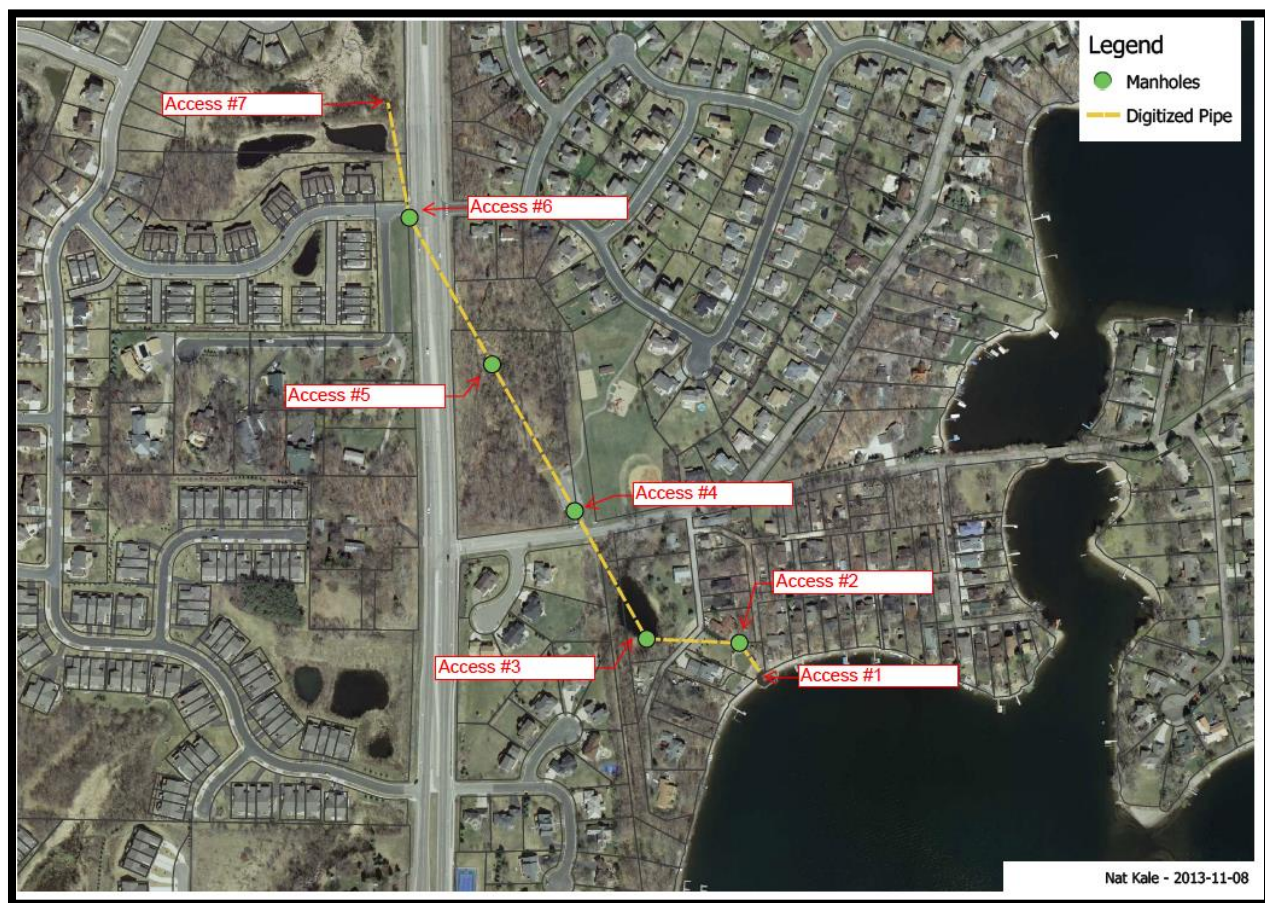
FIGURE 6 LOCATIONS OF OUTLET PIPE AND ACCESS POINTS

In general, the lake outfall pipe is in good to fair condition. They identified one defect that is coded red for immediate attention. The reinforcement is visible on the edge of the pipe on the downstream end of manhole number 3. Exposed steel is subject to rusting and allows water into the concrete pipe. This defect can be repaired with a cementitious coating; however it is in a difficult location being at the end of the pipe.

The pipe also has leaking joints with mineral deposits in every pipe segment and some of these joints are likely the source of the fine deposits found downstream of manhole number 4. They identified a number of dripping leaks, but perhaps the most significant dripping water was found at manhole number 6.

While the volume of water leaking through an individual joint may not be substantial, the accumulation of mineral deposits will affect the hydraulic capacity of the pipeline and perhaps more importantly, the movement of fine soils from the area surrounding the pipe can eventually shorten the life of the pipeline as the supporting soils are lost and the pipe can move. Visu-Sewer recommends the JPA/MOA partners consider a project to inject chemical grout in the leaking joints, before lining the existing pipe. Significant leaks must be stopped to facilitate lining work anyway.

In 2016, the spalling joint and manholes gutter bases will be repaired. Originally, the JPA/MOA partners planned to repair the spalling joint in 2015, but determined it would be more cost effective to repair the spalling joint and smooth the manholes at the same time. The chemical grouting is scheduled to be completed in 2017.
