# 2016 PRIOR LAKE OUTLET SYSTEM ANNUAL OPERATIONS REPORT

By: Jaime Rockney  
PLSLWD Water Resources Specialist  
February 2017

PRIOR LAKE - SPRING LAKE  
WATERSHED DISTRICT

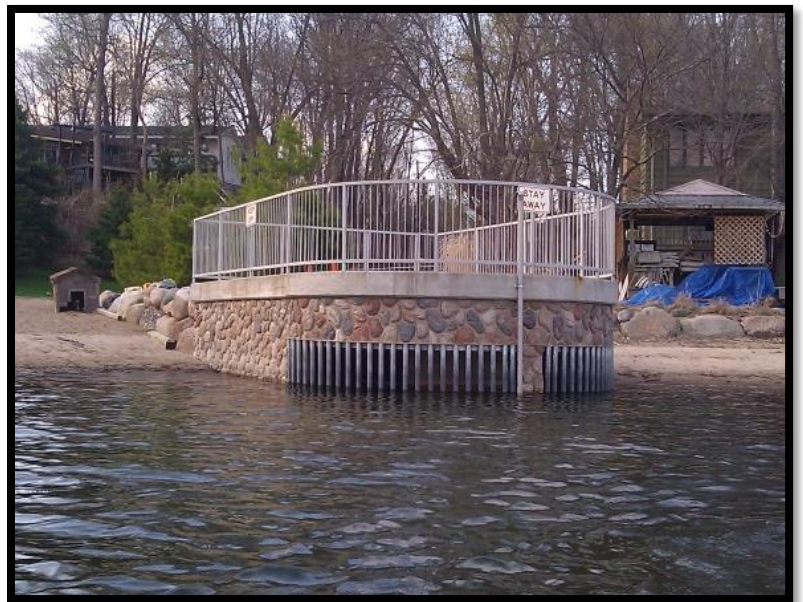
**FIGURE 1**

Given these conditions, a replacement structure was pursued by the District and installed in 2010 (Figure 1). The new design has increased the efficiency of discharging water by allowing the outlet pipe to reach capacity sooner. It has also proven to provide safer conditions for staff during inspections and maintenance, and is self-operating, which will reduce overall operations and maintenance costs. A schematic of the outlet structure is provided in Attachment A.

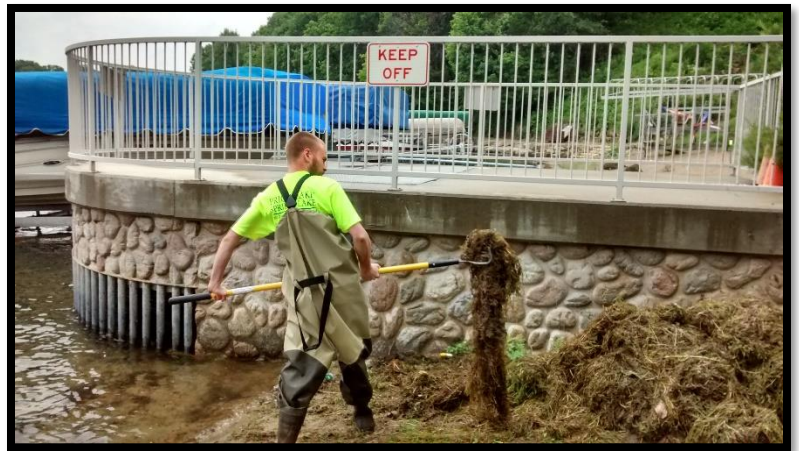
**FIGURE 2**

The new structure needs minimal maintenance to operate. Once Prior Lake reaches 902.5', water starts spilling over the accordion shaped weir located inside the trash rack. Maintenance includes visual inspections, greasing gates, and removing debris from the trash rack. Removing vegetation and other debris from the trash rack is the most time-consuming and labor-intensive task (Figure 2). When the structure is operating (Prior Lake is greater than 902.5'), the structure will be inspected no less than once a week, and as much as twice per day, depending on the lake level and amount of vegetation getting stuck on the trash rack. Inspections and debris removal is typically conducted by PLSLWD staff. During the 2014 flood, however, the City of Prior Lake staff helped remove vegetation once per day and on the weekends in addition to District staff also removing the vegetation daily to ensure the Outlet Structure was not blocked.

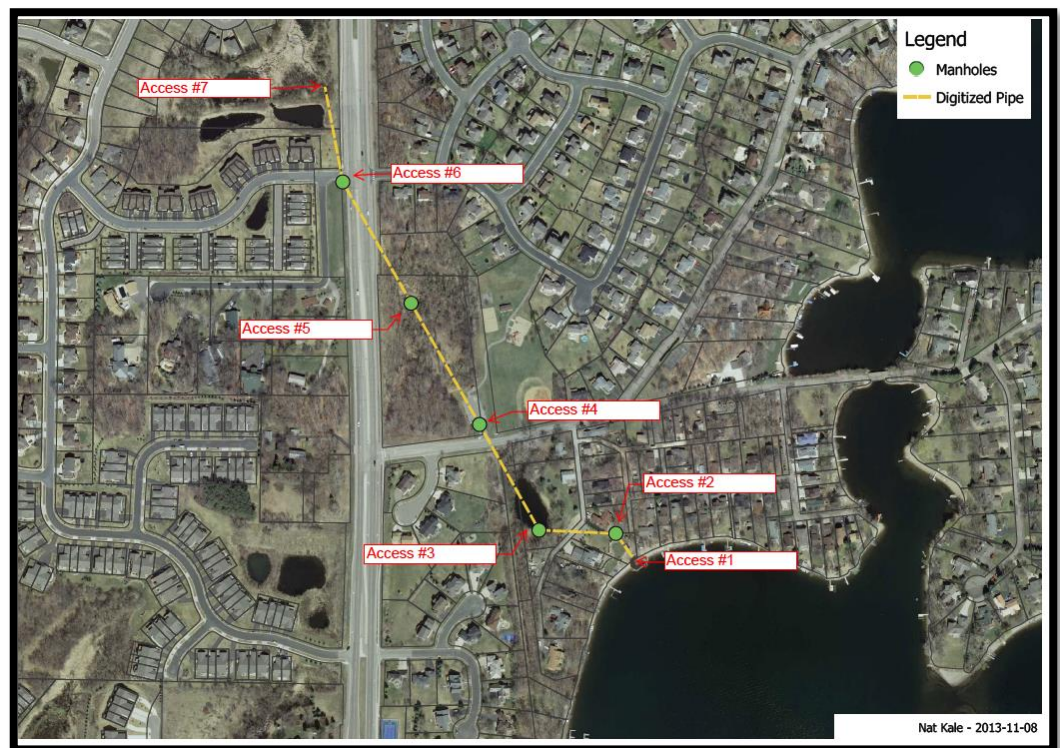
**FIGURE 4**

The Outlet Pipe leads from the Outlet Structure to the beginning, or “daylight,” of the outlet channel. It is buried underground for approximately 2075 feet, with 5 manholes and 7 access points (Figure 4).

Visu-Sewer last televised the entire length of the pipe on September 15, 2015 to look for potential damage, areas in need of repair, blockages, accumulated debris, and to assess whether the pipe is reaching full hydraulic capacity. They concluded there were no pipe blockages from broken pipe,

no significant root intrusion, and no substantial debris, such as tree branches. They did find some areas with deposits of fine material in the bottom of the pipe which restrict the flow by no more than ten percent. They suspect these deposits would be washed out of the pipe by the force of flow when the outlet structure is in use. They also found that the outfall pipe access manholes were not constructed with nice, smooth benches which they suspect could cause substantial headloss during peak flow periods.

In general, the lake outfall pipe is in good to fair condition. They identified one defect that is coded red for immediate attention. The reinforcement is visible on the edge of the pipe on the downstream end of manhole number 3. Exposed steel is subject to rusting and allows water into the concrete pipe.

The pipe also has leaking joints with mineral deposits in every pipe segment and some of these joints are likely the source of the fine deposits. While the volume of water leaking through an individual joint may not be substantial, the accumulation of mineral deposits will affect the hydraulic capacity of the pipeline and perhaps more importantly, the movement of fine soils from the area surrounding the pipe can eventually shorten the life of the pipeline as the supporting soils are lost and the pipe can move.

In 2016, the spalling joint and manholes gutter bases were repaired by IBA Manhole (Figure 5 & Figure 6). This work should decrease turbulence at the manhole benches and allow the pipe to reach full capacity faster.

Chemical grouting is scheduled to be completed in 2017 to address the leaking joints. Following the grouting, another televising will be scheduled in 2017 to document the manhole smoothing, spalling joint, and grout work.

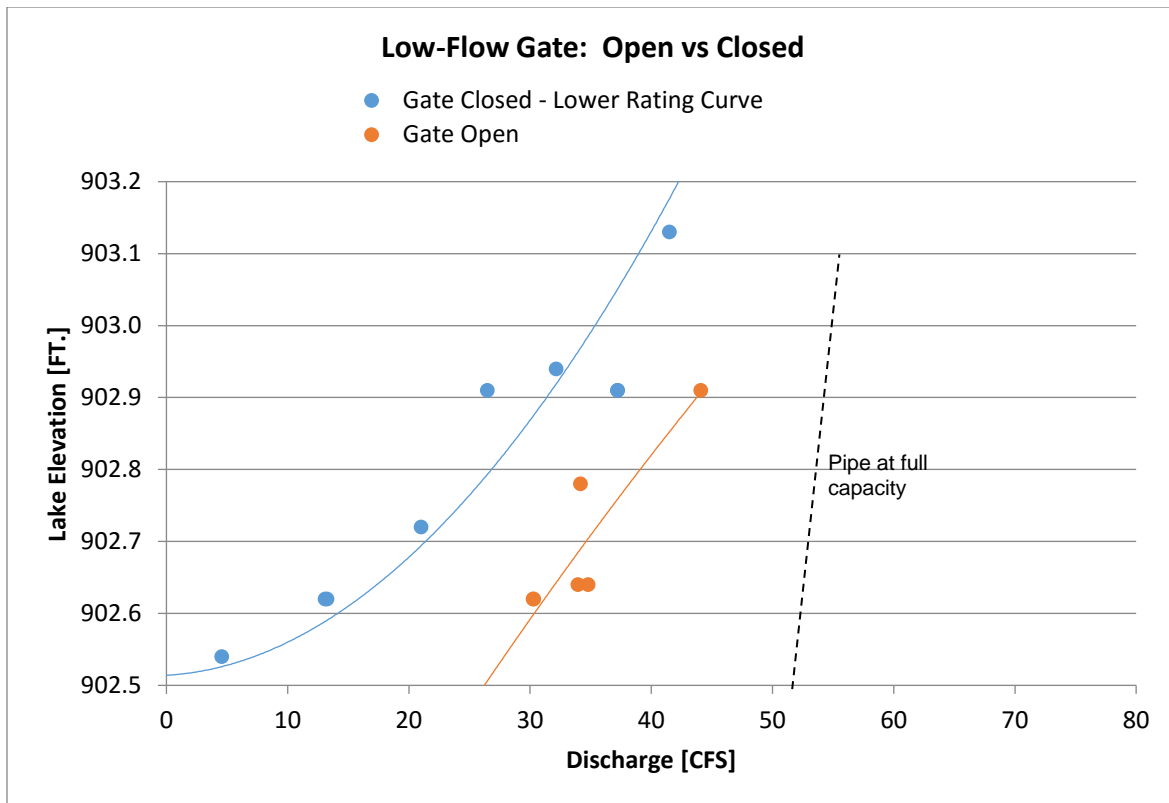
Figure 2 displays actual measurements taken by the District and/or consultants with the gate open and closed. The graph is displayed with the same scale as Figure 1 for easy comparison. It appears the pipe does not meet full capacity at the lake level indicated in Figure 1. Prior to taking flow measurements with the gate open, and according to this design, the PLSLWD was under the belief that any elevation above 902.9' with the gate shut, or 902.7' with the gate open, the pipe was at “full capacity.”

**Figure 2 Field verified flow measurements compared to same scale as Figure 1. Dots are actual measurements, the blue and orange lines are the lines that represent the rating curve, and the dashed, black vertical line is estimated full capacity of the pipe.**

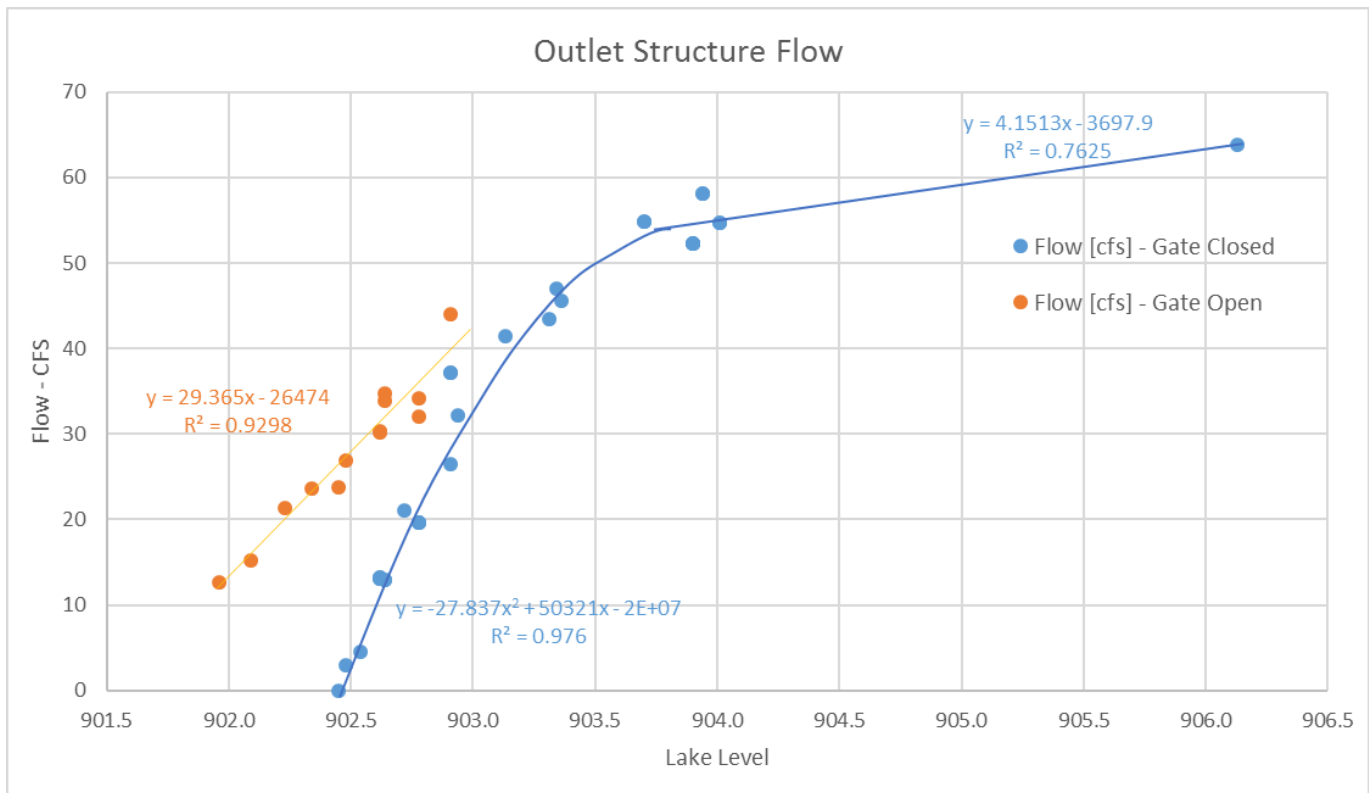
Figure 3 displays almost all the flow measurements taken by District staff and/or consultants since the new structure was built. The rating curves associated with those flow measurements are displayed on the graph. Per this figure, full capacity is reached somewhere between 903.5' and 904'. When lake level is high, hydraulic pressure pushes a little more discharge through the pipe. During the 2014 flood, flow measured 64 cfs (gate was closed) when the lake level was nearly peaked at 906.13' (max lake level during flood was 906.17').

**Figure 3 Flow Measurements (dots) and Rating Curve Equations (lines) for the Outlet Structure (Updated 11/22/16)**

- The 36" underground pipe becomes the limiting factor for flow around 903.5' (rather than 902.9' in original design). See Figure 3.
- The point at which the pipe reaches full capacity with the gate open is undetermined now. Staff will continue to collect flow measurements above 903' until that level is determined.
- Maximum discharge the gate adds when open is about 25 cfs (rather than 33 cfs as indicated in the original design). This is when the lake has just stopped flowing over the weir at approximately 902.45'. As the lake rises or falls from 902.45', flow contribution from the gate decreases. See Figure 4.
