2017 PRIOR LAKE OUTLET SYSTEM ANNUAL OPERATIONS REPORT

By: Jaime Rockney
PLSLWD Water Resources Specialist
February 2018

PRIOR LAKE - SPRING LAKE
WATERSHED DISTRICT

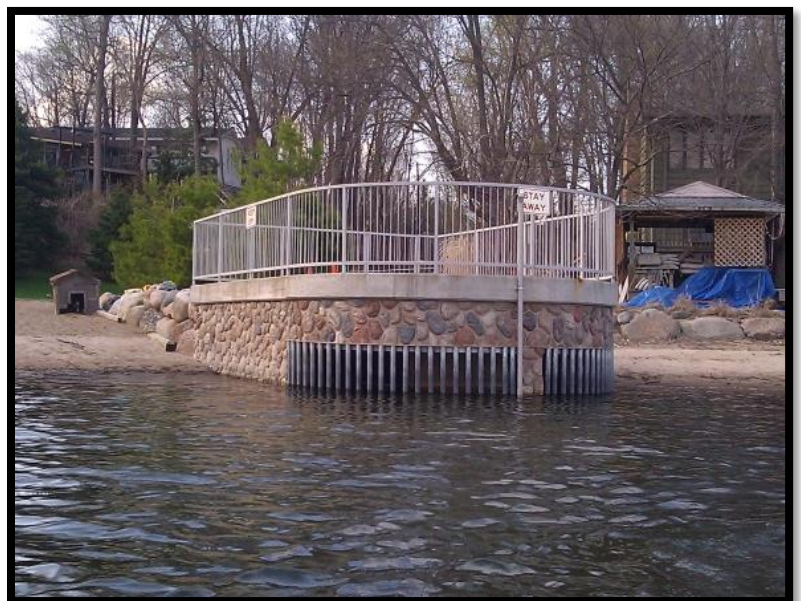
FIGURE 1

Given these conditions, a replacement structure was pursued by the District and installed in 2010 (Figure 1). The new design has increased the efficiency of discharging water by allowing the outlet pipe to reach capacity sooner. It has also proven to provide safer conditions for staff during inspections and maintenance, and is self-operating, which will reduce overall operations and maintenance costs. A schematic of the outlet structure is provided in Attachment A.

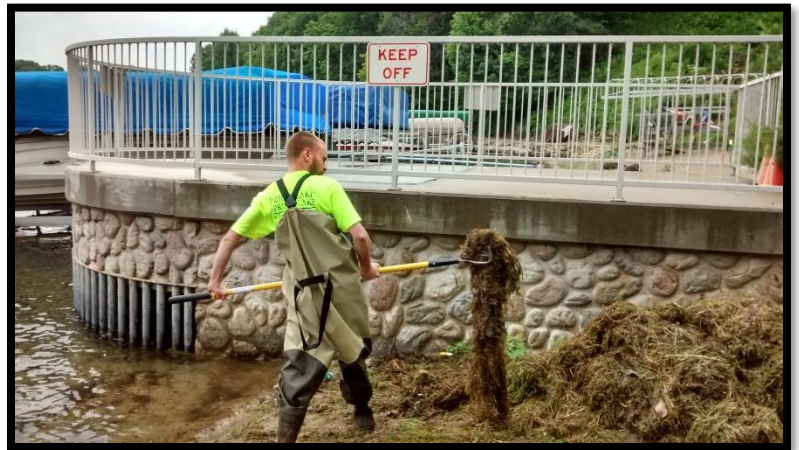
FIGURE 2

The new structure needs minimal maintenance to operate. Once Prior Lake reaches 902.45', water starts spilling over the accordion shaped weir located inside the trash rack. Maintenance includes visual inspections, greasing gates, and removing debris from the trash rack. Removing vegetation and other debris from the trash rack is the most time-consuming and labor-intensive task (Figure 2). When the structure is operating (Prior Lake is greater than 902.45'), the structure will be inspected no less than once a week, and as much as twice per day, depending on the lake level and amount of vegetation getting stuck on the trash rack. Inspections and debris removal is typically conducted by PLSLWD staff. During times when water is high and lots of vegetation is getting stuck on the track rack, the City of Prior Lake staff helped remove vegetation to ensure the Outlet Structure was not blocked.

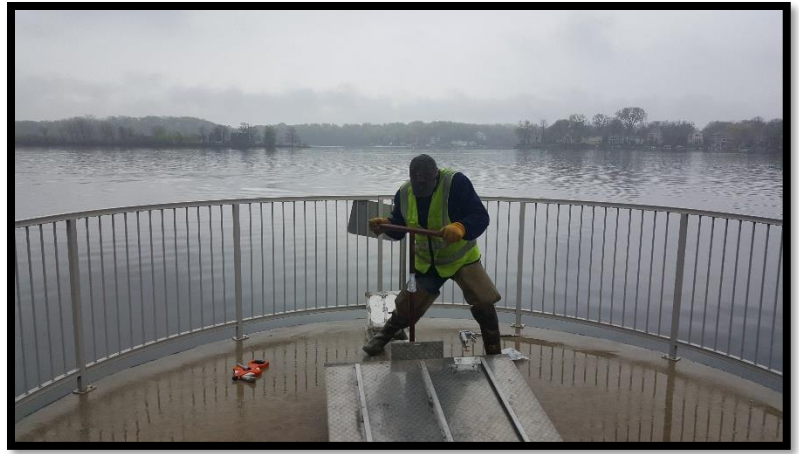
FIGURE 3 – OPENING THE LOW-FLOW GATE

At certain lake levels, the Low Flow gate allows more water through the outlet structure, resulting in the lake level lowering more quickly and creating more storage (see Attachment C). To reduce the risk of flooding, the District opened the Low Flow gate from on April 25 due to anticipated high lake levels. The low-flow gate was closed on June 27 when the lake reached 902.58'. (See Figure 3).

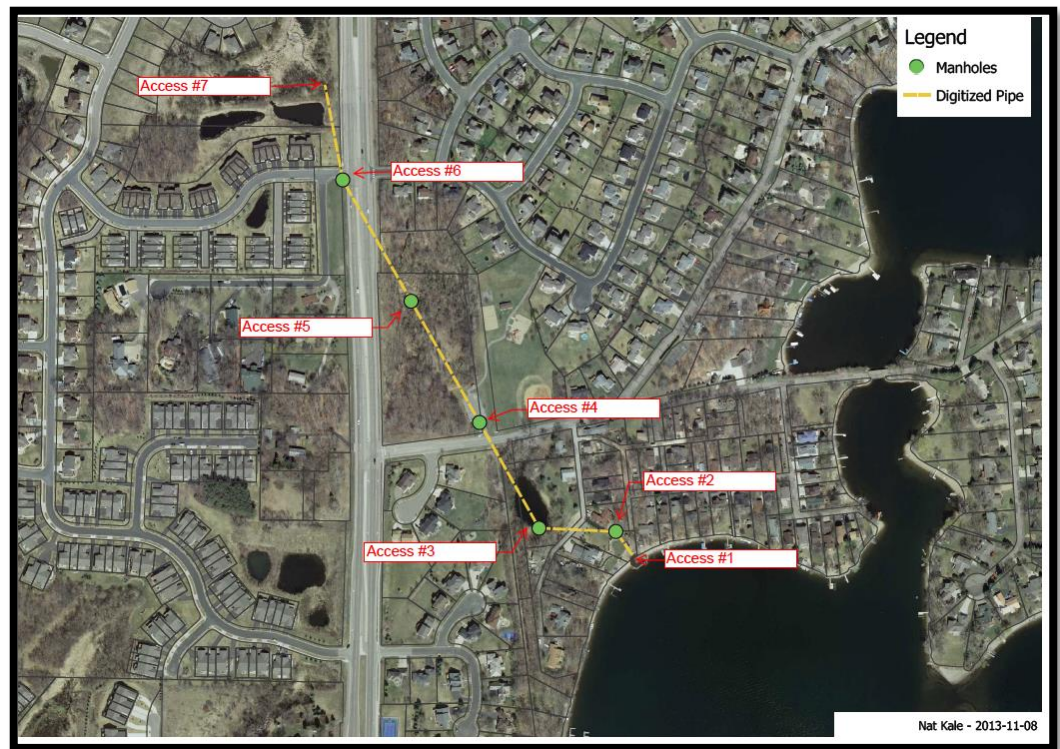
FIGURE 4 – MAP OF OUTLET PIPE

The Outlet Pipe leads from the Outlet Structure to the beginning, or “daylight,” of the outlet channel. It is buried underground for approximately 2075 feet, with 6 manholes and 7 access points (Figure 4).

Visu-Sewer last televised the entire length of the pipe on September 15, 2015 to look for potential damage, areas in need of repair, blockages, accumulated debris, and to assess whether the pipe is reaching full hydraulic capacity. They concluded there were no pipe blockages from broken pipe,

no significant root intrusion, and no substantial debris, such as tree branches. They did find some areas with deposits of fine material in the bottom of the pipe which restrict the flow by no more than ten percent. They suspect these deposits would be washed out of the pipe by the force of flow when the outlet structure is in use. They also found that the

outfall pipe access manholes were not constructed with nice, smooth benches which they suspect could cause substantial headloss during peak flow periods.

In general, the lake outfall pipe is in good to fair condition. They identified one defect that is coded red for immediate attention. The reinforcement is visible on the edge of the pipe on the downstream end of manhole number 3. Exposed steel is subject to rusting and allows water into the concrete pipe.

The pipe also has leaking joints with mineral deposits in every pipe segment and some of these joints are likely the source of the fine deposits. While the volume of water leaking through an individual joint may not be substantial, the accumulation of mineral deposits will affect the hydraulic capacity of the pipeline and perhaps more importantly, the movement of fine soils from the area surrounding the pipe can eventually shorten the life of the pipeline as the supporting soils are lost and the pipe can move.

In 2016, the spalling joint and manholes gutter bases were repaired by IBA Manhole (Figure 5 & Figure 6). This work decreased turbulence at the manhole benches and allows the pipe to reach full capacity faster.

Chemical grouting was scheduled to be completed in 2017 to address the leaking joints. However, due to staff injuries, the company was unable to complete this task in 2017. Following the grouting, another televising will be scheduled in 2018 to document the manhole smoothing, spalling joint, and grout work.

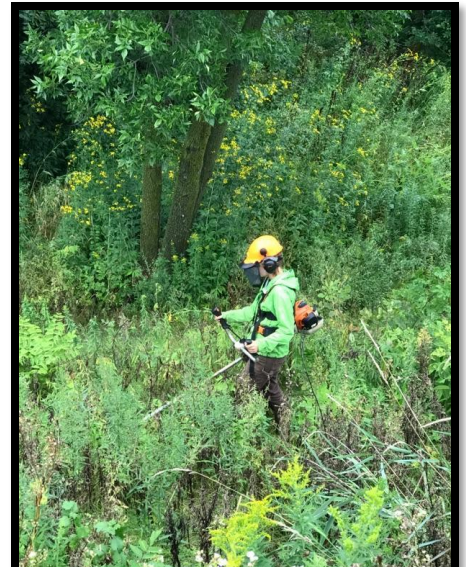
FIGURE 8 - CUTTING INVASIVES IN SEGMENT 1

- 2017
 - Segment 1 – Locust foliar, Parsnip rosette, and thistle spot treatment
 - Segment 2 – Buckthorn foliar treatment, larger than ½” diameter cut/treat
 - Segment 4a – Buckthorn scouting/treating (foliar treat small individuals, cut/treated larger as needed); Pulled loosestrife
 - Segment 4b - Buckthorn scouting/treating (foliar treat small individuals, cut/treat larger as needed); Spot treat thistle northern half – especially pasture
 - CR 16 – Garlic mustard treatment; Pulled loosestrife

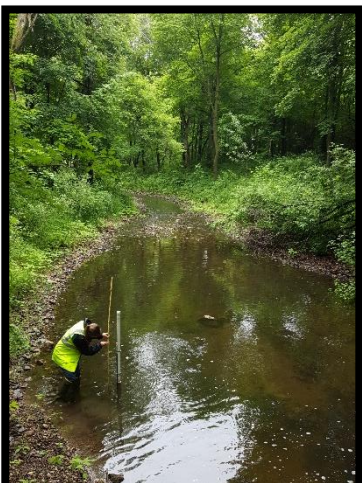
FIGURE 9 - PIKE LAKE PARK MONITORING SITE

PLSLWD and Scott SWCD staff measured flow and stage at the beginning of the Outlet Channel (ST_OTs), in the middle at Pike Lake Park (ST_26A), and the end of the Outlet Channel (ST_32A). Each site recorded stage in 15-minute increments on a level logger recorded. Flow measurements were taken at various stages to create a stage-discharge relationship (rating curve). Flow data can be used to help estimate pollutant loads, calibrate the XP-SWMM model, and determine the level and volume of water flowing through the system. Site ST_OTs is located at the Outlet Structure. Prior Lake's level is recorded using an Ott Level Logger and updated hourly on the PLSLWD website.

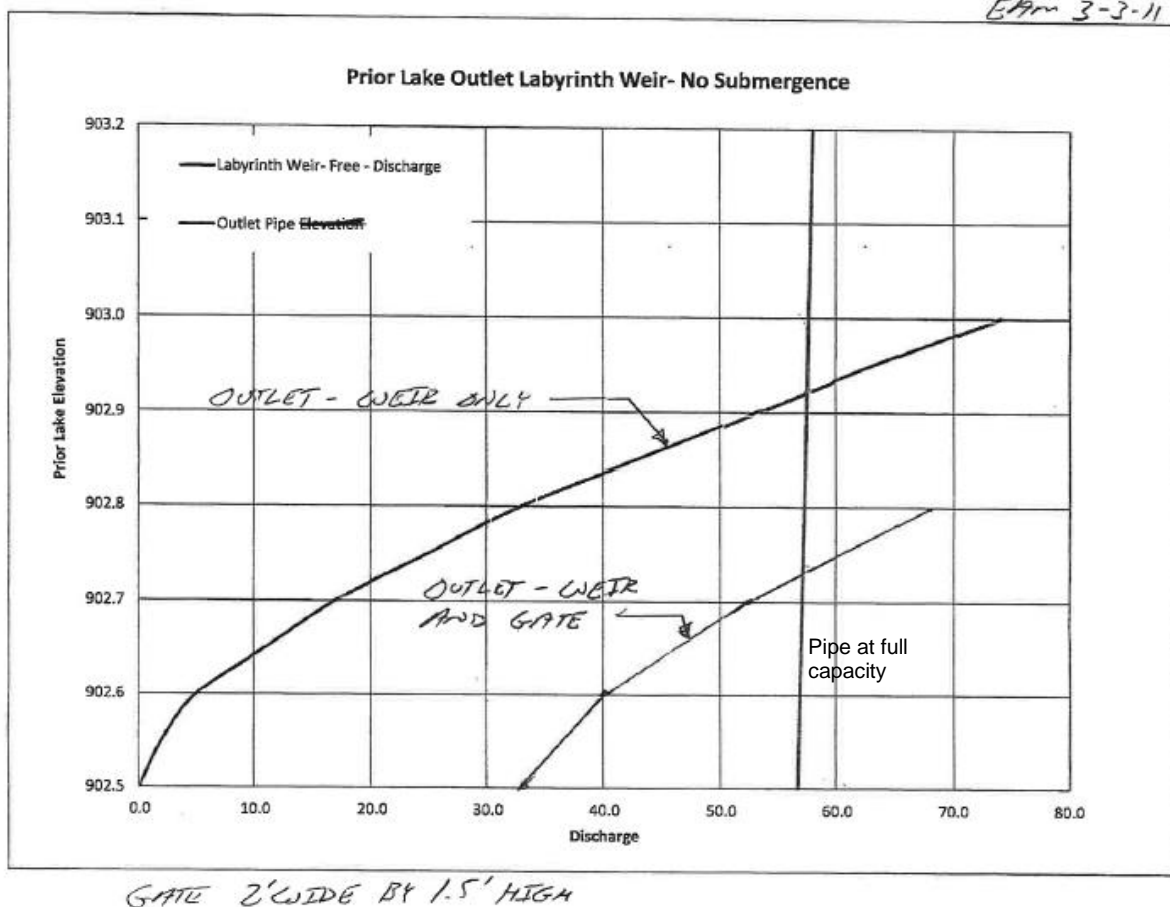
Figure 1 is the “theoretical rating curve developed by Wenck for the new outlet structure. Based on these curves, opening the gate would add as much as 33 cfs to total discharge until the pipe (inlet control) becomes the limiting factor, and reaching full capacity would be reached 0.2 feet sooner [902.7 vs 902.9 where the rating curves intersect the pipe-control curve (the vertical line between 55 and 60 cfs)]” per PLSLWD District Engineer, Carl Almer.

Figure 1 – Original design discharge (CFS) estimates with gate opened (“Outlet-Weir and Gate”) and closed (“Outlet-Weir Only”). Vertical line is estimated full capacity of the pipe.

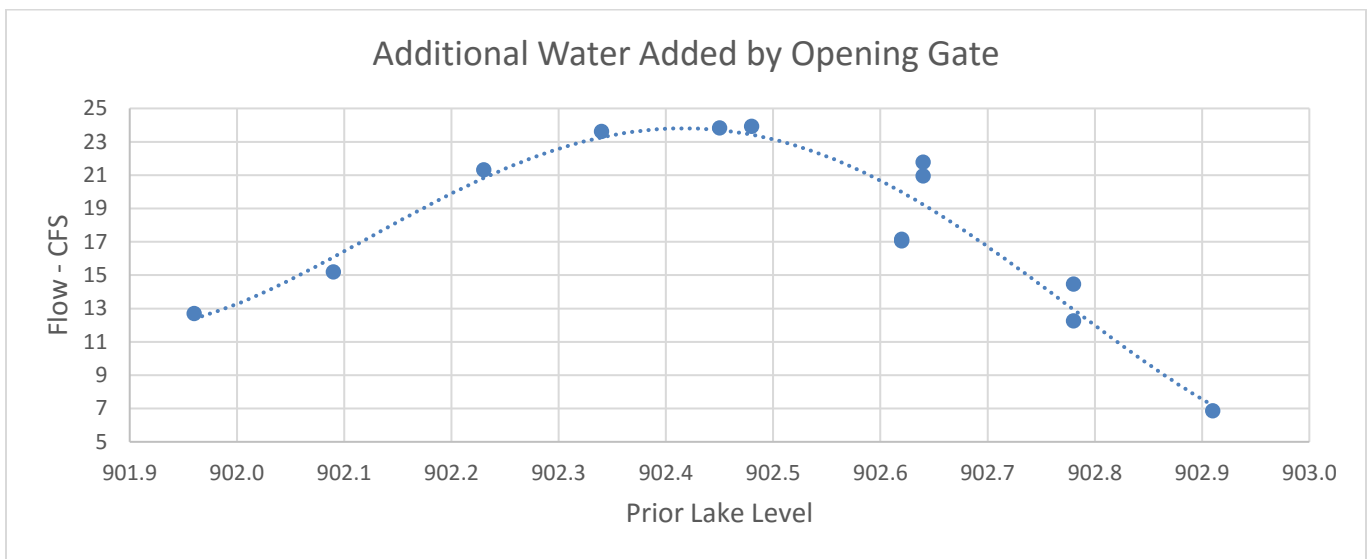
Figure 4 Amount of additional flow discharge when the Low-Flow Gate is open. Blue dots represent “Flow with gate open minus Flow with gate closed”. The line is the average.
