# 2018 PRIOR LAKE OUTLET SYSTEM ANNUAL OPERATIONS REPORT

By: Jaime Rockney  
PLSLWD Water Resources Specialist  
February 2019

PRIOR LAKE – SPRING LAKE  
WATERSHED DISTRICT

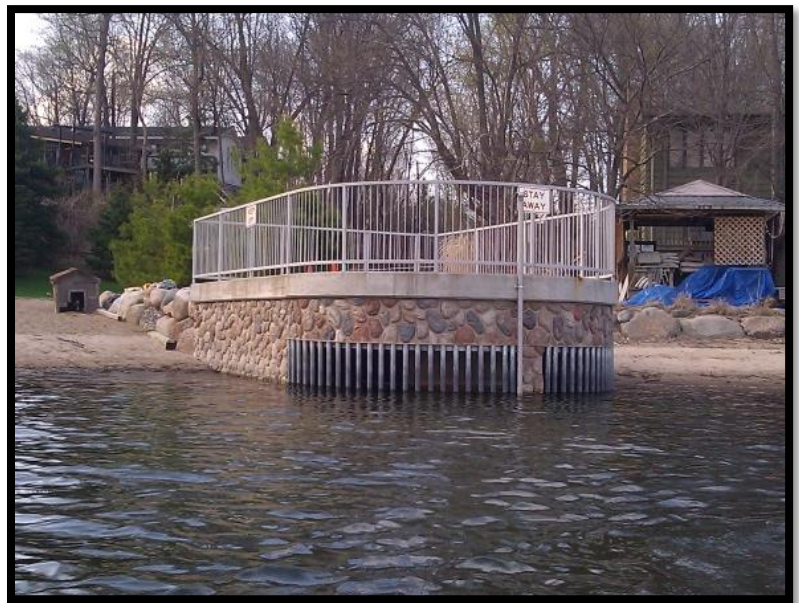
**FIGURE 1**

Given these conditions, a replacement structure was pursued by the District and installed in 2010 (Figure 1). The new design has increased the efficiency of discharging water by allowing the outlet pipe to reach capacity sooner. It has also proven to provide safer conditions for staff during inspections and maintenance, and is self-operating, which will reduce overall operations and maintenance costs. A schematic of the outlet structure is provided in Attachment A.

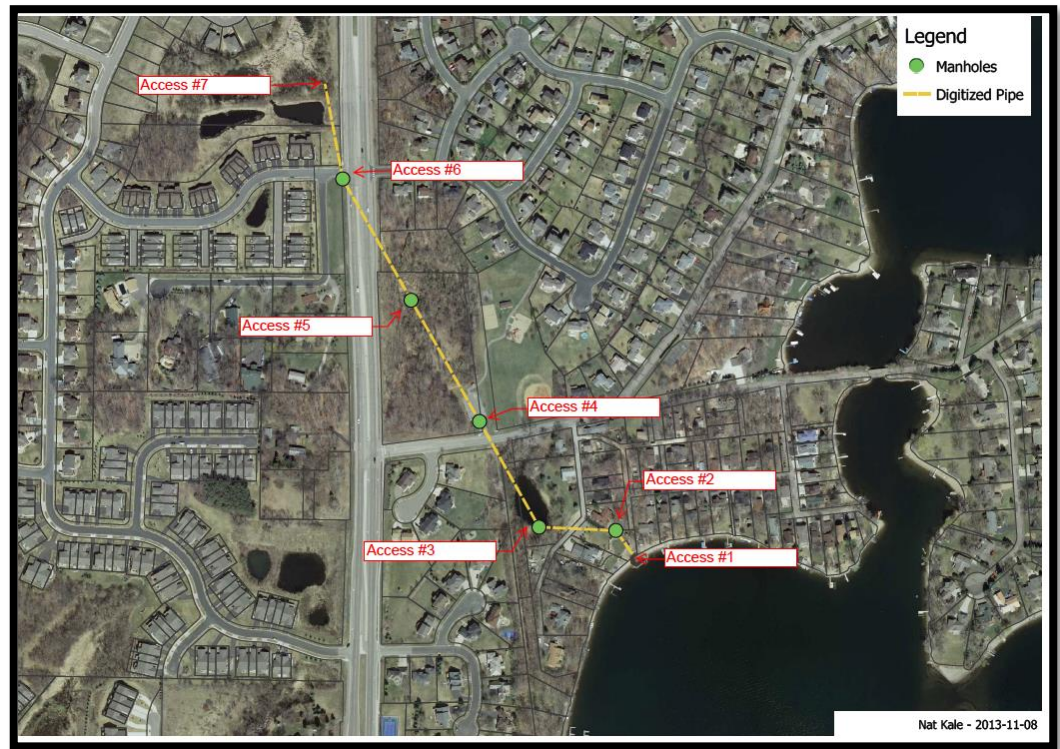
**FIGURE 4 – MAP OF OUTLET PIPE**

The Outlet Pipe leads from the Outlet Structure to the beginning, or “daylight,” of the outlet channel. It is buried underground for approximately 2075 feet, with 5 manholes and 7 access points (Figure 4).

Chemical grouting was scheduled to be completed in 2017 to address leaking joints discovered by Visu-Sewer when they televised the outlet pipe in 2014. However, due to staff injuries, the company was unable to complete this task in 2017. The work was completed March 9, 2018. 120 leaks were sealed, but it was originally estimated to only have 50. As the original leaks were sealed, that forced other leaks to start due to more pressure. Visu-sewer documented all the seals with video.

In 2018, Visu-Sewer televised the pipe after grouting the leaking joints. They televised the pipe each time after grouting joints to look for additional leaks. Many times, after grouting some joints, more leaks would be discovered as the pressure became greater after sealing. VisuSewer continued to televise until no more leaks were found. No red flags were found in the 2018 televising. In general, the lake outfall pipe is in good to fair condition and the pipe will be televised again in 2020.

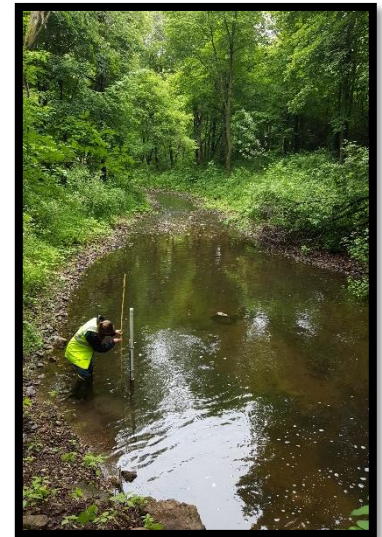
Water quantity monitoring consisted of obtaining continuous stage and flow measurements. PLSLWD and Scott SWCD staff measured flow and stage at the beginning of the Outlet Channel (ST\_OTs), in the middle at Pike Lake Park (ST\_26A – Figure 6), and the end of the Outlet Channel (ST\_32A). Site ST\_OTs was actually located at the Outlet Structure and records the level of Prior Lake using an Ott Level Logger and updated hourly on the PLSLWD website. Scott SWCD also had a site (DLI) under Highway 21, right before Dean Lake, which measures flow (and water quality). Each site recorded stage in 15-minute increments on a level logger recorded. Flow measurements were taken at various stages to create a stage-discharge relationship (rating curve). Flow data can be used to help estimate pollutant loads, calibrate the XP-SWMM model, and determine the level and volume of water flowing through the system.

**FIGURE 6 - PIKE LAKE PARK MONITORING SITE**

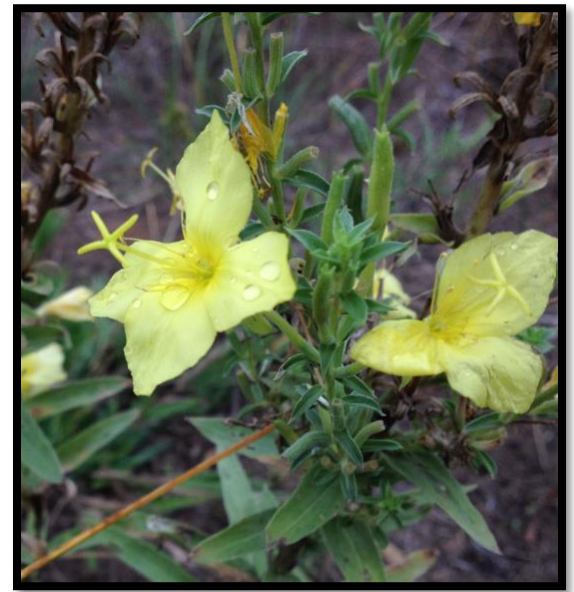
The outlet channel was assessed on foot from Segment 1 to Segment 7 on May 16, July 3, and September 19, 2018. Segment 8, which is under management by the United States Fish & Wildlife Service, was not assessed. For the spring and fall assessments, a series of photographs were taken in each segment to characterize the condition of the outlet channel, assess new areas of bank erosion, and document any obstructions to flow such as down trees, debris piles, or culvert blockages. All images were collected working upstream to downstream in each segment to aid in channel reference. The July survey was for targeted vegetation management. These reports can be found on the PLSLWD website with a summary of recommendations for continued channel and vegetation management in 2019. During these inspections, a species of concern, Fourpoint Evening Primrose, was first discovered in Segment 7 (see Figure 8).

**FIGURE 8 FOURPOINT EVENING PRIMROSE**

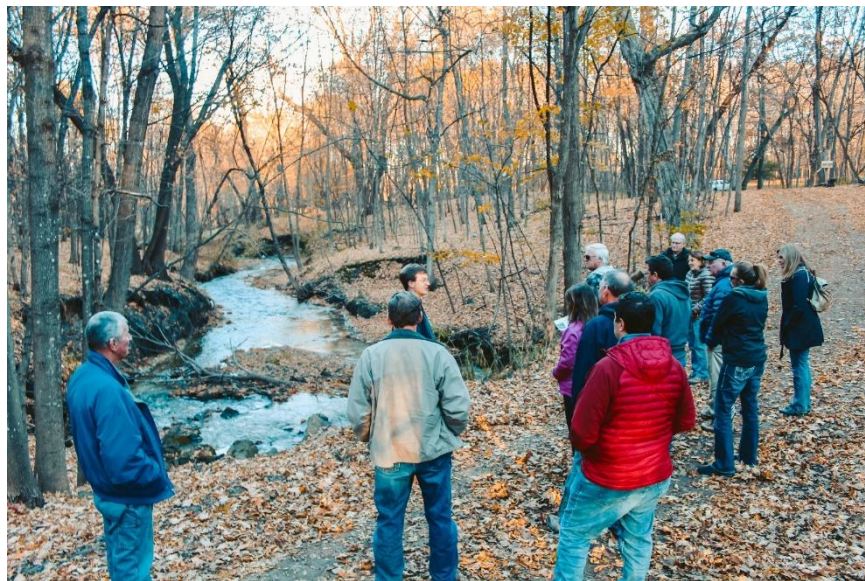
**FIGURE 10 OUTLET TOUR**

A tour of the Outlet Channel was given on October 23, 2018 (see Figure 10). The tour was intended to inform PLSLWD Board Managers and partners of the bank erosion repair projects that will be completed in 2019 due to the 2014 floods. These repair projects will be funded by FEMA.

The Prior Lake Outlet Channel incurred substantial damage during the 2014 flood, including downed trees, accumulated woody debris, sediment accumulation, culvert damage and over 2.8 miles of bank erosion. In 2015, most of the tree and woody debris removal work was completed and one of the culverts (KiciYapi) was repaired by the Shakopee Mdewakanton Sioux Community. Removal of the remaining trees and woody debris, culvert repairs (Gonyea and Kes Field Crossing), and Pike Lake Park stream crossing repair work was completed in 2016. The sediment delta was excavated in spring of 2018. Due to permit and engineering design delays, the Bank Erosion project is expected to begin in the Summer of 2019. The Federal Emergency Management Administration (FEMA) has approved federal funding to cover 75% of the costs of the 2014 flood damage to the PLOC. The State of Minnesota will pay the remaining 25%.
