Project Name | PLOC Channel Inspections**Date** | 2/15/2019**To / Contact info** | Diane Lynch, Jaime Rockney**Cc / Contact info** | Carl Almer**From / Contact info** | Mike Majeski**Regarding** | Channel and Vegetation Inspections – 2018 Summary

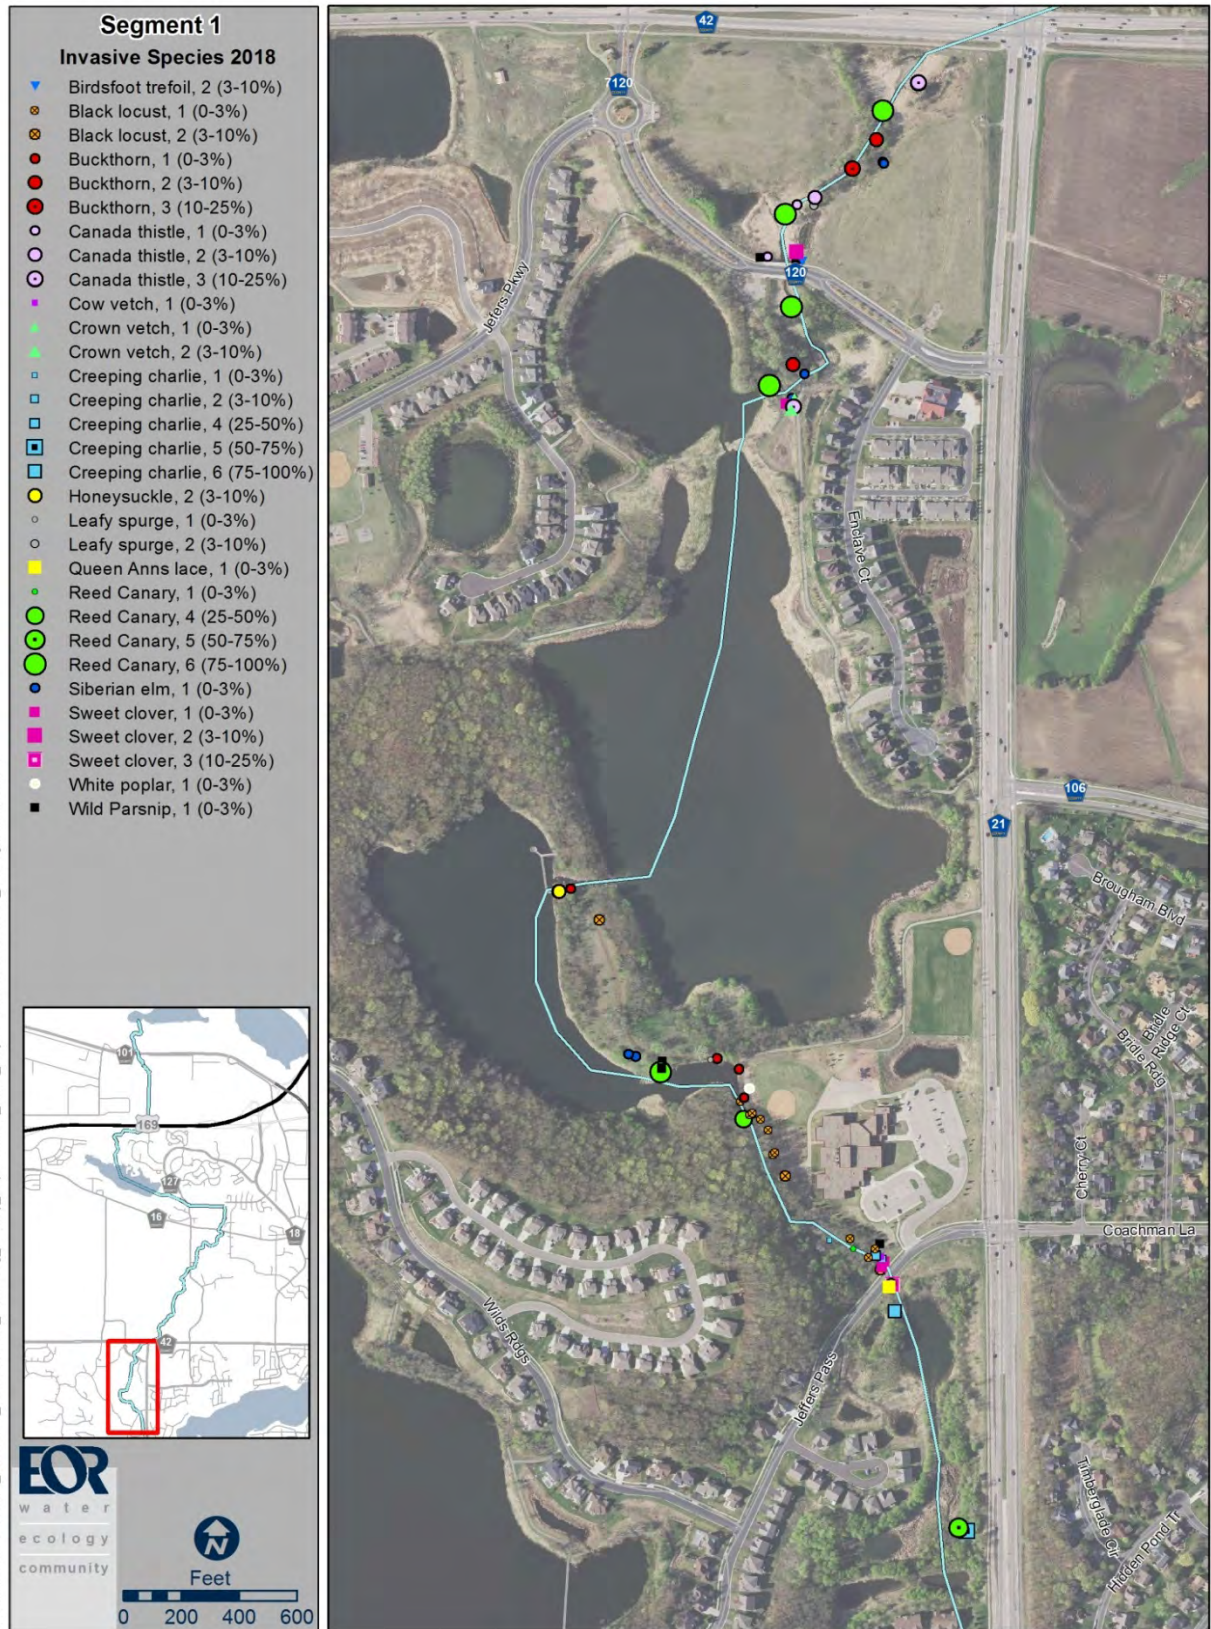
Bank erosion was observed along the left bank adjacent to the boulder cross vane located immediately downstream of Jeffers Pass NW near Jeffers Pond Elementary School (Figure 1). The erosion is the result of flow occurring between the terminus of the boulder vane and the adjacent bank. No other recent bank erosion was observed within this segment. Minor channel obstructions were located in the same areas identified in 2016 including a five-inch diameter ash tree found lying across the channel approximately 200 feet upstream of Fountain Hills Road, and several large tree trunks and branches found lying across and within the channel in the forested reach just upstream of County Road 42. The old field crossing located immediately upstream of CR 42 has mostly eroded away, but the culvert continues to function at lower flows (Figure 2). The trash rack on the upstream end of the CR 42 culvert was not obstructing flow during the channel inspections (Figure 3).

Figure 3. Trash rack at upstream end of CR 42 culvert

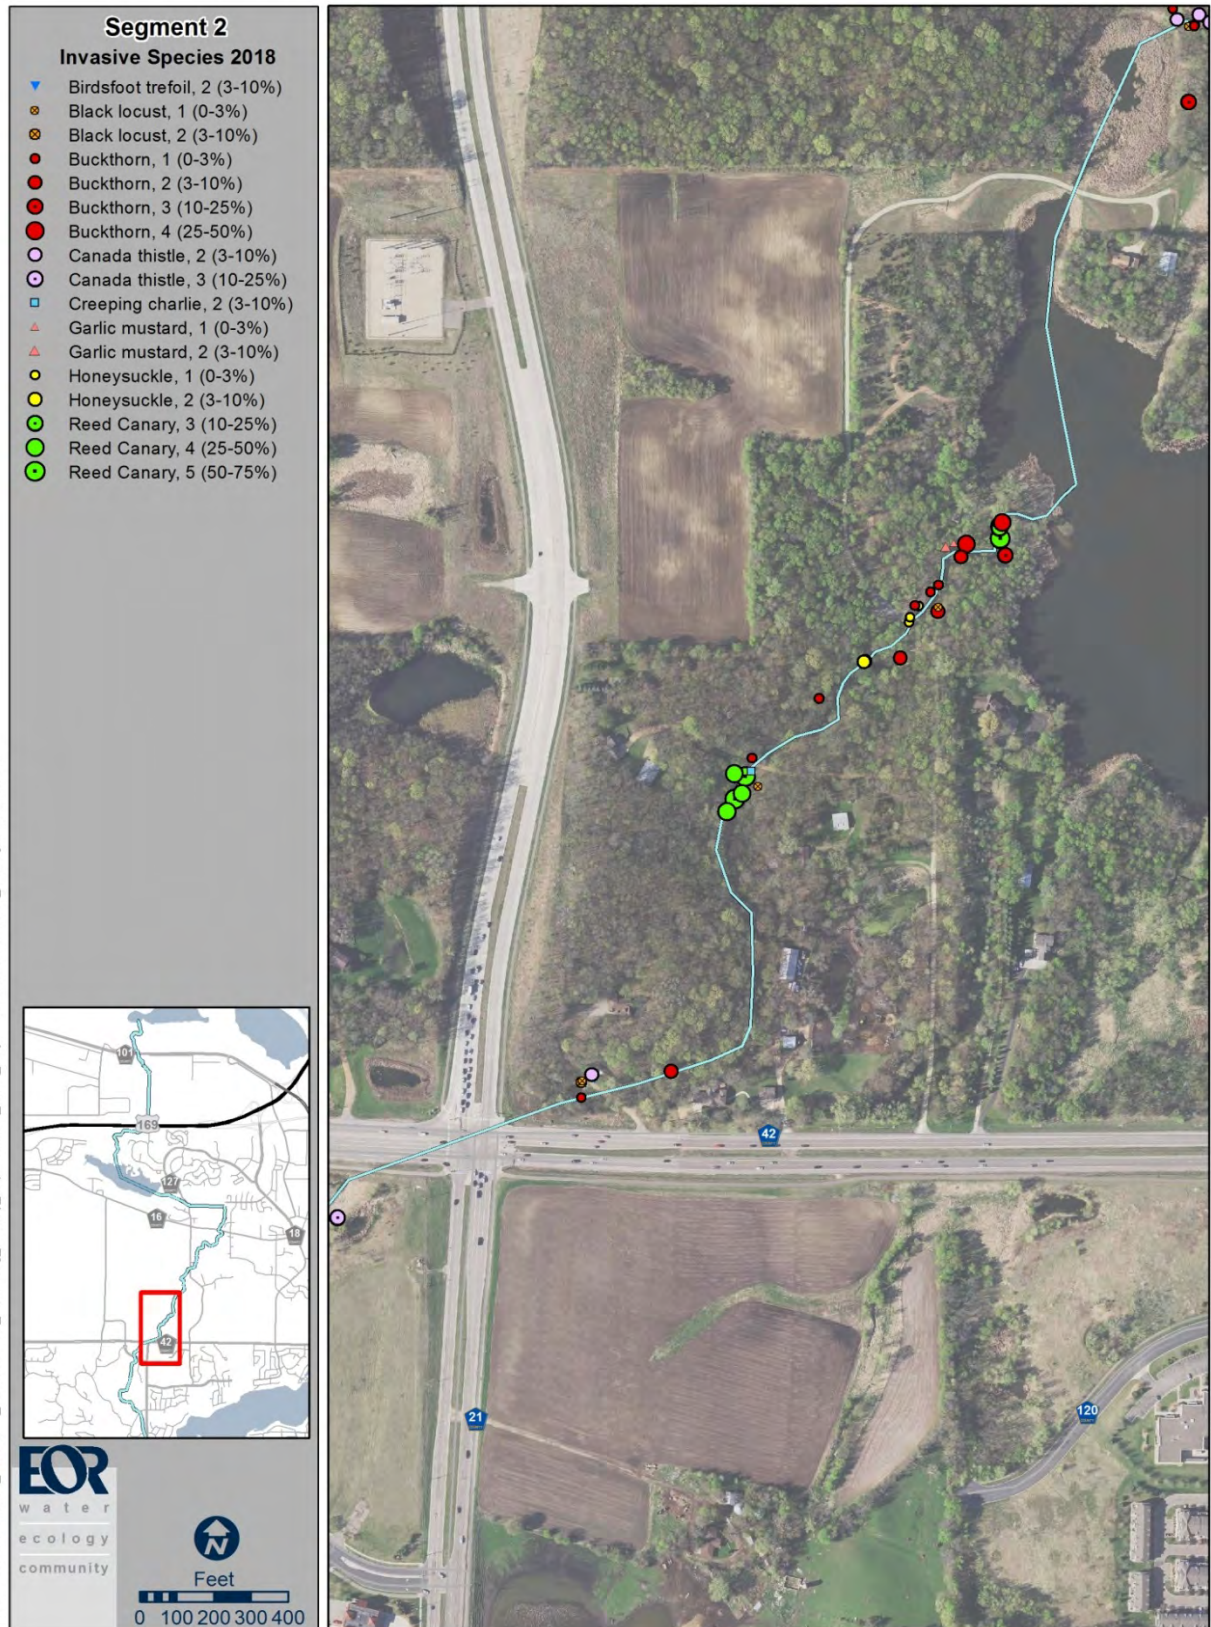
Several down trees were observed across the channel in areas previously identified with bank erosion. In particular, two trees have fallen across the channel just downstream of the 2nd stream crossing due to bank erosion and undercutting of the root boles (Figure 5). Bank erosion continues to occur throughout this segment, particularly in areas damaged by previous flood events. In addition, channel widening is occurring below perched culverts, especially downstream of the 3rd crossing where the riprap in the center of the channel is directing flow into the adjacent stream banks, resulting in localized bank erosion (Figure 6). The bank that was repaired to the east of the 4th crossing at Pike Lake Park is holding up well with vegetation starting to become established (Figure 7). A large sediment delta has formed at the outlet of Segment 2 in Pike Lake (Figure 8). This sediment delta should be removed if future channel work is proposed in Segment 2.

Figure 8. Sediment delta at the outlet of Segment 2 to Pike Lake

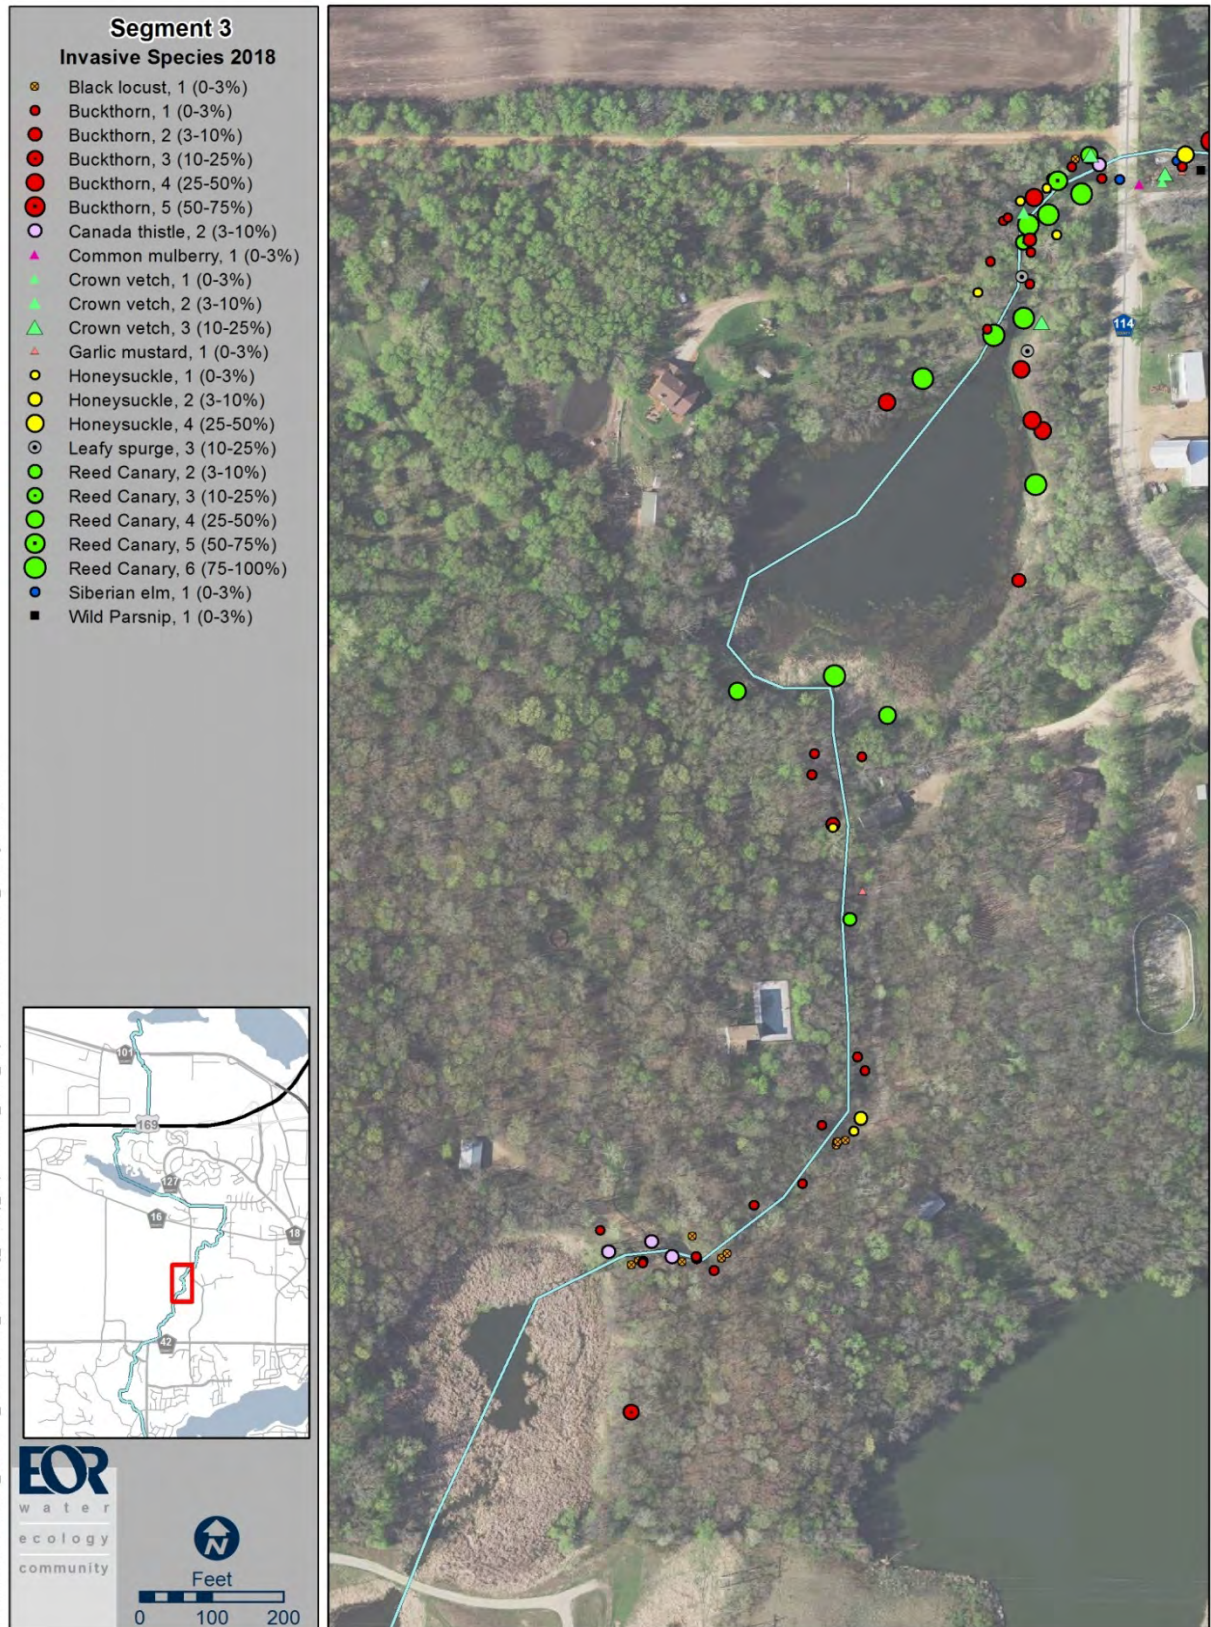
Bank erosion continues to occur in areas previously affected by large flood events, particularly along the reach at the upstream end of the Kici Yapi property (Figure 10). A few eroding banks are beginning to self-heal now that the toe of the slope has been stabilized with rock and vegetation (Figure 11). The stream bank along the left side of the channel downstream of the private driveway crossing continues to erode (Figure 12).

Figure 12. Stream bank erosion along left bank downstream of the private driveway crossing

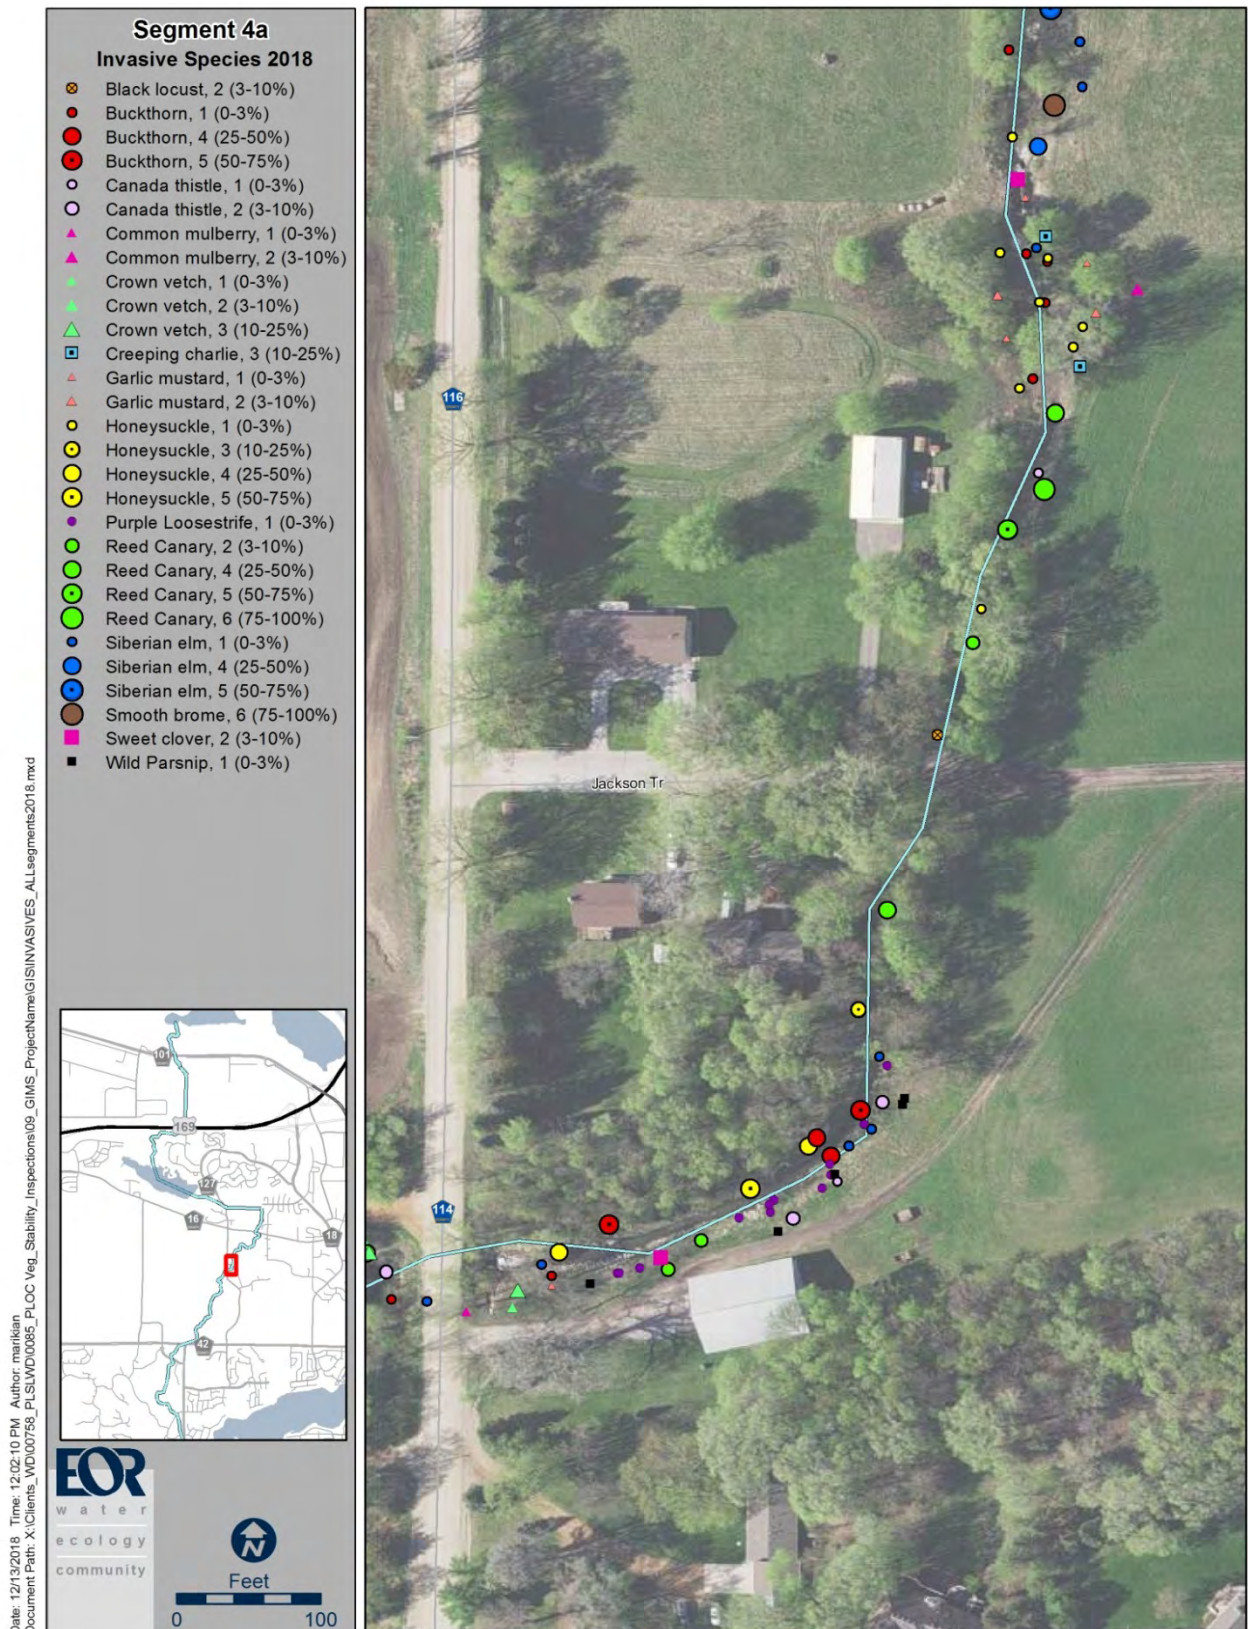
Figure 17. Down box elder tree over the channel at the upstream end of Segment 4B/ cattle pasture

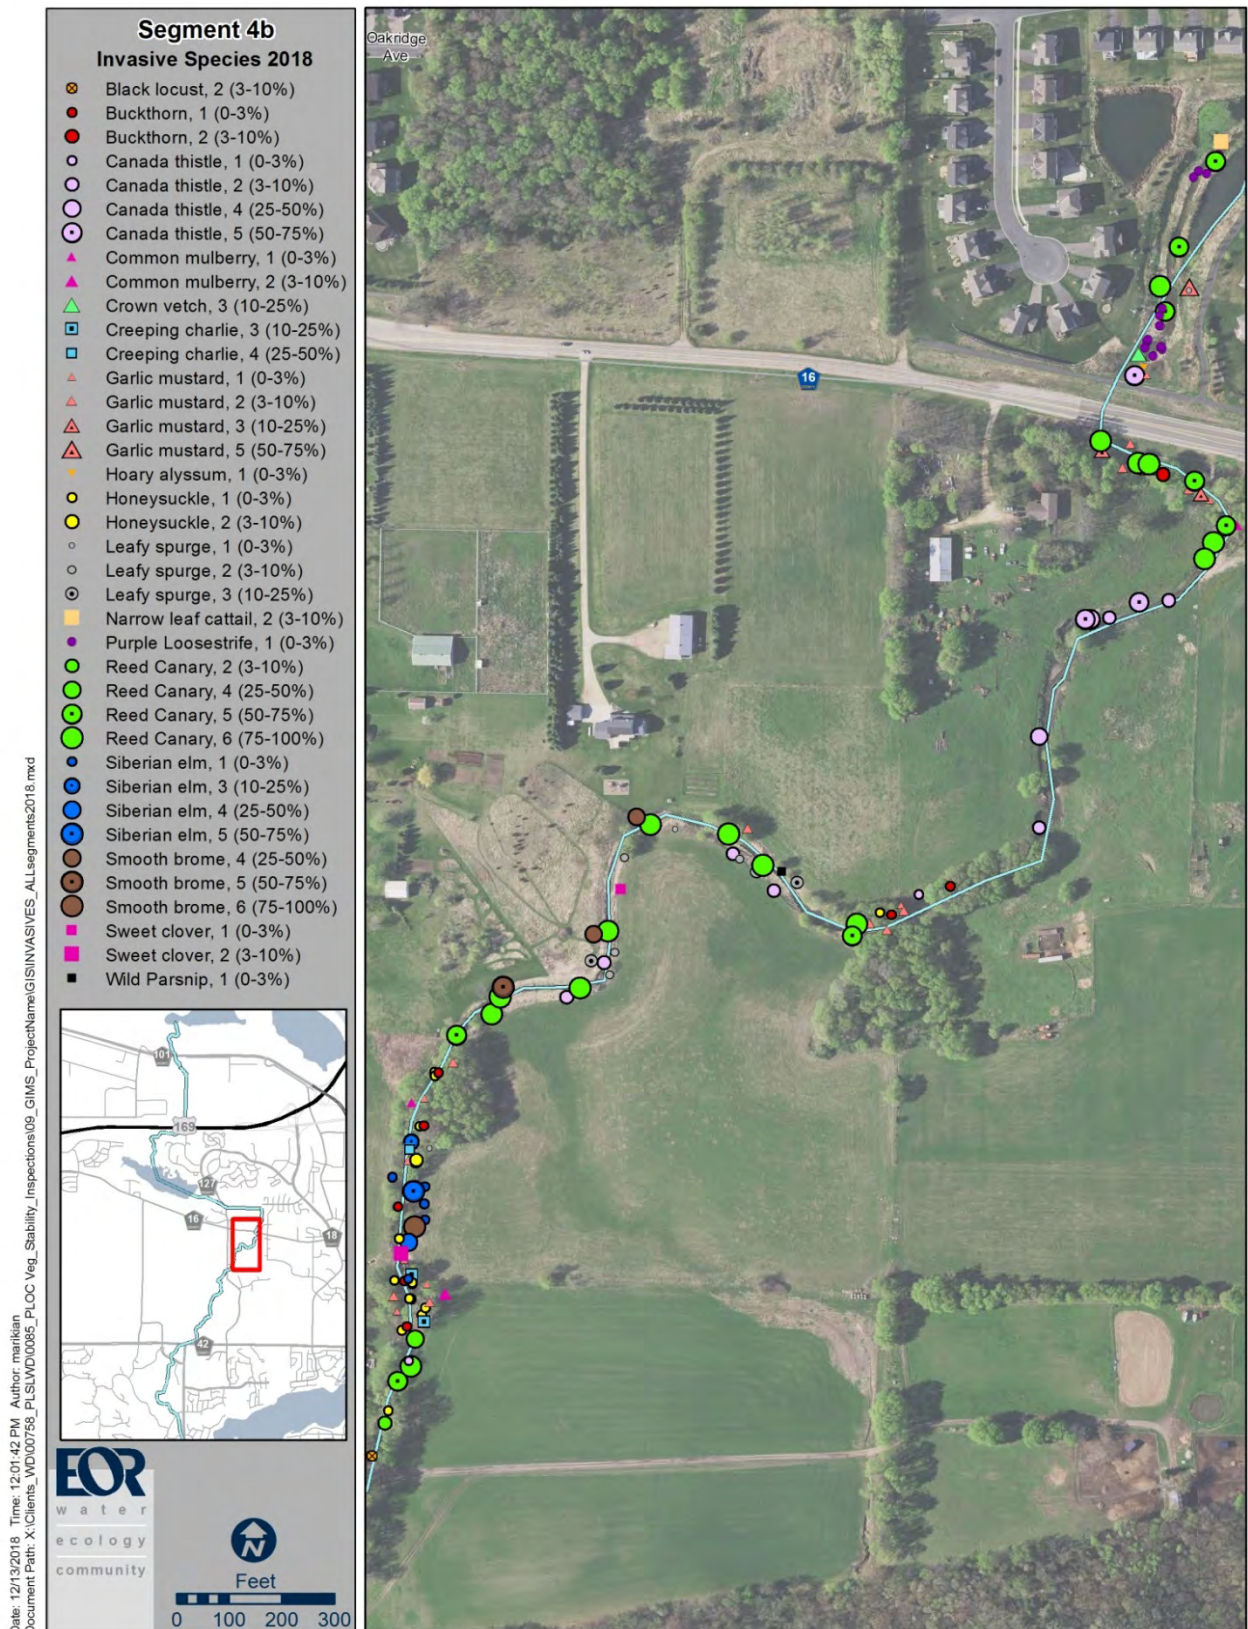
In July 2018, five purple loosestrife (*Lythrum salicaria*) plants and eleven wild parsnip plants were found in the restored reach in Segment 4A. PLSLWD and AES staff were notified immediately after the completion of the survey and the plants were treated with herbicide by AES in mid-July. Reconnaissance for purple loosestrife and wild parsnip basal rosettes should be conducted in early summer of 2019, and any new plants found should be immediately treated with herbicide. A follow-up inspection should occur in late summer of 2019 to search for any plants that were missed during the reconnaissance effort. Common buckthorn and bush honeysuckle saplings were located in areas previously managed and treated by AES. Continued foliar spray treatments will be needed to reduce the population of the saplings in this segment. Figure 18 and Figure 19 show the locations and areal coverages of previously identified invasive species in this segment.

Figure 18. Invasive species and associated areal coverages (in parenthesis) along Segment 4A

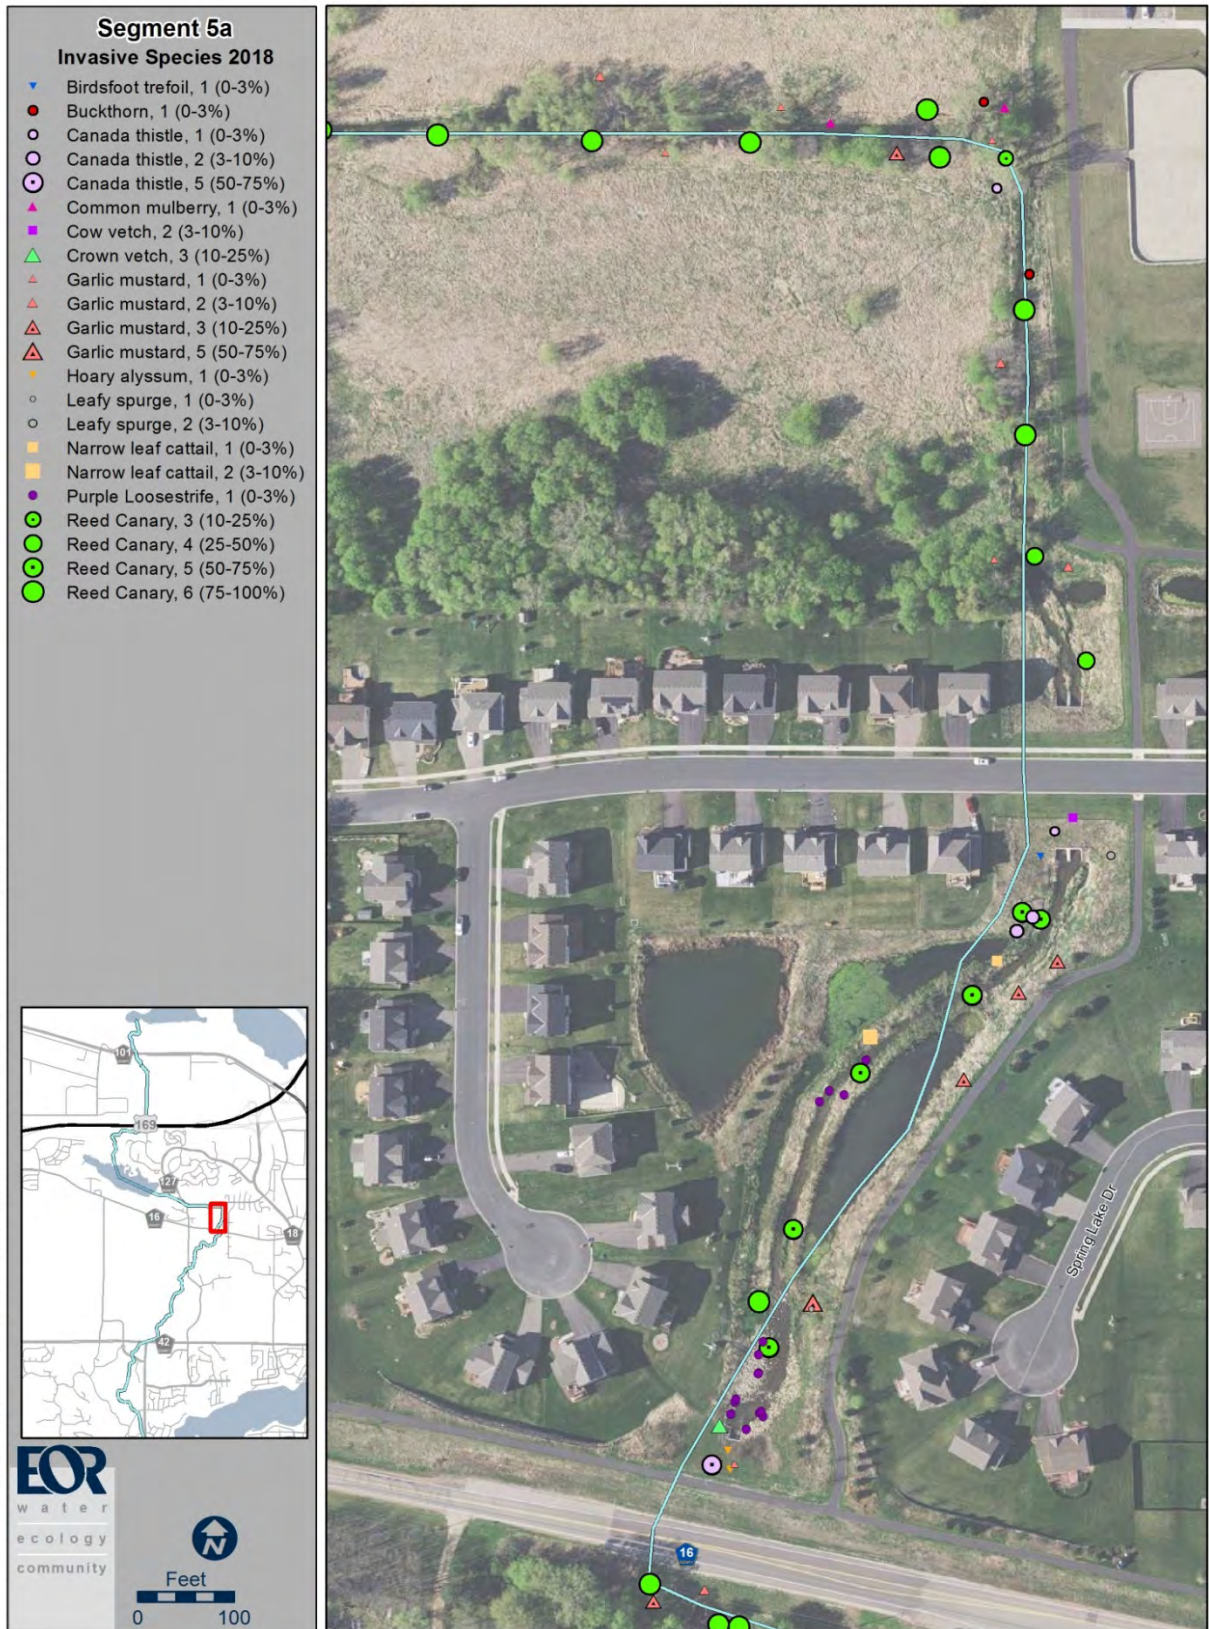
There were no significant channel obstructions found in this segment. A few tree trunks and branches occur within the channel just west of the 90 degree ditch bend in Segment 5B, but do not appear to be obstructing flow at this time (Figure 20). The channel banks throughout this segment are in fairly good condition with reed canary grass (*Phalaris arundinacea*) and tree roots providing ample surface protection (Figure 21). However, stream banks that were damaged by previous flood events continue to slowly erode. Despite recent dredging efforts in the sediment pond downstream of Pike Lake Road, a new sediment delta has already formed at the upstream end of the pond (Figure 22).

Figure 22. Sediment delta located downstream of Pike Lake Trail (Segment 5C)

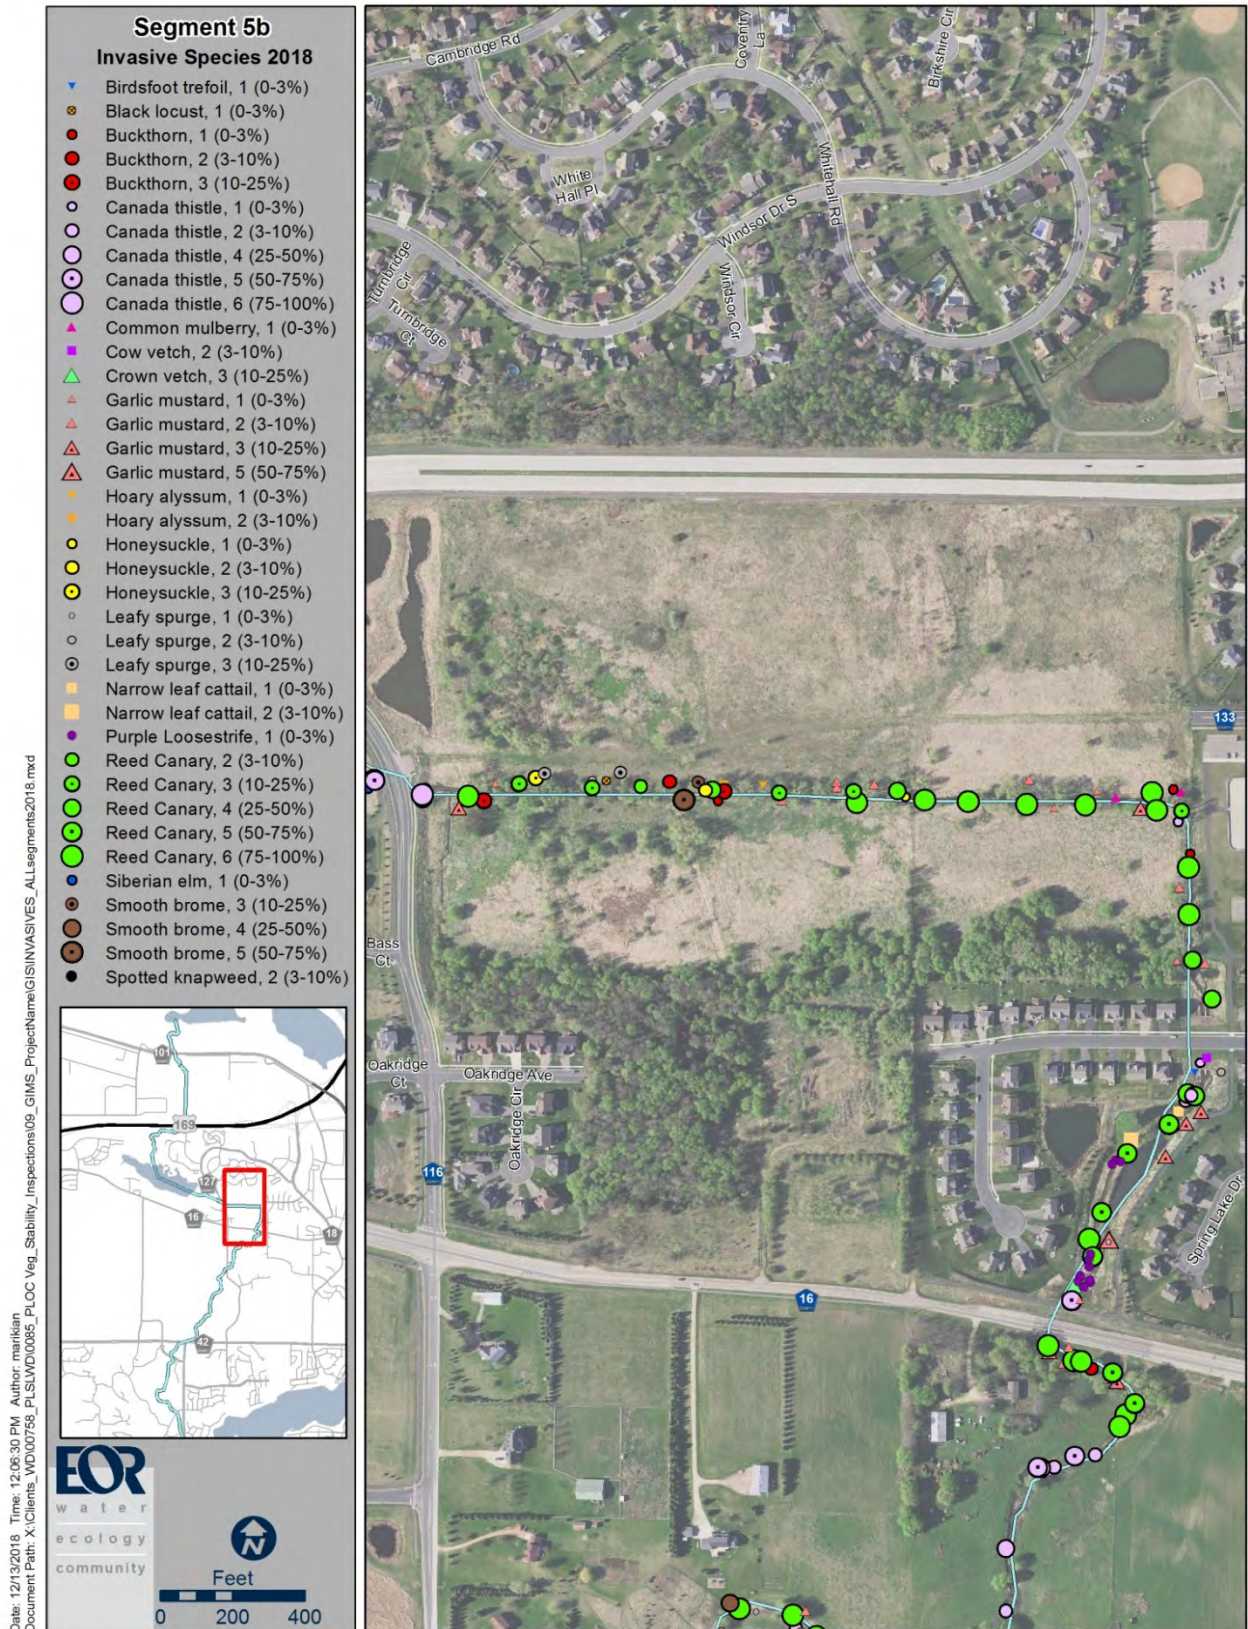
Figure 23. Invasive species and associated areal coverages (in parenthesis) along Segment 5A

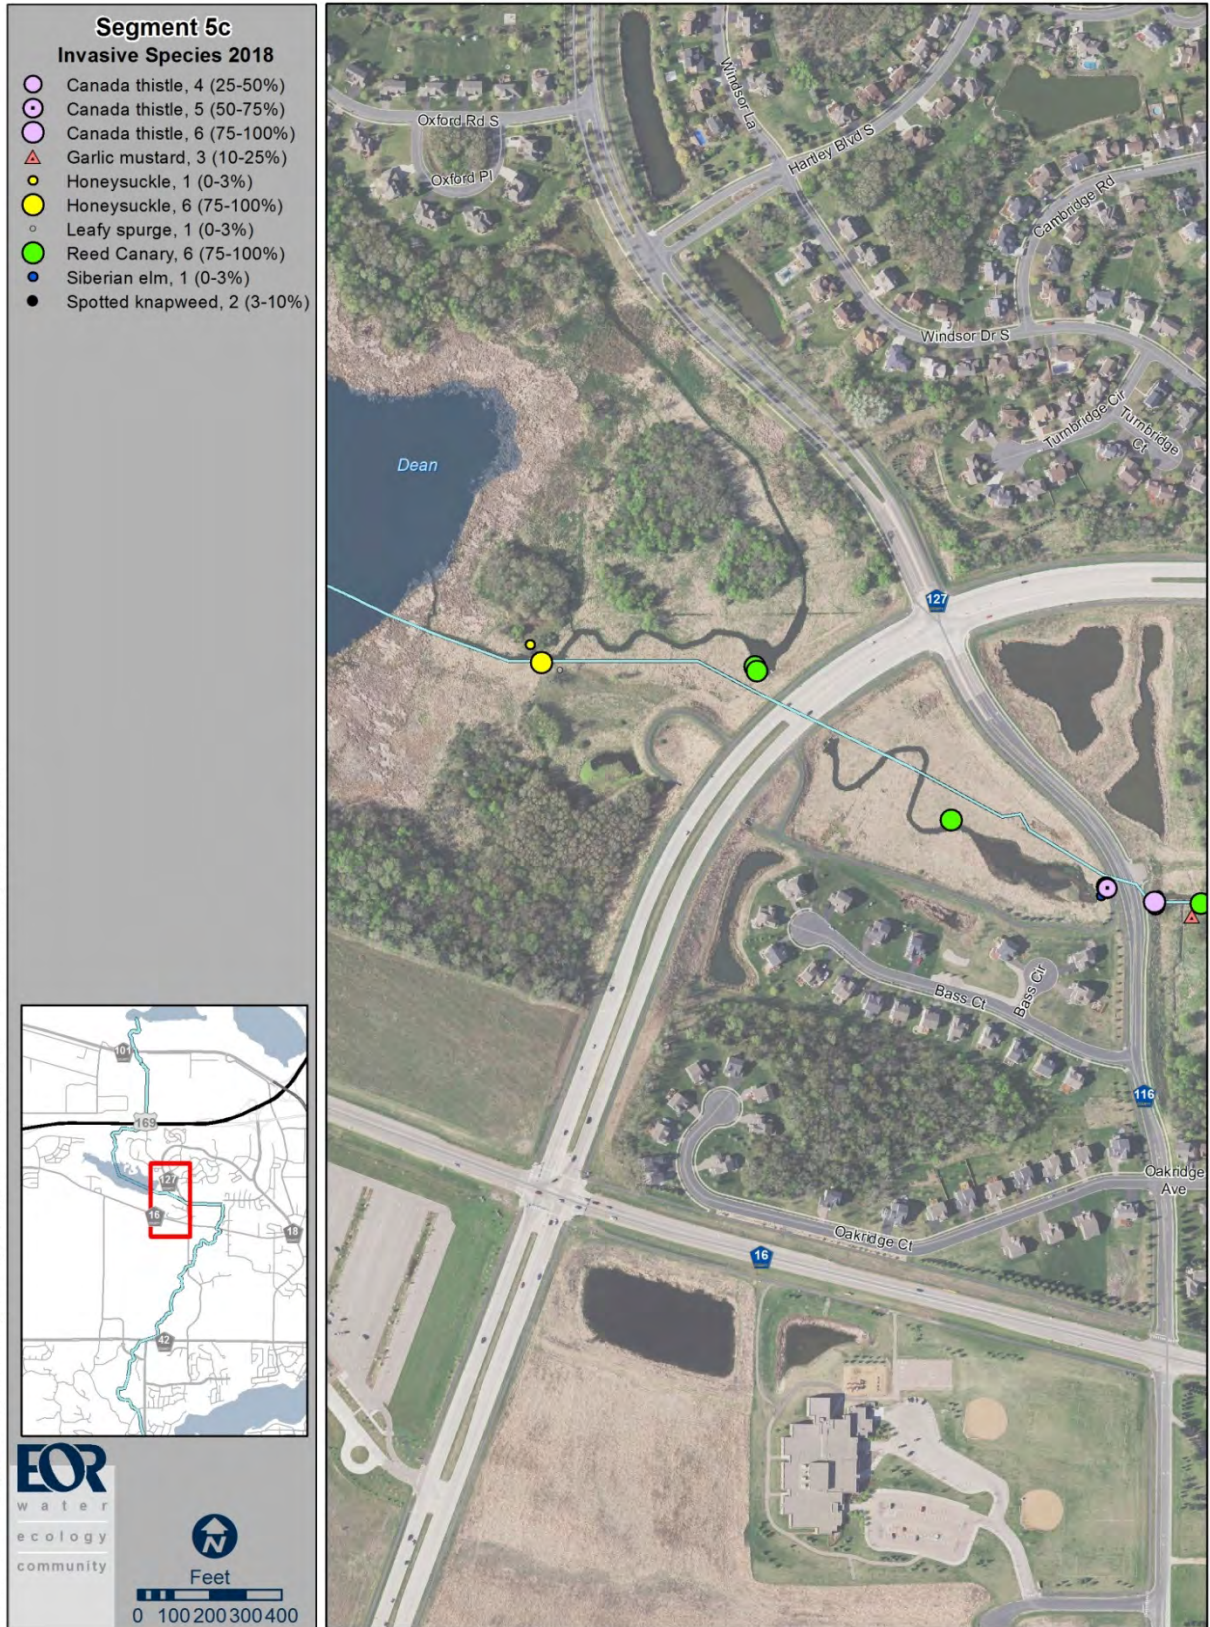
Figure 25. Invasive species and associated areal coverages (in parenthesis) along Segment 5C and Segment 6

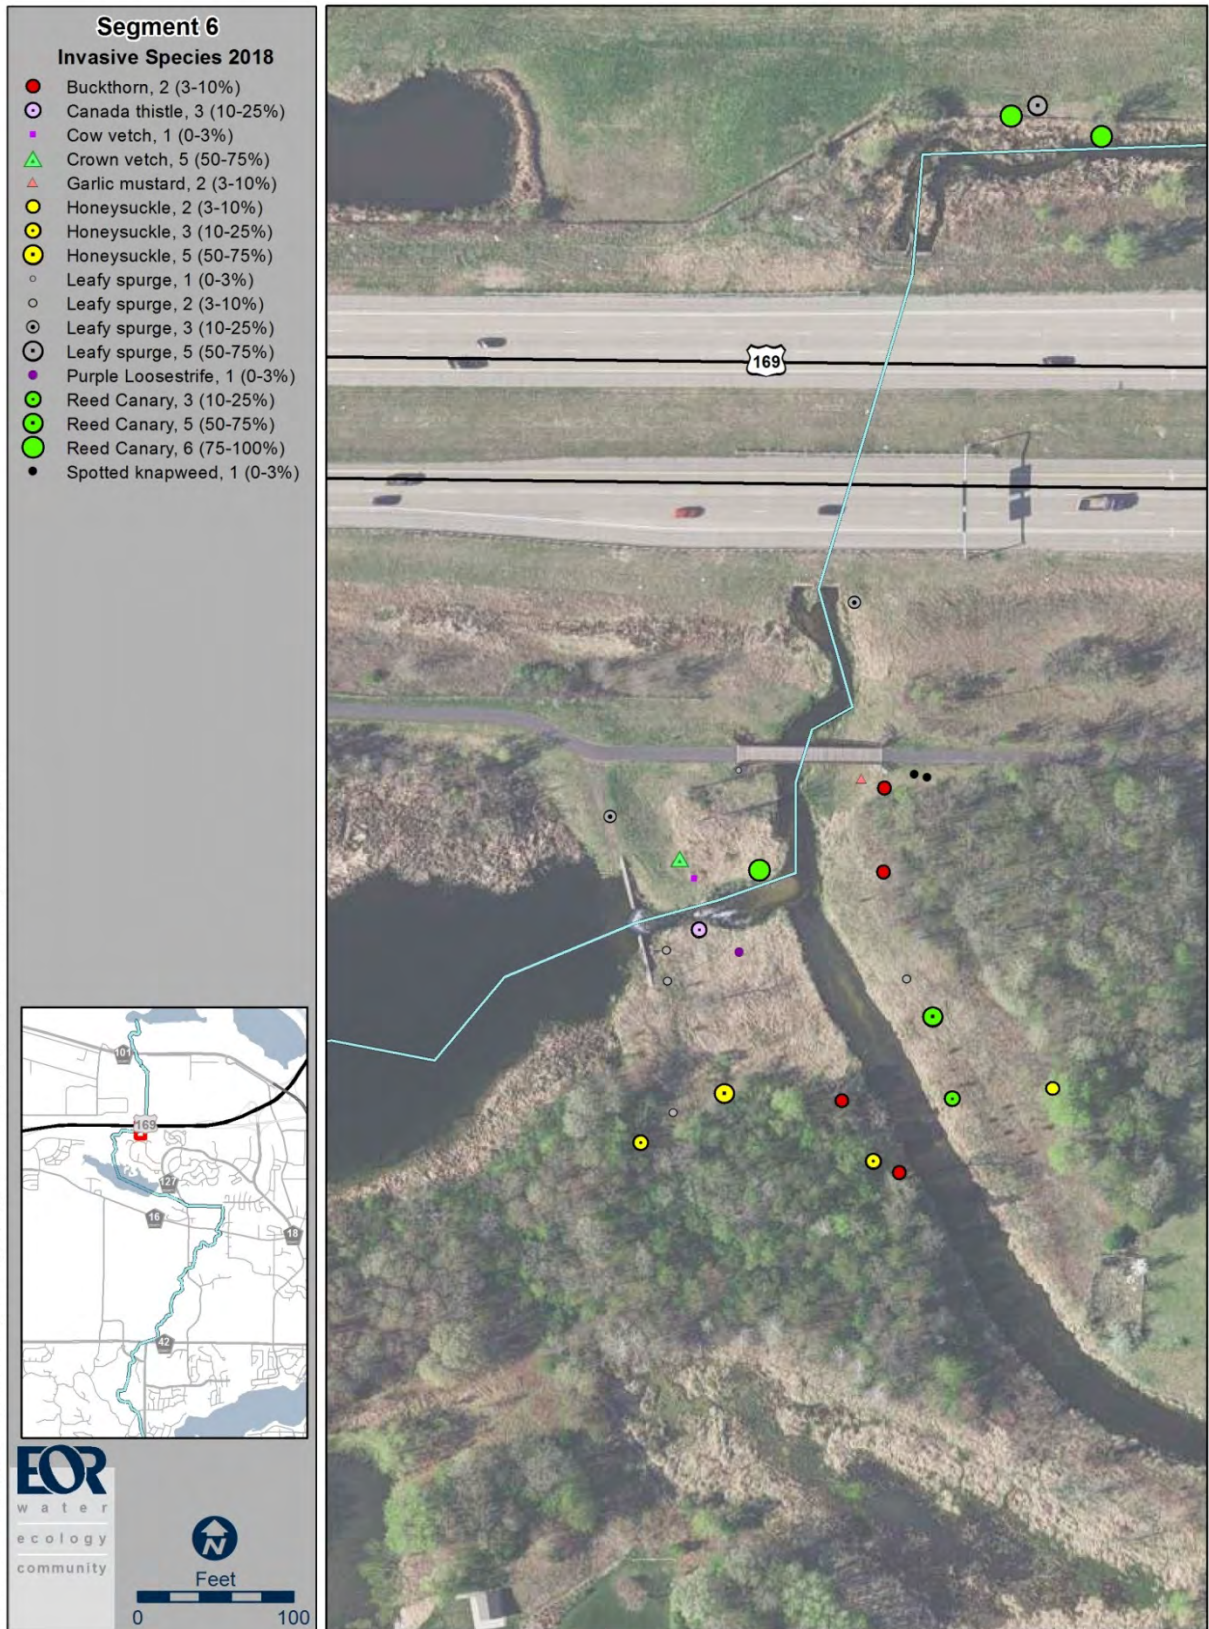
A small sediment delta has formed immediately downstream of the County Road 21 box culverts and is affecting flow through the bypass channel, particularly during low flows (Figure 26). No other channel obstructions were found in this segment. The Deans Lake weir appears to be in good condition and was free of debris at the time of the inspection. The channel banks throughout this segment are well vegetated and show little evidence of bank erosion (Figure 27, Figure 28).

Figure 28. Vegetated stream banks upstream of Highway 169

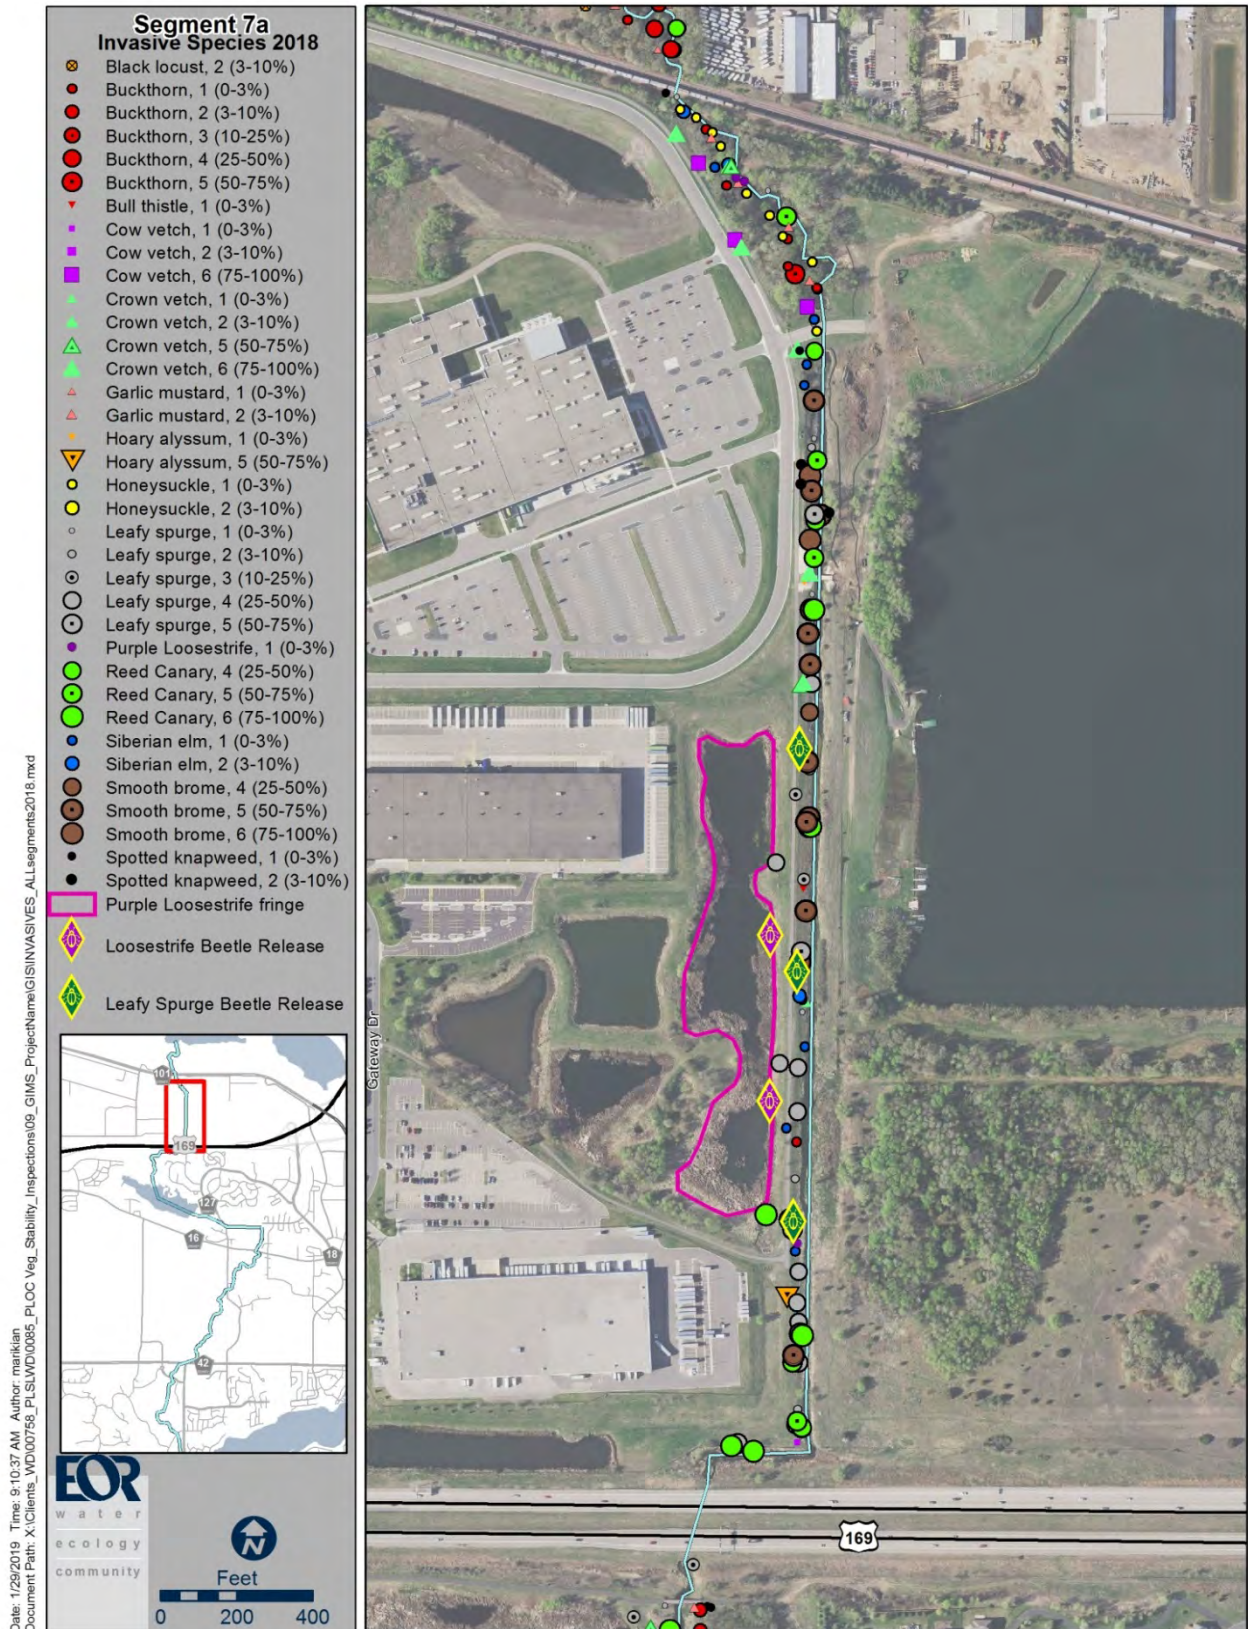
The channel banks between Highway 169 and the Quarry Lake Park crossing are well vegetated and show little evidence of bank erosion (Figure 30). The sheet pile weirs located in this segment are still operational and mostly free of debris. No channel obstructions were found within this segment; however, bank erosion continues to occur in areas damaged by previous flood events, particularly at the far downstream end of Segment 7A (Figure 31). Woody debris still occurs within the channel in Segment 7B, and the large oak tree that had fallen into the channel in 2016 is still partially obstructing flow (Figure 32). Bank erosion in Segment 7B continues to occur in areas previously damaged by flood events. Several trees growing on the channel banks have undercut root boles and will likely fall into the channel if the banks are not restored (Figure 33). In particular, a large bur oak tree located on an outside meander is being threatened by an active bank undercut. Bank toe restoration and a flow deflector would help protect this tree from falling into the channel. At the far downstream end of Segment 7B where the Metropolitan Council Environmental Services interceptor work was completed in the summer of 2017, the channel banks appear to be stable and vegetation has become established (Figure 34).

Figure 34. Vegetated stream banks at the downstream end of Segment 7B where MCES interceptor work was completed in 2017
