Project Name | PLOC Channel Inspections**Date** | 2/15/2019**To / Contact info** | Diane Lynch, Jaime Rockney**Cc / Contact info** | Carl Almer**From / Contact info** | Mike Majeski**Regarding** | Channel and Vegetation Inspections – 2018 Summary

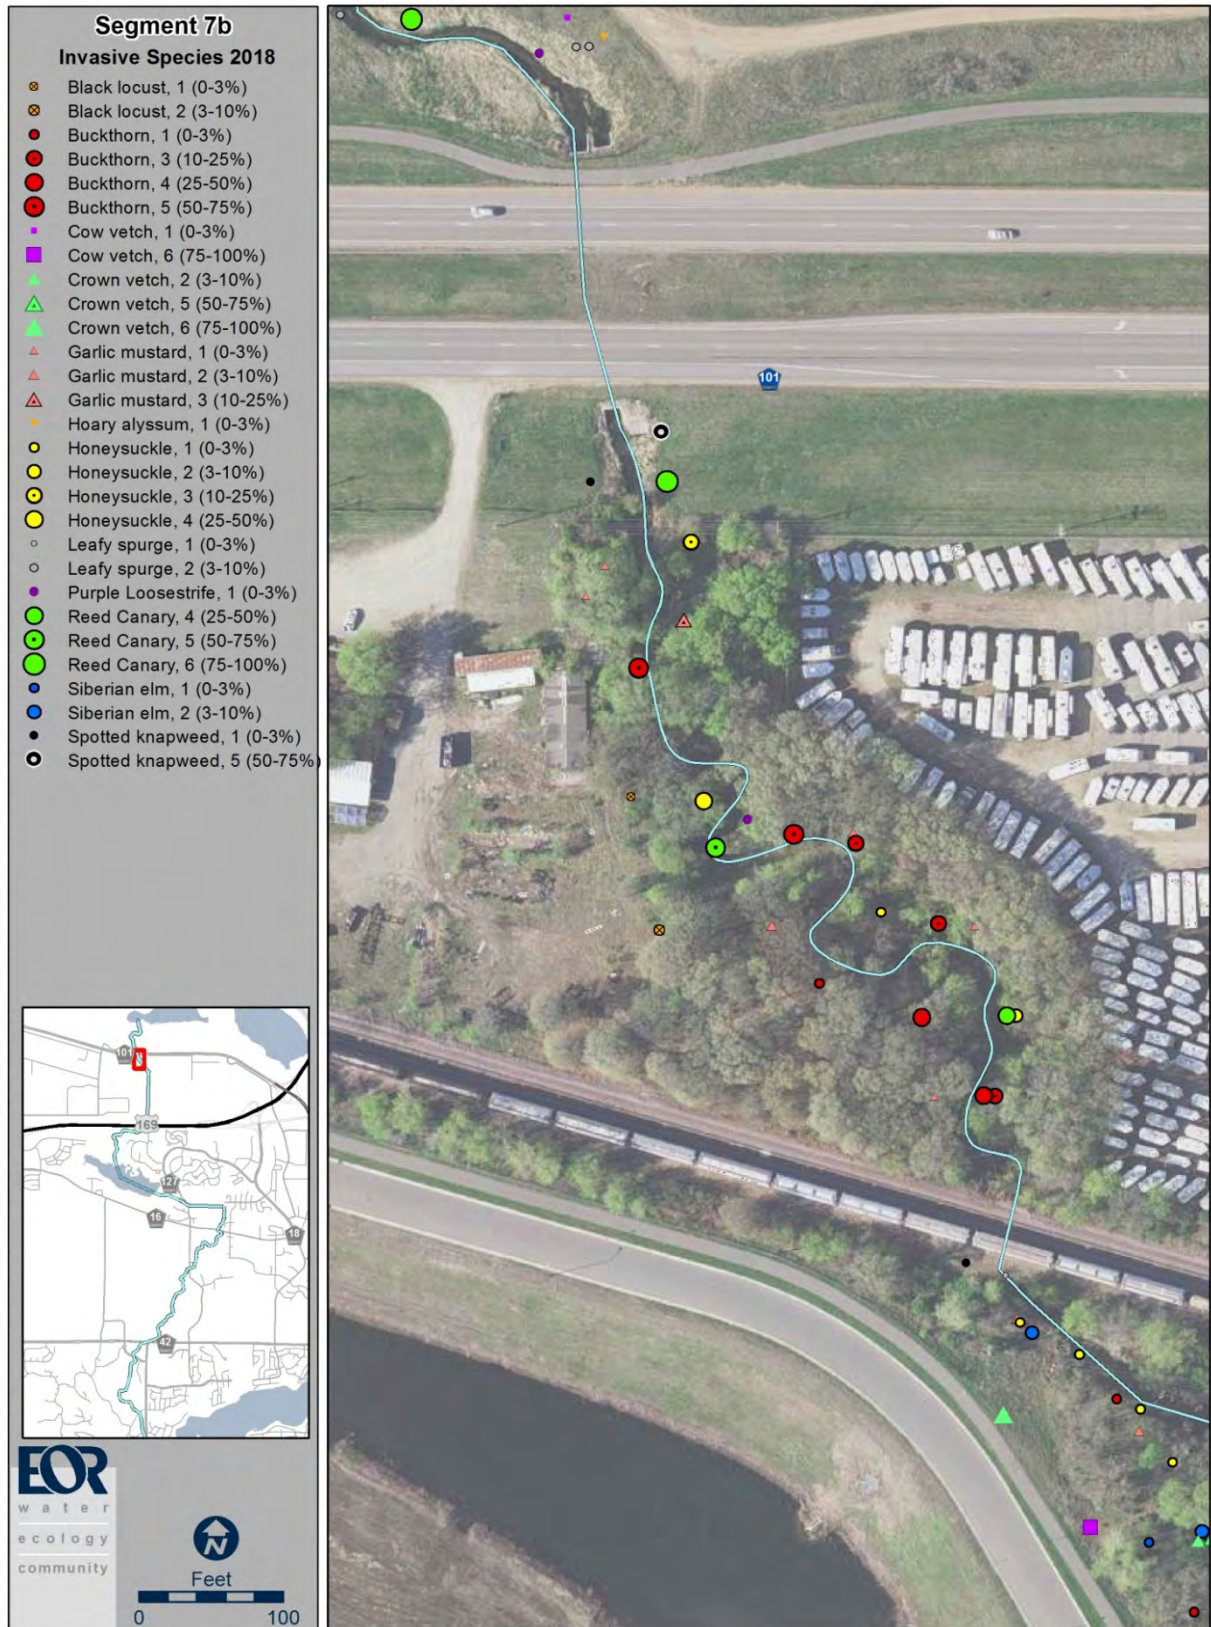
The proliferation of the invasive species crown vetch (*Coronilla varia*) that was documented in 2016 is continuing to spread along the segment. Extensive populations occur along Innovation Road and the Quarry Lake Park crossing. Common buckthorn and bush honeysuckle saplings were located in areas previously managed and treated by AES. Continued foliar spray treatments will be needed to reduce the population of the saplings in this segment. Figure 35 and Figure 36 show the locations and areal coverages of previously identified invasive species in this segment.

Figure 35. Invasive species and associated areal coverages (in parenthesis) along Segment 7A
