2020 PRIOR LAKE OUTLET SYSTEM ANNUAL OPERATIONS REPORT

PRIOR LAKE-SPRING LAKE
WATERSHED DISTRICT

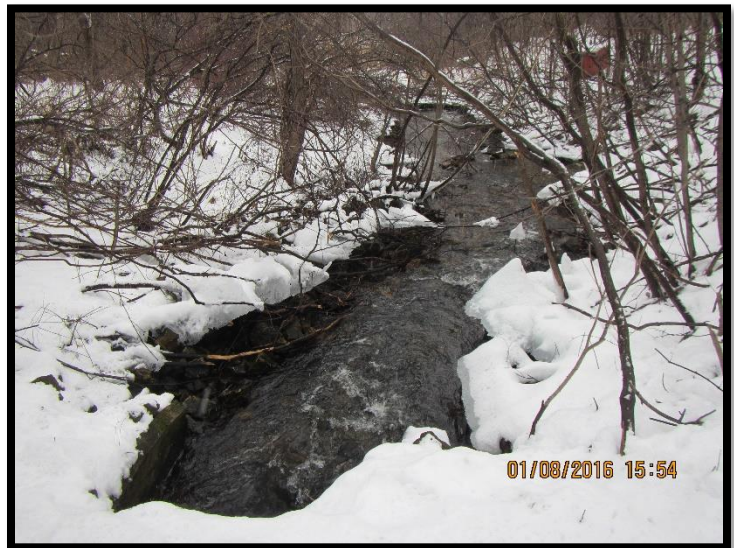
FIGURE 4 THE “DAYLIGHT”: BEGINNING OF THE OUTLET CHANNEL

The Outlet Pipe leads from the Outlet Structure to the beginning, or “daylight,” of the outlet channel (Figure 4). It is buried underground for approximately 2075 feet, with 5 manholes and 7 access points (Figure 5).

In 2020, American Environmental televised the pipe revealing the lake outlet pipe is in good to fair condition, but multiple cracks and fractures were found in some segments. Several options will be weighed to decide the best course of action. Some of these options include sealing the joints that fail pressure tests, lining the pipe, a combination of those two, or pipe bursting.

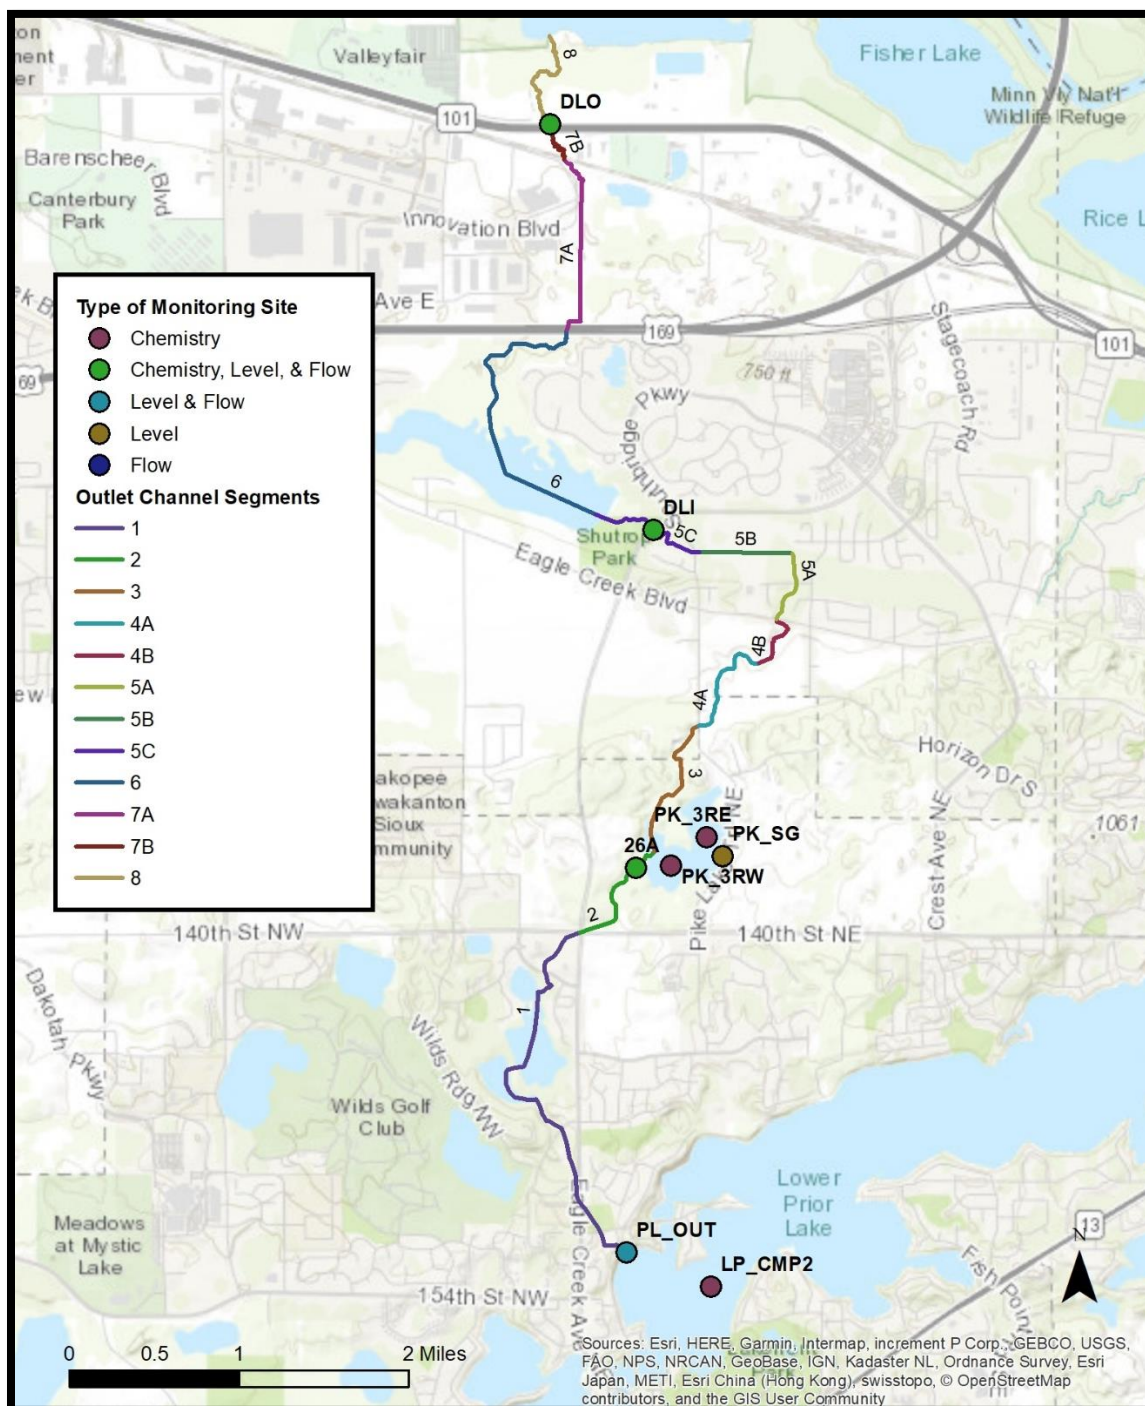
FIGURE 7 – PLOC MONITORING LOCATIONS

Monitoring along the outlet channel in 2020 consisted of water quantity (flow), water quality (chemistry), vegetation surveys, and erosion monitoring (Figure 8). Some of this monitoring is funded by the MOA cooperators, and some is done for other programs or entities.
