Project Name | PLOC Channel & Vegetation Inspections**Date** | 12/30/2021**To / Contact info** | Jaime Rockney, Water Resources Project Manager**Cc / Contact info** | Carl Almer**From / Contact info** | Mike Majeski**Regarding** | Channel and Vegetation Inspections – 2021 Summary

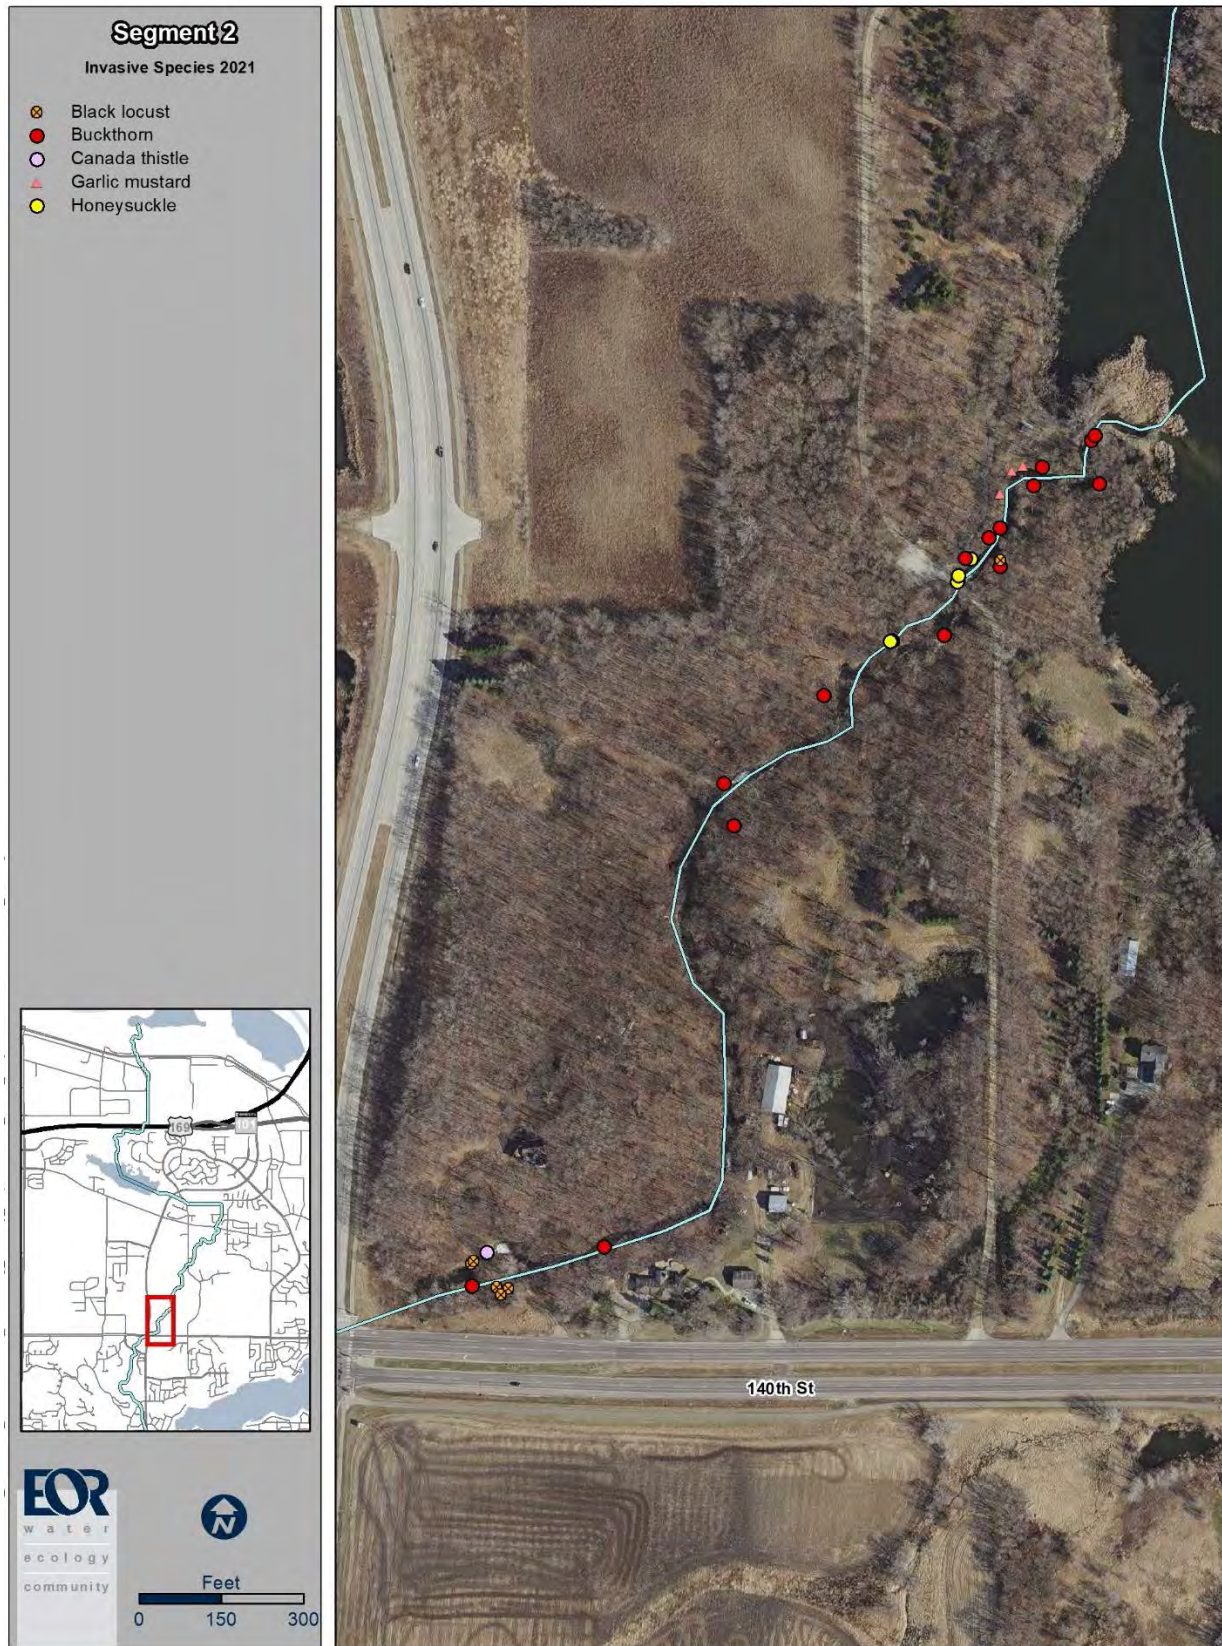
Figure 15. Target invasive species along Segment 2

No new invasive species were found. Figure 15 shows the locations of target invasive species identified in this segment.

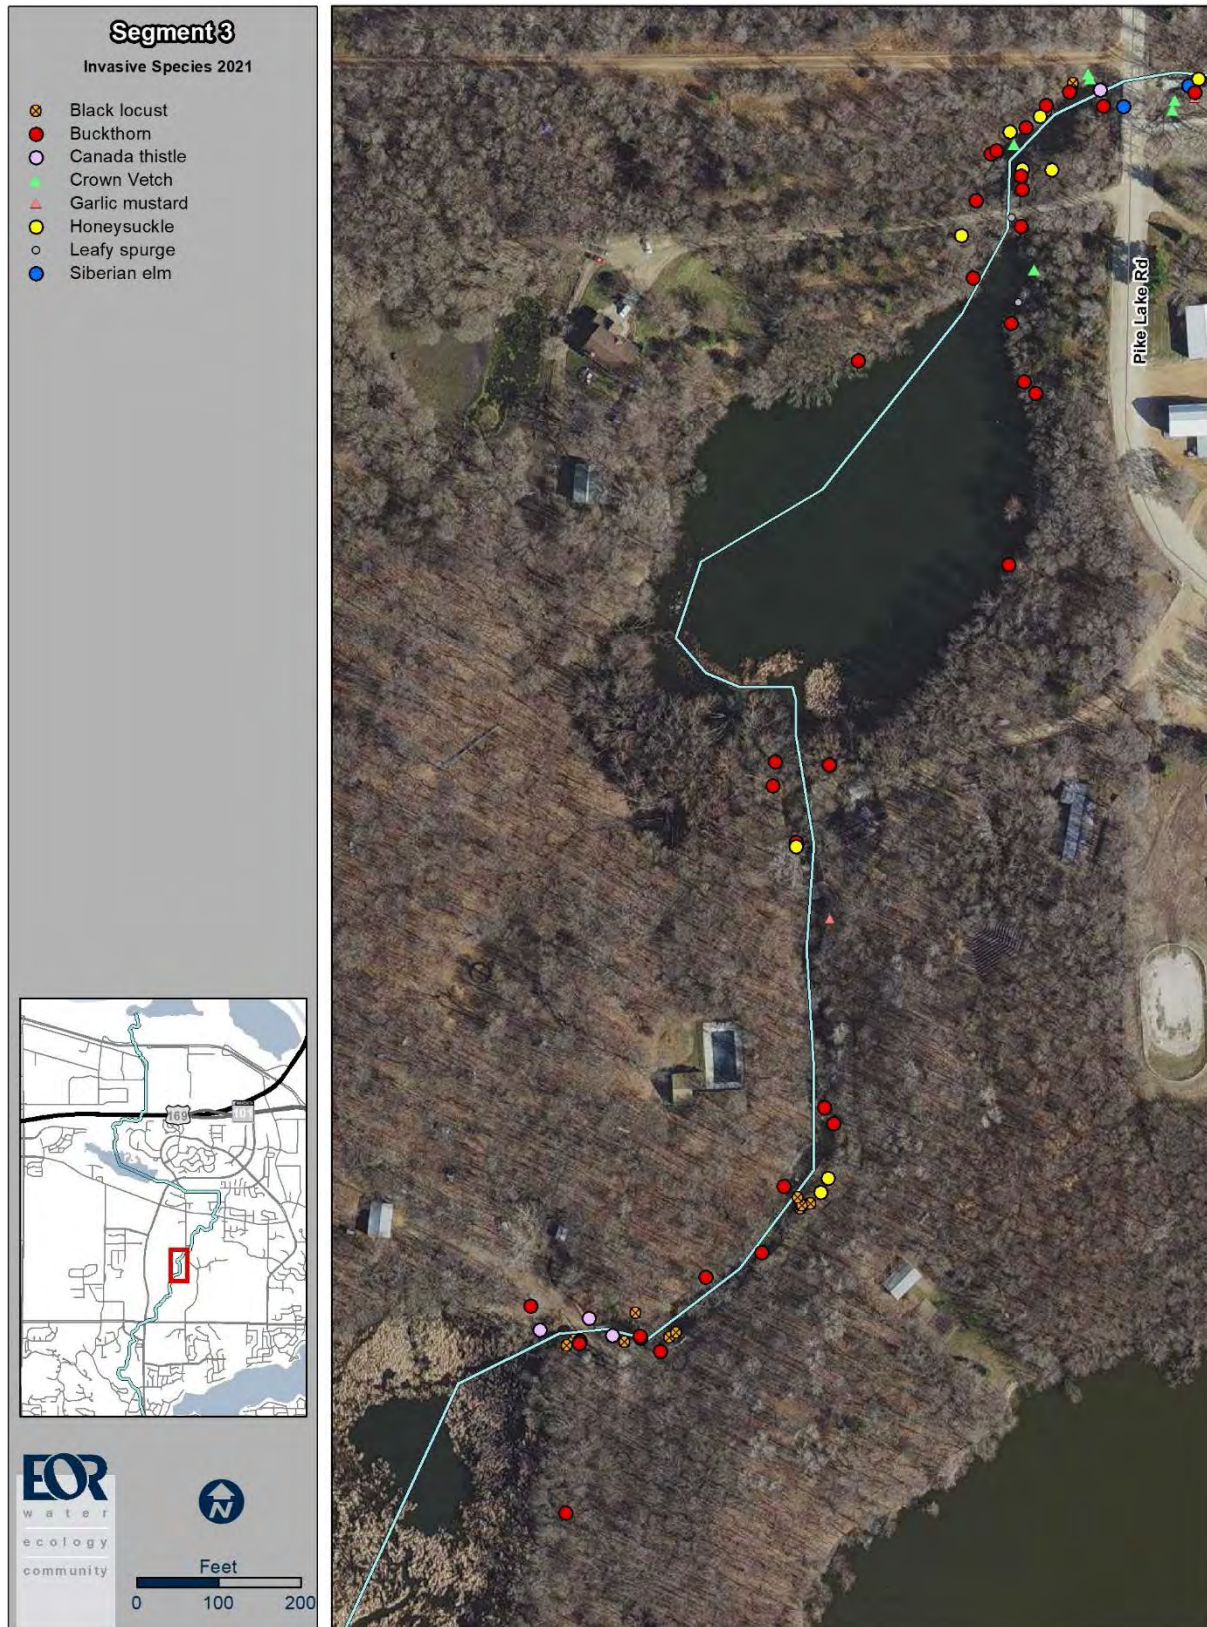
Figure 23. Target invasive species along Segment 3

No new invasive species were found in this segment. Black locust, common buckthorn (*Rhamnus cathartica*) and bush honeysuckle (*Lonicera spp.*) saplings were observed in areas previously managed. Continued management will be needed to reduce the population of woody invasive species in this segment. Figure 23 shows the locations of target invasive species identified in this segment.

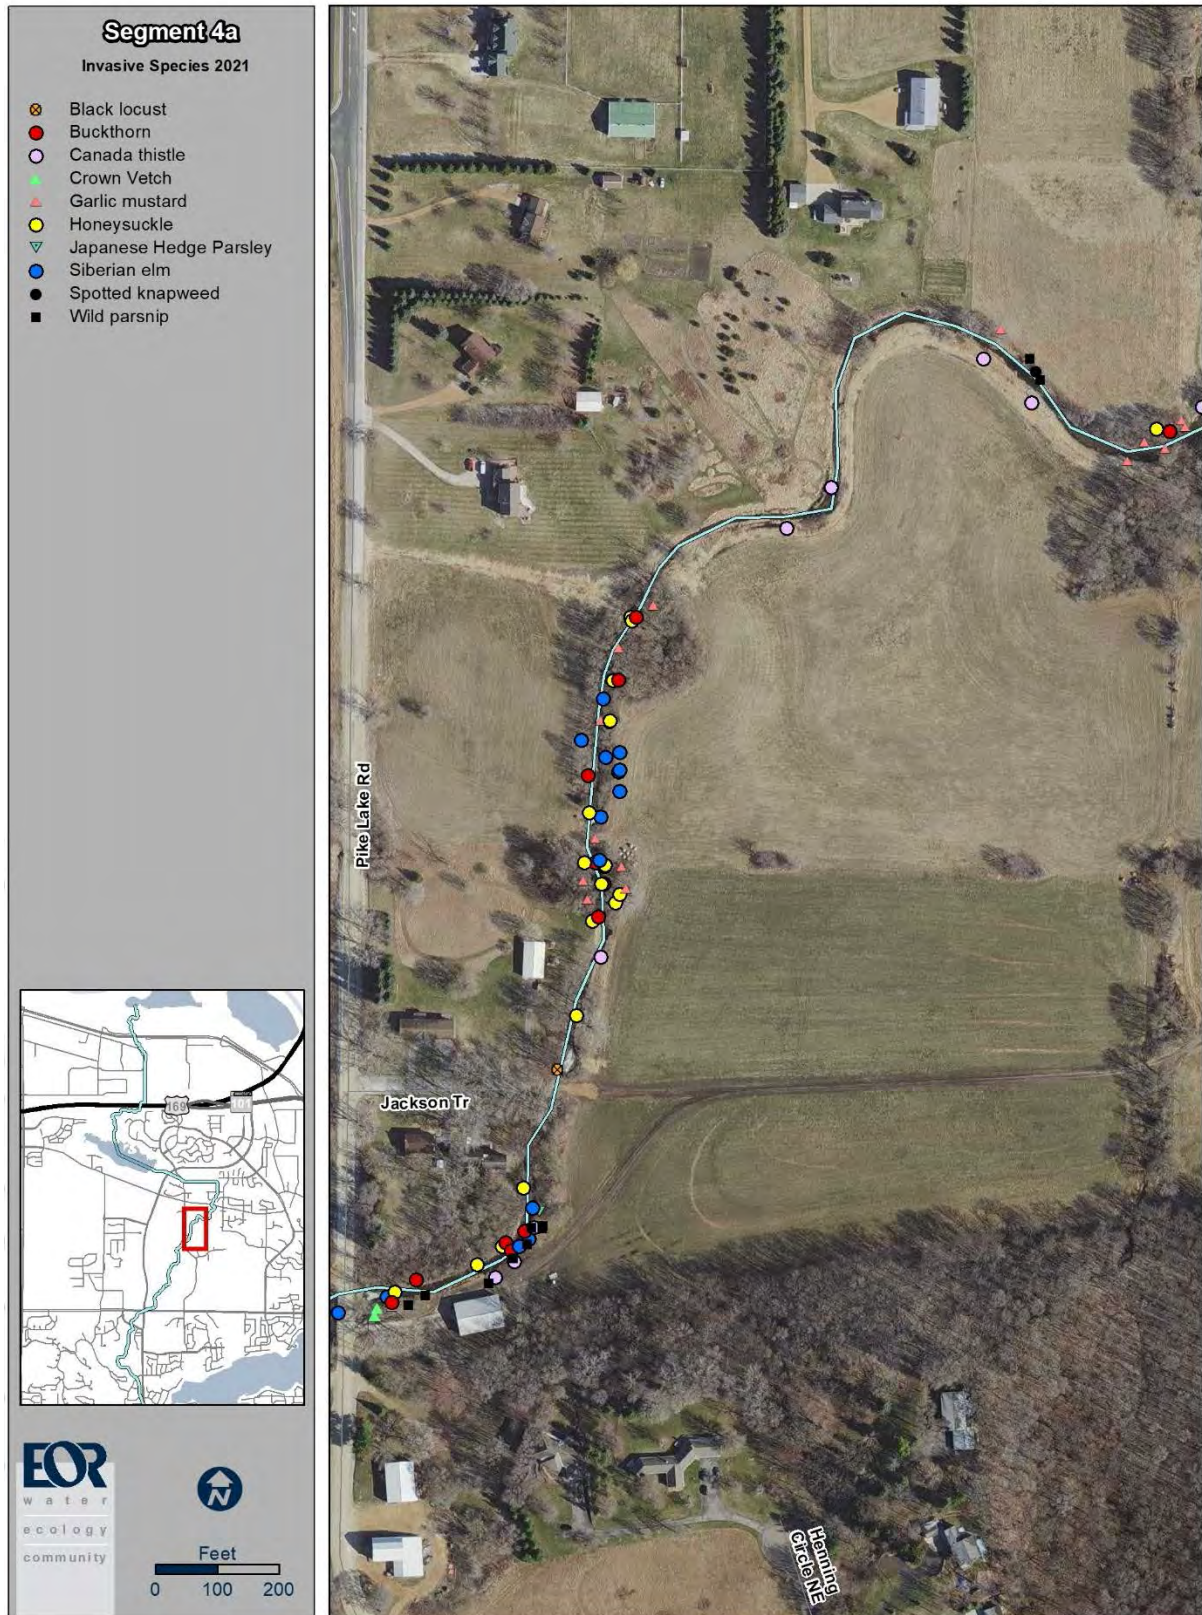
Figure 32. Target invasive species along Segment 4A

During the May and August vegetation inspections, several wild parsnip basal rosettes were found at the upstream end of Segment 4A. In addition, several patches of garlic mustard continue to persist in areas where it was previously managed. Reconnaissance for purple loosestrife was conducted in August and no plants were found. Monitoring and treatment for wild parsnip, garlic mustard, Japanese hedge parsley, and purple loosestrife should continue in 2022 to limit the spread of these species. Any new plants found should be dug up or treated with herbicide with follow-up inspections and treatments conducted in early July to prevent the plants from maturing and producing seed. Woody invasive species including Siberian elm (*Ulmus pumila*), common buckthorn, and bush honeysuckles should be scouted and treated in the fall of 2022. With the new residential development currently under construction between the Gonyea culvert and County Road 16, scouting for satellite populations of invasives is recommended to prevent establishment of new invasives along the outlet channel. Figure 32 and Figure 33 show the locations of target invasive species identified in this segment.

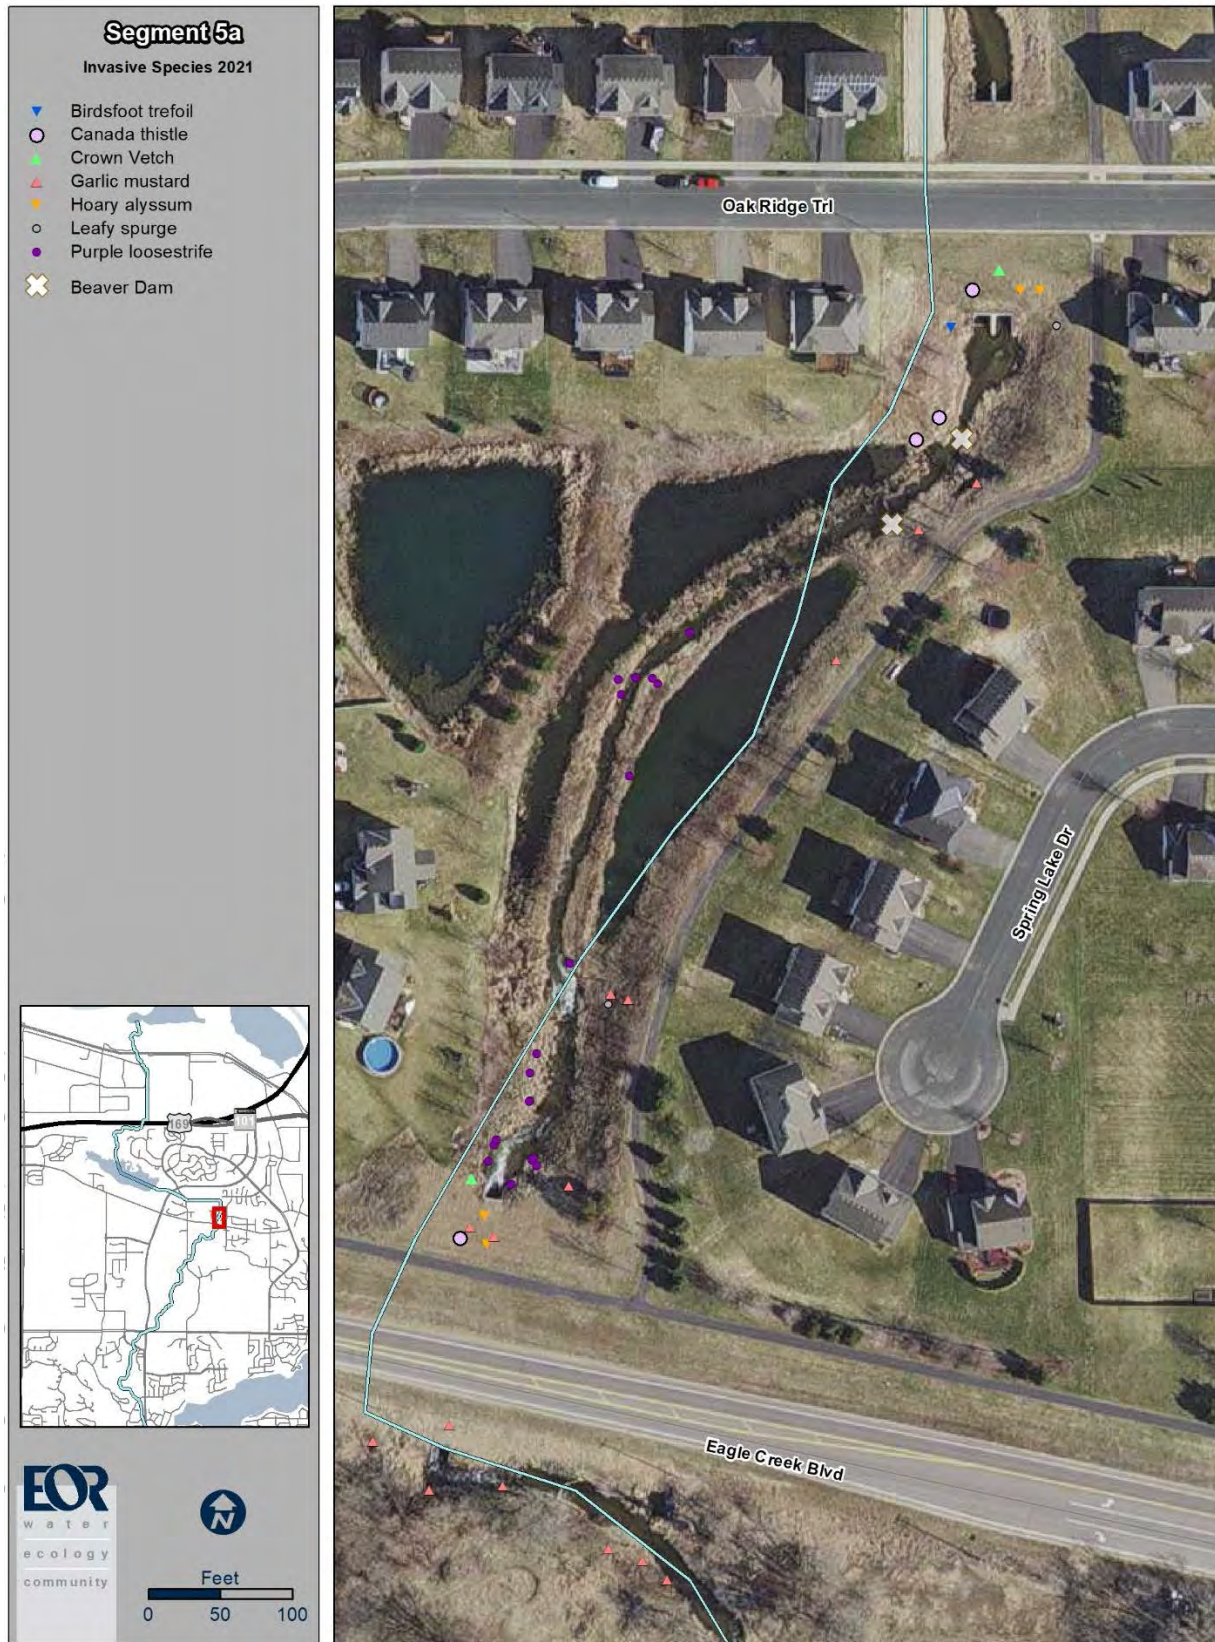
New locations of purple loosestrife were discovered in Segment 5A downstream of the County Road 16 box culverts. In addition, several purple loosestrife plants were found within the wetland adjacent to the sediment pond in Segment 5C and in the stormwater pond to the northeast of Pike Lake Road. The stormwater pond is outside the easement of the PLOC; therefore, coordination with the City of Shakopee is recommended to manage this population since the pond occurs in close proximity to the PLOC. The small patch of invasive common reed (*Phragmites australis*) documented in 2020 in the west stormwater pond of Segment 5A did not have any new growth in 2021. RES treated this patch in the summer of 2020 and it appears the treatment was effective. The wetland areas within Segment 5A should be monitored closely again in the summer of 2022 and any new plants should be promptly treated or removed before seeds develop. Purple loosestrife and phragmites management in this segment is particularly important since the site is located just upstream of Deans Lake which contains a large wetland complex vulnerable to loosestrife and phragmites invasion. Figure 40 and Figure 41 show the locations of target invasive species identified in this segment.

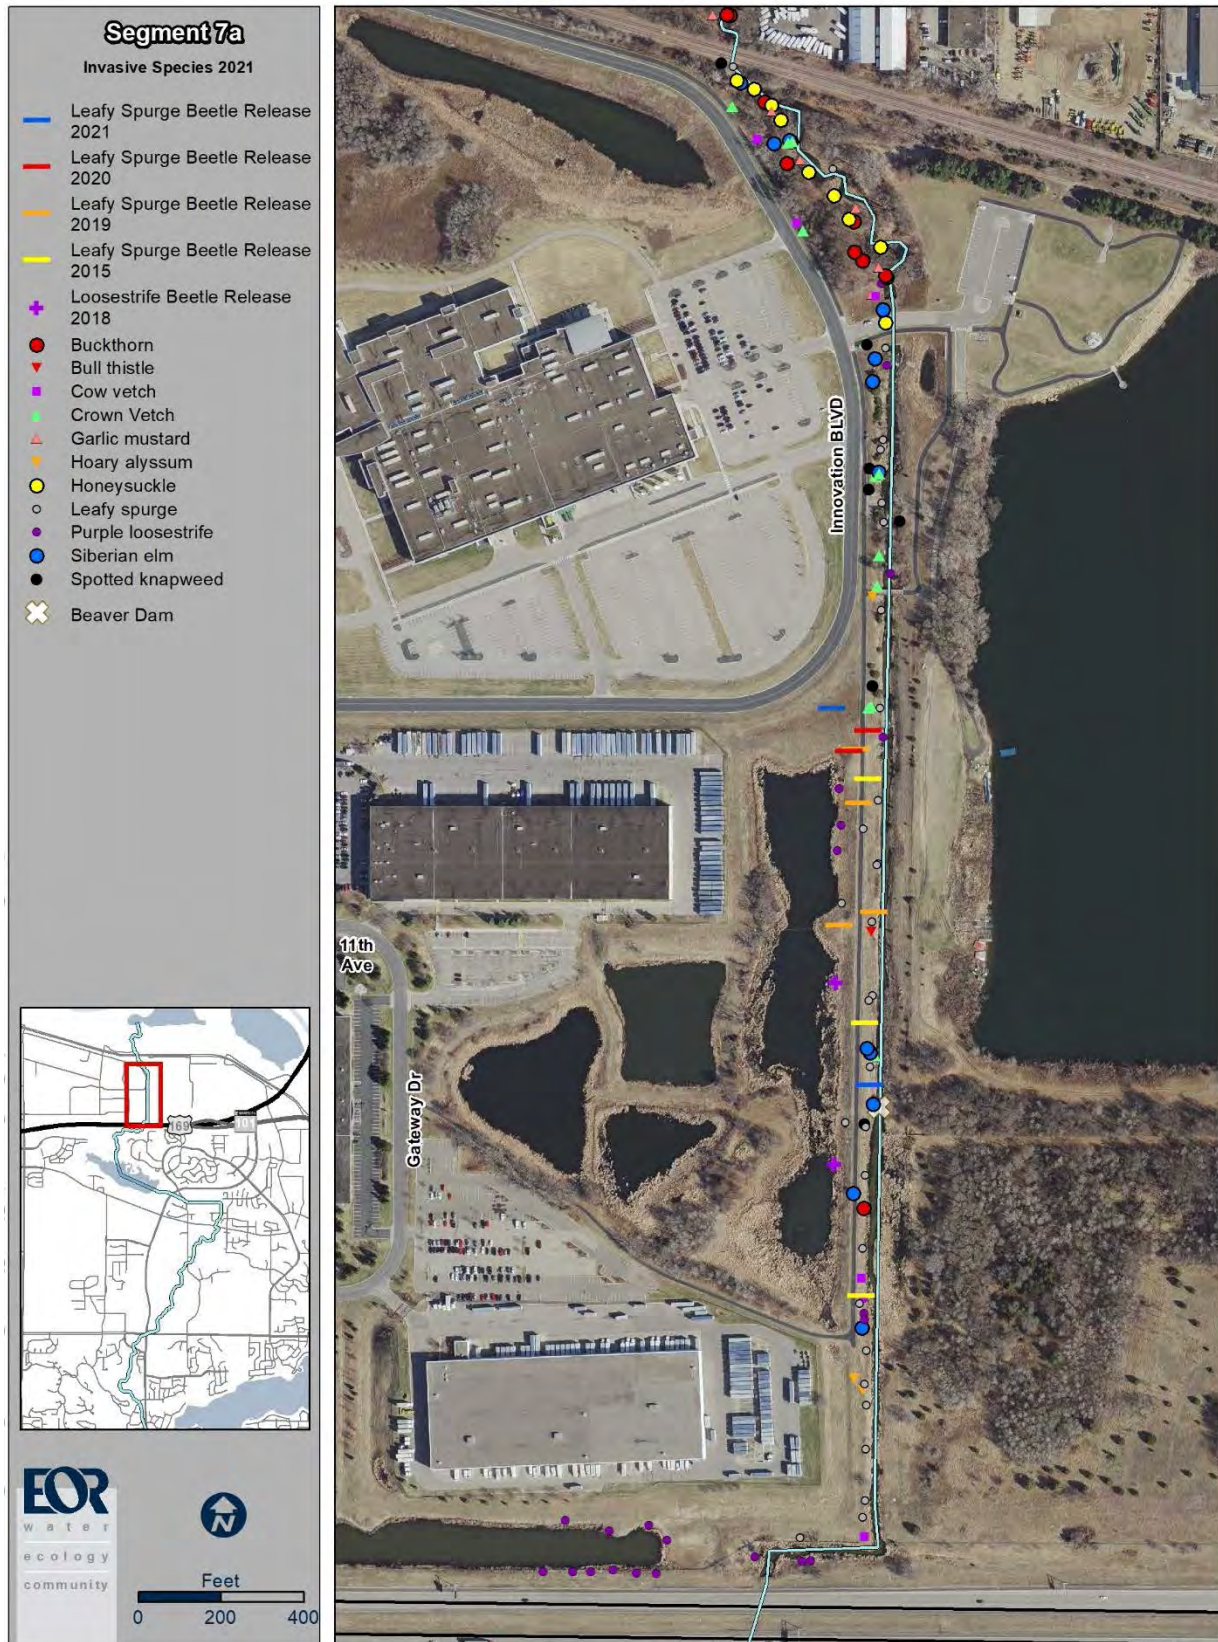
Figure 52. Target invasive species along Segment 7A

On July 1, EOR staff collected several hundred leafy spurge flea beetles from a population discovered west of the intersection of Valley Park Drive and Innovation Blvd. Most of the flea beetles collected were *Aphthona lacertosa*, but some *Aphthona nigriscutis* beetles were also collected. The beetles were released at two separate locations to support previous beetle release efforts in the area (Figure 52).

Monitoring and treatment of garlic mustard, common buckthorn, bush honeysuckle, and other invasives should continue within the wooded areas now that the streambank stabilization project has been completed. Managing for an open canopy along the channel will allow for greater establishment of herbaceous vegetation and promote further self-healing of the stream banks. Figure 52 and Figure 53 show the locations of target invasive species identified in this segment.

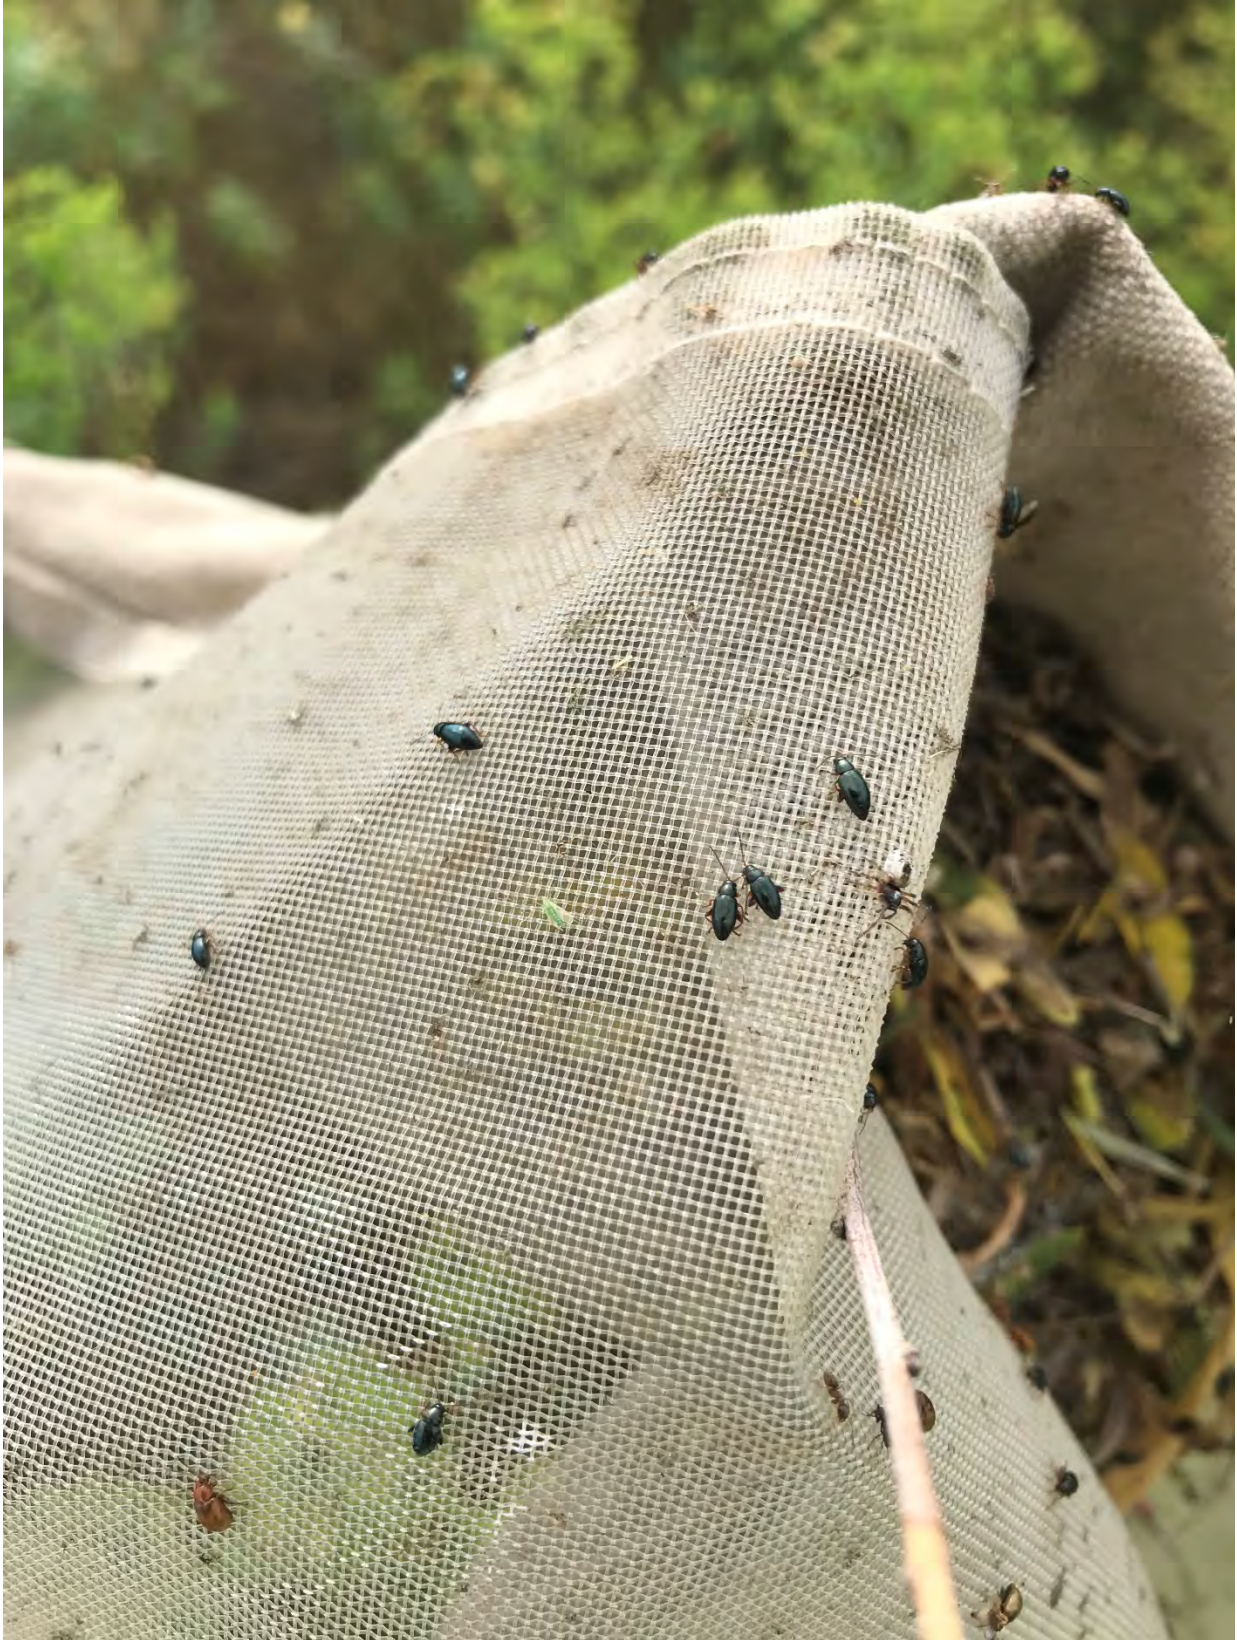
Figure 54. Leafy spurge flea beetles collected and released in Segment 7A in 2021. Most of the beetles were *Aphthona lacertosa* (black beetles) but some *Aphthona nigriscutis* (brown beetles) were also collected
